FACILITY ASSESSMENT REPORT
FOR

Swimming Pool
and
Bathhouse
at
Horowitz Pool at Henry Park

**Horowitz Pool and Bathhouse
Henry Park
Vernon, Connecticut**

**Structural Condition Assessment
Survey and Report**

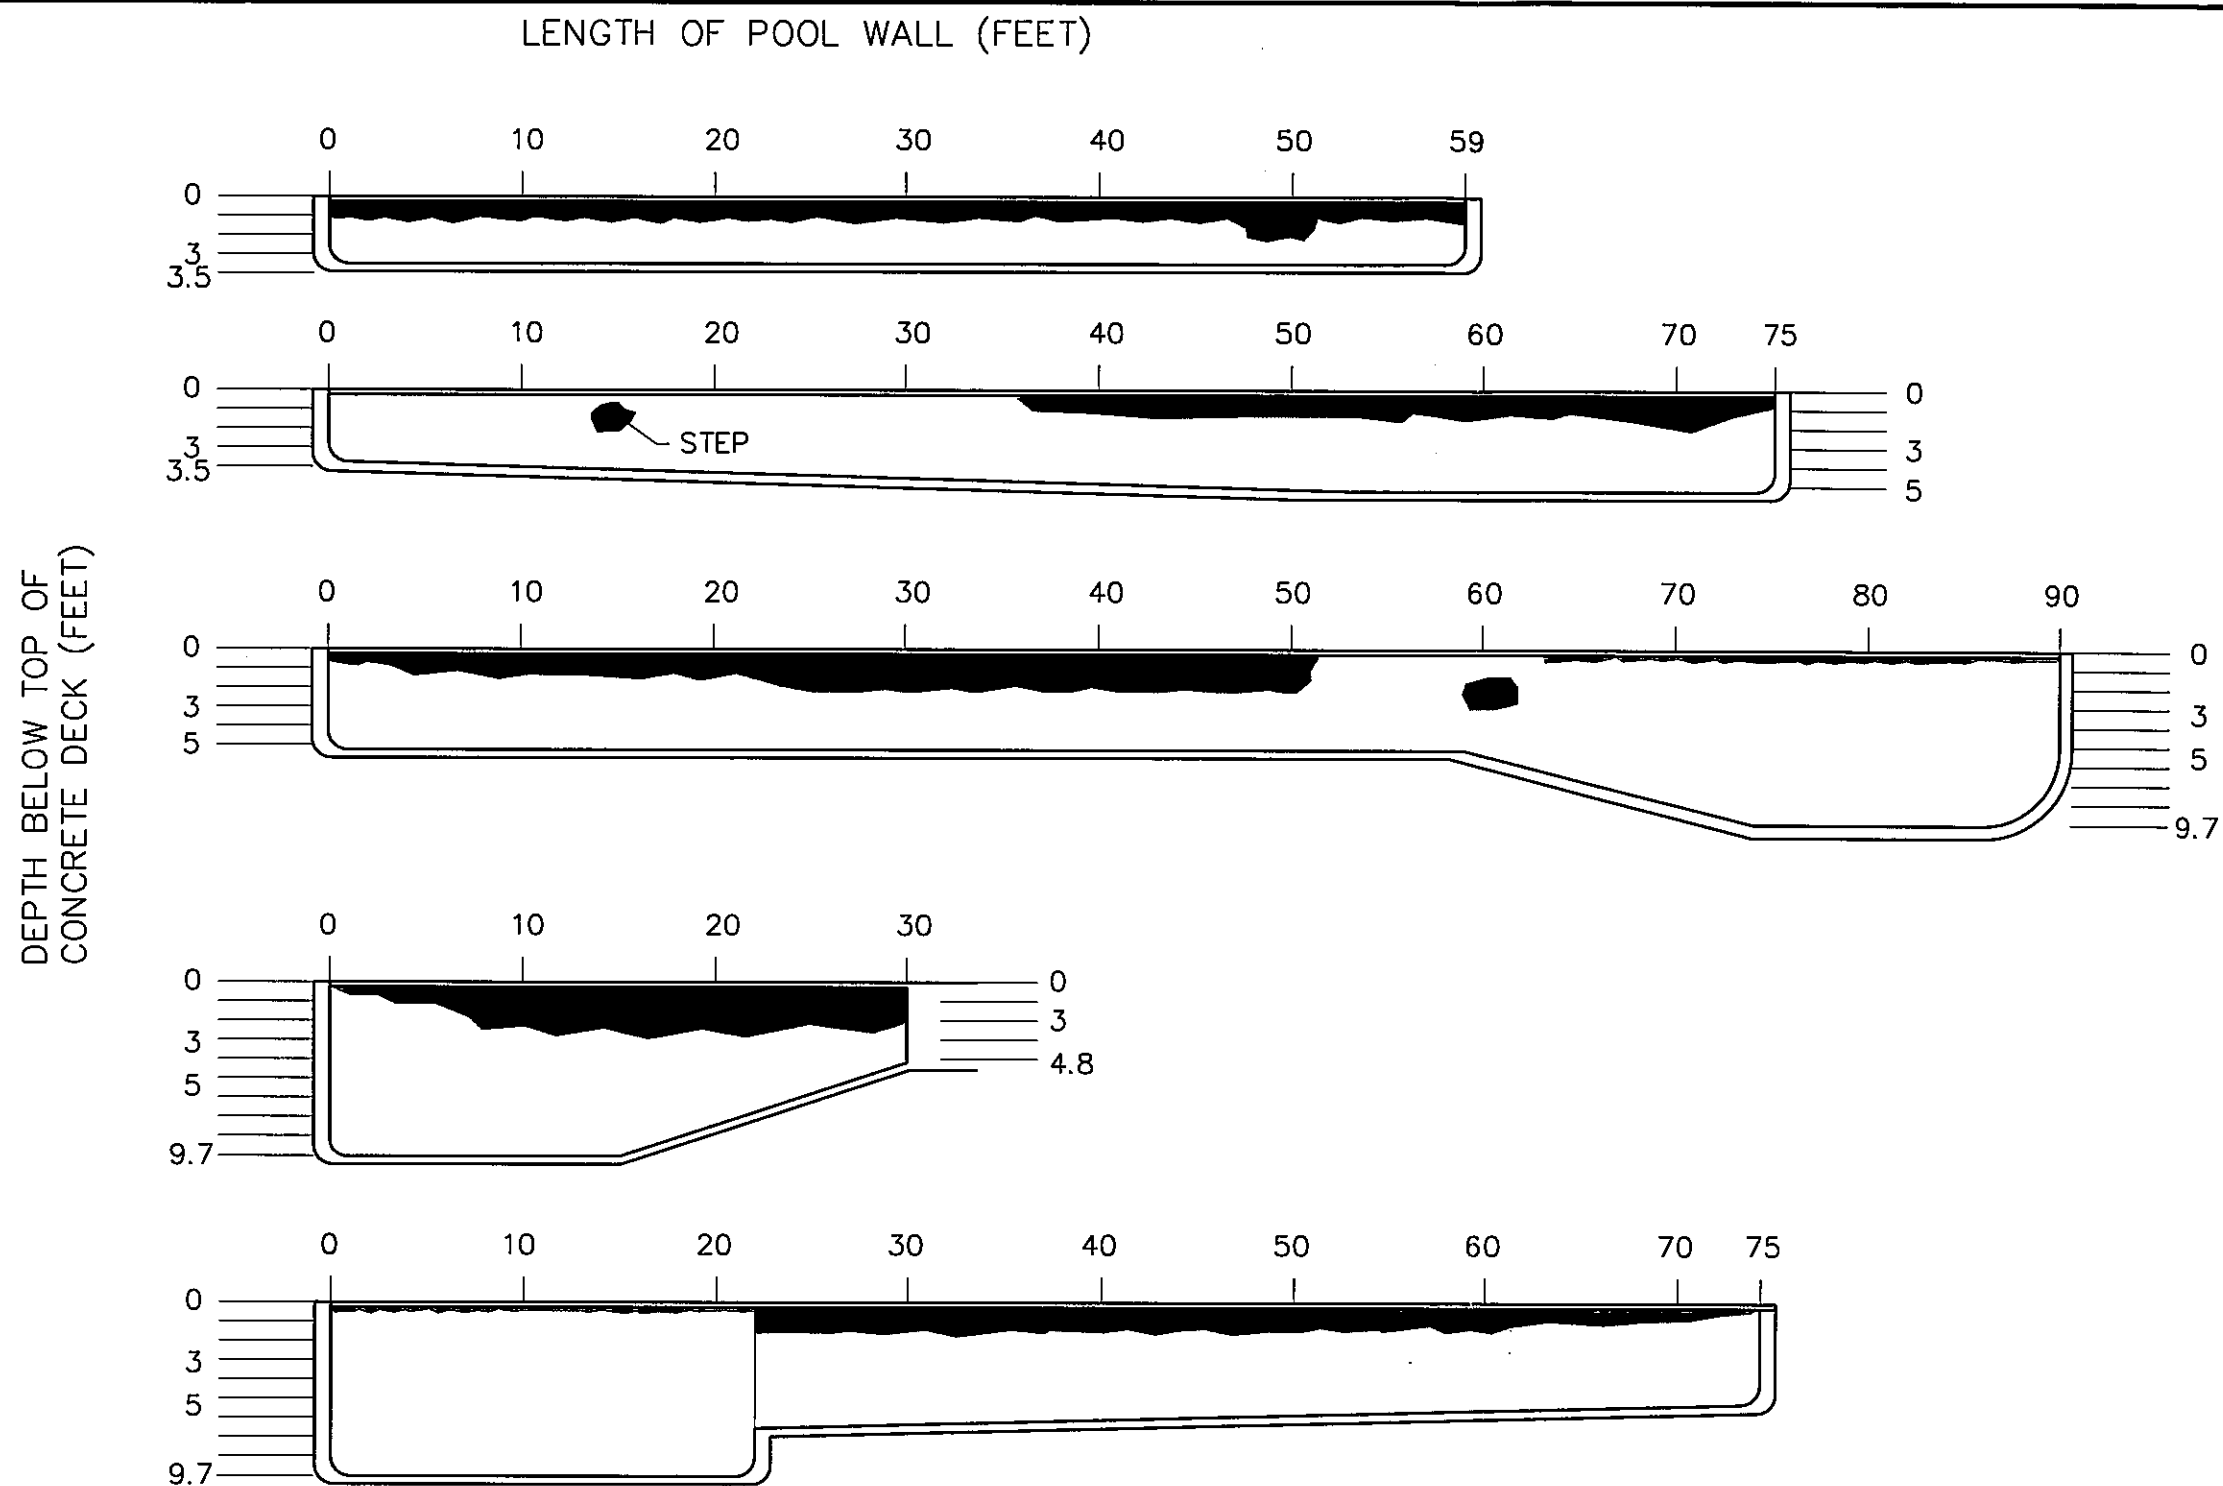
RESULTS OF
WALL SOUNDINGS
HOROWITZ POOL
VERNON, CONNECTICUT
SCALE: 1 IN = 20 FT
OCTOBER 2006

Along the majority of the length of the west wall, at about 1 foot below the waterline, the concrete consistently sounded hollow. At 40 feet from the southwest corner, water was leaking out of the wall. At the northwest corner, the hollow sound dropped down to 2 feet for a 4 feet long section.

Along the north wall, there was a hollow pocket area at the inset stairs. The north wall sounded solid until approaching the pool mid-length where there was a water leak 8-inches down from the waterline. This is the beginning of the patched area noted above. From mid-length to the northeast corner, hollow sound was detected about 8 to 12-inches below the waterline.

Turning the corner to the east wall, the wall is patched and sounds hollow to a 12-inch depth below the waterline, extending about 30 feet. In the next 20-foot wall length, the central east wall portion, the wall rang hollow extending down about 2 feet. After that the hollow sound disappeared and the wall seemed to be in good condition. At the transition between the level 5 feet deep section to the 9.7-foot diving end, there is a pocket of hollow sound.

However, there are some areas of concern that should be evaluated to determine if corrections should be made, or if the present condition will be left. There are hollow sounding pockets that indicate delamination described in **Section VI** above. Water seems to be present behind the pool walls in some areas. We believe this is surface runoff that is not properly draining away from the pool, since groundwater is at, or below a depth of 10.9 feet.

- 1) Remove the concrete deck around the pool.
- 2) Cut away the top of the pool wall which shows signs of delamination. Removing 1'-0" of the top of the pool wall will address most of the areas that are suspect based upon the soundings.
- 3) Replace the top of the wall with new concrete and possibly a new gutter system.
- 4) Within the area of new concrete wall, replace the material behind the pool walls with a free draining sand and gravel, or

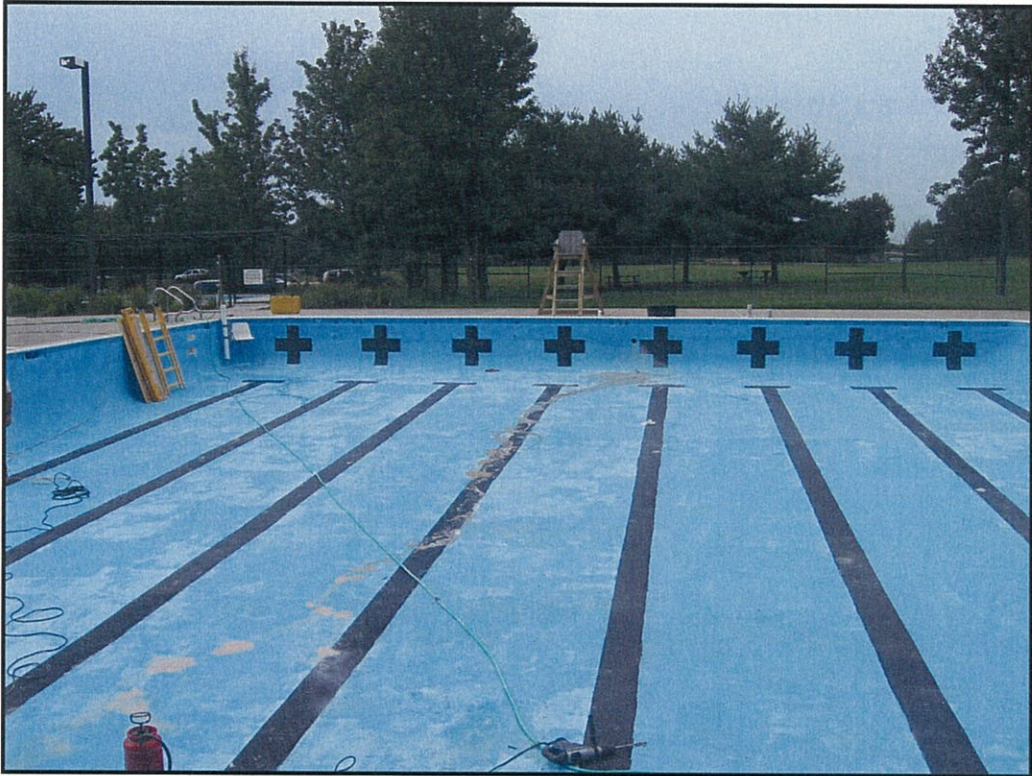
Photo P-3: Exposed Pool Walls and Floor

discuss general concerns and problems with the pool and made overall observation to visually investigate the pool walls and floor surface. **(See Photo P-3)**. Beginning at the shallow end of the pool at the southwest corner and advancing clockwise, the turquoise painted plaster surface appears to have been patched along half the north wall where paint was peeling. The walls appear to be in satisfactory condition for a pool constructed about 16 years ago. The walls are darker along the waterline and fade with depth to the floor. The floor is scuffed from use, particularly at either end of the swimming lanes.

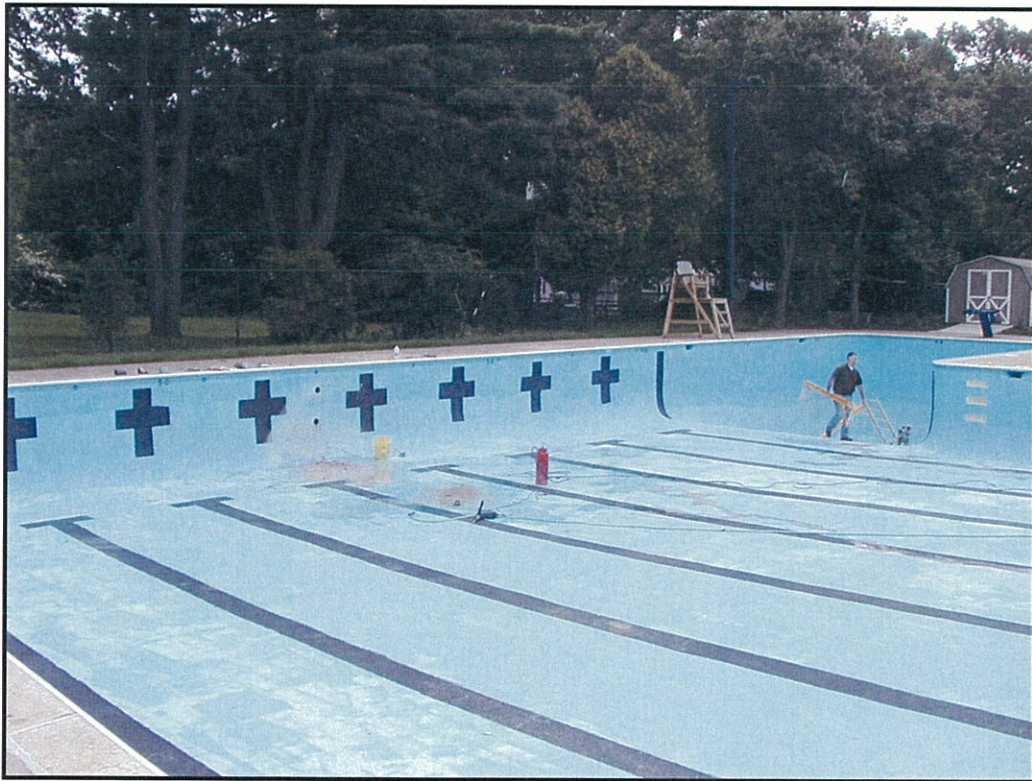
Photo P-4: Pool Wall Core Boring At East Wall

Concurrent with sounding the walls, GNCB monitored IMTL's concrete core and chloride sampling. **(See Appendix D: IMTL Pool Plan and Photo P-4).** The plan shows locations where IMTL cored through the concrete pool walls and slab at GNCB's direction. The purpose of the coring was to obtain samples for testing to determine concrete compressive strength. The core sample compressive strength ranged from 2,480 to 5,600 psi and cores were free of obvious defects. The cores also document concrete thickness at various locations within the pool and we were able to observe the quality of concrete retrieved.

Chloride samples are analyzed to determine the chloride content in the concrete. Low levels of chloride were detected. The levels are below the amount allowed by the American Concrete Institute ACI 222. If chloride levels were greater, in combination with air and water, reinforcing steel would be subject to an environment conducive for corrosion to occur.

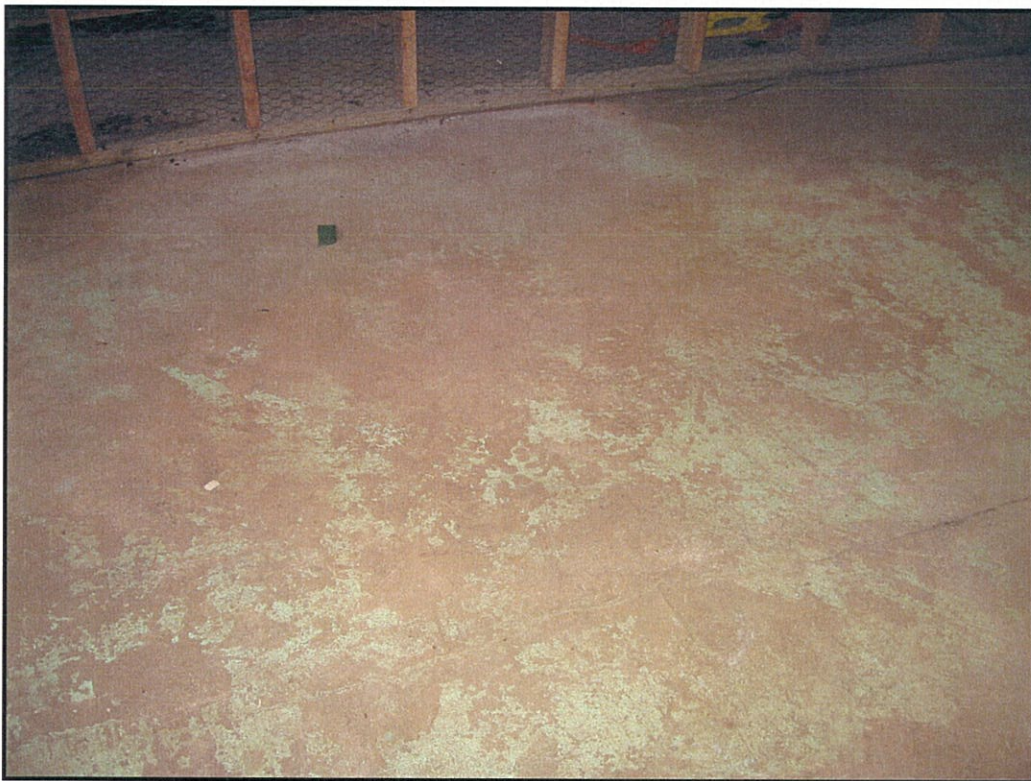
Photo P-6: Bathhouse Concrete Floor Slab

Below grade, the bathhouse building is constructed of concrete foundation walls and a concrete floor slab. Foundation walls appear to be plumb and not cracked, although the north wall appears to have retained moisture and paint is peeling. **(See Photo P-5 and Drawings 4 and 5)**. Maintenance personnel indicated to GNCB that during periods of heavy rain, water enters the basement area at the base of the wall; water drains to a sump and drainage outlets. The floor slab has minor cracks and stains, yet continues to serve its function. **(See Photo P-6)**.

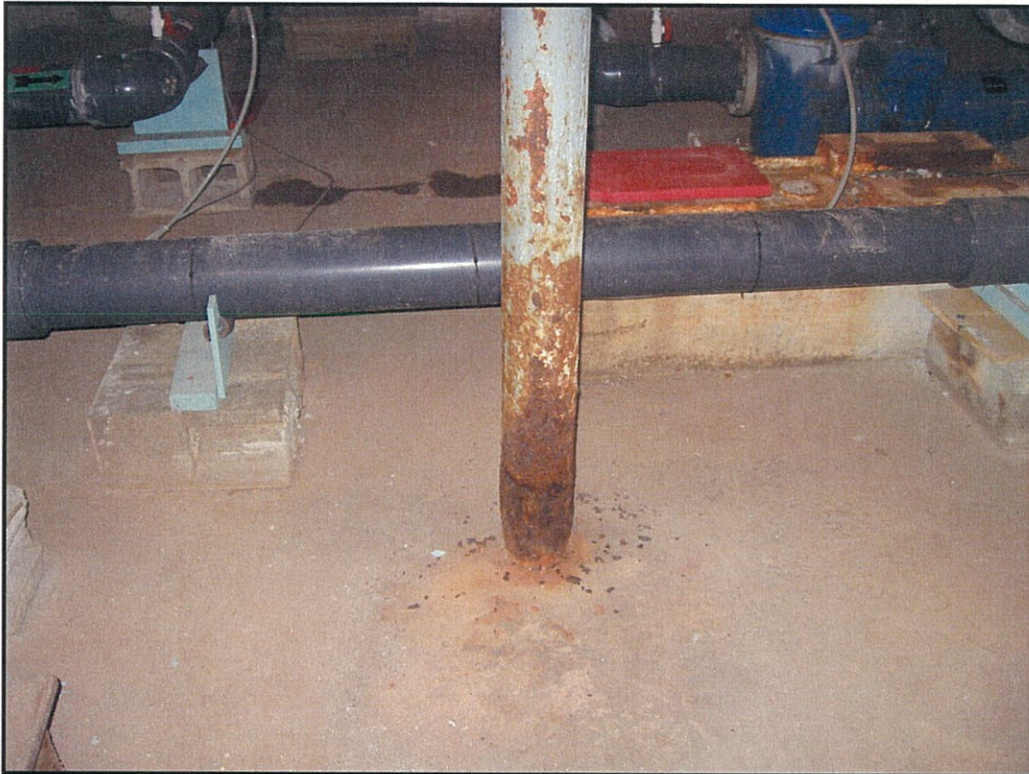
Photo P-7: Bathhouse Column Corrosion

mechanical equipment has corroded at the base. **(See Photo P-7).** The column cap plates are bolted to the underside of the centerline steel beam. **(See Photo P-8).** The painted wide flange steel beam is 8-inches wide by 8-1/8-inches deep and spans east/west. The flange thickness is 7/16-inches. This corresponds most closely to a W8x31 or W8x35 shape.

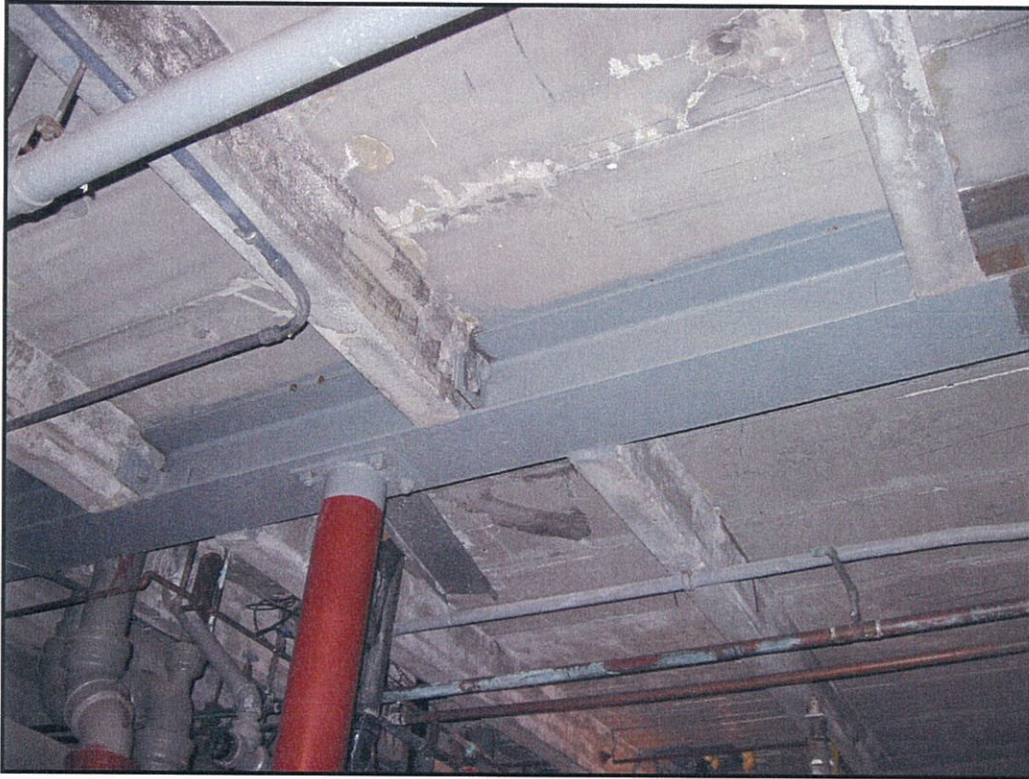
Photo P-9: Bathhouse Concrete Floor Joist Reinforcement Exposed

The steel reinforcing was exposed where concrete has spalled off. This revealed 2-No. 6 bars to reinforce the bottom of the joist and 2 No. 5 bars at the top. Steel tie rods run perpendicular to the joists at midspan for joist bridging. **(See Photo P-10).**

- Repair the areas where concrete is spalling from the planks and joists. We recommend contacting a concrete repair specialist, who could specify the proper product and perform the repairs. This could be incorporated into the specifications for the project and performed under the direction of the Architect.
- Provide site drainage to direct water away from the building.
- Provide a drainage system at the perimeter of the building.
- Damp proof the existing foundation wall.
- Maintain the existing sump pump in the building for any water that does enter in spite of the repairs.
- Repair the leaks from above that are seeping through the floor and damaging the concrete floor plank and joist system.

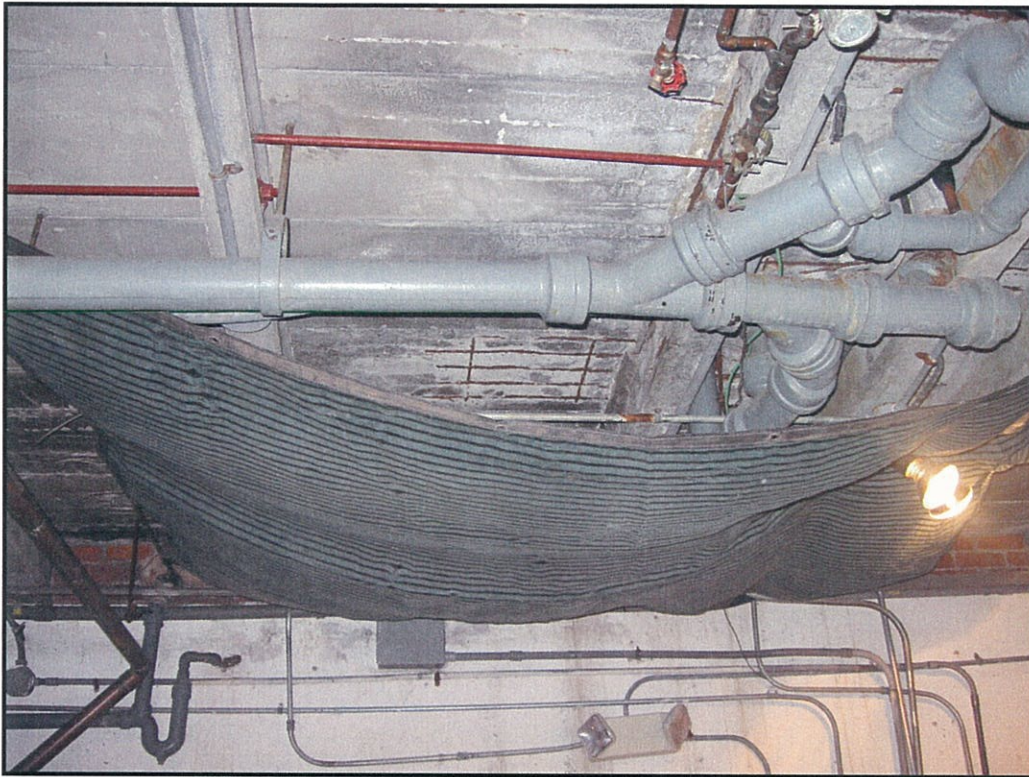
Photo P-11: Concrete Spalled From Underside of Bathhouse Floor

intrusion, particularly in areas where there are showers and/or toilets above. Water leaking through the floor has caused the underside of the concrete floor plank to spall off, exposing steel reinforcing. Moisture corrodes the exposed steel reinforcing. The concrete has spalled on the north side enough to require installation of netting to catch the falling concrete. **(See Photo P-11).**

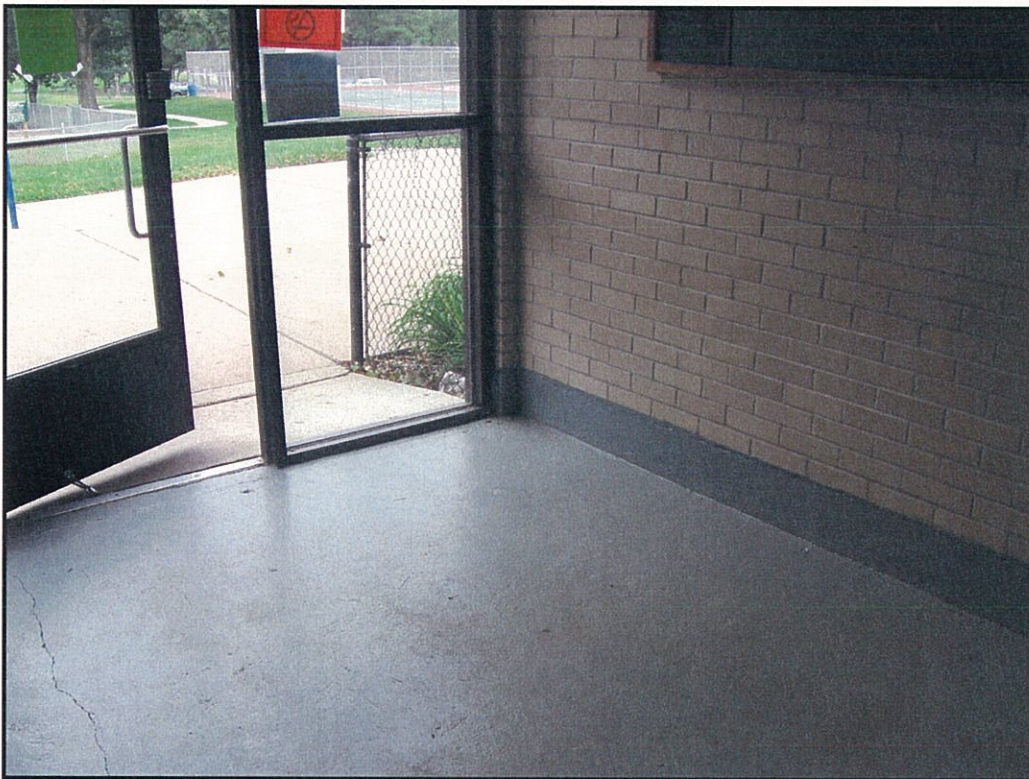
Photo P-14: Bathhouse Lobby Floor

At the interior, there is a central lobby area. Dressing rooms and shower rooms are on either side of the lobby where water leaks through the floor. **(See Photos P-14, P-15, P-16).**
