# SAYREVILLE BOARD OF EDUCATION

## JESSE SELOVER SCHOOL FACILITY ASSESSMENT

School Name: Jesse Selover School

School Address: 150 Lincoln Street, South Amboy, New Jersey 08879

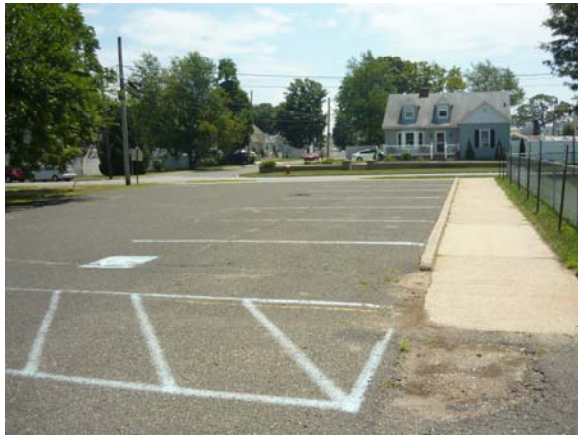
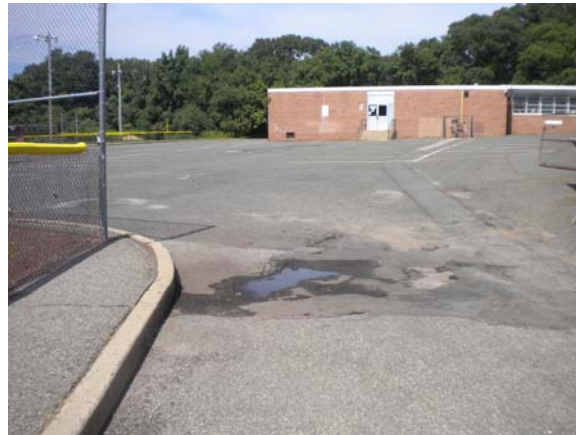
### Parking and Barrier Free Entrances

The parking areas are patched and showing signs of aging and deterioration. The pitch of the existing pavement may require revised drainage calculations and sub-surface structures. If a portion of the asphalt pavement is to be utilized for playground or recess activities, a separation of parking/driveway from the play area is recommended and should be designated and demarcated with traffic controlling gates and fences, bollards, curb stops and speed humps. At least 4 spaces should be marked Barrier Free and be located near Barrier Free entrances of the school.

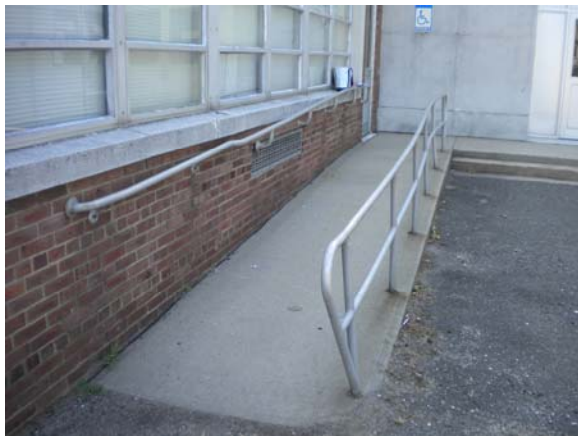
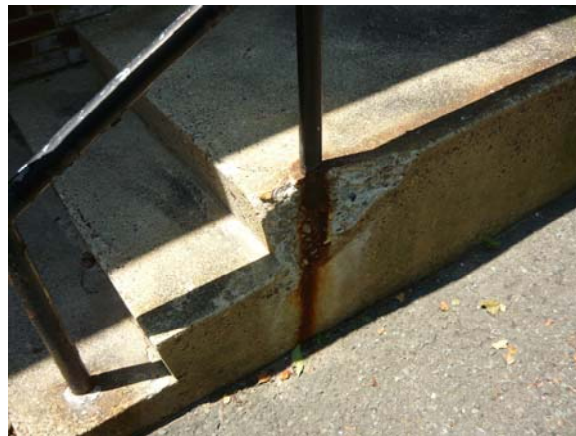
### Exterior Stairs & Handrails

The present condition of existing stairs and handrails is compromised due to exposure to the elements and age. That noted, they pose unsafe and hazardous conditions. Several existing stairs have risers that vary in height, beyond accepted tolerances. New stairs with non-slip nosings, consistent riser height and new handrails and guardrails are recommended for safety and code compliance.

Most of the current handrails also lack the code required 12" extensions at the top and bottom of the stairs along with the required edge barrier and guardrails at each open side of the stair. Handrails are required by current code to be on both sides of a stair or ramp.

The steel railings have rusted over time and as noted above, are no longer code-compliant. It is recommended that all handrails be replaced with compliant handrails and guardrails. The new railings should be set into new reinforced concrete and stair assemblies.

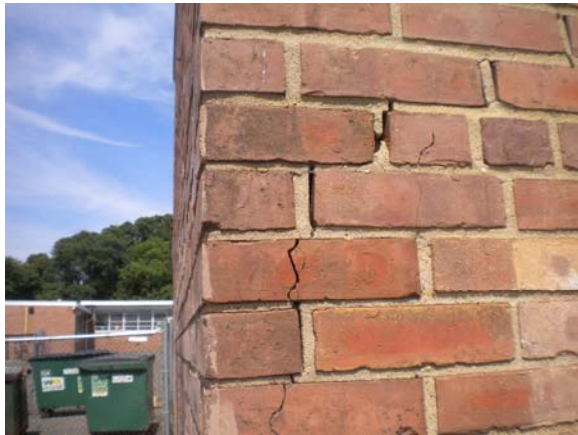
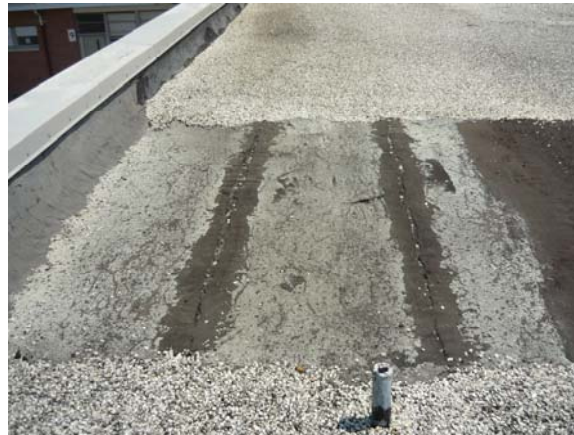
### Exterior Walls

Existing masonry walls are in a poor condition. The cracking which has occurred is indicative of settling foundations and freeze/thaw damage due to water infiltration. Some of these cracks have been filled with caulk, but many remain untreated. These cracks are allowing for water to penetrate the building and increase the damage via thermal expansion and contraction. Signs of cracking/settlement are most evident at the rear of the building and should be addressed promptly.

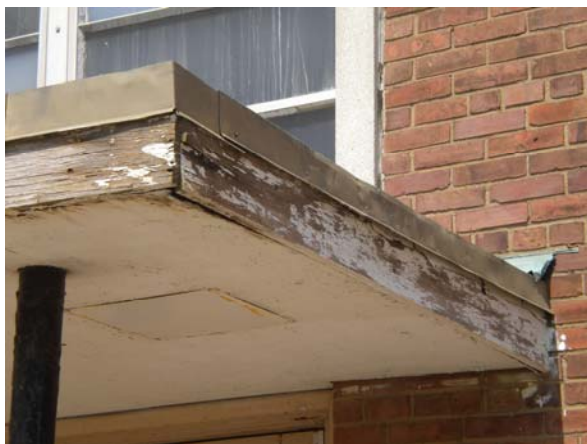
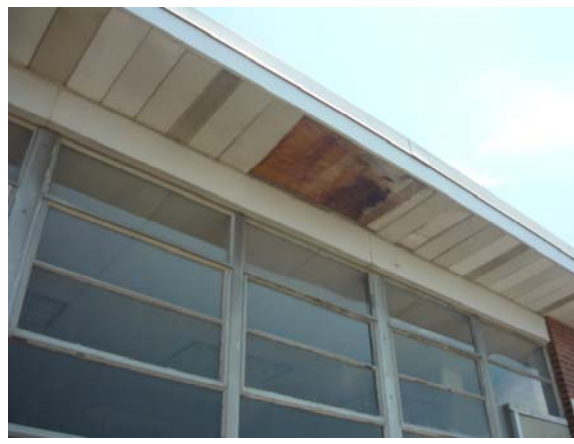
### Entrance System/Canopy

The side entrance stairwell door's existing canopy shows signs of extreme weathering. The existing roof will need to be replaced. The existing lighting appears to have been replaced, but should be upgraded to meet current emergency lighting standards. The columns will need to be thoroughly cleaned and all rust removed and the columns repainted.

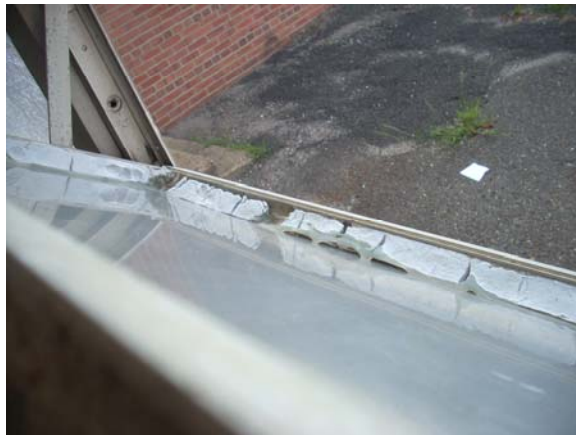
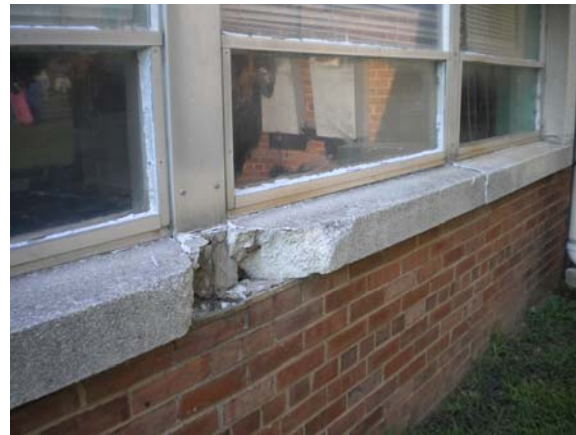
### Windows

Replacing the existing single pane project-in windows with a dual glazed project-out window with insect screens will save energy costs over time by reducing consumption. The interior head, jamb and sills show signs of water infiltration, which if not mitigated can result in mold and/or damage to other building components. The glazing compound is scaling away from the glass and will ultimately fail, causing the glass to fall out of the window frames. There are several sections of exterior and interior sills which have cracked and fallen out, exposing the window and wall structure to the weather. The flashing at the exterior head and sills were not properly lapped, allowing for water to penetrate into the wall system.

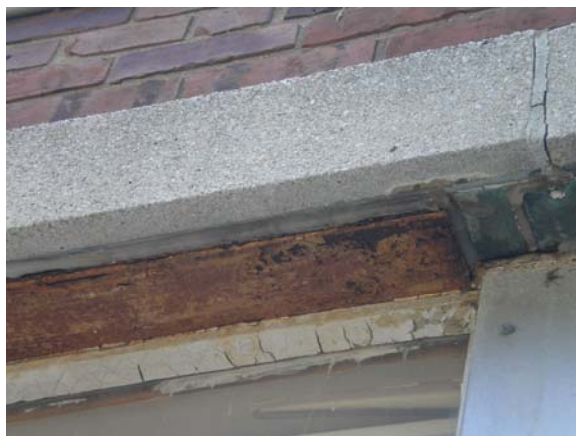
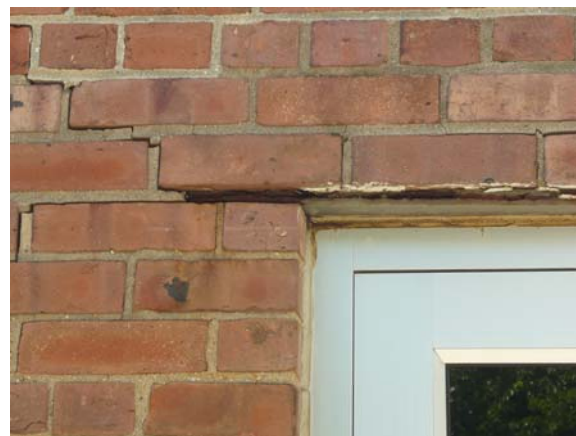
### Exterior Doors

Doors are showing signs of weathering and should be replaced. The four Kindergarten classroom exterior doors should be replaced as part of the window upgrade in order to provide a more comfortable thermal environment for students.

The lintels have swelled and displaced brick units, creating openings in the exterior walls for moisture infiltration. It is highly recommended that the compromised lintels as well as the existing windows be replaced.

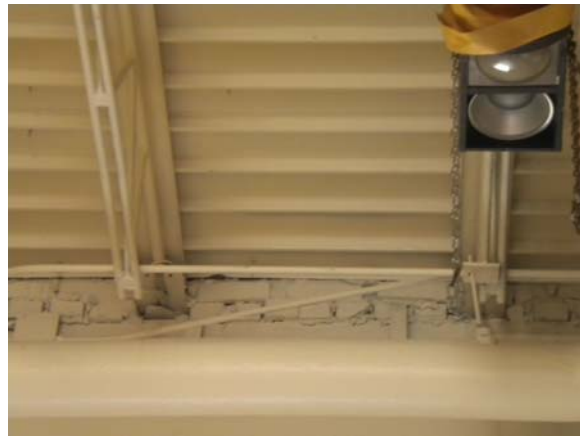
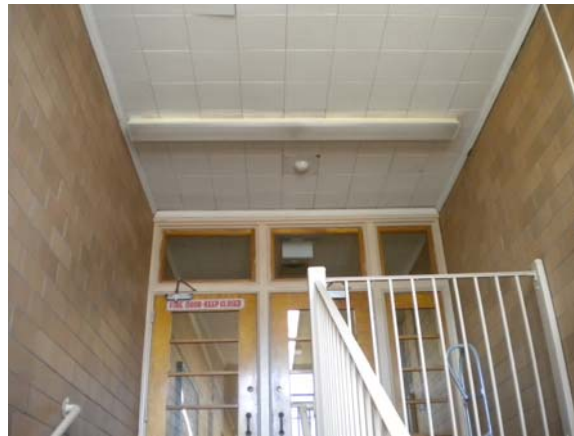
### Super Structure, Columns and Beams

The existing structure is comprised of a concrete and CMU foundation wall with a crawl space below most of the first floor and the built lower level. The lower level has a concrete one way slab with beam structure, with the exception of the gym, which has a sloped structure consisting of metal deck which open web metal joists at 16" on center. At the stage portion of the gym, the joists are bearing on the exterior wall of the building and were set and leveled using brick. Over time some of the mortar has degraded and fallen out of the brick leveling portion of the wall. These courses of brick should be carefully inspected with a man-lift and possibly re-mortared. The accessible crawl space below the stage should undergo air monitoring to confirm whether or not the presence of mold exists.

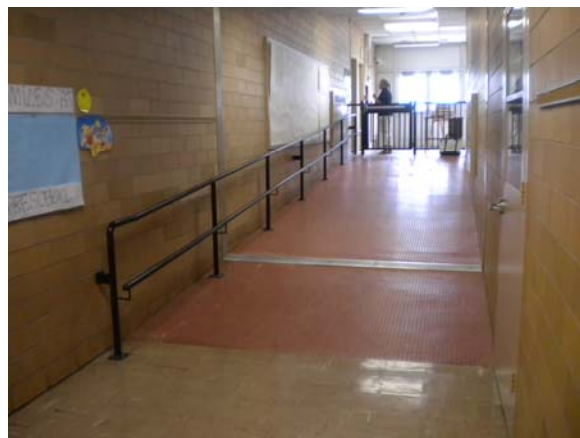
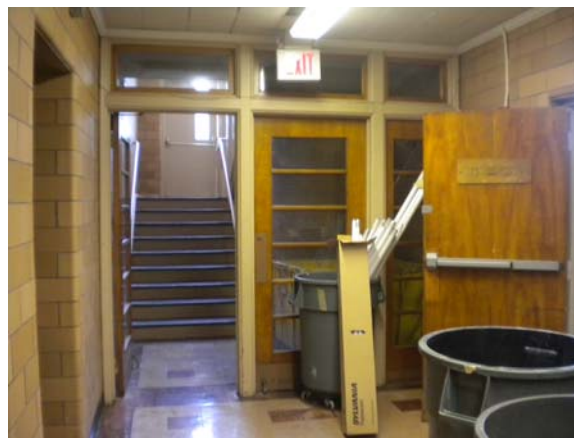
### Interior Stairs, Ramps and Handrails

The existing ramps and stair within the school do not comply with current codes, however, since the existing use classification is not changing, the code does not require either the stair or the ramp to meet current code standards. It is recommended that when possible the handrails be modified to have the 12" extensions at the top and bottom rail of each stair run.

The existing stairway is a vertical connection that under today's code requires a one-hour rated fire barrier. This would include new doors and enclosure walls to be fire rated for occupants.

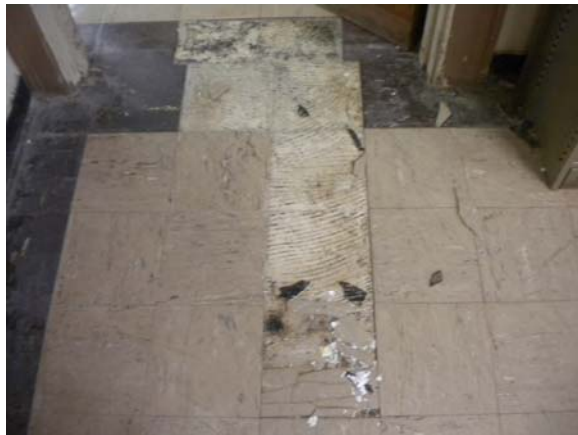
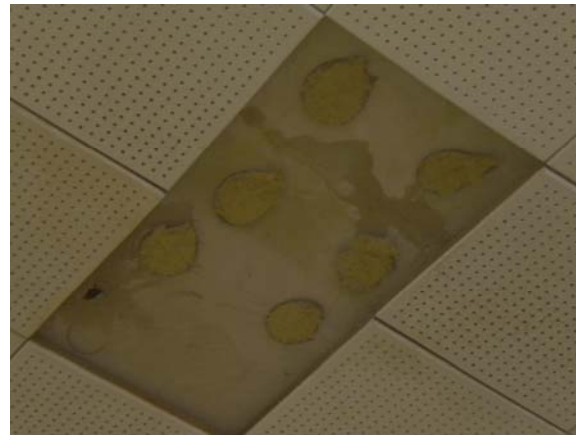
### Flooring

A majority of the school's flooring is vinyl asbestos tile which appears to be in fair condition with several exceptions. The lower level VAT in the gym, maintenance room and storage areas is in poor condition and breaking apart. Any areas where the VAT is broken should be remediated before the building is fully occupied.

The majority of spaces contain 12" x 12" glued-on spline ceiling in fair to poor condition. Classroom lighting is also fair to poor with pendant light fixtures. Some classrooms have been updated with new light fixtures and ceiling tile. A new ceiling with a high level of noise reduction control and durability is recommended to be installed.

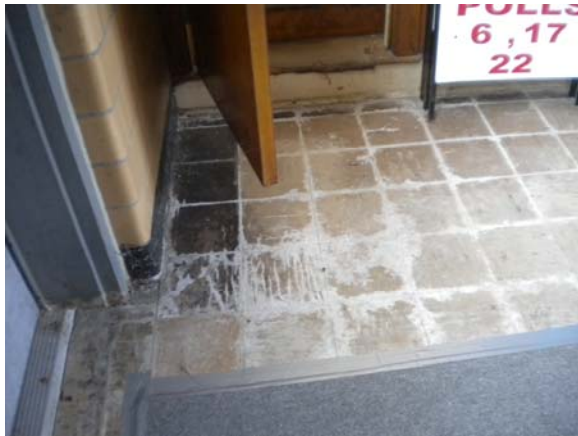
### Multi-Purpose Room

The existing multi-purpose room consists of glazed block walls, a compromised VAT floor and no finished ceiling with any acoustical value (existing spline ceiling removed).

The stage does not include a wheelchair lift or other means of ADA-compliant access, nor does it contain stage rigging such as curtains, etc.

While the space may serve adequately as a Cafeteria based on the adjacent warming kitchen, its size is not conducive for use as a gymnasium. If used temporarily as a true multi-purpose room including curriculum for physical education, the space will need to be outfitted with wall-padding, a new floor system, lighting and an appropriate ceiling. Other concerns for utilizing this space as a gym are the existing windows, glazed block walls and deteriorating VAT flooring. This space will serve as the school's only lunch room as well as gym, which may lead to some scheduling conflicts (unless students eat lunch in their classrooms).

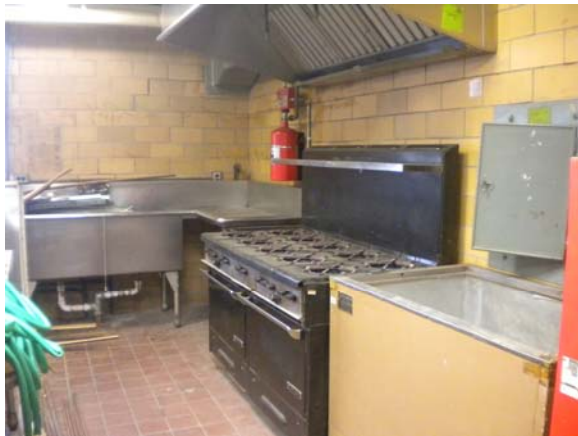
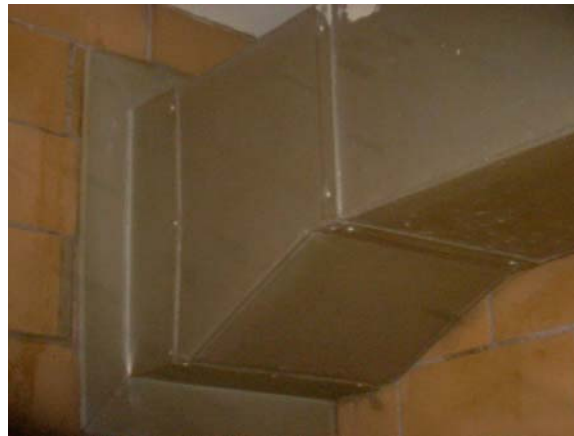
### Kitchen

The existing kitchen facilities appear to be in fair condition. The quarry tile flooring and glazed block walls are in good condition. There are two roll up windows, one larger opening for students to receive food from the serving line and a smaller window located adjacent to the dishwasher where students would drop off their trays and garbage for processing and cleaning.

If the kitchen is to serve as a cooking kitchen, the stove, dishwasher, freezer, cooler, three part sink, hand wash sink, warming racks may need to be replaced and all plumbing and gas connections evaluated. The existing stove is gas and does have a hood and a fire suppression system, both will need to be brought up to current code for safety. It was noted that the existing sanitary plumbing lines run below the kitchen ceiling, which is currently not allowed by code. The existing grease trap may need to be replaced based on current requirements.

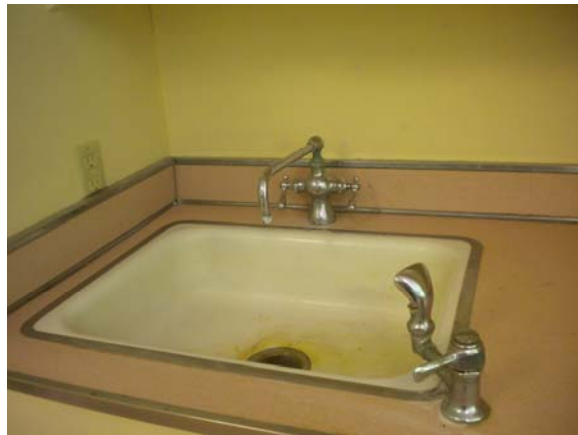
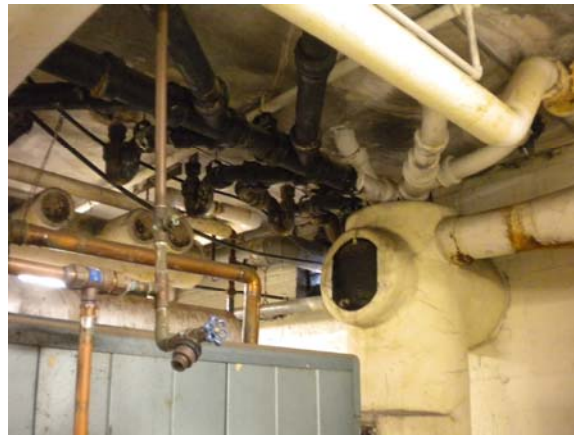
### Domestic Water System

Our recommendation is to replace the existing piping with copper tubing. Also, any galvanized steel branch line piping should be replaced wherever it joins with a newly installed copper riser. (A special dielectric material can be installed between the two dissimilar metals to negate the reaction if they must be connected).

The existing sanitary plumbing lines are also in questionable condition. Dirty water, leaks and a foul smell emphasize the aging conditions of the existing system. Sanitary lines routed below the kitchen ceiling create a concern for health, welfare and safety of students, teachers and staff. Our recommendation is to install new sanitary lines in the existing crawl space. The crawl space should also be monitored for leaks and odors in order to confirm that the sanitary system is performing properly.

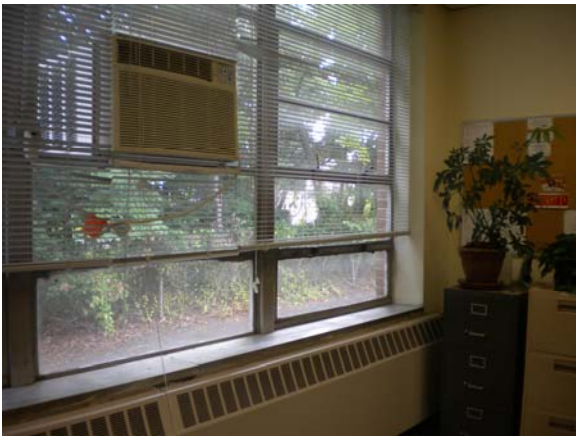
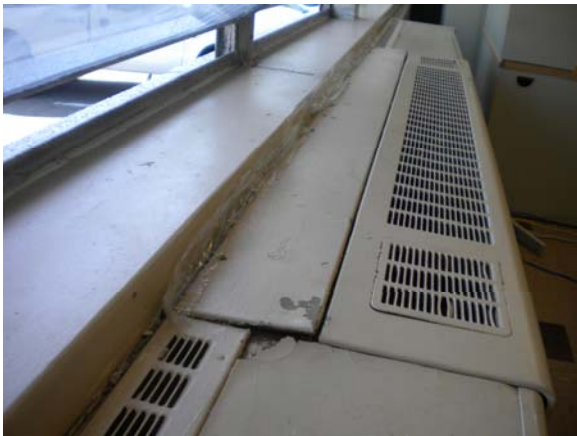
### Heating and Ventilation Upgrades

The boiler in the 1959 wing has been replaced recently along with the classroom unit ventilators in that wing. The existing steam boiler in the original 1954 building should be replaced with two new, condensing type boilers for hot water. This work should occur prior to building occupancy along with the replacement of the existing unit ventilators in the classrooms and office spaces in that original portion of the building. A compatible ATC system should also be installed to control the new equipment.

A new air-handling unit should also be provided to replace the existing unit under the stage in the MPR. The existing ductwork will be re-used, however should be cleaned prior to restarting the system.

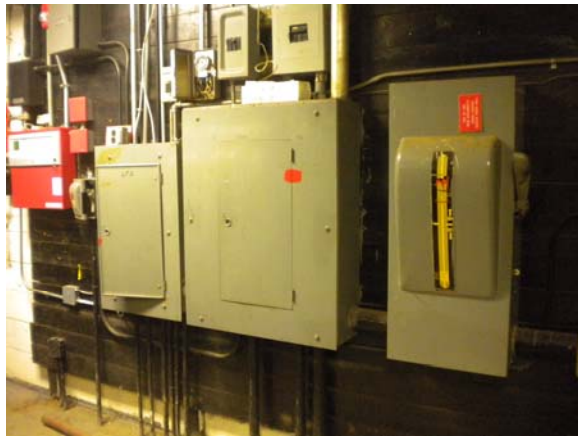
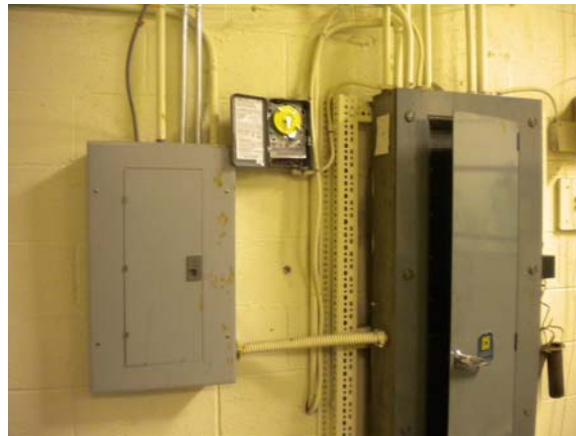
### Electrical Service

The electrical service has two existing, original main panels one at 400 amp and one at 600 amp each with a corresponding service meter. There are several potential upgrade options for the electrical service. One option is to upgrade one of the existing services to 1000 amps, replace existing main panels/CT cabinets, and feed the entire building from one location. This would require replacing the existing panels and feeders and existing branch circuiting would be replaced on a project specific basis. Another option would be to coordinate with the utility to secure approval for an increase in electrical service based on the building's demand.

Existing master clock and P.A. system will need to be completely upgraded. Currently, most classrooms do not have any clock or communication system available. The original P.A. system appears to be in the Main Office on the side wall. The new P.A. system should be a low-voltage system capable of multiple, simultaneous conversations on separate channels throughout the facility through call in switches and loudspeaker assemblies. A programmable master clock system is usually integrated with the P.A. system and telephone systems so that any telephone in the facility can, with the proper authorization code, make announcements over the P.A. system. The system should be expandable to meet future addition needs and be programmable from a master computer terminal located in the Main Office.

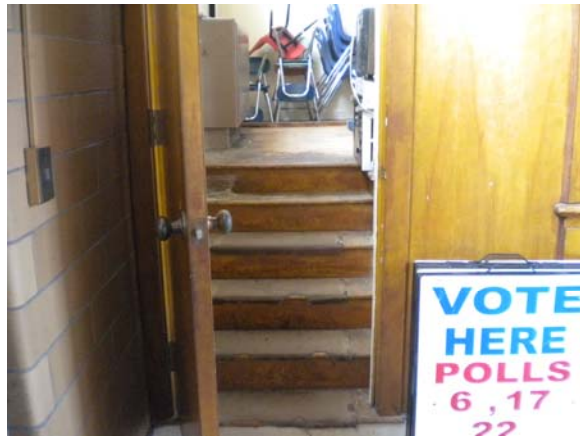
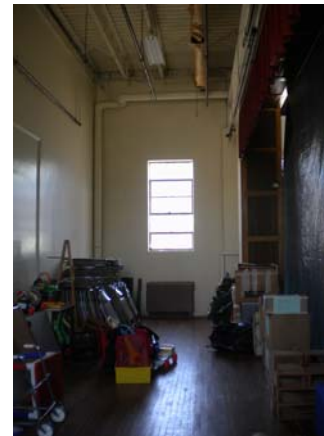
### Stage

The stage is in fair condition, however the doors and stairs to the stage are not Barrier Free.

The front curtain valance is in place, however the flame-spread rating is probably inadequate, and no other stage curtains are presently installed.

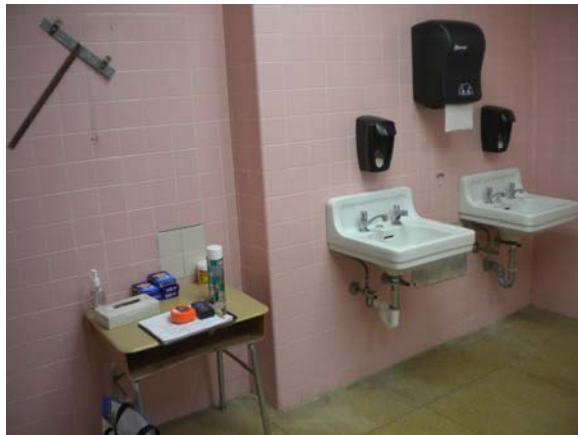
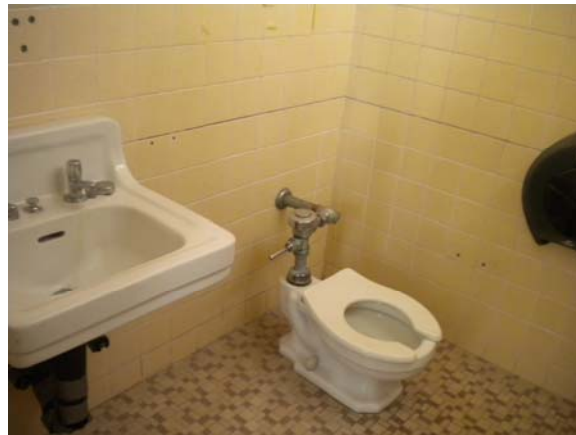
### Toilet Rooms

Although some renovation work has taken place, many components are not fully compliant. For example; the lack of door clearances at the two toilet rooms adjacent to the Teachers Lounge, the mounting height for some soap and paper towels dispensers throughout the building, and the toilet compartment sizes do not comply with the Barrier Free standards. The existing bathrooms could be re-configured to be more compliant, fixtures replaced to be low flow and at the proper mounting heights and accessories, like soap dispensers, paper towel dispensers and mirrors appropriately installed for ADA compliance.

Each proposed Kindergarten classroom is equipped with a single occupancy toilet and lavatory which does not comply with the overall size required for barrier free access. Two of the existing toilets will need to be replaced to comply with the lower height required in Kindergarten classroom facilities. These classroom toilets do have an exhaust fan installed through the existing window and a large radiator under the window which are recommended to be replaced with updated, energy efficient models.

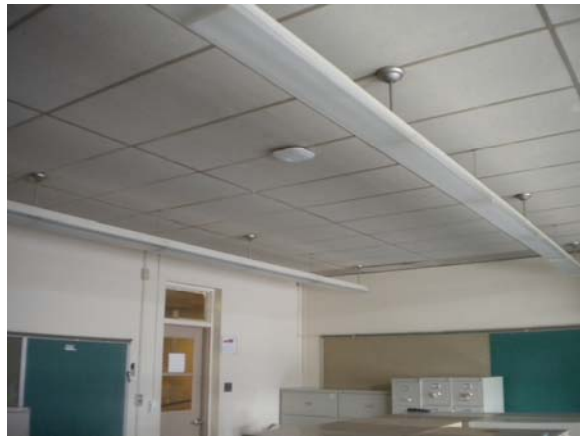
### Interior Lighting

Lighting is a major energy consumer within any building, accounting for approximately 26% of electrical costs in schools. The integration of occupancy sensors within the existing classrooms can help to minimize electrical costs. Light fixtures which produce both direct and indirect light would be the most desirable.

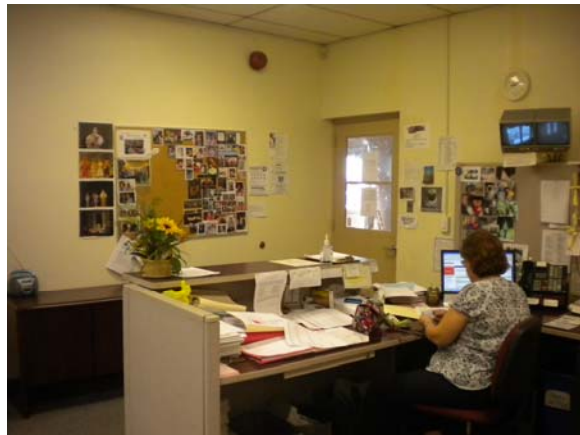
### Security System

Existing motion detectors appear to be located in a ceiling corner in all rooms. The main panel appears to be in the lower level boiler room.

QuickStart brand Fire Alarm panel located in lower level boiler room. It appears to have been updated or installed in 2008. The extent to which the current panel can be expanded has not been confirmed. It does appear to be an addressable system. The panel would better serve the facility if it were located in the Main Office.
