**WARRIOR RUN
SCHOOL DISTRICT**
Excellence in Education

Exterior Wall Forensic Study
Warrior Run School

Brick Study Completed on High School

Josh Carney and D. Ishmael Keener
Carney Engineering Group
10/16/2014

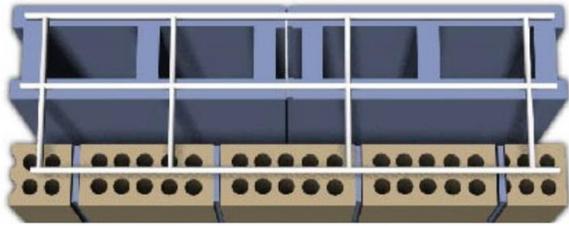
Figure 1: Wall Type 1- Ladder Type Wire Reinforcement

mortar of the brick veneer and CMU joints (see Figure 1). There is an air gap, measuring roughly one inch, between the brick veneer and CMU backup. No waterproofing or insulation was noted in this wall type.

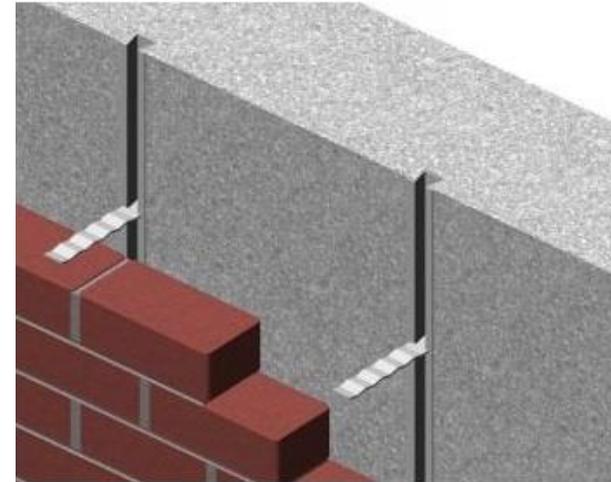
Figure 3: Wall Type 3- Dovetail Wall Tie

Wall Type 3 consists of brick veneer with a poured concrete backup. The brick veneer is tied to the poured concrete backup with a dovetail tie. This particular tie is embedded in the brick mortar joint and connected to a track that is fixed to the poured concrete backup (see Figure 3). No waterproofing or insulation was noted in this wall type.

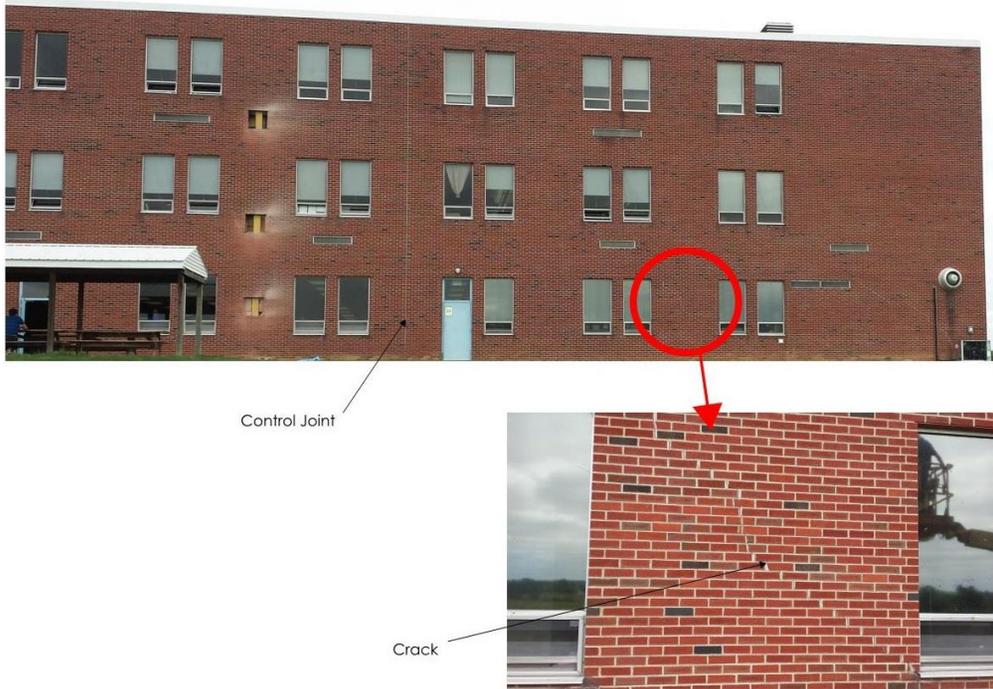
Figure 4: South Wall

- Inclined cracking at several locations (see example in Figure 4).
- One full height control joint (see Figure 4).

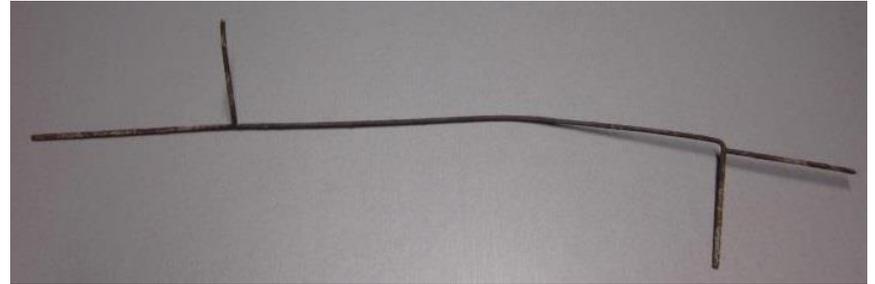
Figure 5: South Wall, First Floor Ladder Type Wire Joint Reinforcement

- Wall Type 1
- The ladder joint reinforcement wire has surface corrosion (see Figures 5 and 6).

Surface Corrosion

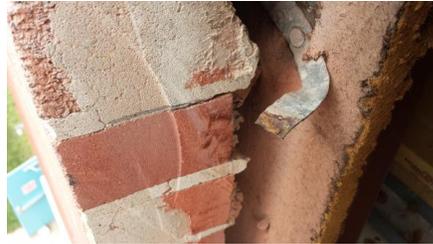
Failed Corrugated Wall Tie

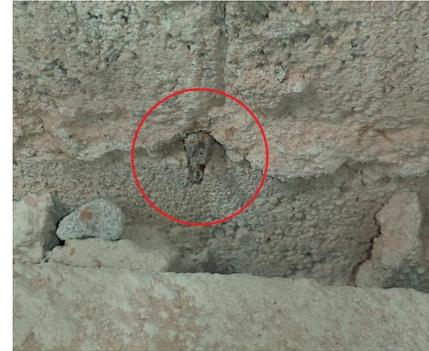
Corroded Joint Reinforcement

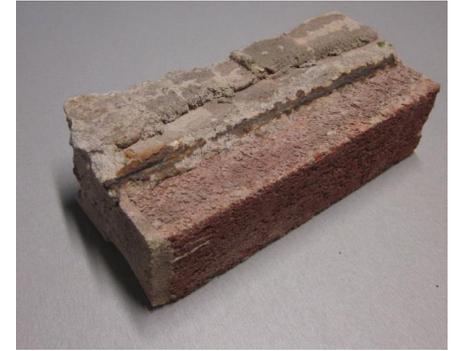
Brick with Corroded Joint Reinforcement

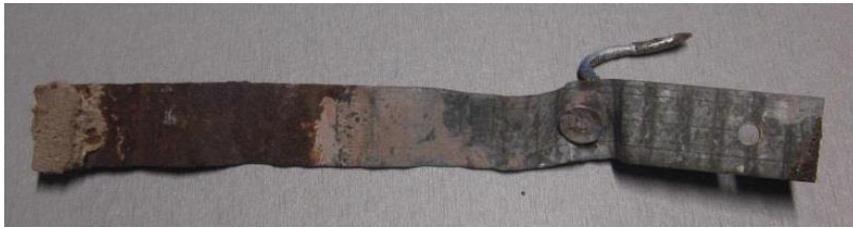
Figure 7: South Wall, Second Floor Corrugated Wall Tie

- Wall Type 2
- The brick ties are spaced at 16" O.C. vertically and 24" O.C. horizontally.
- The brick ties show moderate corrosion in the portion of the tie embedded in the brick mortar joints (see Figure 7).

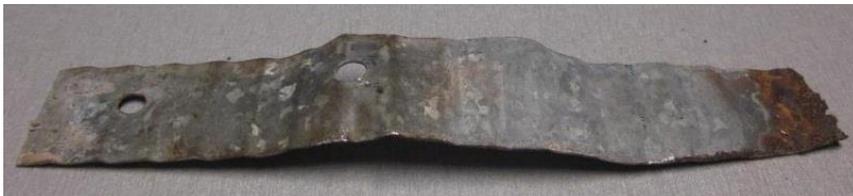
Figure 8: South Wall, Third Floor Corrugated Wall Tie

- Wall Type 2
- The brick ties are spaced at 16" O.C. vertically and 24" O.C. horizontally.
- The brick ties show extensive corrosion. The portion of the tie embedded in the brick mortar joint is corroded through (see Figure 8).

In the long term, and to ensure a reasonable life cycle for the building, it is our opinion that the veneer and backup light gage framing will need to be completely removed and a new backup, drainage, insulation, and veneer system be installed. Once the brick veneer is removed, the wall system will be required to meet current building codes. This will include widening the wall to include insulation and a larger cavity behind the veneer. To achieve this, the foundation will need to have brick shelf added to accommodate the wider wall above. It is also likely that new structural steel may be required at larger openings such as the front entrance to accommodate the increase in wall width. It should be noted that the primary gravity load bearing system of columns, girders, and joists was noted to be in excellent condition, with no significant evidence of deterioration.

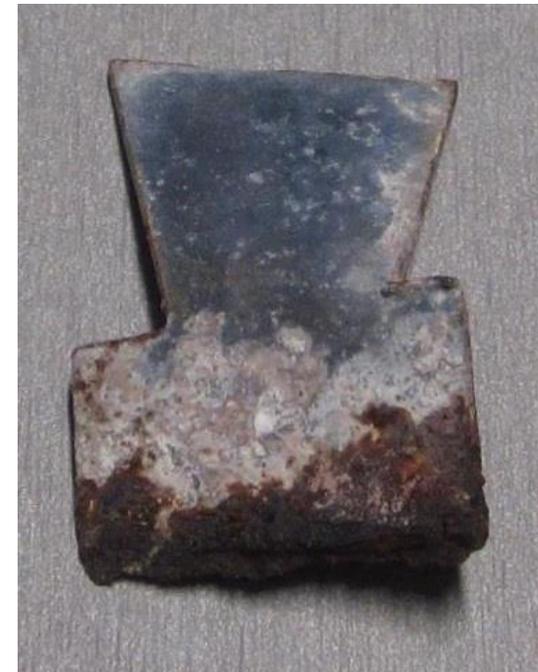
Figure 9: East Gymnasium Wall, Dovetail Wall Tie Corrosion

- Wall Type 3
- No control joints were noted.
- The dovetail wall tie shows extensive corrosion. The portion of the tie embedded in the brick mortar joint is corroded through (see Figure 9).

To remedy the problem of the failed mortar joints and bowing wall we suggest removing the current wire reinforcing and mortar joints (every sixth course of brick) and replace the ties with a Helifix wall tie (see Figure 13) and to repoint the horizontal joints. This will serve to provide more secure and durable veneer attachments as well as limiting opportunity for further wall deterioration from corroding wires. We do not suggest trying to shift the wall back, and instead recommend monitoring the bowing of the wall over time by installing movement gauges. We do feel at this time that the amount of movement is structurally unsafe, and believe it will not move further once repaired. Helifix ties would be installed at a 16" x 24" grid spacing over the full extent of the exterior gymnasium walls.

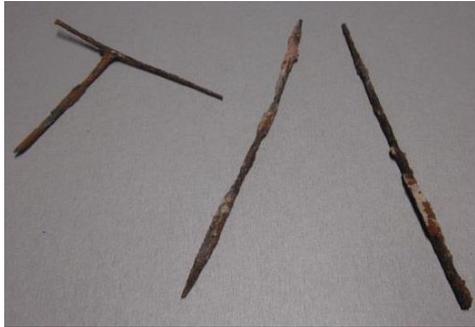
Figure 10: East Gymnasium, Ladder Type Wire Joint Reinforcement

- Wall Type 1
- There are no control joints.
- The ladder joint reinforcement system shows extensive corrosion. The wire is corroded through in one observed location (see Figures 10 and 11).
- The wall is bowing out in several locations.
