PEDESTRIAN  
ACCESSIBILITY  
STUDY

Medford, Massachusetts

June 2021

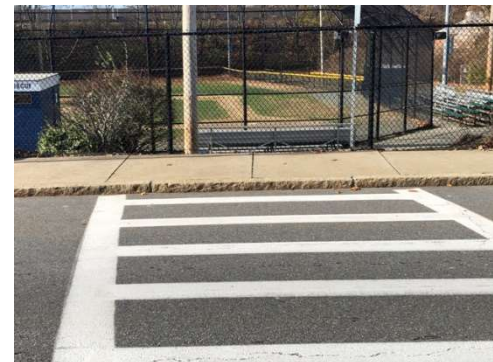
Missing ramp on Fulton St.

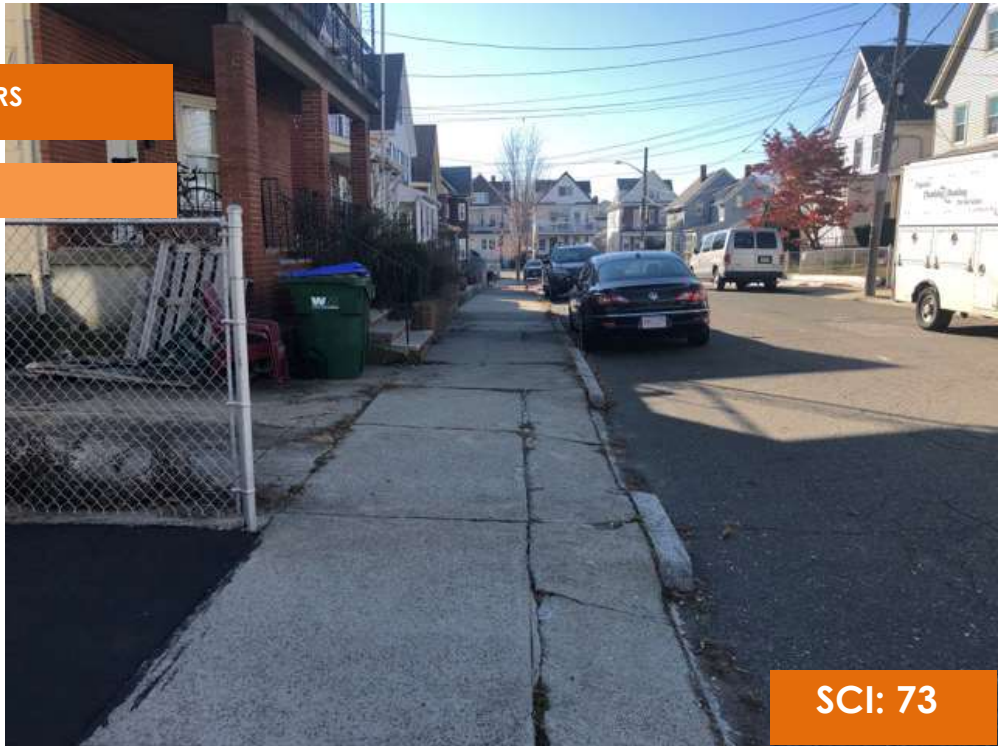
Leyden Street

LOCALIZED REPAIRS

SCI: 73

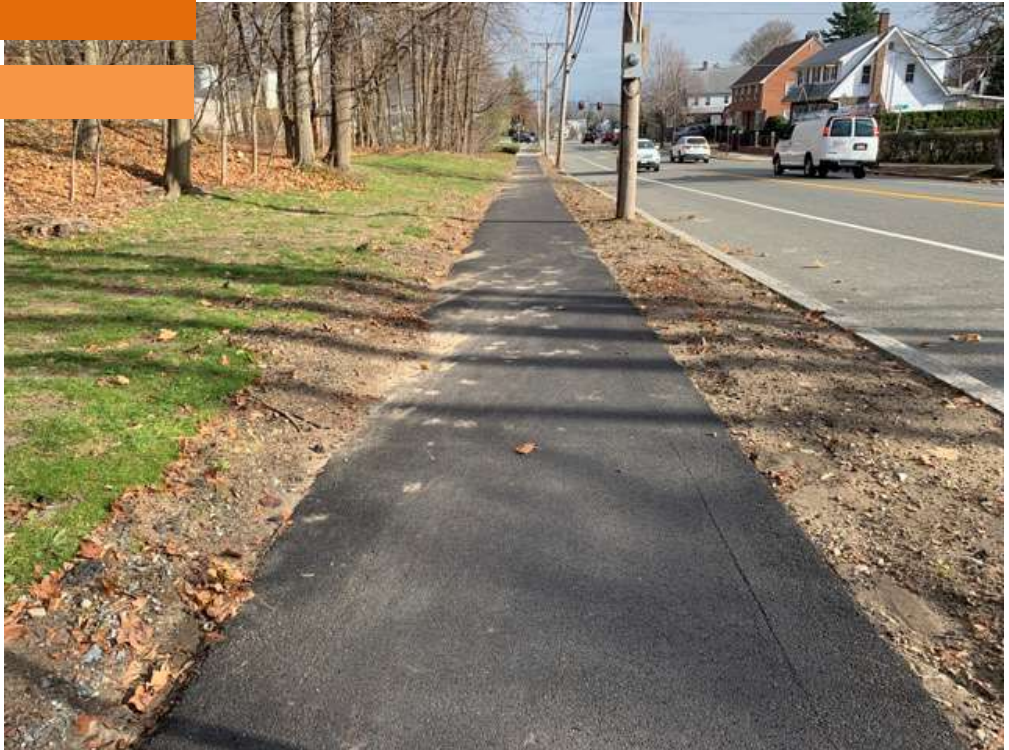
Lawrence Road

DO NOTHING

SCI: 99

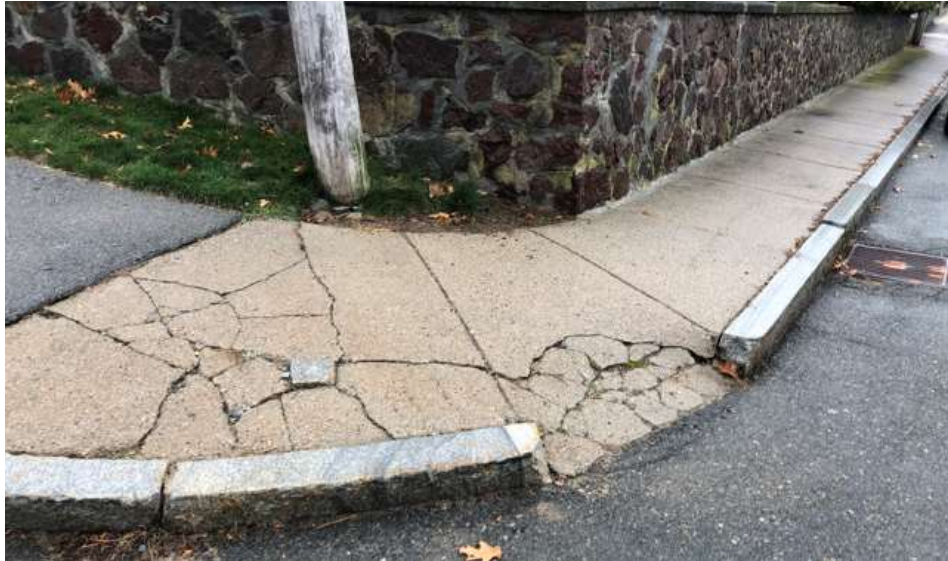
Clematis Road

The distribution of apron slopes City-wide are relatively good as most ramps achieve an acceptable MAAB slope less than 8.3%. However, there are a significant number of ramps which have apron slopes exceeding 12% which significantly impedes accessibility. A majority of these ramps are made of portland concrete cement and are found through out the city. A few examples of these are shown below.

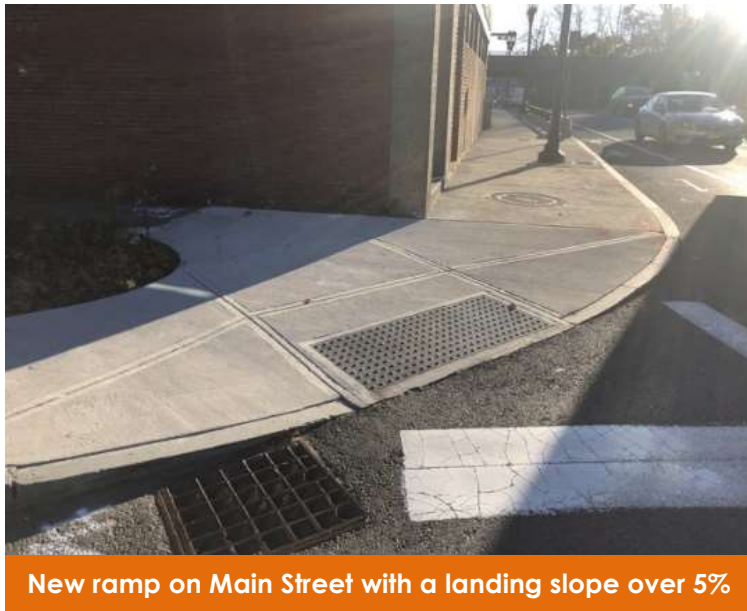
New ramp on Main Street with a landing slope over 5%

Nitsch/Stantec Team observed some 'newly constructed' ramps which were minimally non-compliant due to workmanship, which can be improved in the future with better field layout and inspection. By putting a little more effort to build it right the first time, the City can get more benefit from its asset investment in the network. The image to the left shows a new ramp built on Main Street that failed the landing slope compliance.
