July 31, 2017
File: 1911.033altr.doc

Alameda Unified School District
2060 Challenger Drive
Alameda, California 94501

Re: Geotechnical Engineering Investigation
Evaluation of Liquefaction Risk and Liquefaction Induced Settlement Potential
Edison Elementary School Campus
2700 Buena Vista Avenue
Alameda, California

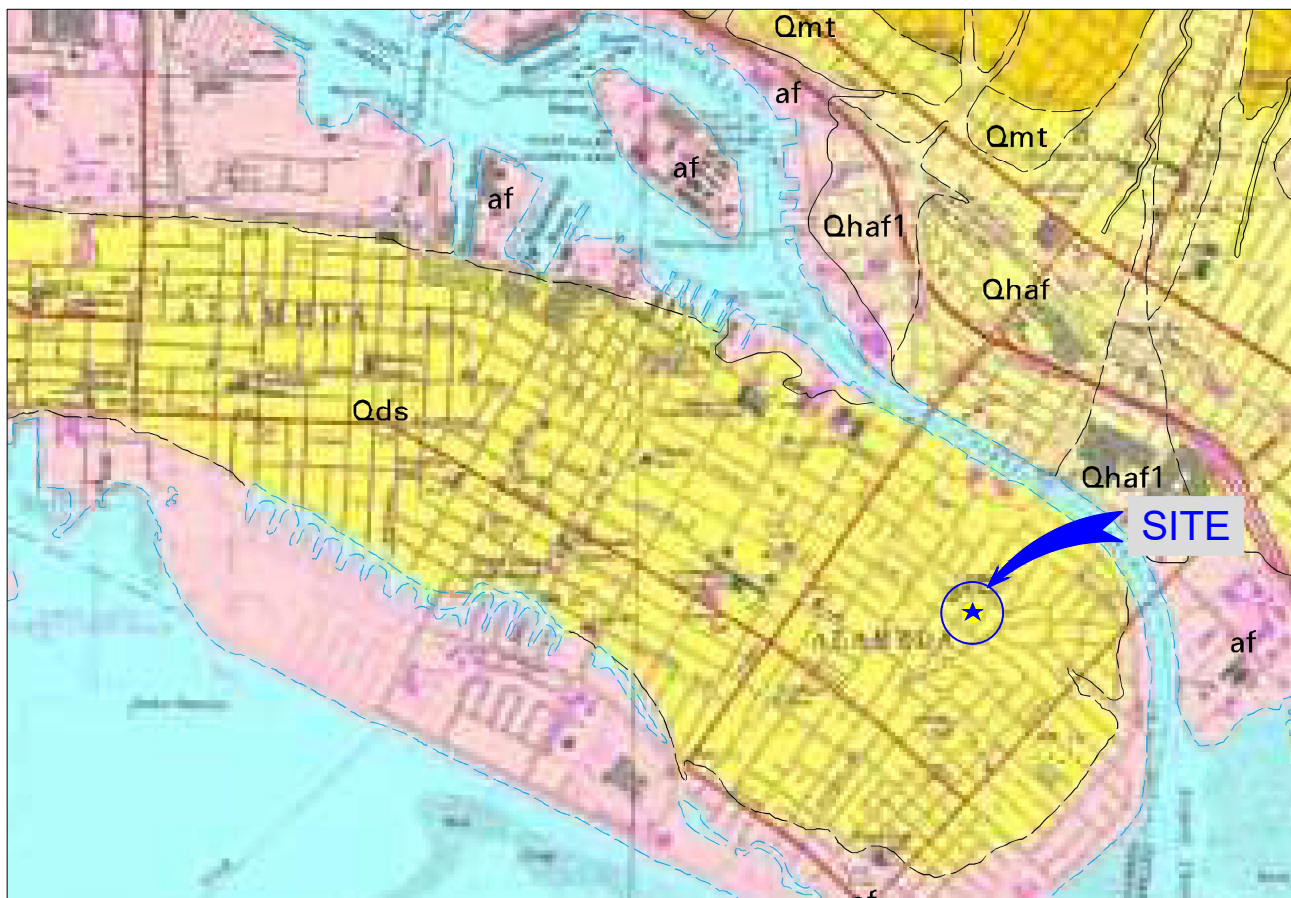
REGIONAL GEOLOGIC MAP

Geologic mapping¹ indicates the site is located in an area underlain by dune sands, as shown on Figure 3. No significant artificial (manmade) fills or soft clay (Bay Mud) underlie the subject site.

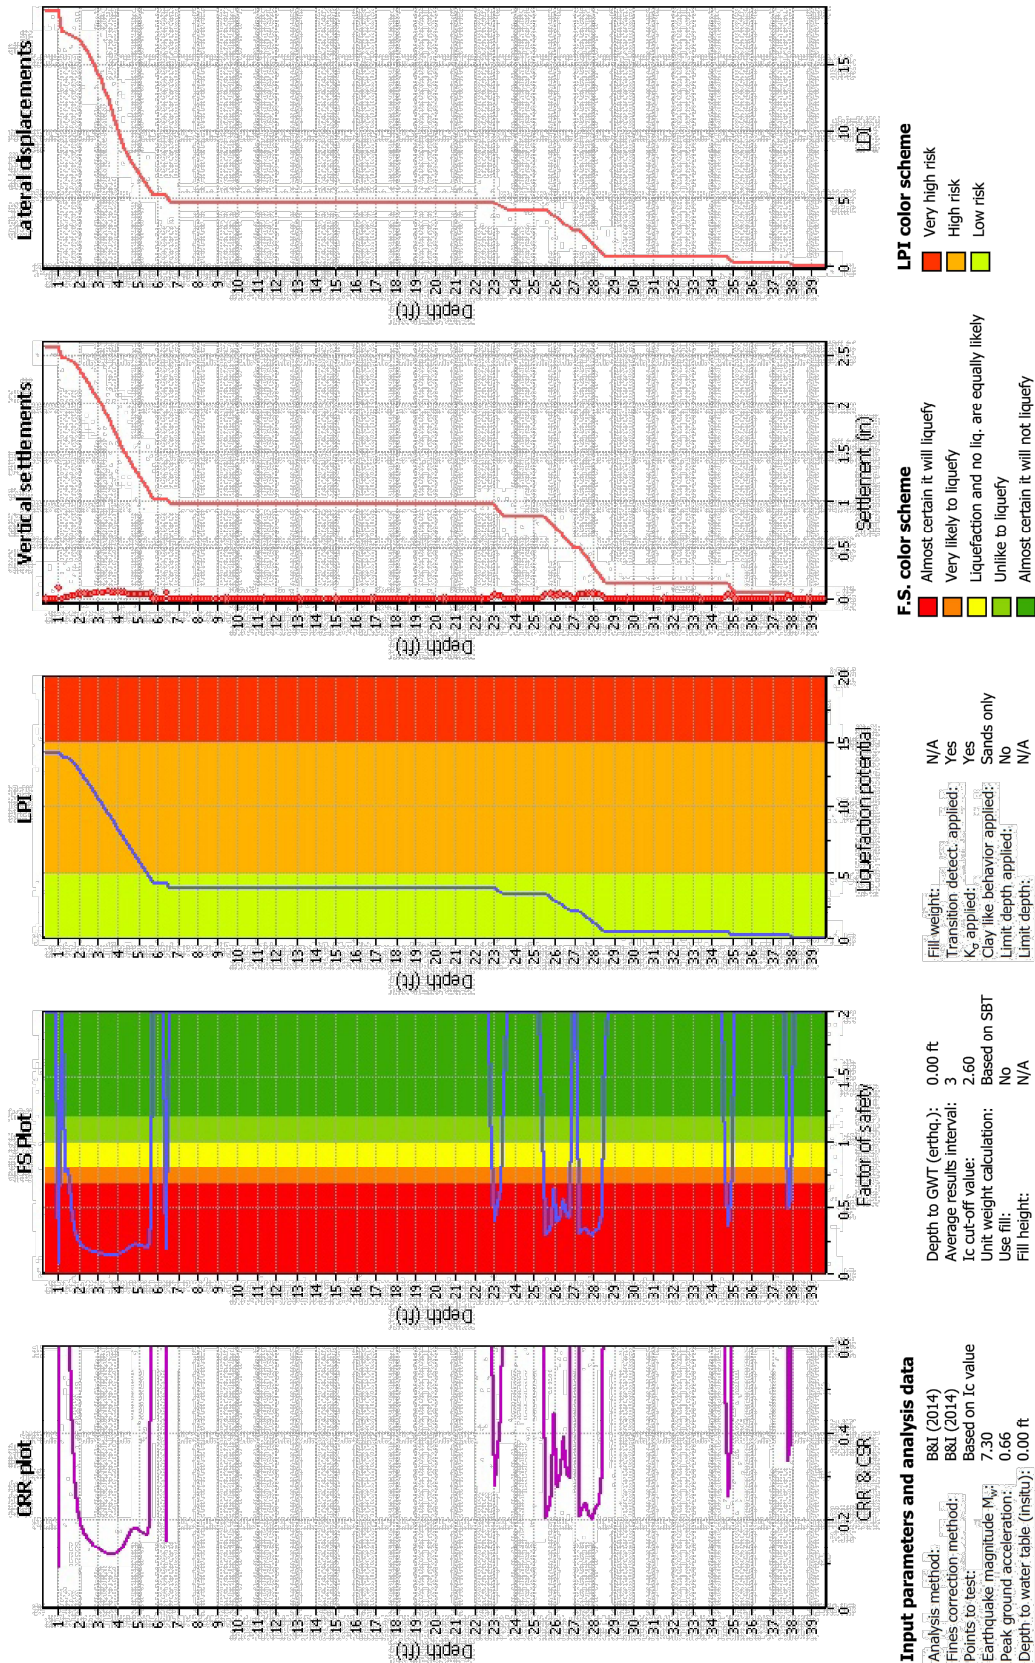
CPT-1 LIQUEFACTION ANALYSIS

Potential liquefaction of sandy layers between one and eight feet below the ground surface may result in ground surface settlement of between roughly 0.5-inches to 2.0-inches, based on the liquefaction analyses discussed above, and as shown on Figures 5 through 8. Potential liquefaction induced differential ground surface settlement within a given building footprint area is estimated to be approximately one half of the total settlement (approximately 0.5 to 1.0-inch).
