October 24, 2017 File: 1911.038altr.doc

Alameda Unified School District 2060 Challenger Drive Alameda, California 94501

Re: Geotechnical Engineering Investigation Evaluation of Liquefaction Risk and Liquefaction Induced Settlement Potential Alameda High School Campus 2201 Encinal Avenue Alameda, California

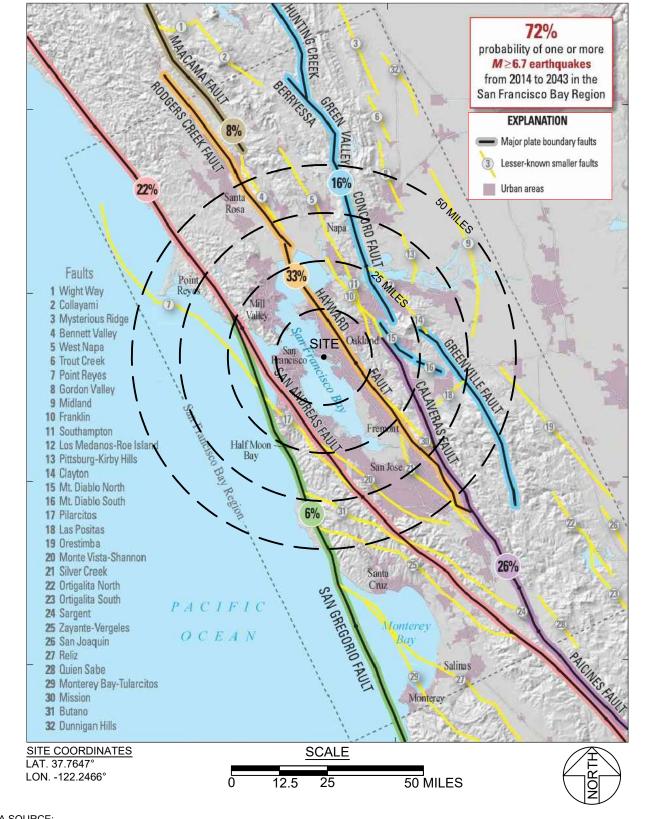
The San Francisco Bay Region is located in a seismically active area and the existing improvements will therefore experience the effects of future earthquakes. Such earthquakes could occur on any of several active faults within the region. These faults are shown on the Active Fault Map, Figure 4.

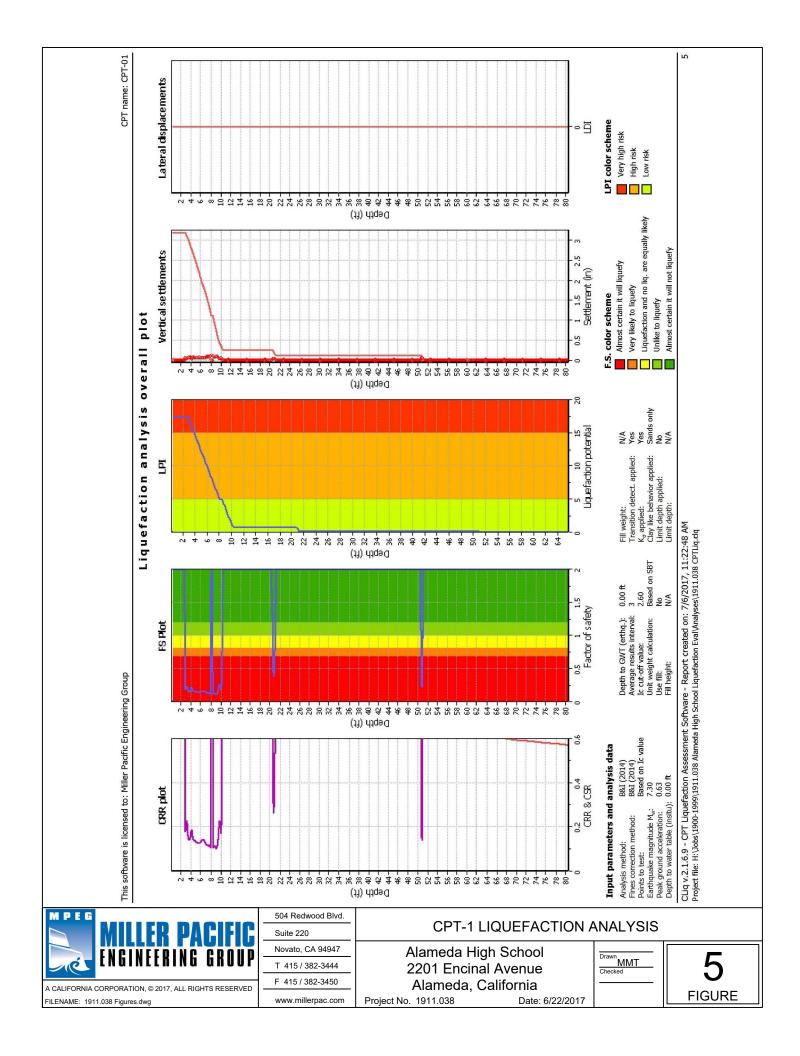
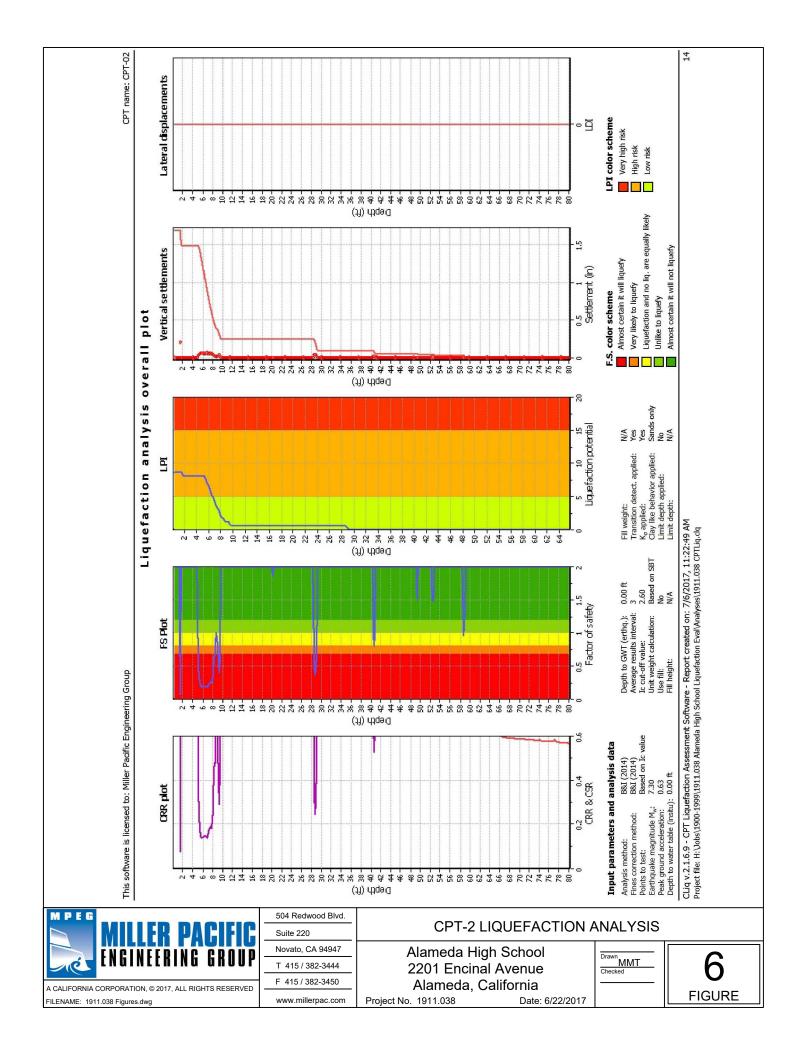
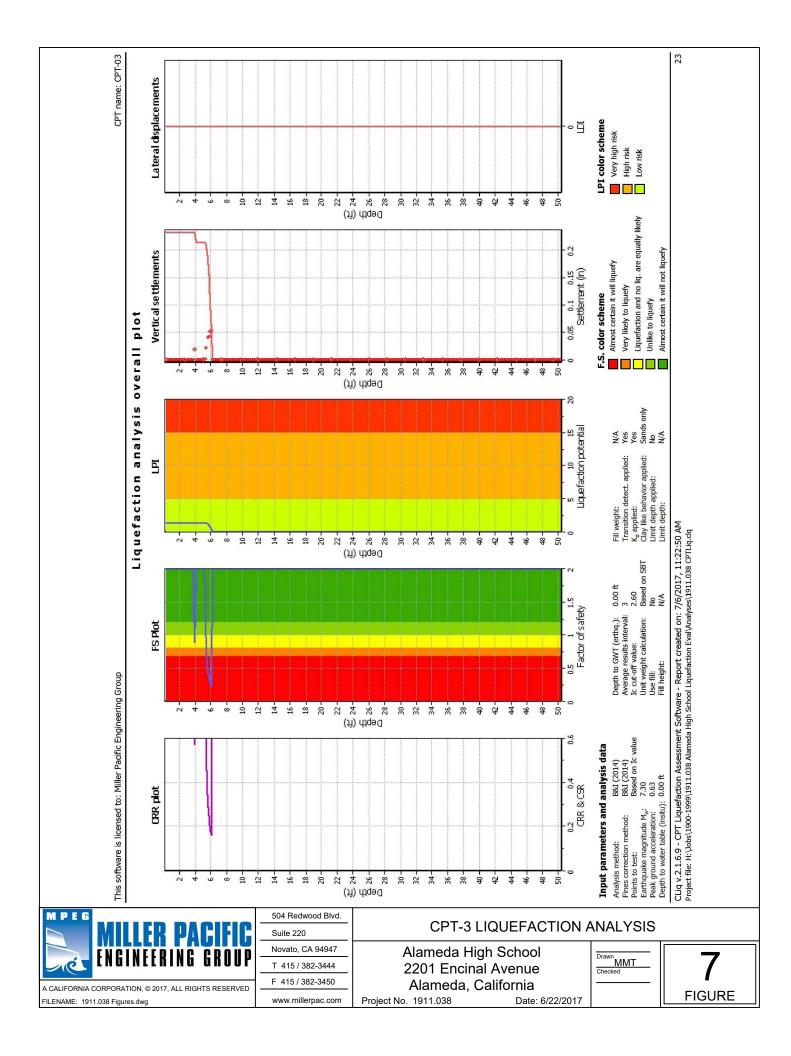
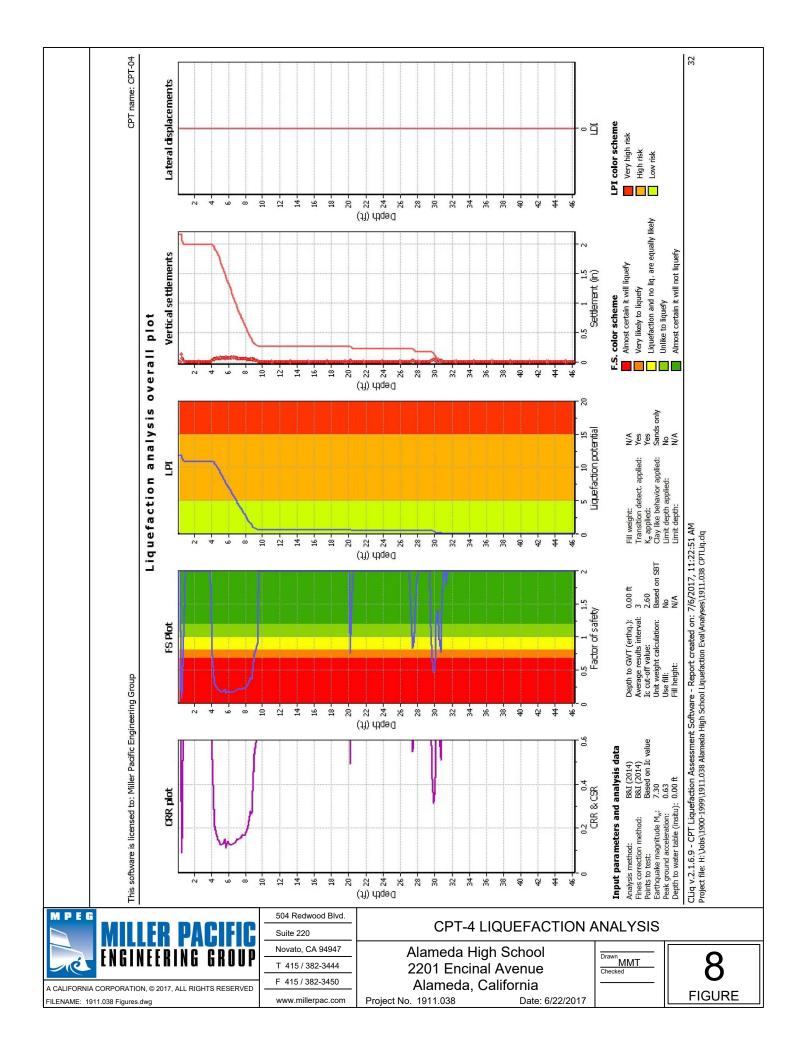
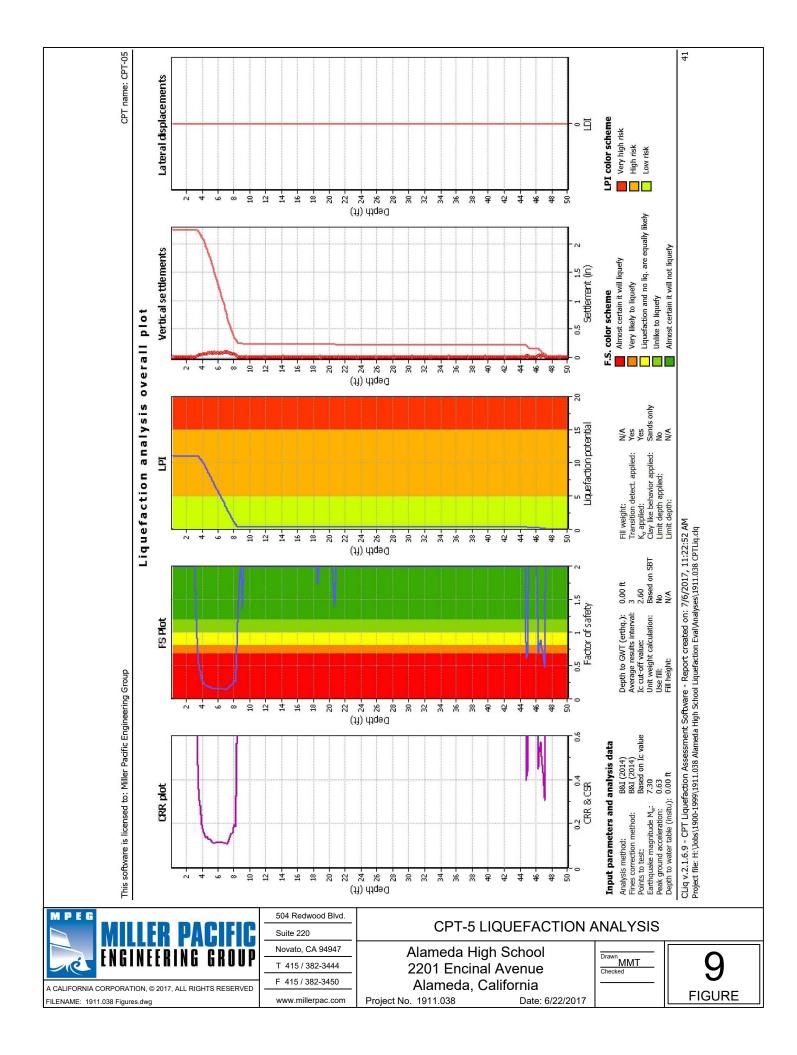
Potential liquefaction of sandy layers between three and ten feet below the ground surface may result in ground surface settlement of between roughly 1.5-inches to 3.0-inches, based on the liquefaction analyses discussed above, and as shown on Figures 5 through 9. Potential liquefaction induced differential ground surface settlement within a given building footprint area is estimated to be approximately one half of the total settlement (approximately 0.75 to 1.5-inch).
