# Bay Farm Elementary School

BAY FARM ES  
4/30/2012

## Alameda USD Facilities Assessment

## Facility Assessment Spreadsheet

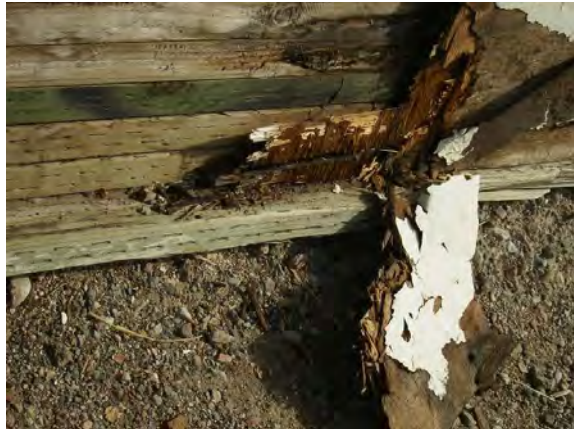
CATEGORY		DESCRIPTION	PHOTO & SITE PLAN	ESTIMATED TAKE OFF		COST / UNIT	TOTAL COST
				Quantity	Unit		
6	Existing Deficiency	(4) Portable classrooms: paint peeling off at metal panels; faded at paneling	#5, #10				
	Recommended Remedy	Repair roof leaks, replace with cement board panel/ trim, prep and repaint		4,000	SF	\$12	\$48,000
7	Existing Deficiency	(4) Portable classrooms: downspouts discharge on wood foundation; dry rot	#17, #18				
	Recommended Remedy	Replace with concrete foundation and ramps; Add site drainage, and new RWLs		32	CY	\$650	\$20,800
8	Existing Deficiency	(1) Portable classroom: missing handrail at ramp wall; gutter downspout drops on wood foundation w/ dry rot	#11, #19				
	Recommended Remedy	Replace with concrete foundation and ramps; Add site drainage, and new RWLs		8	CY	\$650	\$5,200
9	Existing Deficiency	(2) westside Portable classrooms: wood foundation deteriorated	#6, #12, #13

Recommended Remedy	Replace with concrete foundation and ramps; Add site drainage, and new RWLs	CONC	16	CY	\$650	\$10,400
10	Existing Deficiency	(2) westside Portable classrooms: wood siding deteriorated	#14, #15				
	Recommended Remedy	Replace siding with cement board panel/trim		1,000	SF	\$6	\$6,000
11	Existing Deficiency	(2) Butterfly Garden Portables: wood foundation has dry rot					
	Recommended Remedy	Replace with concrete foundation and ramps; Add site drainage, and new RWLs		32	CY	\$650	\$20,800
12	Existing Deficiency	No Trash Enclosure at this Site					
	Recommended Remedy	Install a 2-Bin Trash Enclosure per Health Dept. standards		1	LS	\$15,000	\$15,000
13	Existing Deficiency	(2) Butterfly Garden Portables: wood siding & trim has deteriorated	#16, #21, #22, #23, #24				
	Recommended Remedy	Replace siding with cement board panel/trim		2,480	SF	\$6	\$14,880

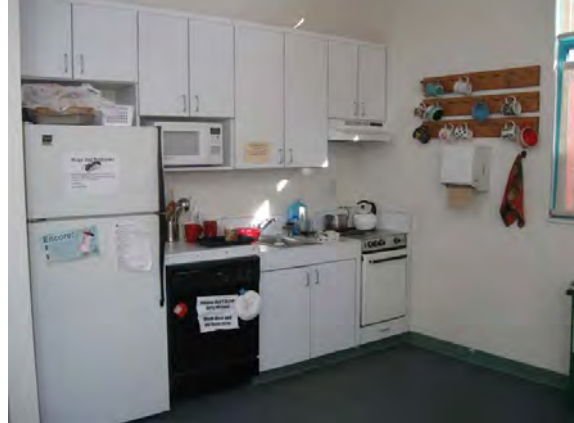
25

CATEGORY		DESCRIPTION	PHOTO & SITE PLAN	ESTIMATED TAKE OFF		COST / UNIT	TOTAL COST
				Quantity	Unit		
2	Existing Deficiency	No evidence of separate irrigation service for site.					
	Recommended Remedy	Recommend installation of separate irrigation service and backflow device.		1	Srv	\$18,000	\$18,000
<b>2) Architectural</b>							<b>\$1,005,080</b>
<b>A) Exterior</b>							
<b>i) ACCESS</b>							
1	Existing Deficiency	<b>Main Entry:</b> pavement heave projection near Admin.	#1				
	Recommended Remedy	* Further investigation required (see Civil Item #8). Allowance for replace concrete.	Allow	1	LS	\$1,800	\$1,800
2	Existing Deficiency	<b>Site Pavers:</b> Numerous trip hazards	#2, #3, #7, #8				
	Recommended Remedy	Replace pavers with conc. walkway		3,600	SF	\$16	\$57,600
3	Existing Deficiency	<b>Media Center:</b> Occupant load for main room requires 2nd Exit	#26				
	Recommended Remedy	Add 36" Exit door at east wall, with conc. walkway		1	Exit	\$5,000	\$5,000
