Edison Elementary School

EDISON ES
4/30/2012

Alameda USD Facilities Assessment

Edison Elementary School
Facility Assessment Spreadsheet

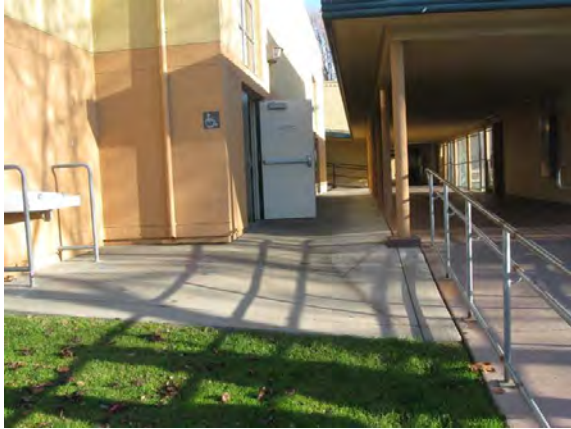
2) Architectural							\$1,577,520
A) Exterior							
i) ACCESS							
1	Existing Deficiency	Multi-Use Bldg: non-accessible drinking fountain; exceeds 2% cross slope	#1, #2				
	Recommended Remedy	replace fountain; regrade/pave access		1	LS	\$10,000	\$10,000
2	Existing Deficiency	Multi-Use Bldg: Egress ramp exceeds 5%	#3				
	Recommended Remedy	Add accessible hand rail		24	LF	\$35	\$840

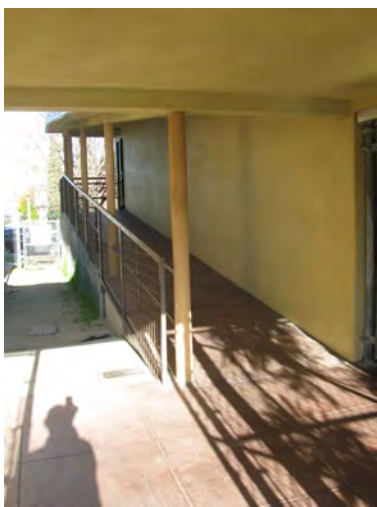
7

2	Existing Deficiency	Admin. Bldg: Egress ramp exceeds 30-ft, with no wall handrail or adequate lighting	#7				
	Recommended Remedy	Reconstruct ramp to conform; add handrail at wall and overhead lighting		1,900	SF	\$22	\$41,800
3	Existing Deficiency	Classroom wings: degraded exterior wood doors	#8				
	Recommended Remedy	Replace all exterior doors with galv. steel frames with FRP doors and new hardware		27	Doors	\$3,200	\$86,400
4	Existing Deficiency	No Trash Enclosure at this Site					
	Recommended Remedy	Install a 2-Bin Trash Enclosure per Health Dept. standards		1	LS	\$15,000	\$15,000
5	Existing Deficiency	Exterior windows w/ Plexiglas beyond Service life					
	Recommended Remedy	Replace all windows with Alum. frame & dual pane glass		6,200	SF	\$44	\$272,800
6	Existing Deficiency	Roof: BUR roofing at end of service life					
	Recommended Remedy	Replace all roofing, scuppers, caps and flashings		29,000	SF	\$9	\$261,000

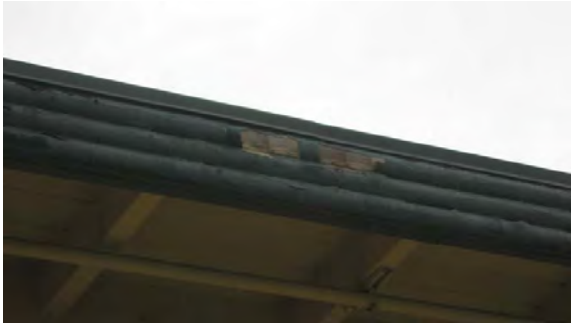
CATEGORY		DESCRIPTION	PHOTO & SITE PLAN	ESTIMATED TAKE OFF		COST / UNIT	TOTAL COST
				Quantity	Unit		
8	Existing Deficiency	Wood flag pole; non code compliant		NA			
	Recommended Remedy	Replace with Aluminum pole		1	EA	\$2,500	\$2,500
9	Existing Deficiency	Roof Fascia: paint peeling, wood deteriorating	#11				
	Recommended Remedy	Preferred: replace with cement board fascia / repaint		2,400	LF	\$13	\$31,200
10	Existing Deficiency	Portable C19: steel rusting; torn vent screen; no ramp handrail at wall; wood foundation degraded	#9, #12, #13, #14, #15				
	Recommended Remedy	Replace with concrete foundation and ramp; replace with cement board panel/trim; replace vents; handrails; add site drainage and new RWLs		1,560	SF	\$10	\$15,600
11	Existing Deficiency	Portable C17-18: steel rusting; missing vent screen; wood foundation degraded	#10, #16, #21				
	Recommended Remedy	Replace with concrete foundation and ramp; replace with cement board panel/trim; replace vents; handrails; add site drainage and new RWLs		3,200	SF	\$8	\$25,600

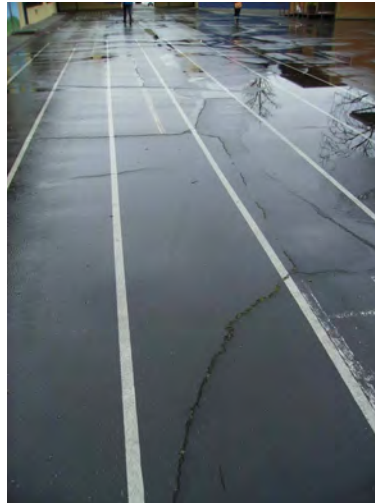
19

12	Existing Deficiency	Modular C20-22: ponded water at accessible ramp w/ temporary classroom ramps; paint degraded.	#22, #23, #24, #25				
	Recommended Remedy	Replace with concrete ramps; adjust asphalt for sheet flow; replace with cement bd. panel/trim; add site drainage and new RWLs		4,700	SF	\$18	\$84,600
13	Existing Deficiency	Portable C23: excessive steel rust; no site drainage; wood foundation degraded; wood siding damaged.	#17, #18, #26				
	Recommended Remedy	Replace with concrete foundation and ramp; replace with cement board panel/trim; replace vents; handrails; add site drainage and new RWLs		1,560	SF	\$18	\$28,080
14	Existing Deficiency	Asphalt Play Yard: excessive cracking	#19, #27				
	Recommended Remedy	SEE CIVIL ITEM # 11					\$0

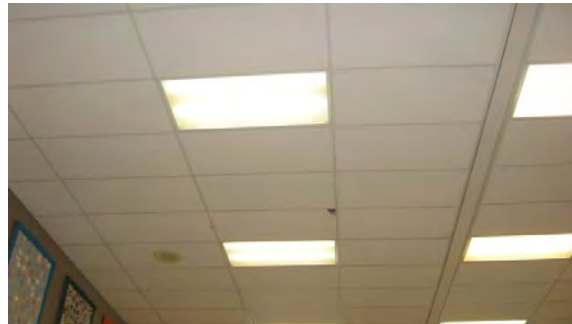
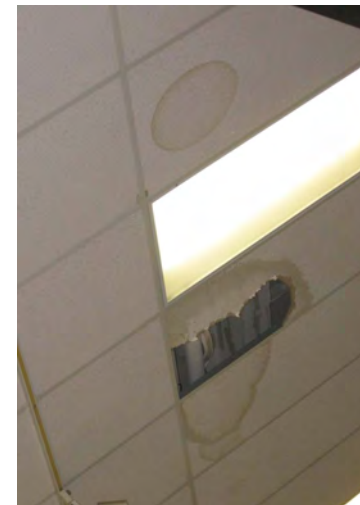
CATEGORY		DESCRIPTION	PHOTO & SITE PLAN	ESTIMATED TAKE OFF		COST / UNIT	TOTAL COST
		Quantity	Unit				
) Interior							
i) GENERAL & MAINTENANCE							
1	Existing Deficiency	Multi-Use: roof leaks, damaged ceiling tiles	#28, #29				
	Recommended Remedy	Replace ceiling tiles		3,800	SF	\$5.00	\$19,000
	Existing Deficiency	Classroom/ corridor flooring at end of service life					
	Recommended Remedy	Replace all flooring with resilient flooring, and walk-off Entry carpet mat.		26,800	SF	\$5.00	\$134,000
	Existing Deficiency	Interior painting wall covering at end of service life					
	Recommended Remedy	Repaint all interiors		29,000	SF	\$2.00	\$58,000
2	Existing Deficiency	Corridor lighting: required daytime lighting	#30, #31				
	Recommended Remedy	Add LED ceiling fixtures	Allow	800	SF	\$75	\$60,000
3	Existing Deficiency	Multi-Use Toilet: sink is not accessible compliant	#32				
	Recommended Remedy	Relocate flash hot water heater.		1	EA	\$2,100	\$2,100
