Henry Haight Elementary School

HENRY HAIGHT ES
4/30/2012

Alameda USD Facilities Assessment

Haight Elementary School
Facility Assessment Spreadsheet

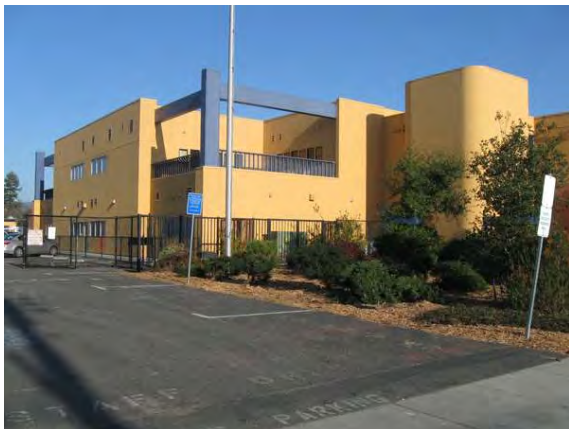
i) ACCESS							
1	Existing Deficiency	Staff Parking: stall doesn't allow passenger side egress on pavement.	#1				
	Recommended Remedy	Add 3-ft conc. walkway, designate stalls for carpool	ALLOW	300	SF	\$17	\$5,100
ii) DEFERRED MAINTENANCE							
1	Existing Deficiency	Exterior doors have reached end of service life					
	Recommended Remedy	Replace all ext. doors with metal frame and FRP door		25	EA	\$4,400	\$110,000
2	Existing Deficiency	No Trash Enclosure at this Site					
	Recommended Remedy	Install a 2-Bin Trash Enclosure per Health Dept. standards		1	LS	\$15,000	\$15,000
3	Existing Deficiency	SW 2nd Fl Deck: window leaks; end of service life	#2, #7				
	Recommended Remedy	Replace all exterior windows with new alum frame, dual pane glass		1,800	SF	\$44	\$79,200
4	Existing Deficiency	South Stairwells: Moisture penetration; paint spall	#1, #8, #9				
	Recommended Remedy	Strip CMU, reseal & repaint entire exterior	ALLOW	1,800	SF	\$12	\$21,600

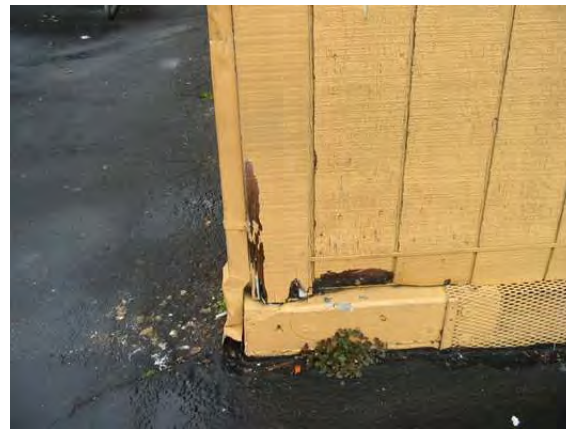
3

CATEGORY	DESCRIPTION	PHOTO & SITE PLAN	ESTIMATED TAKE OFF		COST / UNIT	TOTAL COST
			Quantity	Unit		
6 Existing Deficiency	C24 Modular: plywood siding/ trim and downspouts damaged	#3, #4, #10				
Recommended Remedy	Replace east wall with cement board panel/ trim and repaint. Replace downspouts with RWL		480	SF	\$9	\$4,320
7 Existing Deficiency	C25 Portable: wood foundation has dry rot; missing vent screens	#5, #6				
Recommended Remedy	Replace wood foundation with concrete.		15	CY	\$900	\$13,500
8 Existing Deficiency	C26 & C27 Portables: wood foundation has dry rot; damaged/ missing downspouts and no site drainage.	#11, #16, #17				
Recommended Remedy	Replace wood foundation with concrete, add site drainage and RWLs		30	CY	\$900	\$27,000

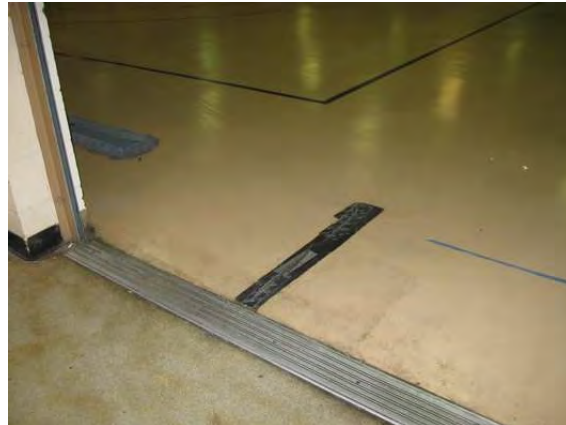
12

i) GENERAL & MAINTENANCE						
1 Existing Deficiency	Multi-Purpose: floor covering has numerous rips and holes; moveable partitions hard to move	#12, #13				
Recommended Remedy	Replace with district standard athletic floor covering; replace tracking hardware		5,000	SF	\$5.50	\$27,500
2 Existing Deficiency	Classroom/ corridor flooring at end of service life					
Recommended Remedy	Replace all flooring with resilient flooring, and walk-off Entry carpet mat.		28,700	SF	\$5.00	\$143,500
3 Existing Deficiency	Interior painting wall covering at end of service life					
Recommended Remedy	Repaint all interiors		28,700	SF	\$2.00	\$57,400
4 Existing Deficiency	Multi-Purpose Stage: missing accessible lift					
Recommended Remedy	Install Accessible Lift		1	EA	\$25,000	\$25,000
5 Existing Deficiency	Kitchen: CMU painted walls, base cove and flooring, no longer compliant per Health code	#14				
Recommended Remedy	Install epoxy flooring w/ cove base and FRP panels		1,080	SF	\$4	\$4,320

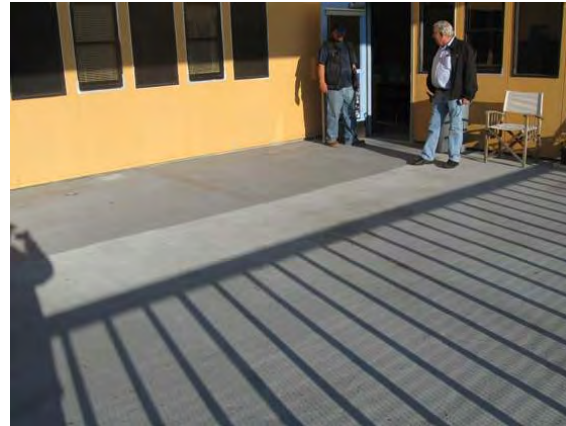
15

5	Existing Deficiency	Main Roof: repair damaged roof and apply cool roof coating					
	Recommended Remedy	Repair roofing and insulation per Report. Apply cool roof on entire roof (Repair area = 3,000 sf)		34,100	SF	\$9	\$306,900
	Existing Deficiency	2nd Floor Decks: Leaks at perimeter	#15				
	Recommended Remedy	Replace entire deck.		2,700	SF	\$12	\$32,400
