Donald Lum Elementary School

Alameda USD Facilities Assessment

**Lum Elementary School
Facility Assessment Spreadsheet**

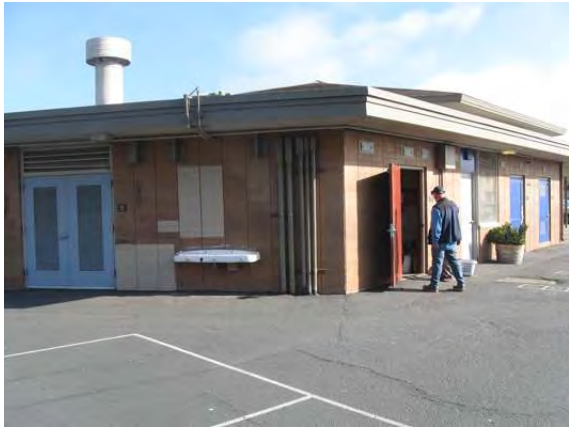
2) Architectural						\$1,606,400
A) Exterior						
i) ACCESS						
1 Existing Deficiency	Playground: drink fountain is non accessible	#1				
Recommended Remedy	Replace with accessible DF and pipe barriers		1	PAIR	\$5,000	\$5,000
ii) DEFERRED MAINTENANCE						
1 Existing Deficiency	Corridor fascia; wood damage	#2, #3, #4				
Recommended Remedy	Check for insect damage, repair and repaint		1,200	LF	\$4	\$4,800
2 Existing Deficiency	Wood siding/trims: wood check and peeling paint.	#7				
Recommended Remedy	repair/replace, prep and repaint		17,800	SF	\$3	\$53,400
3 Existing Deficiency	CMU walls: discolored and different colors	#5				
Recommended Remedy	Reseal and repaint CMU block		17,800	SF	\$5	\$89,000

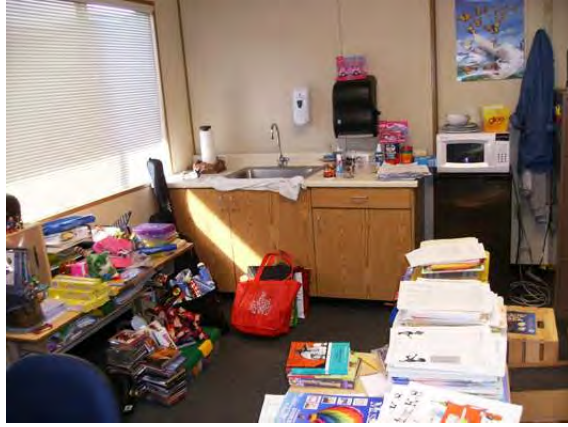
22

5	Existing Deficiency	B3 & B4 Portables: damages ceiling tiles; worn out floor carpet; aged wall paneling, windows, & door	#24, #25				
	Recommended Remedy	See Item #8 above. Provide new modular		1	LS	103000	\$103,000
6	Existing Deficiency	Music Portable: classroom sink is non-accessible; replace ceiling tiles	#22, #26				
	Recommended Remedy	See Item #8 above. Provide new modular		1	LS	103000	\$103,000
7	Existing Deficiency	Day Care Modular: damaged ceiling tile from roof leaks	#23				
	Recommended Remedy	Reseal/ repair roof and replace damaged tiles; replace carpet with resilient tile and carpet walk-off entry		1,200	SF	\$12	\$14,400
