# Washington Elementary School

# Alameda USD Facilities Assessment

**Washington Elementary School  
Facility Assessment Spreadsheet**

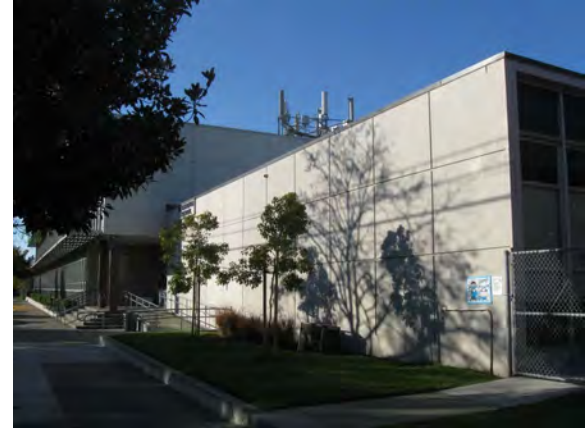
3

CATEGORY	DESCRIPTION	PHOTO & SITE PLAN	ESTIMATED TAKE OFF		COST / UNIT	TOTAL COST
			Quantity	Unit		
<b>ii) DEFERRED MAINTENANCE</b>						
<b>1</b>	<b>Existing Deficiency</b>	<b>All Cast-in Place Walls:</b> shearwall cracking and paint deterioration	#3, #8, #9			
	<b>Recommended Remedy</b>	Restore concrete surface for new sealer/ and repaint entire campus		4,000	SF	\$9
<b>2</b>	<b>Existing Deficiency</b>	<b>Alum. Window Wall:</b> missing sills, bottom panels deteriorating, and single glazed	#10, #4, #20			
	<b>Recommended Remedy</b>	Replace all windows with Alum. frame & dual pane glass		13,800	SF	\$55
<b>3</b>	<b>Existing Deficiency</b>	Exterior doors beyond service life				
	<b>Recommended Remedy</b>	Replace all ext. doors with metal frame and FRP door		24	EA	\$4,400
<b>4</b>	<b>Existing Deficiency</b>	BUR roof at end of service life				
	<b>Recommended Remedy</b>	Replace all roofs with new 30-yr BUR w/ Cool roof coating		52,210	SF	\$9

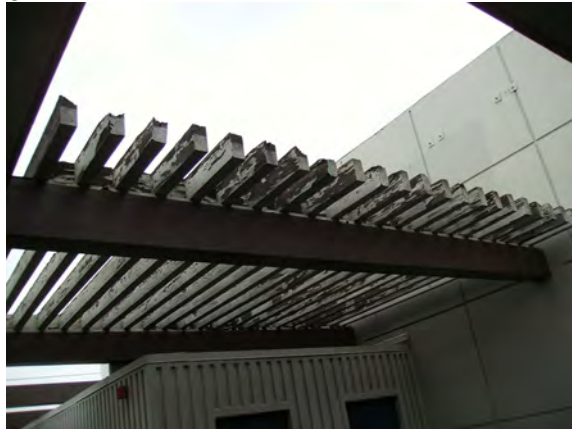
5

<b>5</b>	<b>Existing Deficiency</b>	No Trash Enclosure at this Site				
	<b>Recommended Remedy</b>	Install a 2-Bin Trash Enclosure per Health Dept. standards		1	LS	\$15,000
<b>6</b>	<b>Existing Deficiency</b>	<b>Multi-Use Entry:</b> overhead wood trellis dry rot	#5			
	<b>Recommended Remedy</b>	Remove wood beam trellis complete. Patch all anchor holes		850	SF	\$6
<b>7</b>	<b>Existing Deficiency</b>	<b>Exterior wall-mounted conduit and boxes:</b> extensive rusting.	#11			
	<b>Recommended Remedy</b>	Add U.G. conduit and pullboxes in playyard before paving, for expansion of data/power/ signal systems	ALLOW	1	LS	\$75,000
<b>B) Interior</b>						
<b>i) GENERAL &amp; MAINTENANCE</b>						
<b>1</b>	<b>Existing Deficiency</b>	<b>2-Story Seismic Gap:</b> water damage and shear cracking.	#15			
	<b>Recommended Remedy</b>	Replace with (N) expansion cover		48	LF	\$60
<b>2</b>	<b>Existing Deficiency</b>	Classroom/ Corridor flooring at end of service life	NA

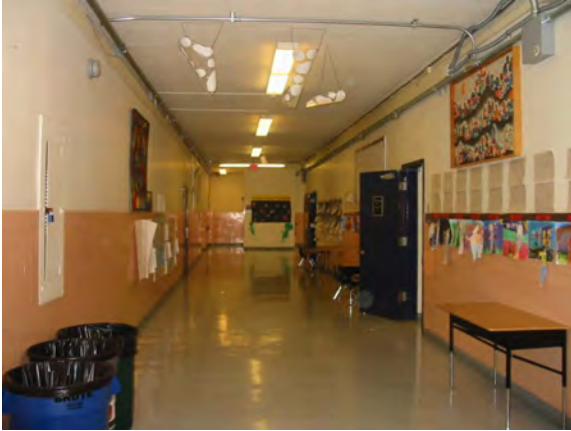
14

<b>Recommended Remedy</b>	Provide window shade treatment at south windows	ALLOW	1,800	SF	\$12	\$21,600
<b>8 Existing Deficiency</b>	<b>All Corridors:</b> exposed conduit, boxes for data, signal and power.	#14				
<b>Recommended Remedy</b>	Add suspended acoustic ceiling with drop in fixtures		7,600	SF	\$14	\$106,400
<b>9 Existing Deficiency</b>	<b>Main Entry Lobby:</b> drink fountain is non-accessible; Fire hose is not allowed.	#16				
<b>Recommended Remedy</b>	Replace D. fountain, and remove fire hose.		1	LOT	\$15,000	\$15,000
<b>10 Existing Deficiency</b>	<b>Kindergarten Staff Rm:</b> Kitchen sink is non-accessible	#17				
<b>Recommended Remedy</b>	Replace cabinets, sink, appliances, add exhaust fan		12	LF	\$700	\$8,400
