Frank Otis Elementary School

FRANK OTIS ES
4/30/2012

Alameda USD Facilities Assessment

**Otis Elementary School
Facility Assessment Spreadsheet**

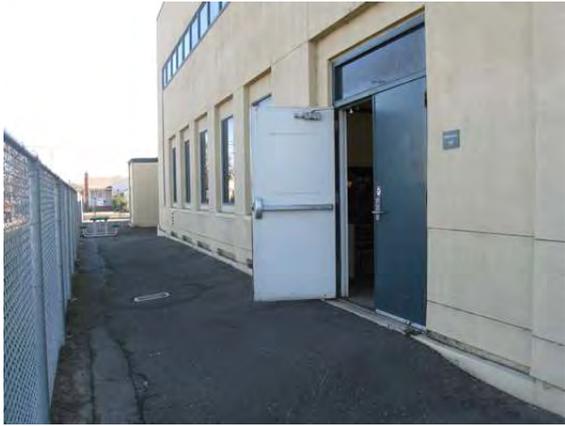
CATEGORY	DESCRIPTION	PHOTO & SITE PLAN	ESTIMATED TAKE OFF		COST / UNIT	TOTAL COST
			Quantity	Unit		
2) Architectural						\$1,380,580
A) Exterior						
i) ACCESS						
1	Existing Deficiency	Multi-Use: (2) Exit door ramps exceeds 2% cross-slope	#1	2		
	Recommended Remedy	Regrade/pave for landing and exit path of travel Item covered in Civil #10				\$0
2	Existing Deficiency	Library: Egress door is non-accessible	#2, #3	1		
	Recommended Remedy	Regrade/pave for exit ramp path of travel. Item covered in Civil #4				\$0
3	Existing Deficiency	Asphalt Play Yard: excessive cracking	#4 #5			
	Recommended Remedy	Grind, grade, and re-pave		34,000	SF	\$6.00 \$204,000
ii) DEFERRED MAINTENANCE						
1	Existing Deficiency	Wood flag pole; non code compliant				
	Recommended Remedy	Replace with Aluminum pole		1	EA	\$2,500.00 \$2,500
2	Existing Deficiency	1951 Bldgs: Plaster cracking, moisture penetration, possible framing dry rot	#6, #7, #8, #11, #12

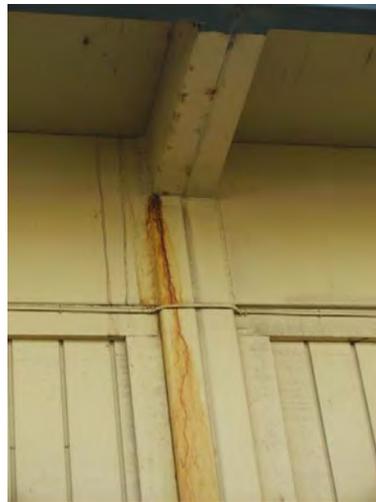
CATEGORY	DESCRIPTION	PHOTO & SITE PLAN	ESTIMATED TAKE OFF		COST / UNIT	TOTAL COST
			Quantity	Unit		
7 Existing Deficiency	Modular Rms 114/115: wood siding degraded; steel structures rusting; units at end of service life	#9, #13, #14				
Recommended Remedy	Replace with all new modular buildings		3,072	SF	\$15.00	\$46,080
Existing Deficiency	4 Portable Classrooms: roof downspouts drop on wood footing with no site drainage. Beginning dry rot.					
Recommended Remedy	Add site drainage to street, install on new concrete footings and ramps, and install new RWLs.		4	EA	\$9,000.00	\$36,000
8 Existing Deficiency	Rain Gutter & Leaders leak	#16				
Recommended Remedy	Repair or Replace gutters and leaders		0		Included above	\$0
9 Existing Deficiency	Plaster and wood paint has service life has been exceeded.					
Recommended Remedy	Repaint entire school exterior (not included in item #2 above)		19,000	SF	\$3.00	\$57,000

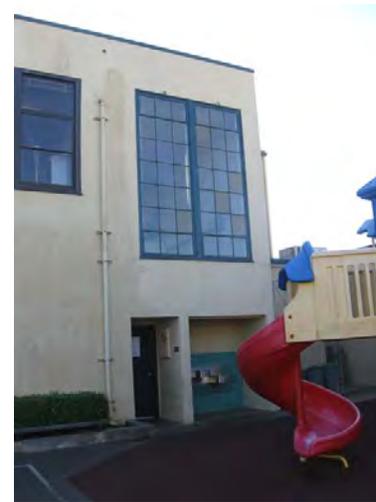
10

Recommended Remedy	Redesign with combination of stucco and metal siding; repaint complete		14,000	SF	\$15.00 \$210,000
3	Existing Deficiency	2-Story Bldg: stairwell windows unsafe; service life exceeded	#10			
	Recommended Remedy	Replace windows at all Bldgs with Alum. frame & dual pane glass		40	SF	\$80.00 \$3,200
4	Existing Deficiency	BUR roof at end of service life				
	Recommended Remedy	Replace all roofs with new 30-yr BUR w/ Cool roof coating		35,500	SF	\$9.00 \$319,500
5	Existing Deficiency	Exterior doors at end of service life				
	Recommended Remedy	Install painted galv. metal door frames with FRP doors and new hardware with high-security keying		42	EA	\$4,400.00 \$184,800
6	Existing Deficiency	No Trash Enclosure at this Site				
	Recommended Remedy	Install a 2-Bin Trash Enclosure per Health Dept. standards		1	LS	\$15,000.00 \$15,000

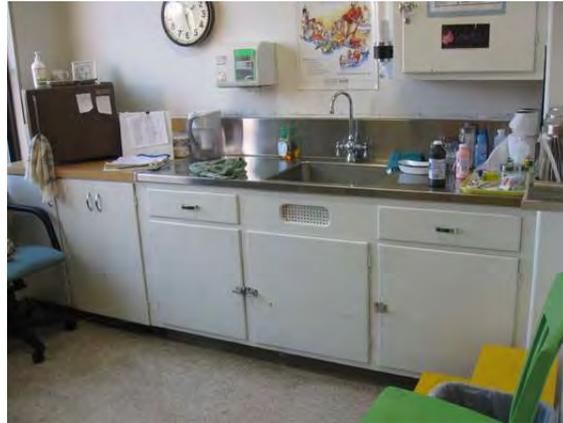
15

i) GENERAL & MAINTENANCE						
1 Existing Deficiency	Health Office: non-accessible sink	#15				
Recommended Remedy	Replace cabinetry & sink	Allow	24	LF	\$500.00	\$12,000
2 Existing Deficiency	2-Story Corridors are dark					
Recommended Remedy	Install new acoustic tile drop ceiling with new troffer fixtures. See Electrical Lighting item also		7,000	SF	\$6.00	\$42,000
3 Existing Deficiency	Deteriorated painted wall and trim finish					
Recommended Remedy	Repaint all interior walls, trims, doors, and other painted items		35,500	SF	\$2.00	\$71,000
4 Existing Deficiency	Classroom/ Corridor flooring at end of service life					
Recommended Remedy	Replace all flooring with resilient flooring, and walk-off Entry carpet mat.		35,500	SF	\$5.00	\$177,500
