Paden Elementary School

PADEN ES
4/30/2012

Alameda USD Facilities Assessment

**Paden Elementary School
Facility Assessment Spreadsheet**

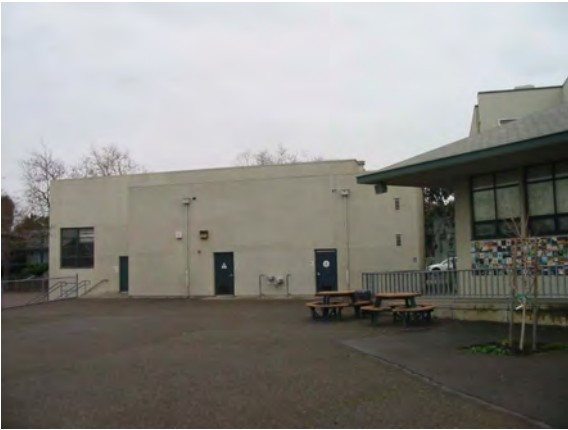
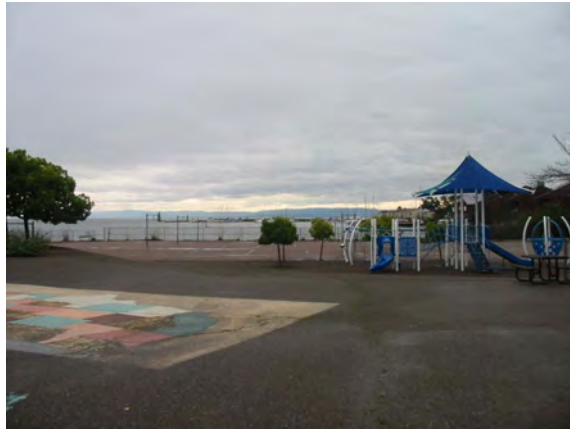
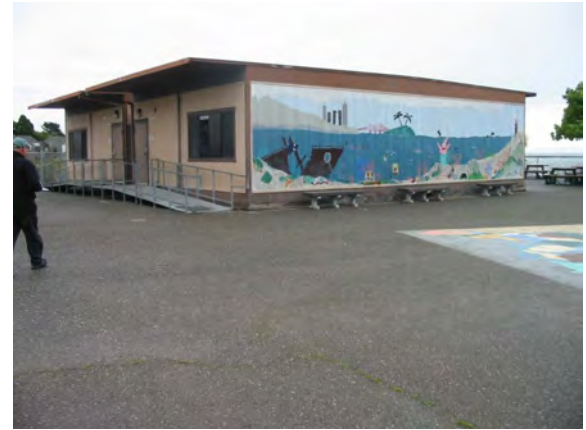
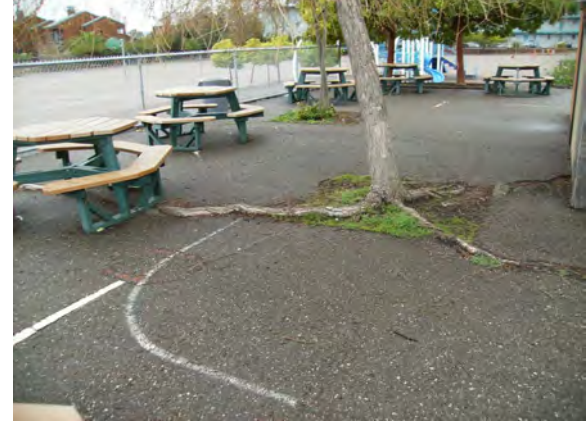
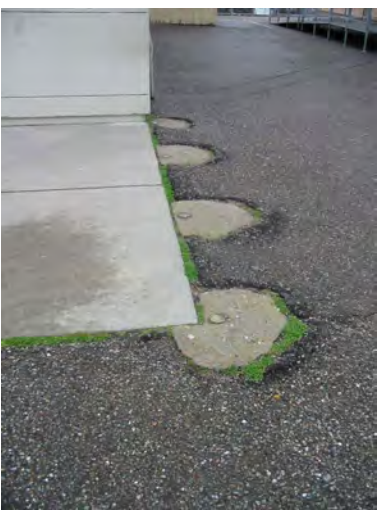
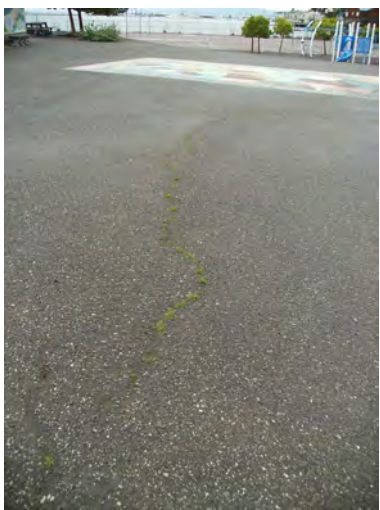
| CATEGORY | | DESCRIPTION | PHOTO & SITE PLAN | ESTIMATED TAKE OFF | | COST / UNIT | TOTAL COST |
|---|---|---|---|---|---|---|---|
| 1 | Existing Deficiency | Upper Playground: numerous trip hazards | #1, #2, #3, #6, #7, #8 | | | | |

| CATEGORY | | DESCRIPTION | PHOTO & SITE PLAN | ESTIMATED TAKE OFF | | COST / UNIT | TOTAL COST |
|---|---|---|---|---|---|---|---|
| | Recommended Remedy | Grind, regrade, and repave asphalt. | | 24,000 | SF | \$5.89 | \$141,360 |

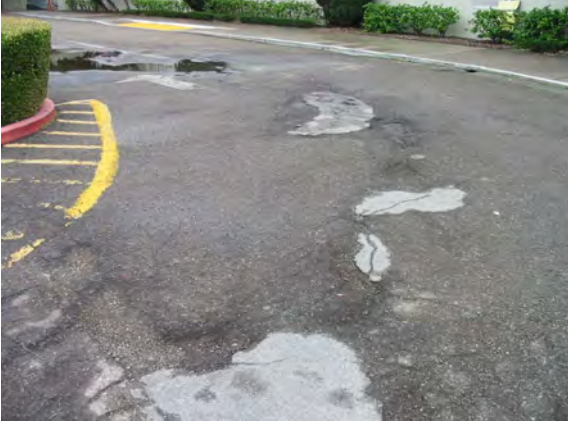
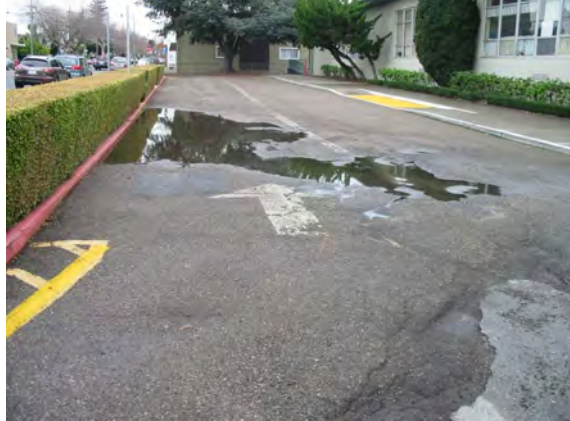
| CATEGORY | | DESCRIPTION | PHOTO & SITE PLAN | ESTIMATED TAKE OFF | | COST / UNIT | TOTAL COST |
|---|---|--|---|---|---|---|---|
| 2 | Existing Deficiency | Student Drop-off: deteriorated pavement | #4, #5 | | | | |

| CATEGORY | DESCRIPTION | PHOTO & SITE PLAN | ESTIMATED TAKE OFF | COST / UNIT | TOTAL COST | |
|---|--|---|---|---|---|---|
| 5 Existing Deficiency | Drop-Off Zone: Pavement badly deteriorated. | 5C | | | | |
| Recommended Remedy | Grind existing asphalt for possible reuse elsewhere as CI 2 AB. Repave with 3" min. new asphalt. Restripe per existing. | | 7,400 | SF | \$7.00 | \$51,800 |

| CATEGORY | | DESCRIPTION | PHOTO & SITE PLAN | ESTIMATED TAKE OFF | | COST / UNIT | TOTAL COST |
|---|---|--|---|---|---|---|---|
| | Recommended Remedy | Grind, regrade, and repave asphalt. See Civil #5 | | | | | \$0 |

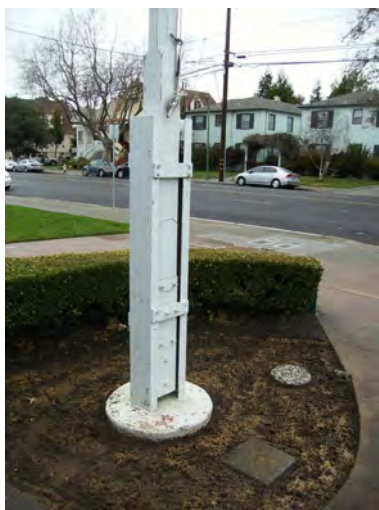
9

| CATEGORY | | DESCRIPTION | PHOTO & SITE PLAN | ESTIMATED TAKE OFF | | COST / UNIT | TOTAL COST |
|---|---|--|---|---|---|---|---|
| 1 | Existing Deficiency | Wood flag pole; non code compliant | #9 | | | | |

| CATEGORY | | DESCRIPTION | PHOTO & SITE PLAN | ESTIMATED TAKE OFF | | COST / UNIT | TOTAL COST |
|---|---|--|---|---|---|---|---|
| | Recommended Remedy | Replace with Aluminum pole | | 1 | EA | \$2,500.00 | \$2,500 |

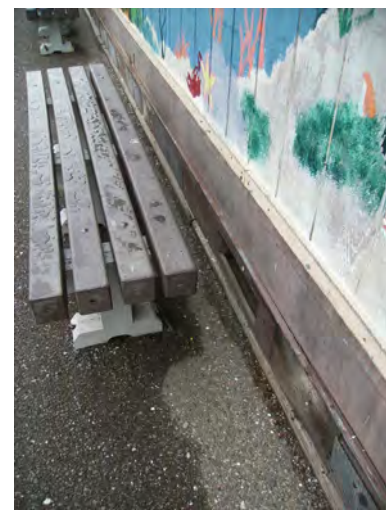
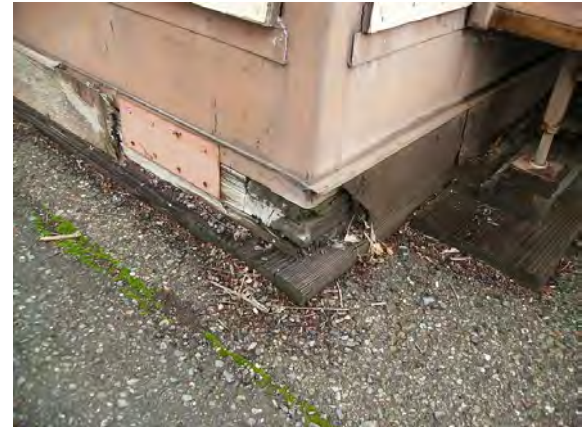
| CATEGORY | | DESCRIPTION | PHOTO & SITE PLAN | ESTIMATED TAKE OFF | | COST / UNIT | TOTAL COST |
|---|---|--|---|---|---|---|---|
| 4 | Existing Deficiency | (2) Portables: wood foundation has dry rot, and missing vent screens | #10, #13 | | | | |

| CATEGORY | | DESCRIPTION | PHOTO & SITE PLAN | ESTIMATED TAKE OFF | | COST / UNIT | TOTAL COST |
|---|---|--|---|---|---|---|---|
| | Recommended Remedy | Preferred: Replace with concrete footing and add Site Drainage inlets, and new RWLs | | 28 | CY | \$650.00 | \$18,200 |

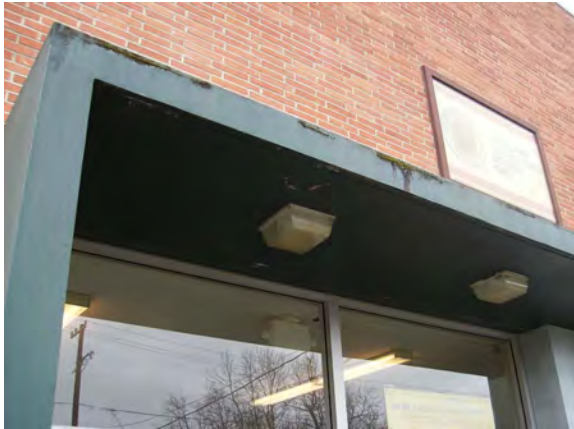
11

| CATEGORY | | DESCRIPTION | PHOTO & SITE PLAN | ESTIMATED TAKE OFF | | COST / UNIT | TOTAL COST |
|---|---|--|---|---|---|---|---|
| 2 | Existing Deficiency | Entry Canopy: water damage at plaster framing. | #11 | | | | |

| CATEGORY | | DESCRIPTION | PHOTO & SITE PLAN | ESTIMATED TAKE OFF | | COST / UNIT | TOTAL COST |
|---|---|--|---|---|---|---|---|
| | Recommended Remedy | Remove roofing membrane, dry rot & repair/replace plaster, framing & membrane | | 2,000 | SF | \$10.00 | \$20,000 |

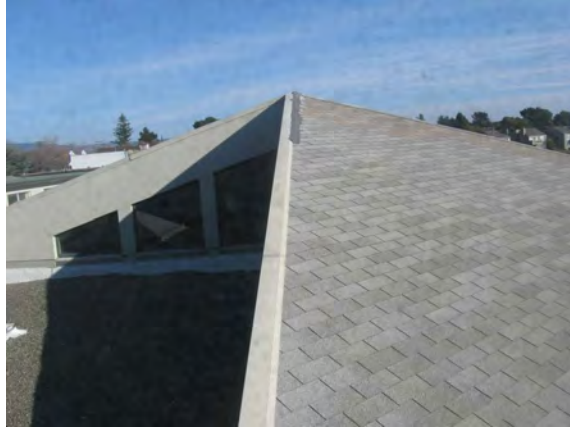
12

| CATEGORY | | DESCRIPTION | PHOTO & SITE PLAN | ESTIMATED TAKE OFF | | COST / UNIT | TOTAL COST |
|---|---|--|---|---|---|---|---|
| 3 | Existing Deficiency | Entire Roof: Rake flashing leaks, shingles at end of service life | #12 | | | | |

| CATEGORY | | DESCRIPTION | PHOTO & SITE PLAN | ESTIMATED TAKE OFF | | COST / UNIT | TOTAL COST |
|---|---|--|---|---|---|---|---|
| | Recommended Remedy | Replace with S.S.Metal roof where shingled, and new BUR where flat Include allowance for dry rot reframing at Media Center | | 30,100 | SF | \$18.00 | \$541,800 |

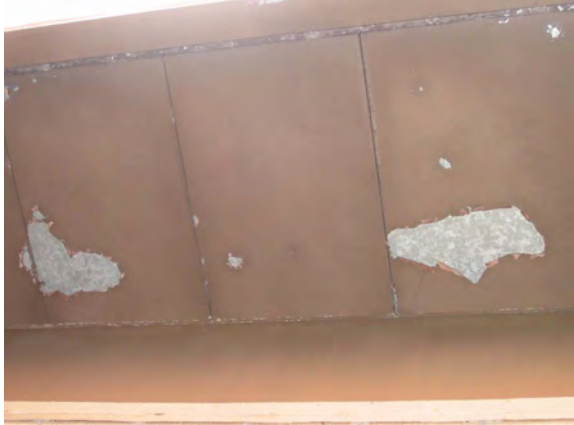
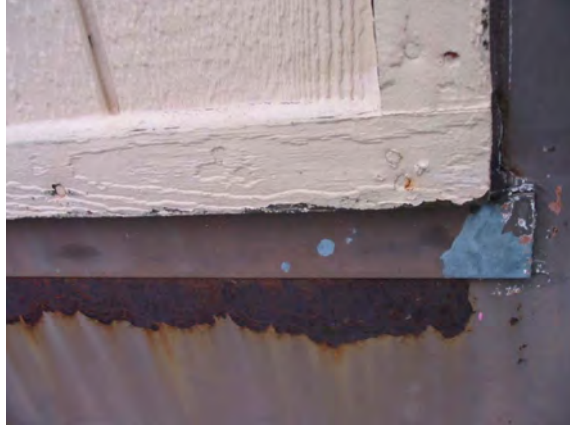
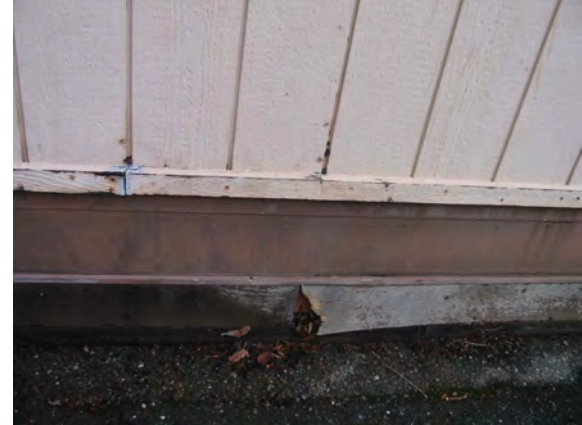
| CATEGORY | | DESCRIPTION | PHOTO & SITE PLAN | ESTIMATED TAKE OFF | | COST / UNIT | TOTAL COST |
|---|---|--|---|---|---|---|---|
| 5 | Existing Deficiency | (2) Portables: Metal paint peeling, wood siding/trim nails rusting out. | #14, #15, #16 | | | | |

| CATEGORY | | DESCRIPTION | PHOTO & SITE PLAN | ESTIMATED TAKE OFF | | COST / UNIT | TOTAL COST |
|---|---|--|---|---|---|---|---|
| | Recommended Remedy | Reclad in cement board panel/trim & repaint | | 1,600 | SF | \$7.00 | \$11,200 |

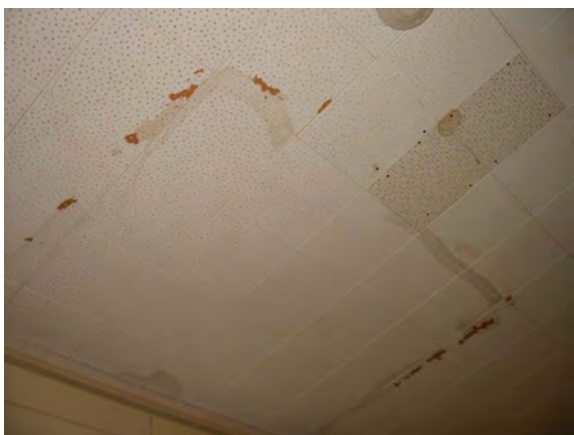
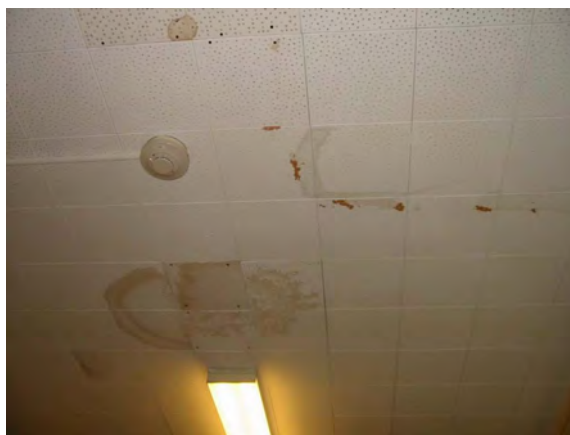
| CATEGORY | DESCRIPTION | PHOTO & SITE PLAN | ESTIMATED TAKE OFF | COST / UNIT | TOTAL COST |
|---|---|--|---|---|---|
| 1 | Existing Deficiency | 2-Story Wing: water damaged 1st. Fl. ceiling tiles and exposed conduit | #17, #18 | | |

| CATEGORY | DESCRIPTION | PHOTO & SITE PLAN | ESTIMATED TAKE OFF | COST / UNIT | TOTAL COST |
|---|---|--|---|---|---|
| | Recommended Remedy | Install new acoustic tile drop ceiling with new troffer fixtures. See Electrical Lighting item also | | 1,600 SF | \$7.00 \$11,200 |

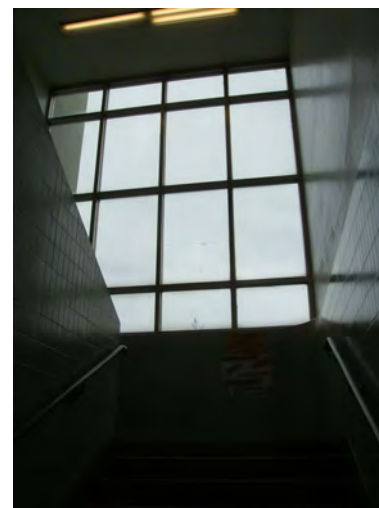
19

| CATEGORY | DESCRIPTION | PHOTO & SITE PLAN | ESTIMATED TAKE OFF | COST / UNIT | TOTAL COST |
|---|---|--|---|---|---|
| 2 | Existing Deficiency | 2-Story Wing: Stairwell window bullet holes | #19 | | |

| CATEGORY | DESCRIPTION | PHOTO & SITE PLAN | ESTIMATED TAKE OFF | COST / UNIT | TOTAL COST |
|---|---|--|---|---|---|
| | Recommended Remedy | See Item #6 above | | 200 SF | \$0.00 \$0 |
