William G. Paden
Elementary School
444 Central Avenue

William G. Paden Elementary School - Background Information

William G. Paden Elementary School - Existing Conditions Summary

William G. Paden Elementary School - Facilities Needs Spreadsheet

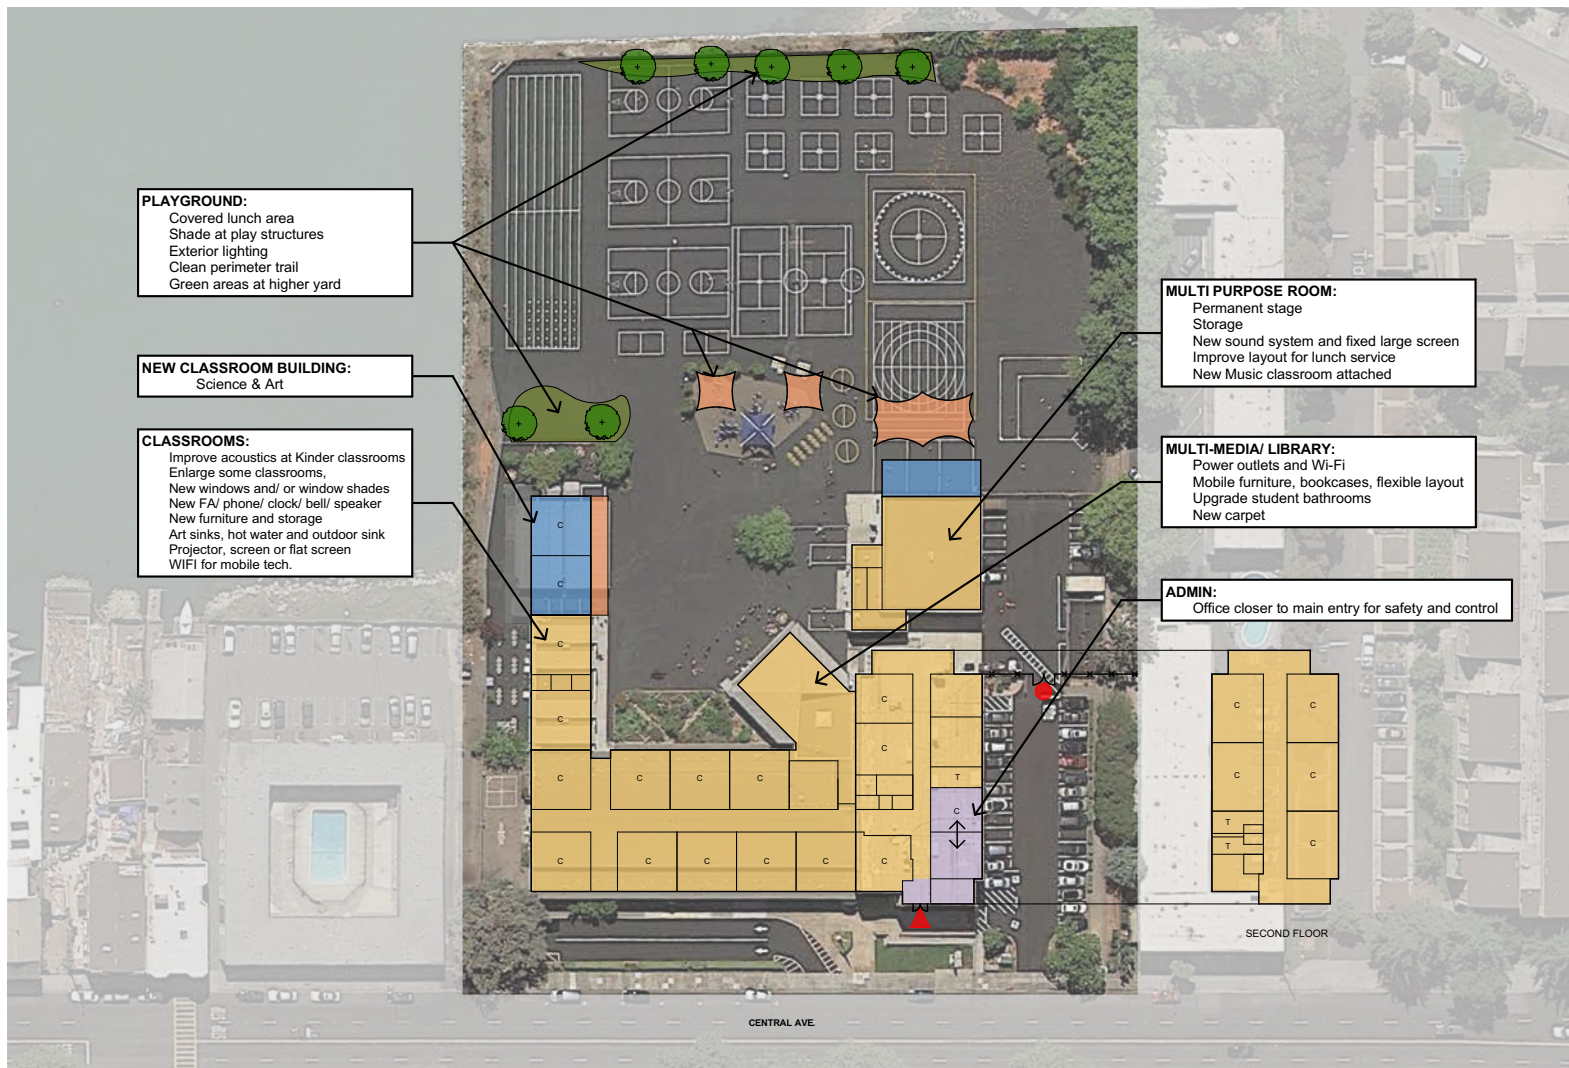
WILLIAM G. PADEN ELEMENTARY SCHOOL SITE PLAN

PLAYGROUND:
 Covered lunch area
 Shade at play structures
 Exterior lighting
 Clean perimeter trail
 Green areas at higher yard

NEW CLASSROOM BUILDING:
 Science & Art

CLASSROOMS:
 Improve acoustics at Kinder classrooms
 Enlarge some classrooms,
 New windows and/ or window shades
 New FA/ phone/ clock/ bell/ speaker
 New furniture and storage
 Art sinks, hot water and outdoor sink
 Projector, screen or flat screen
 WIFI for mobile tech.

MULTI PURPOSE ROOM:
 Permanent stage
 Storage
 New sound system and fixed large screen
 Improve layout for lunch service
 New Music classroom attached

MULTI-MEDIA/ LIBRARY:
 Power outlets and Wi-Fi
 Mobile furniture, bookcases, flexible layout
 Upgrade student bathrooms
 New carpet

ADMIN:
 Office closer to main entry for safety and control
