# Lincoln Middle School

LINCOLN MS  
4/30/2012

## Alameda USD Facilities Assessment

**Lincoln Middle School**  
**Facility Assessment Spreadsheet**

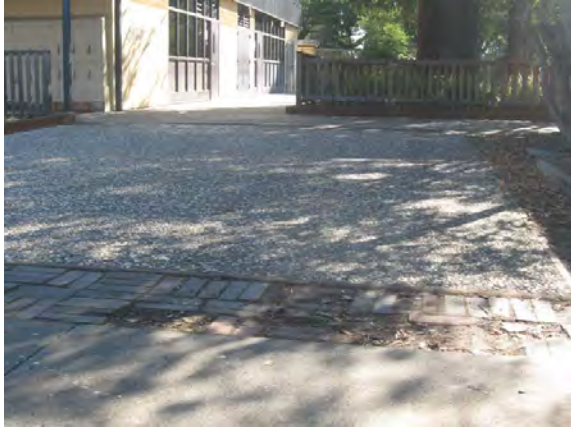
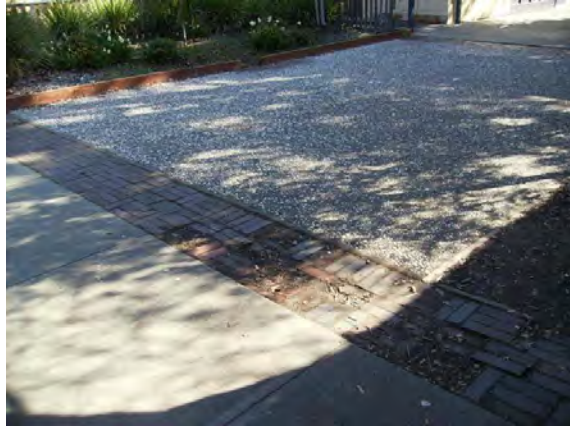
CATEGORY		DESCRIPTION	PHOTO & SITE PLAN	ESTIMATED TAKE OFF Quantity	Unit	COST / UNIT	TOTAL COST
2) Architectural							\$3,115,563
A) Exterior							
i) ACCESS							
1	Existing Deficiency	Courtyard Paving: numerous trip hazards	#1, #2				
	Recommended Remedy	Replace pavers with concrete walks		600	SF	\$20	\$12,000
2	Existing Deficiency	Playground & Parking Lot : excessive asphalt cracking and trip hazards.	#3, #4, #5, #7				
	Recommended Remedy	Grind existing asphalt, regrade, and repave		51,000	SF	\$6.00	\$306,000
3	Existing Deficiency	Bike Cage: Existing cage to small by double					
	Recommended Remedy	Double size of chainlink Bike Cage and add lighting		200	SF	\$30.00	\$6,000
4	Existing Deficiency	Play Yard: Volleyball inserts are trip hazard and rusted out, poles beyond service life.					
	Recommended Remedy	Replace insert with brass or SS, and provide new poles		6	SETS	\$500.00	\$3,000
ii) DEFERRED MAINTENANCE

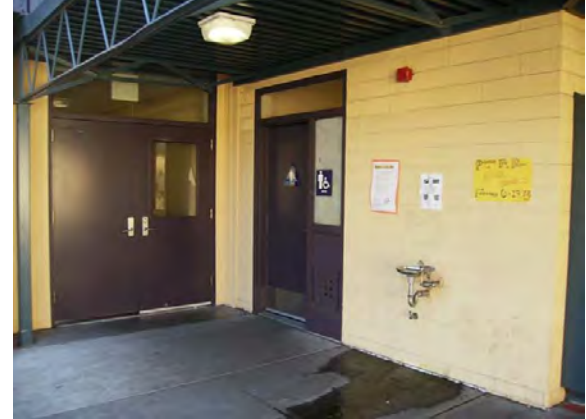
1	Existing Deficiency	MC/Lib Entry: drinking fountain is non accessible	#6				
	Recommended Remedy	replace w/ compliant D.F. and place pipe barriers		1	PAIR	\$6,000	\$6,000
2	Existing Deficiency	Restroom Bldg: Boys & Girls drink fountains are non accessible	#11				
	Recommended Remedy	replace w/ compliant D.F. and place pipe barriers		2	PAIR	\$6,000	\$12,000
3	Existing Deficiency	Multi-Use Bldg: accessible D.F. is non compliant	#13				
	Recommended Remedy	Add pipe barriers		1	PAIR	\$500	\$500
4	Existing Deficiency	2-Story Modular: stairs/ rails have excessive corrosion	#8, #9, #10, #14, #15				
	Recommended Remedy	prep, treat steel, and repaint		140	LF	\$35	\$4,900
5	Existing Deficiency	Corridor Lockers: many corroded and broken	#17				
	Recommended Remedy	Replace with new District standard Pemko lockers		1,100	EA	\$425	\$467,500
6	Existing Deficiency	Roofs: BUR roofing at end of service life; roof drains missing strainers and most are clogged

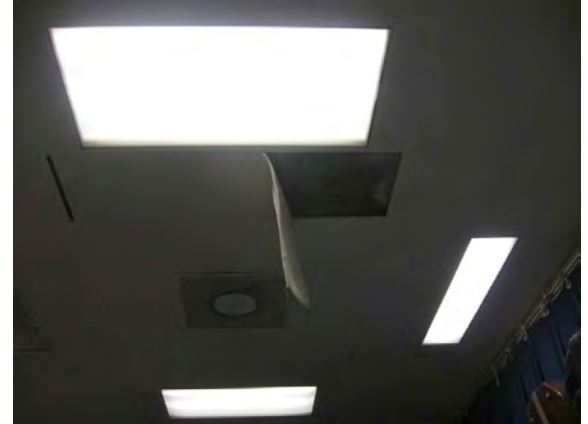
16

<b>i) GENERAL &amp; MAINTENANCE</b>						
<b>1</b> Existing Deficiency	Music Room: delaminating ceiling tiles	#16				
Recommended Remedy	Replace ceiling tiles		1,200	SF	\$5	\$6,000
<b>2</b> Existing Deficiency	Multi-Use: tears in gym flooring; moveable partition binds	#18, #21				
Recommended Remedy	Install District standard concrete athletic floor covering; replace partitions with lightweight manual panels.	Allow	8,400	SF	\$5	\$42,000
<b>3</b> Existing Deficiency	Toilet Modulars: sinks are missing drain line boots; urinal partitions missing.	#22				
Recommended Remedy	Install molded rubber boots; install partitions w/ floor/ceiling support.		6	Sinks	\$1,600	\$9,600
			2	Partitions	\$2,400	\$4,800
<b>4</b> Existing Deficiency	Media Center: non compliant fire exits from stored equipment	#23, #24				
Recommended Remedy	Add storage space on campus	Allow	2,000	SF	\$200	\$400,000
<b>5</b> Existing Deficiency	ClassRm 713, 712 Sinks: non accessible	#19, #25

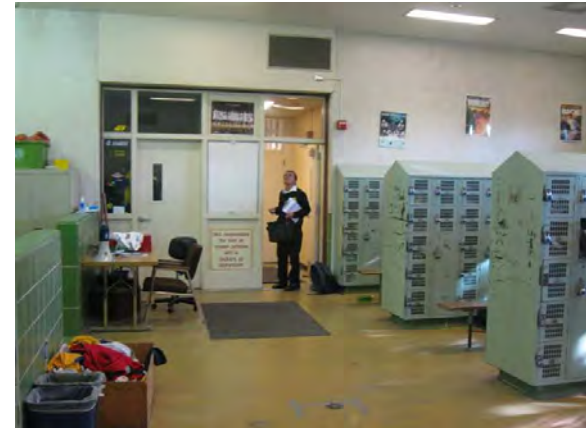
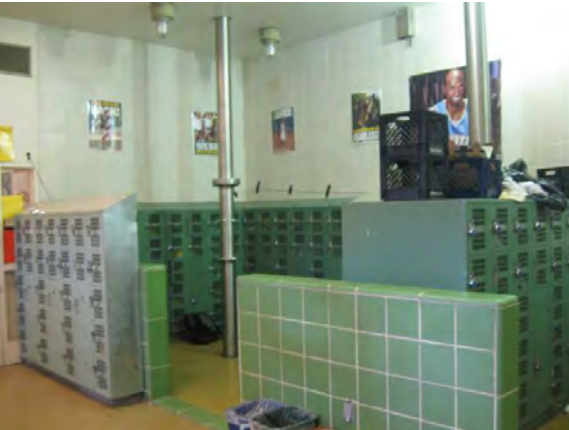
Recommended Remedy	Replace cabinetry and sinks	Allow	48	LF	\$600	\$28,800
<b>6</b> Existing Deficiency	Boy/Girls Locker Rms: replace older lockers	#26, #27				
Recommended Remedy	Replace with new District standard lockers		200	EA	\$438	\$87,500

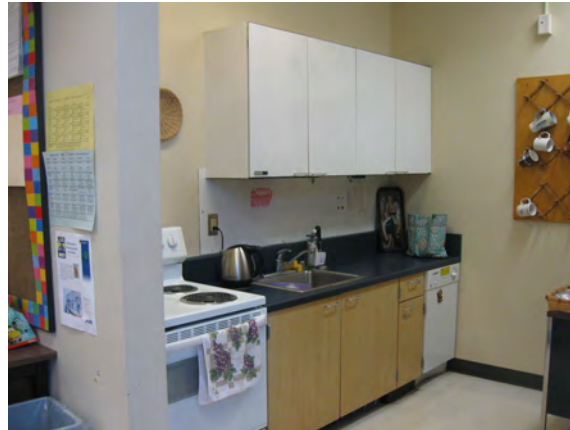
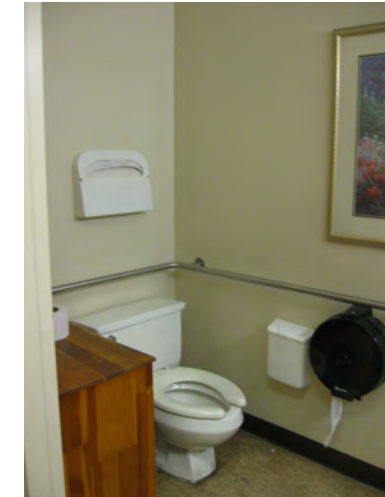
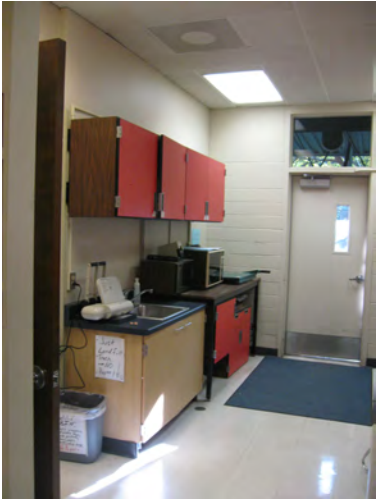
CATEGORY		DESCRIPTION	PHOTO & SITE PLAN	ESTIMATED TAKE OFF		COST / UNIT	TOTAL COST
				Quantity	Unit		
7	Existing Deficiency	Admin: Staff toilets and Kitchen need upgrade	#28, #29, #30				
	Recommended Remedy	Upgrade walls, flooring cabinets and appliances. Add exhaust fan at stove	ALLOW	1	LS	\$55,000	\$55,000
8	Existing Deficiency	Deteriorated painted walls, trims and misc. finish					
	Recommended Remedy	Repaint all interior walls, trims, doors, and other painted items		55,325	SF	\$1.50	\$82,988
9	Existing Deficiency	All flooring at end of service life					
	Recommended Remedy	Replace all flooring with resilient flooring, and walk-off Entry carpet mat at classrooms		35,000	SF	\$5	\$175,000
10	Future Needs:	Campus enrollment will expand in future					
	Recommended Remedy	Add (6) more Modular units in Playground area		6	EA	\$60,000	\$360,000
<b>3) Mechanical / Plumbing</b>							<b>\$1,199,894</b>
<b>A) Exterior</b>
