Will C. Wood Middle School

WOOD MS
4/30/2012

Alameda USD Facilities Assessment

**Wood Middle School
Facility Assessment Spreadsheet**

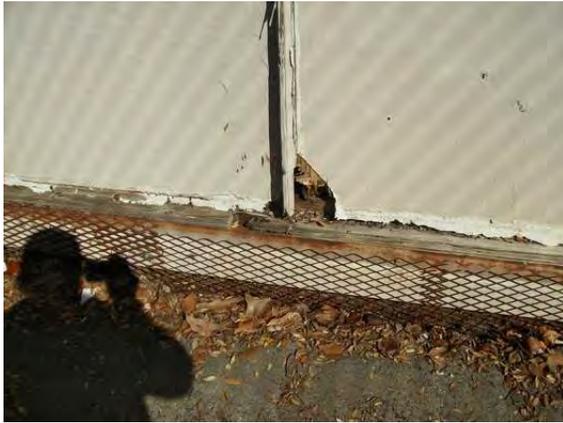
14

5	Existing Deficiency	Exterior painted finish is deteriorated	NA			
	Recommended Remedy	Reseal and repaint all exterior walls, trims fascia, etc.		63,870	SF	\$2
6	Existing Deficiency	Exterior doors beyond service life	NA			
	Recommended Remedy	Replace all ext. doors with metal frame and FRP door		45	EA	\$4,400
7	Existing Deficiency	3-Story Bldg: steel moment frames need constant painting and are unsightly	#7	Allow		
	Recommended Remedy	Design and place non-corrosive metal clad sheathing		1	LS	\$90,000
8	Existing Deficiency	Modular Wings A,B, & C: exterior paneling at end of service life; steel frame corrosion; paint chipping/ spalling	#13,14,15, 16,17,18			
	Recommended Remedy	Replace with new modulares.	#19, 20, 21, 25	13,440	SF	\$71.00
