# Alameda High School

ALAMEDA HS  
04/30/2012

# Alameda USD Facilities Assessment

**Alameda High School**  
**Facility Assessment Spreadsheet**

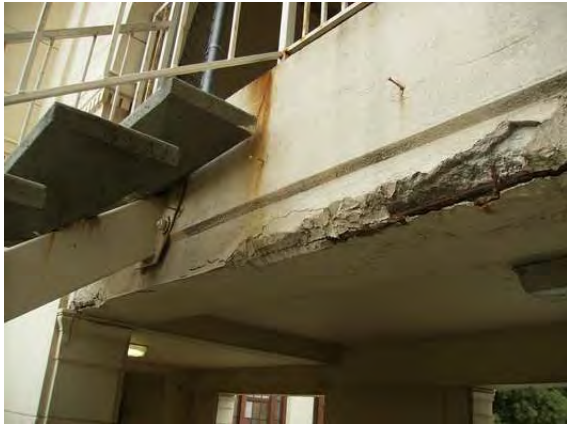
CATEGORY		DESCRIPTION	PHOTO & SITE PLAN	ESTIMATED TAKE OFF		COST / UNIT	TOTAL COST
Quantity	Unit						
10	Existing Deficiency	<b>West Wing Bridge:</b> Egress Stair not structurally compliant; rebar corrosion and concrete spalling;	#13, #14, #19				
	Recommended Remedy	Replace Stair with new compliant design; use specialty epoxy concrete repair		14	CY	\$850	\$11,900
11	Existing Deficiency	<b>West Wing Bridge:</b> terrazzo and concrete steps deteriorating	#15, #16				
	Recommended Remedy	Repair or replace treads		144	SF	\$14	\$2,016
12	Existing Deficiency	<b>West Wing:</b> Loading Dock function & stair damage					
	Recommended Remedy	Reconfigure dock with tailgate lift; repair concrete stair and install new guard/ handrails	Allow	1	LS	\$20,000	\$20,000
13	Existing Deficiency	<b>West Wing East elevation;</b> rails non compliant; <b>North/South elevations:</b> All rails have excessive corrosion with deterioration.	#21,22,26, &27

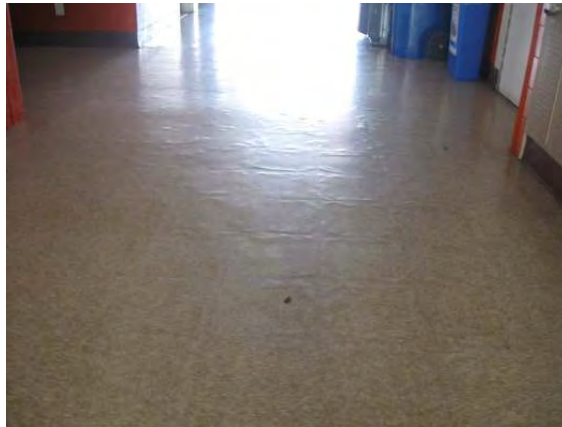
45

<b>i) GENERAL &amp; MAINTENANCE</b>							
1	Existing Deficiency	<b>Academic &amp; Tech Arts Bldgs:</b> 1st floor vinyl tile is delaminating from excessive moisture release	#45				
	Recommended Remedy	Strip tile, bead blast, seal concrete and apply new VCT		2,200	SF	\$10	\$22,000
2	Existing Deficiency	<b>Tech Arts Bldg:</b> Corridor drink fountain is non compliant	#47				
	Recommended Remedy	Add pipe barriers		1	Pair	\$225	\$225
3	Existing Deficiency	<b>West Wing:</b> 1st floor ceiling damage; concrete pedestal trip hazzard	#52, #53				
	Recommended Remedy	Confirm leak is repaired and repair area, or replace with entire new corridor ceiling; Install new District standard lockers on pedestal or demo and replace concrete floor.		11,210	SF	\$6.37	\$71,408

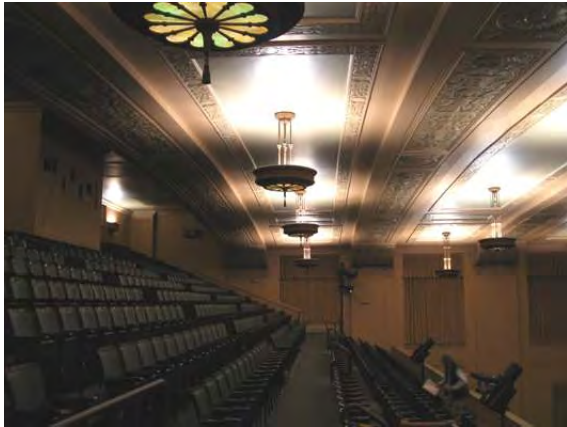
63

8	Existing Deficiency	<b>Theater Bldg 1st Fl Lobby:</b> some plaster damage and paint scalling in Lobby	#56, #60				
	Recommended Remedy	Investigate cause and repair plaster; repaint		800	SF	\$5	\$4,000
9	Existing Deficiency	<b>Theater Bldg: 2nd Fl Corridor:</b> no accessible drink fountain; exposed wall pipe; broken lockers; and ceiling tile delamination;	#57, #59, #61, #62				
	Recommended Remedy	Replace D. fountain with accessible fountain; replace lockers with new district standard, and repair wall and ceiling tiles.		9,500	SF	\$11	\$104,500
10	Existing Deficiency	<b>Theater Bldg: 3rd Fl Corridor;</b> no accessible drink fountain; dim lighting.	#69, #70				
	Recommended Remedy	Replace D. fountain with accessible fountain; add solatube skylighting (Includes all infrastructure needed)	Allow	1	LS	\$8,500	\$8,500
11	Existing Deficiency	<b>Theater Balcony:</b> no accessible seating from 2nd or 3rd level; stage lighting poles not seismic braced	#63, #71

Recommended Remedy	Reconfigure platform for more depth to allow wheelchair seating; Structurally design lighting	Allow	1	LS	\$45,000	\$45,000
12	Existing Deficiency	<b>Theater Balcony 2nd Fl:</b> no handrail and needs minimum floor lighting during performance	#72				
	Recommended Remedy	Confirm ramp is less than 8.33%, add handrails and strip lighting		360	SF	\$24	\$8,640
13	Existing Deficiency	<b>Patton Gym:</b> 84-yr old interior finishes are beyond service life	#99, #105				
	Recommended Remedy	Remove all radiators, piping, misc. items from brick walls; install furring and GWB; repaint		13,800	SF	\$10	\$138,000

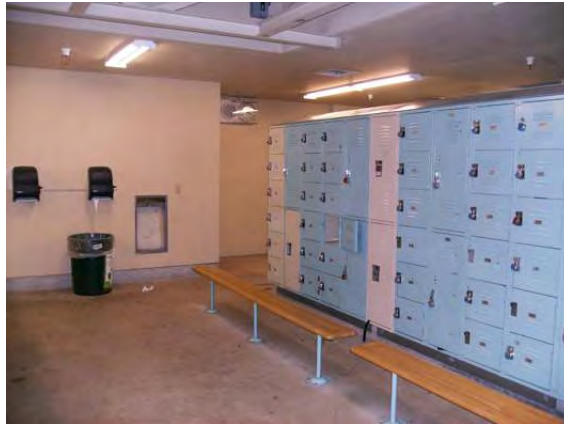
67

CATEGORY		DESCRIPTION	PHOTO & SITE PLAN	ESTIMATED TAKE OFF		COST / UNIT	TOTAL COST
Quantity	Unit						
23	Existing Deficiency	<b>Gym - Boys Locker Rm:</b> many broken lockers; dingy, faded walls, deteriorated concrete floor.	#67				
	Recommended Remedy	Replace lockers, add tile wainscot, solatube daylighting, and epoxy flooring.		3,066	SF	\$55.28	\$169,488
24	Existing Deficiency	<b>Gym - Girls Locker Rm:</b> dingy wall, and stained concrete flooring.	#74,75, &76				
	Recommended Remedy	Add solatube daylighting, epoxy flooring, and paint walls		1,200	SF	\$33	\$39,600
25	Existing Deficiency	<b>Gym - West Exit Corridor:</b> Deteriorated wall board, doors and exposed electrical box.	#77, #78, #79				
	Recommended Remedy	Remove electrical box, repair walls, prep and repaint , and install 8-ft corner guards.		1,488	SF	\$8	\$11,904
26	Existing Deficiency	<b>Pool Bldg:</b> concrete floor is degraded; piping/roof framing exposed; wall finishes not durable	#121, 122, 123,124,125

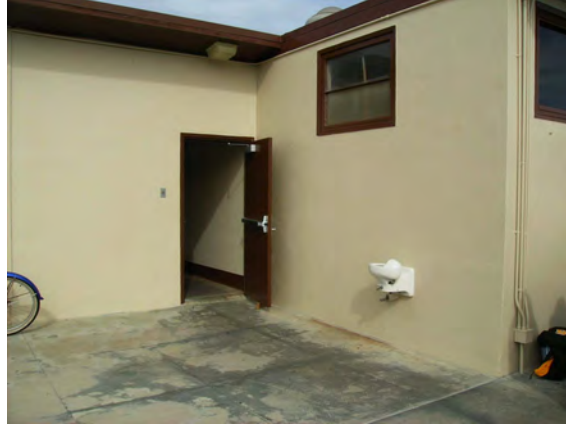
81

CATEGORY		DESCRIPTION	PHOTO & SITE PLAN	ESTIMATED TAKE OFF		COST / UNIT	TOTAL COST
Quantity	Unit						
7	Existing Deficiency	<b>Pool Bldg:</b> locker room to pool deck non compliant and numerous slope and crack issues	#81, #82, #83				
	Recommended Remedy	Remove and replace concrete deck		1,800	SF	\$23	\$41,400
8	Campus Wide Deficiency	<b>Student Lockers:</b> most are in need of repairs at hinges and latches					
	Recommended Remedy	Replace w/ district Standard Pemco lockers		2,000	EA	\$650	\$1,300,000
ii)	<b>DEFERRED MAINTENANCE</b>						
1	Campus Wide Deficiency	<b>Roof:</b> BUR roofing at end of service life, except Tech Arts & Academic Bldgs					
	Recommended Remedy	Replace all roofing, scuppers, drains, caps and flashings except at Tech Arts & Academic		73,000	SF	\$9	\$657,000
2	Campus Wide Deficiency	<b>All Bldg. Exteriors:</b> painted finish is deteriorated					
	Recommended Remedy	Reseal and repaint all exterior walls, trims fascia, etc.		44,000	SF	\$5	\$220,000

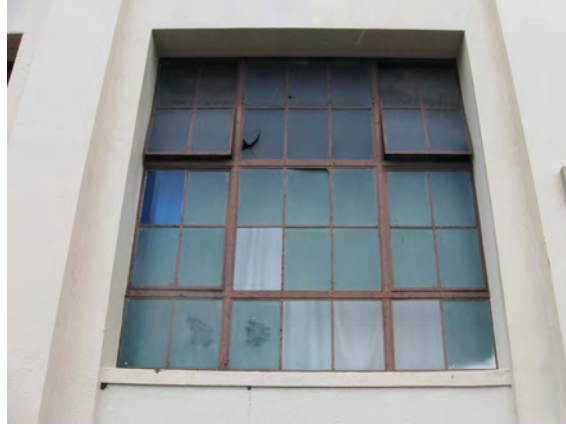
84

Recommended Remedy	Reconstruct stair to accessible ramp		400	SF	\$90	\$36,000
18	Existing Deficiency	<b>Patton Gym:</b> All (E) windows wood and steel frame windows have reached end of service life	#84, #85, #88				
	Recommended Remedy	Replace all windows with FRP sash and IGU tempered glazing		800	SF	\$40	\$32,000
19	Existing Deficiency	<b>Patton Gym:</b> Roll-up door jamb and header damaged and deteriorating.	#80, #90				
	Recommended Remedy	Repair wall framing/ install new metal jamb & header, and new roll-up door		1	LS	\$18,000	\$18,000

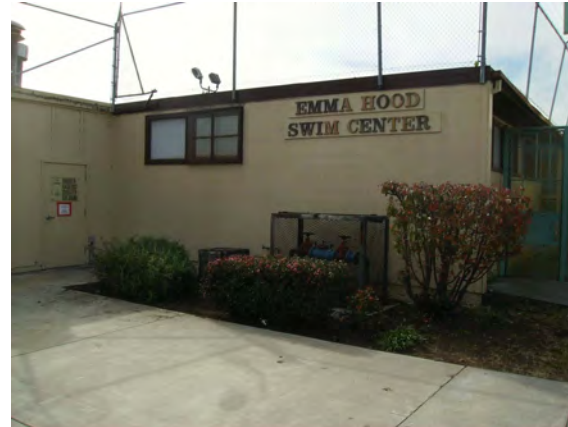
94

23	Existing Deficiency	<b>Pool Bldg:</b> entire exterior needs replacement	#94,95,96,97				
	Recommended Remedy	Replace: all doors w/ galv feames & FRP; all windows w/ alum. dual glazed; BUR roofing w/ cool roof coating; all fascia, trim, paneling with cement board materials; paint complete		1	LS	\$175,000	\$175,000
24	Existing Deficiency	<b>Pool Bldg:</b> entire pool fence. Lighting and bleachers are rusted and beyond service life	#98, #101, #102				
	Recommended Remedy	Replace all chainlink use galv. with polycoat on all posts, mesh and accessories		320	LF	\$75	\$24,000

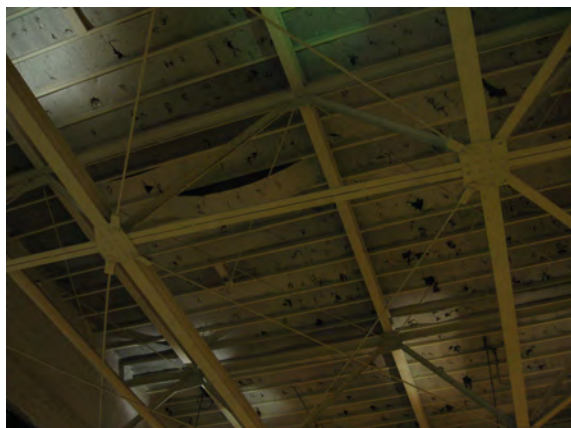
104

CATEGORY		DESCRIPTION	PHOTO & SITE PLAN	ESTIMATED TAKE OFF		COST / UNIT	TOTAL COST
Quantity	Unit						
14	Existing Deficiency	<b>Patton Gym:</b> Ceiling insulation is delaminating	#104				
	Recommended Remedy	Remove, replace with insulated, acoustic ceiling		11,600	SF	\$7	\$81,200
15	Existing Deficiency	<b>Patton Gym:</b> Hardwood floor is moisture damaged at end of service life	#100, #103				
	Recommended Remedy	Remove all flooring and replace with new maple cushion floor system		9,000	SF	\$21.50	\$193,500
16	Existing Deficiency	<b>Patton Gym:</b> Wood bleachers are splintered and broken	#106, #107				
	Recommended Remedy	Replace all bleachers with polyvinyl seating		1	LS	\$60,000	\$60,000
17	Existing Deficiency	<b>Patton Gym:</b> all interior doors are wood and at end of service life	#108, #109, #110, #111				
	Recommended Remedy	Replace all interior doors with galv. metal frames, and FRP doors throughout	ALLOW	15	EA	\$4,400	\$66,000
