# Encinal High School

## Alameda USD Facilities Assessment

**Encinal High School**  
**Facility Assessment Spreadsheet**

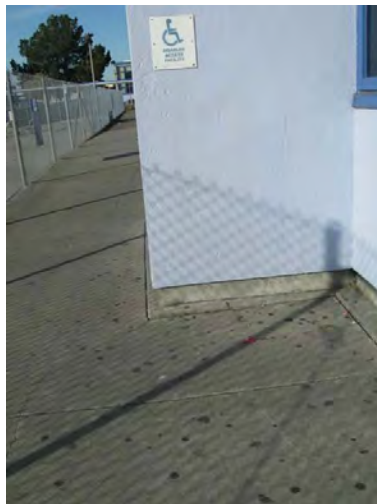
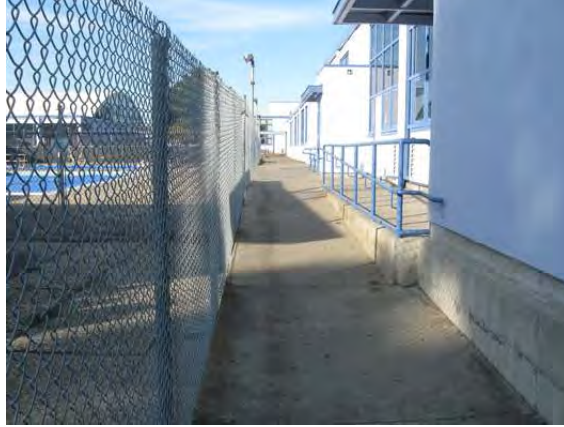
CATEGORY	DESCRIPTION	PHOTO & SITE PLAN	ESTIMATED TAKE OFF Quantity Unit	COST / UNIT	TOTAL COST
<b>2) Architectural</b>					<b>\$5,345,070</b>
<b>A) EXTERIOR</b>					
<b>i) ACCESS</b>					
<b>1</b>	Existing Deficiency	<b>Parking Lots:</b> asphalt pavement deteriorated and cracking. <b>Playground:</b> asphalt cracking and deteriorating.	#1,2,3,4,7 & 8		
	Recommended Remedy	Included In CIVIL Items # 22. 23 & 24			
<b>2</b>	Existing Deficiency	<b>Wing 700:</b> per current Code equal circulation egress is required	#5		
	Recommended Remedy	Add Accessible ramp with stair at North end	400	SF	\$20.00 \$8,000
<b>3</b>	Existing Deficiency	<b>ACLC Portables:</b> asphalt accessible walkway is non compliant	#5,8 & 11		
	Recommended Remedy	Replace with concrete walkway and landing pads	1	LS	\$5,000.00 \$5,000
<b>4</b>	Existing Deficiency	<b>Science Wing Ramp;</b> exceeds 2% cross-slope. Walkway appears to be subsiding	#9, #12

Recommended Remedy	geotechnical report at this location required; Remove pavement, install sub-surface drainage at retaining wall, regrade, and re-pave	1	ls	\$35,000.00 \$35,000
<b>5</b>	Existing Deficiency	<b>Pool Deck;</b> 1 D.I. exceeds 2% cross-slope; trip hazards at drains	#59, #62		
	Recommended Remedy	Demo/ replace concrete & DI to not exceed 2% crossslope	1,400	sf	\$22.00 \$30,800
<b>ii) DEFERRED MAINTENANCE</b>					
<b>1</b>	Existing Deficiency	<b>Admin. Bldg:</b> south facing window/ fascia leaks; ceiling tiles damaged and loose. Repair stucco holes and repaint east Entry wall	#10, #13, #14		
	Recommended Remedy	Redesign detailing and replace all windows; replace loose and damaged tiles	1,800	SF	\$45.00 \$81,000
<b>2</b>	Existing Deficiency	<b>Wing 100/200:</b> south facing windows leak at head jambs & sill.	#17, #18		
	Recommended Remedy	Redesign detailing and replace all windows; replace loose and damaged tiles	600	SF	\$45.00 \$27,000

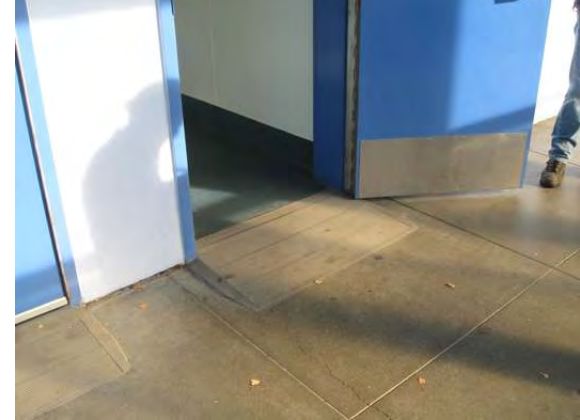
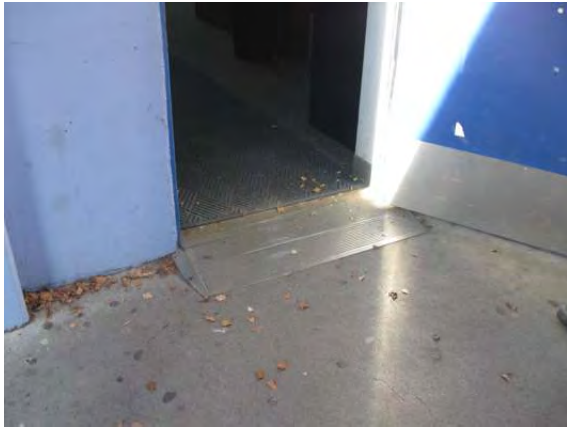
CATEGORY		DESCRIPTION	PHOTO & SITE PLAN	ESTIMATED TAKE OFF Quantity Unit		COST / UNIT	TOTAL COST
3	Existing Deficiency	<b>Elevator Tower:</b> south wall cement plaster is delaminating from CMU wall; excessive moisture penetration through block wall	#15, #19, #20				
	Recommended Remedy	Investigate const. details and specifications for recommendation. Complete removal is probable. (Allow Repairs to finishes and new Elastomeric Coating on CMU)	Allow	400	SF	\$15.00	\$6,000
4	Existing Deficiency	<b>Wing 100/200:</b> North Facing Windows: are single pane w/steel fame & putty. <b>Wings 300, 400,</b> and <b>Business</b> are wood sash with putty. All are close to end of service life.	#27, #28				
	Recommended Remedy	Replace all windows in Wing 300-400 with Alum., dual glass units		18,000	SF	\$32.00	\$576,000
5	Existing Deficiency	<b>Wing 300/400 Classrooms:</b> Pemko exit ramps at outward opening doors are no longer ADA compliant (See Civil item #14)	#16, #21

Recommended Remedy	Replace with new concrete landing. (Cost in Civil)		14	EA	\$1,200.00	\$16,800
6	Existing Deficiency	<b>Corridor Toilets (Media &amp; Bus. Wing):</b> Sewer ine leaking in plumbing wall.	#29				
	Recommended Remedy	Open up wall, replace all piping and install inew fixtures , tile wall, and partitions.		10	EA	\$3,500.00	\$35,000
7	Existing Deficiency	<b>ACLC Portables:</b> wood foundation subject to dry rot from downspouts discharge	#22, #23				
	Recommended Remedy	Replace with concrete foundations/ ramps; add site drainage and new RWLs	Allow	320	LF	\$45.00	\$14,400
8	Existing Deficiency	<b>Tri-High Portables:</b> wood panel and trim deterioration; foundation dry rot from downspout discharge	#24, #25, #30, #37				
	Recommended Remedy	Add concrete foundation and ramp; add site drainage and RWLs. Replace these portables with new Modulares		6,144	SF	\$120.00	\$737,280
9	Existing Deficiency	<b>ROTC Portable:</b> bumper damage at wall; downsout discharge on wood foundation	#26, #38

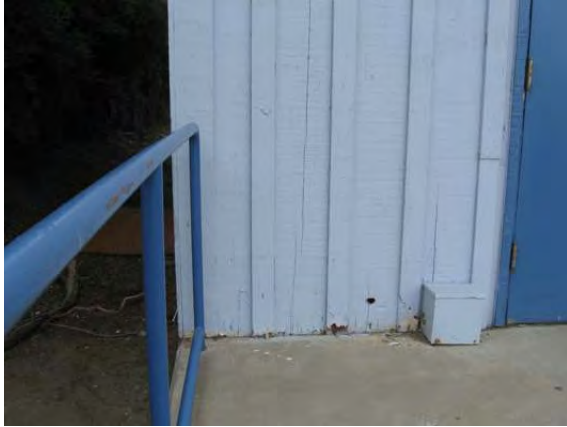
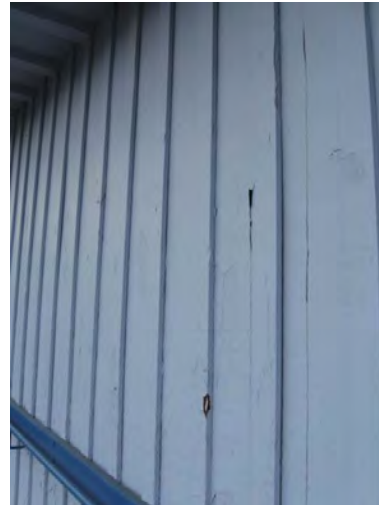
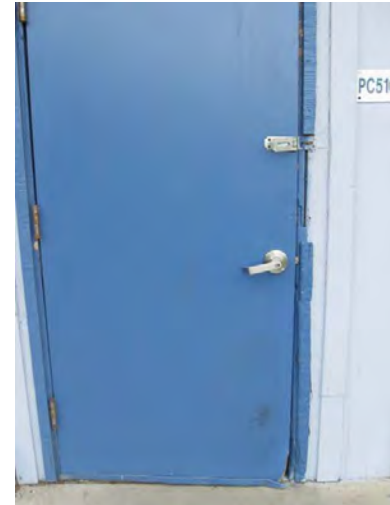
CATEGORY		DESCRIPTION	PHOTO & SITE PLAN	ESTIMATED TAKE OFF Quantity Unit		COST / UNIT	TOTAL COST
10	Existing Deficiency	<b>PC 510 Modular:</b> board and batt siding/ trim and door deteriorating.	#31, #39, #40				
	Recommended Remedy	Replace exterior wood with cement board paneling/ trim and metal door and jamb.		1	LS	\$4,000.00	\$4,000
11	Existing Deficiency	<b>Roof:</b> BUR roofing at end of service life, except Gym					
	Recommended Remedy	Replace all roofing, scuppers, drains, caps and flashings		117,000	SF	\$9.00	\$1,053,000
12	Existing Deficiency	<b>All Bldg. Exteriors:</b> painted finish is deteriorated					
	Recommended Remedy	Reseal and repaint all exterior walls, trims fascia, etc.		117,000	SF	\$1.00	\$117,000
13	Existing Deficiency	<b>Exterior doors:</b> have reached end of service life					
	Recommended Remedy	Replace all ext. doors with metal frame and FRP door		60	EA	\$4,400.00	\$264,000

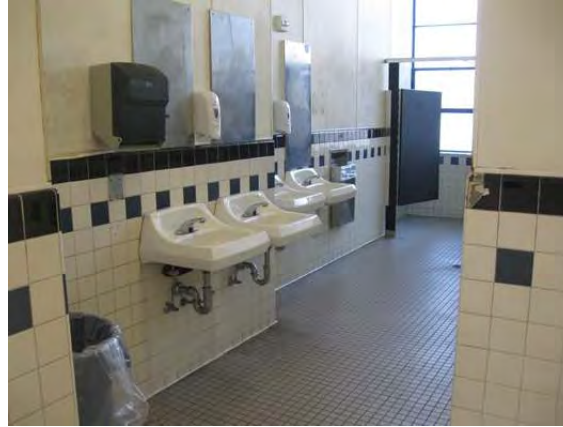
32

<b>1</b>	<b>Existing Deficiency</b>	<b>Wing 100/200 Student Toilets:</b> Sinks missing drainline padded boot; no accessible soap dispenser (40" AFF)	#32				
	<b>Recommended Remedy</b>	Install padded boots, reset 1 soap dispenser, repair tiles and install corner guard.		4	EA	\$1,200.00	\$4,800
<b>2</b>	<b>Existing Deficiency</b>	<b>Wing 100/200 Student Toilets:</b> FRP panels damaged, discolored; damaged tiles	#33, #47				
	<b>Recommended Remedy</b>	Replace with full wall tile		600	SF	\$10.00	\$6,000
<b>3</b>	<b>Existing Deficiency</b>	<b>Wing 100/200:</b> 2nd Fl. Staff Toilet sink is non compliant.	#48				
	<b>Recommended Remedy</b>	Relocate sink at 24" to centerline from wall.		1	EA	\$4,000.00	\$4,000
<b>4</b>	<b>Existing Deficiency</b>	<b>Media Center:</b> south facing windows and roof leaks	#34, #49				
	<b>Recommended Remedy</b>	Replace all ceiling tile with new		5,800	SF	\$7.00	\$40,600
<b>5</b>	<b>Existing Deficiency</b>	<b>Gym Locker Rms:</b> Staff toilet sink not compliant	#71

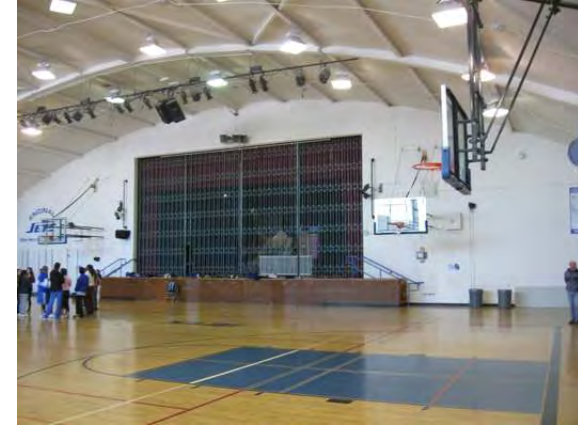
36

<b>10</b>	<b>Existing Deficiency</b>	<b>Gym 'Crows Nest' :</b> lighting & sound control wiring/ equipment no longer works	#36				
	<b>Recommended Remedy</b>	Replace conduit/ wiring, and new lighting/ sound controls for stage productions		1	ls	\$75,000.00	\$75,000

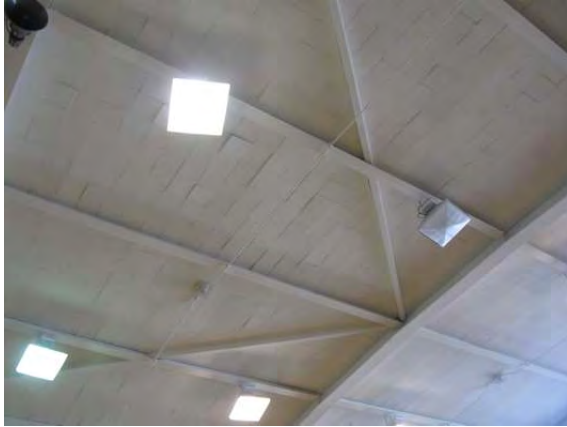
41

CATEGORY		DESCRIPTION	PHOTO & SITE PLAN	ESTIMATED TAKE OFF		COST / UNIT	TOTAL COST
				Quantity	Unit		
11	Existing Deficiency	<b>Gym Ceiling Tile:</b> tiles are delaminating	#41, #55				
	Recommended Remedy	Replace all ceiling tiles		10,800	SF	\$3.00	\$32,400
12	Existing Deficiency	<b>Wing 600 - Ceramics Rm:</b> non accessible sink, and non-compliant door clearance	#42, #43				
	Recommended Remedy	Relocate water heater; replace sink and re-plumb for ADA knee clearance; Reverse door swing and reconfigure wall for ADA clearance		1	LS	\$5,500.00	\$5,500
13	Existing Deficiency	<b>Wing 600 - Home Econ:</b> non-compliant headroom clearance at Exhaust hood	#44				
	Recommended Remedy	Remove Exhaust hood, patch/ repaint		1	EA	\$1,500.00	\$1,500
14	Existing Deficiency	<b>Wing 700 - Cafeteria:</b> Staff toilet room is non Accessible <b>Kitchen:</b> flooring wall and cove base doesn't meet Health code	#45, #56, #57

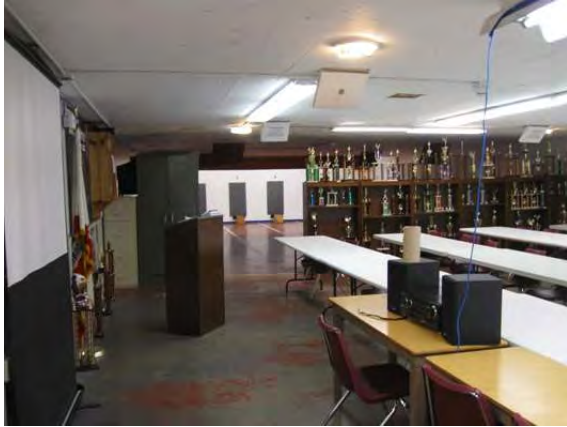
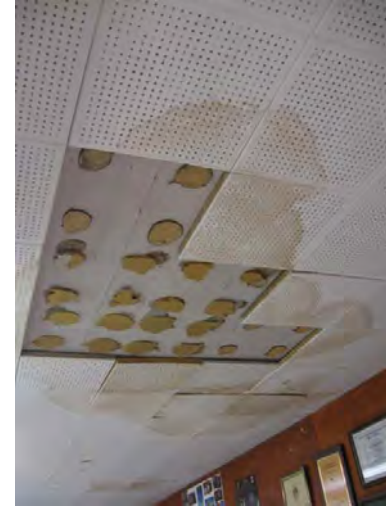
Recommended Remedy	Reconfigure toilet layout; remodel electrical wall and replace flooring/base with epoxy		200	SF	\$75.00	\$15,000
15	Existing Deficiency	<b>Gym - ROTC Basement:</b> Floor and ceiling deterioration	#51, #53				
	Recommended Remedy	Investigate basement ceiling leaks; replace ceiling tiles and new vinyl floor covering		1,200	SF	\$8.00	\$9,600
16	Existing Deficiency	<b>Wing 400 Boys Toilet:</b> non accessible sink	#52				
	Recommended Remedy	Replace with compliant sinks, and soap dispenser		1	EA	\$2,400.00	\$2,400
17	Existing Deficiency	<b>All slab on grade (SOG) concrete floors:</b> excessive moisture impedes flooring bond	NA				
	Recommended Remedy	Prior to new flooring, strip/etch concrete, and apply vapor barrier		117,000	sf	\$5.00	\$585,000
18	Existing Deficiency	<b>Classroom/ Corridor flooring:</b> at end of service life	NA				
	Recommended Remedy	Replace all flooring with resilient flooring, and walk-off Entry carpet mat.		58,000	SF	\$5.00	\$290,000

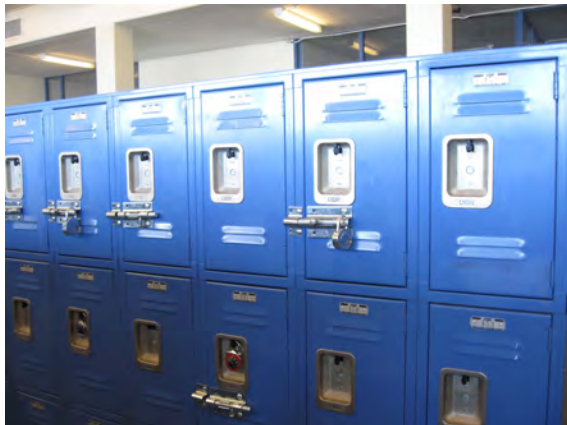
72

<b>Recommended Remedy</b>	Reconfigure Staff toilet Rm.		130	SF	\$75.00	\$9,750
<b>6</b>	<b>Existing Deficiency</b>	<b>Boys Locker Rm;</b> many locker hasps are broken	#72				
	<b>Recommended Remedy</b>	Replace with District standard 'Pemco' Gym Lockers (include girls)		420	EA	\$650.00	\$273,000
<b>7</b>	<b>Existing Deficiency</b>	<b>Gym Stage:</b> no accessible lift	#36				
	<b>Recommended Remedy</b>	Reconfigure for installed lift		1	LS	\$25,000.00	\$25,000
<b>8</b>	<b>Existing Deficiency</b>	<b>Gym Bleachers:</b> wood seats are splintering	#54				
	<b>Recommended Remedy</b>	Replace with new metal or polyvinyl (Like American Eagle)	Allow	500	Seats	\$75.00	\$37,500
<b>9</b>	<b>Existing Deficiency</b>	<b>Gym Stage:</b> security and back drop curtains at end of service life; back stage door has to stair/access	#36				
	<b>Recommended Remedy</b>	Install new flex-metal security screen and fire-retardant back curtains. Replace all curtain and lighting rigging.		1	ls	\$35,000.00	\$35,000
