Academy Of Alameda

SUMMARY OF SCHOOL CAMPUS

ACADEMY OF ALAMEDA
4/30/2012

Alameda USD Facilities Assessment

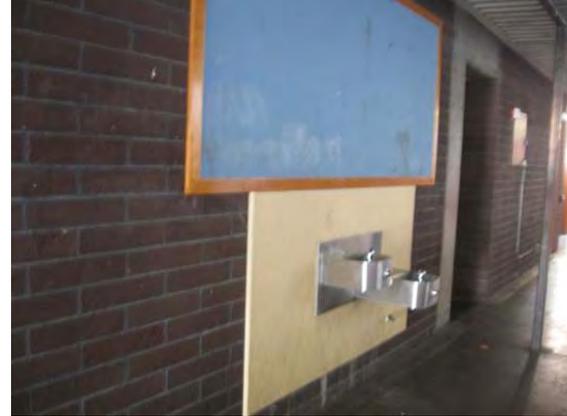
5

CATEGORY	DESCRIPTION	PHOTO & SITE PLAN	ESTIMATED TAKE OFF		COST / UNIT	TOTAL COST
			Quantity	Unit		
6	Existing Deficiency Corridor D. Fountain: non compliant Playground D. Fountain: non compliant	#5 #9				
	Recommended Remedy Add pipe barriers @ corridor; Replace D. Fountains at Playground		1	LS	\$8,000	\$8,000
7	Existing Deficiency Corridor Gap: dirt space with uneven adjacent pavements creates trip hazard. Also See Civil Item iii (1).	#10				
	Recommended Remedy Fill in gap with trench drain/grate, and concrete paving; paint higher curb yellow.		40	SF	\$57	\$2,280
8	Existing Deficiency ADA Drink Fountains: DF at play yard is non-compliant, and none at NEA courtyard	#25				
	Recommended Remedy Replace (E) DF and provide level concrete area; add (2) DFs at 1st and 2nd Floors of NEA		1	LS	\$9,000	\$9,000
ii) DEFERRED MAINTENANCE						
1	Existing Deficiency 2nd Fl. Guard Rail: not compliant with current 42" rail height.	#6

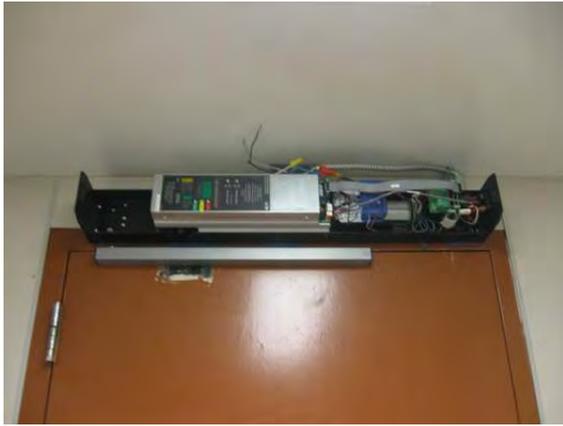
11

Recommended Remedy Replace with 42" rail		240	LF	\$42	\$10,080
2	Existing Deficiency Multi-Purpose Girls Restroom: Accessible door opener broken	#11				
	Recommended Remedy Replace with new		1	EA	\$900	\$900
3	Existing Deficiency Exterior Doors: most exterior doors are wood at end of service life	#12, #17				
	Recommended Remedy Replace all ext. doors with metal frame and FRP door		42	DOORS	\$4,400	\$184,800
4	Existing Deficiency NEA Portable: wood foundation plate dry rot; no site drainage for downspouts; some wood/ metal deterioration	#13, #14				
	Recommended Remedy Add site drainage, concrete foundationb/ramp, and replace with new Modular		1	LS	\$120,000	\$120,000
5	Existing Deficiency Corridor Lockers: many lockers missing latches and deteriorated; end of service life					
	Recommended Remedy Replace with District standard Pemko lockers		500	EA	\$650	\$325,000
6	Existing Deficiency Roofs: BUR roofing at end of service life

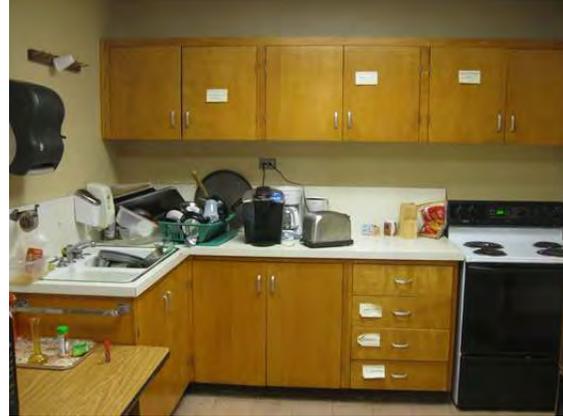
15

i) GENERAL & MAINTENANCE						
1 Existing Deficiency	Staff Lounge: non accessible kitchen sink	#15				
Recommended Remedy	Replace base cabinet and sink		12	LF	\$700	\$8,400
2 Existing Deficiency	Cafeteria Kitchen: non-working oven and mixer; no longer Health Code compliant; equipment at end of service life	#16				
Recommended Remedy	Replace Exhaust hood, and upgrade equipment to "food prep" facility. Tile over (E) brick area (300 sf)		1	LS	\$145,000	\$145,000
3 Existing Deficiency	Cafeteria/Gym: no daylighting	#20				
Recommended Remedy	Add Solatube daylighting skylights.	ALLOW	12	EA	\$1,700	\$20,400
4 Existing Deficiency	Classroom Sinks: non accessible throughout	#21, #22, #23				
Recommended Remedy	replace base cabinets, countertop and sink.		12	SINKS	\$4,800	\$57,600
5 Existing Deficiency	Cadet Classroom: floor mounted electrical outlets are broken and trip hazards; floor covering is damaged	#18, #19 #24, #26
