Building Information - Yellow Springs Exempted Village (45674) - Mills Lawn Elementary / Middle School

Building Pictures - Yellow Springs Exempted Village(45674) - Mills Lawn Elementary / Middle School (24919)

47,324 Total Existing Square Footage
1952,1957,2002 Building Dates
K-6 Grades
374 Current Enrollment
25 Teaching Stations
8.84 Site Acreage

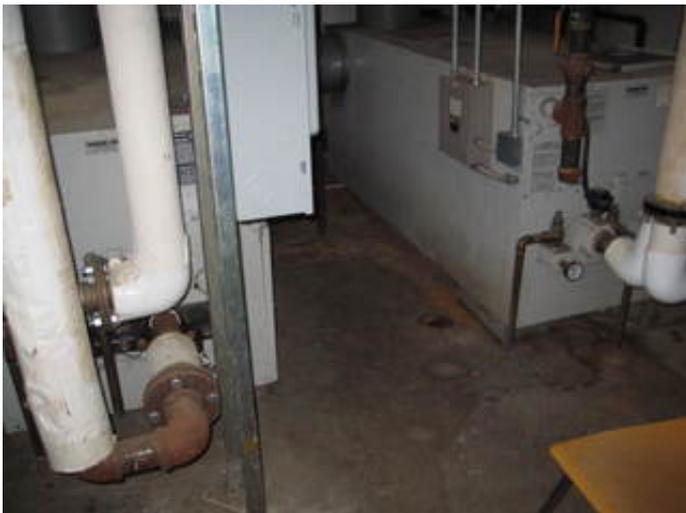
Description: The existing system for the 1952 Original Construction is a natural gas fired heated water boiler type system, installed in 1952, and is in fair condition. The system in the 1957 Addition is an extension of that found in the 1952 Original Construction. The existing system for the 2002 Addition is a natural gas fired packaged roof top unit type system, installed in 2002, and is in fair condition. 2-pipe vs. 4-pipe designations are not applicable in this facility, as no central air conditioning is provided. The 1952 Original Construction is equipped with (2) Copper-fin II boilers, manufactured by Lochinvar, are believed to be installed in 1998, and are in fair condition. Heating water is distributed to terminal units consisting of unit ventilators, cabinet heaters, unit heaters, fin tubes, air handlers, and roof top units. The 2002 Addition is equipped with (2) ducted packaged roof top units (with DX cooling and natural gas/hot water heat), manufactured by York, were installed in 2002, and are in fair condition. Heated air is distributed to terminal units consisting of multiple VAV boxes. All terminal equipment is original to each addition and is in fair condition. The system does not appear to comply with the 15 CFM per person fresh air requirements of the Ohio Building Code mechanical code and Ohio School Design Manual. The pneumatic, digital, and DDC type system temperature controls are original to each addition, with incremental upgrades, and are in fair to poor condition. The system does not feature individual temperature controls in all spaces required by the OSDM. The overall system does not feature any central energy recovery systems. The 1952 Original Construction is not equipped with widespread louvered interior doors to facilitate Corridor utilization as return air plenums. The remainder of the overall facility is not equipped with louvered interiors doors. The existing system is ducted in the 2002 Addition and a portion of the 1952 Original Construction and 1957 Addition, but the ductwork cannot be integrated into a possible future system due to arrangement, air volume, and routing of existing ductwork. The existing system is not ducted in the remainder of the overall facility, and floor to structural deck heights will accommodate the installation of properly sized ductwork for a future Ohio School Design Manual approved system. The overall heating system is evaluated as not being in safe and efficient working order, and long term life expectancy of the existing system is not anticipated. The structure is not equipped with central air conditioning. The site does not contain underground fuel tanks.

Rating: 3 Needs Replacement

Natural Gas Fired Heated Water Boilers

Recommendations: Provide new overall heating, ventilating, and air conditioning system to achieve compliance with Ohio Building Code and Ohio School Design Manual standards. Replace existing ductwork in the 2002 Addition and a portion of the 1952 Original Construction and 1957 Addition to facilitate efficient exchange of conditioned air. Convert to ducted system the remainder of the overall facility to facilitate efficient exchange of conditioned air.

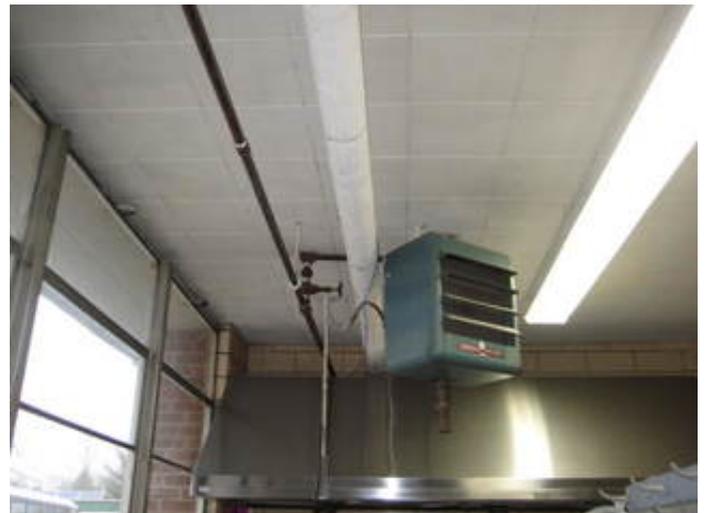
Unit Heater

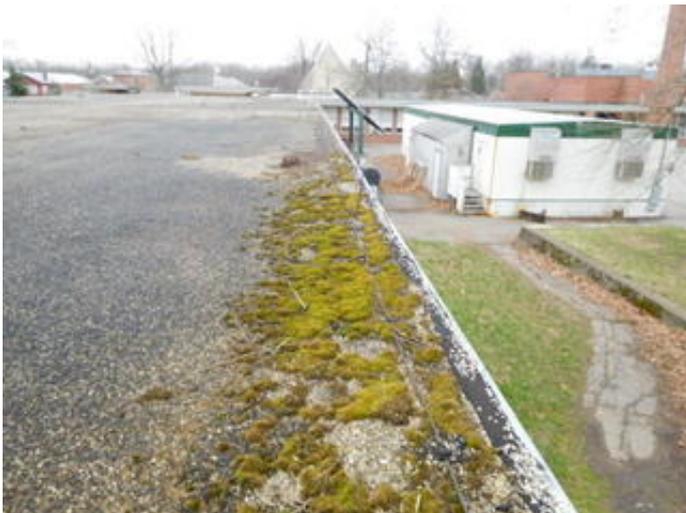
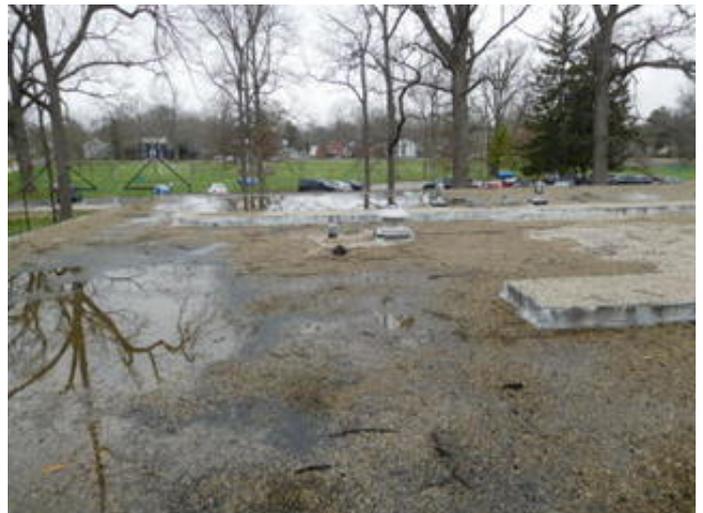
Description: The roof over the Original Construction is a built-up system with gravel ballast that was installed in 1952, and is in poor condition. The roof over the 1957 Addition is a built-up system with gravel ballast that was installed in 1957, and is in poor condition. The roof over the 2002 Addition is a built-up system with gravel ballast that was installed in 2002, and is in fair condition. There are no District reports of current leaking. No signs of past leaking were observed during the physical assessment. Access to the roof was gained by access hatch that is in poor condition. Fall safety protection cages are not required, and are not provided. There were observations of standing water on the roof. Metal cap flashings and copings are in fair to poor condition. Roof storm drainage is addressed through a system of roof drains, which are properly located, and in fair to poor condition. The roof of the Original Construction and the 1957 Addition are not equipped with overflow roof drains though they will be required in areas of roof replacement. No problems requiring attention were encountered with any roof penetrations. There are not any covered walkways attached to this structure.

Rating: 3 Needs Replacement

Built-Up Roof with Gravel Ballast

Recommendations: The roof over the overall facility requires replacement to meet Ohio School Design Manual guidelines due to condition and age of system and projected lifecycle. The flashing and coping on the overall facility require replacement due to condition. Due to existing conditions roof drains require replacement on the overall facility with the exception of the 2002 Addition. Due to age and condition replace the existing access ladder and hatch. Provide two new roof access ladders. Replace existing roof drains and sumps due to condition and replacement of the roofing system. Provide new overflow roof drains and piping.

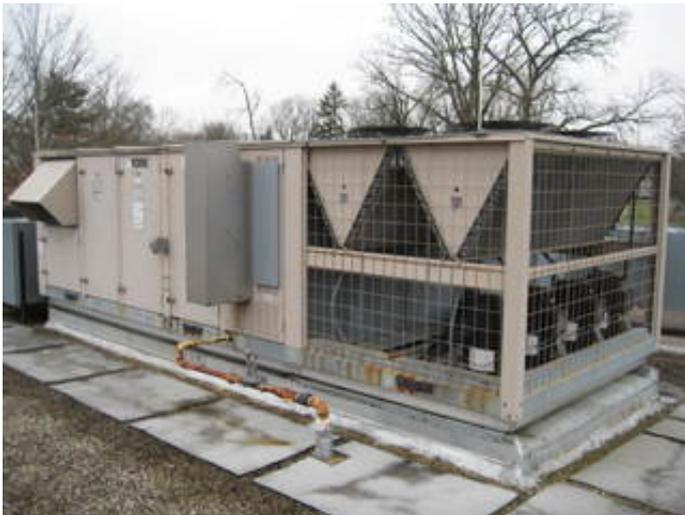
Description: The overall facility is not equipped with a central air conditioning system. Window units are provided at multiple Classroom locations throughout the overall facility, as well as in the Teacher's Lounge. An isolated room system consisting of ductless split AC wall cassettes with (2) condensing units (pad mounted and located on the exterior) is provided in the Administrative Offices in the 1952 Original Construction. An isolated room system consisting of a single ducted HVAC/furnace type unit and (1) condensing unit (pad mounted and located on the exterior) is provided in the Administrative Office Conference Room of the 2002 Addition. An isolated room system consisting of (2) ducted packaged air cooled York roof top units (with DX cooling and natural gas/hot water heat) is provided in the majority of the 2002 Addition and the Multi-Purpose Room (Gymnasium/Student Dining) and Media Center of the 1952 Original Construction. The ventilation system in the overall facility consists of unit ventilators and roof top units, original to each addition and in fair condition, providing fresh air to Classrooms, and air handlers and roof top units, original to each addition and in fair condition, providing fresh air to other miscellaneous spaces such as Multi-Purpose Room (Gymnasium/Student Dining) and Media Center. Relief air venting is provided by louvered interior doors, ceiling plenums / being ducted back through energy recovery units, central relief fans, air handlers, and roof top units. The ventilation system does not meet the Ohio Building Code 15 CFM per occupant fresh air requirement. The overall system is not compliant with Ohio Building Code and Ohio School Design Manual requirements. Dust collection systems are not required in this facility though no system is provided. The Art program is equipped with a kiln, and existing kiln ventilation is inadequate, and in fair condition. General building exhaust systems for Restrooms, Storage Rooms, Art Rooms, and Custodial Closets are inadequately placed, and in fair condition.

Rating: 2 Needs Repair

Roof Top Unit

Recommendations: Provide an air conditioning system to meet with Ohio Building Code and Ohio School Design Manual requirements. Replace general building exhaust systems located in Restrooms, Storage Rooms, and Custodial Closets. Pricing included in Item A. Replace the existing Art Program's kiln ventilation system due to age, condition, and lack of OSDM compliance.

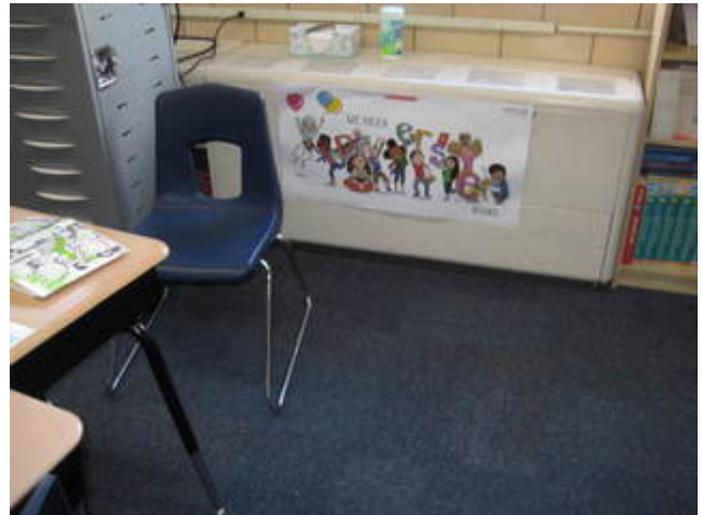
Unit Ventilator

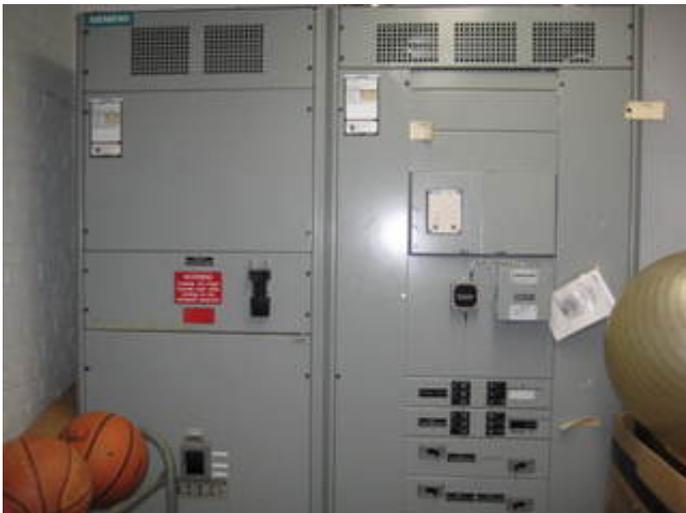
Description: The electrical system provided to the 2002 Addition is a 208Y/120 volts, 1,200 amp, 3 phase and 4 wire system installed in 2002, and is in good to fair condition. The systems in the 1952 Original Construction and 1957 Addition are an extension of that found in the 2002 Addition. Power is provided to the school by a single utility owned, pad-mounted transformer located at the front of the School, and in fair condition. The panel systems are original to each Addition, are in fair condition, and for the most part cannot be expanded to add additional capacity. The Classrooms are not equipped with adequate electrical outlets. The typical Classroom contains (5) general purpose outlets, (0) dedicated outlets for each Classroom computer, and (1) dedicated outlet for each Classroom television/ceiling mounted projector. Some Classrooms are equipped with as many as (6) general purpose outlets, while others are equipped with as few as (3) general purpose outlets. There are not any spaces that have no electrical outlets. The Corridors are equipped with adequate electrical outlets for servicing. Adequate GFI protected exterior outlets are not provided around the perimeter of the building. The facility is not equipped with an emergency generator. Adequate lightning protection safeguards appear to be provided and are in fair condition. Stage lighting power system including control panel, breakers, and dimmers is inadequately provided, in fair condition and does not meet OSDM requirements. The overall electrical system does not fully meet Ohio School Design Manual requirements in supporting the current needs of the school, and will be inadequate to meet the facility's future needs.

Rating: 3 Needs Replacement

Main Electrical Distribution Panel

Recommendations: The entire electrical system requires replacement to meet Ohio School Design Manual guidelines for overall capacity due to age, condition, lack of OSDM-required features, and to accommodate the addition of an air conditioning system. Provide an emergency generator, with funding included in the electrical system replacement. Replace the existing lightning protection safeguards in the overall facility, including associated grounding system, with funding included in the electrical system replacement.

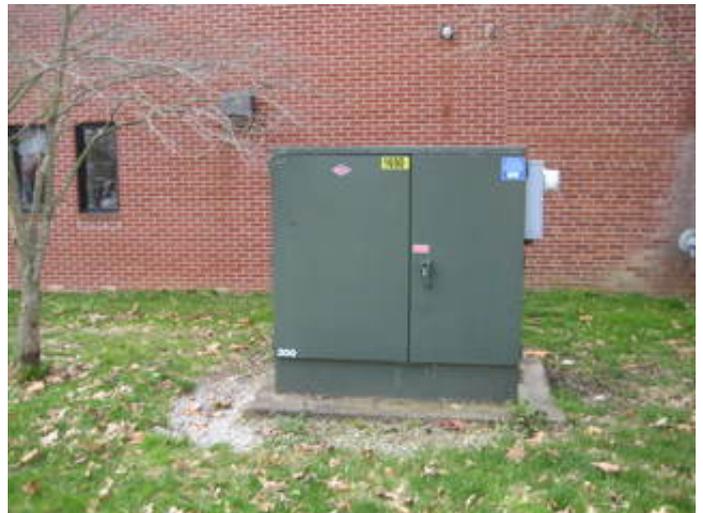
Pad Mounted Transformer

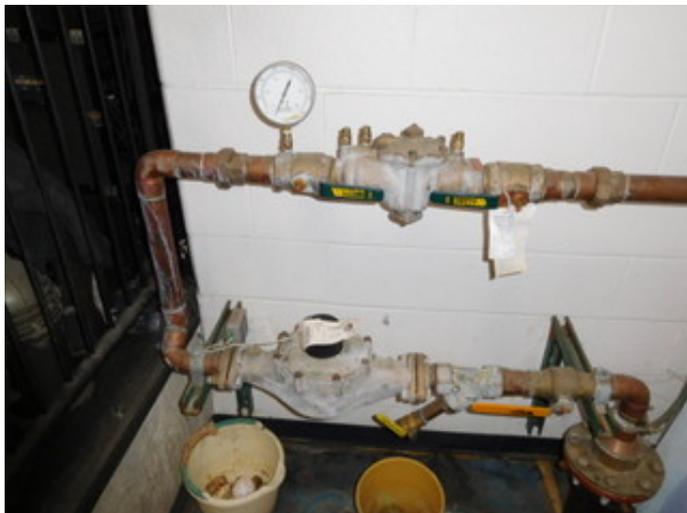
Description:	<p>The service entrance is equipped with a reduced pressure back flow preventer in fair condition. A water treatment system is not provided, though none is needed. The domestic water supply piping in the overall facility is copper and galvanized, is original to each addition, and is in fair condition. The waste piping in the overall facility is cast iron and galvanized, is original to each addition, and is in fair condition. The facility is equipped with a 71 gallon gas water heater in good condition. The school contains 2 Large Group Restrooms for boys, 2 Large Group Restrooms for girls, 0 Locker Room Restrooms for boys, 0 Locker Room Restrooms for girls, 3 Restrooms associated with specialty Classrooms, 8 Restrooms for Individual Classrooms, and 5 Restrooms for staff. Boys' Large Group Restrooms contain 2 ADA and 1 non-ADA wall mounted flush valve toilets, 6 ADA and 1 non-ADA wall mounted flush valve and waterless urinals, as well as 2 ADA wall mounted lavatories and 2 non-ADA countertop lavatories. Girls' Large Group Restrooms contain 2 ADA and 6 non-ADA wall mounted flush valve toilets, as well as 2 ADA wall mounted lavatories and 2 non-ADA countertop lavatories. Individual Classroom Restrooms contain 2 ADA and 7 non-ADA wall and floor mounted flush valve toilets, 2 ADA wall mounted urinals, as well as 3 ADA and 4 non-ADA countertop and wall mounted lavatories. Staff Restrooms contain 2 ADA and 2 non-ADA wall mounted flush valve toilets, 1 non-ADA floor mounted tank type toilet, as well as 2 ADA and 3 non-ADA wall mounted lavatories. Condition of fixtures is good to fair. The facility is equipped with 2 ADA and 4 non-ADA electric water coolers, in good to fair condition. The 22 Elementary Classrooms are not equipped with sink mounted type drinking fountains. Special Education Classroom is equipped with the required Restroom facilities, and fixtures are in good to fair condition. Kitchen is equipped with the required Restroom, and fixtures are in fair to poor condition. Kindergarten / Pre-K Classrooms are equipped with Restroom facilities, and fixtures are in poor condition. Kitchen fixtures consist of 1 single compartment sink, 1 double compartment sink, and 1 triple compartment sink, which are all in fair condition. The Kitchen is not equipped with a grease interceptor. The Kitchen is provided the required 140 degree hot water supply. The school does not full meet the OBC requirements for fixtures. Relative to LEED requirements, the school is not equipped with low flow type fixtures, but is equipped with waterless urinals. Per OBC and OSDM requirements this facility should be equipped with 6 toilets, 2 urinals, 8 lavatories, 22 Classroom sink mounted drinking fountains, and 4 electric water coolers. Observations revealed that the school is currently equipped with 30 toilets, 9 urinals, 26 lavatories, 5 Classroom sink mounted drinking fountains, and 6 electric water coolers. ADA requirements are not met for fixtures and drinking fountains see Item O. Custodial Closets are properly located and are adequately provided with required service sinks or floor drain sinks, which are in fair to poor condition. Science Classrooms are not equipped with required utility sink, gas / compressed air connections, and safety shower / eyewash. Due to existing grade configuration, no Biology or Chemistry Classroom acid waste systems are required. Adequate exterior wall hydrants are not provided.</p>

Incoming Domestic Water Service Backflow Preventer

Rating:	3 Needs Replacement
Recommendations:	<p>Due to age, condition, LEED, and OBC and OSFC requirements, provide 23 new toilets, 21 new lavatories, 3 new electric water coolers, 22 new lavatory mounted type drinking fountains. Replace water supply and sanitary waste piping in the 1952 Original Construction and the 1957 Addition due to age and condition. Replace reduced pressure back flow preventer due to age and condition. Provide for the replacement and addition of exterior hose bibs to meet OSDM Standards. Provide funding for a new grease trap in the kitchen. Provide funding for a new grease interceptor in the art classroom. See Item J for replacement of kitchen fixtures. See Item O for replacement of fixtures related to ADA requirements. Provide the Science Classroom with the required utility sink, gas connections, compressed air connections, and safety shower / eyewash stations. Provide required sink mounted type drinking fountains in Elementary Classroom spaces.</p>

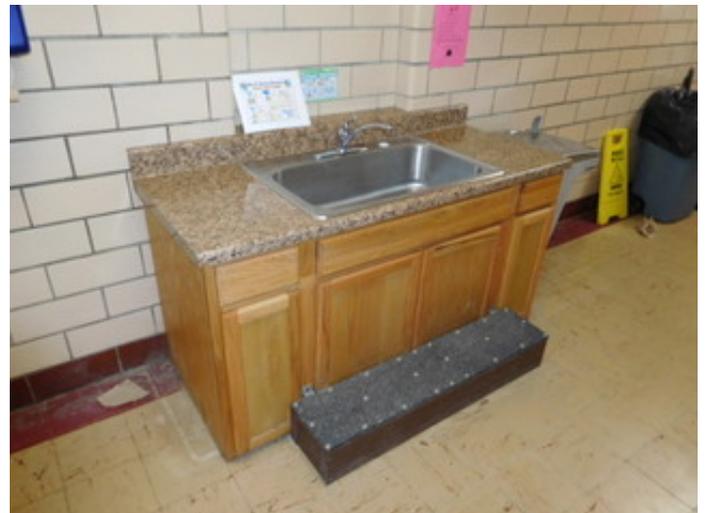
Classroom Sink

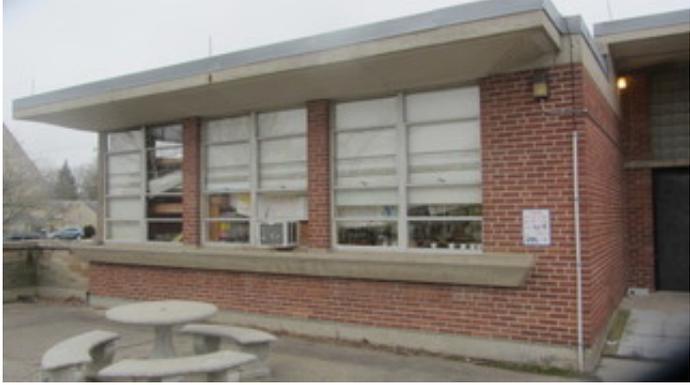
Description: The 1952 Original Construction is equipped with an aluminum frame window with single glazed type window system, which was installed in 1952, and is in poor condition. The window system features operable windows throughout most portions of the building, and operable windows are equipped with opening limiters in poor condition and insect screens where provided in fair to poor condition. Window system seals are in poor condition, with frequent air and water infiltration being experienced. Window system hardware is in poor condition. The 1957 Addition is equipped with an aluminum frame window with double glazed insulated glazing and insulated panel type window system, and is in fair condition. Date of installation was not available. The window system features operable windows throughout most portions of the building, and operable windows are equipped with opening limiters in fair condition and insect screens where provided in fair condition. Window system seals are in fair condition. The District reported that moderate air and water infiltration is being experienced. Window system hardware is in fair condition. The 2002 Addition is equipped with thermally broken aluminum frame windows with double glazed insulated glazing type window system, which was installed in 2002, and is in good condition. The window system features operable and inoperable windows throughout the building, and operable windows are equipped with opening limiters in good condition and insect screens in good condition. Window system seals are in good condition, with no air and water infiltration being experienced. Window system hardware is in good condition. The window systems in the overall facility feature surface mounted shades, which are in fair condition. The window system in the 2002 Conference Room Addition feature surface mounted vertical blinds in fair condition. This facility is not equipped with any curtain wall systems. There are glass block windows in the 1952 Original Construction, in fair condition. The exterior doors in the 1952 Original Construction are equipped with aluminum frame transoms with insulated FRP panels, in good to fair condition and wood frame transoms with single pane glazing in poor condition. Exterior door vision panels in the FRP doors are tempered double glazed insulated glazing in good to fair condition. Exterior door vision panels in the wood doors are single pane wire glazing in poor condition. The exterior doors in the 1957 Addition are equipped with aluminum frame sidelights and transoms with tempered double glazed insulated glazing and insulated metal panels in good to fair condition. Exterior door vision panels are tempered double glazed insulated glazing, in good to fair condition. The exterior doors in the 2002 Addition are equipped with aluminum frame sidelights and transoms with tempered double glazed insulated glazing, in good condition. Exterior door vision panels are tempered single pane glazing. The school does contain 2 skylights which are equipped with aluminum frames and insulated fiberglass panels, in good condition. The school does not contain any clerestories. Interior glass is OSDM-compliant. Window security grilles are not provided for ground floor windows. There is a 94 SF Greenhouse in the 1957 Addition, and it is in poor condition.

Rating: 3 Needs Replacement

1952 Original Construction Typical Classroom Windows

Recommendations: Replace the existing non-insulated window system with a new insulated window system with integral blinds to meet with Ohio School Design Manual requirements in the 1952 Original Construction. Replace the existing glass block with a new insulated window system with integral blinds to meet with Ohio School Design Manual requirements in the 1952 Original Construction. Replace the existing insulated window system in the 1957 Addition due to condition with a new insulated window system with integral blinds to meet with Ohio School Design Manual requirements. Replace the existing insulated panel system in the 1957 Addition due to condition with a new insulated panel system. Replace non-insulated glazing in transoms and sidelights at exterior doors in the 1952 Original Construction and 1957 Addition. Replace existing greenhouse in the 1957 Addition due to condition. Replace single glazed door vision panels in the 2002 Addition. Replace blinds in the 2002 Addition.

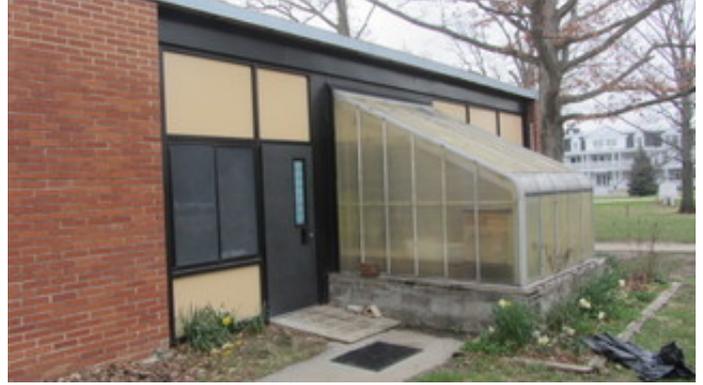
1957 Addition Typical Window System and Greenhouse

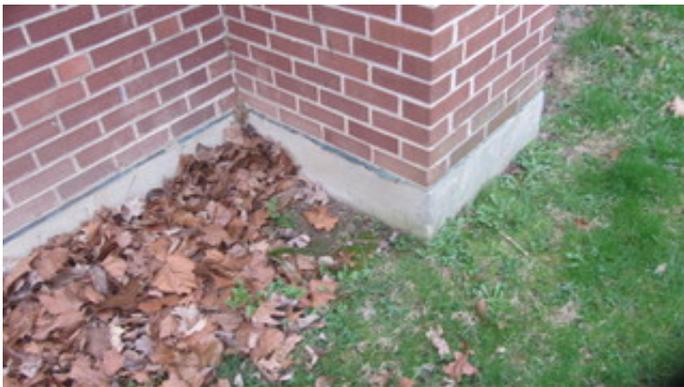
Description: The overall facility is equipped with concrete foundation walls on concrete spread footings, which displayed no locations of significant differential settlement, cracking, or leaking, and are in good to fair condition. Areas of minor cracking and spalling were observed through the overall facility. The District reports that there has been no past leaking due to foundation issues. No grading or site drainage deficiencies were noted around the perimeter of the structure that are contributing or could contribute to foundation or wall structural deterioration.

Rating: 2 Needs Repair

Typical 1952 Original Construction Exposed Foundation

Recommendations: Repair areas of cracking and spalling through the overall facility.

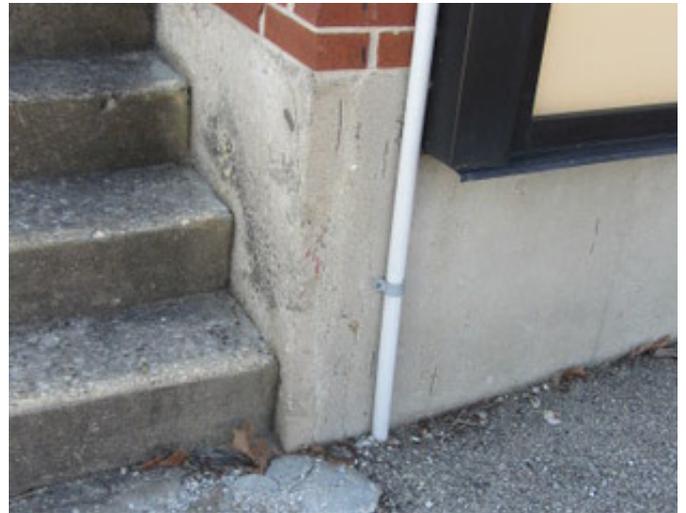
1957 Addition Exposed Concrete Foundation

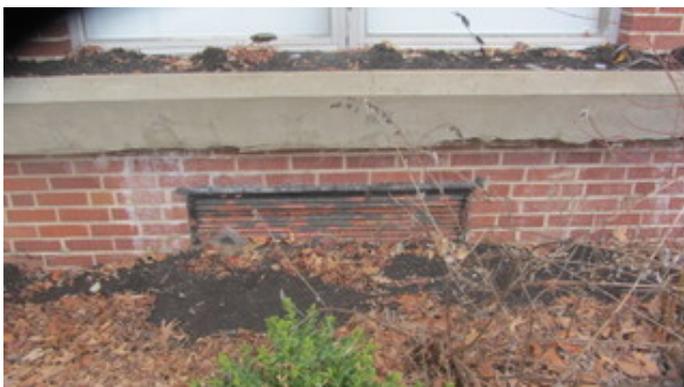
1952 Original Construction Window Sill and Unit Ventilator Opening

Rating:	2 Needs Repair
Recommendations:	<p>Provide tuckpointing in all areas of mortar deterioration as required through the overall facility. Provide masonry repairs as necessary in the 1952 Original Construction and 1957 Addition. Provide masonry tuckpointing for existing chimney in the 1952 Original Construction. Provide masonry infill in the 1952 Original Construction. Provide masonry cleaning, sealing and caulking as required through the overall facility. Recaulk existing exterior and interior control joints through the overall facility. Repair concrete window sills in the 1952 Original Construction. Repair concrete soffits in the 1952 Original Construction. Repair entrance canopy in the 1952 Original Construction. Repair and provide metal flashing for exposed tectum soffits in the 1957 Addition. Replace non-code compliant railing at the 1952 Original Construction Mechanical Room Entry. Repair concrete steps and walls at the 1952 Original Construction Mechanical Room Entry. Replace concrete walkway and railing at the 1957 Addition. Prep and paint exposed steel lintels through the overall facility. Exterior wall insulation deficiencies are addressed in Item J. Replacement of insulated metal panels in 1957 Addition is addressed in Item F.</p>

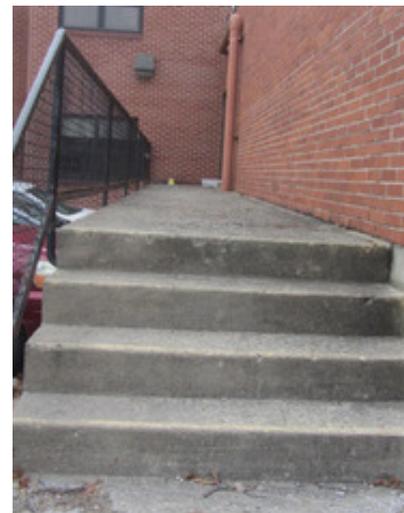
1957 Addition Concrete Walkway

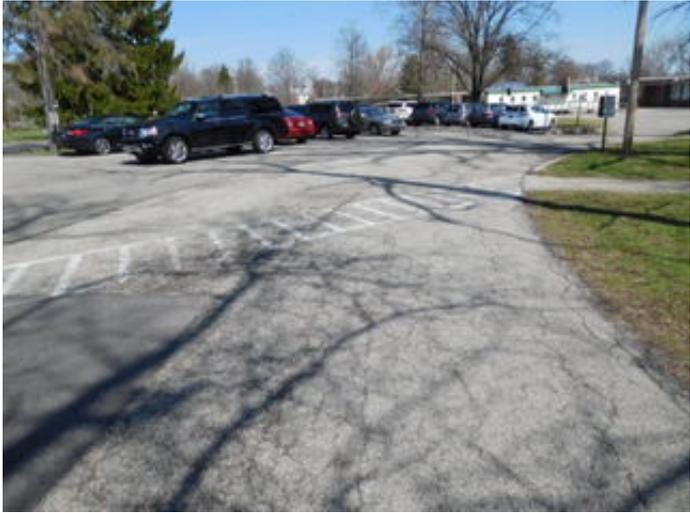
Asphalt Condition

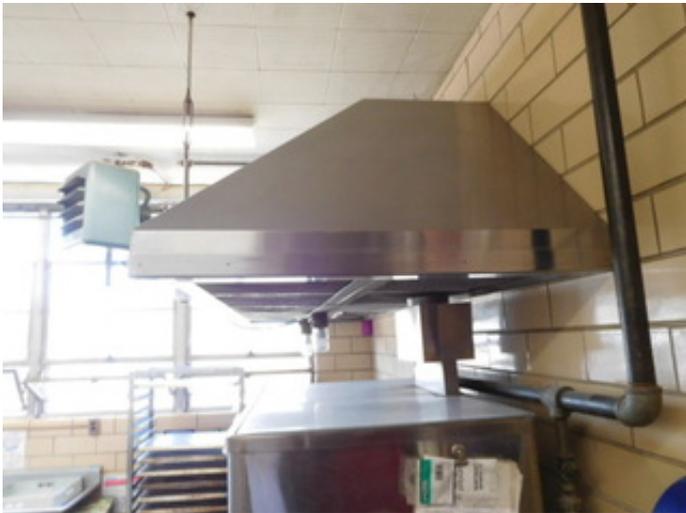
Existing kitchen hood in the Original Construction

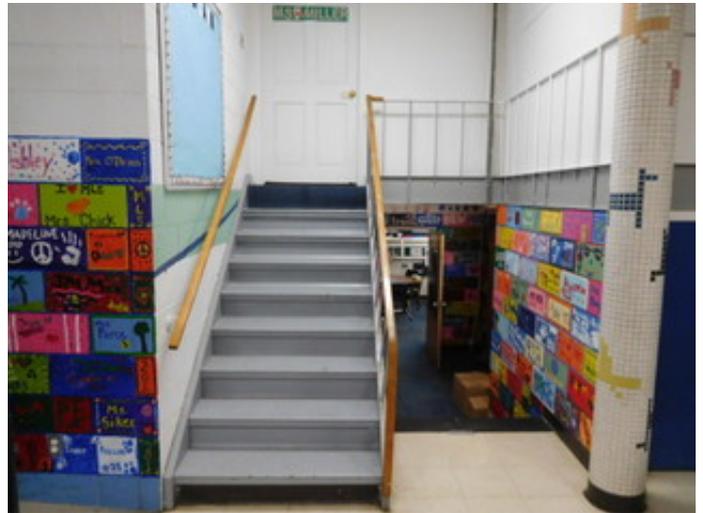
Stairs and handrail in the 1957 Addition
