Building Information - Yellow Springs Exempted Village (45674) - Yellow Springs High School/McKinney Middle School

Program Type	Expedited Local Partnership Program (ELPP)
Setting	Small City
Assessment Name	Yellow Springs High with EEA Update & Related Scope Adjustments
Assessment Date (on-site; non-EEA)	2017-03-29
Kitchen Type	Full Kitchen
Cost Set:	2018
Building Name	Yellow Springs High School/McKinney Middle School
Building IRN	42416
Building Address	420 East Enon Road
Building City	Yellow Springs
Building Zipcode	45387
Building Phone	(937) 767-7224
Acreage	37.82
Current Grades:	7-12
Teaching Stations	22
Number of Floors	3
Student Capacity	412
Current Enrollment	383
Enrollment Date	2017-03-29
Enrollment Date is the date in which the current enrollment was taken.	
Number of Classrooms	1
Historical Register	NO
Building's Principal	Mr. Tim Krier
Building Type	Middle/High

Yellow Springs High School/McKinney Middle School, which is not on the National Register of Historic Buildings, and originally constructed in 1963, is a three story, 74,229 square foot brick, painted corrugated galbestos panels, EIFS, insulated metal panels, and painted concrete building located on the outer edge

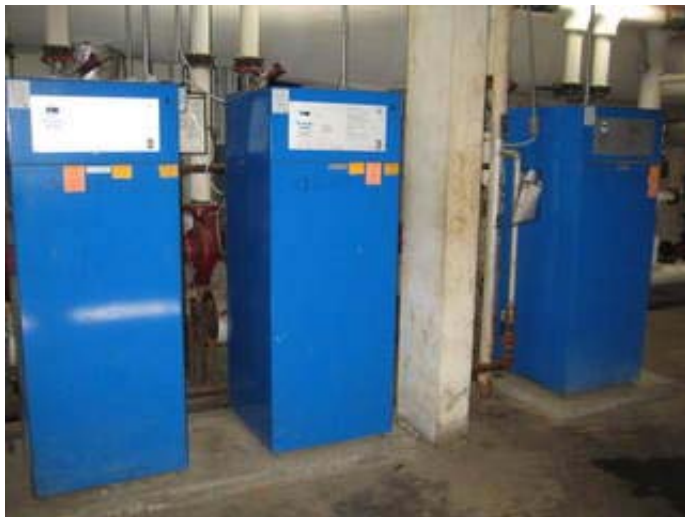
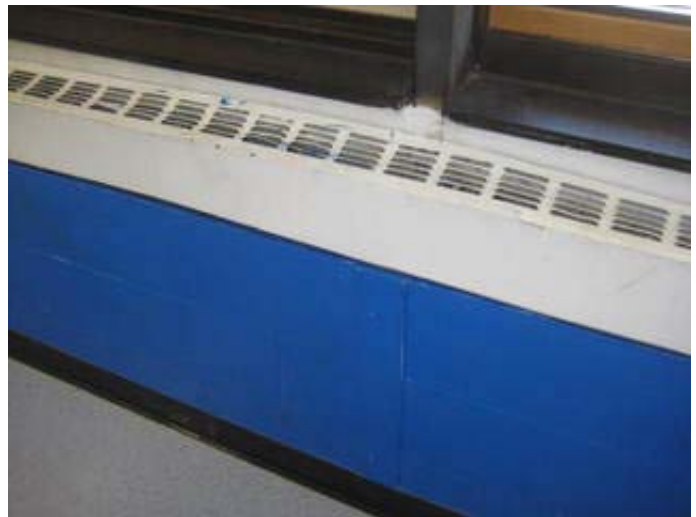
The existing system for the overall facility is a natural gas fired heated water boiler type system, installed in 1963, with some recent upgrades, and is in fair condition. The existing systems for the 1988 and 2002 Additions are natural gas fired packaged roof top unit type system, installed in 1988 and 2002, and are in fair condition. 2-pipe vs. 4-pipe designations are not applicable in this facility, as no central air conditioning is provided. The (3) heated water boilers, manufactured by Patterson-Kelley Co., are assumed to be installed in 1998 and are in fair condition. Heating water is distributed to terminal units consisting of unit ventilators, cabinet heaters, unit heaters, fin tubes, air handlers, and multiple roof top units. The 1988 Addition is equipped with (6) ducted packaged roof top units (with DX cooling and natural gas/hot water heat), manufactured by Trane, were installed in 1988, and are in fair condition. Heated air is distributed to terminal units consisting of multiple VAV boxes. The 2002 Addition is equipped with (5) ducted packaged roof top units (with DX cooling and natural gas/hot water heat), manufactured by York, were installed in 2002, and are in fair condition. Heated air is distributed to terminal units consisting of multiple VAV boxes. All terminal equipment is original to each addition and is in fair condition. The system does not comply with the 15 CFM per person fresh air requirements of the Ohio Building Code mechanical code and Ohio School Design Manual. The pneumatic, digital, and DDC type system temperature controls are original to each addition with incremental upgrades and are in fair condition. The system does not feature individual temperature controls in all spaces required by the OSDM. The overall system does not feature any central energy recovery systems. The 1963 Original Construction is equipped with widespread louvered interior doors to facilitate Corridor utilization as return air plenums. The remainder of the overall facility is not equipped with louvered interior doors to facilitate Corridor utilization as return air plenums. The existing system is ducted in the 1988 and 2002 Additions and a portion of the 1963 Original Construction, but the ductwork cannot be integrated into a possible future system due to arrangement, air volume, and routing of existing ductwork. The existing system in the remainder of the overall facility is not ducted, and floor to structural deck heights will not accommodate the installation of properly sized ductwork for a future Ohio School Design Manual approved system. The overall heating system is evaluated as not being in safe and efficient working order, and long term life expectancy of the existing system is not anticipated. The structure is not equipped with central air conditioning. The site does not contain underground fuel tanks.

3 Needs Replacement

Natural Gas Fired Heated Water Boilers

Heating Water Fin Tube Heater

Provide new overall heating, ventilating, and air conditioning system to achieve compliance with Ohio Building Code and Ohio School Design Manual standards. Replace existing ductwork in the 1988 and 2002 Additions and a portion of the 1963 Original Construction to facilitate efficient exchange of conditioned air. Convert to ducted system the remainder of the overall facility to facilitate efficient exchange of conditioned air. Provide architectural soffits to accommodate the installation of ductwork.

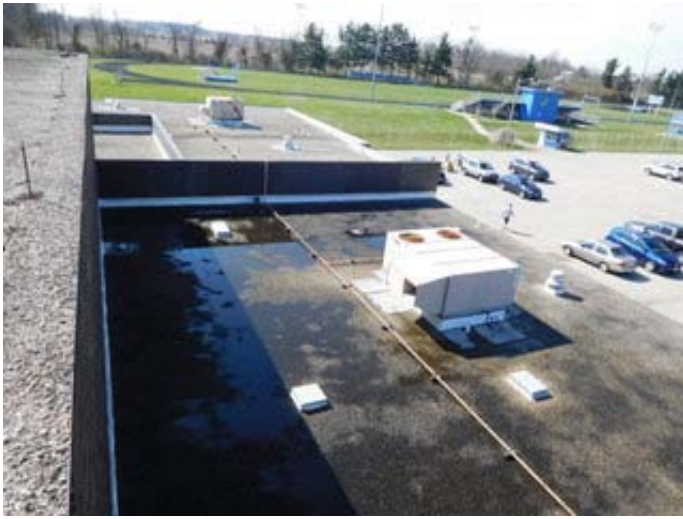
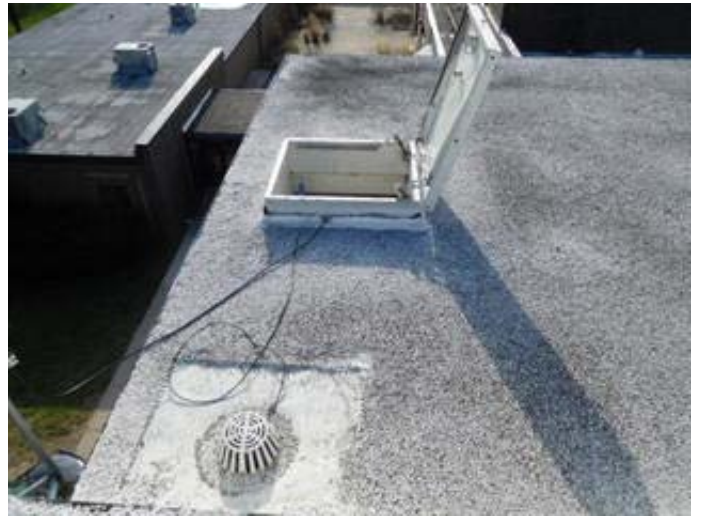
Description: The roof over the Original Construction is a built-up system with gravel ballast that was installed in 1994, and is in fair condition; portions of the Original Construction were replaced with a built-up system in 2009, and is in fair condition. The roof over the 1988 Addition is a modified bitumen system that was installed in 2003, and is in fair condition. The roof over the 1999 Addition is a built-up system with gravel ballast that was installed in 1999, and is in fair condition. The roof over the 2002 Addition is a built-up system with gravel ballast that was installed in 2004, and is in good to fair condition. There are no District reports of current leaking. No signs of past leaking were observed during the physical assessment. Access to portions of the roof was gained by access hatches that are in poor condition. Fall safety protection cages are not required. There were observations of standing water on the roof. Metal cap flashings and stone copings are in fair to poor condition. Roof storm drainage is addressed through a system of gutters and downspouts and roof drains, which are properly located, and in fair condition. The roof is not equipped with overflow roof drains in all additions though they will be required in areas of roof replacement. No problems requiring attention were encountered with any roof penetrations. There are not any covered walkways attached to this structure.

Rating: 3 Needs Replacement

Typical Roof

Recommendations: The roof over the overall facility requires replacement to meet Ohio School Design Manual guidelines due to age of system and projected lifecycle. The flashing and coping on the overall facility require replacement due to condition. Due to existing conditions roof drains require replacement on the overall facility with the exception of the 2002 Addition. Due to existing conditions gutters and downspouts and roof drains require replacement. Provide funding for overflow roof drains and piping for the Original construction and the 1999 Addition. Due to age and condition provide for the replacement of two roof access ladders and hatches. Provide one new roof access ladder and hatch to provide access to all roof areas. Provide funding for guardrails to be added at the location of the two existing roof access hatches due to life safety.

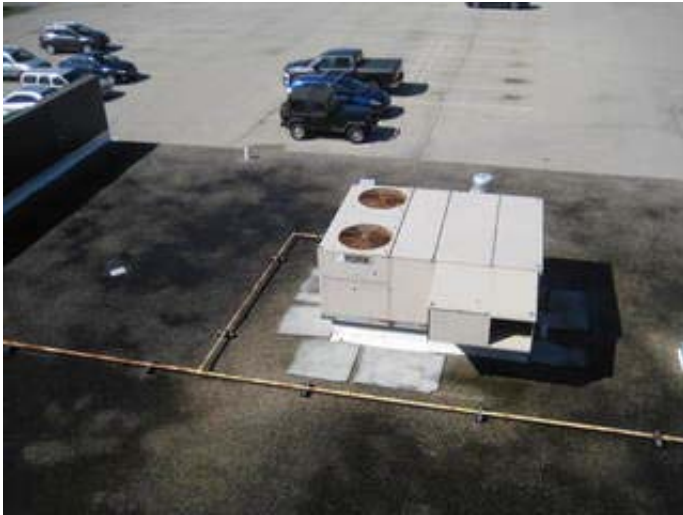
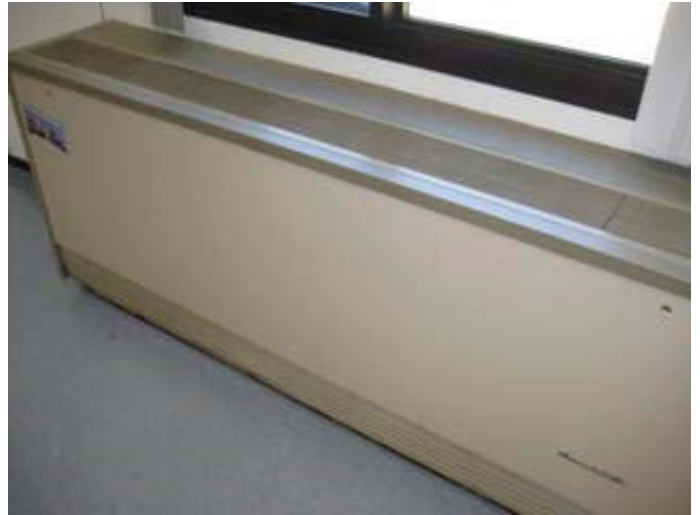
Description: The overall facility is not equipped with a central air conditioning system. Window units are located in several Classroom locations in the overall facility. An isolated room system consisting of an electric fired LG ducted split VRF type system (with the condensing units pad mounted and located on the exterior) is provided in the 3-story portion of the 1963 Original Construction. Isolated room systems consisting of multiple ducted packaged air cooled Trane and York roof top units (with DX cooling and natural gas/hot water heating) are provided in the Administrative Offices of the 1963 Original Construction, as well as throughout the 1998 and 2002 Additions. The ventilation system in the overall facility consists of unit ventilators, air handlers, and roof top units, original to each addition and in fair condition, providing fresh air to Classrooms, and air handlers and roof top units, original to each addition and in fair condition, providing fresh air to other miscellaneous spaces such as Gymnasium, Student Dining, and Media Center. Relief air venting is provided by louvered interior doors, central relief fans, air handlers, and roof top units. The ventilation system does not meet the Ohio Building Code 15 CFM per occupant fresh air requirement. The overall system is not compliant with Ohio Building Code and Ohio School Design Manual requirements. Dust collection systems are not required. The Art program is equipped with two (2) kilns, and existing kiln ventilation is inadequate, and in fair condition. General building exhaust systems for Restrooms, Storage Rooms, Art Rooms, and Custodial Closets are inadequately placed, and in fair condition.

Rating: 2 Needs Repair

Roof Top Unit

Unit Ventilator

Recommendations: Provide an air conditioning system to meet with Ohio Building Code and Ohio School Design Manual requirements. Replace general building exhaust systems located in Restrooms, Storage Rooms, and Custodial Closets. Pricing included in Item A. Replace the existing Art Program's kiln ventilation system due to age, condition, and lack of OSDM compliance.

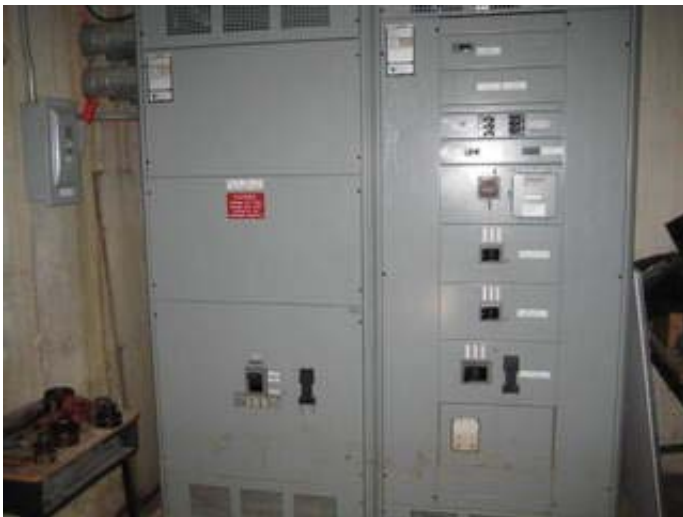
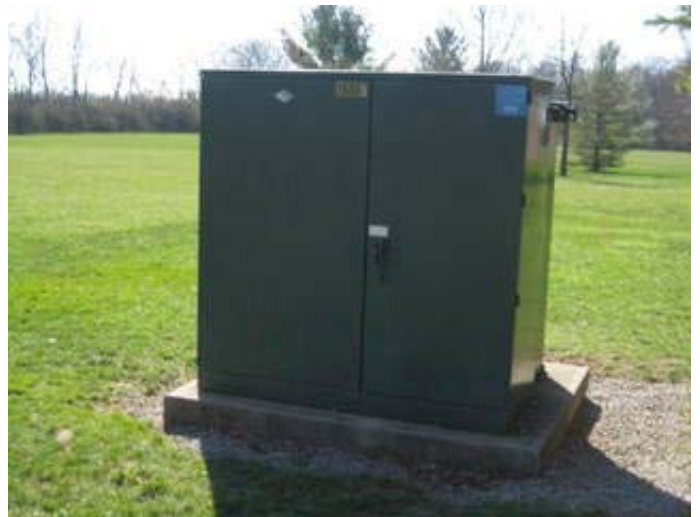
Description: The electrical system provided to the 2002 Addition is a 120/208 volts, 1,600 amp, 3 phase and 4 wire system installed in 2002, and is in good to fair condition. The systems in the 1963 Original Condition and 1988 and 1999 Additions are an extension of that found in the 2002 Addition. Power is provided to the school by a single utility owned, pad-mounted transformer located outside the Mechanical Room, and in fair condition. The panel systems, original to each addition, are in fair condition, and for the most part cannot be expanded to add additional capacity. The Classrooms are not equipped with adequate electrical outlets. The typical Classroom contains (6) general purpose outlets, (0) dedicated outlets for each Classroom computer, and (1) dedicated outlet for each Classroom television/ceiling mounted projector. Some Classrooms are equipped with as many as (7) general purpose outlets, while others are equipped with as few as (4) general purpose outlets. There are not any spaces that have no electrical outlets. The Corridors are equipped with adequate electrical outlets for servicing. Adequate GFI protected exterior outlets are not provided around the perimeter of the building. The facility is not equipped with an emergency generator. Adequate lightning protection safeguards are not provided. Stage lighting power system including control panel, breakers, and dimmers is inadequately provided, in fair condition and does not fully meet OSDM requirements. The overall electrical system does not fully meet Ohio School Design Manual requirements in supporting the current needs of the school, and will be inadequate to meet the facility's future needs.

Rating: 3 Needs Replacement

Main Electrical Distribution Panel

Pad Mounted Transformer

Recommendations: The entire electrical system requires replacement to meet Ohio School Design Manual guidelines for overall capacity due to age and condition, lack of OSDM-required features, and to accommodate the addition of an air conditioning system. Provide an emergency generator, with funding included in the electrical system replacement. Provide adequate lightning protection safeguards in the overall facility, including associated grounding system, with funding included in the electrical system replacement.

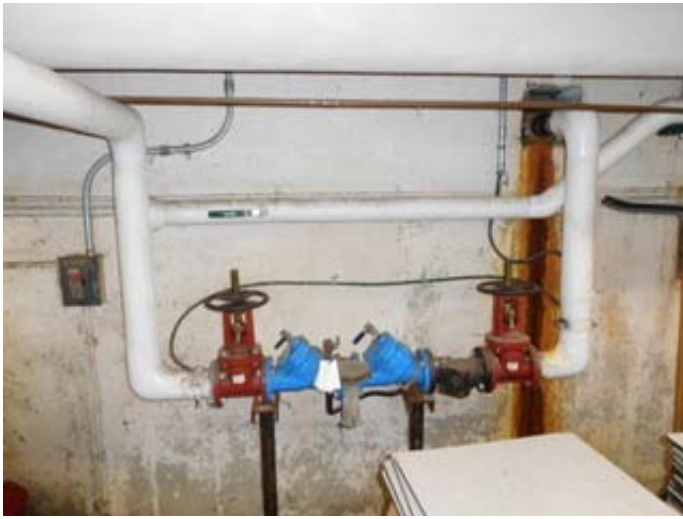
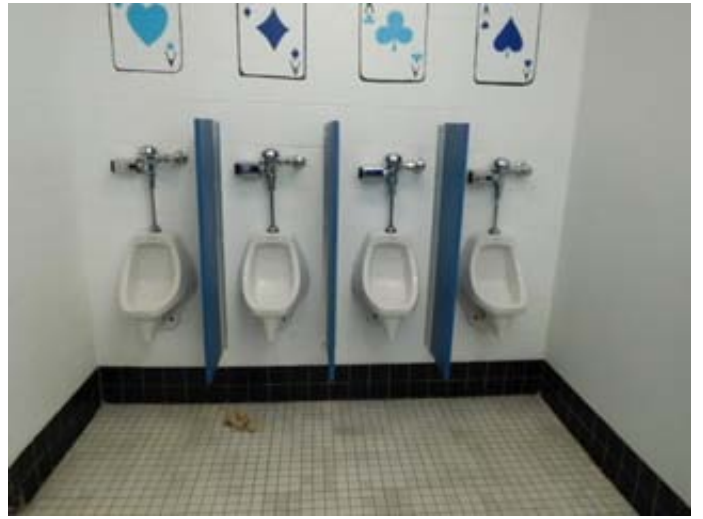
Description:	<p>The service entrance is equipped with a reduced pressure back flow preventer in good to fair condition. A water treatment system is not provided, though none is needed. The domestic water supply piping in the overall facility is copper and galvanized, is original to each addition, and is in fair condition. The waste piping in the overall facility is cast iron, with some galvanized, is original to each addition, and is in good to fair condition. The facility is equipped with a 40 gallon electric water heater in good to fair condition, and a 91 gallon gas water heater in good condition, with 1 separate 250 gallon storage tank in poor condition. The school contains 3 Large Group Restrooms for boys, 3 Large Group Restrooms for girls, 1 Locker Room Restroom for boys, 1 Locker Room Restroom for girls, 1 Restroom associated with specialty Classrooms, and 2 Restrooms for staff. Boys' Large Group Restrooms contain 3 ADA and 3 non-ADA wall and floor mounted flush valve and tank type toilets, 4 ADA and 5 non-ADA wall mounted flush valve urinals, as well as 5 ADA and 2 non-ADA countertop and wall mounted lavatories. Girls' Large Group Restrooms contain 3 ADA and 8 non-ADA wall and floor mounted tank type and flush valve toilets, as well as 5 ADA and 2 non-ADA countertop and wall mounted lavatories. Boys' Locker Room Restrooms contain 0 ADA and 1 non-ADA wall mounted flush valve toilets, 0 ADA and 1 non-ADA wall mounted flush valve urinals, 0 ADA and 1 non-ADA countertop lavatories, as well as 0 ADA and 9 non-ADA showers. Girls' Locker Room Restrooms contain 0 ADA and 2 non-ADA wall mounted flush valve toilets, as well as 0 ADA and 2 non-ADA countertop lavatories, as well as 0 ADA and 8 non-ADA showers. Staff Restrooms contain 0 ADA and 3 non-ADA wall and floor mounted tank type and flush valve toilets, 0 ADA and 0 non-ADA urinals, as well as 0 ADA and 3 non-ADA wall mounted lavatories. Condition of fixtures is good to fair. The facility is equipped with 0 ADA and 0 non-ADA drinking fountains, as well as 2 ADA and 7 non-ADA electric water coolers, in good to fair condition. High School Special Education Classrooms are equipped with 0 ADA and 0 non-ADA sink mounted type drinking fountains. Special Education Classroom is equipped with the required Restroom facilities, and fixtures are in fair condition. Kitchen is not equipped with the required Restroom. Heath Clinic is not equipped with the required Restroom. Due to existing grade configuration, Kindergarten / Pre-K Classroom Restroom considerations are not relevant. Kitchen fixtures consist of 2 single compartment sink and 1 triple compartment sink, which are in fair condition. The Kitchen is not equipped with a grease interceptor. The Kitchen is provided the required 140 degree hot water supply. The school meets the OBC requirements for fixtures. Relative to LEED requirements, the school is not equipped with low flow type fixtures. Per OBC and OSDM requirements this facility should be equipped with 8 toilets, 2 urinals, 10 lavatories, 1 Classroom sink mounted drinking fountains, and 5 electric water coolers. Observations revealed that the school is currently equipped with 28 toilets, 10 urinals, 25 lavatories, 0 Classroom sink mounted drinking fountains, and 9 electric water coolers. ADA requirements are not met for fixtures and drinking fountains see Item O. Custodial Closets are properly located and are adequately provided with required service sinks or floor drain sinks, which are in fair condition. Science Classrooms / Project Laboratories / Career Tech Laboratories are equipped with required utility sink, gas / compressed air connections, and safety shower / eyewash in good to fair condition. Biology and Chemistry Classrooms are not equipped with acid waste systems and neutralization tanks. Adequate exterior wall hydrants are not provided.</p>

Backflow Preventers

Typical Restroom Urinals

Rating:	3 Needs Replacement
Recommendations:	<p>To facilitate the school's compliance with OBC and OSFC fixture requirements, provide 2 new toilets, 2 new lavatories and 1 new lavatory mounted type drinking fountains. Due to age, condition, LEED, and OSFC requirements, provide 22 new toilets, 21 new lavatories, 8 new urinals and 4 new electric water coolers. Replace water supply and sanitary waste piping in the 1963 Original Construction and 1988 Addition. Due to age replace the electric hot water heater in the 1988 Addition. Due to age and condition, replace the 250 gallon hot water storage tank. Due to age and condition replace all showers in the Original Construction. See Item O for replacement of fixtures related to ADA requirements. Provide the Science Classrooms with the required gas connections, compressed air connections, and safety shower / eyewash stations. Provide the Biology and Chemistry Classrooms with the required acid waste systems and neutralization tanks. See Item J for replacement of Kitchen fixtures. Replace one and provide three new exterior wall hydrants to meet OSFC requirements. Provide the Kitchen with a grease trap interceptor. Replace existing Custodial Closet sinks due to age and condition.</p>

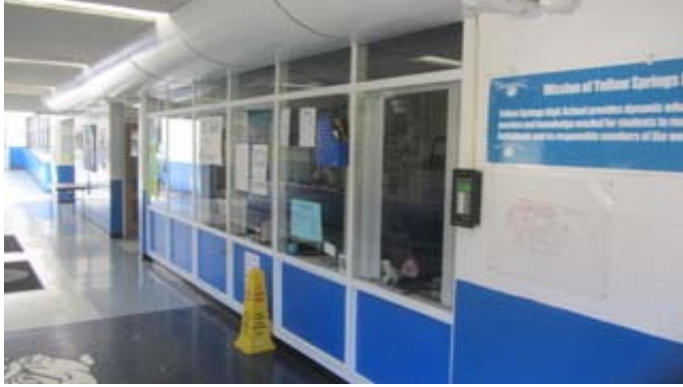
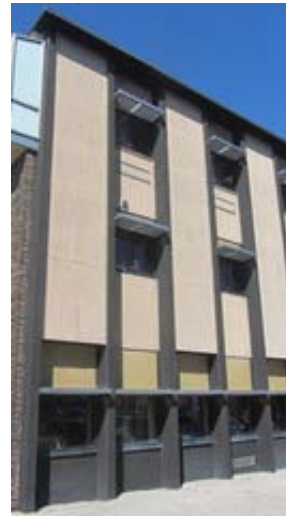
The 1963 Original Construction is equipped with aluminum frame windows double glazed insulated glazing type window systems. There are two different window systems which appear to have been installed at two different dates. There is an aluminum framed curtain wall system located at the east stair tower which was installed in 2006, and is in good condition. The window system located in Classrooms appears to be older than 2006, and is in fair condition. Windows in the curtain wall system are inoperable. Windows located in Classrooms and Corridors are operable. Operable windows are equipped with opening limiters in fair condition and insect screens where provided in fair to poor condition. The 1988 Addition is equipped with aluminum frame windows with double glazed insulated glazing type window system, which was installed in 1988, and is in fair to poor condition. The window system features operable windows in most portions of the building, and operable windows are equipped with opening limiters in fair condition and insect screens in fair to poor condition. The 1999 Addition is equipped with aluminum frame windows with double glazed insulated glazing type window system, which was installed in 2006, and is in good condition. The window system features inoperable windows throughout the building. The 2002 Addition is equipped with aluminum frame windows with double glazed insulated glazing type window system, which was installed in 2002, and is in good condition. The window system features operable and inoperable windows throughout the building, and operable windows are equipped with opening limiters in good condition and insect screens where provided in good to fair condition. Window system seals in the 1963 Original Construction and 1999 Addition are in good to fair condition, with minimal air and water infiltration being experienced. Window system hardware is in good to fair condition. Window system seals in the 1988 Addition are in fair to poor condition, with moderate frequent air and water infiltration being experienced. Window system seals in the 2002 Addition are in good condition, with no air and water infiltration being experienced. Window system hardware is in good condition. The window systems feature surface mounted blinds and shades, which are in fair to poor condition. This facility does not feature any glass block windows. The exterior doors in the overall facility are equipped with aluminum and hollow metal frame sidelights and transoms with tempered single pane and double glazed insulated glazing, in good to fair condition. Exterior door vision panels are tempered single pane and double glazed insulated glazing. The school does not contain skylights. The school does contain 2 clerestories located on the third floor roof of the 1963 Original Construction featuring aluminum frames with insulated glazing, which are in good condition. Interior glass is in the 1963 Original Construction is not OSDM-compliant due to OBC requirements for safety glass in openings located within 36 inches of walking surfaces, larger than 9 square feet or located within 18 inches of door openings. Window security grilles are not provided for ground floor windows. There is a 20 SF Greenhouse located on the third floor of the 1963 Original Construction, and it is in poor condition. There is a 28 SF Greenhouse located in the 2002 Addition and it is in good condition.

3 Needs Replacement

1963 Original Construction Interior Glazing

1963 Original Construction Classroom Windows

Provide a new insulated window system with integral blinds to meet with Ohio School Design Manual requirements in the 1963 Original Construction and 1988 Addition. Replace window single glazed transoms and sidelights at exterior doors of the 1963 Original Construction. Replace existing greenhouse in the 1963 Original Construction. Replace single glazed door vision panels in the 2002 Addition. Replace damaged screens in the 2002 Addition. Provide new blinds in the 2002 Addition. Replace non-code compliant interior glazing in the 1963 Original Construction.

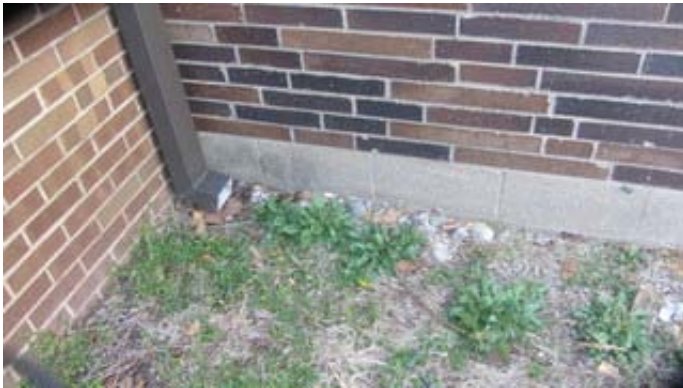
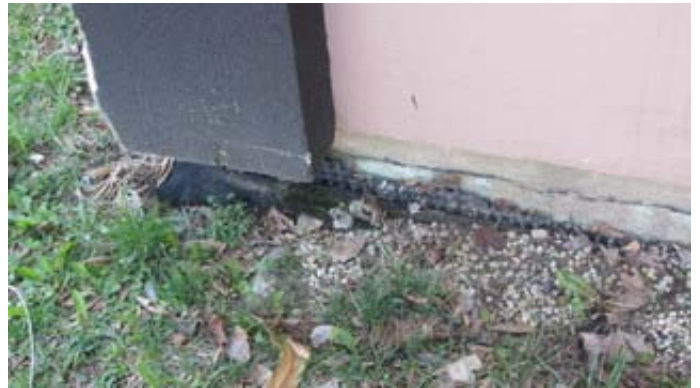
Rating: 2 Needs Repair

1963 Original Constructiton Exposed Foundation

1999 Addition Foundation

Recommendations: Repair areas of cracking and open masonry joints in the 1963 Original Construction and 1988 Addition. Regrade depressed areas under emergency roof drains in the 1963 Original Construction. Repair leaks in Mechanical Room walls.

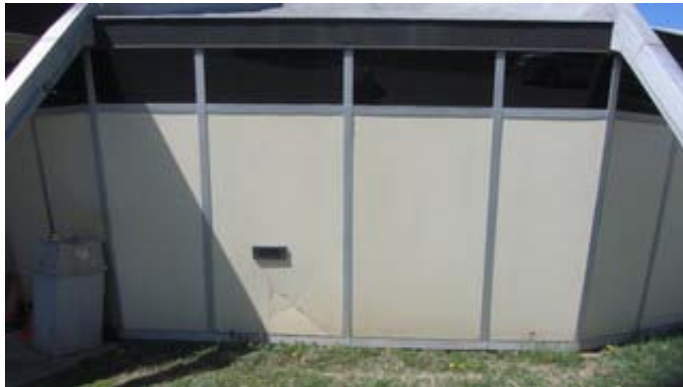
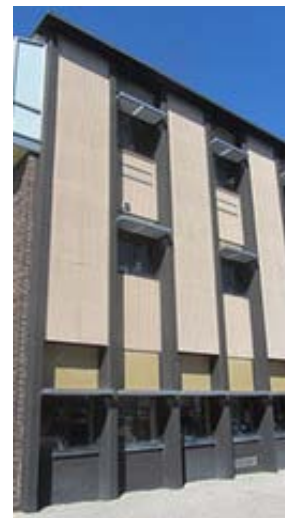
Rating: 2 Needs Repair

Insulated panels at 1963 Original Construction Music Room

1963 Original Construction Three Story Structure

Other: Exterior Masonry Repairs	\$15.00	sq.ft. (Qty)		1,474 Required	4,420 Required	480 Required		940 Required	\$109,710.00	Repair exterior masonry as required throughout the overall facility.
Other: Galbestos Panel Replacement	\$50.00	sq.ft. (Qty)			3,264 Required				\$163,200.00	Replace Galbestos Panels in the 1963 Original Construction.
Other: Insulated Panel Replacement	\$50.00	sq.ft. (Qty)		4,392 Required		60 Required			\$222,600.00	Replace insulated metal panels in the 1963 Original Construction.
Other: Interior Masonry Repairs	\$15.00	sq.ft. (Qty)		3,860 Required	560 Required		200 Required	470 Required	\$76,350.00	Repair interior masonry as required throughout the overall facility.
Other: Prep and Paint Exposed Concrete Structure	\$10.00	sq.ft. (Qty)			6,368 Required				\$63,680.00	Prep and paint exposed concrete structural elements in the 1963 Original Construction.
Other: Prep and Paint Exposed Steel Lintels	\$8.00	sq.ft. (Qty)		780 Required		60 Required	8 Required	214 Required	\$8,496.00	Prep and paint exposed steel lintels through the overall facility.

Other: Provide Masonry Infill	\$27.00	sq.ft. (Qty)		96 Required					\$2,592.00	Provide masonry infill in the 1963 Original Construction.
Other: Railing Replacement	\$85.00	ln.ft.			65 Required				\$5,525.00	Replace non-code compliant railings.
Other: Recaulk Exterior Control Joints	\$5.50	ln.ft.		841 Required	407 Required	45 Required		256 Required	\$8,519.50	Recaulk existing control joints.
Other: Repoint Stone Sills	\$7.50	ln.ft.				64 Required			\$480.00	Repoint stone window sills through the 1988 Addition.
Other: Wood Soffit Replacement	\$25.00	sq.ft. (Qty)				250 Required			\$6,250.00	Replace wood soffits in 1988 Addition.
Sum:			\$891,130.25	\$383,421.00	\$366,726.75	\$59,971.00	\$12,791.50	\$68,220.00

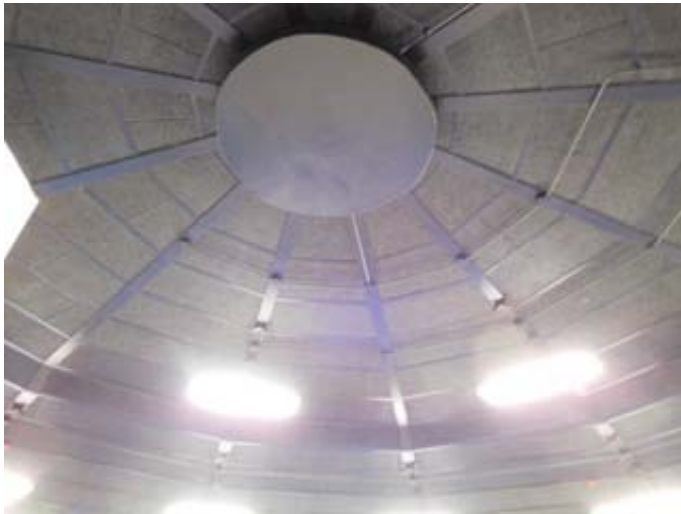
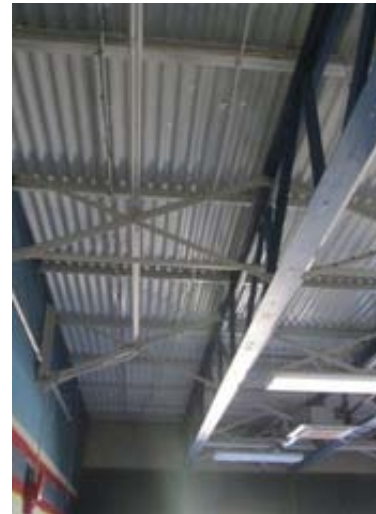
1963 Original Construction Music Room Roof Structure

1963 Original Construction Student Dining Roof Structure

Recommendations: Remove and replace wood floor, wall and roof construction in the 1988 Addition with code compliant construction that meets with Ohio School Design Manual Requirements. Provide funding for an investigation and correction of the structural issues at the intermediate floors of the 1963 Original Construction. Refer to Item A for funding of architectural soffits to accommodate HVAC, electrical, and plumbing scopes of work.

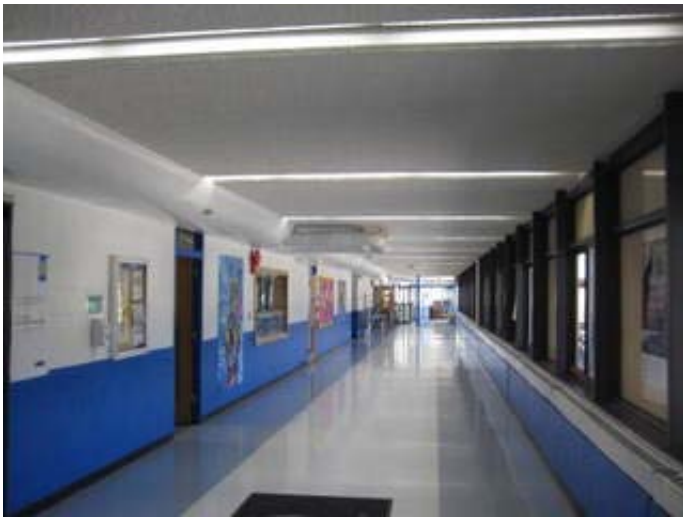
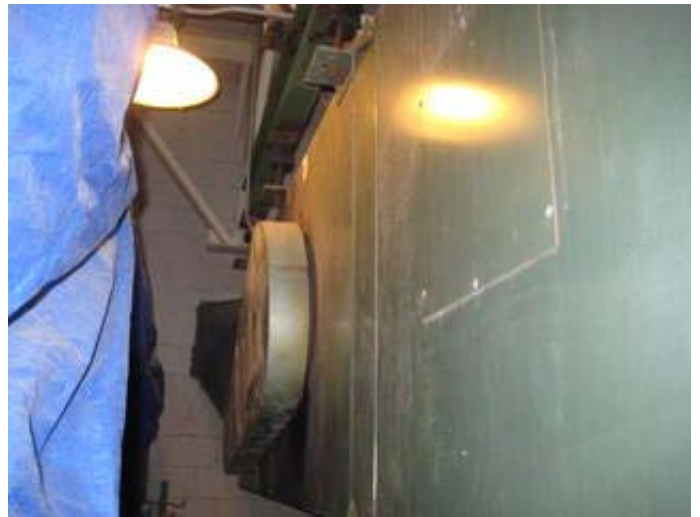
Typical Corridor Fluorescent Light Fixtures

Service Area Incandescent Light Fixture

Recommendations: Provide complete replacement of lighting system due to age, condition, lighting levels, utilization of incandescent fixtures, lack of multilevel switching, and installation of systems outlined in Items A, C, J, and U.

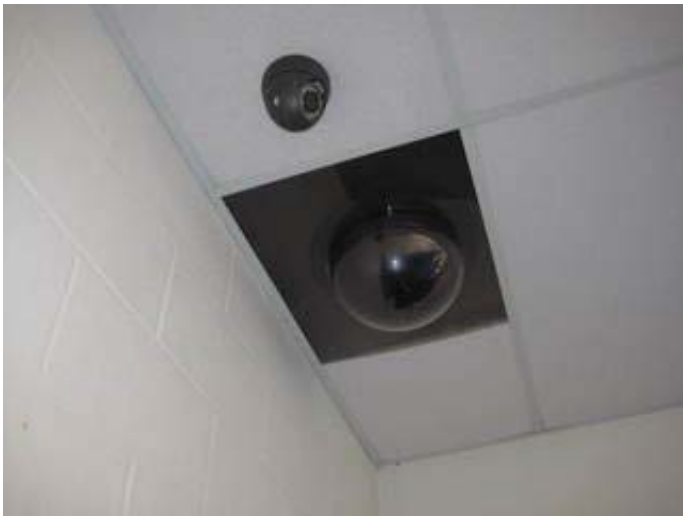
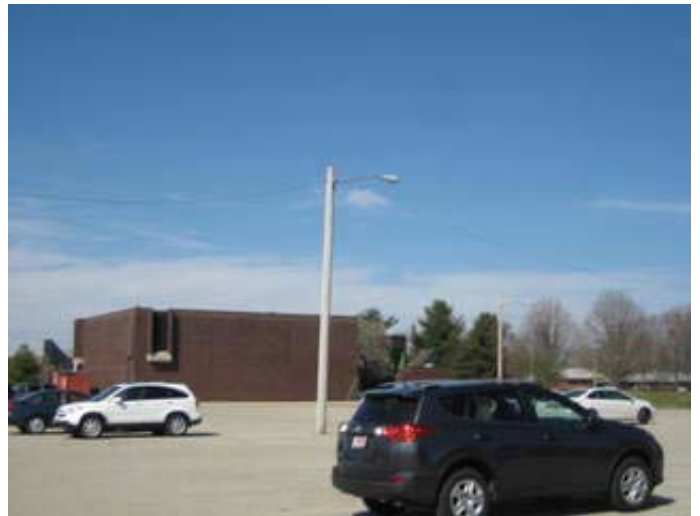
Security System CCTV Camera

Pole Mounted HID High Pressure Sodium Light Fixture

Recommendations: Provide complete replacement of security system to meet Ohio School Design Manual guidelines. Provide complete replacement of exterior site lighting system to meet Ohio School Design Manual guidelines. Provide OSDM-compliant playground fencing, funding included in complete replacement of security system. Provide a secure entrance Vestibule between the main entry area and Administrative Offices.

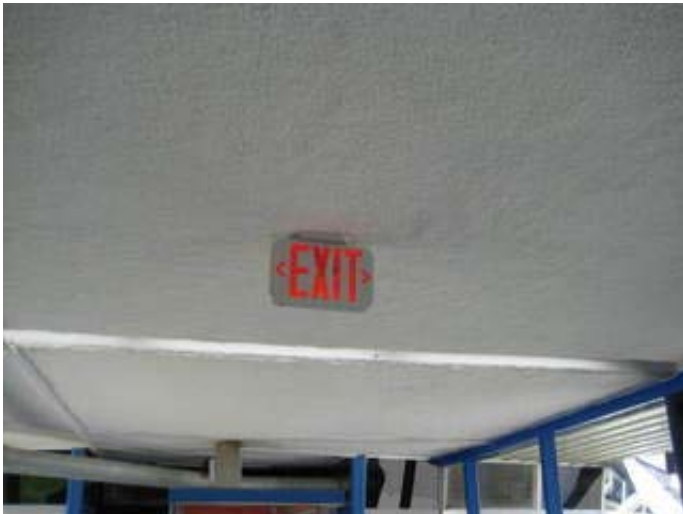
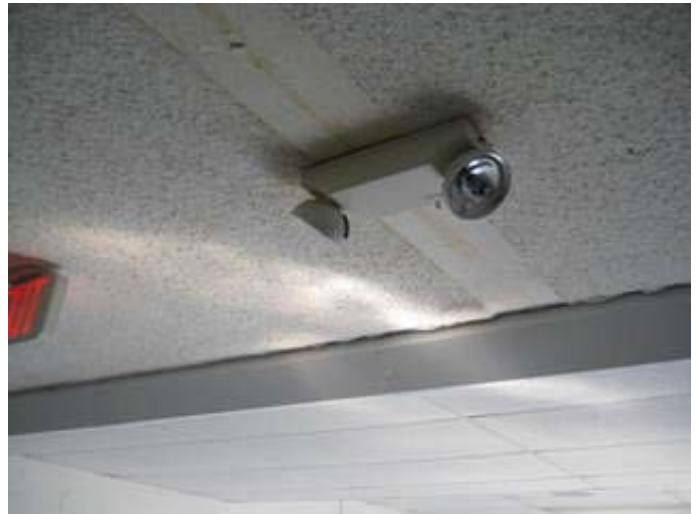
Exit Sign

Emergency Egress Light Fixture

Recommendations: Provide complete replacement of emergency / egress lighting system to meet Ohio School Design Manual and Ohio Building Code guidelines.

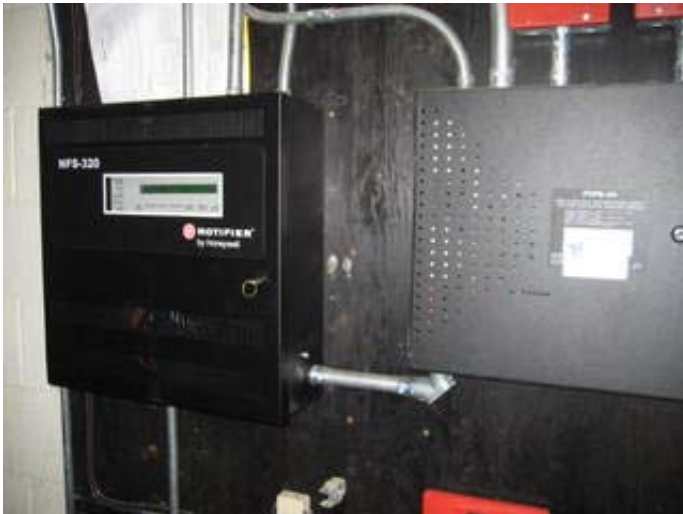
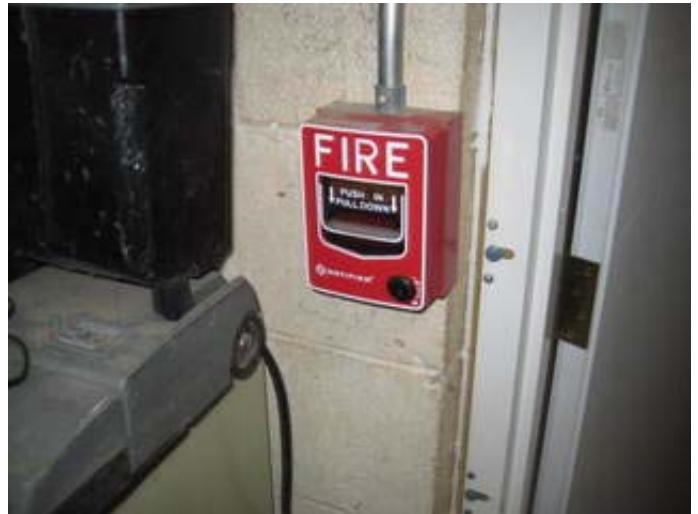
Fire Alarm System Control Panel

Fire Alarm System Manual Pull Station

Recommendations: Provide complete replacement of fire alarm system to meet OBC, NFPA, and Ohio School Design Manual guidelines.

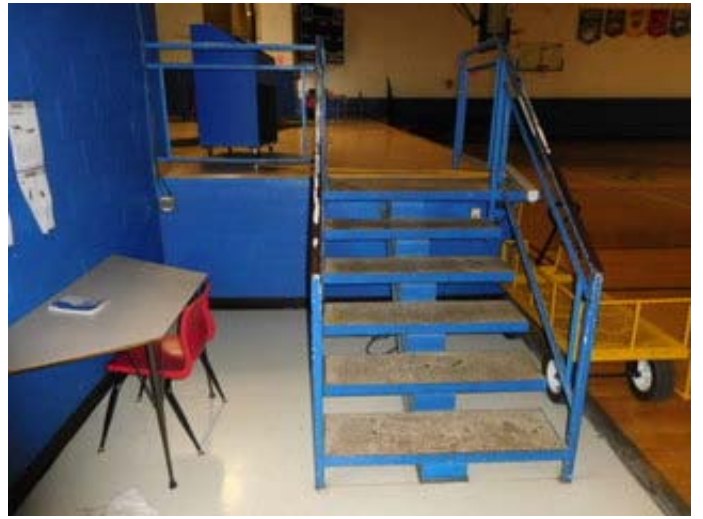
Non-ADA Compliant Stage Access

Other: New ADA Restroom	\$15,000.00	each		1 Required	1 Required				\$30,000.00	Provide required ADA Restrooms for Kitchen and Health Clinic to meet requirements.
Sum:			\$85,445.80	\$51,746.40	\$26,201.20	\$4,382.80	\$88.80	\$3,026.60

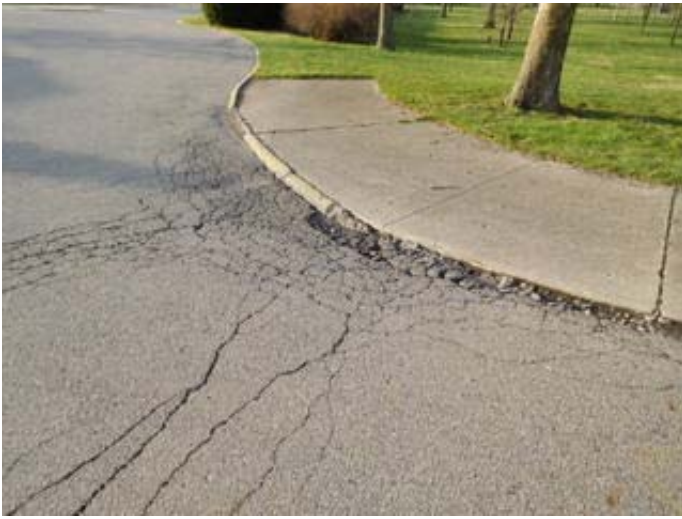
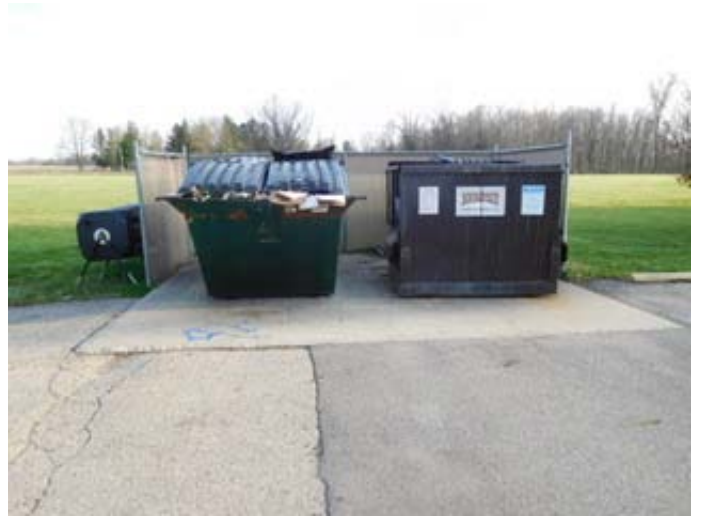
Asphalt, Curb, and Sidewalk Condition

Concrete Dumpster Pad

Provide Concrete Dumpster Pad:	\$2,400.00	each		1 Required					\$2,400.00	(for two dumpsters)
Base Sitework Allowance for Unforeseen Circumstances	\$50,000.00	allowance		Required					\$50,000.00	Include this and one of the next two. (Applies for whole building, so only one addition should have this item)
Sitework Allowance for Unforeseen Circumstances for buildings between 0 SF and 100,000 SF	\$1.50	sq.ft. (of entire building addition)		Required	Required	Required	Required	Required	\$111,343.50	Include this one or the next. (Each addition should have this item)
Sum:			\$585,961.45	\$339,990.37	\$44,259.00	\$10,371.00	\$666.00	\$190,675.08

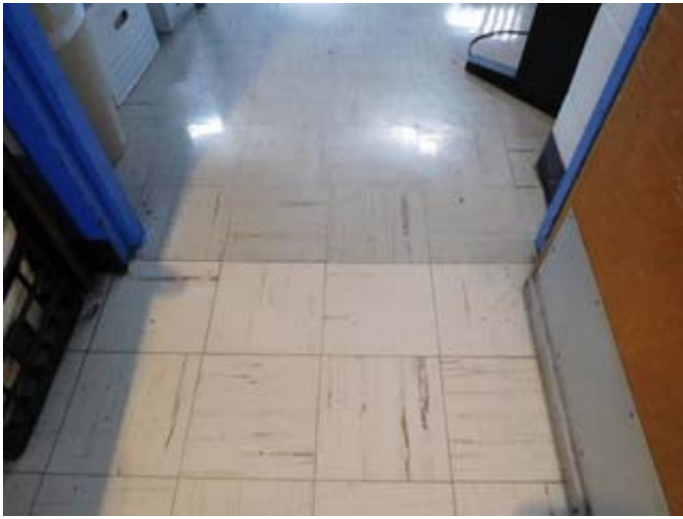
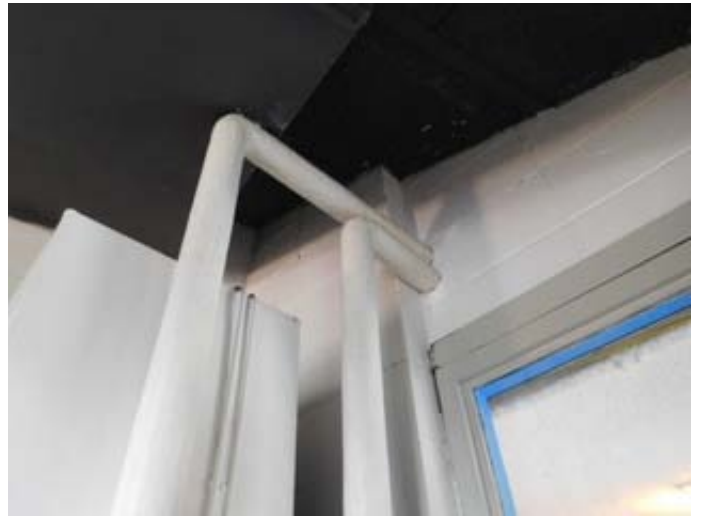
VAT Flooring

Pipe Insulation

Other: Chalkboard Mastic Removal	\$2.00	sq.ft. (Qty)			2,840 Required	360 Required	0 Required	800 Required	\$8,000.00	Provide for the removal of chalkboard mastic.
Other: Corrugated Galbestos Panel Removal	\$50.00	sq.ft. (Qty)			2,000 Required				\$100,000.00	Provide for the removal of exterior corrugated Galbestos Panels
Other: Cove Base Mastic Removal	\$1.00	in.ft.			2,965 Required	1,170 Required		780 Required	\$4,915.00	Provide for the removal of cove base mastic.
Other: EHA Other Hazard	\$1.00	per unit			3,000 Required				\$3,000.00	XRF testing for lead-based paint is recommended for compliance with EPA's RRP Program.
Other: Fume Hood Removal	\$10,000.00	each			1 Required				\$10,000.00	Provide for the removal of Science Classroom fume hoods
Sum:			\$386,886.30	\$23,728.20	\$303,741.60	\$51,681.40	\$44.40	\$7,690.70

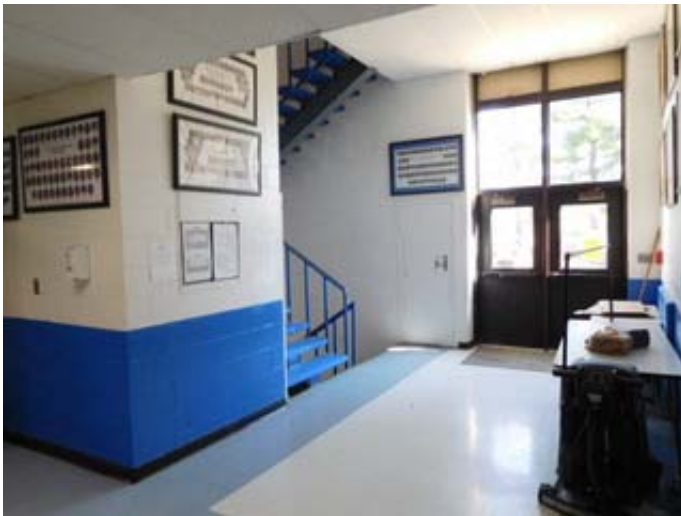
Existing Stair Tower with fire alarm No 2 hour Enclosure
