Building Information - Yellow Springs Exempted Village (45674) - Mills Lawn Elementary / Middle School

Program Type	Expedited Local Partnership Program (ELPP)
Setting	Small City
Assessment Name	Mills Lawn Elementary / Middle with EEA & Related Scope Adjustments
Assessment Date (on-site; non-EEA)	2017-03-29
Kitchen Type	Full Kitchen
Cost Set:	2017
Building Name	Mills Lawn Elementary / Middle School
Building IRN	24919
Building Address	200 South Walnut Street
Building City	Yellow Springs
Building Zipcode	45387
Building Phone	(937) 767.7217
Acreage	8.84
Current Grades:	K-6
Teaching Stations	25
Number of Floors	2
Student Capacity	378
Current Enrollment	374
Enrollment Date	2017-03-29
Enrollment Date is the date in which the current enrollment was taken.	
Number of Classrooms	23
Historical Register	NO
Building's Principal	Mr. Matthew Housh
Building Type	Elementary/Middle

Building Construction Information - Yellow Springs Exempted Village (45674) - Mills Lawn Elementary / Middle School (24919)

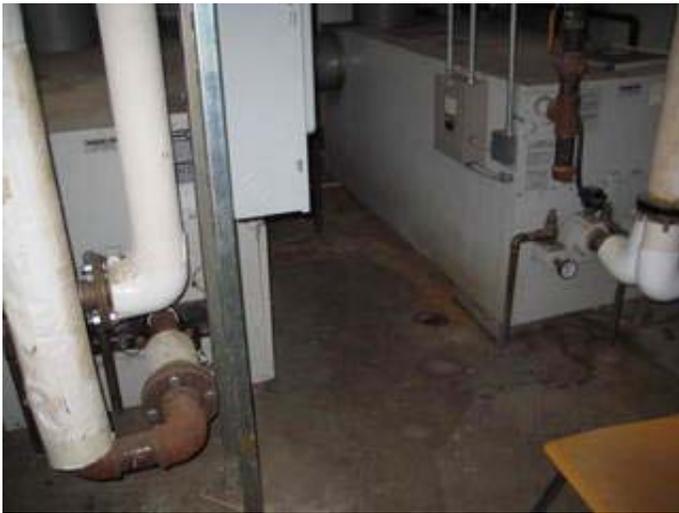
Description: The existing system for the 1952 Original Construction is a natural gas fired heated water boiler type system, installed in 1952, and is in fair condition. The system in the 1957 Addition is an extension of that found in the 1952 Original Construction. The existing system for the 2002 Addition is a natural gas fired packaged roof top unit type system, installed in 2002, and is in fair condition. 2-pipe vs. 4-pipe designations are not applicable in this facility, as no central air conditioning is provided. The 1952 Original Construction is equipped with (2) Copper-fin II boilers, manufactured by Lochinvar, are believed to be installed in 1998, and are in fair condition. Heating water is distributed to terminal units consisting of unit ventilators, cabinet heaters, unit heaters, fin tubes, air handlers, and roof top units. The 2002 Addition is equipped with (2) ducted packaged roof top units (with DX cooling and natural gas/hot water heat), manufactured by York, were installed in 2002, and are in fair condition. Heated air is distributed to terminal units consisting of multiple VAV boxes. All terminal equipment is original to each addition and is in fair condition. The system does not appear to comply with the 15 CFM per person fresh air requirements of the Ohio Building Code mechanical code and Ohio School Design Manual. The pneumatic, digital, and DDC type system temperature controls are original to each addition, with incremental upgrades, and are in fair to poor condition. The system does not feature individual temperature controls in all spaces required by the OSDM. The overall system does not feature any central energy recovery systems. The 1952 Original Construction is not equipped with widespread louvered interior doors to facilitate Corridor utilization as return air plenums. The remainder of the overall facility is not equipped with louvered interiors doors. The existing system is ducted in the 2002 Addition and a portion of the 1952 Original Construction and 1957 Addition, but the ductwork cannot be integrated into a possible future system due to arrangement, air volume, and routing of existing ductwork. The existing system is not ducted in the remainder of the overall facility, and floor to structural deck heights will accommodate the installation of properly sized ductwork for a future Ohio School Design Manual approved system. The overall heating system is evaluated as not being in safe and efficient working order, and long term life expectancy of the existing system is not anticipated. The structure is not equipped with central air conditioning. The site does not contain underground fuel tanks.

Rating: 3 Needs Replacement

Natural Gas Fired Heated Water Boilers

Recommendations: Provide new overall heating, ventilating, and air conditioning system to achieve compliance with Ohio Building Code and Ohio School Design Manual standards. Replace existing ductwork in the 2002 Addition and a portion of the 1952 Original Construction and 1957 Addition to facilitate efficient exchange of conditioned air. Convert to ducted system the remainder of the overall facility to facilitate efficient exchange of conditioned air.

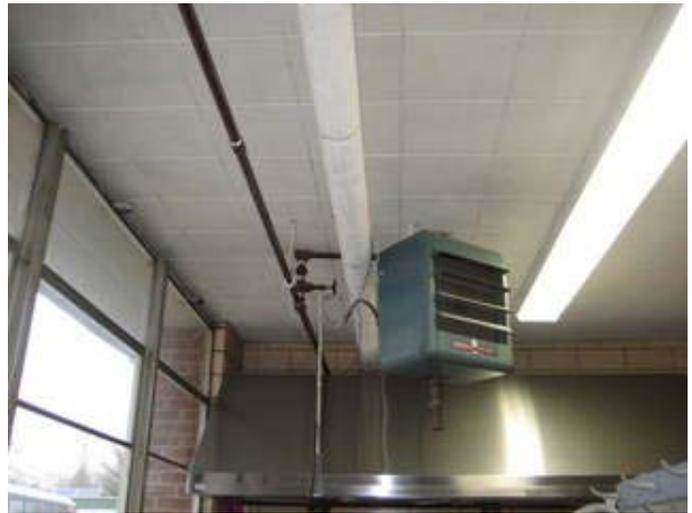
Unit Heater

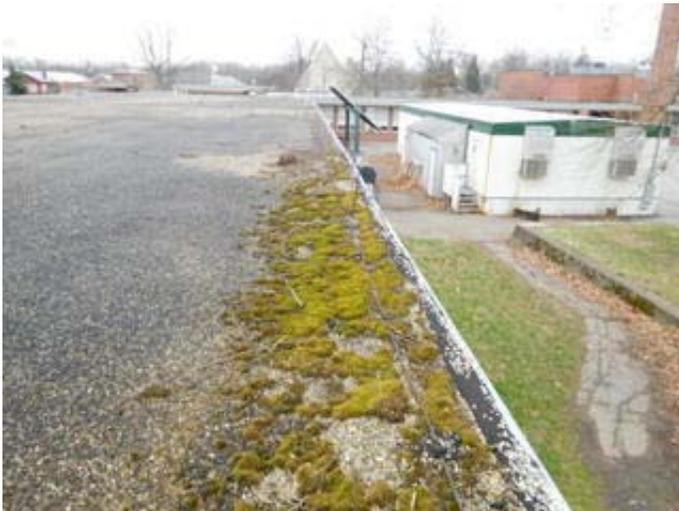
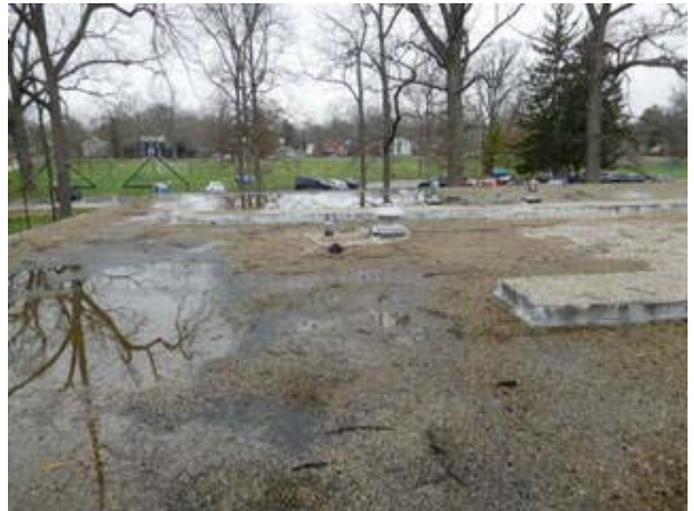
Description: The roof over the Original Construction is a built-up system with gravel ballast that was installed in 1952, and is in poor condition. The roof over the 1957 Addition is a built-up system with gravel ballast that was installed in 1957, and is in poor condition. The roof over the 2002 Addition is a built-up system with gravel ballast that was installed in 2002, and is in fair condition. There are no District reports of current leaking. No signs of past leaking were observed during the physical assessment. Access to the roof was gained by access hatch that is in poor condition. Fall safety protection cages are not required, and are not provided. There were observations of standing water on the roof. Metal cap flashings and copings are in fair to poor condition. Roof storm drainage is addressed through a system of roof drains, which are properly located, and in fair to poor condition. The roof of the Original Construction and the 1957 Addition are not equipped with overflow roof drains though they will be required in areas of roof replacement. No problems requiring attention were encountered with any roof penetrations. There are not any covered walkways attached to this structure.

Rating: 3 Needs Replacement

Built-Up Roof with Gravel Ballast

Recommendations: The roof over the overall facility requires replacement to meet Ohio School Design Manual guidelines due to condition and age of system and projected lifecycle. The flashing and coping on the overall facility require replacement due to condition. Due to existing conditions roof drains require replacement on the overall facility with the exception of the 2002 Addition. Due to age and condition replace the existing access ladder and hatch. Provide two new roof access ladders. Replace existing roof drains and sumps due to condition and replacement of the roofing system. Provide new overflow roof drains and piping.

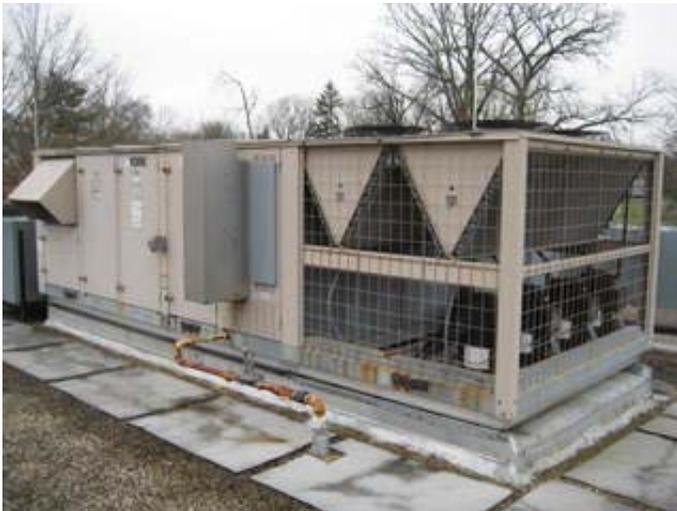
Description: The overall facility is not equipped with a central air conditioning system. Window units are provided at multiple Classroom locations throughout the overall facility, as well as in the Teacher's Lounge. An isolated room system consisting of ductless split AC wall cassettes with (2) condensing units (pad mounted and located on the exterior) is provided in the Administrative Offices in the 1952 Original Construction. An isolated room system consisting of a single ducted HVAC/furnace type unit and (1) condensing unit (pad mounted and located on the exterior) is provided in the Administrative Office Conference Room of the 2002 Addition. An isolated room system consisting of (2) ducted packaged air cooled York roof top units (with DX cooling and natural gas/hot water heat) is provided in the majority of the 2002 Addition and the Multi-Purpose Room (Gymnasium/Student Dining) and Media Center of the 1952 Original Construction. The ventilation system in the overall facility consists of unit ventilators and roof top units, original to each addition and in fair condition, providing fresh air to Classrooms, and air handlers and roof top units, original to each addition and in fair condition, providing fresh air to other miscellaneous spaces such as Multi-Purpose Room (Gymnasium/Student Dining) and Media Center. Relief air venting is provided by louvered interior doors, ceiling plenums / being ducted back through energy recovery units, central relief fans, air handlers, and roof top units. The ventilation system does not meet the Ohio Building Code 15 CFM per occupant fresh air requirement. The overall system is not compliant with Ohio Building Code and Ohio School Design Manual requirements. Dust collection systems are not required in this facility though no system is provided. The Art program is equipped with a kiln, and existing kiln ventilation is inadequate, and in fair condition. General building exhaust systems for Restrooms, Storage Rooms, Art Rooms, and Custodial Closets are inadequately placed, and in fair condition.

Rating: 2 Needs Repair

Roof Top Unit

Recommendations: Provide an air conditioning system to meet with Ohio Building Code and Ohio School Design Manual requirements. Replace general building exhaust systems located in Restrooms, Storage Rooms, and Custodial Closets. Pricing included in Item A. Replace the existing Art Program's kiln ventilation system due to age, condition, and lack of OSDM compliance.

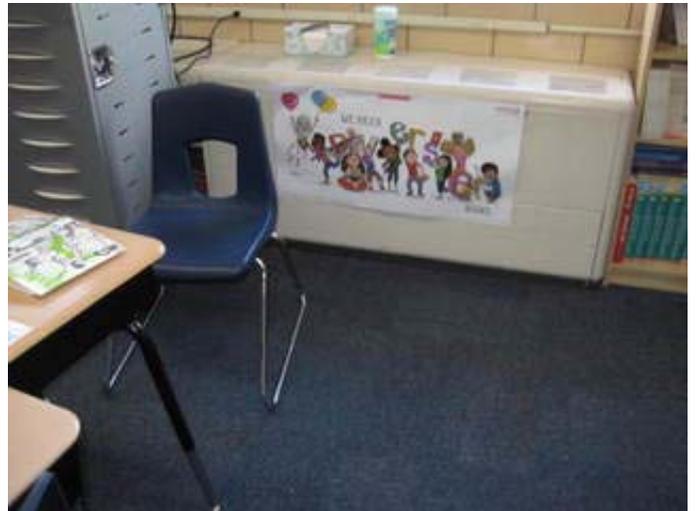
Unit Ventilator

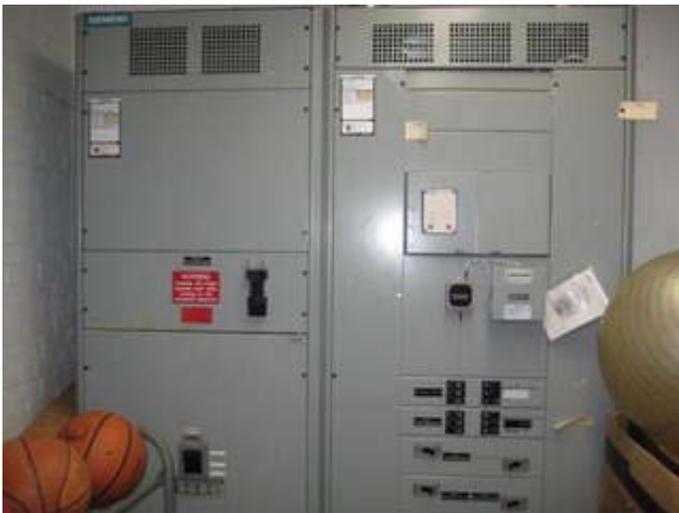
Description: The electrical system provided to the 2002 Addition is a 208Y/120 volts, 1,200 amp, 3 phase and 4 wire system installed in 2002, and is in good to fair condition. The systems in the 1952 Original Construction and 1957 Addition are an extension of that found in the 2002 Addition. Power is provided to the school by a single utility owned, pad-mounted transformer located at the front of the School, and in fair condition. The panel systems are original to each Addition, are in fair condition, and for the most part cannot be expanded to add additional capacity. The Classrooms are not equipped with adequate electrical outlets. The typical Classroom contains (5) general purpose outlets, (0) dedicated outlets for each Classroom computer, and (1) dedicated outlet for each Classroom television/ceiling mounted projector. Some Classrooms are equipped with as many as (6) general purpose outlets, while others are equipped with as few as (3) general purpose outlets. There are not any spaces that have no electrical outlets. The Corridors are equipped with adequate electrical outlets for servicing. Adequate GFI protected exterior outlets are not provided around the perimeter of the building. The facility is not equipped with an emergency generator. Adequate lightning protection safeguards appear to be provided and are in fair condition. Stage lighting power system including control panel, breakers, and dimmers is inadequately provided, in fair condition and does not meet OSDM requirements. The overall electrical system does not fully meet Ohio School Design Manual requirements in supporting the current needs of the school, and will be inadequate to meet the facility's future needs.

Rating: 3 Needs Replacement

Main Electrical Distribution Panel

Recommendations: The entire electrical system requires replacement to meet Ohio School Design Manual guidelines for overall capacity due to age, condition, lack of OSDM-required features, and to accommodate the addition of an air conditioning system. Provide an emergency generator, with funding included in the electrical system replacement. Replace the existing lightning protection safeguards in the overall facility, including associated grounding system, with funding included in the electrical system replacement.

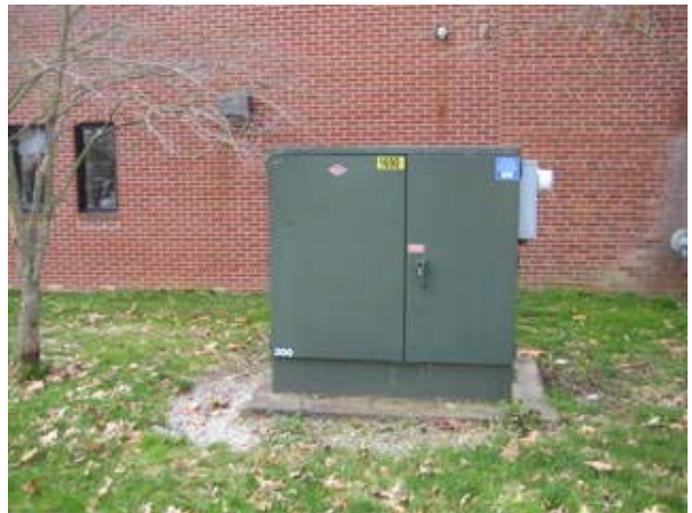
Pad Mounted Transformer

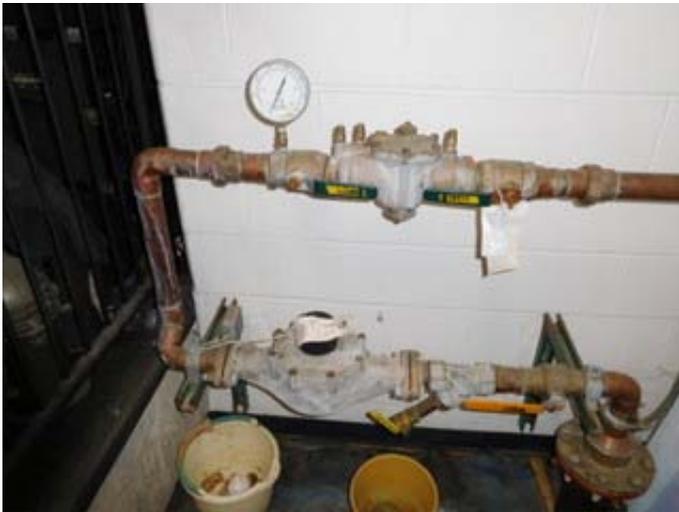
Description:	<p>The service entrance is equipped with a reduced pressure back flow preventer in fair condition. A water treatment system is not provided, though none is needed. The domestic water supply piping in the overall facility is copper and galvanized, is original to each addition, and is in fair condition. The waste piping in the overall facility is cast iron and galvanized, is original to each addition, and is in fair condition. The facility is equipped with a 71 gallon gas water heater in good condition. The school contains 2 Large Group Restrooms for boys, 2 Large Group Restrooms for girls, 0 Locker Room Restrooms for boys, 0 Locker Room Restrooms for girls, 3 Restrooms associated with specialty Classrooms, 8 Restrooms for Individual Classrooms, and 5 Restrooms for staff. Boys' Large Group Restrooms contain 2 ADA and 1 non-ADA wall mounted flush valve toilets, 6 ADA and 1 non-ADA wall mounted flush valve and waterless urinals, as well as 2 ADA wall mounted lavatories and 2 non-ADA countertop lavatories. Girls' Large Group Restrooms contain 2 ADA and 6 non-ADA wall mounted flush valve toilets, as well as 2 ADA wall mounted lavatories and 2 non-ADA countertop lavatories. Individual Classroom Restrooms contain 2 ADA and 7 non-ADA wall and floor mounted flush valve toilets, 2 ADA wall mounted urinals, as well as 3 ADA and 4 non-ADA countertop and wall mounted lavatories. Staff Restrooms contain 2 ADA and 2 non-ADA wall mounted flush valve toilets, 1 non-ADA floor mounted tank type toilet, as well as 2 ADA and 3 non-ADA wall mounted lavatories. Condition of fixtures is good to fair. The facility is equipped with 2 ADA and 4 non-ADA electric water coolers, in good to fair condition. The 22 Elementary Classrooms are not equipped with sink mounted type drinking fountains. Special Education Classroom is equipped with the required Restroom facilities, and fixtures are in good to fair condition. Kitchen is equipped with the required Restroom, and fixtures are in fair to poor condition. Heath Clinic is equipped with the required Restroom, and fixtures are in fair to poor condition. Kindergarten / Pre-K Classrooms are equipped with Restroom facilities, and fixtures are in poor condition. Kitchen fixtures consist of 1 single compartment sink, 1 double compartment sink, and 1 triple compartment sink, which are all in fair condition. The Kitchen is not equipped with a grease interceptor. The Kitchen is provided the required 140 degree hot water supply. The school does not full meet the OBC requirements for fixtures. Relative to LEED requirements, the school is not equipped with low flow type fixtures, but is equipped with waterless urinals. Per OBC and OSDM requirements this facility should be equipped with 6 toilets, 2 urinals, 8 lavatories, 22 Classroom sink mounted drinking fountains, and 4 electric water coolers. Observations revealed that the school is currently equipped with 30 toilets, 9 urinals, 26 lavatories, 5 Classroom sink mounted drinking fountains, and 6 electric water coolers. ADA requirements are not met for fixtures and drinking fountains see Item O. Custodial Closets are properly located and are adequately provided with required service sinks or floor drain sinks, which are in fair to poor condition. Science Classrooms are not equipped with required utility sink, gas / compressed air connections, and safety shower / eyewash. Due to existing grade configuration, no Biology or Chemistry Classroom acid waste systems are required. Adequate exterior wall hydrants are not provided.</p>

Incoming Domestic Water Service Backflow Preventer

Rating:	3 Needs Replacement
Recommendations:	<p>Due to age, condition, LEED, and OBC and OSFC requirements, provide 23 new toilets, 21 new lavatories, 3 new electric water coolers, 22 new lavatory mounted type drinking fountains. Replace water supply and sanitary waste piping in the 1952 Original Construction and the 1957 Addition due to age and condition. Replace reduced pressure back flow preventer due to age and condition. Provide for the replacement and addition of exterior hose bibs to meet OSDM Standards. Provide funding for a new grease trap in the kitchen. Provide funding for a new grease interceptor in the art classroom. See Item J for replacement of kitchen fixtures. See Item O for replacement of fixtures related to ADA requirements. Provide the Science Classroom with the required utility sink, gas connections, compressed air connections, and safety shower / eyewash stations. Provide required sink mounted type drinking fountains in Elementary Classroom spaces.</p>

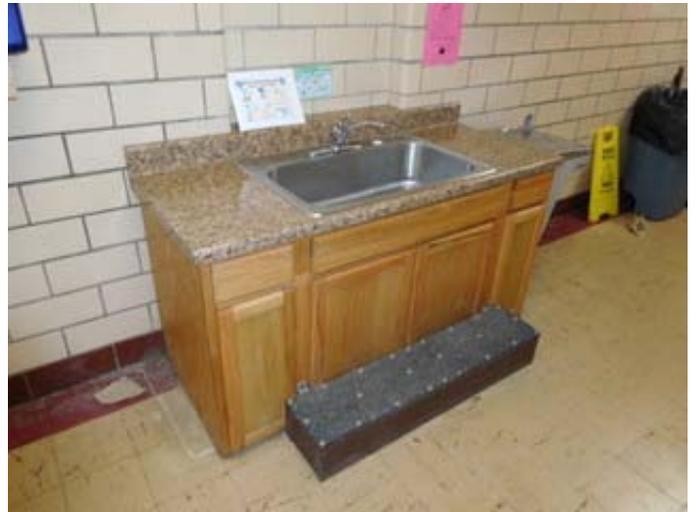
Classroom Sink

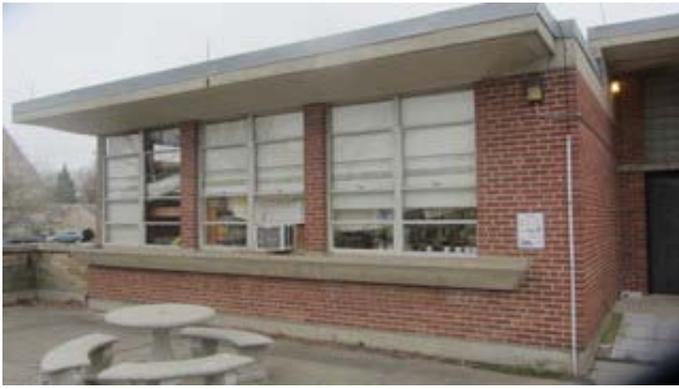
The 1952 Original Construction is equipped with an aluminum frame window with single glazed type window system, which was installed in 1952, and is in poor condition. The window system features operable windows throughout most portions of the building, and operable windows are equipped with opening limiters in poor condition and insect screens where provided in fair to poor condition. Window system seals are in poor condition, with frequent air and water infiltration being experienced. Window system hardware is in poor condition. The 1957 Addition is equipped with an aluminum frame window with double glazed insulated glazing and insulated panel type window system, and is in fair condition. Date of installation was not available. The window system features operable windows throughout most portions of the building, and operable windows are equipped with opening limiters in fair condition and insect screens where provided in fair condition. Window system seals are in fair condition. The District reported that moderate air and water infiltration is being experienced. Window system hardware is in fair condition. The 2002 Addition is equipped with thermally broken aluminum frame windows with double glazed insulated glazing type window system, which was installed in 2002, and is in good condition. The window system features operable and inoperable windows throughout the building, and operable windows are equipped with opening limiters in good condition and insect screens in good condition. Window system seals are in good condition, with no air and water infiltration being experienced. Window system hardware is in good condition. The window systems in the overall facility feature surface mounted shades, which are in fair condition. The window system in the 2002 Conference Room Addition feature surface mounted vertical blinds in fair condition. This facility is not equipped with any curtain wall systems. There are glass block windows in the 1952 Original Construction, in fair condition. The exterior doors in the 1952 Original Construction are equipped with aluminum frame transoms with insulated FRP panels, in good to fair condition and wood frame transoms with single pane glazing in poor condition. Exterior door vision panels in the FRP doors are tempered double glazed insulated glazing in good to fair condition. Exterior door vision panels in the wood doors are single pane wire glazing in poor condition. The exterior doors in the 1957 Addition are equipped with aluminum frame sidelights and transoms with tempered double glazed insulated glazing and insulated metal panels in good to fair condition. Exterior door vision panels are tempered double glazed insulated glazing, in good to fair condition. The exterior doors in the 2002 Addition are equipped with aluminum frame sidelights and transoms with tempered double glazed insulated glazing, in good condition. Exterior door vision panels are tempered single pane glazing. The school does contain 2 skylights which are equipped with aluminum frames and insulated fiberglass panels, in good condition. The school does not contain any clerestories. Interior glass is OSDM-compliant. Window security grilles are not provided for ground floor windows. There is a 94 SF Greenhouse in the 1957 Addition, and it is in poor condition.

3 Needs Replacement

1952 Original Construction Typical Classroom Windows

Replace the existing non-insulated window system with a new insulated window system with integral blinds to meet with Ohio School Design Manual requirements in the 1952 Original Construction. Replace the existing glass block with a new insulated window system with integral blinds to meet with Ohio School Design Manual requirements in the 1952 Original Construction. Replace the existing insulated window system in the 1957 Addition due to condition with a new insulated window system with integral blinds to meet with Ohio School Design Manual requirements. Replace the existing insulated panel system in the 1957 Addition due to condition with a new insulated panel system. Replace non-insulated glazing in transoms and sidelights at exterior doors in the 1952 Original Construction and 1957 Addition. Replace existing greenhouse in the 1957 Addition due to condition. Replace single glazed door vision panels in the 2002 Addition. Replace blinds in the 2002 Addition.

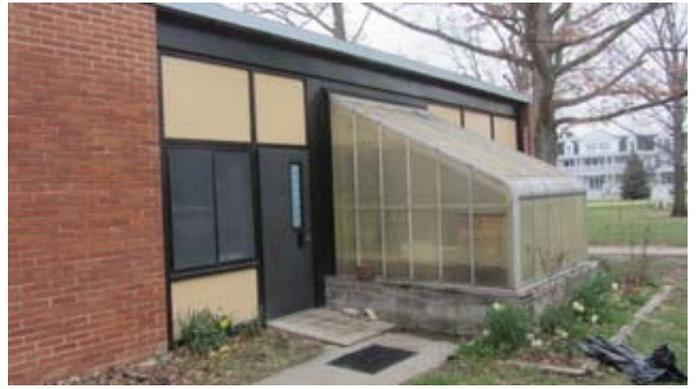
1957 Addition Typical Window System and Greenhouse

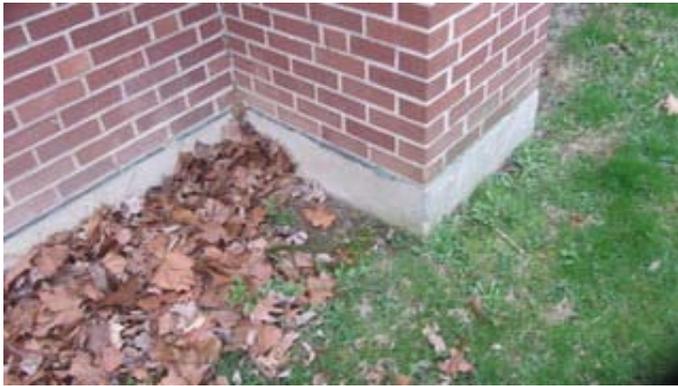
Description: The overall facility is equipped with concrete foundation walls on concrete spread footings, which displayed no locations of significant differential settlement, cracking, or leaking, and are in good to fair condition. Areas of minor cracking and spalling were observed through the overall facility. The District reports that there has been no past leaking due to foundation issues. No grading or site drainage deficiencies were noted around the perimeter of the structure that are contributing or could contribute to foundation or wall structural deterioration.

Rating: 2 Needs Repair

Typical 1952 Original Construction Exposed Foundation

Recommendations: Repair areas of cracking and spalling through the overall facility.

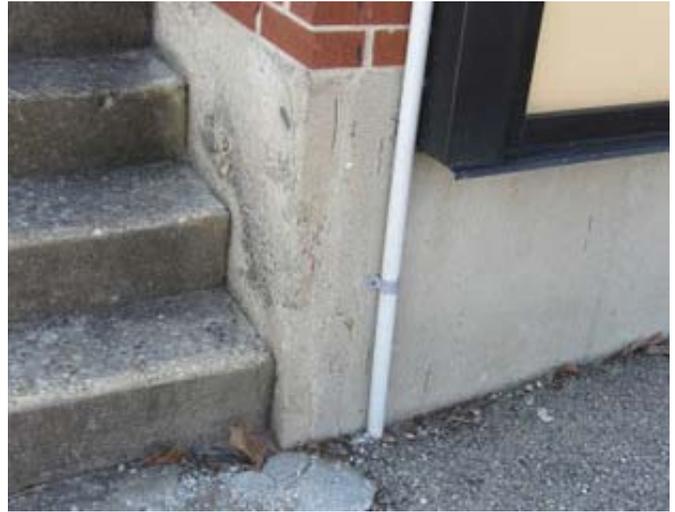
1957 Addition Exposed Concrete Foundation

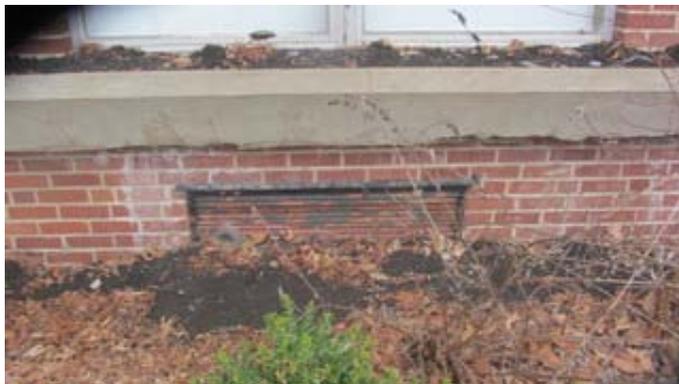
1952 Original Construction Window Sill and Unit Ventilator Opening

Rating:	2 Needs Repair
Recommendations:	<p>Provide tuckpointing in all areas of mortar deterioration as required through the overall facility. Provide masonry repairs as necessary in the 1952 Original Construction and 1957 Addition. Provide masonry tuckpointing for existing chimney in the 1952 Original Construction. Provide masonry infill in the 1952 Original Construction. Provide masonry cleaning, sealing and caulking as required through the overall facility. Recaulk existing exterior and interior control joints through the overall facility. Repair concrete window sills in the 1952 Original Construction. Repair concrete soffits in the 1952 Original Construction. Repair entrance canopy in the 1952 Original Construction. Repair and provide metal flashing for exposed tectum soffits in the 1957 Addition. Replace non-code compliant railing at the 1952 Original Construction Mechanical Room Entry. Repair concrete steps and walls at the 1952 Original Construction Mechanical Room Entry. Replace concrete walkway and railing at the 1957 Addition. Prep and paint exposed steel lintels through the overall facility. Exterior wall insulation deficiencies are addressed in Item J. Replacement of insulated metal panels in 1957 Addition is addressed in Item F.</p>

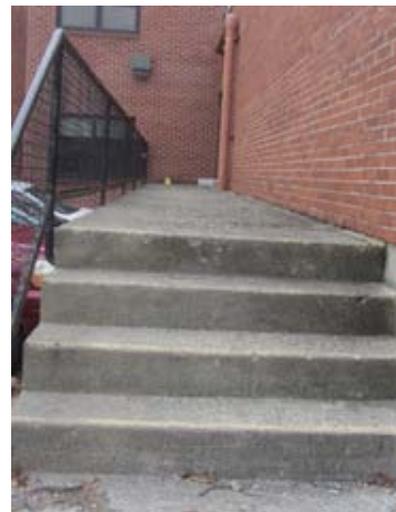
1957 Addition Concrete Walkway

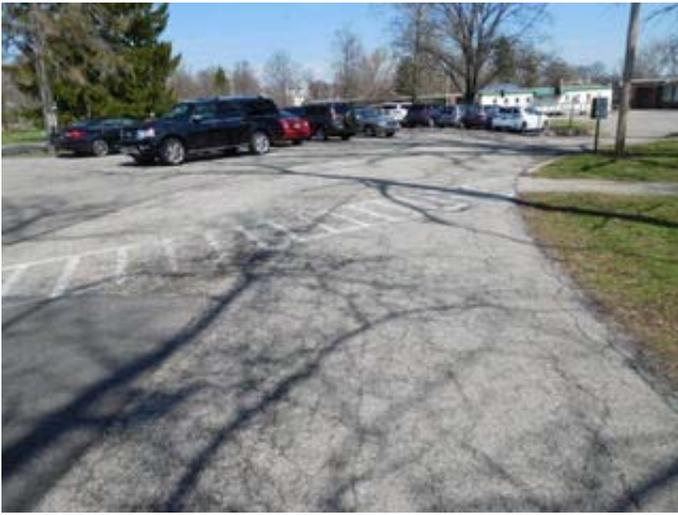
Asphalt Condition

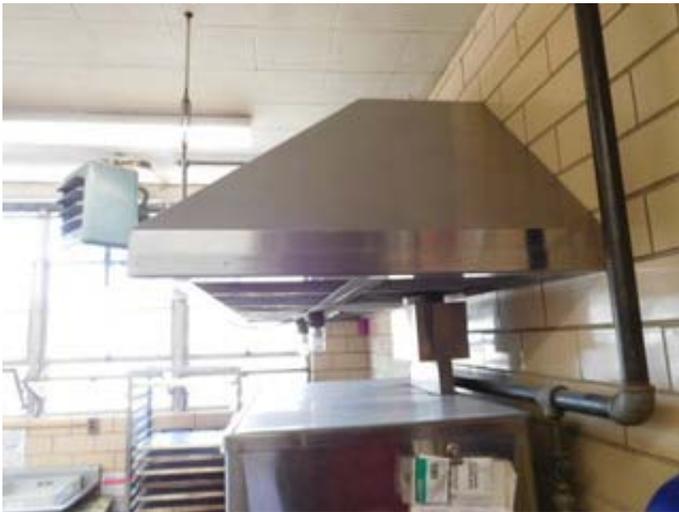
Existing kitchen hood in the Original Construction

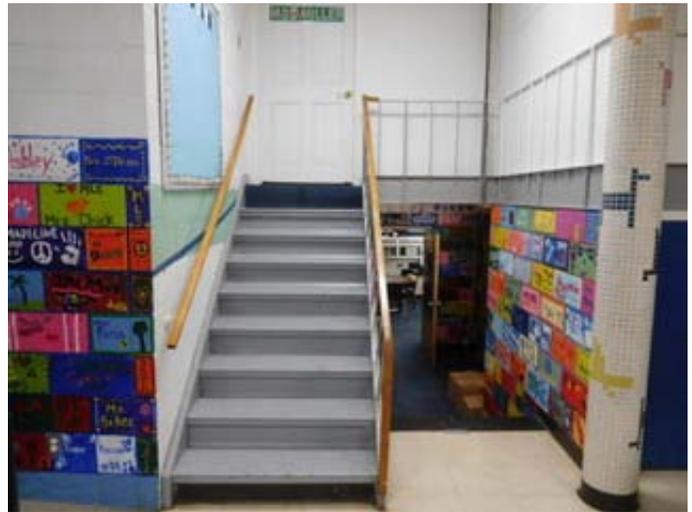
Stairs and handrail in the 1957 Addition
