Physical Building and Educational
Assessment
Yellow Springs Schools
Yellow Springs, Ohio

Project No. 219001.00

May 22, 2019

Physical Building and Educational Assessment

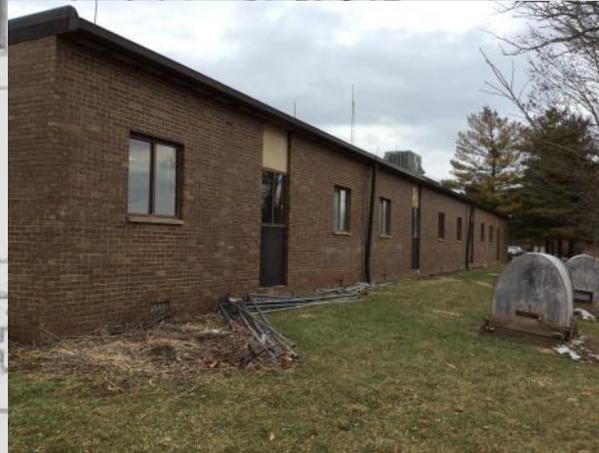
- Age - 31 years
- IAQ
- Structure (wood), crawlspace

- If the need is truly 1-5 years
- Over 1-5 years, additions or renovations
- Prior to 1990 are not as energy efficient, quiet or accommodating
- Process to “phase out” any over 20 years old.

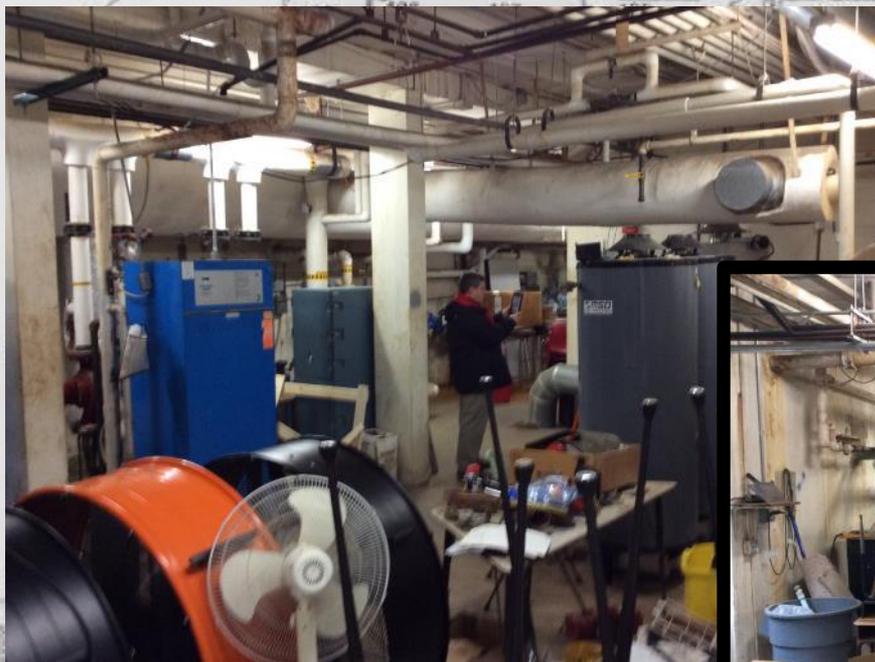
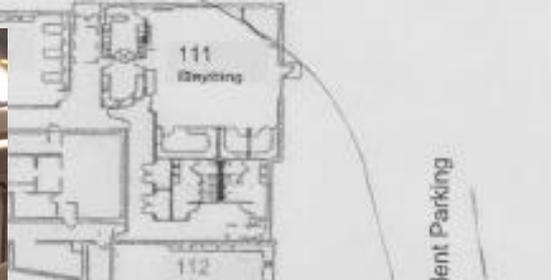
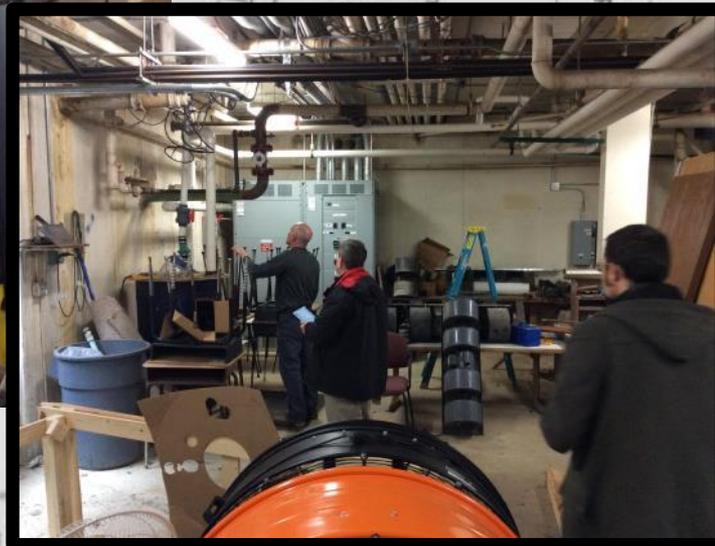
HVAC AND PLUMBING

- No fire protection system (sprinklers) exist
 - Most of overall plumbing system is beyond useful life
- Overall HVAC system has exceeded useful life, 2002 units should be replaced within 5-10 years

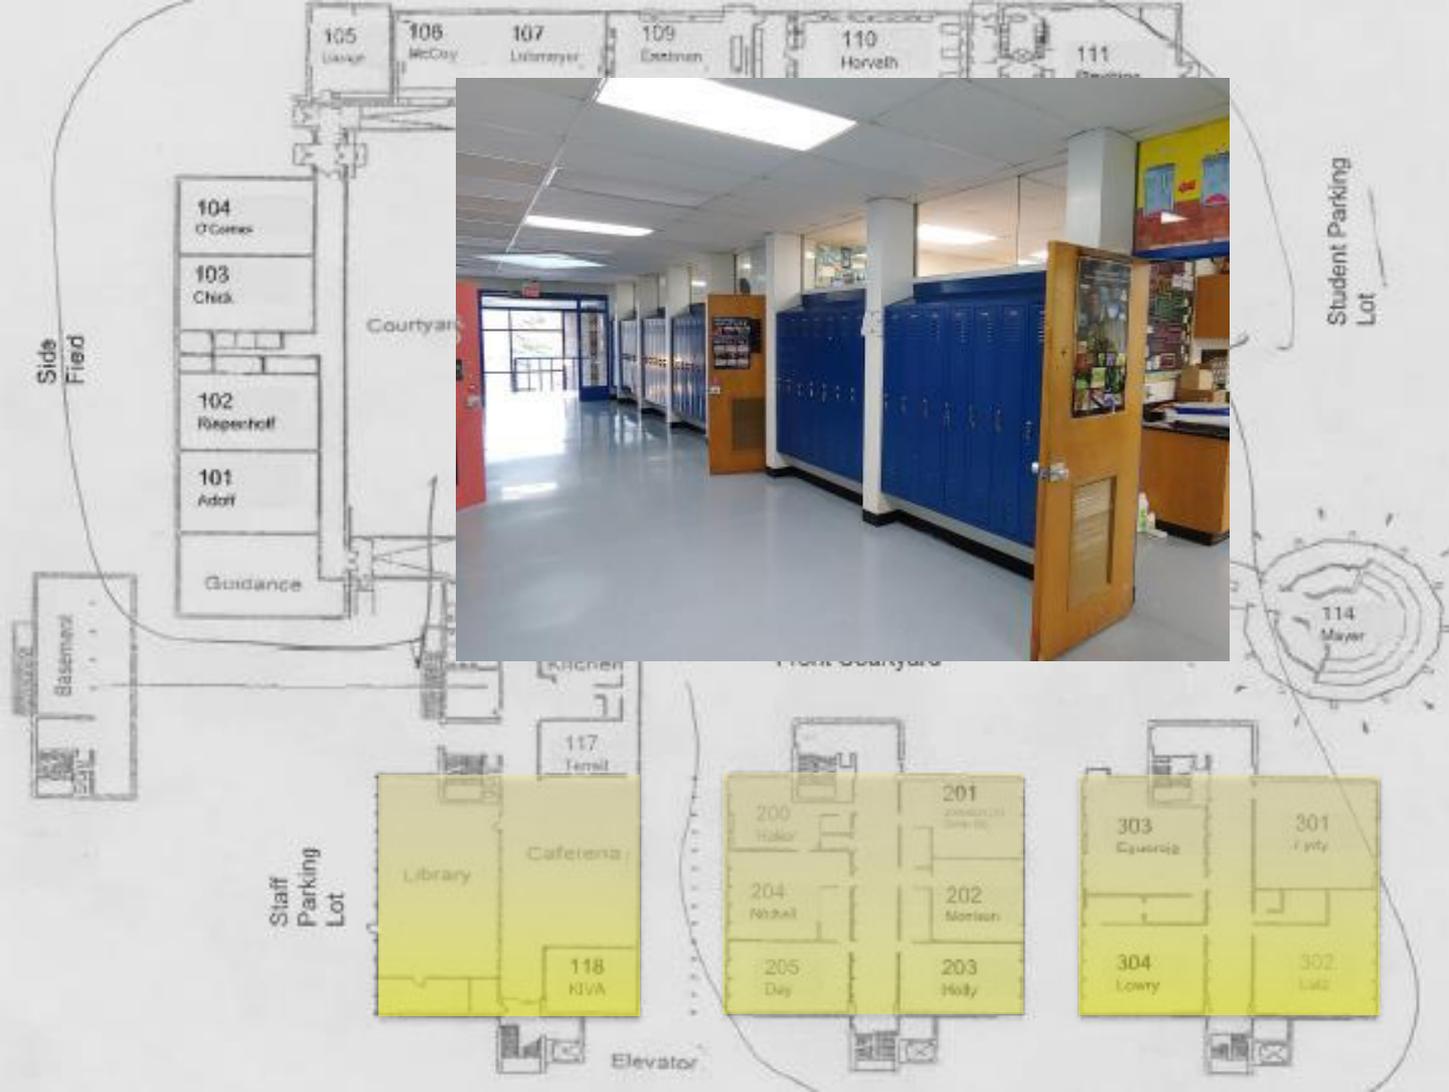
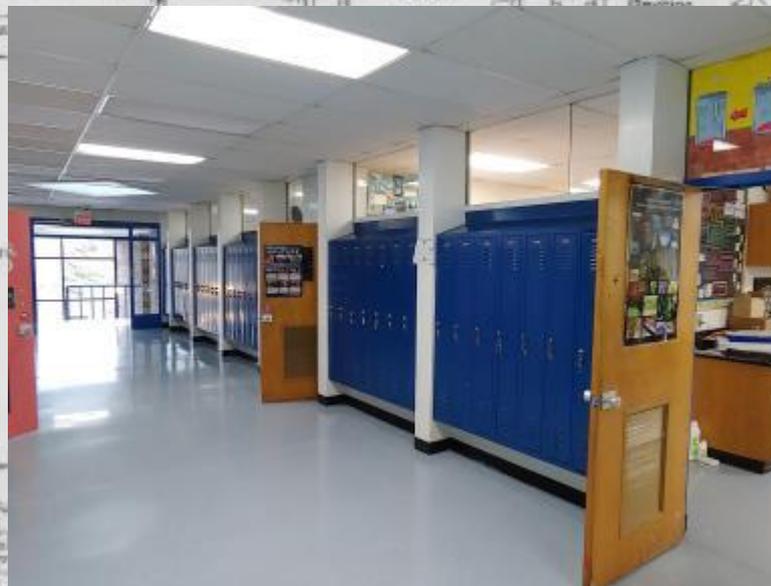
No bearing walls
- could be
reconfigured

Multiple level
small footprint
limits
collaboration

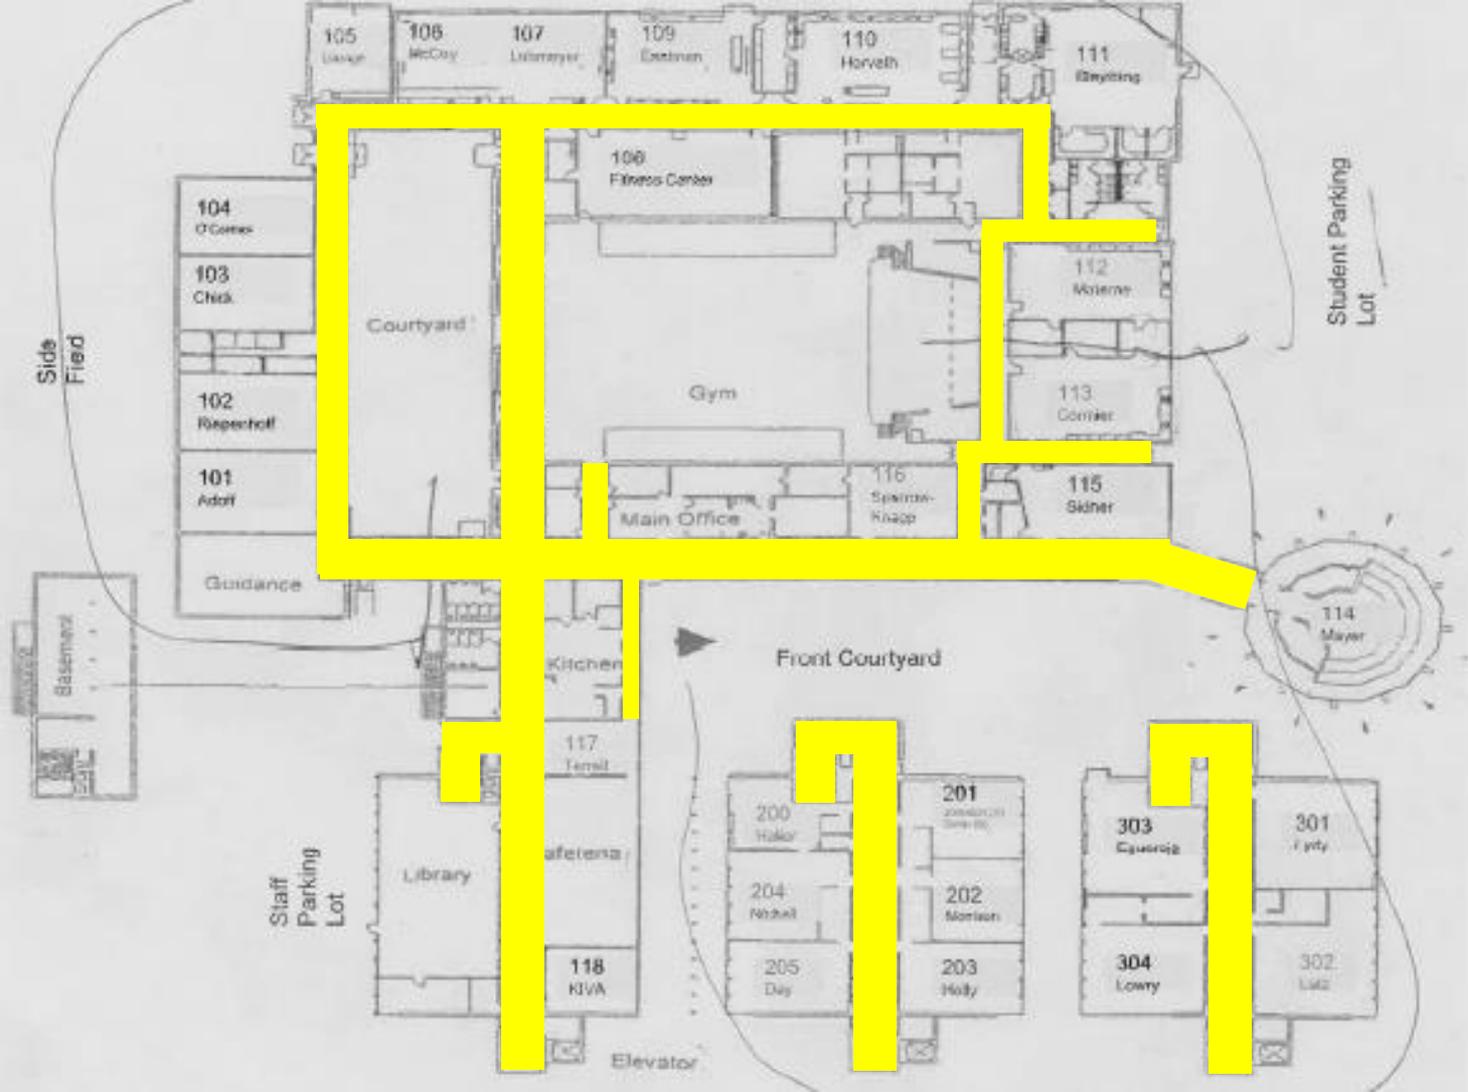
Convolved
circulation

Excess
circulation

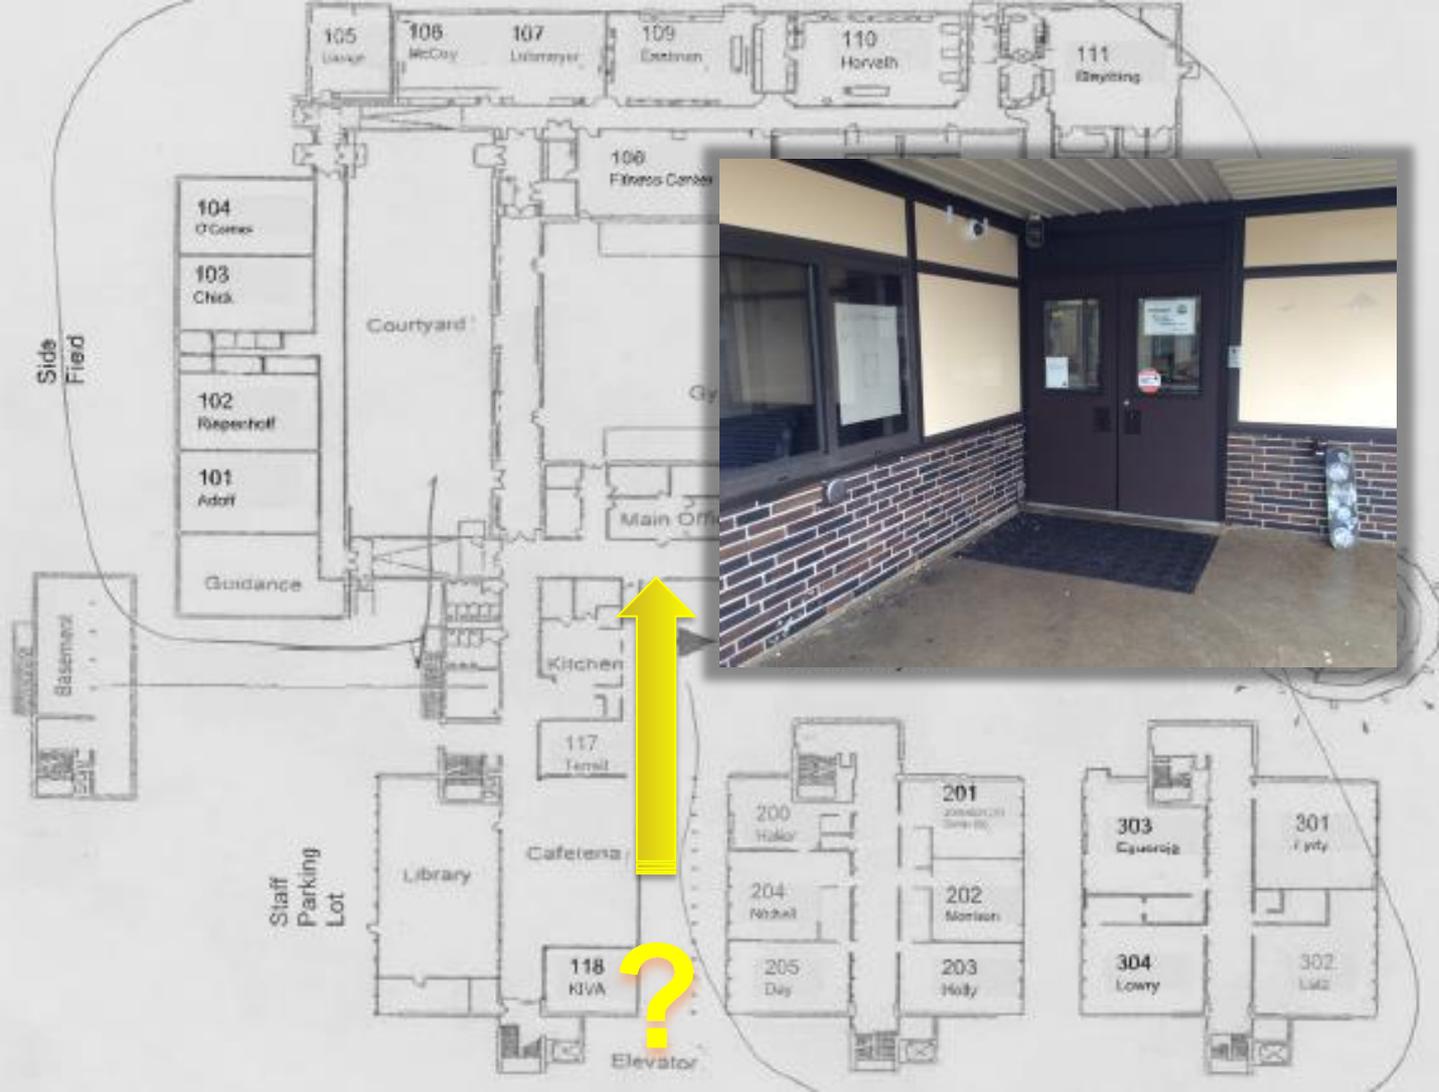
Uninspiring

No secure vestibule

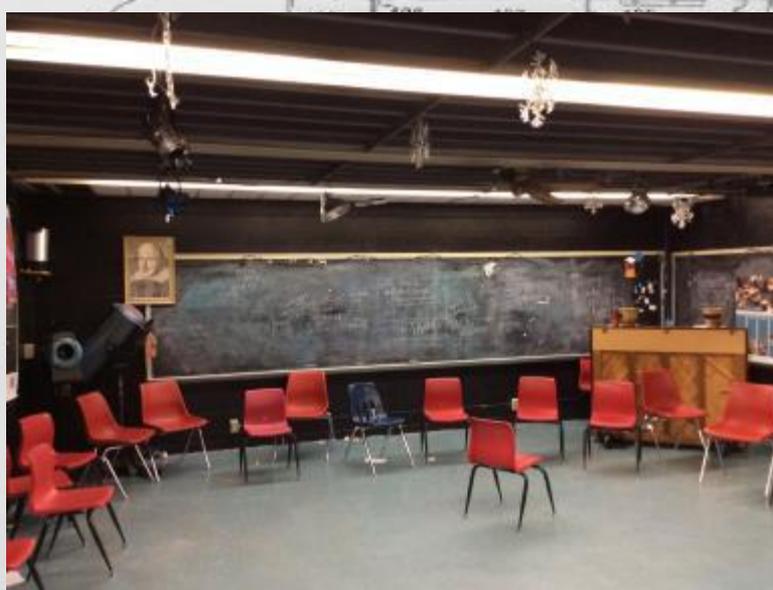
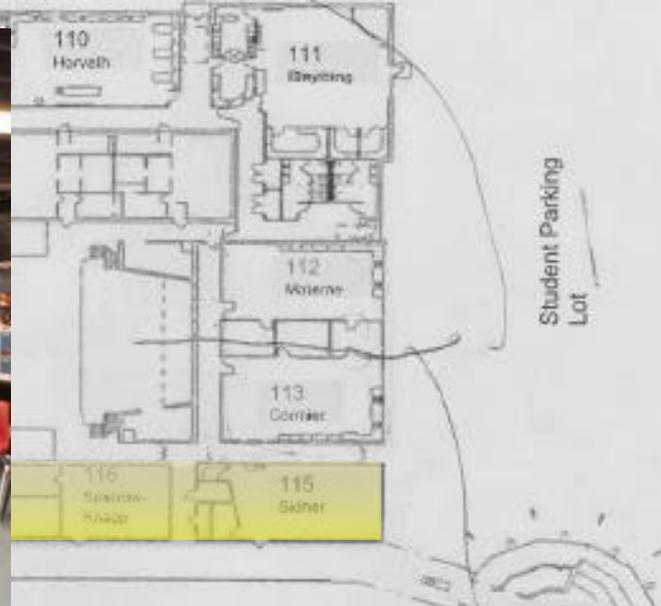
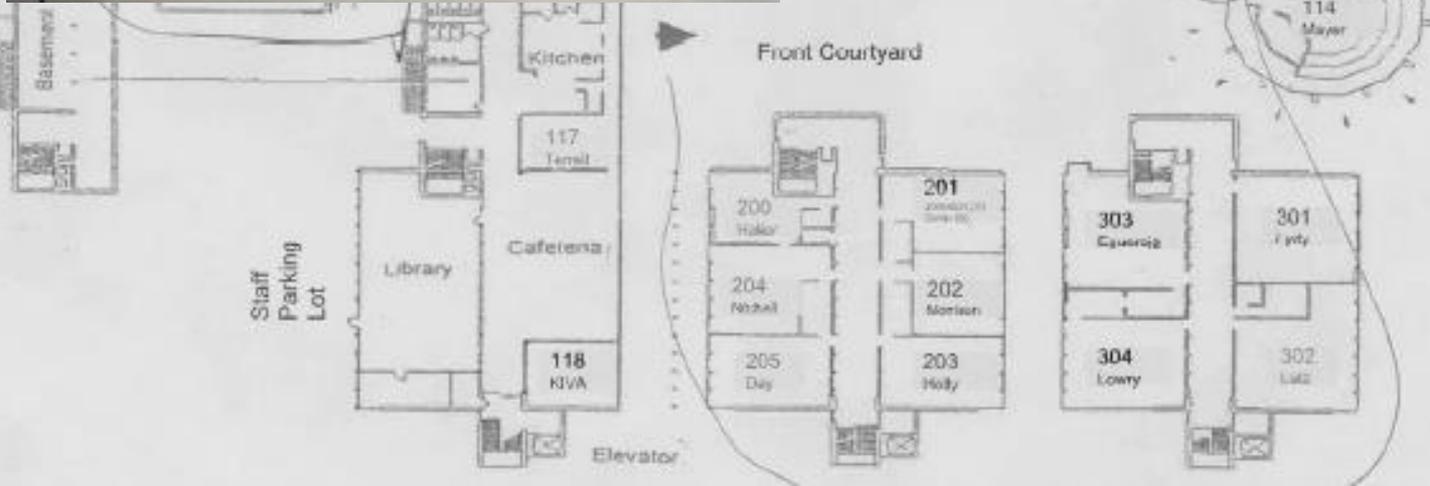
Limited height for activities

Deep roof deck has no capacity for hanging equipment

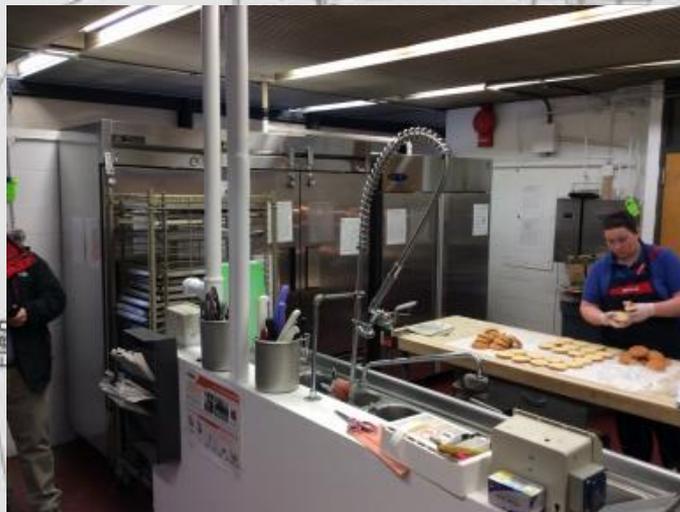
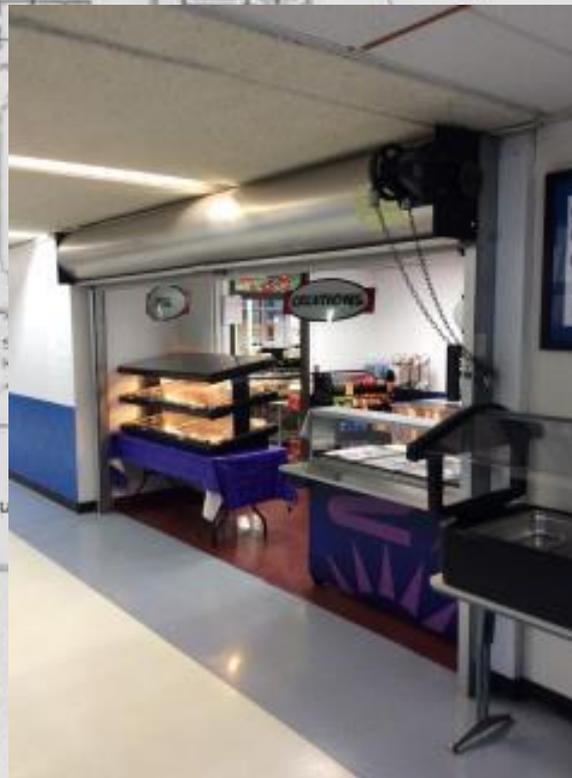
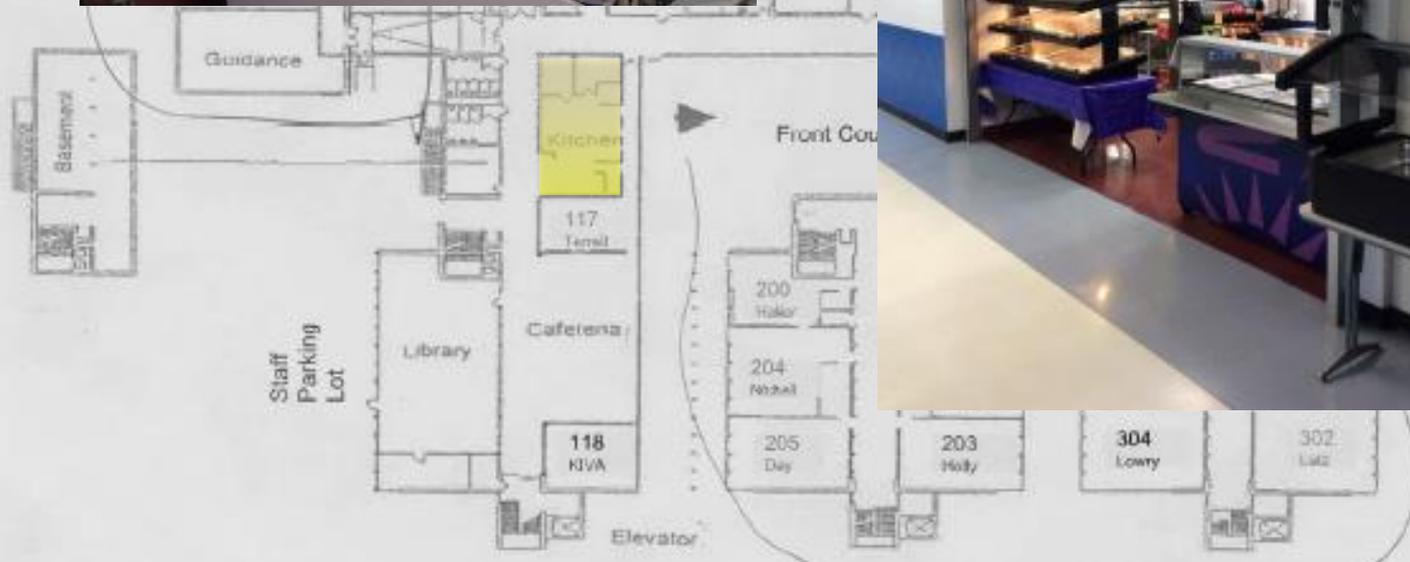
Minimal space for
prep and serving

Limited ability to
offer healthy and
fresh options

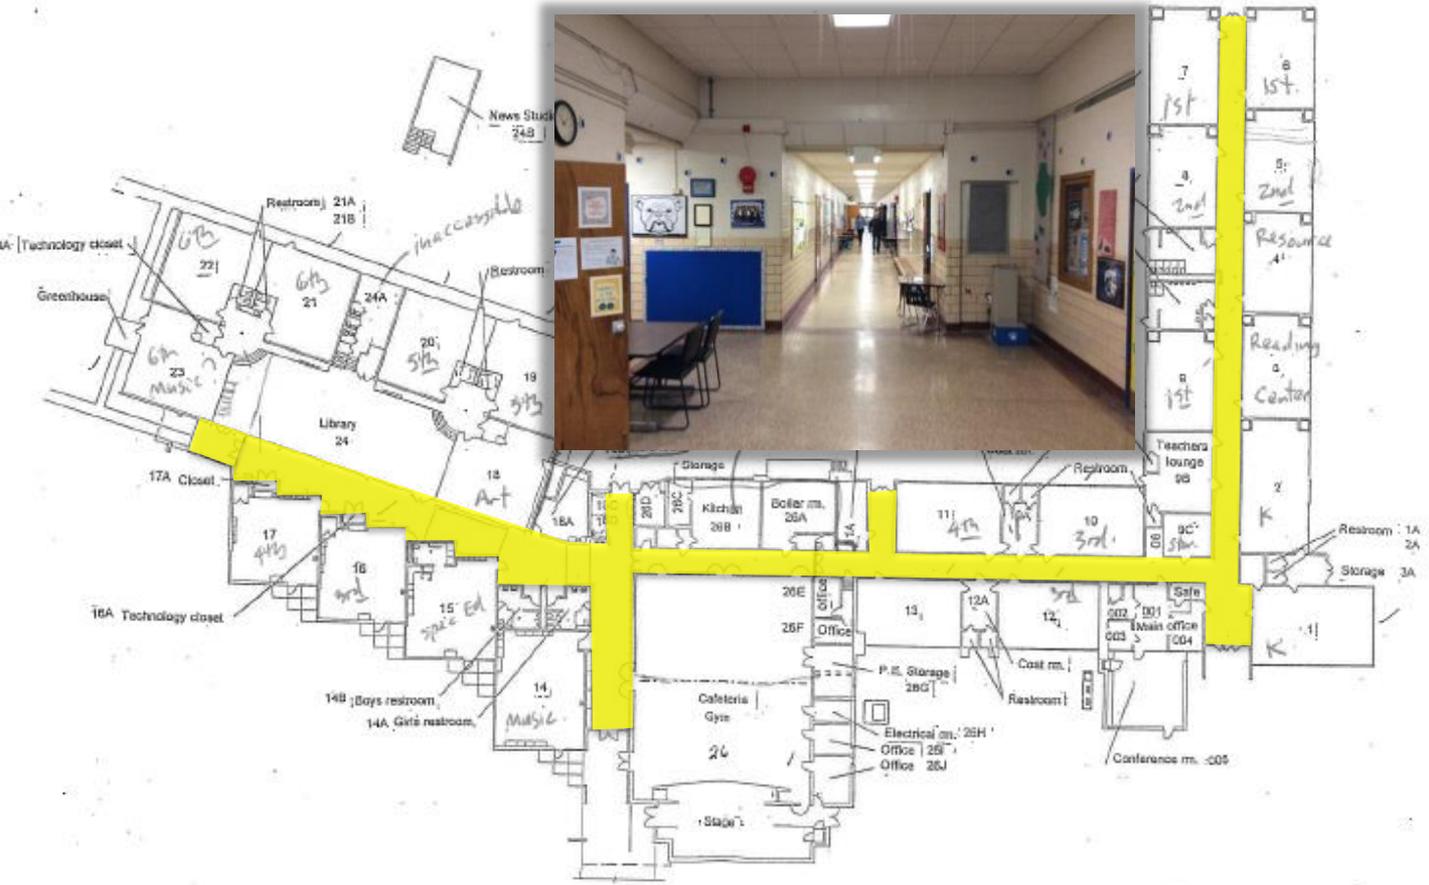
Very long
circulation paths

Disconnect
between areas of
the building

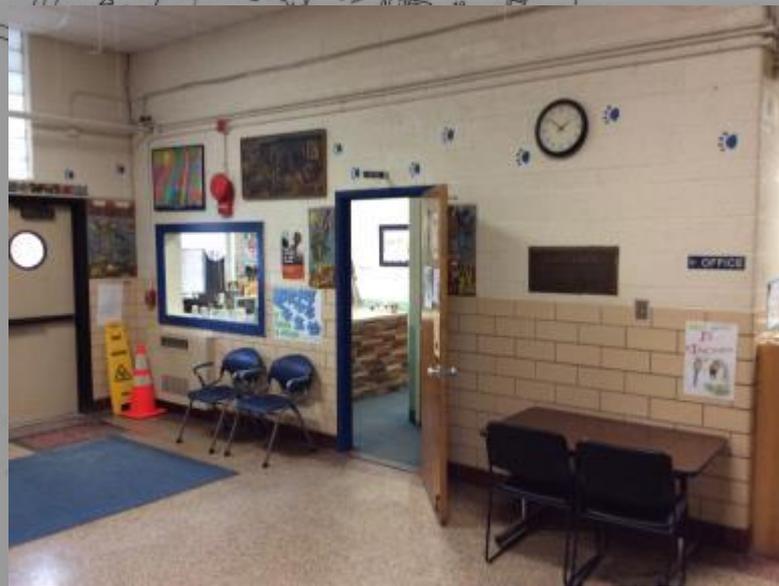
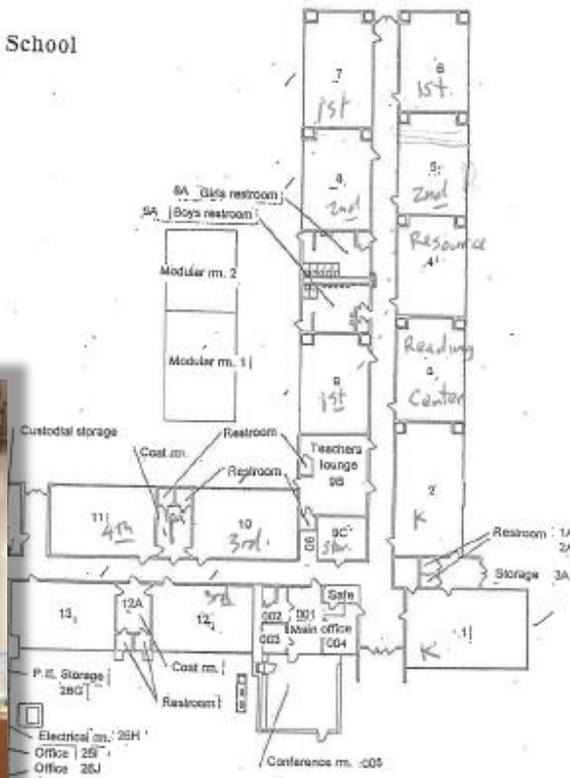
Not fully
controlled and
secured

Not welcoming

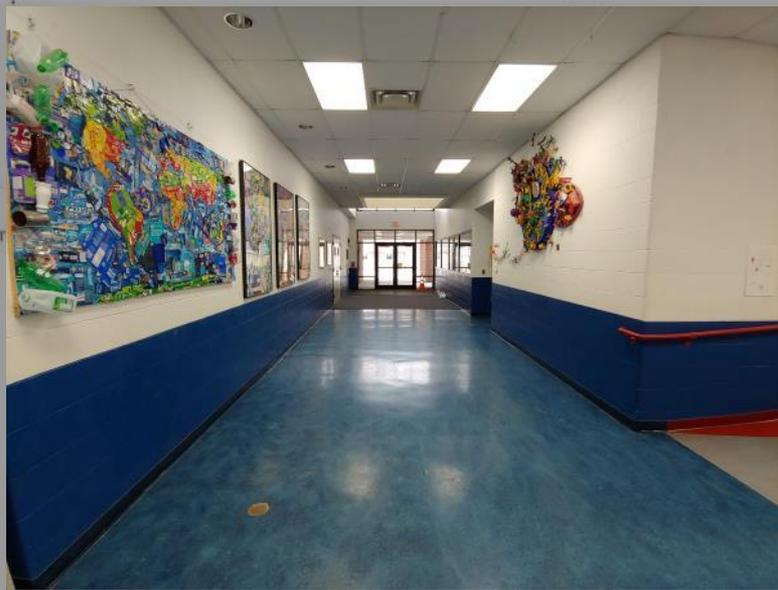
Narrow gauge footprint – long and narrow classrooms

High ceilings but low structure
