# YELLOW SPRINGS SCHOOLS – GENERAL STRUCTURAL CONDITION REPORT OF HIGH SCHOOL AND MIDDLE SCHOOL

Prepared by: Shell + Meyer Associates, Inc., Structural Engineers

Date: July 3, 2018

Re: Yellow Springs Schools  
High School and Middle School General Structural Observation  
SMA Project No.: 18.800.118

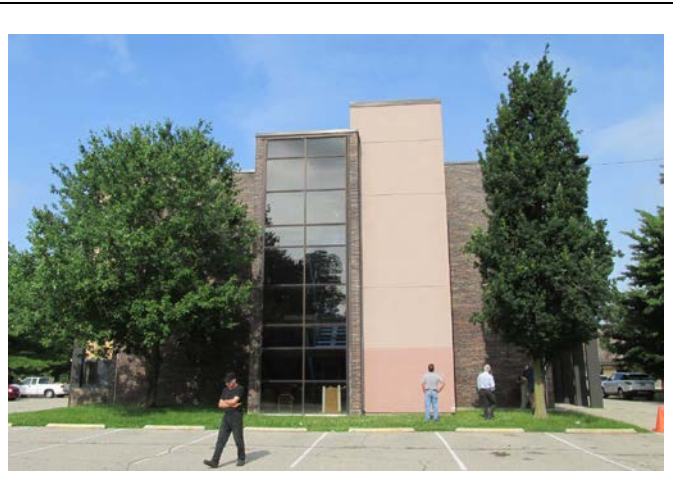
1. The east exterior wall of the high school (Photo 2) is separated by the steel floor joist and deck system by a 1/2 - 1 inch thick expansion joint material. This material does not provide a solid surface for the tile to bear and has caused the tile to break at this joint (Photos 3 & 4).

Photo 2 – East Elevation of Existing High School

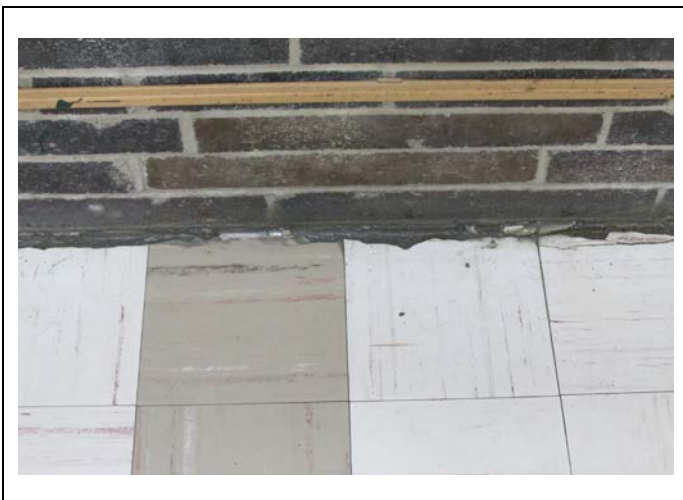
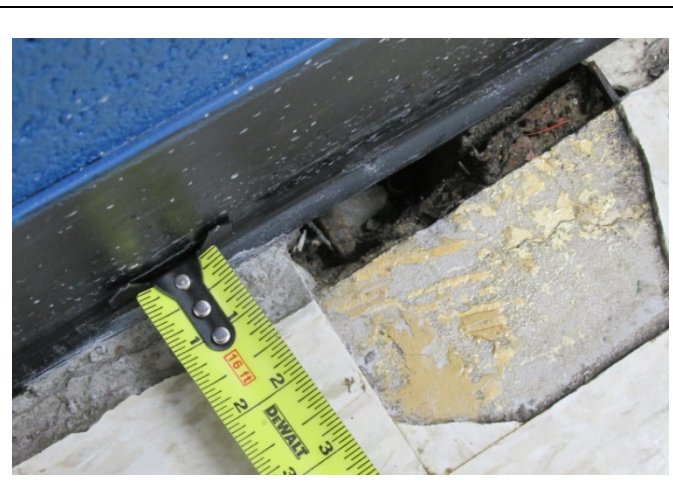
Photo 3 – Expansion joint between wall and floor

Photo 4 – Expansion joint between wall and floor (Enlarged)

- a. Expansion joint material is not required here and if the tile is repaired this joint material can be removed and replaced with a more rigid material to give the tile support.

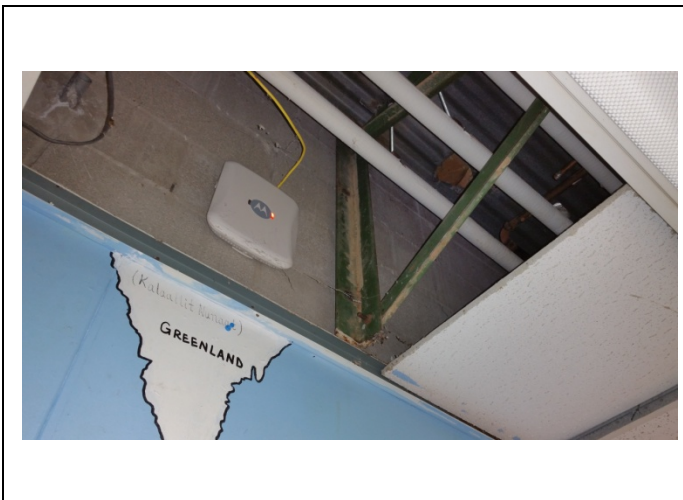
2. The steel joist bridging terminates at the exterior wall but some of the bolts that connect the bridging the exterior wall are missing or were never installed (Photo 5).

Photo 5 – Typical Bridging Angle with Missing Anchorage Bolt to Wall

- a. The existing bridging shall be attached to the exterior CMU wall with new HILTI HIT HY 70 Adhesive Anchoring System using appropriately sized screen anchors. Use 5/8 inch minimum diameter anchors. Follow all of the Manufacturer's Published Installation Instructions.

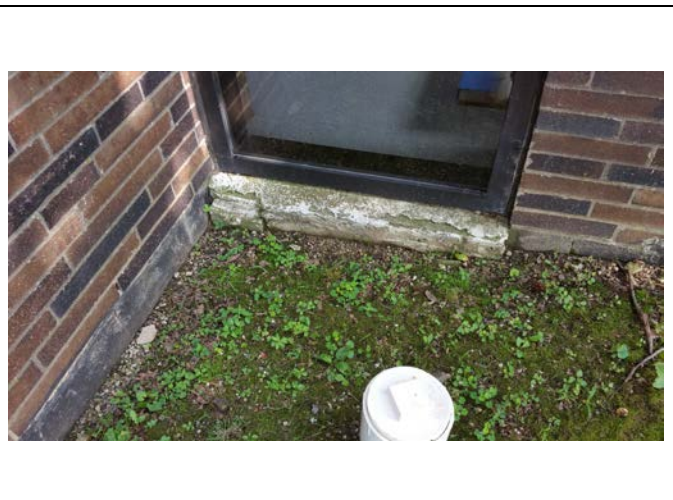
3. The remaining items observed were related to general shrinkage and temperature cracking of the brick veneer or cracking of concrete due to multiple freeze-thaw cycles.

Photo 6 – General condition of exterior concrete

- a. This does not pose an immediate structural concern, however it is recommended that the brick be tuck pointed to repair cracked mortar joints and that exterior cracked concrete be pressure injected with an epoxy adhesive to minimize further damage. (Photo 6)

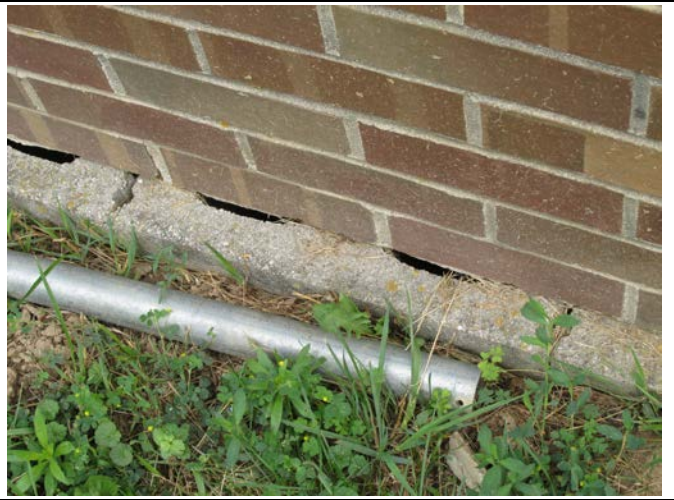
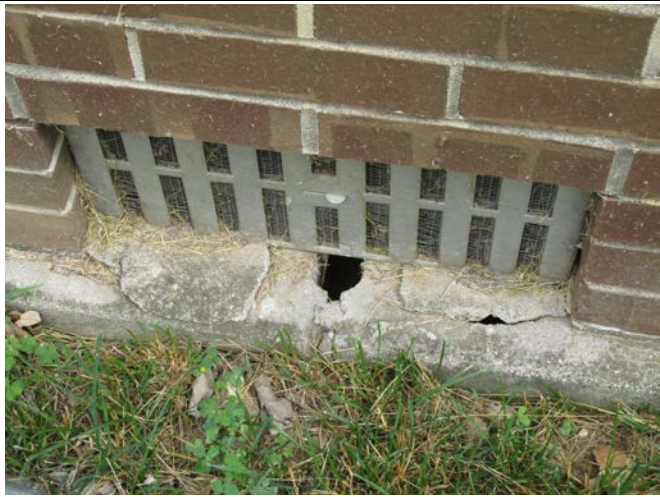
1. The brick veneer of the south wall does not align with the ungrouted CMU foundation. As a result the cores of the CMU foundation become exposed as the veneer line tracks inward from east to west. (Photos 8 & 9). This has allowed water and moisture to enter into the crawl space.

Photo 8 – Exposed cells of block foundation along South Elevation

Photo 9 – Openings in Foundation at Crawl Space Vent

- a. Exposed cores should be grouted solid and recommendations for waterproofing of the foundation walls and moisture barriers in the crawl space should be obtained from others.

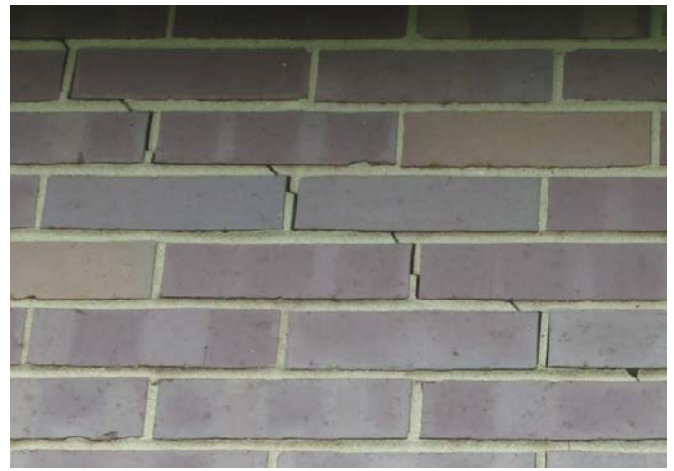
2. The remaining items observed were related to general shrinkage and temperature cracking of the brick veneer or cracking of concrete due to multiple freeze-thaw cycles.

Photo 10 – General shrinkage cracks in brick veneer

- a. This does not pose an immediate structural concern, however it is recommended that the brick be tuck pointed to repair cracked mortar joints and that exterior cracked concrete be pressure injected with an epoxy adhesive to minimize further damage. (Photo 10)

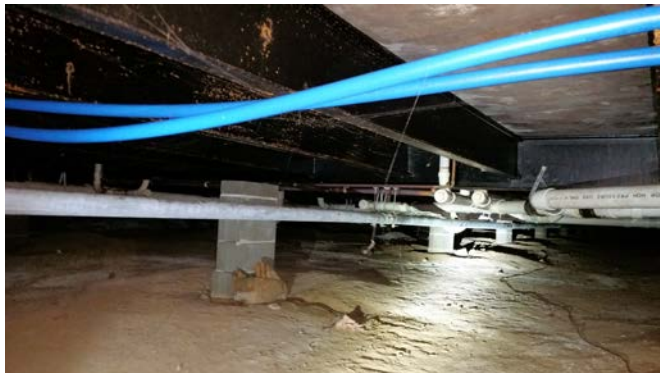
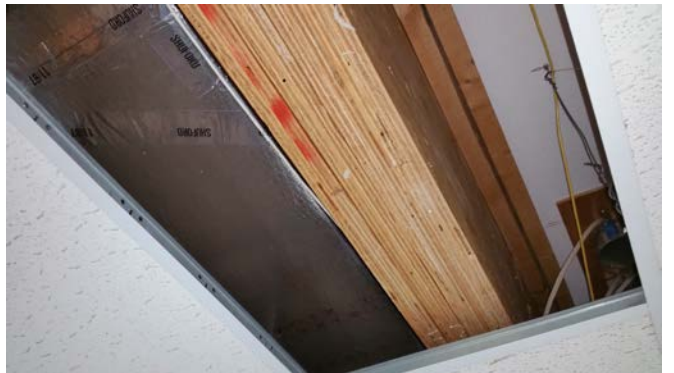
3. Photos 11 & 12 indicate the basic modular framing consisting of steel floor beams on CMU piers in the crawl space and engineered lumber beams and modular panels for the roof construction.

- a. Structurally there were no visible issues regarding the modular construction.

Photo 11 – Crawl Space Framing

Photo 12 – Typical Modular Roof Framing
