Yellow Springs

Exempted Village School District

FACILITIES TASK FORCE MEETING

PHYSICAL ASSESSMENT

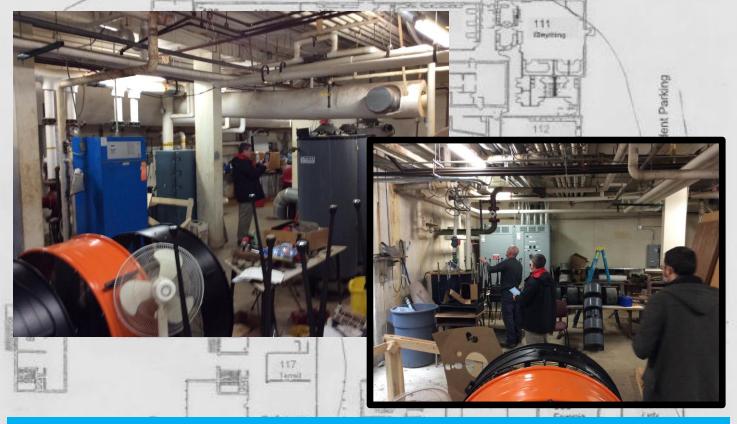
- Most of overall plumbing system is beyond useful life
- Overall HVAC system has exceeded useful life, 2002 units should be replaced within 5-10 years

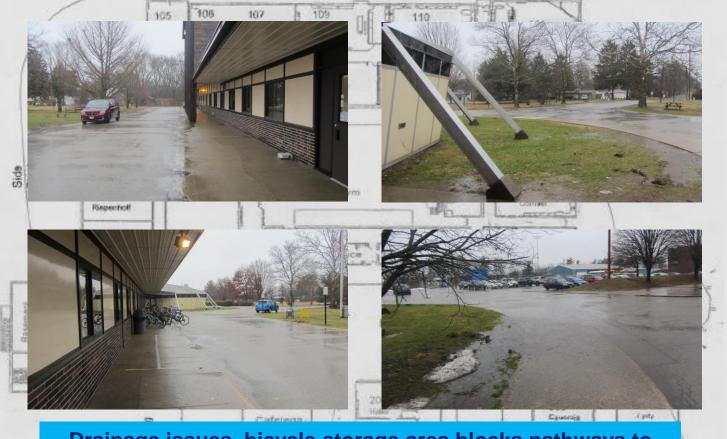
Drainage issues, bicycle storage area blocks pathways to main entrances, no separation of pedestrian an vehicular traffic, lack of adequate storm system to manage runoff.

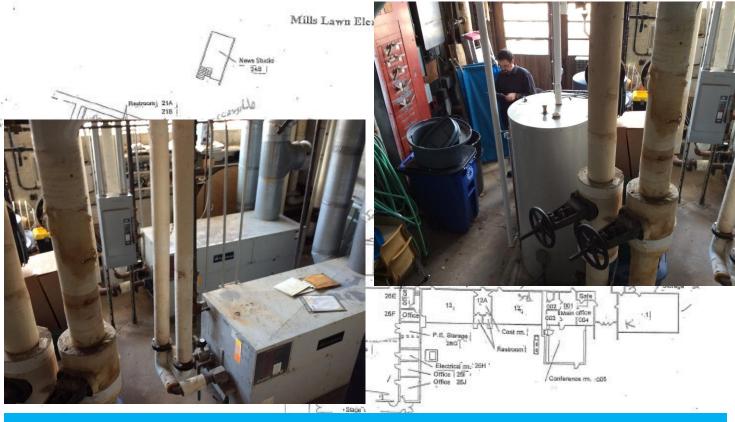
- No fire protection system (sprinklers) exist
- Most of overall plumbing system is beyond useful life
- Overall HVAC system has exceeded useful life, 2002 units should be replaced within 5-10 years

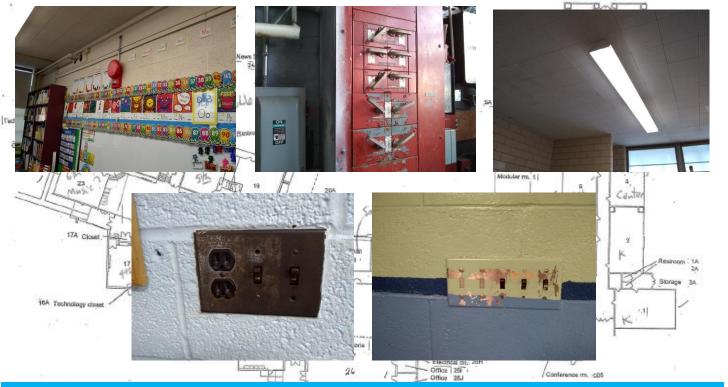
- Majority of panel boards are original and/or in poor condition.
- HVAC upgrades will likely require electrical service replacement.
- Lighting and emergency/exit lighting should be upgraded to LED.
 - Receptacles and switches throughout due for replacement

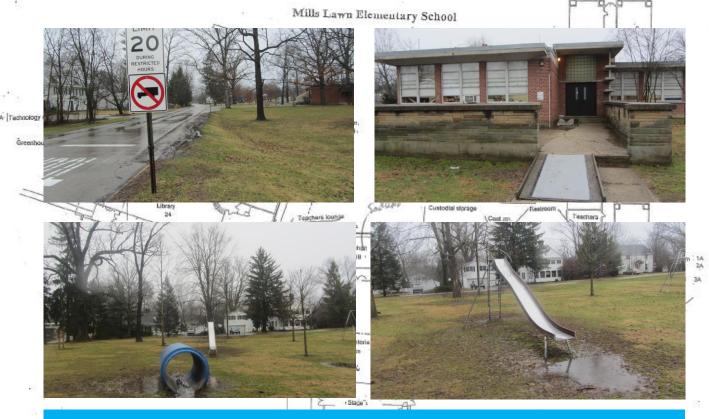
Inadequate student drop-off/pick-up (Limestone and Elm), drainage issues, accessible routes, fall protection at play equipment
