## BRIDGE NO. 03936

78250 - VERNON  
DART HILL ROAD  
over  
HOCKANUM RIVER

Routine Inspection

10/16/2017

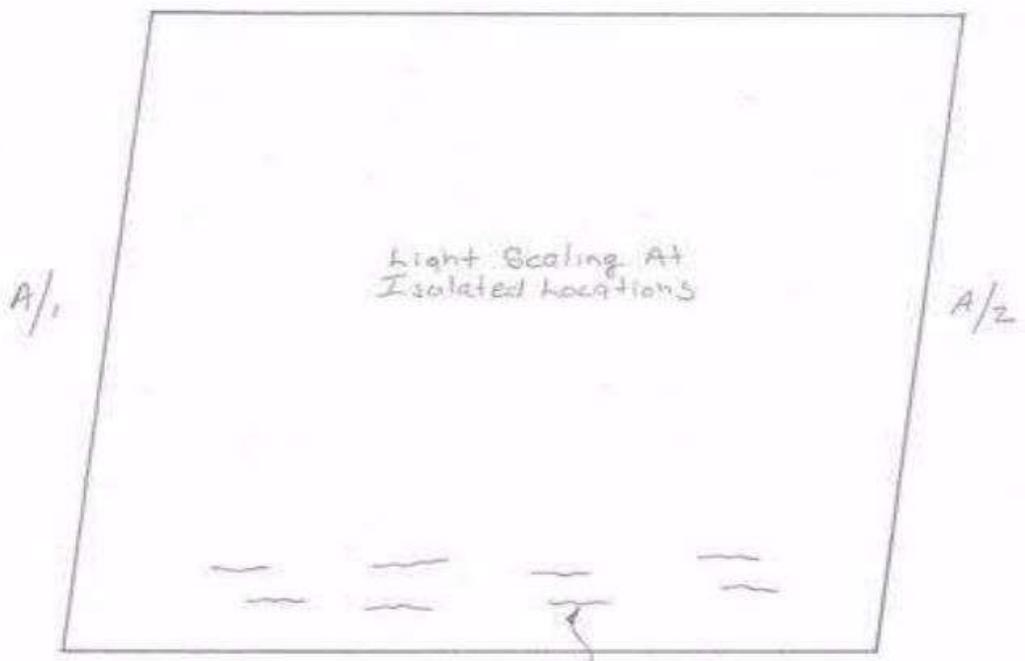
UNDERSIDE OF SLAB

Stringers:	N	-
Girders:	6	The underside of the slab has light scaling at isolated locations and random longitudinal cracks with efflorescence especially near the south edge. Both fascias have horizontal and vertical hairline cracks with efflorescence and the south fascia has moderate to heavy scaling up to full length x full height x up to 3" deep with exposed rebar.
Floor Beams:	N	-
Trusses - General:	N	-
Trusses - Portals:	N	-
Trusses - Bracing:	N	-
Paint:	N	-
Rust:	N	-
Machinery Movable Span:	N	-
Rivets & Bolts:	N	
Welds - Cracks:	N	
Timber Decay:	N	
Concrete Cracking:	6	See "GIRDERS" above.
Collision Damage:	8	-
Member Alignment:	N	-
Deflection Under Load:	N	-
Vibration Under Load:	N	-
Stand Pipes:	N	-
Catwalks:		-
Movable Inspection System:		-
Barrel Ladders:	N	-

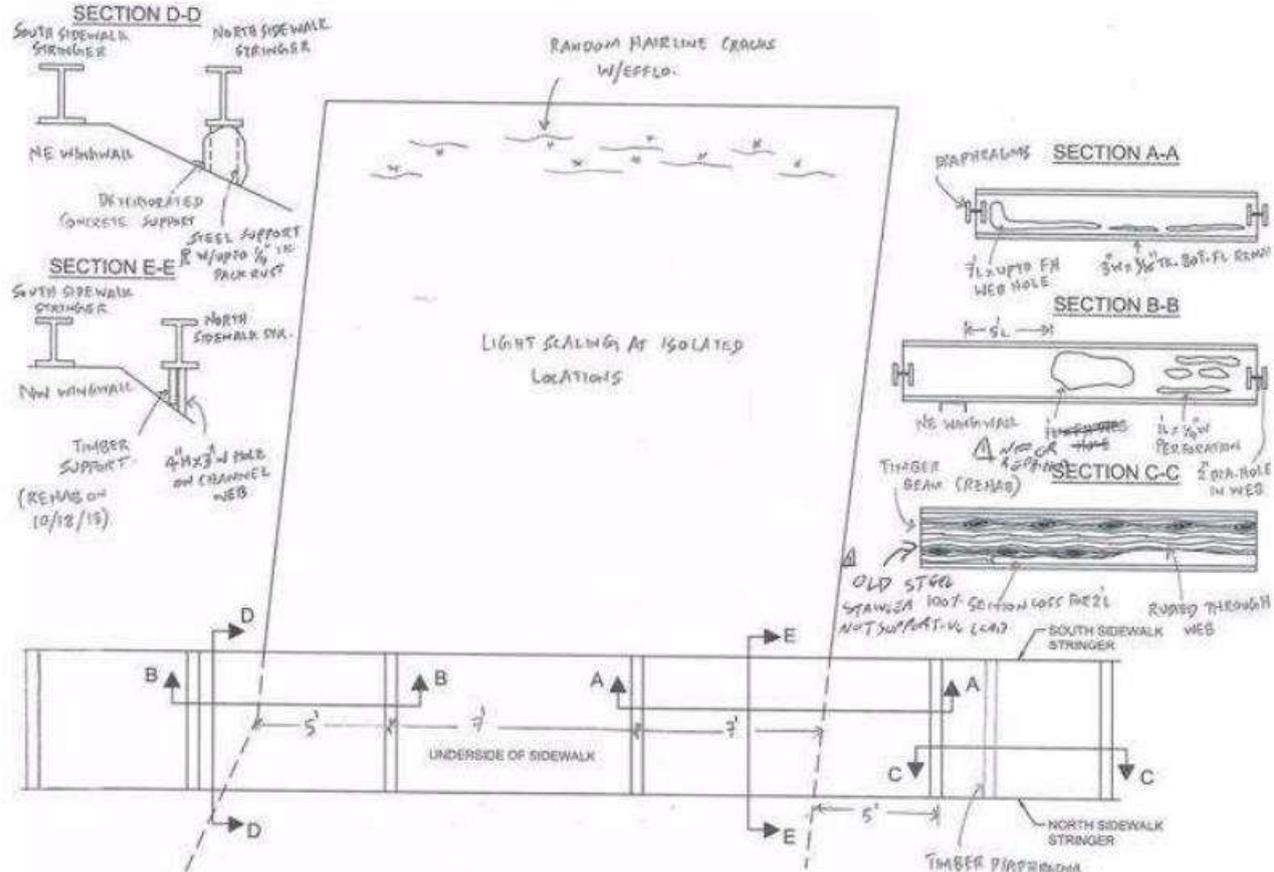
SIDEWALK SUPPORTS

Overlay: 8	No deficiencies.
Deck - Str. Condition: N	See girders.
Curbs: N	-
Median: N	-
Sidewalks: 3	<p>There a pedestrian bridge adjacent to the brdige that is supported by WW1A and 2A. The sidewalk is not connected to the superstructure slab.</p> <p>There is moderate to heavy rusting on the sidewalk stringers and diaphragms with section loss and perforations up to full height and up to 3" wide x up to knife edge remaining on the bottom flange of the south sidewalk stringer.</p> <p>There is a 6' long web plate added to the south sidewalk stringer between diaphragms 1 and 2 from the west abutment.</p> <p>The north sidewalk stringer near the west end has heavy rusting with multiple perforations up to 2' long and up to full height. A timber stringer was installed to support the load since the steel stringer is severely deteriorated.</p> <p>Also the vertical steel channel section supporting the north sidewalk stringer at the northwest wingwall, has section loss on the flanges and a 4" high x 3" wide hole in web.</p> <p>There is significant deflection of the sidewalk mainly on the north side from only one pedestrian live load. The span of the north stringer is greater than the south stringer due to the flared wingwall supports.</p>

**GENERAL NOTES:**  
 - AS A PART OF REHABILITATION ON 10/18/17, SIDEWALK TIMBER PLANTS WERE REPLACED, TIMBER BEAM & DIAPHRAGM WERE ADDED TO REINFORCE SIDEWALK STRINGER  
 - SIDEWALK STRINGERS & DIAPHRAGMS HAVE MOD. RUSTING THROUGHOUT W/ ISOLATED HEAVY RUSTING W/ SECTION LOSS

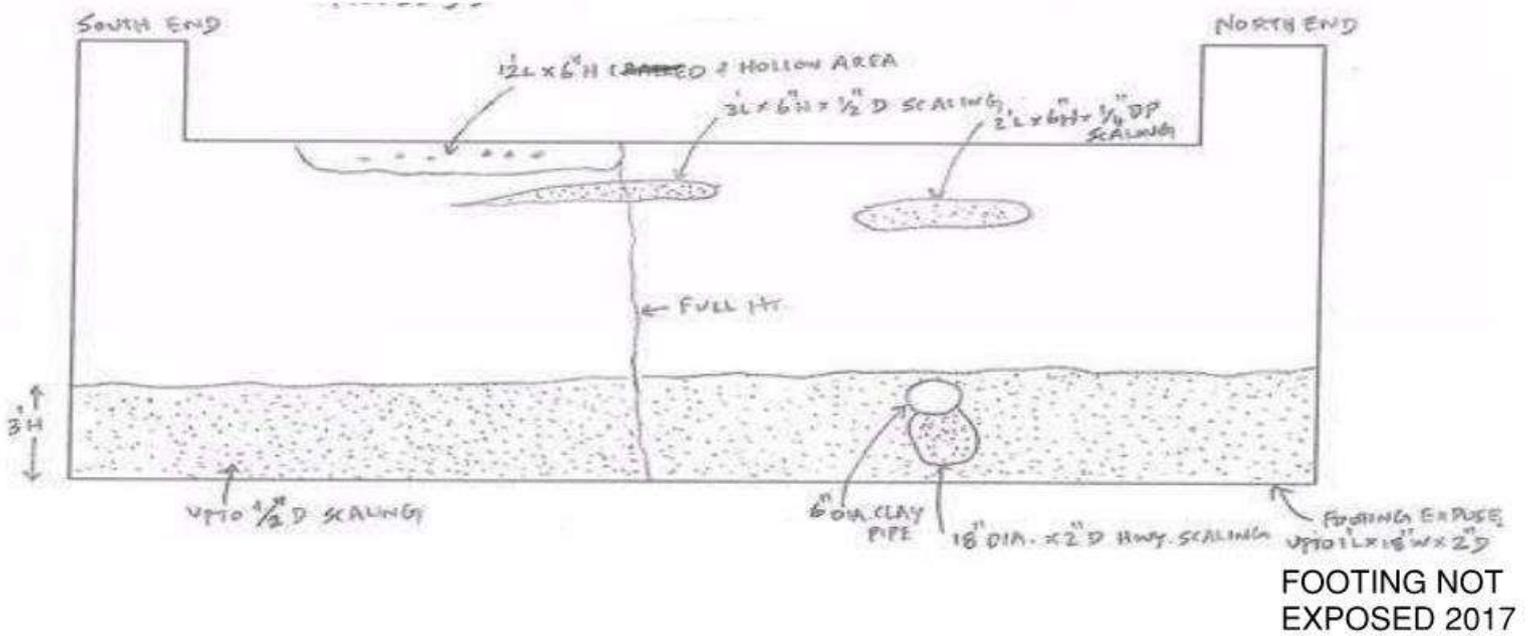
ABUTMENT # 1 WEST

Abutments - Stem:	6	<p>Both abutment stems have light scaling at random locations, moderate scaling up to 3' high x 1/2" deep above the waterline and a full height vertical crack near mid-span ranging from hairline to 1/8" wide.</p> <p>Abutment 1 stem has a 12' long x 6" high scale and hollow area at the top near mid-span. In addition, there is a 6" diameter outlet pipe near the bottom of the stem and there is heavy scaling up to 18" diameter x 2" deep below the pipe.</p> <p>Abutment 2 stem has heavy scaling up to 3" deep at the bottom near mid-span. In addition there is an 18" long x 4" high x 1" deep spall at the top near mid-span and an 18" long diagonal crack at the top at the north end.</p>
Abutments - Backwall:	N	-
Abutments - Footings:	6	Abutment 2 footing is exposed at the north end for 6' long x 18" wide x up to 3" deep.
Abutments - Settlement:	8	-
Abutments - Wingwalls:	6	<p>All wingwalls have light scaling at isolated locations, moderate scaling up to 3' high x 1/2" deep above the waterline for full length and random horizontal and vertical cracks ranging from hairline to 1/8" wide except for the southeast wingwall.</p> <p>In addition, all wingwalls have moderate to heavy edge scaling up to 5' long x 2' high x 6" deep and a 1' diameter x up to 3" deep spall on the cap at the top of WW 1B and WW 2BI. WW 1B has a 1' long x 10"</p>

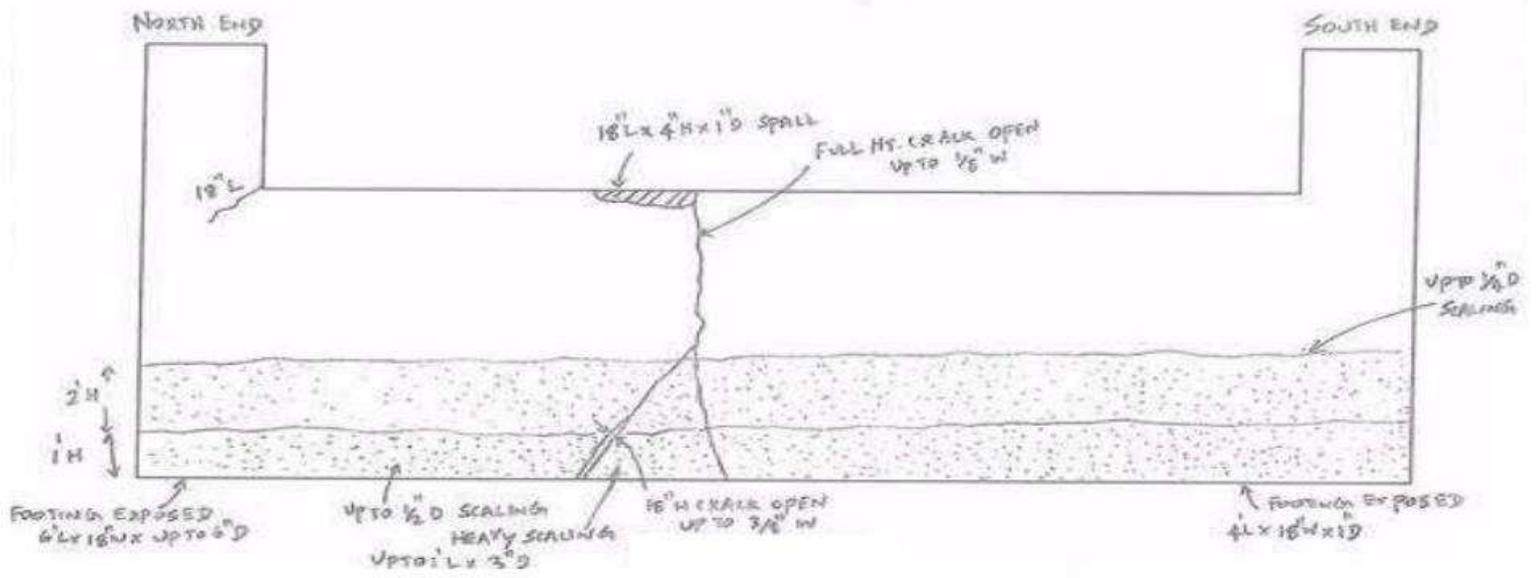
ABUTMENT # 2 EAST

high x 10" deep spall near the bottom at the south end.
Piers/Bents - Caps:	N	-
Piers/Bents - Pile Bent:	N	-
Piers/Bents - Columns:	N	-
Piers/Bents - Footings:	N	-
Piers/Bents - Settlement:	N	-
Erosion - Scour:	6	Abutment 2 footing is exposed at the north end for 6' long x 18" wide x up to 6" deep.
Concrete Crack - Spall:	6	See "ABUTMENTS-STEM" above.
Steel Corrosion:	N	-
Paint:	N	-
Timber Decay:	N	-
Collision Damage:	8	-
Debris:	N	-

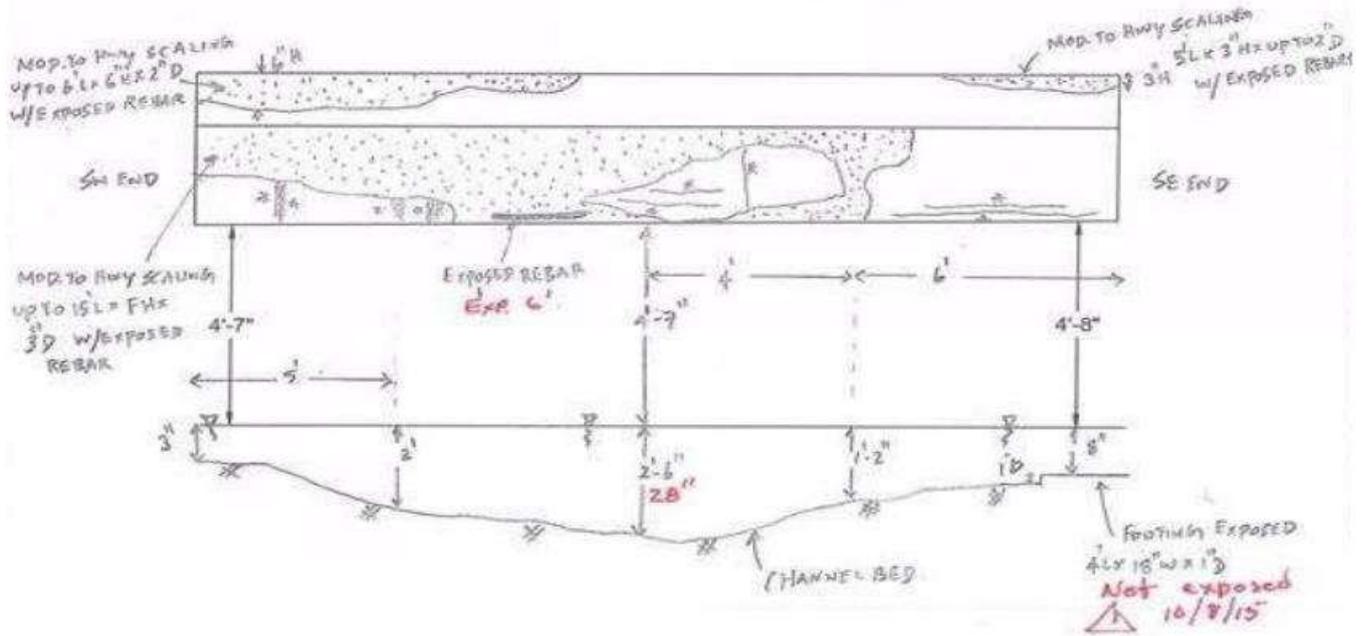
SOUTH ELEVATION (outlet)

Very little change 2017

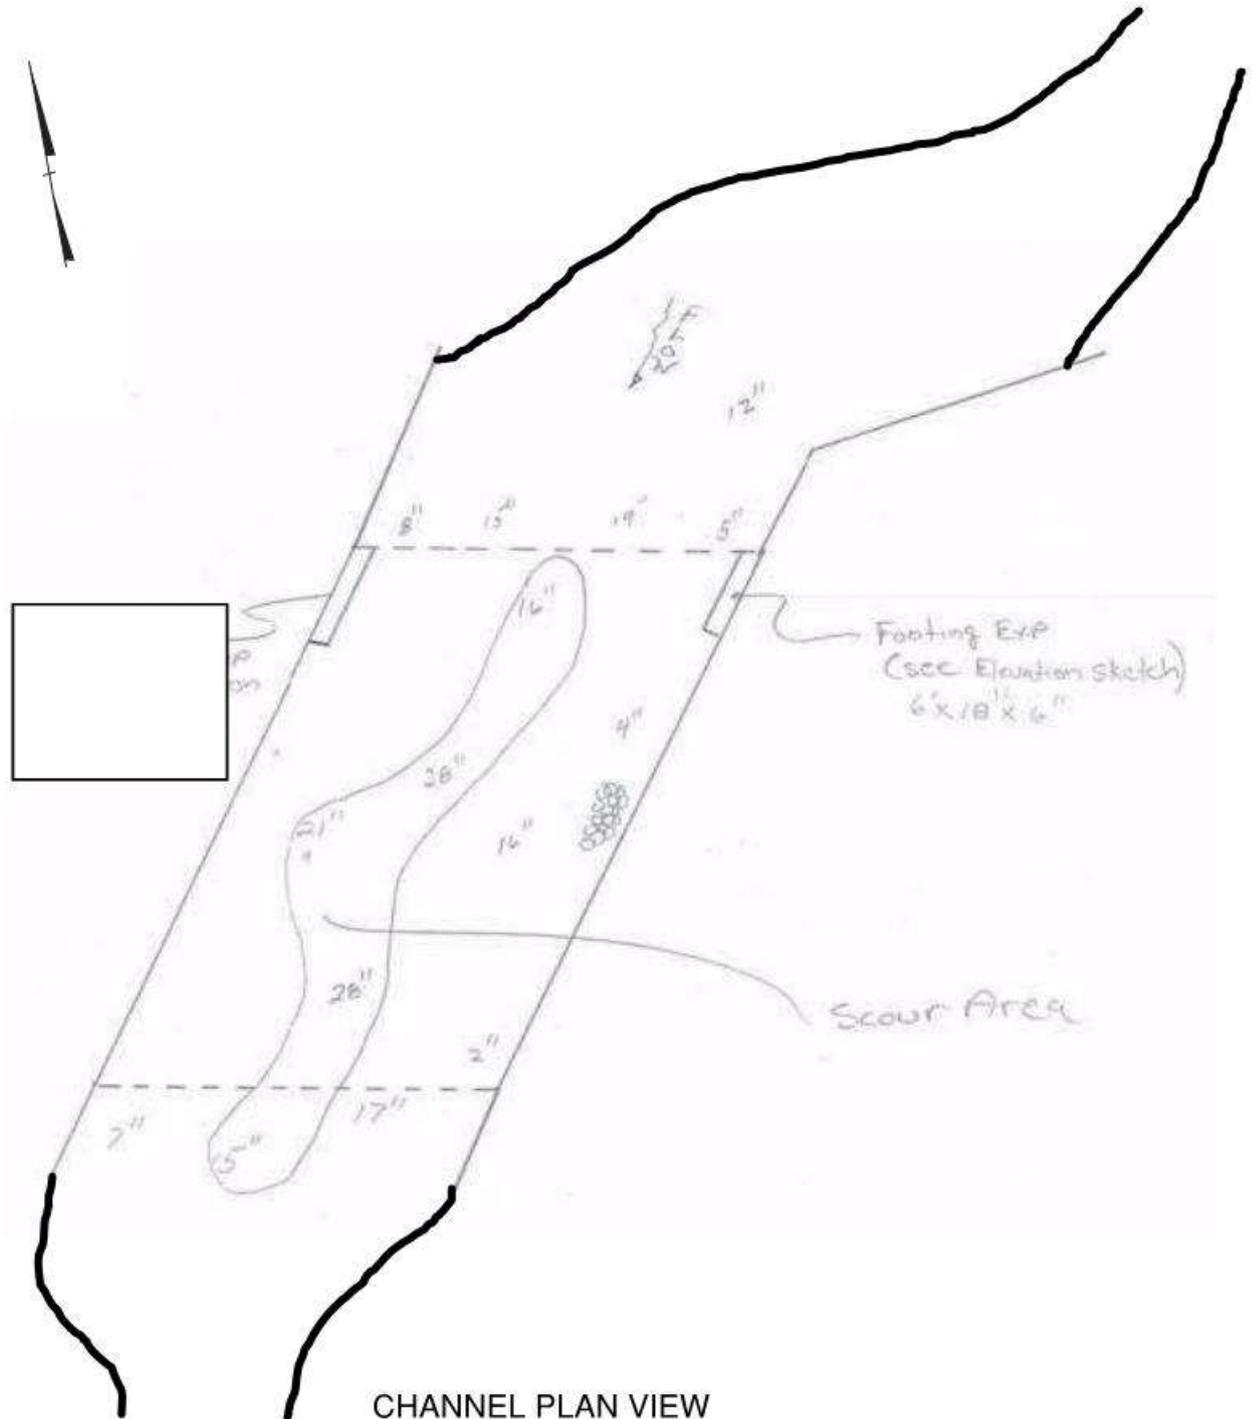
CHANNEL PLAN VIEW

Channel - Scour:	6	There is a 6' wide strip of scour along the middle of the channel averaging 15" to 28" deep.
Embankment - Erosion:	6	All embankments show moderate erosion and undercutting up to 2' high with exposed tree roots. There is light encroachment along the northwest and the southwest banks.
Debris:	6	Minor timber debris along wingwall 2A.
Vegetation:	6	All banks are well vegetated.
Channel Change:	6	There is light meandering of the channel noted along the structure inlet due to its alignment. The scour along the middle of the channel and the light embankment encroachment at the northwest and the southwest banks results in slight channel change.
Fender - System:	N	-
Spur Dikes and Jetties:	N	-
Rip Rap:	8	There is light rip rap placed along the inlet and at the outlet of the channel and along the portion of the east abutment.

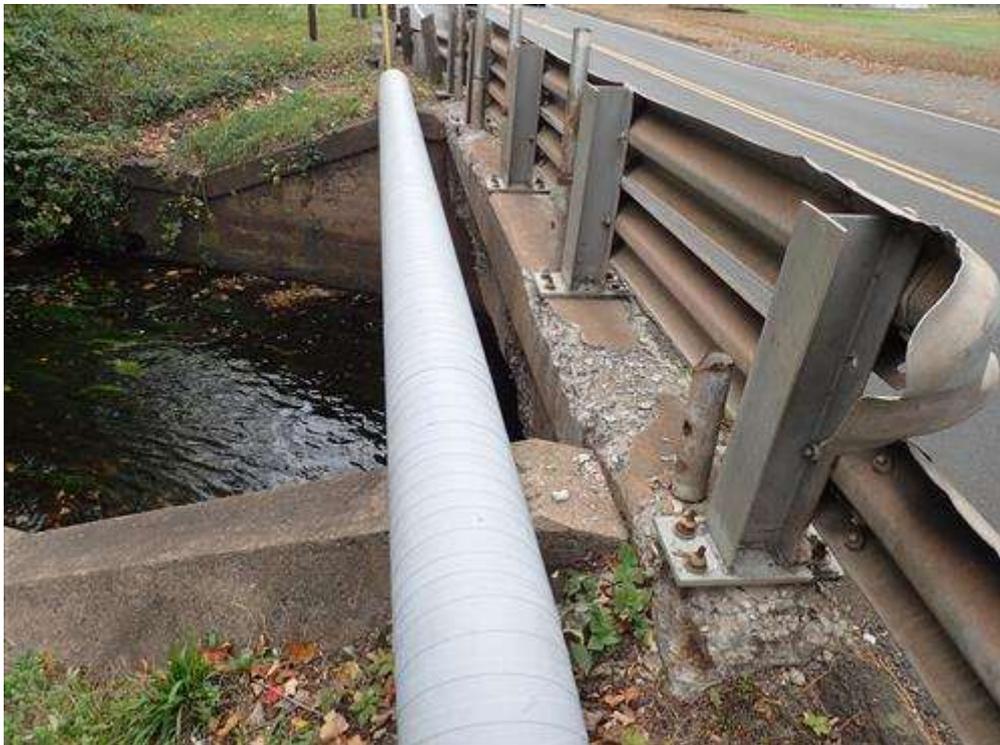
Photo Number: 6

There is a 12" diameter insulated water main adjacent to the south fascia.

Utility across south elevation

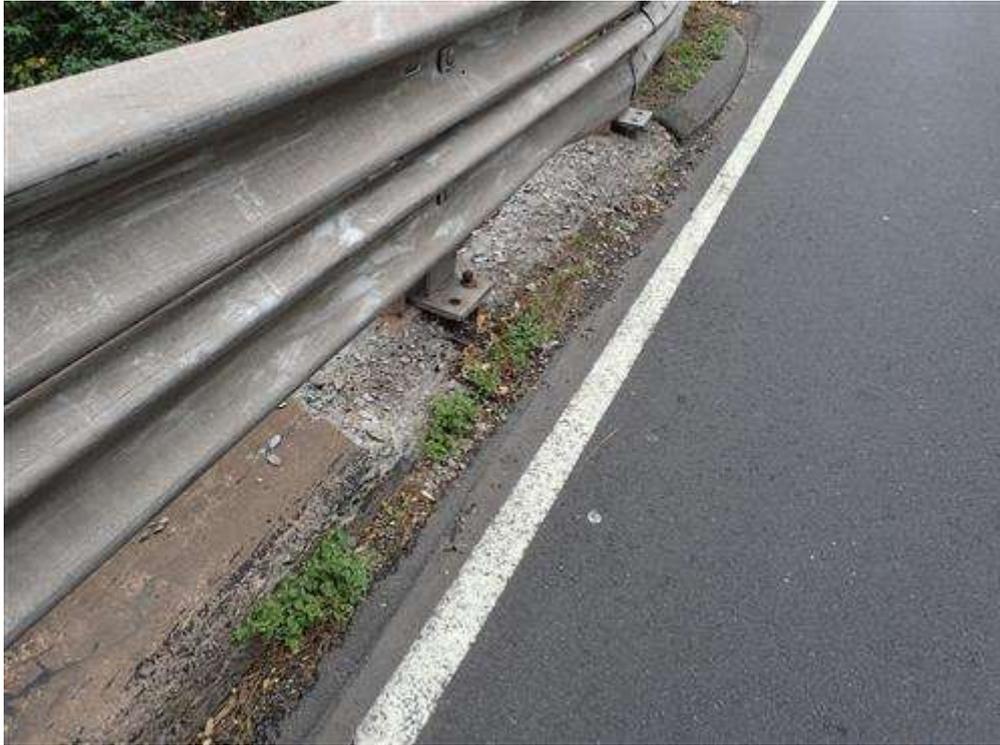
Photo Number: 7

Parapet: 4	<p>The concrete rail base/parapet along both fascias has isolated transverse and vertical hairline cracks with and without efflorescence and moderate to heavy scaling at isolated locations.</p> <p>The north fascia of the north parapet adjacent to the south sidewalk stringer has up to 15' long x up to 6" high x up to 3" deep scaling and the south face has a 2' long x 8" high x 3" deep scaling.</p> <p>The south fascia of the south parapet has heavy scaling on both ends up to 6' long x up to 6" high x 2" deep with exposed rebar. The scaling extends up to full width x full height on the north face of the parapet resulting in the undermining of the W-beam post anchor bolts, up to full height on both ends.</p> <p>Curb reveals South 7 inches North 9 inches</p>

Severe scale on south railbase inside face

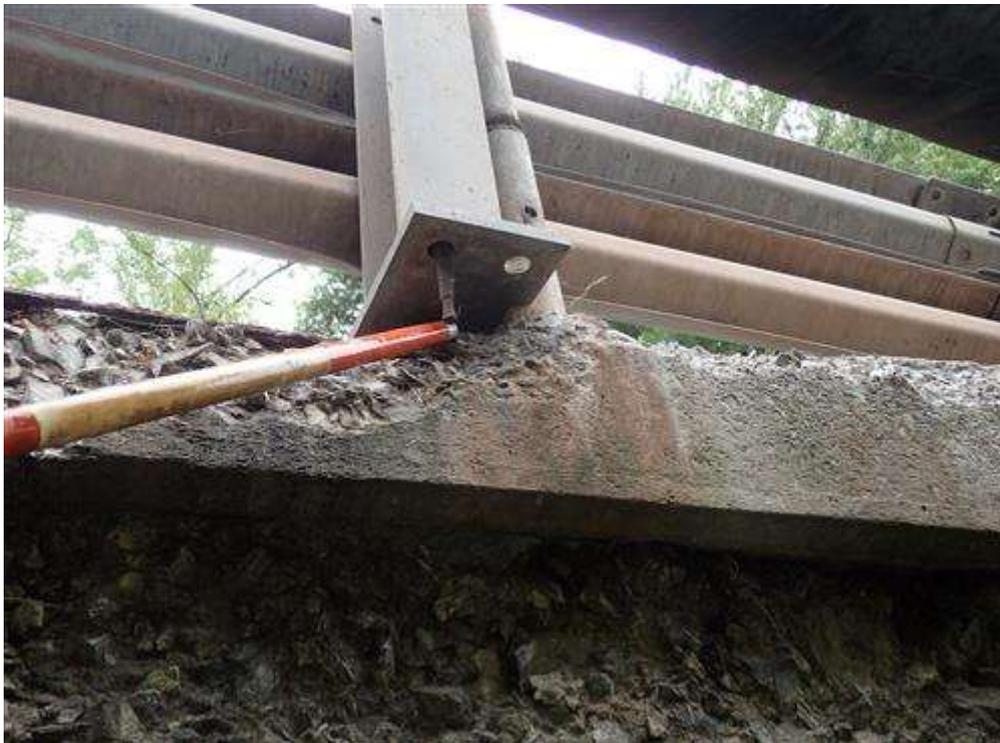
Photo Number: 8

Railing: 4 The original two pipe rail system is still in place along both fascias with only posts remaining and missing pipe rails along the south fascia. The pipe rail system has peeling paint with light surface rust.  
 In addition, the metal beam rail attached to W-beam posts are carried over the bridge parapet from the approach roadway along both fascias. The north railing has single metal beam rail and the W-beam posts are bolted on the top of the parapets. No rails on the south.  
 The W-beam post at the west end of the south parapet has all 4 anchor bolts missing. In addition, the remaining 3 of 4 W-beam posts have undermining of the anchor bolts up to full height with light rusting and several anchor bolt nuts are not fully engaged and backed off up to 3/4".

South railbase spall undermining H post

**Comments:** MBR has exposed anchor bolts from severe scale in concrete rail base.

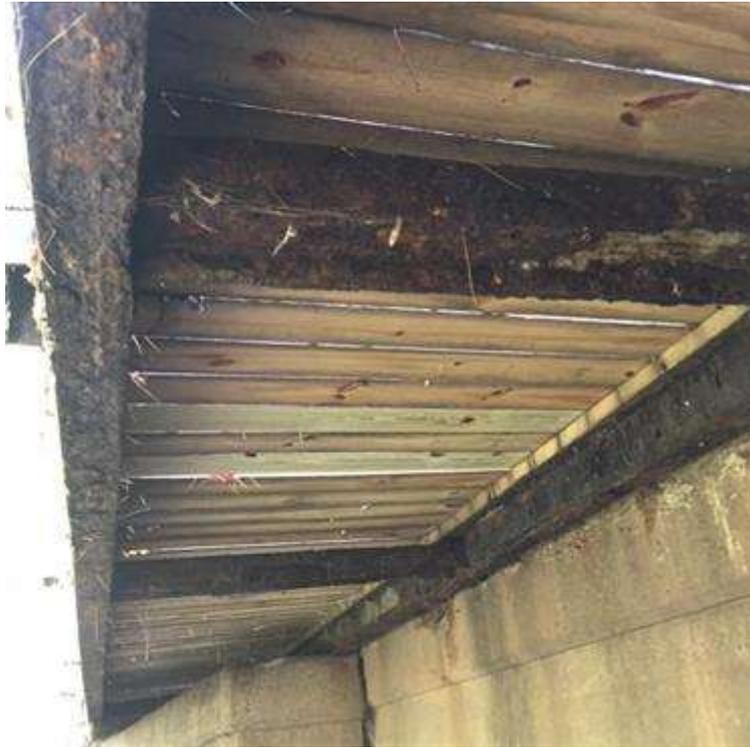
Photo Number: 11

Sidewalk girders with pitting and laminar rust

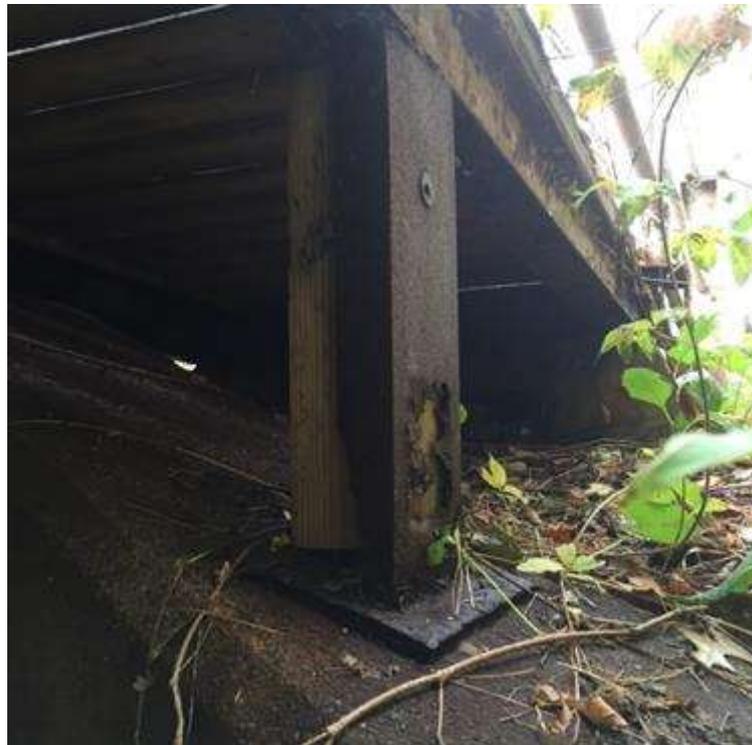
Photo Number: 12

Fence: 4 The 4' high chain link fence along the north end of the sidewalk has light rust on the horizontal rails and posts. The chain link fence posts over the river is supported by the W-shape steel section which is welded to the web of the sidewalk stringers. The W-shape sections have section loss including perforations in the web.

Steel H posts sidewalk supports with perfs at northwest

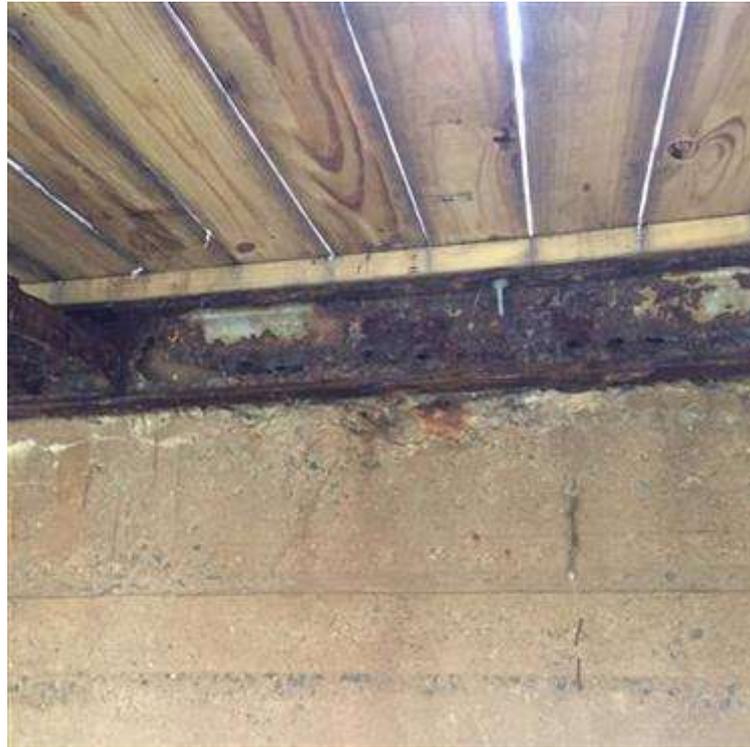
Photo Number: 13

Sidewalk cross diaphragms with several perforations in web area

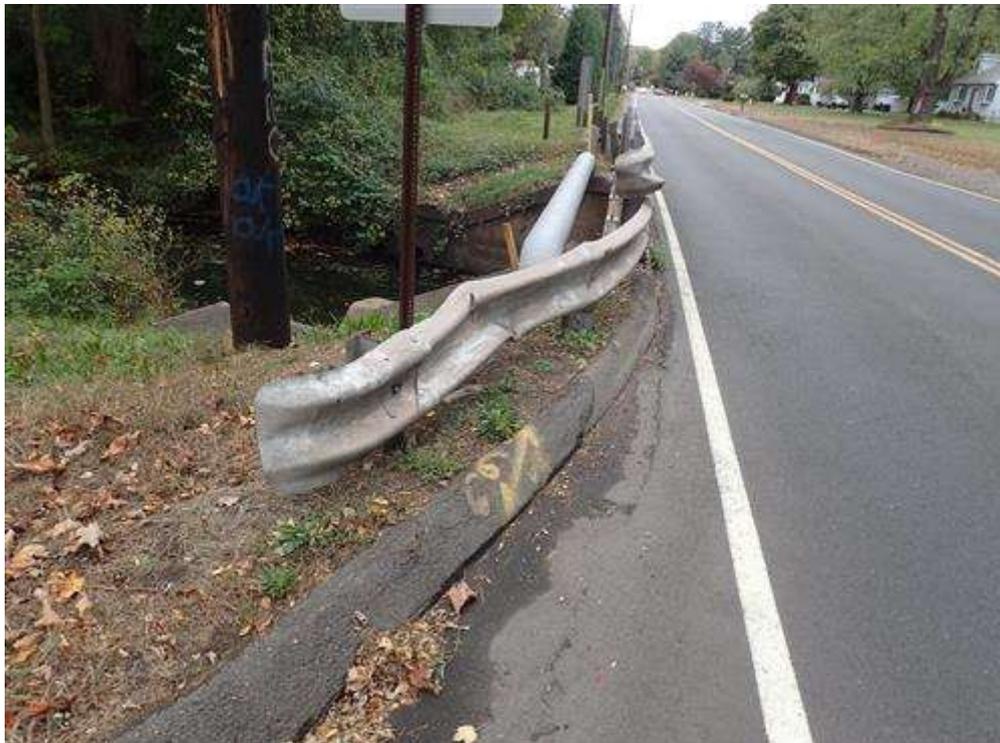
Photo Number: 14

Approach Guide Rail: 5 There are metal beam approach guiderails along both sides of each approach. The southeast approach guiderail has moderate collision damage and the northeast approach guiderail has minor collision damage.

Collision damage at southeast M.B,R

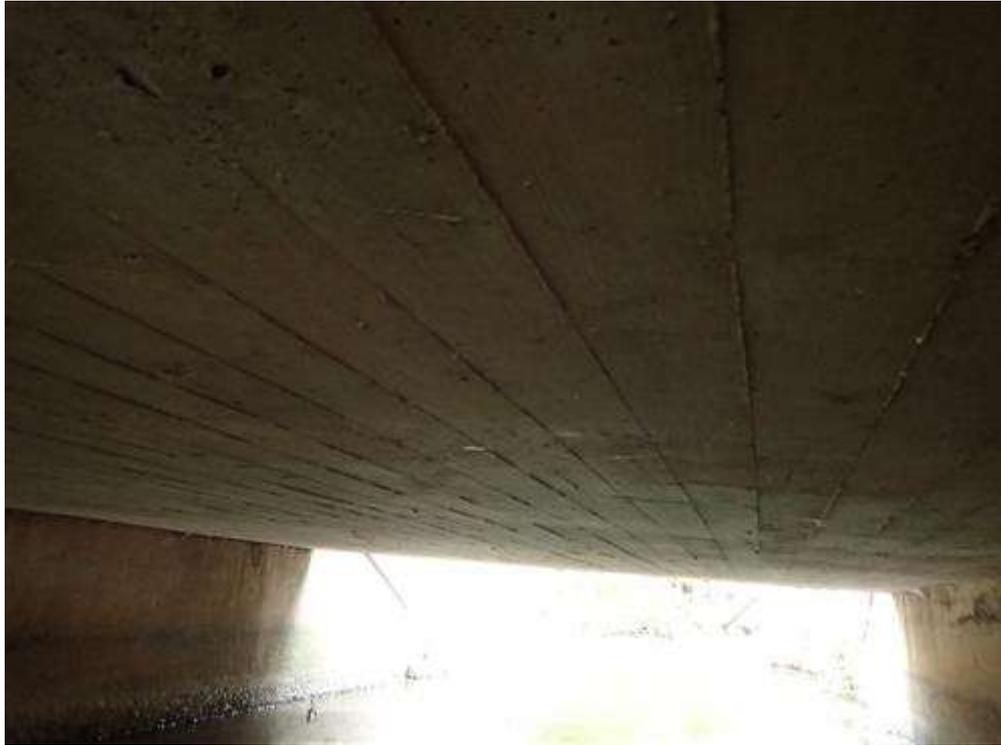
Photo Number: 15

Underside of deck

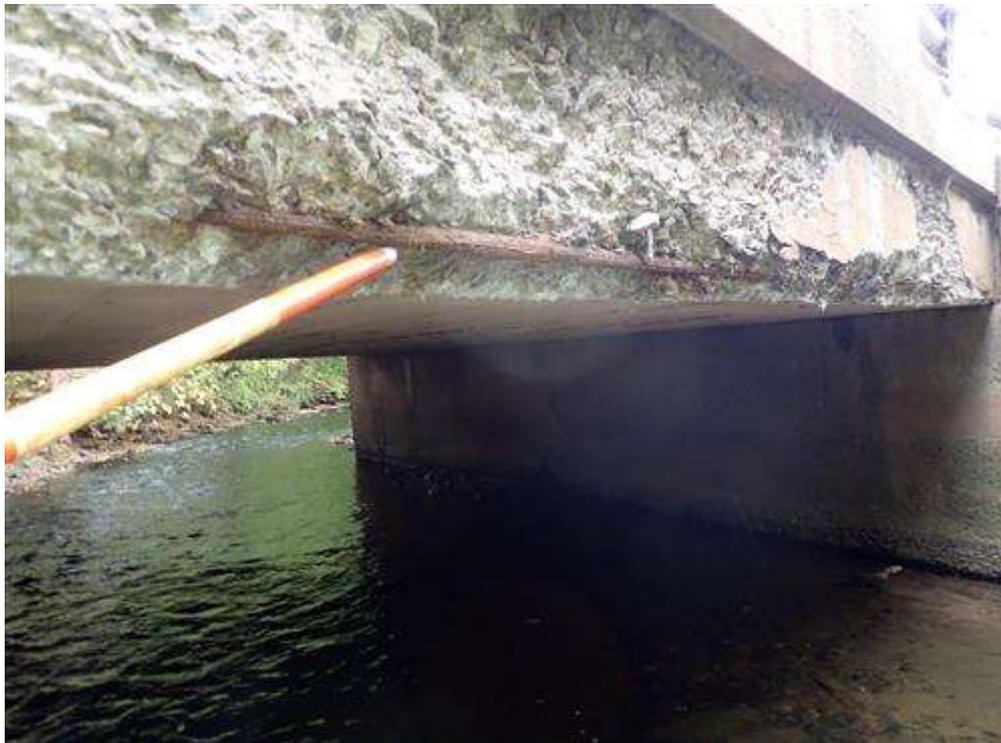
Photo Number: 16

South railbase severe scale with exposed rebar

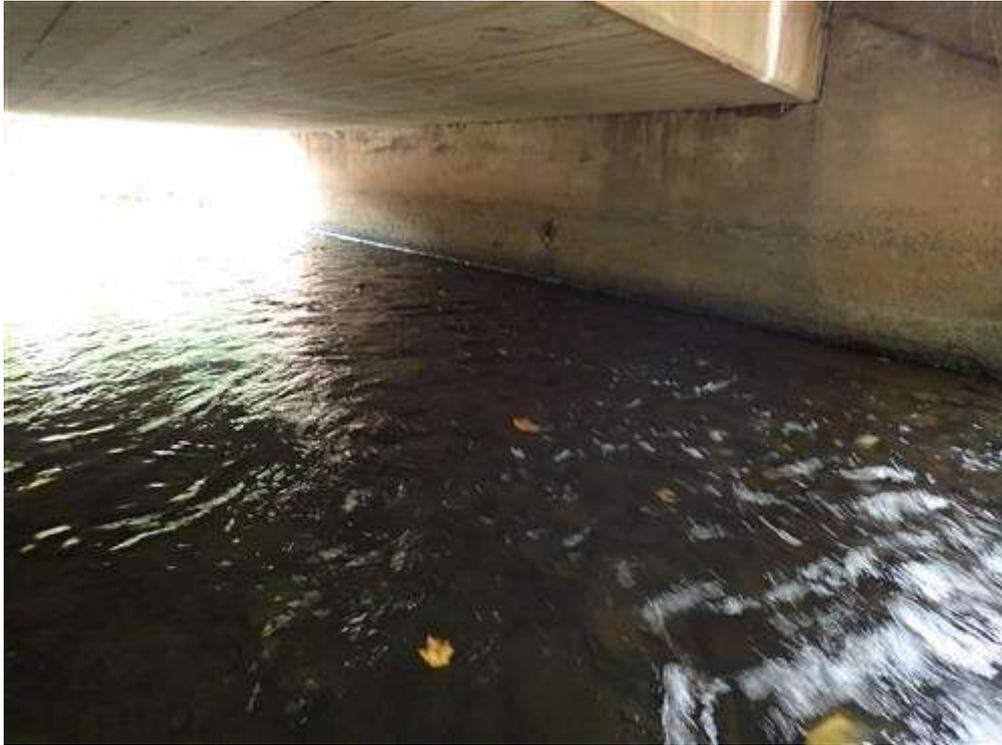
Photo Number: 17

Abutment # 1 (west)

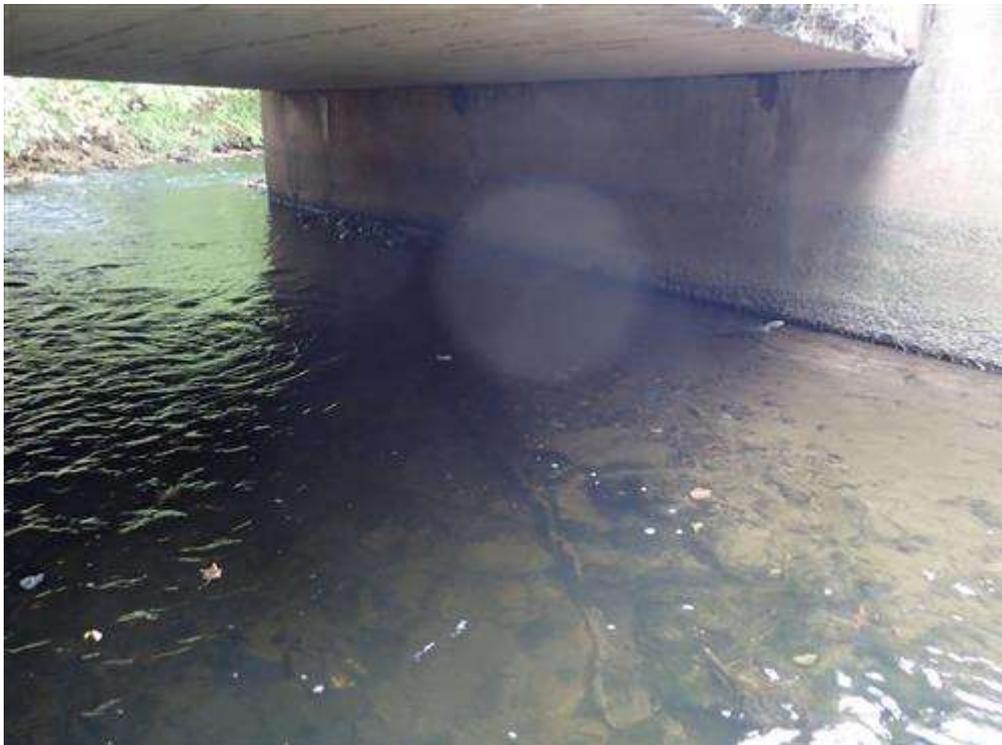
Photo Number: 18

Abutment # 2 (east)

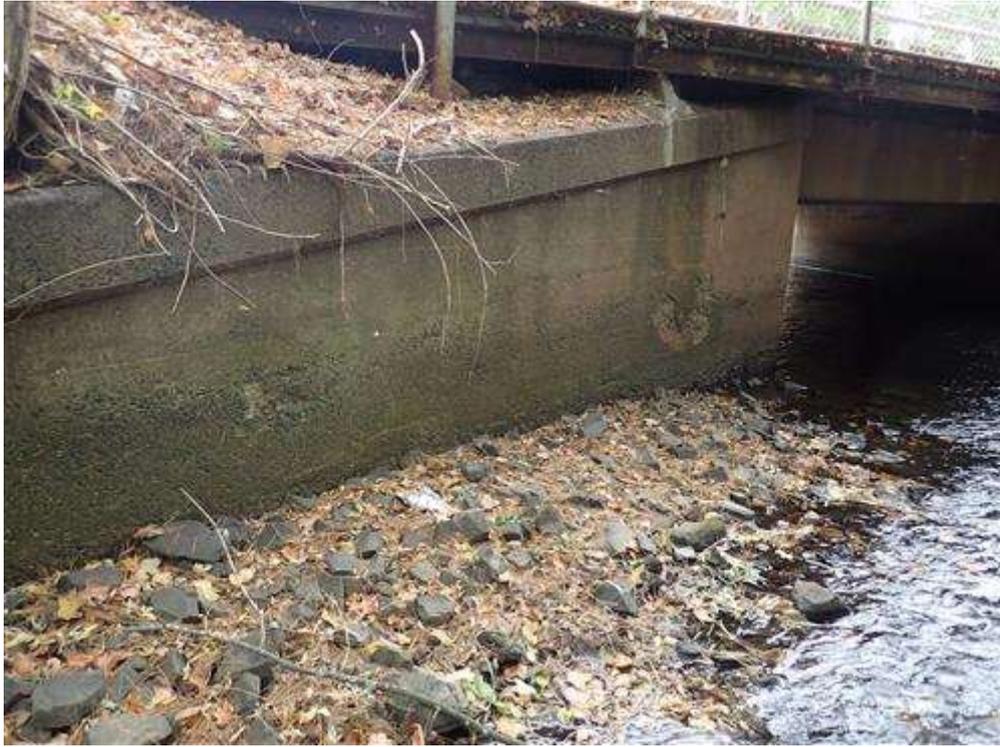
Photo Number: 19

Approach Embankment: 7 There is an erosion behind the southeast wingwall 2B up to 15' long x 4' wide x up to 1.5' deep.

Northeast wingwall 2B

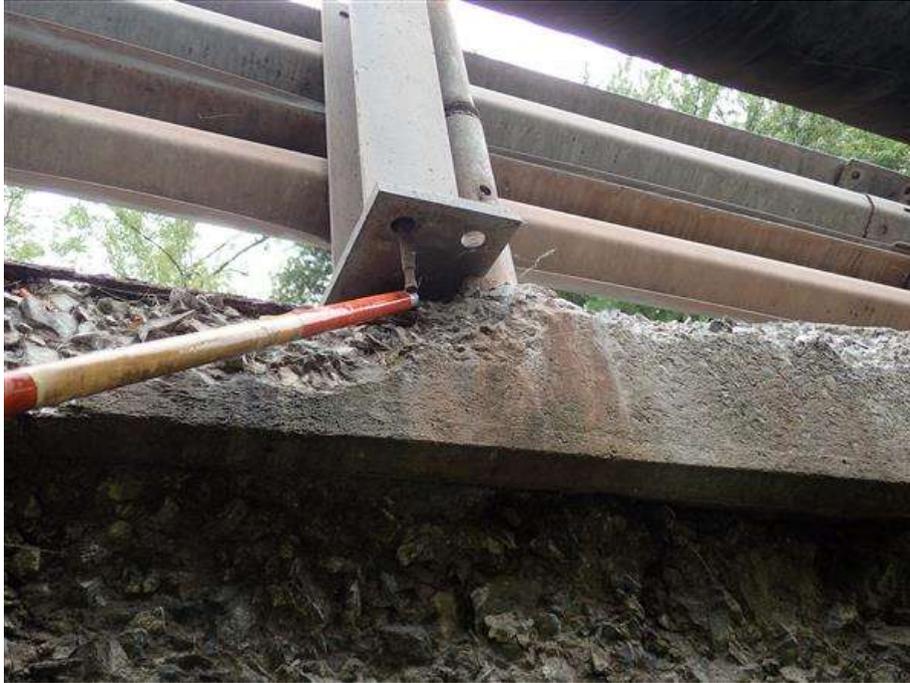
South railbase spall undermining H post
