**Building Information - Yellow Springs Exempted Village (45674) - Yellow Springs High School/McKinney Middle School**

**Building Pictures - Yellow Springs Exempted Village(45674) - Yellow Springs High School/McKinney Middle School(42416)**

**GENERAL DESCRIPTION**

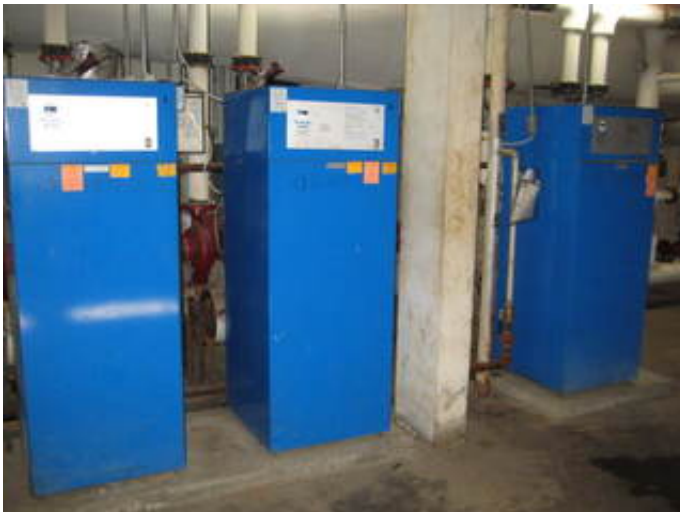
The existing system for the overall facility is a natural gas fired heated water boiler type system, installed in 1963, with some recent upgrades, and is in fair condition. The existing systems for the 1988 and 2002 Additions are natural gas fired packaged roof top unit type system, installed in 1988 and 2002, and are in fair condition. 2-pipe vs. 4-pipe designations are not applicable in this facility, as no central air conditioning is provided. The (3) heated water boilers, manufactured by Patterson-Kelley Co., are assumed to be installed in 1998 and are in fair condition. Heating water is distributed to terminal units consisting of unit ventilators, cabinet heaters, unit heaters, fin tubes, air handlers, and multiple roof top units. The 1988 Addition is equipped with (6) ducted packaged roof top units (with DX cooling and natural gas/hot water heat), manufactured by Trane, were installed in 1988, and are in fair condition. Heated air is distributed to terminal units consisting of multiple VAV boxes. The 2002 Addition is equipped with (5) ducted packaged roof top units (with DX cooling and natural gas/hot water heat), manufactured by York, were installed in 2002, and are in fair condition. Heated air is distributed to terminal units consisting of multiple VAV boxes. All terminal equipment is original to each addition and is in fair condition. The system does not comply with the 15 CFM per person fresh air requirements of the Ohio Building Code mechanical code and Ohio School Design Manual. The pneumatic, digital, and DDC type system temperature controls are original to each addition with incremental upgrades and are in fair condition. The system does not feature individual temperature controls in all spaces required by the OSDM. The overall system does not feature any central energy recovery systems. The 1963 Original Construction is equipped with widespread louvered interior doors to facilitate Corridor utilization as return air plenums. The remainder of the overall facility is not equipped with louvered interior doors to facilitate Corridor utilization as return air plenums. The existing system is ducted in the 1988 and 2002 Additions and a portion of the 1963 Original Construction, but the ductwork cannot be integrated into a possible future system due to arrangement, air volume, and routing of existing ductwork. The existing system in the remainder of the overall facility is not ducted, and floor to structural deck heights will not accommodate the installation of properly sized ductwork for a future Ohio School Design Manual approved system. The overall heating system is evaluated as not being in safe and efficient working order, and long term life expectancy of the existing system is not anticipated. The structure is not equipped with central air conditioning. The site does not contain underground fuel tanks.

3 Needs Replacement

Natural Gas Fired Heated Water Boilers

Provide new overall heating, ventilating, and air conditioning system to achieve compliance with Ohio Building Code and Ohio School Design Manual standards. Replace existing ductwork in the 1988 and 2002 Additions and a portion of the 1963 Original Construction to facilitate efficient exchange of conditioned air. Convert to ducted system the remainder of the overall facility to facilitate efficient exchange of conditioned air. Provide architectural soffits to accommodate the installation of ductwork.

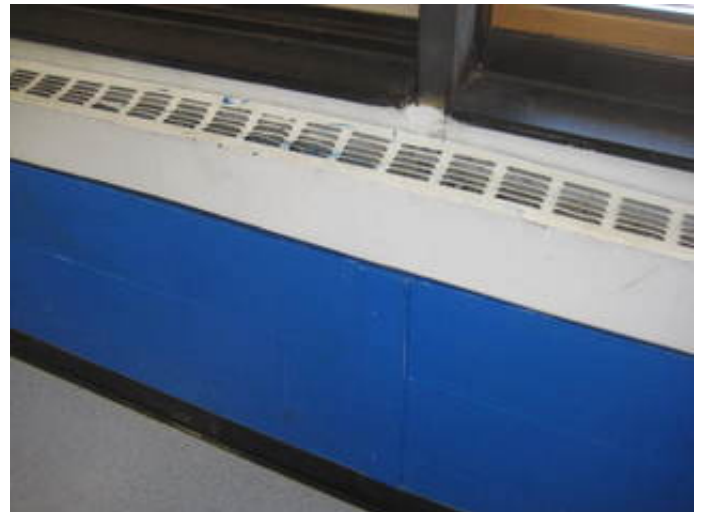
Heating Water Fin Tube Heater

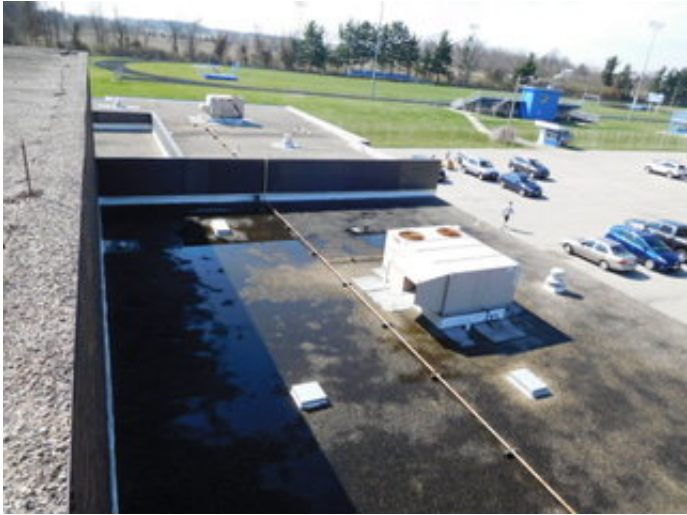
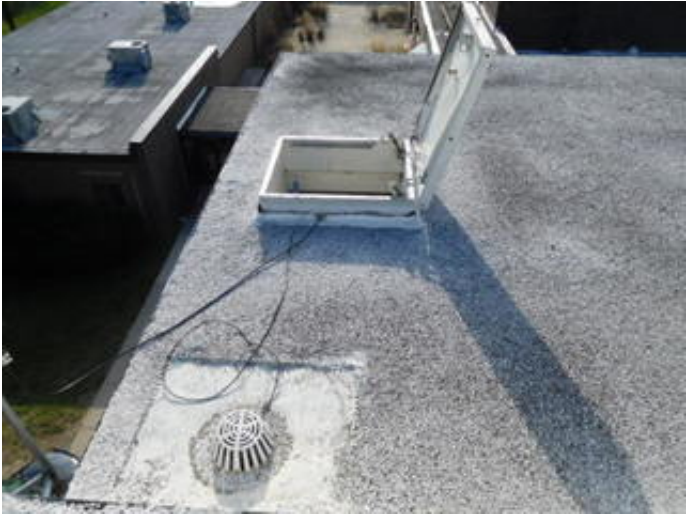
**Description:** The roof over the Original Construction is a built-up system with gravel ballast that was installed in 1994, and is in fair condition; portions of the Original Construction were replaced with a built-up system in 2009, and is in fair condition. The roof over the 1988 Addition is a modified bitumen system that was installed in 2003, and is in fair condition. The roof over the 1999 Addition is a built-up system with gravel ballast that was installed in 1999, and is in fair condition. The roof over the 2002 Addition is a built-up system with gravel ballast that was installed in 2004, and is in good to fair condition. There are no District reports of current leaking. No signs of past leaking were observed during the physical assessment. Access to portions of the roof was gained by access hatches that are in poor condition. Fall safety protection cages are not required. There were observations of standing water on the roof. Metal cap flashings and stone copings are in fair to poor condition. Roof storm drainage is addressed through a system of gutters and downspouts and roof drains, which are properly located, and in fair condition. The roof is not equipped with overflow roof drains in all additions though they will be required in areas of roof replacement. No problems requiring attention were encountered with any roof penetrations. There are not any covered walkways attached to this structure.

**Rating:** 3 Needs Replacement

Typical Roof

**Recommendations:** The roof over the overall facility requires replacement to meet Ohio School Design Manual guidelines due to age of system and projected lifecycle. The flashing and coping on the overall facility require replacement due to condition. Due to existing conditions roof drains require replacement on the overall facility with the exception of the 2002 Addition. Due to existing conditions gutters and downspouts and roof drains require replacement. Provide funding for overflow roof drains and piping for the Original construction and the 1999 Addition. Due to age and condition provide for the replacement of two roof access ladders and hatches. Provide one new roof access ladder and hatch to provide access to all roof areas. Provide funding for guardrails to be added at the location of the two existing roof access hatches due to life safety.

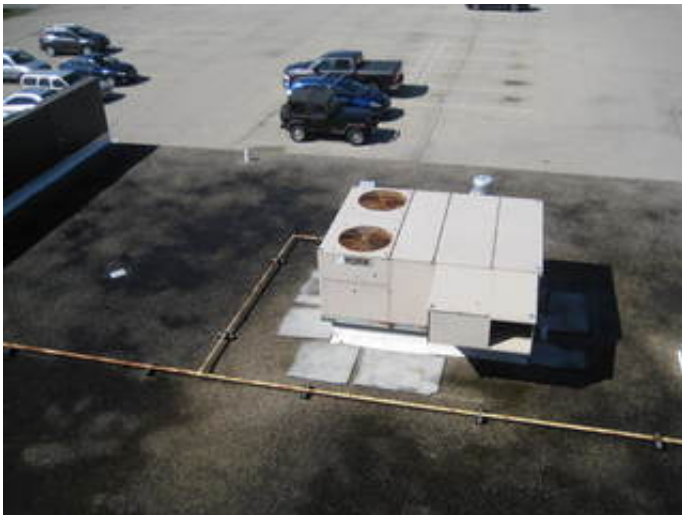
**Description:** The overall facility is not equipped with a central air conditioning system. Window units are located in several Classroom locations in the overall facility. An isolated room system consisting of an electric fired LG ducted split VRF type system (with the condensing units pad mounted and located on the exterior) is provided in the 3-story portion of the 1963 Original Construction. Isolated room systems consisting of multiple ducted packaged air cooled Trane and York roof top units (with DX cooling and natural gas/hot water heating) are provided in the Administrative Offices of the 1963 Original Construction, as well as throughout the 1998 and 2002 Additions. The ventilation system in the overall facility consists of unit ventilators, air handlers, and roof top units, original to each addition and in fair condition, providing fresh air to Classrooms, and air handlers and roof top units, original to each addition and in fair condition, providing fresh air to other miscellaneous spaces such as Gymnasium, Student Dining, and Media Center. Relief air venting is provided by louvered interior doors, central relief fans, air handlers, and roof top units. The ventilation system does not meet the Ohio Building Code 15 CFM per occupant fresh air requirement. The overall system is not compliant with Ohio Building Code and Ohio School Design Manual requirements. Dust collection systems are not required. The Art program is equipped with two (2) kilns, and existing kiln ventilation is inadequate, and in fair condition. General building exhaust systems for Restrooms, Storage Rooms, Art Rooms, and Custodial Closets are inadequately placed, and in fair condition.

**Rating:** 2 Needs Repair

Roof Top Unit

**Recommendations:** Provide an air conditioning system to meet with Ohio Building Code and Ohio School Design Manual requirements. Replace general building exhaust systems located in Restrooms, Storage Rooms, and Custodial Closets. Pricing included in Item A. Replace the existing Art Program's kiln ventilation system due to age, condition, and lack of OSDM compliance.

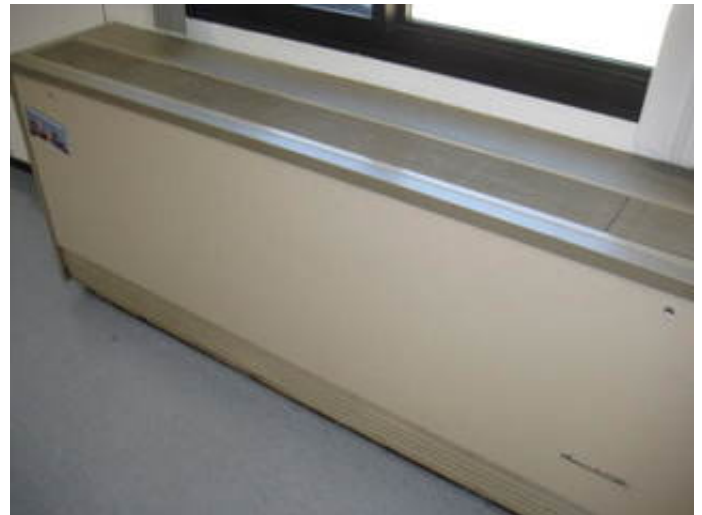
Unit Ventilator

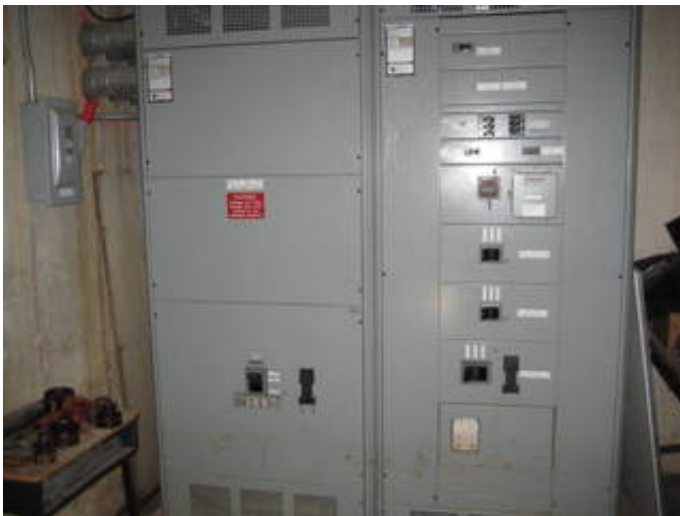
**Description:** The electrical system provided to the 2002 Addition is a 120/208 volts, 1,600 amp, 3 phase and 4 wire system installed in 2002, and is in good to fair condition. The systems in the 1963 Original Condition and 1988 and 1999 Additions are an extension of that found in the 2002 Addition. Power is provided to the school by a single utility owned, pad-mounted transformer located outside the Mechanical Room, and in fair condition. The panel systems, original to each addition, are in fair condition, and for the most part cannot be expanded to add additional capacity. The Classrooms are not equipped with adequate electrical outlets. The typical Classroom contains (6) general purpose outlets, (0) dedicated outlets for each Classroom computer, and (1) dedicated outlet for each Classroom television/ceiling mounted projector. Some Classrooms are equipped with as many as (7) general purpose outlets, while others are equipped with as few as (4) general purpose outlets. There are not any spaces that have no electrical outlets. The Corridors are equipped with adequate electrical outlets for servicing. Adequate GFI protected exterior outlets are not provided around the perimeter of the building. The facility is not equipped with an emergency generator. Adequate lightning protection safeguards are not provided. Stage lighting power system including control panel, breakers, and dimmers is inadequately provided, in fair condition and does not fully meet OSDM requirements. The overall electrical system does not fully meet Ohio School Design Manual requirements in supporting the current needs of the school, and will be inadequate to meet the facility's future needs.

**Rating:** 3 Needs Replacement

Main Electrical Distribution Panel

**Recommendations:** The entire electrical system requires replacement to meet Ohio School Design Manual guidelines for overall capacity due to age and condition, lack of OSDM-required features, and to accommodate the addition of an air conditioning system. Provide an emergency generator, with funding included in the electrical system replacement. Provide adequate lightning protection safeguards in the overall facility, including associated grounding system, with funding included in the electrical system replacement.

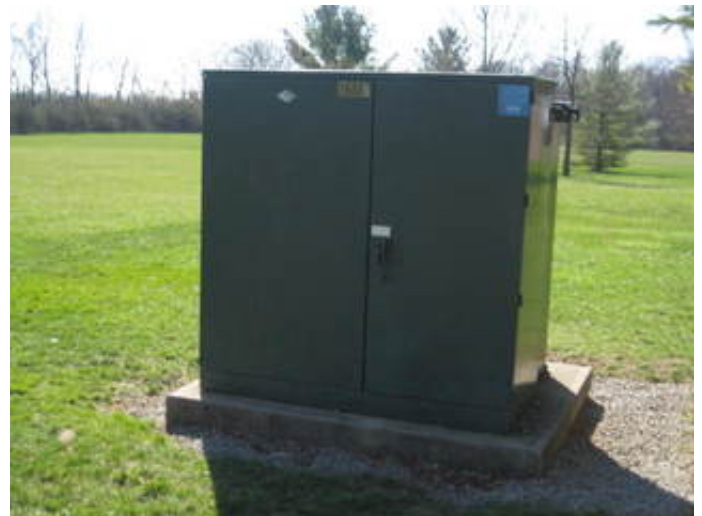
Pad Mounted Transformer

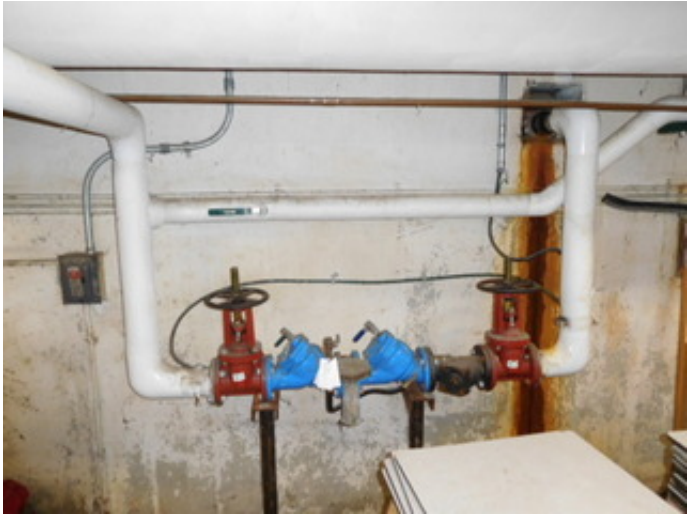
Description:	<p>The service entrance is equipped with a reduced pressure back flow preventer in good to fair condition. A water treatment system is not provided, though none is needed. The domestic water supply piping in the overall facility is copper and galvanized, is original to each addition, and is in fair condition. The waste piping in the overall facility is cast iron, with some galvanized, is original to each addition, and is in good to fair condition. The facility is equipped with a 40 gallon electric water heater in good to fair condition, and a 91 gallon gas water heater in good condition, with 1 separate 250 gallon storage tank in poor condition. The school contains 3 Large Group Restrooms for boys, 3 Large Group Restrooms for girls, 1 Locker Room Restroom for boys, 1 Locker Room Restroom for girls, 1 Restroom associated with specialty Classrooms, and 2 Restrooms for staff. Boys' Large Group Restrooms contain 3 ADA and 3 non-ADA wall and floor mounted flush valve and tank type toilets, 4 ADA and 5 non-ADA wall mounted flush valve urinals, as well as 5 ADA and 2 non-ADA countertop and wall mounted lavatories. Girls' Large Group Restrooms contain 3 ADA and 8 non-ADA wall and floor mounted tank type and flush valve toilets, as well as 5 ADA and 2 non-ADA countertop and wall mounted lavatories. Boys' Locker Room Restrooms contain 0 ADA and 1 non-ADA wall mounted flush valve toilets, 0 ADA and 1 non-ADA wall mounted flush valve urinals, 0 ADA and 1 non-ADA countertop lavatories, as well as 0 ADA and 9 non-ADA showers. Girls' Locker Room Restrooms contain 0 ADA and 2 non-ADA wall mounted flush valve toilets, as well as 0 ADA and 2 non-ADA countertop lavatories, as well as 0 ADA and 8 non-ADA showers. Staff Restrooms contain 0 ADA and 3 non-ADA wall and floor mounted tank type and flush valve toilets, 0 ADA and 0 non-ADA urinals, as well as 0 ADA and 3 non-ADA wall mounted lavatories. Condition of fixtures is good to fair. The facility is equipped with 0 ADA and 0 non-ADA drinking fountains, as well as 2 ADA and 7 non-ADA electric water coolers, in good to fair condition. High School Special Education Classrooms are equipped with 0 ADA and 0 non-ADA sink mounted type drinking fountains. Special Education Classroom is equipped with the required Restroom facilities, and fixtures are in fair condition. Kitchen is not equipped with the required Restroom. Heath Clinic is not equipped with the required Restroom. Due to existing grade configuration, Kindergarten / Pre-K Classroom Restroom considerations are not relevant. Kitchen fixtures consist of 2 single compartment sink and 1 triple compartment sink, which are in fair condition. The Kitchen is not equipped with a grease interceptor. The Kitchen is provided the required 140 degree hot water supply. The school meets the OBC requirements for fixtures. Relative to LEED requirements, the school is not equipped with low flow type fixtures. Per OBC and OSDM requirements this facility should be equipped with 8 toilets, 2 urinals, 10 lavatories, 1 Classroom sink mounted drinking fountains, and 5 electric water coolers. Observations revealed that the school is currently equipped with 28 toilets, 10 urinals, 25 lavatories, 0 Classroom sink mounted drinking fountains, and 9 electric water coolers. ADA requirements are not met for fixtures and drinking fountains see Item O. Custodial Closets are properly located and are adequately provided with required service sinks or floor drain sinks, which are in fair condition. Science Classrooms / Project Laboratories / Career Tech Laboratories are equipped with required utility sink, gas / compressed air connections, and safety shower / eyewash in good to fair condition. Biology and Chemistry Classrooms are not equipped with acid waste systems and neutralization tanks. Adequate exterior wall hydrants are not provided.</p>

Backflow Preventers

Rating:	3 Needs Replacement
Recommendations:	<p>To facilitate the school's compliance with OBC and OSFC fixture requirements, provide 2 new toilets, 2 new lavatories and 1 new lavatory mounted type drinking fountains. Due to age, condition, LEED, and OSFC requirements, provide 22 new toilets, 21 new lavatories, 8 new urinals and 4 new electric water coolers. Replace water supply and sanitary waste piping in the 1963 Original Construction and 1988 Addition. Due to age replace the electric hot water heater in the 1988 Addition. Due to age and condition, replace the 250 gallon hot water storage tank. Due to age and condition replace all showers in the Original Construction. See Item O for replacement of fixtures related to ADA requirements. Provide the Science Classrooms with the required gas connections, compressed air connections, and safety shower / eyewash stations. Provide the Biology and Chemistry Classrooms with the required acid waste systems and neutralization tanks. See Item J for replacement of Kitchen fixtures. Replace one and provide three new exterior wall hydrants to meet OSFC requirements. Provide the Kitchen with a grease trap interceptor. Replace existing Custodial Closet sinks due to age and condition.</p>

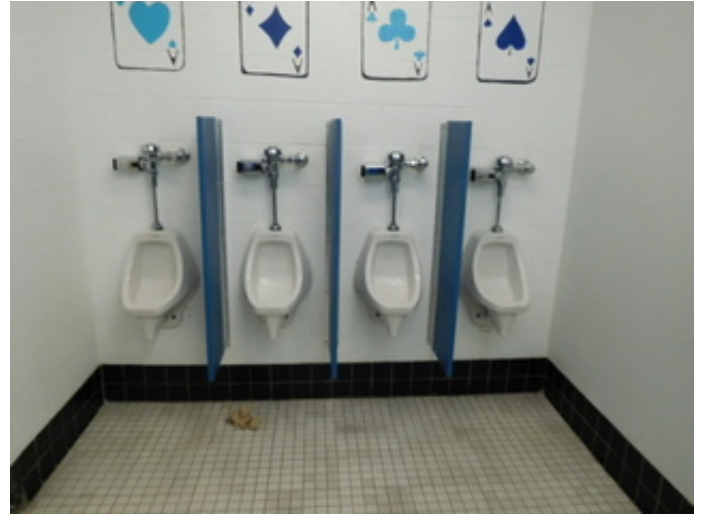
Typical Restroom Urinals

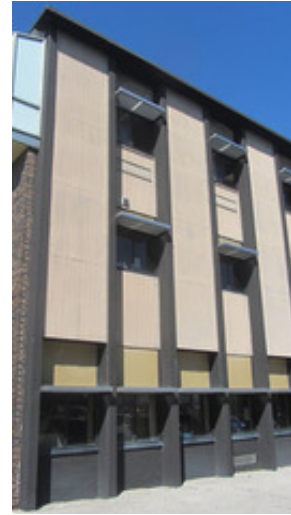
1963 Original Construction Classroom Windows

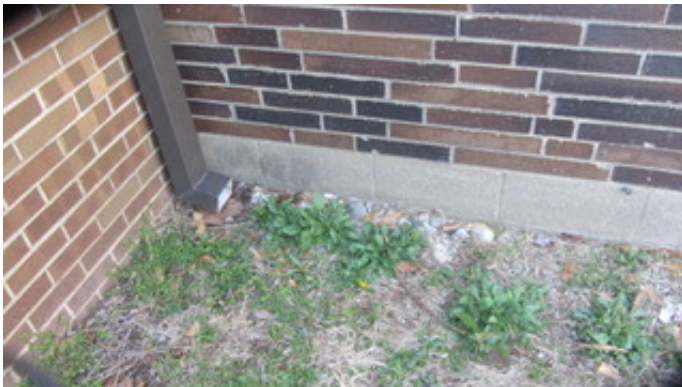
1963 Original Construction Exposed Foundation

**Recommendations:** Repair areas of cracking and open masonry joints in the 1963 Original Construction and 1988 Addition. Regrade depressed areas under emergency roof drains in the 1963 Original Construction. Repair leaks in Mechanical Room walls.

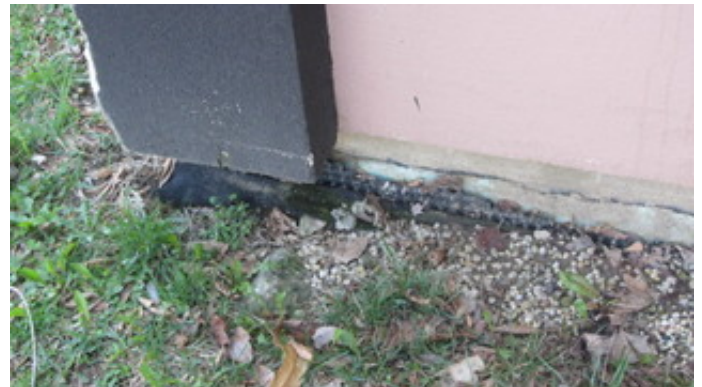
1999 Addition Foundation

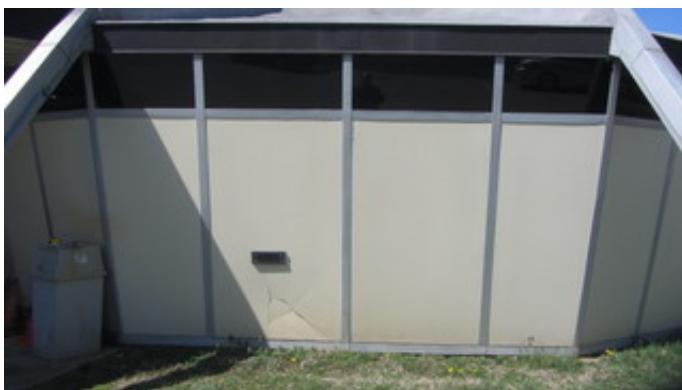
Insulated panels at 1963 Original Construction Music Room

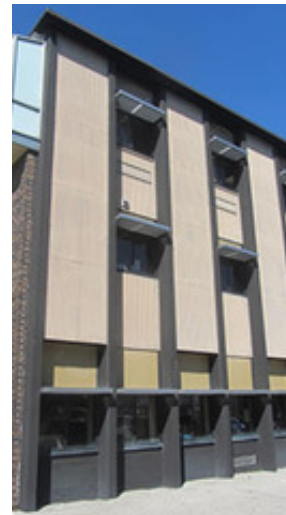
1963 Original Construction Three Story Structure

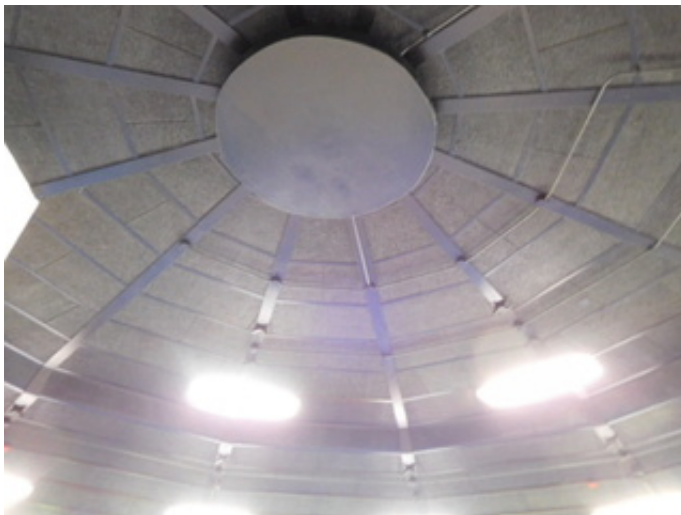
1963 Original Construction Music Room Roof Structure

**Recommendations:** Remove and replace wood floor, wall and roof construction in the 1988 Addition with code compliant construction that meets with Ohio School Design Manual Requirements. Provide funding for an investigation and correction of the structural issues at the intermediate floors of the 1963 Original Construction. Refer to Item A for funding of architectural soffits to accommodate HVAC, electrical, and plumbing scopes of work.

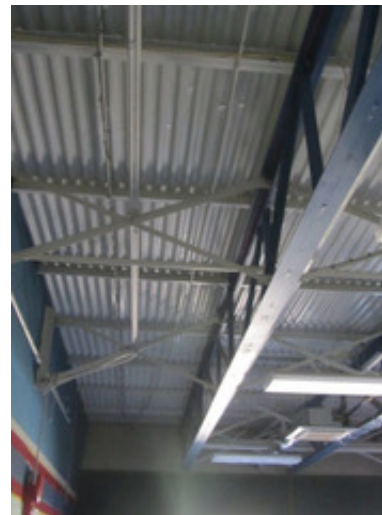
1963 Original Construction Student Dining Roof Structure

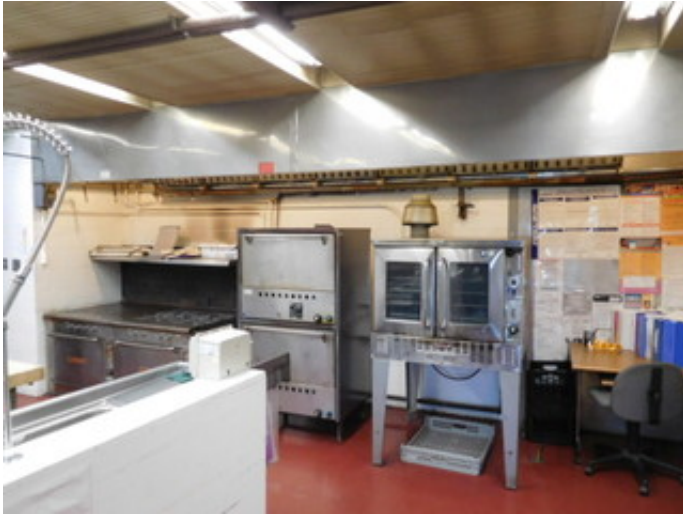
Kitchen Hood & Equipment

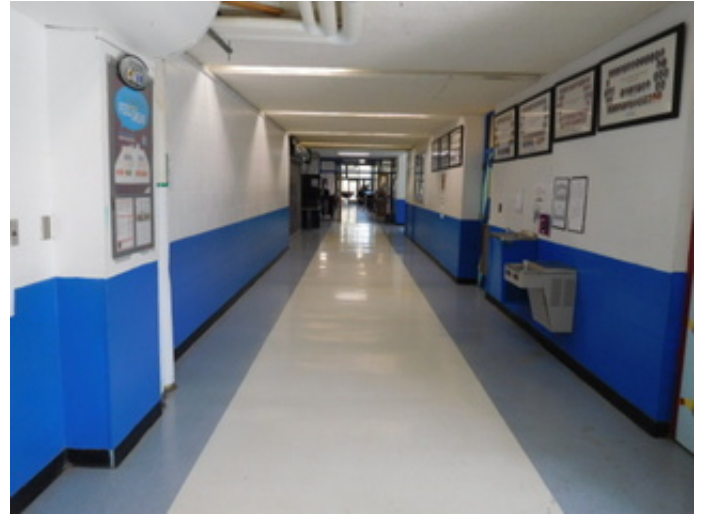
Typical Corridor Finishes

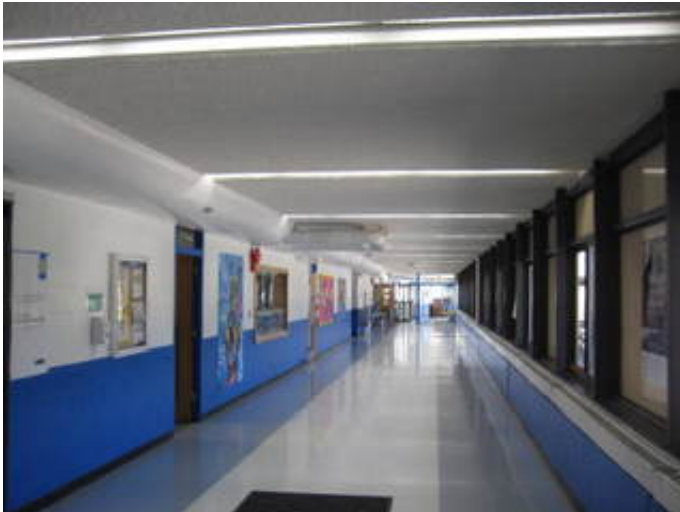
Typical Corridor Fluorescent Light Fixtures

Provide complete replacement of lighting system due to age, condition, lighting levels, utilization of incandescent fixtures, lack of multilevel switching, and installation of systems outlined in Items A, C, J, and U.

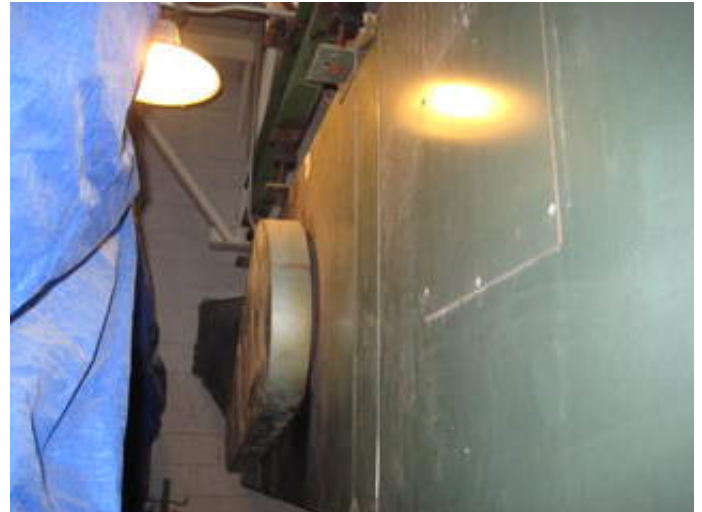
Service Area Incandescent Light Fixture

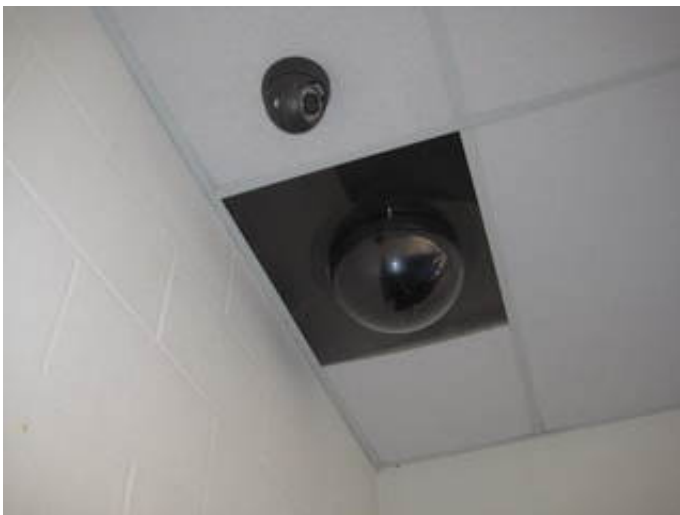
Security System CCTV Camera

**Recommendations:** Provide complete replacement of security system to meet Ohio School Design Manual guidelines. Provide complete replacement of exterior site lighting system to meet Ohio School Design Manual guidelines. Provide OSDM-compliant playground fencing, funding included in complete replacement of security system. Provide a secure entrance Vestibule between the main entry area and Administrative Offices.

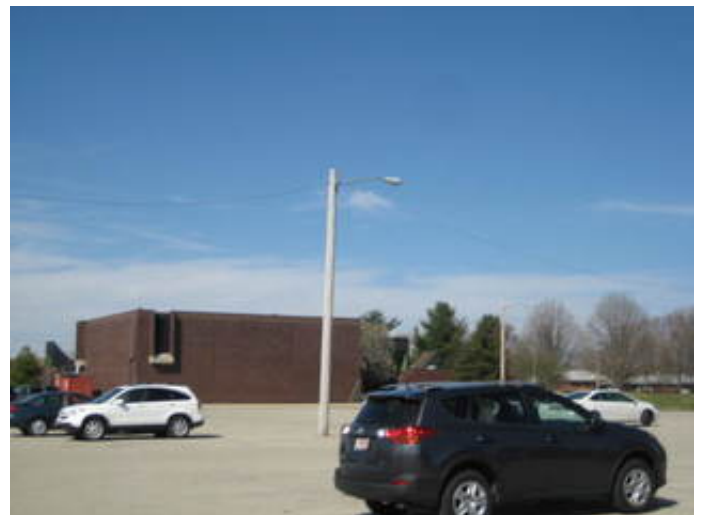
Pole Mounted HID High Pressure Sodium Light Fixture

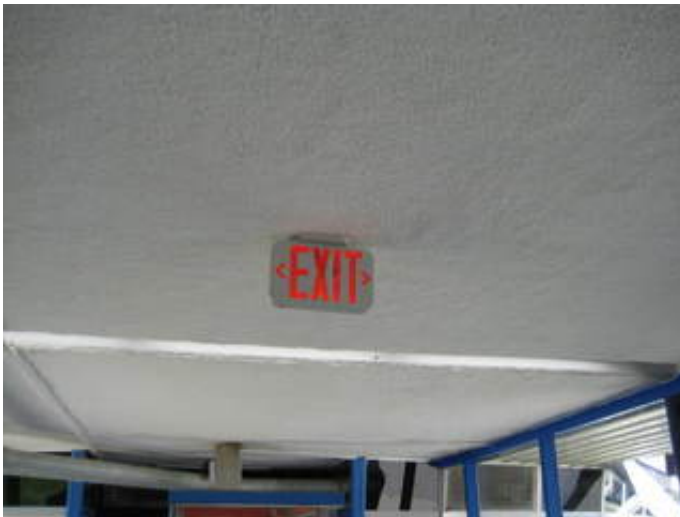
Exit Sign

**Recommendations:** Provide complete replacement of emergency / egress lighting system to meet Ohio School Design Manual and Ohio Building Code guidelines.

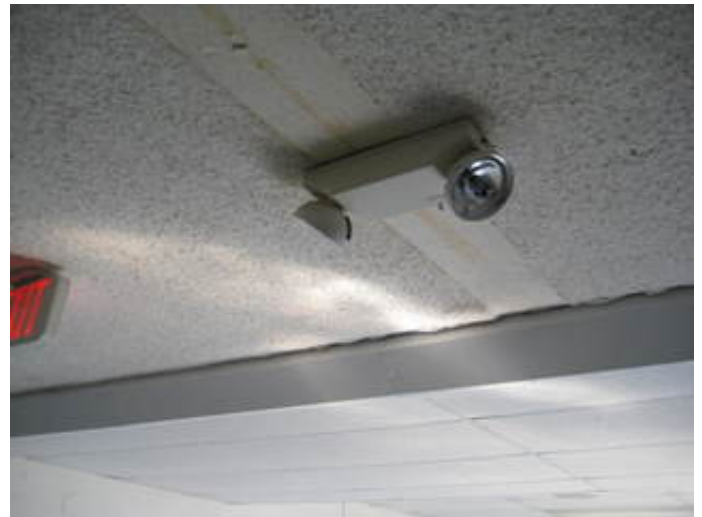
Emergency Egress Light Fixture

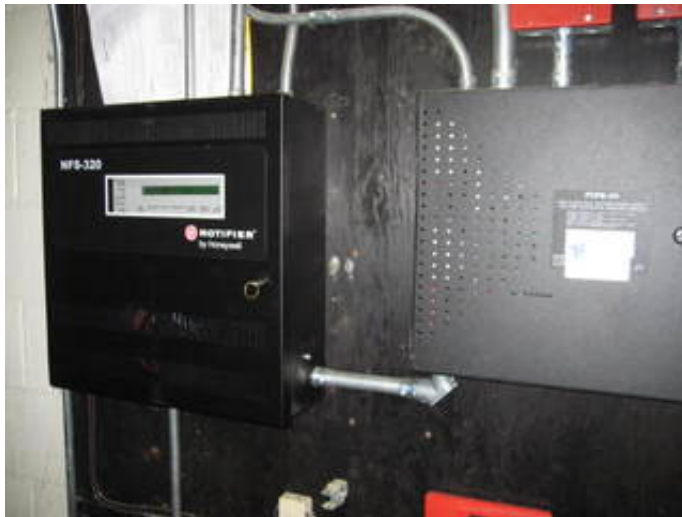
Fire Alarm System Control Panel

**Recommendations:** Provide complete replacement of fire alarm system to meet OBC, NFPA, and Ohio School Design Manual guidelines.

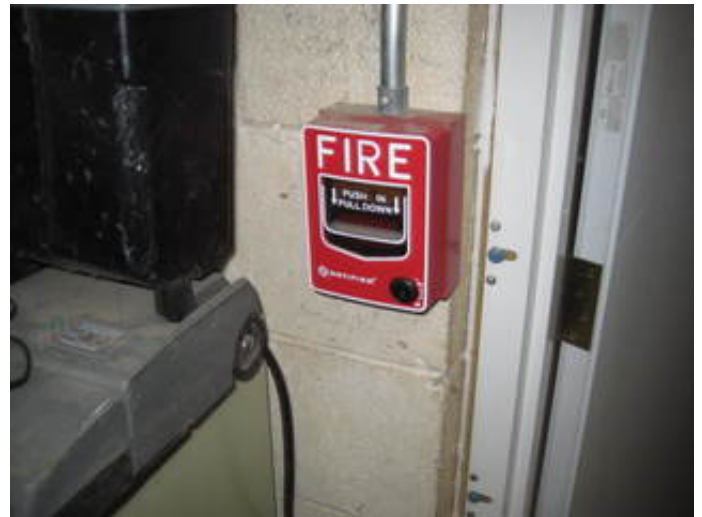
Fire Alarm System Manual Pull Station

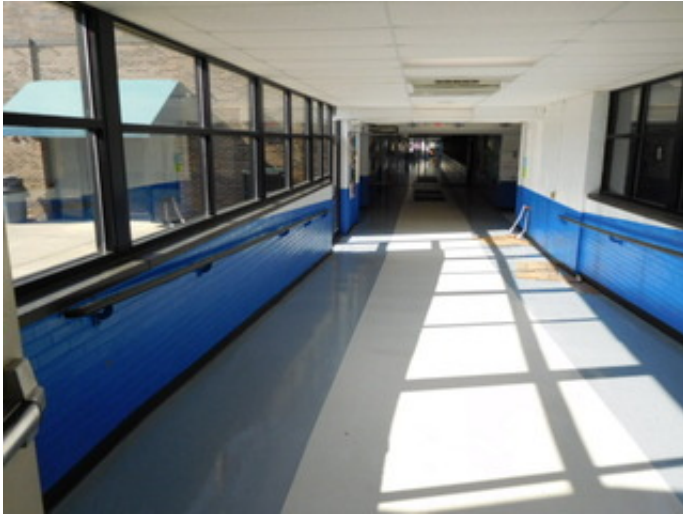
ADA Compliant Ramp

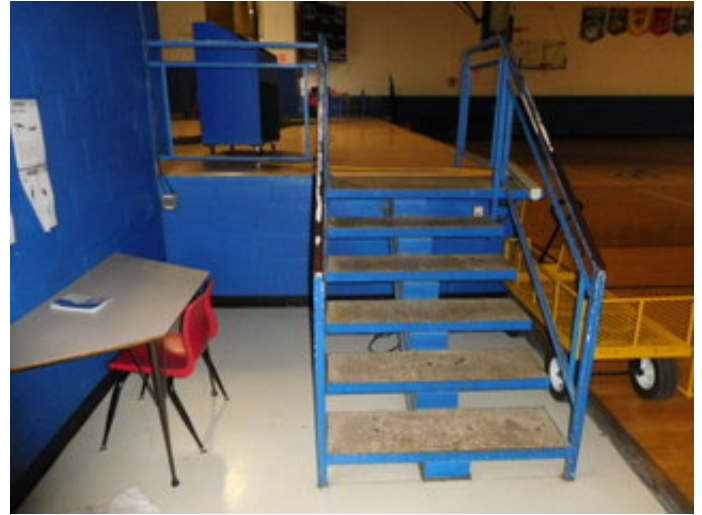
Non-ADA Compliant Stage Access

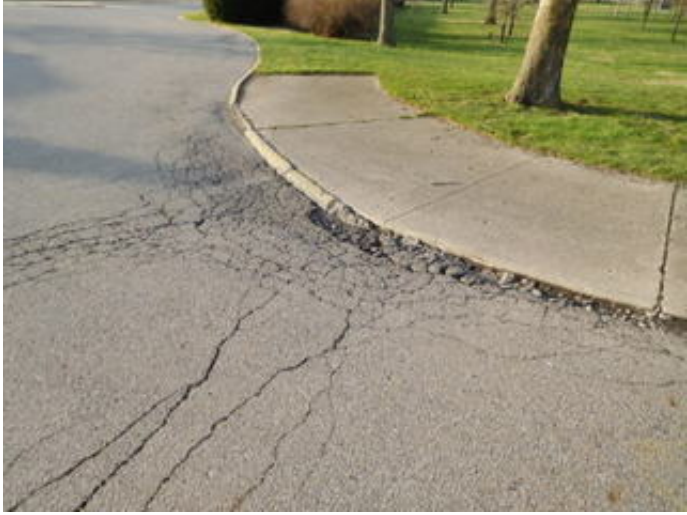
Asphalt, Curb, and Sidewalk Condition

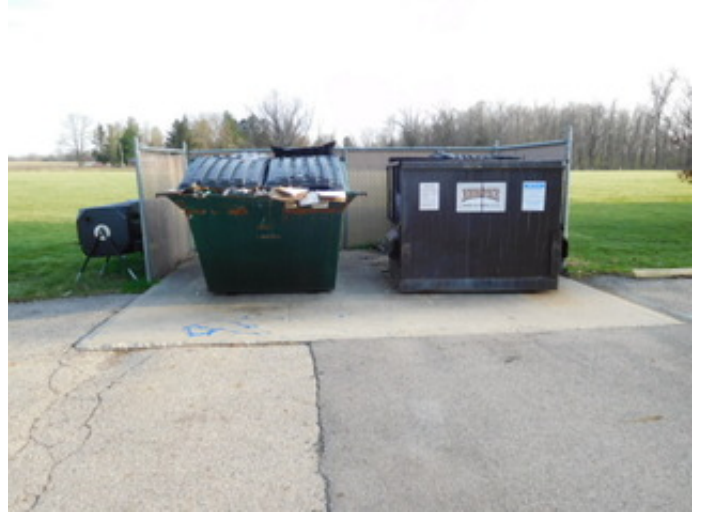
Concrete Dumpster Pad

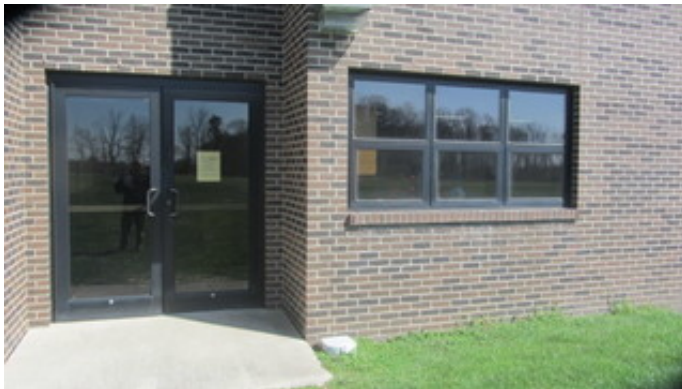
2002 Addition Exterior Door and Window

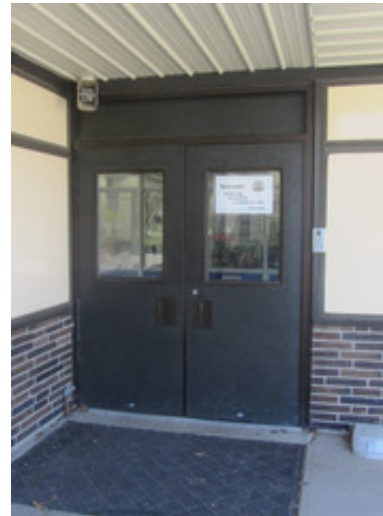
1963 Original Construction Main Entry Doors

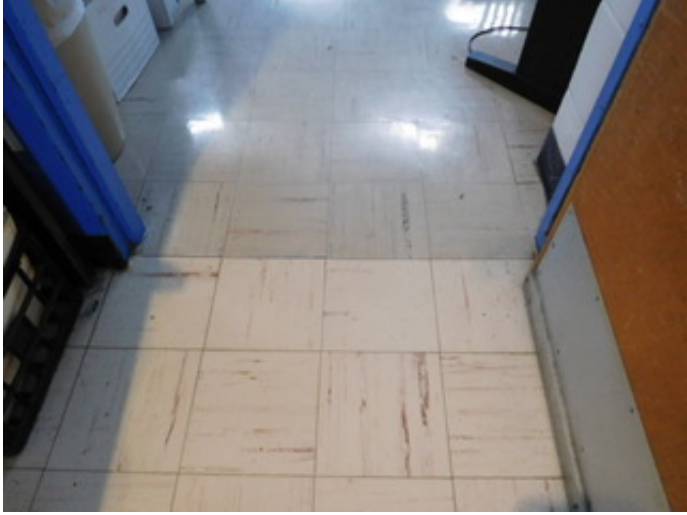
VAT Flooring

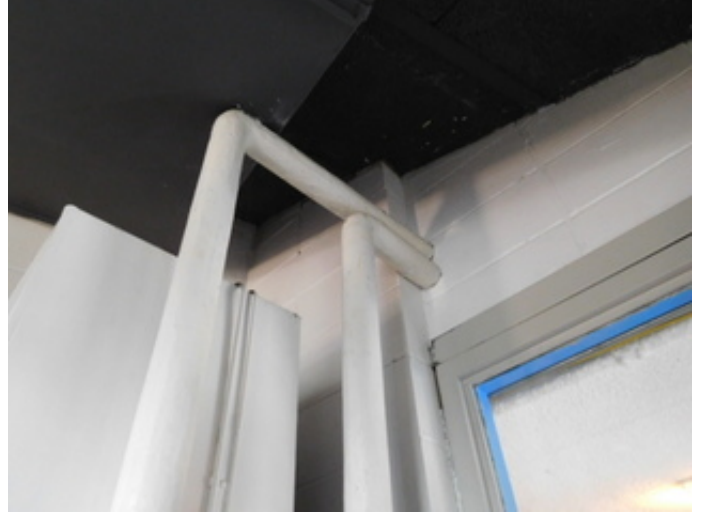
Pipe Insulation

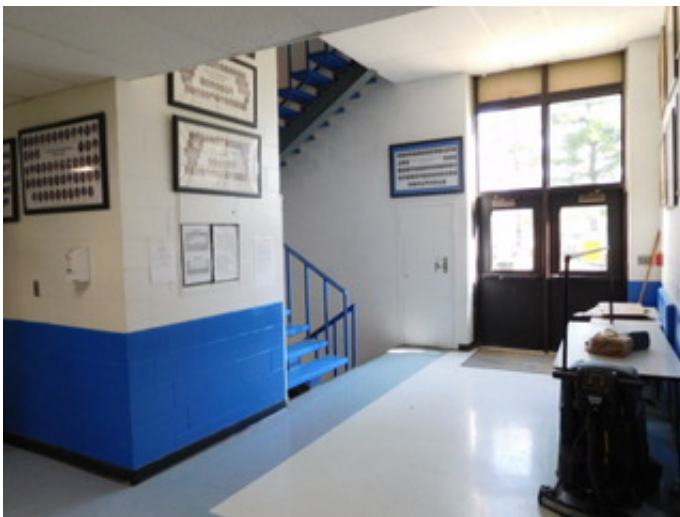
Existing Stair Tower with fire alarm No 2 hour Enclosure

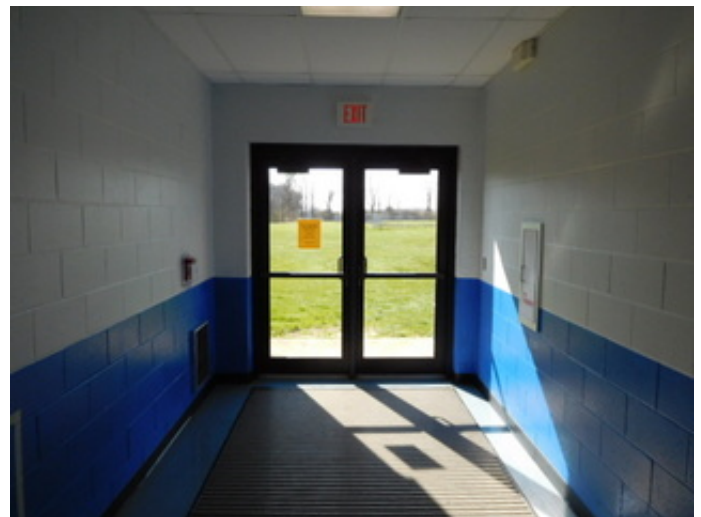
Typical Exit with Exit Signage, Fire Extinguisher, and Pull Station
