Building Information - Yellow Springs Exempted Village (45674) - Mills Lawn Elementary / Middle School

Building Pictures - Yellow Springs Exempted Village(45674) - Mills Lawn Elementary / Middle School (24919)

GENERAL DESCRIPTION

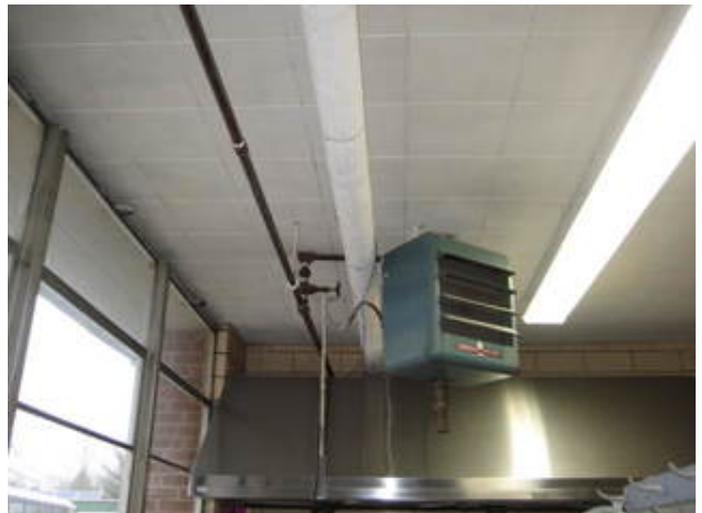
Description: The existing system for the 1952 Original Construction is a natural gas fired heated water boiler type system, installed in 1952, and is in fair condition. The system in the 1957 Addition is an extension of that found in the 1952 Original Construction. The existing system for the 2002 Addition is a natural gas fired packaged roof top unit type system, installed in 2002, and is in fair condition. 2-pipe vs. 4-pipe designations are not applicable in this facility, as no central air conditioning is provided. The 1952 Original Construction is equipped with (2) Copper-fin II boilers, manufactured by Lochinvar, are believed to be installed in 1998, and are in fair condition. Heating water is distributed to terminal units consisting of unit ventilators, cabinet heaters, unit heaters, fin tubes, air handlers, and roof top units. The 2002 Addition is equipped with (2) ducted packaged roof top units (with DX cooling and natural gas/hot water heat), manufactured by York, were installed in 2002, and are in fair condition. Heated air is distributed to terminal units consisting of multiple VAV boxes. All terminal equipment is original to each addition and is in fair condition. The system does not appear to comply with the 15 CFM per person fresh air requirements of the Ohio Building Code mechanical code and Ohio School Design Manual. The pneumatic, digital, and DDC type system temperature controls are original to each addition, with incremental upgrades, and are in fair to poor condition. The system does not feature individual temperature controls in all spaces required by the OSDM. The overall system does not feature any central energy recovery systems. The 1952 Original Construction is not equipped with widespread louvered interior doors to facilitate Corridor utilization as return air plenums. The remainder of the overall facility is not equipped with louvered interiors doors. The existing system is ducted in the 2002 Addition and a portion of the 1952 Original Construction and 1957 Addition, but the ductwork cannot be integrated into a possible future system due to arrangement, air volume, and routing of existing ductwork. The existing system is not ducted in the remainder of the overall facility, and floor to structural deck heights will accommodate the installation of properly sized ductwork for a future Ohio School Design Manual approved system. The overall heating system is evaluated as not being in safe and efficient working order, and long term life expectancy of the existing system is not anticipated. The structure is not equipped with central air conditioning. The site does not contain underground fuel tanks.

Rating: 3 Needs Replacement

Natural Gas Fired Heated Water Boilers

Unit Heater

Recommendations: Provide new overall heating, ventilating, and air conditioning system to achieve compliance with Ohio Building Code and Ohio School Design Manual standards. Replace existing ductwork in the 2002 Addition and a portion of the 1952 Original Construction and 1957 Addition to facilitate efficient exchange of conditioned air. Convert to ducted system the remainder of the overall facility to facilitate efficient exchange of conditioned air.

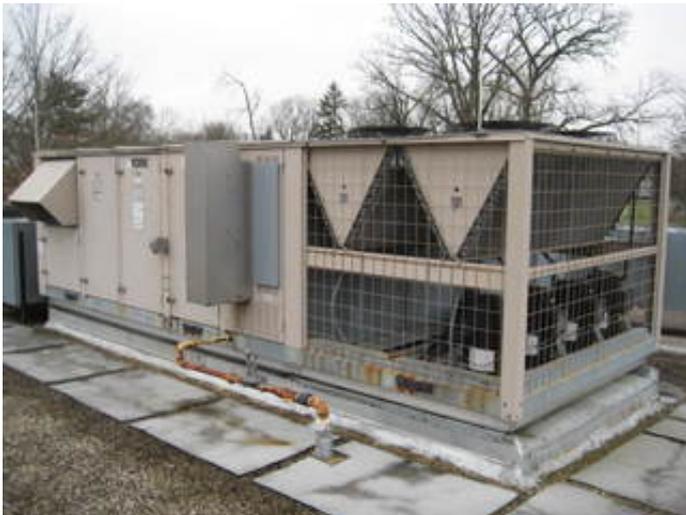
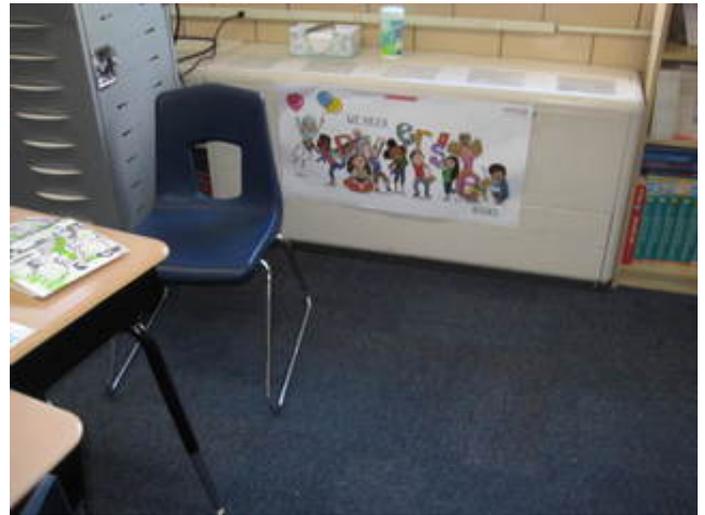
Description: The overall facility is not equipped with a central air conditioning system. Window units are provided at multiple Classroom locations throughout the overall facility, as well as in the Teacher's Lounge. An isolated room system consisting of ductless split AC wall cassettes with (2) condensing units (pad mounted and located on the exterior) is provided in the Administrative Offices in the 1952 Original Construction. An isolated room system consisting of a single ducted HVAC/furnace type unit and (1) condensing unit (pad mounted and located on the exterior) is provided in the Administrative Office Conference Room of the 2002 Addition. An isolated room system consisting of (2) ducted packaged air cooled York roof top units (with DX cooling and natural gas/hot water heat) is provided in the majority of the 2002 Addition and the Multi-Purpose Room (Gymnasium/Student Dining) and Media Center of the 1952 Original Construction. The ventilation system in the overall facility consists of unit ventilators and roof top units, original to each addition and in fair condition, providing fresh air to Classrooms, and air handlers and roof top units, original to each addition and in fair condition, providing fresh air to other miscellaneous spaces such as Multi-Purpose Room (Gymnasium/Student Dining) and Media Center. Relief air venting is provided by louvered interior doors, ceiling plenums / being ducted back through energy recovery units, central relief fans, air handlers, and roof top units. The ventilation system does not meet the Ohio Building Code 15 CFM per occupant fresh air requirement. The overall system is not compliant with Ohio Building Code and Ohio School Design Manual requirements. Dust collection systems are not required in this facility though no system is provided. The Art program is equipped with a kiln, and existing kiln ventilation is inadequate, and in fair condition. General building exhaust systems for Restrooms, Storage Rooms, Art Rooms, and Custodial Closets are inadequately placed, and in fair condition.

Rating: 2 Needs Repair

Roof Top Unit

Unit Ventilator

Recommendations: Provide an air conditioning system to meet with Ohio Building Code and Ohio School Design Manual requirements. Replace general building exhaust systems located in Restrooms, Storage Rooms, and Custodial Closets. Pricing included in Item A. Replace the existing Art Program's kiln ventilation system due to age, condition, and lack of OSDM compliance.

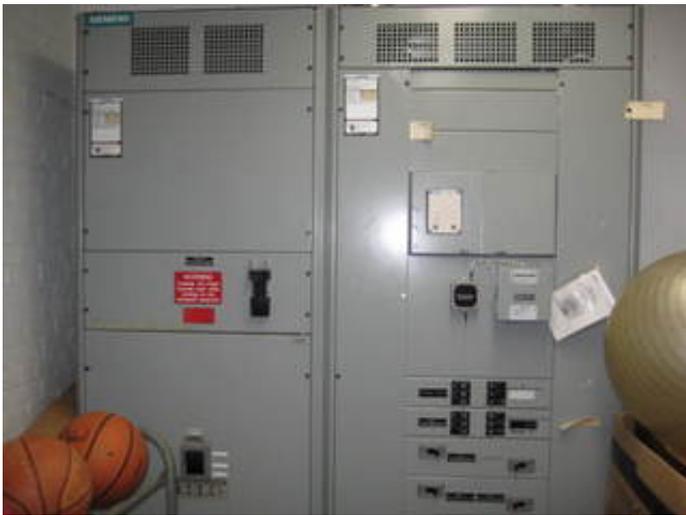
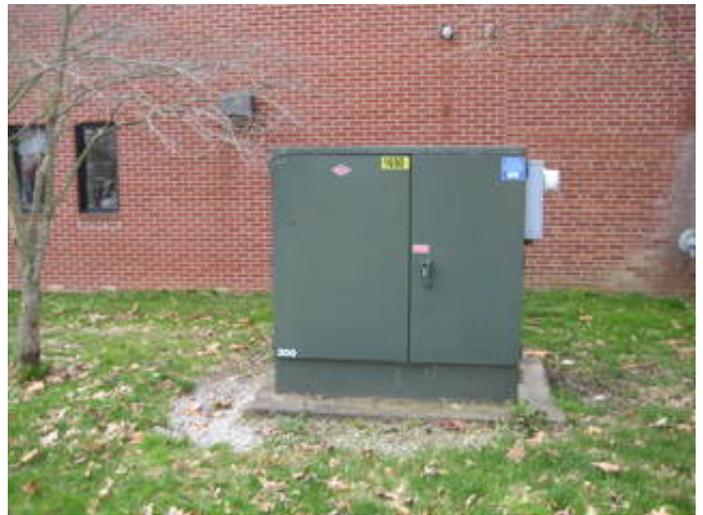
Description: The electrical system provided to the 2002 Addition is a 208Y/120 volts, 1,200 amp, 3 phase and 4 wire system installed in 2002, and is in good to fair condition. The systems in the 1952 Original Construction and 1957 Addition are an extension of that found in the 2002 Addition. Power is provided to the school by a single utility owned, pad-mounted transformer located at the front of the School, and in fair condition. The panel systems are original to each Addition, are in fair condition, and for the most part cannot be expanded to add additional capacity. The Classrooms are not equipped with adequate electrical outlets. The typical Classroom contains (5) general purpose outlets, (0) dedicated outlets for each Classroom computer, and (1) dedicated outlet for each Classroom television/ceiling mounted projector. Some Classrooms are equipped with as many as (6) general purpose outlets, while others are equipped with as few as (3) general purpose outlets. There are not any spaces that have no electrical outlets. The Corridors are equipped with adequate electrical outlets for servicing. Adequate GFI protected exterior outlets are not provided around the perimeter of the building. The facility is not equipped with an emergency generator. Adequate lightning protection safeguards appear to be provided and are in fair condition. Stage lighting power system including control panel, breakers, and dimmers is inadequately provided, in fair condition and does not meet OSDM requirements. The overall electrical system does not fully meet Ohio School Design Manual requirements in supporting the current needs of the school, and will be inadequate to meet the facility's future needs.

Rating: 3 Needs Replacement

Main Electrical Distribution Panel

Pad Mounted Transformer

Recommendations: The entire electrical system requires replacement to meet Ohio School Design Manual guidelines for overall capacity due to age, condition, lack of OSDM-required features, and to accommodate the addition of an air conditioning system. Provide an emergency generator, with funding included in the electrical system replacement. Replace the existing lightning protection safeguards in the overall facility, including associated grounding system, with funding included in the electrical system replacement.

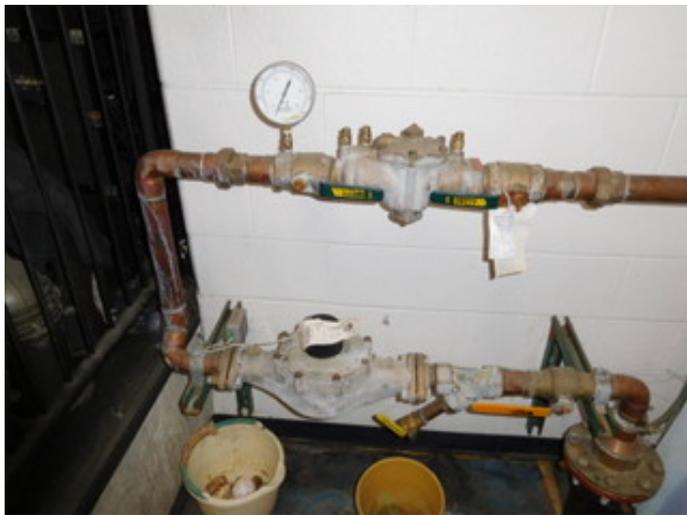
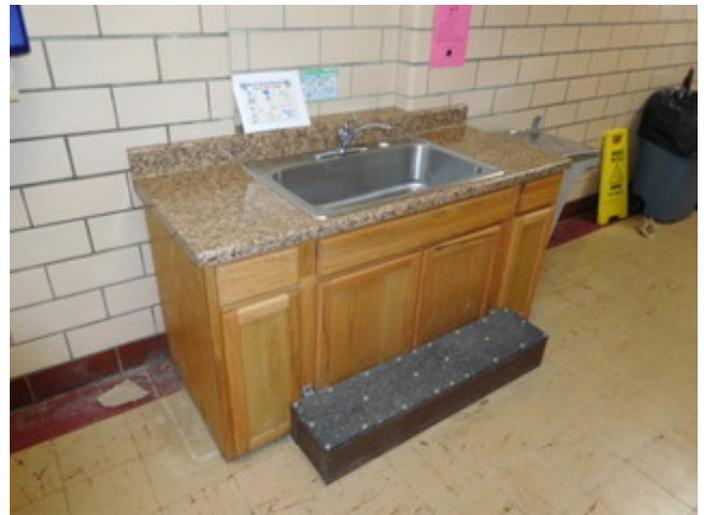
Description:	<p>The service entrance is equipped with a reduced pressure back flow preventer in fair condition. A water treatment system is not provided, though none is needed. The domestic water supply piping in the overall facility is copper and galvanized, is original to each addition, and is in fair condition. The waste piping in the overall facility is cast iron and galvanized, is original to each addition, and is in fair condition. The facility is equipped with a 71 gallon gas water heater in good condition. The school contains 2 Large Group Restrooms for boys, 2 Large Group Restrooms for girls, 0 Locker Room Restrooms for boys, 0 Locker Room Restrooms for girls, 3 Restrooms associated with specialty Classrooms, 8 Restrooms for Individual Classrooms, and 5 Restrooms for staff. Boys' Large Group Restrooms contain 2 ADA and 1 non-ADA wall mounted flush valve toilets, 6 ADA and 1 non-ADA wall mounted flush valve and waterless urinals, as well as 2 ADA wall mounted lavatories and 2 non-ADA countertop lavatories. Girls' Large Group Restrooms contain 2 ADA and 6 non-ADA wall mounted flush valve toilets, as well as 2 ADA wall mounted lavatories and 2 non-ADA countertop lavatories. Individual Classroom Restrooms contain 2 ADA and 7 non-ADA wall and floor mounted flush valve toilets, 2 ADA wall mounted urinals, as well as 3 ADA and 4 non-ADA countertop and wall mounted lavatories. Staff Restrooms contain 2 ADA and 2 non-ADA wall mounted flush valve toilets, 1 non-ADA floor mounted tank type toilet, as well as 2 ADA and 3 non-ADA wall mounted lavatories. Condition of fixtures is good to fair. The facility is equipped with 2 ADA and 4 non-ADA electric water coolers, in good to fair condition. The 22 Elementary Classrooms are not equipped with sink mounted type drinking fountains. Special Education Classroom is equipped with the required Restroom facilities, and fixtures are in good to fair condition. Kitchen is equipped with the required Restroom, and fixtures are in fair to poor condition. Heath Clinic is equipped with the required Restroom, and fixtures are in fair to poor condition. Kindergarten / Pre-K Classrooms are equipped with Restroom facilities, and fixtures are in poor condition. Kitchen fixtures consist of 1 single compartment sink, 1 double compartment sink, and 1 triple compartment sink, which are all in fair condition. The Kitchen is not equipped with a grease interceptor. The Kitchen is provided the required 140 degree hot water supply. The school does not full meet the OBC requirements for fixtures. Relative to LEED requirements, the school is not equipped with low flow type fixtures, but is equipped with waterless urinals. Per OBC and OSDM requirements this facility should be equipped with 6 toilets, 2 urinals, 8 lavatories, 22 Classroom sink mounted drinking fountains, and 4 electric water coolers. Observations revealed that the school is currently equipped with 30 toilets, 9 urinals, 26 lavatories, 5 Classroom sink mounted drinking fountains, and 6 electric water coolers. ADA requirements are not met for fixtures and drinking fountains see Item O. Custodial Closets are properly located and are adequately provided with required service sinks or floor drain sinks, which are in fair to poor condition. Science Classrooms are not equipped with required utility sink, gas / compressed air connections, and safety shower / eyewash. Due to existing grade configuration, no Biology or Chemistry Classroom acid waste systems are required. Adequate exterior wall hydrants are not provided.</p>

Incoming Domestic Water Service Backflow Preventer

Classroom Sink

Rating:	3 Needs Replacement
Recommendations:	<p>Due to age, condition, LEED, and OBC and OSFC requirements, provide 23 new toilets, 21 new lavatories, 3 new electric water coolers, 22 new lavatory mounted type drinking fountains. Replace water supply and sanitary waste piping in the 1952 Original Construction and the 1957 Addition due to age and condition. Replace reduced pressure back flow preventer due to age and condition. Provide for the replacement and addition of exterior hose bibs to meet OSDM Standards. Provide funding for a new grease trap in the kitchen. Provide funding for a new grease interceptor in the art classroom. See Item J for replacement of kitchen fixtures. See Item O for replacement of fixtures related to ADA requirements. Provide the Science Classroom with the required utility sink, gas connections, compressed air connections, and safety shower / eyewash stations. Provide required sink mounted type drinking fountains in Elementary Classroom spaces.</p>

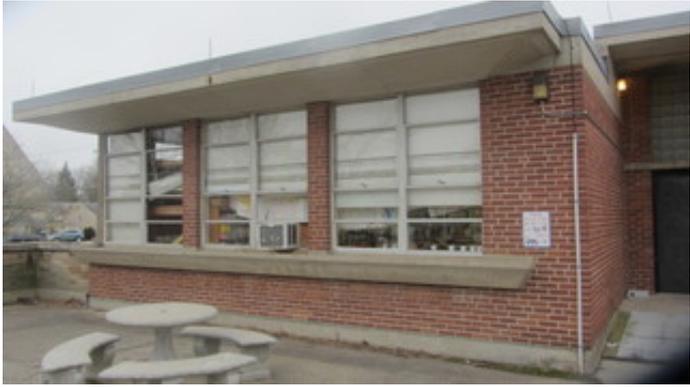
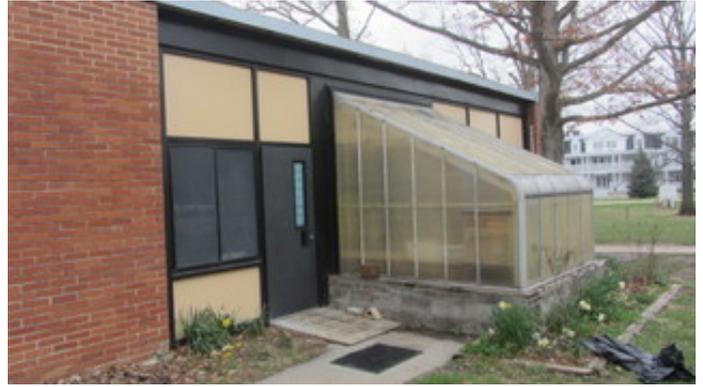
Description: The 1952 Original Construction is equipped with an aluminum frame window with single glazed type window system, which was installed in 1952, and is in poor condition. The window system features operable windows throughout most portions of the building, and operable windows are equipped with opening limiters in poor condition and insect screens where provided in fair to poor condition. Window system seals are in poor condition, with frequent air and water infiltration being experienced. Window system hardware is in poor condition. The 1957 Addition is equipped with an aluminum frame window with double glazed insulated glazing and insulated panel type window system, and is in fair condition. Date of installation was not available. The window system features operable windows throughout most portions of the building, and operable windows are equipped with opening limiters in fair condition and insect screens where provided in fair condition. Window system seals are in fair condition. The District reported that moderate air and water infiltration is being experienced. Window system hardware is in fair condition. The 2002 Addition is equipped with thermally broken aluminum frame windows with double glazed insulated glazing type window system, which was installed in 2002, and is in good condition. The window system features operable and inoperable windows throughout the building, and operable windows are equipped with opening limiters in good condition and insect screens in good condition. Window system seals are in good condition, with no air and water infiltration being experienced. Window system hardware is in good condition. The window systems in the overall facility feature surface mounted shades, which are in fair condition. The window system in the 2002 Conference Room Addition feature surface mounted vertical blinds in fair condition. This facility is not equipped with any curtain wall systems. There are glass block windows in the 1952 Original Construction, in fair condition. The exterior doors in the 1952 Original Construction are equipped with aluminum frame transoms with insulated FRP panels, in good to fair condition and wood frame transoms with single pane glazing in poor condition. Exterior door vision panels in the FRP doors are tempered double glazed insulated glazing in good to fair condition. Exterior door vision panels in the wood doors are single pane wire glazing in poor condition. The exterior doors in the 1957 Addition are equipped with aluminum frame sidelights and transoms with tempered double glazed insulated glazing and insulated metal panels in good to fair condition. Exterior door vision panels are tempered double glazed insulated glazing, in good to fair condition. The exterior doors in the 2002 Addition are equipped with aluminum frame sidelights and transoms with tempered double glazed insulated glazing, in good condition. Exterior door vision panels are tempered single pane glazing. The school does contain 2 skylights which are equipped with aluminum frames and insulated fiberglass panels, in good condition. The school does not contain any clerestories. Interior glass is OSDM-compliant. Window security grilles are not provided for ground floor windows. There is a 94 SF Greenhouse in the 1957 Addition, and it is in poor condition.

Rating: 3 Needs Replacement

1952 Original Construction Typical Classroom Windows

1957 Addition Typical Window System and Greenhouse

Recommendations: Replace the existing non-insulated window system with a new insulated window system with integral blinds to meet with Ohio School Design Manual requirements in the 1952 Original Construction. Replace the existing glass block with a new insulated window system with integral blinds to meet with Ohio School Design Manual requirements in the 1952 Original Construction. Replace the existing insulated window system in the 1957 Addition due to condition with a new insulated window system with integral blinds to meet with Ohio School Design Manual requirements. Replace the existing insulated panel system in the 1957 Addition due to condition with a new insulated panel system. Replace non-insulated glazing in transoms and sidelights at exterior doors in the 1952 Original Construction and 1957 Addition. Replace existing greenhouse in the 1957 Addition due to condition. Replace single glazed door vision panels in the 2002 Addition. Replace blinds in the 2002 Addition.

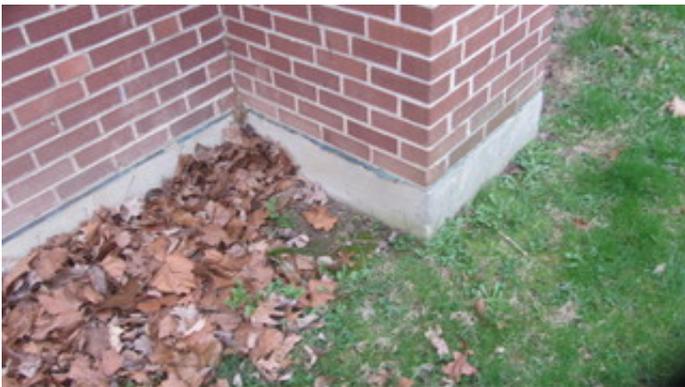
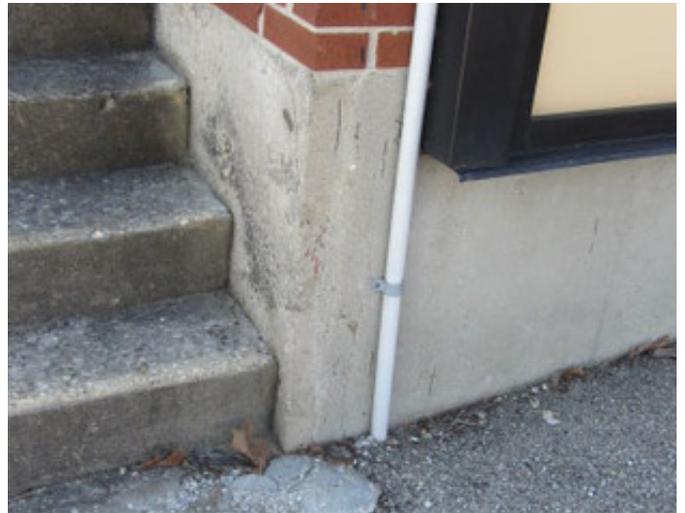
Description: The overall facility is equipped with concrete foundation walls on concrete spread footings, which displayed no locations of significant differential settlement, cracking, or leaking, and are in good to fair condition. Areas of minor cracking and spalling were observed through the overall facility. The District reports that there has been no past leaking due to foundation issues. No grading or site drainage deficiencies were noted around the perimeter of the structure that are contributing or could contribute to foundation or wall structural deterioration.

Rating: 2 Needs Repair

Typical 1952 Original Construction Exposed Foundation

1957 Addition Exposed Concrete Foundation

Recommendations: Repair areas of cracking and spalling through the overall facility.

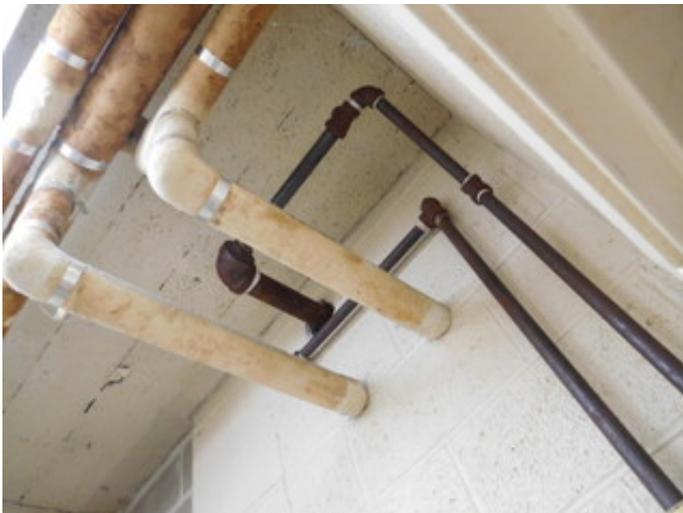
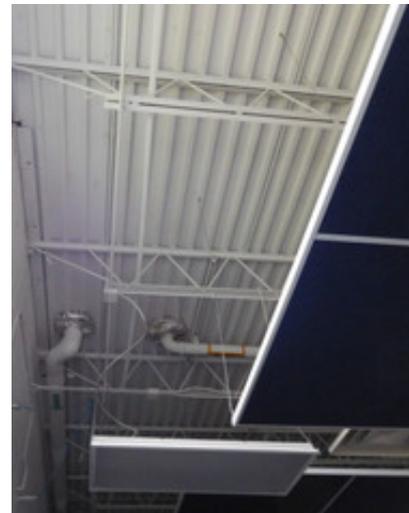
Description: The floor construction of the base floor of the overall facility is concrete slab on grade type construction, and is in good condition. There are no crawl spaces. There is a utility tunnel in the 1957 Addition. The intermediate floor system in the 1957 and 2002 Addition is metal form deck on steel joist type construction, and is in good condition. Ceiling to structural deck spaces are sufficient to accommodate HVAC, electrical, and plumbing scopes of work in required renovations. The roof construction of the 1952 Original Construction is cast-in-place concrete type construction, and is in good condition. The roof construction of the 1957 Addition is tectum on steel joist type construction, and is in good condition. The roof construction of the 2002 Addition is metal form deck on steel joist type construction, and is in good condition.

1952 Original Construction Typical Roof Construction

2002 Addition Typical Roof Construction

Recommendations: Refer to Item A for funding of architectural soffits to accommodate HVAC, electrical, and plumbing scopes of work. Existing conditions require no renovation or replacement at the present time.

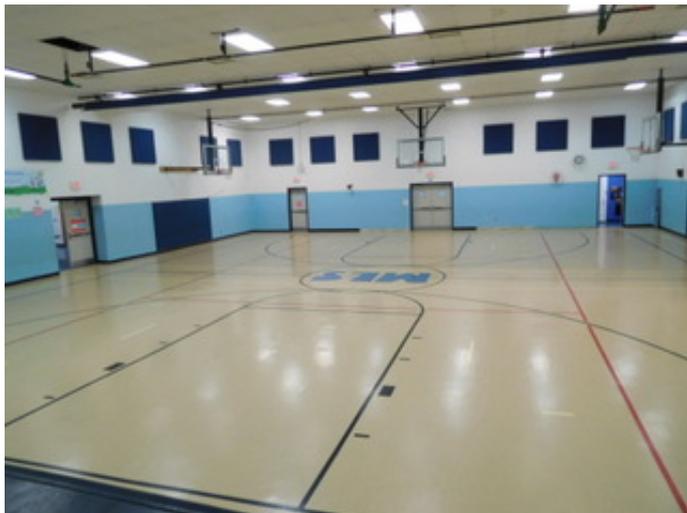
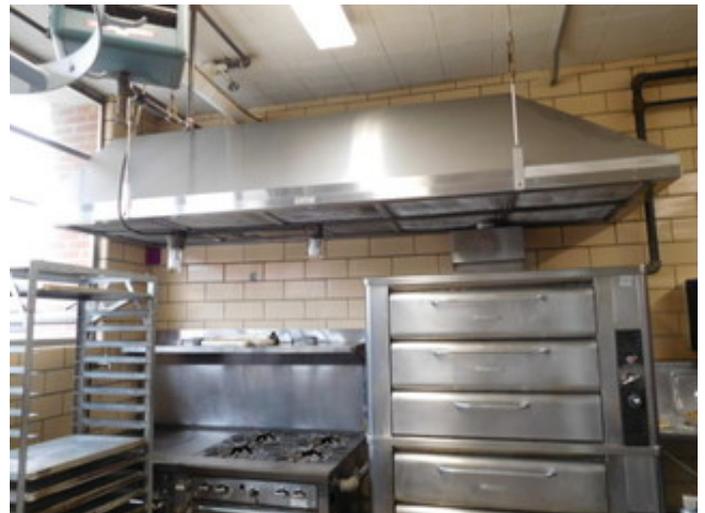
Gymnasium Finishes

Kitchen Hood

Rating:	3 Needs Replacement
Recommendations:	<p>Provide complete replacement of finishes and casework due to condition and installation of systems outlined in Items A, C, D, E, I, K, L, M, N, T, U, and W. Provide for the replacement of toilet partitions due to age and condition. Provide for the replacement of toilet accessories. Provide for replacement of interior doors in the 1952 Original Construction and 1957 Addition due to age and condition. Provide for the replacement of interior fire doors as noted in the School District provided AHERA reports, with abatement included in Item T. Provide for terrazzo floor repair due to condition. Provide for gymnasium bleachers. Provide for the replacement of the Art program kiln due to condition, with funding for exhaust system provided in Item C. Provide for additional wall insulation in the 1952 Original Construction and 1957 Addition. Provide for the replacement of a walk-in cooler and freezer due to age and condition. Provide for the replacement of the kitchen hood due to age and condition. Provide for the complete replacement of Kitchen equipment due to age and condition. Provide for Stage equipment allowances due to age and condition. Provide for appropriate sound attenuation acoustical surface treatments in the Media Center. Provide for the replacement of hard plaster, gypsum board, acoustical ceiling tile, and window panels due to work in Item T. Funding for the replacement of resilient flooring due to work in Item T is provided for in Complete Replacement of Finishes.</p>

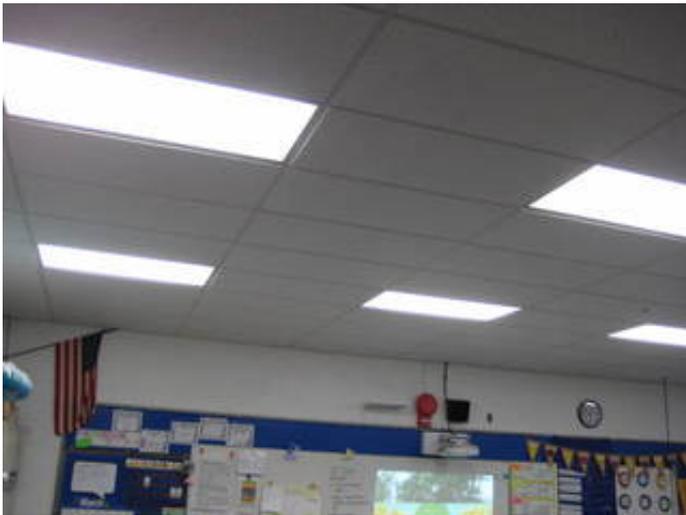
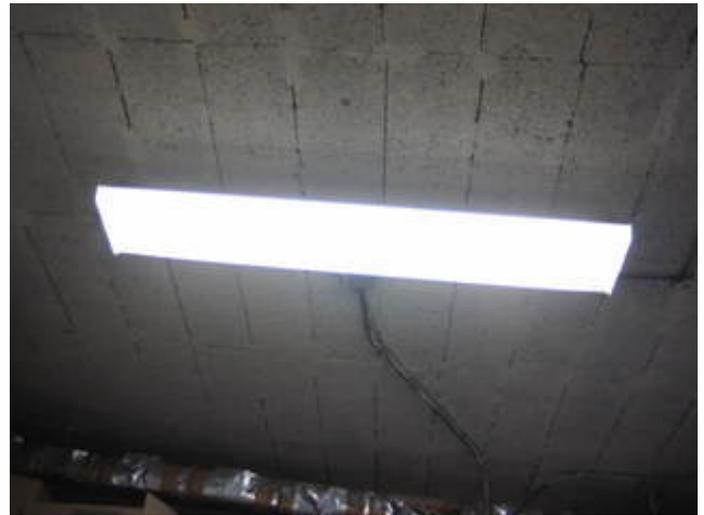
Rating: 3 Needs Replacement

Typical Fluorescent Classroom Light Fixtures

Service Area Fluorescent Light Fixture

Recommendations: Provide complete replacement of lighting system due to age, condition, lighting levels, utilization of incandescent fixtures, lack of multilevel switching, and installation of systems outlined in Items A, C, J, and U.

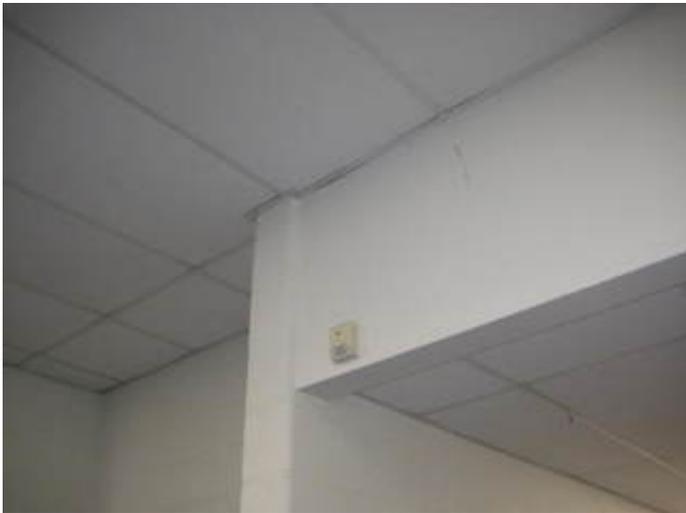
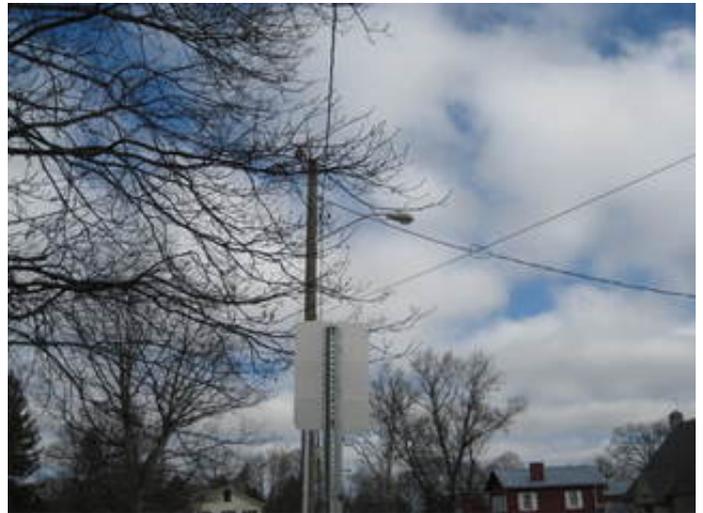
Rating: 3 Needs Replacement

Security System Motion Detection Device

Pole Mounted HID Exterior Light Fixture

Recommendations: Provide complete replacement of security system to meet Ohio School Design Manual guidelines. Provide complete replacement of exterior site lighting system to meet Ohio School Design Manual guidelines. Provide OSDM-compliant playground fencing, funding included in complete replacement of security system. Provide a secure entrance Vestibule between the main entry area and Administrative Offices.

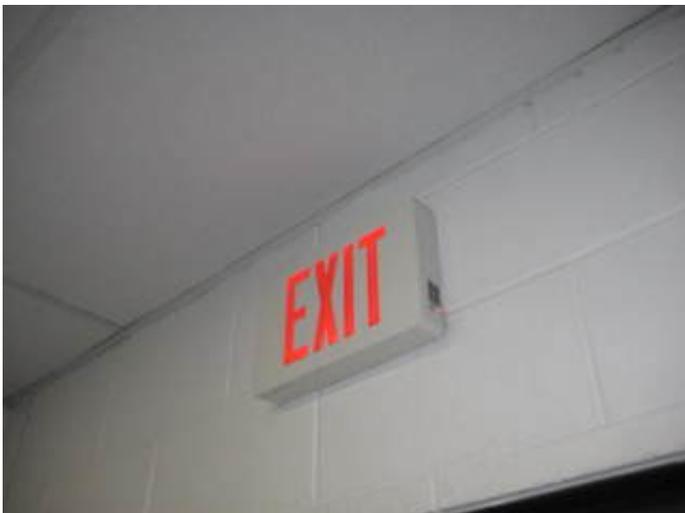
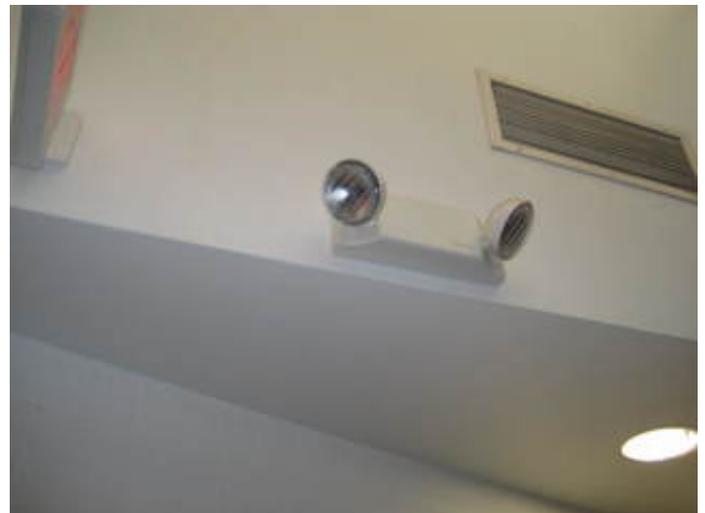
Rating: 3 Needs Replacement

Exit Sign

Emergency Egress Light Fixture

Recommendations: Provide complete replacement of emergency / egress lighting system to meet Ohio School Design Manual and Ohio Building Code guidelines.

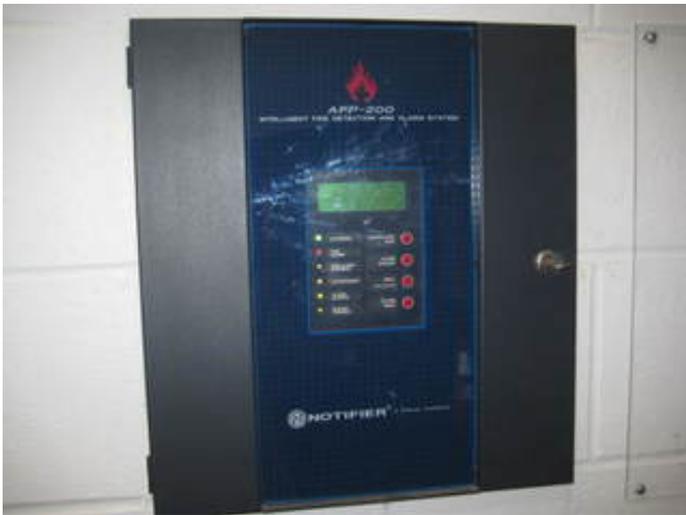
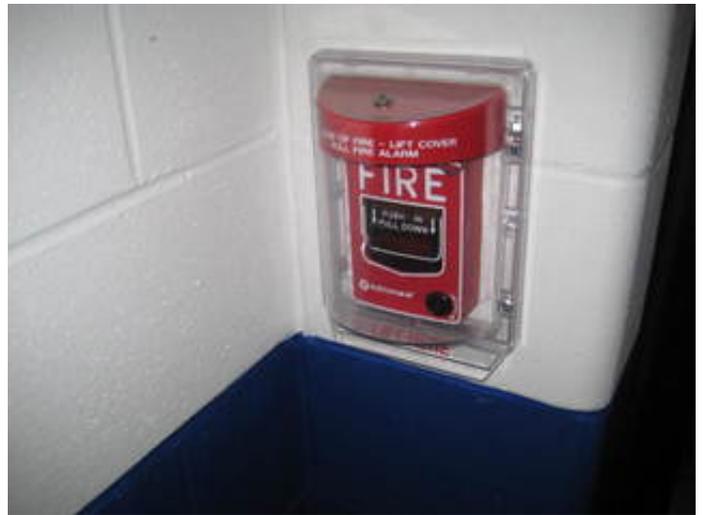
Fire Alarm System Control Panel

2002 Addition Fire Alarm System Manual Pull Station

Recommendations: Provide complete replacement of fire alarm system to meet OBC, NFPA, and Ohio School Design Manual guidelines.

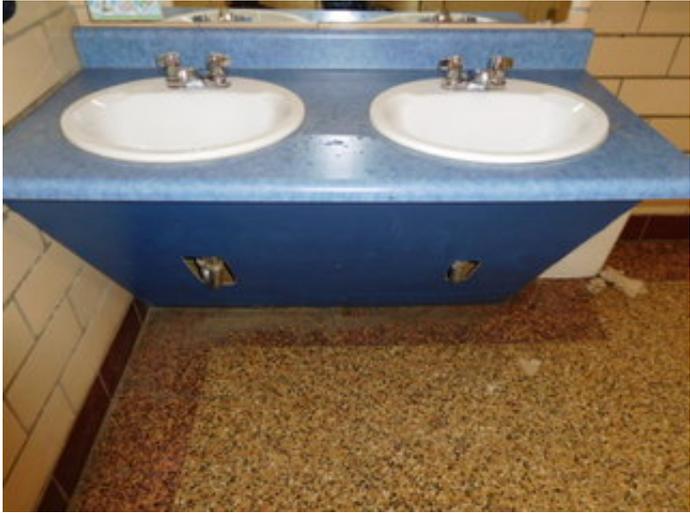
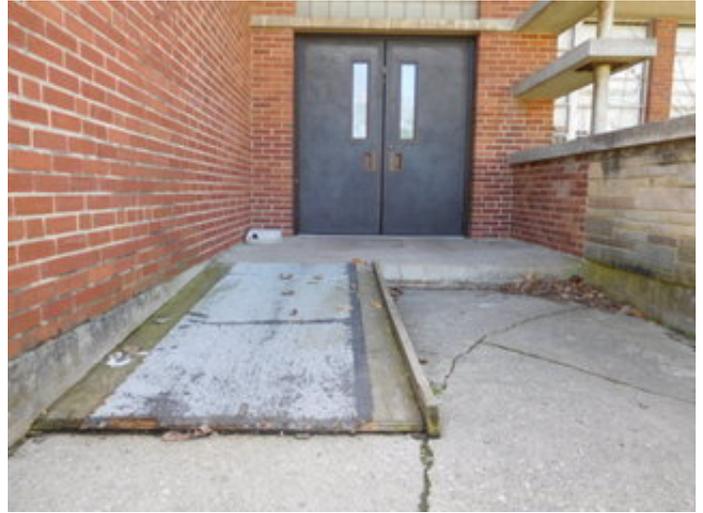
Typical Restroom Lavatory

ADA Access Ramp

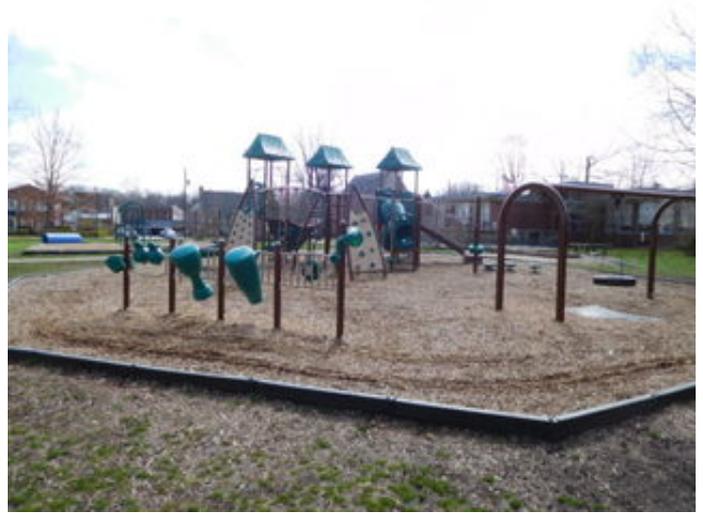
Asphalt Condition

Typical Playground Equipment

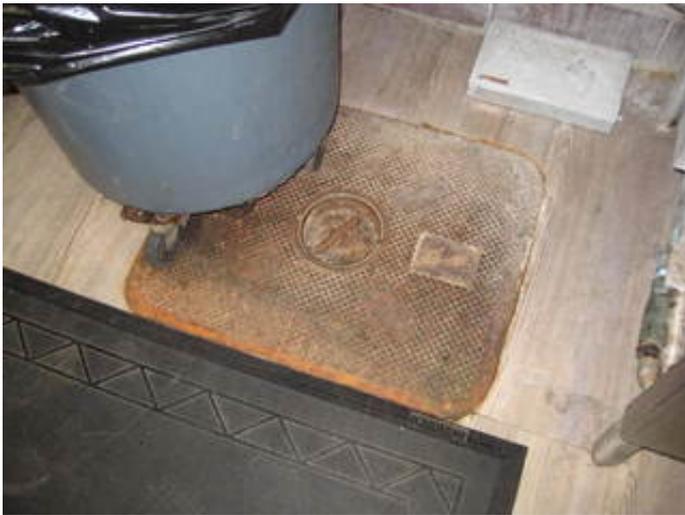
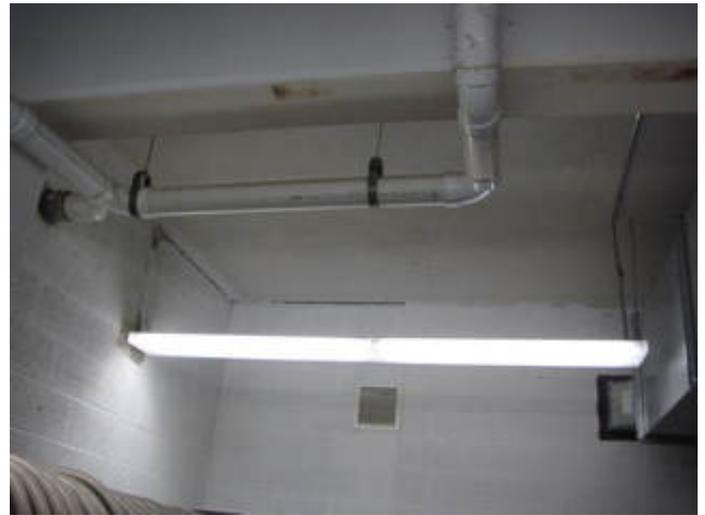
Kitchen Grease Trap Interceptor

Sanitary Waste Piping

Recommendations: Existing conditions require no renovation or replacement at the present time.

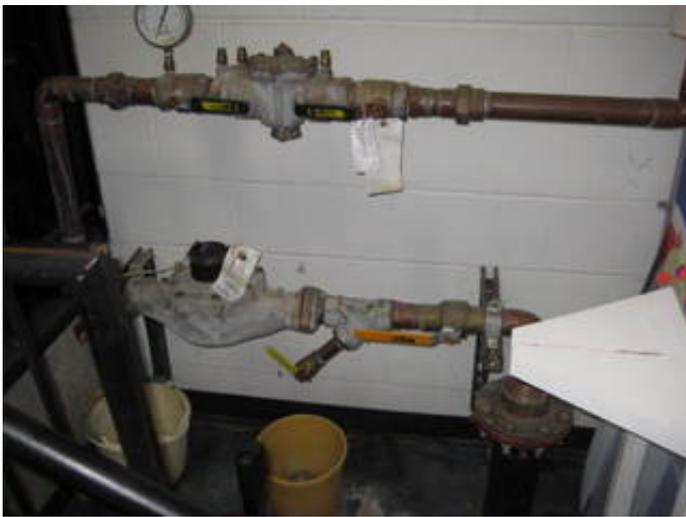
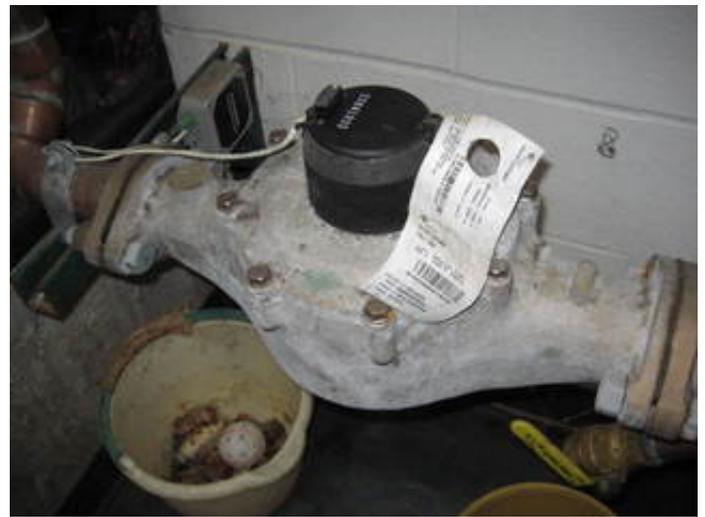
Incoming Domestic Water Service Line

Incoming Domestic Water Meter

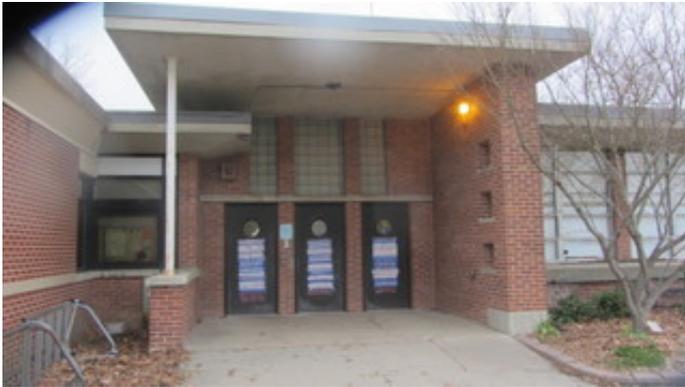
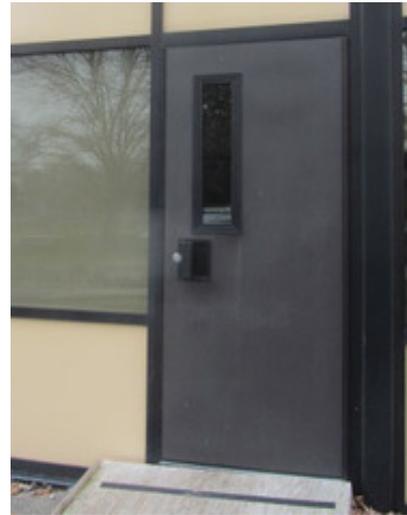
1952 Original Construction Main Entry Doors

1957 Addition Typical Classroom Door

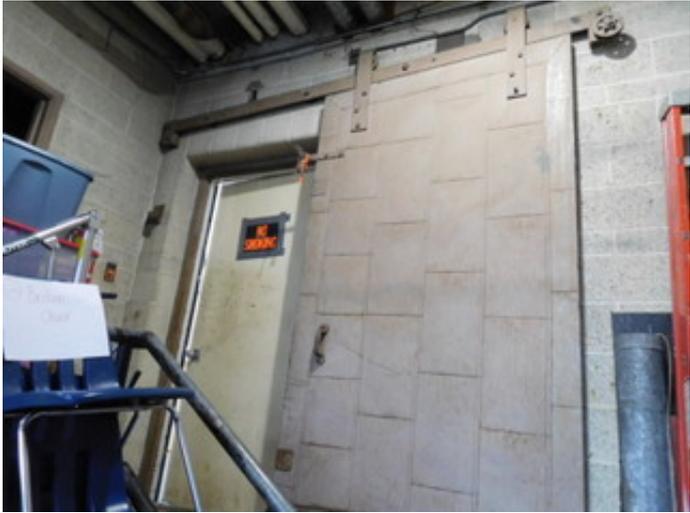
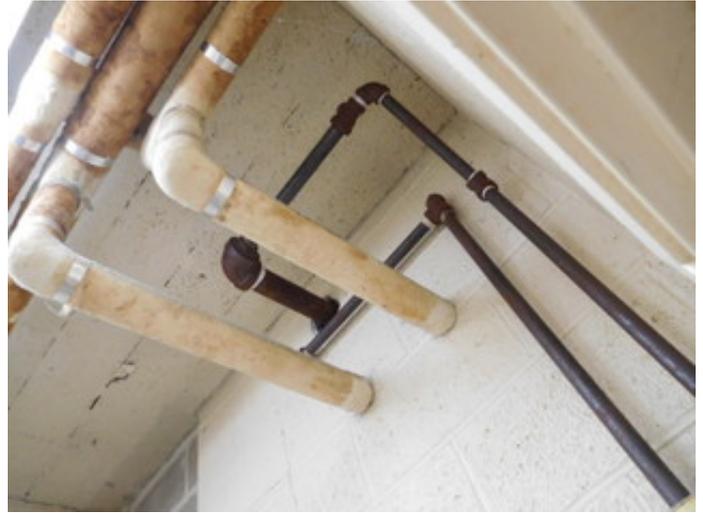
Fire Door

Pipe Insulation

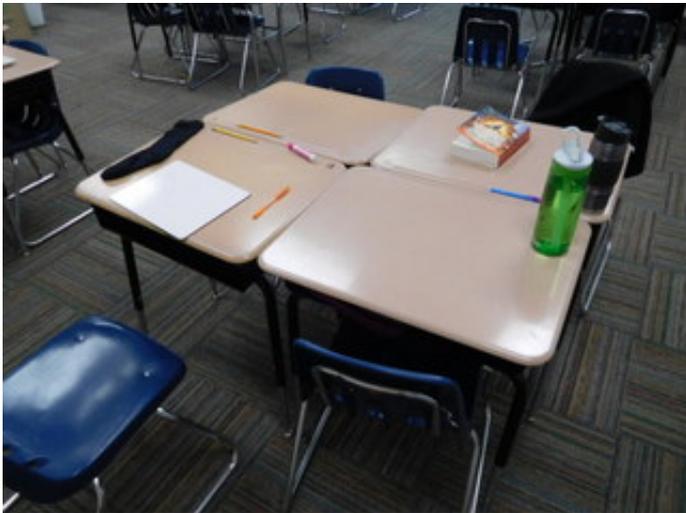
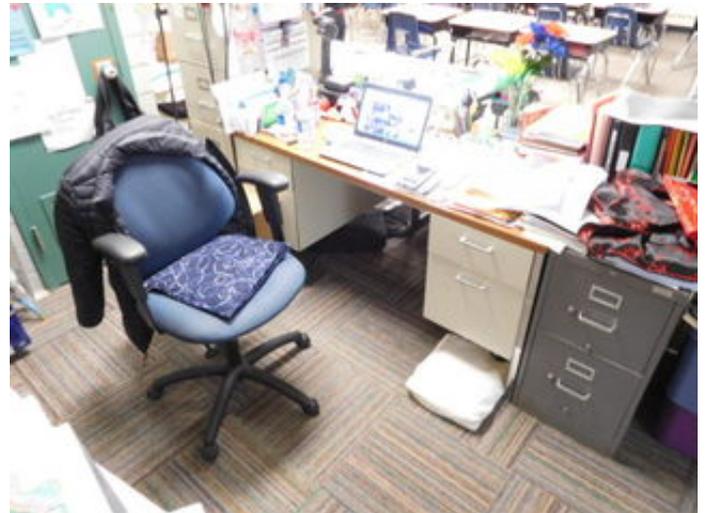
Typical Student Desk and Chair

Typical Teacher Desk and Chair

Recommendations: Provide for replacement of outdated or inadequate furnishings.

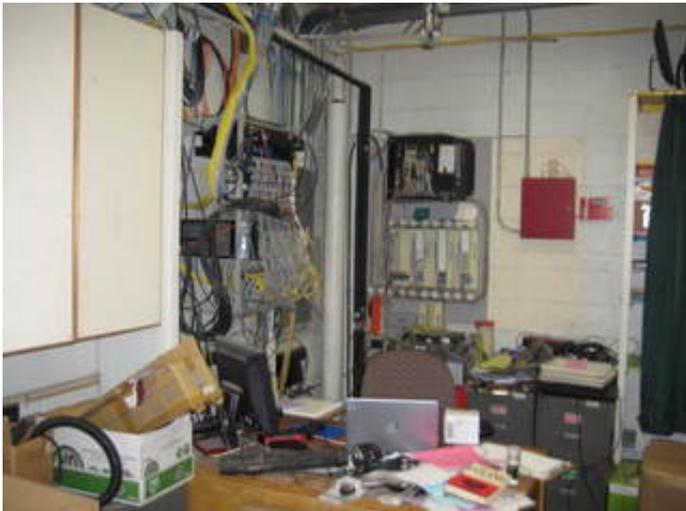
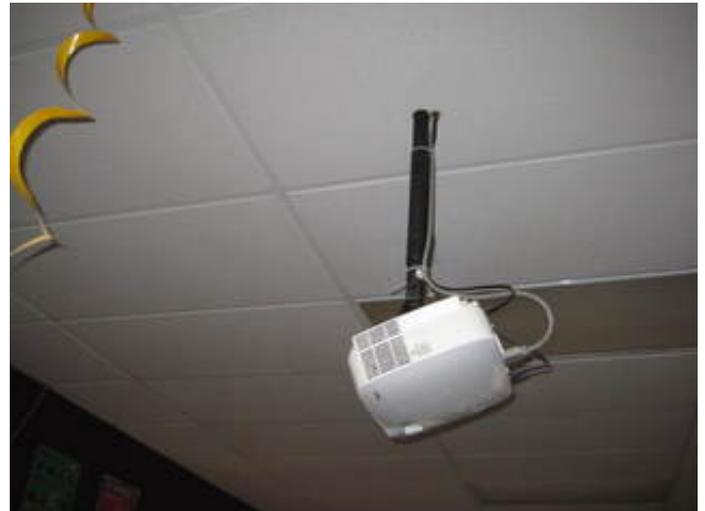
IT System Data Rack

IT System Classroom Projector
