Building Information - Yellow Springs Exempted Village (45674) - Yellow Springs High School/McKinney Middle School

Building Pictures - Yellow Springs Exempted Village(45674) - Yellow Springs High School/McKinney Middle School(42416)

GENERAL DESCRIPTION

Yellow Springs High School/McKinney Middle School, which is not on the National Register of Historic Buildings, and originally constructed in 1963, is a three story, 74,229 square foot brick, painted corrugated galbestos panels, EIFS, insulated metal panels, and painted concrete building located on the outer edge of a small town residential setting, next to rural property. The existing facility features a conventionally partitioned design, and does not utilize modular buildings. The structure of the 1963 Original Construction contains load bearing masonry as well as concrete columns with brick veneer type exterior wall construction, with load bearing masonry type wall construction in the interior. The structure of the 1988 Addition contains brick veneer on a wood frame type exterior wall construction with wood frame type wall construction on the interior. The structure of the 1999 Addition contains load bearing masonry walls with

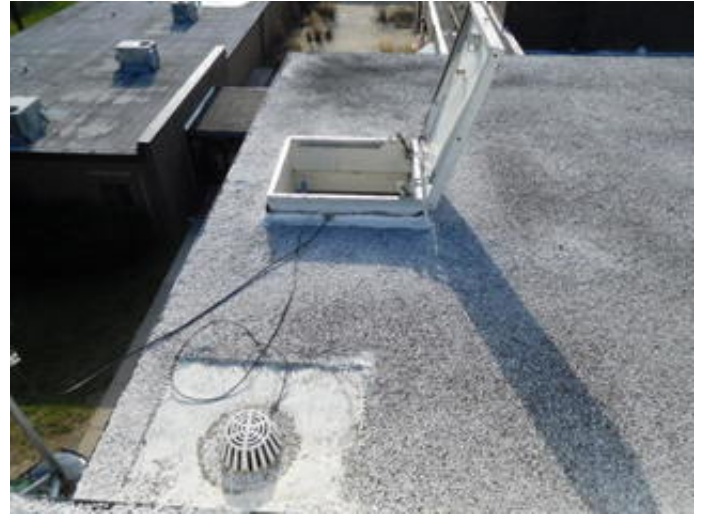
Description: The roof over the Original Construction is a built-up system with gravel ballast that was installed in 1994, and is in fair condition; portions of the Original Construction were replaced with a built-up system in 2009, and is in fair condition. The roof over the 1988 Addition is a modified bitumen system that was installed in 2003, and is in fair condition. The roof over the 1999 Addition is a built-up system with gravel ballast that was installed in 1999, and is in fair condition. The roof over the 2002 Addition is a built-up system with gravel ballast that was installed in 2004, and is in good to fair condition. There are no District reports of current leaking. No signs of past leaking were observed during the physical assessment. Access to portions of the roof was gained by access hatches that are in poor condition. Fall safety protection cages are not required. There were observations of standing water on the roof. Metal cap flashings and stone copings are in fair to poor condition. Roof storm drainage is addressed through a system of gutters and downspouts and roof drains, which are properly located, and in fair condition. The roof is not equipped with overflow roof drains in all additions though they will be required in areas of roof replacement. No problems requiring attention were encountered with any roof penetrations. There are not any covered walkways attached to this structure.

Rating: 3 Needs Replacement

Typical Roof

Recommendations: The roof over the overall facility requires replacement to meet Ohio School Design Manual guidelines due to age of system and projected lifecycle. The flashing and coping on the overall facility require replacement due to condition. Due to existing conditions roof drains require replacement on the overall facility with the exception of the 2002 Addition. Due to existing conditions gutters and downspouts and roof drains require replacement. Provide funding for overflow roof drains and piping for the Original construction and the 1999 Addition. Due to age and condition provide for the replacement of two roof access ladders and hatches. Provide one new roof access ladder and hatch to provide access to all roof areas. Provide funding for guardrails to be added at the location of the two existing roof access hatches due to life safety.

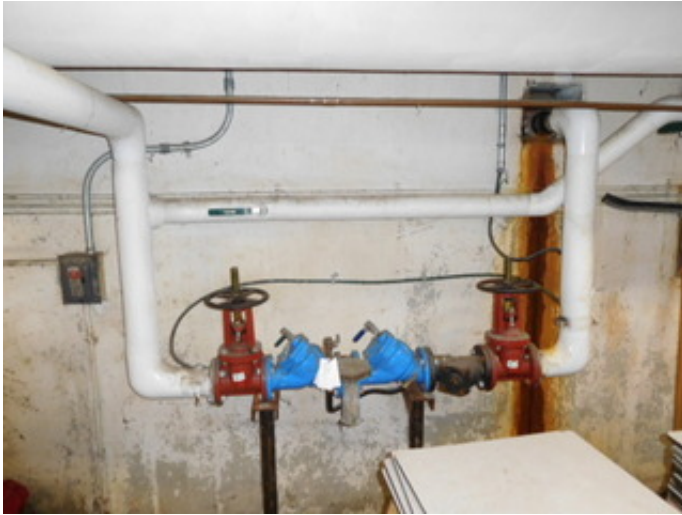
Description:	<p>The service entrance is equipped with a reduced pressure back flow preventer in good to fair condition. A water treatment system is not provided, though none is needed. The domestic water supply piping in the overall facility is copper and galvanized, is original to each addition, and is in fair condition. The waste piping in the overall facility is cast iron, with some galvanized, is original to each addition, and is in good to fair condition. The facility is equipped with a 40 gallon electric water heater in good to fair condition, and a 91 gallon gas water heater in good condition, with 1 separate 250 gallon storage tank in poor condition. The school contains 3 Large Group Restrooms for boys, 3 Large Group Restrooms for girls, 1 Locker Room Restroom for boys, 1 Locker Room Restroom for girls, 1 Restroom associated with specialty Classrooms, and 2 Restrooms for staff. Boys' Large Group Restrooms contain 3 ADA and 3 non-ADA wall and floor mounted flush valve and tank type toilets, 4 ADA and 5 non-ADA wall mounted flush valve urinals, as well as 5 ADA and 2 non-ADA countertop and wall mounted lavatories. Girls' Large Group Restrooms contain 3 ADA and 8 non-ADA wall and floor mounted tank type and flush valve toilets, as well as 5 ADA and 2 non-ADA countertop and wall mounted lavatories. Boys' Locker Room Restrooms contain 0 ADA and 1 non-ADA wall mounted flush valve toilets, 0 ADA and 1 non-ADA wall mounted flush valve urinals, 0 ADA and 1 non-ADA countertop lavatories, as well as 0 ADA and 9 non-ADA showers. Girls' Locker Room Restrooms contain 0 ADA and 2 non-ADA wall mounted flush valve toilets, as well as 0 ADA and 2 non-ADA countertop lavatories, as well as 0 ADA and 8 non-ADA showers. Staff Restrooms contain 0 ADA and 3 non-ADA wall and floor mounted tank type and flush valve toilets, 0 ADA and 0 non-ADA urinals, as well as 0 ADA and 3 non-ADA wall mounted lavatories. Condition of fixtures is good to fair. The facility is equipped with 0 ADA and 0 non-ADA drinking fountains, as well as 2 ADA and 7 non-ADA electric water coolers, in good to fair condition. High School Special Education Classrooms are equipped with 0 ADA and 0 non-ADA sink mounted type drinking fountains. Special Education Classroom is equipped with the required Restroom facilities, and fixtures are in fair condition. Kitchen is not equipped with the required Restroom. Heath Clinic is not equipped with the required Restroom. Due to existing grade configuration, Kindergarten / Pre-K Classroom Restroom considerations are not relevant. Kitchen fixtures consist of 2 single compartment sink and 1 triple compartment sink, which are in fair condition. The Kitchen is not equipped with a grease interceptor. The Kitchen is provided the required 140 degree hot water supply. The school meets the OBC requirements for fixtures. Relative to LEED requirements, the school is not equipped with low flow type fixtures. Per OBC and OSDM requirements this facility should be equipped with 8 toilets, 2 urinals, 10 lavatories, 1 Classroom sink mounted drinking fountains, and 5 electric water coolers. Observations revealed that the school is currently equipped with 28 toilets, 10 urinals, 25 lavatories, 0 Classroom sink mounted drinking fountains, and 9 electric water coolers. ADA requirements are not met for fixtures and drinking fountains see Item O. Custodial Closets are properly located and are adequately provided with required service sinks or floor drain sinks, which are in fair condition. Science Classrooms / Project Laboratories / Career Tech Laboratories are equipped with required utility sink, gas / compressed air connections, and safety shower / eyewash in good to fair condition. Biology and Chemistry Classrooms are not equipped with acid waste systems and neutralization tanks. Adequate exterior wall hydrants are not provided.</p>

Backflow Preventers

Rating:	3 Needs Replacement
Recommendations:	<p>To facilitate the school's compliance with OBC and OSFC fixture requirements, provide 2 new toilets, 2 new lavatories and 1 new lavatory mounted type drinking fountains. Due to age, condition, LEED, and OSFC requirements, provide 22 new toilets, 21 new lavatories, 8 new urinals and 4 new electric water coolers. Replace water supply and sanitary waste piping in the 1963 Original Construction and 1988 Addition. Due to age replace the electric hot water heater in the 1988 Addition. Due to age and condition, replace the 250 gallon hot water storage tank. Due to age and condition replace all showers in the Original Construction. See Item O for replacement of fixtures related to ADA requirements. Provide the Science Classrooms with the required gas connections, compressed air connections, and safety shower / eyewash stations. Provide the Biology and Chemistry Classrooms with the required acid waste systems and neutralization tanks. See Item J for replacement of Kitchen fixtures. Replace one and provide three new exterior wall hydrants to meet OSFC requirements. Provide the Kitchen with a grease trap interceptor. Replace existing Custodial Closet sinks due to age and condition.</p>

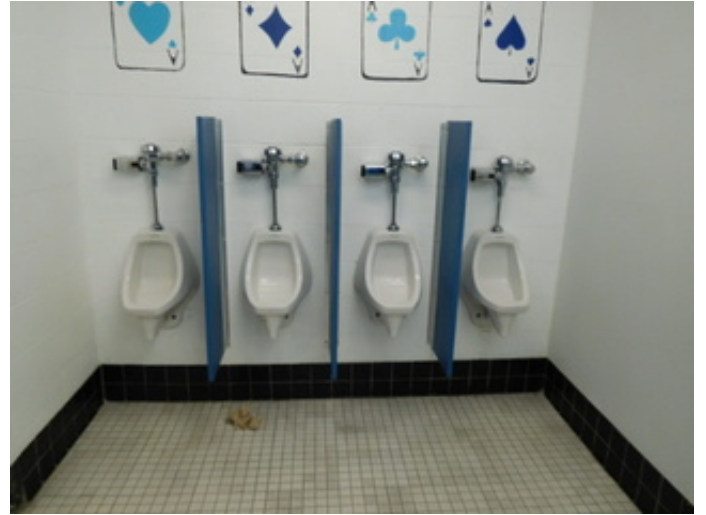
Typical Restroom Urinals

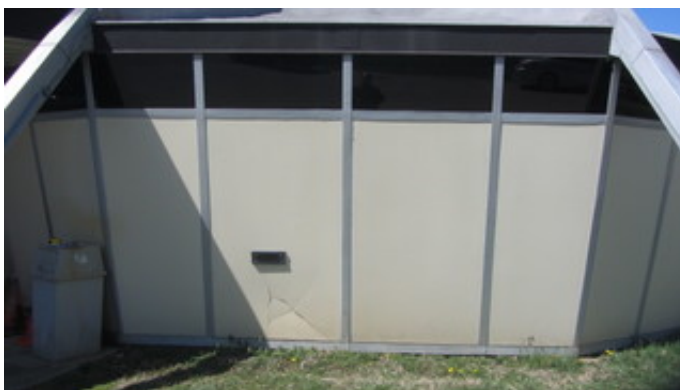
Insulated panels at 1963 Original Construction Music Room

Other: Provide Masonry Infill	\$27.00	sq.ft. (Qty)		96 Required					\$2,592.00	Provide masonry infill in the 1963 Original Construction.
Other: Railing Replacement	\$85.00	ln.ft.			65 Required				\$5,525.00	Replace non-code compliant railings.
Other: Recaulk Exterior Control Joints	\$5.50	ln.ft.		841 Required	407 Required	45 Required		256 Required	\$8,519.50	Recaulk existing control joints.
Other: Repoint Stone Sills	\$7.50	ln.ft.				64 Required			\$480.00	Repoint stone window sills through the 1988 Addition.
Other: Wood Soffit Replacement	\$25.00	sq.ft. (Qty)				250 Required			\$6,250.00	Replace wood soffits in 1988 Addition.
Sum:			\$939,608.50	\$398,437.50	\$379,014.50	\$72,622.50	\$13,401.50	\$76,132.50

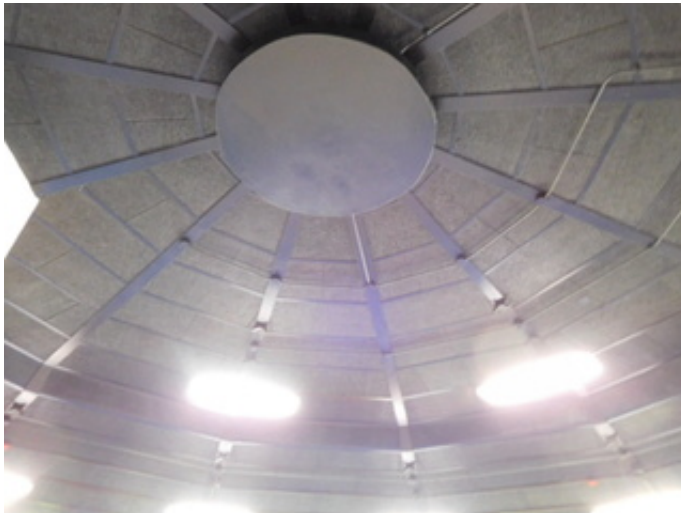
Rating: 2 Needs Repair

1963 Original Construction Music Room Roof Structure

Recommendations: Remove and replace wood floor, wall and roof construction in the 1988 Addition with code compliant construction that meets with Ohio School Design Manual Requirements. Provide funding for an investigation and correction of the structural issues at the intermediate floors of the 1963 Original Construction. Refer to Item A for funding of architectural soffits to accommodate HVAC, electrical, and plumbing scopes of work.

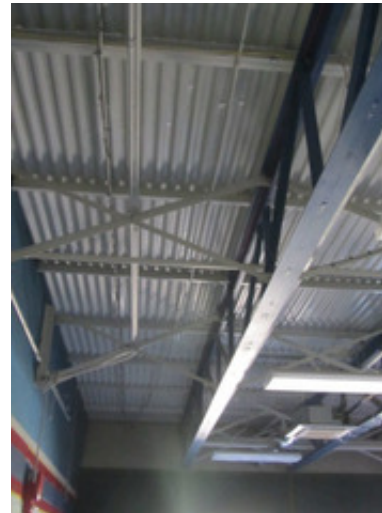
1963 Original Construction Student Dining Roof Structure

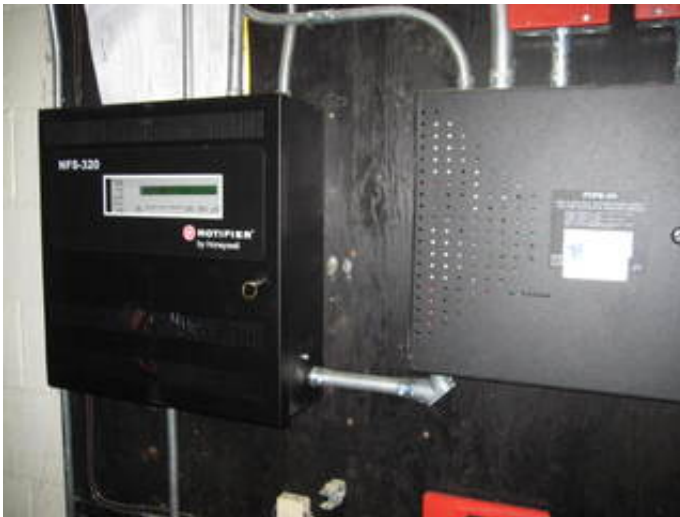
Rating: 3 Needs Replacement

Fire Alarm System Control Panel

Fire Alarm System Manual Pull Station

Recommendations: Provide complete replacement of fire alarm system to meet OBC, NFPA, and Ohio School Design Manual guidelines.

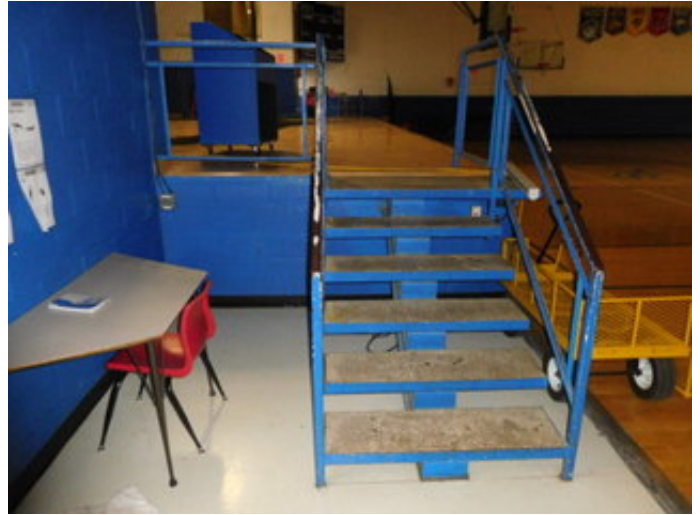
Non-ADA Compliant Stage Access

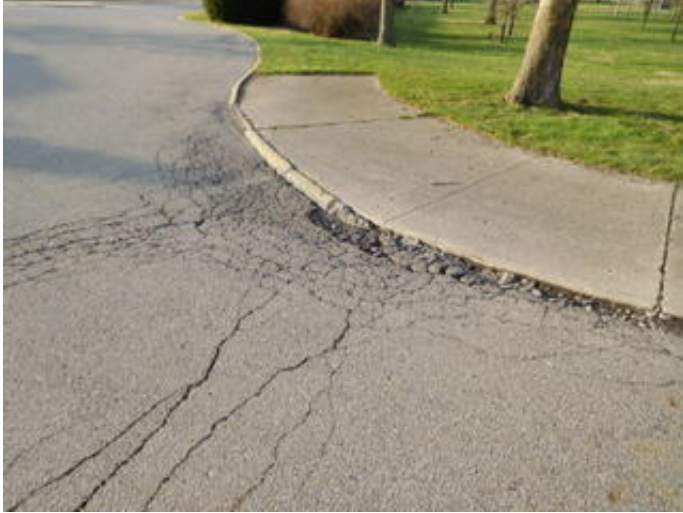
Asphalt, Curb, and Sidewalk Condition
