2021

Stamford HS Stadium Facility Assessment & Analysis Report

Stamford High Stadium
55 Strawberry Hill Avenue
Stamford, Connecticut 06902

StudioJAED
42 Weybosset Street, Suite 403
Providence, RI 02903
401.648.0884

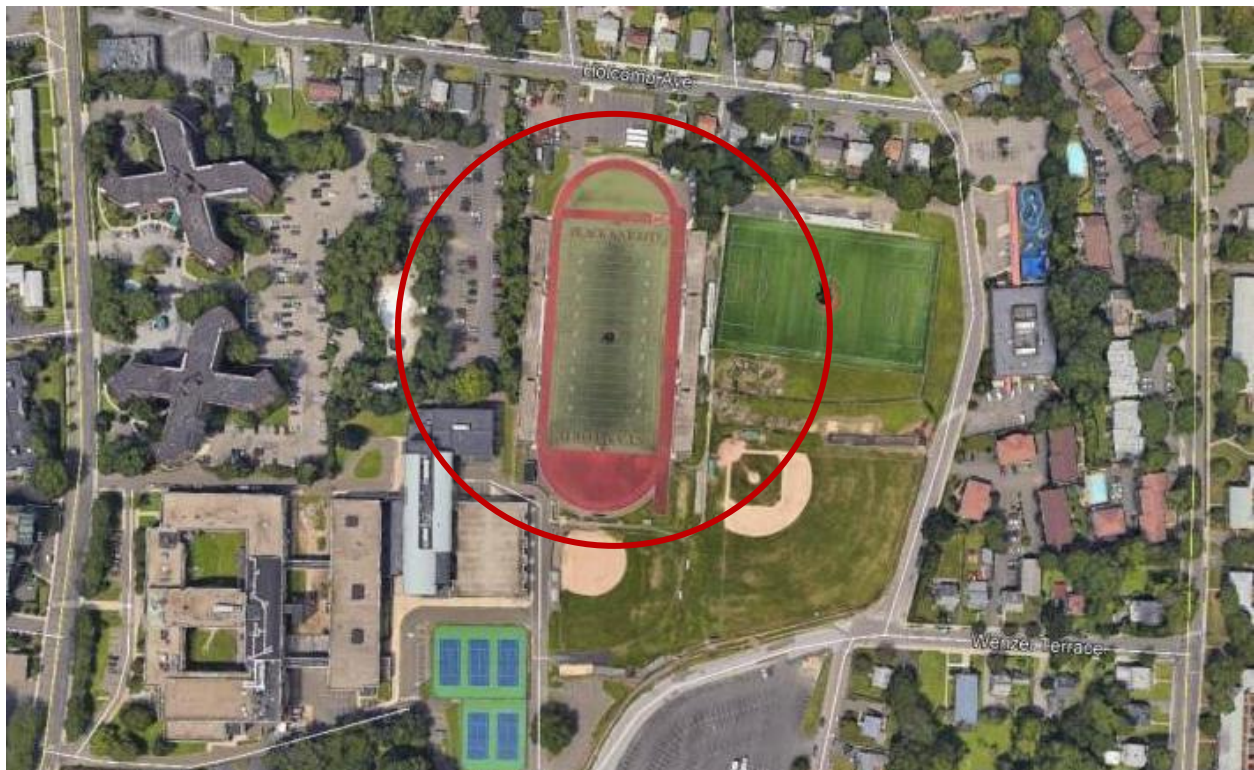
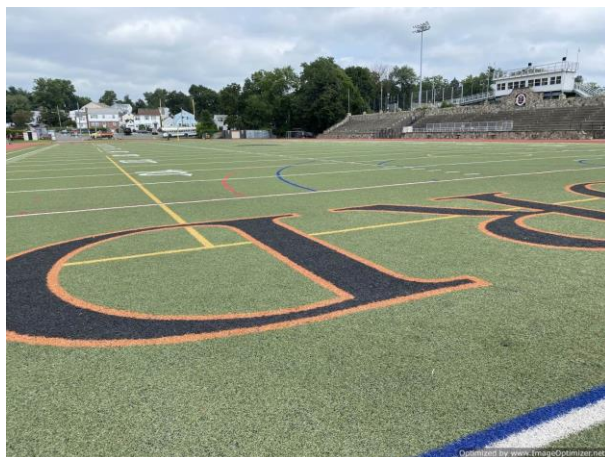
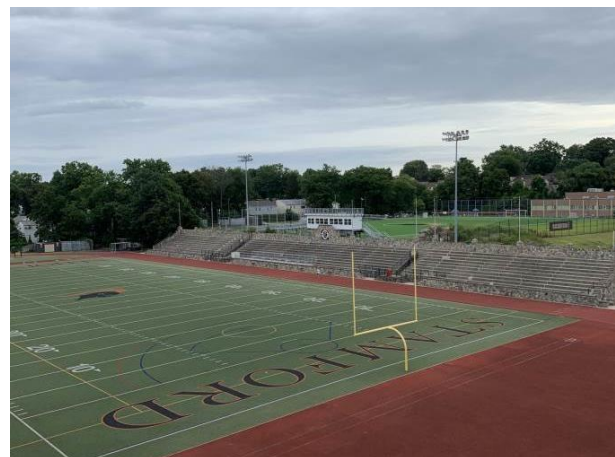
The property is located at Stamford High, Stamford, Fairfield County Connecticut on approximately 14.99 acres. Site lighting is minimal and a photometric plan should be done to see where deficiencies exist. Fencing is provided along the north, south, and east property lines and around the tennis courts, baseball fields, soccer field, and east parking lots. The perimeter fencing is in good condition with isolated sections of damage. Grass baseball and softball fields appear to be in good condition. The football field and soccer field are constructed of artificial turf in good condition.

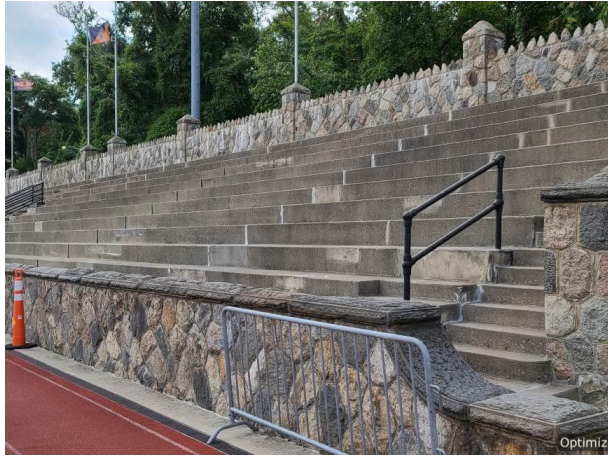
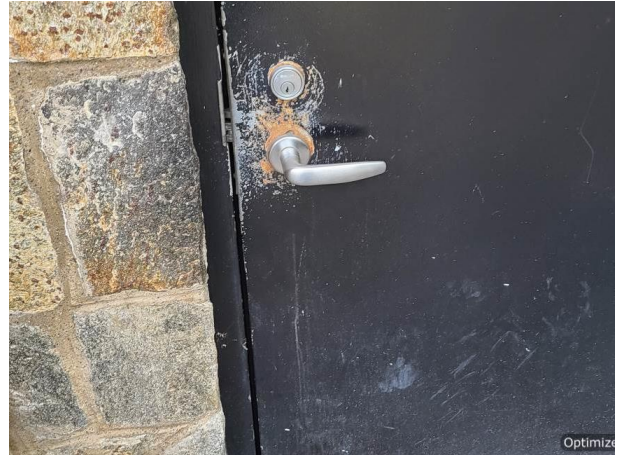
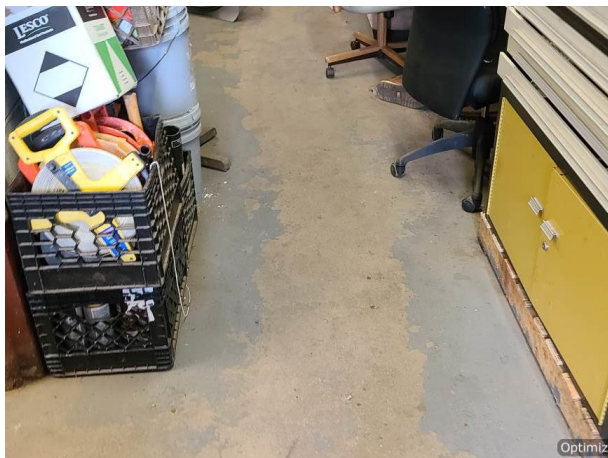
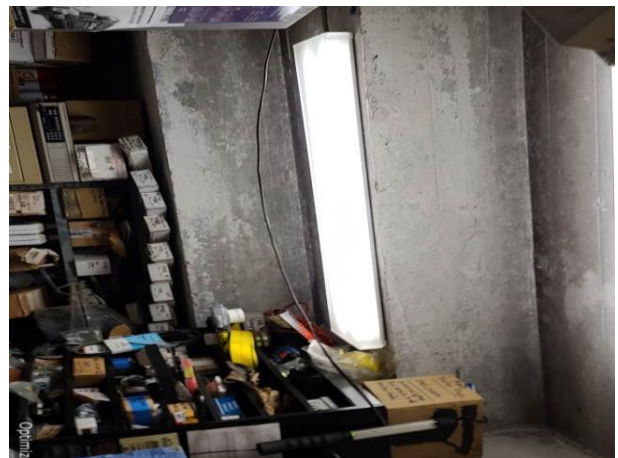
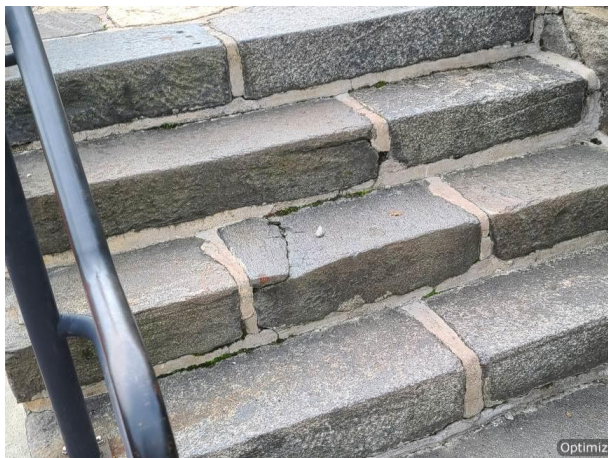
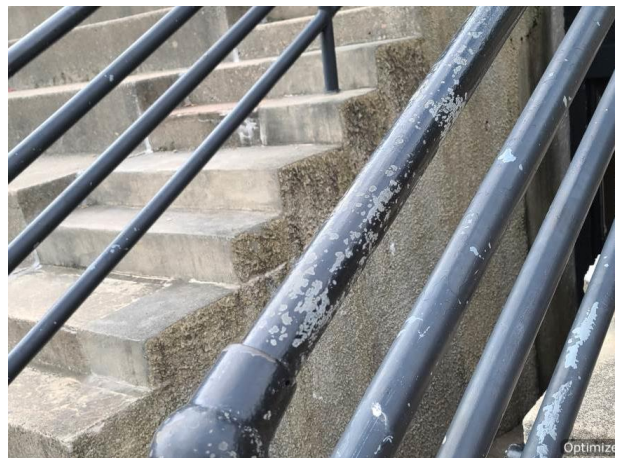
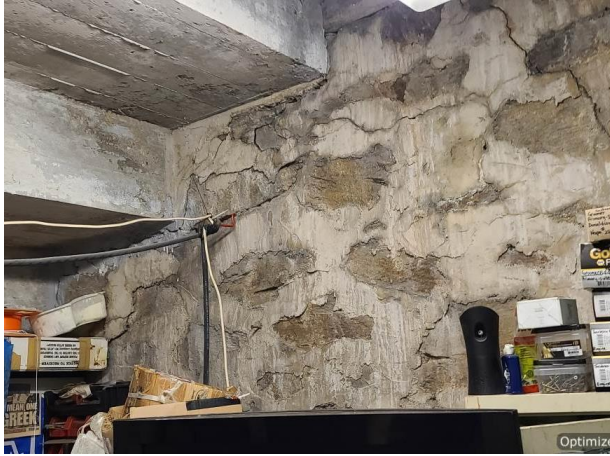
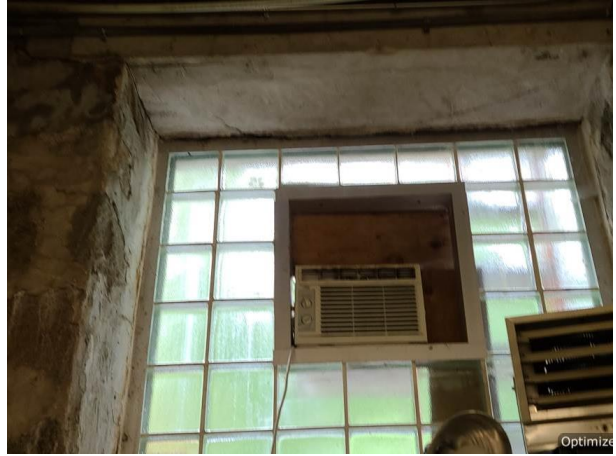
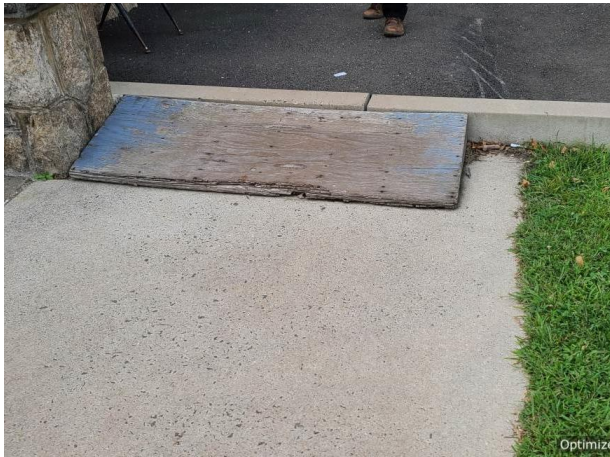
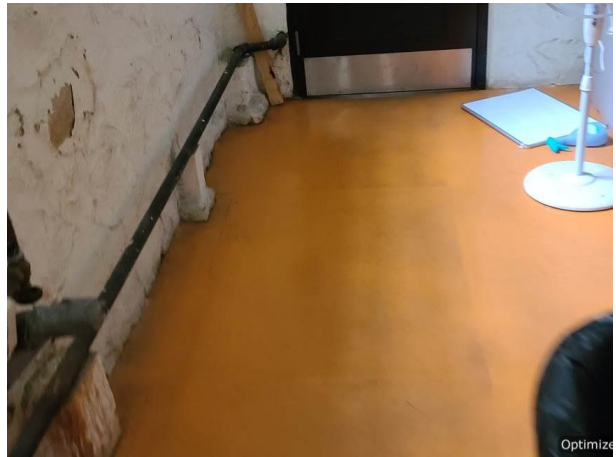
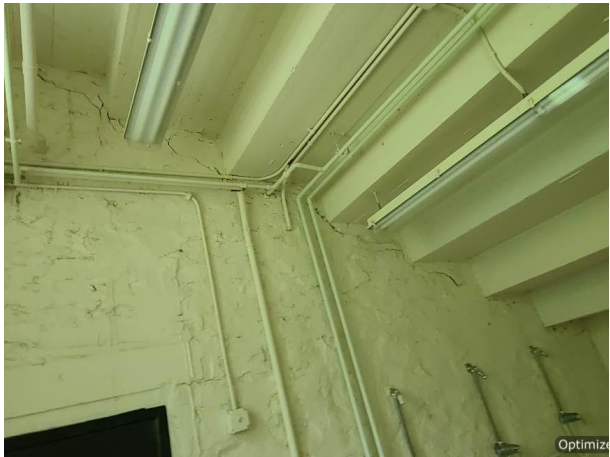
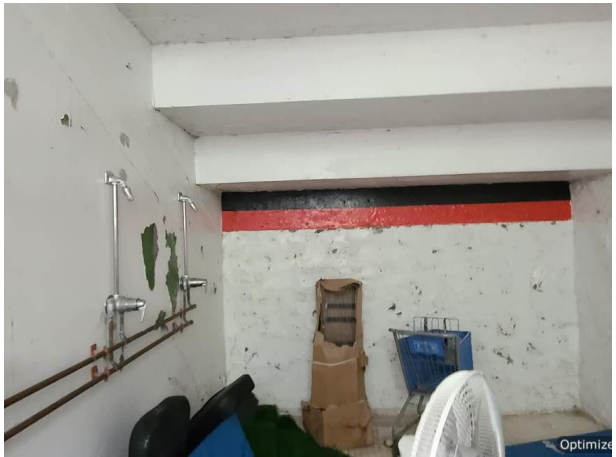
In general, the building envelope is in overall fair to poor condition and the interior construction / finishes are in fair condition as shown in the images below.

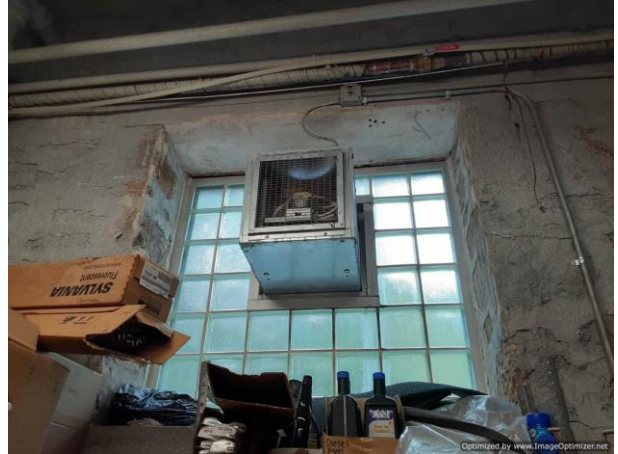
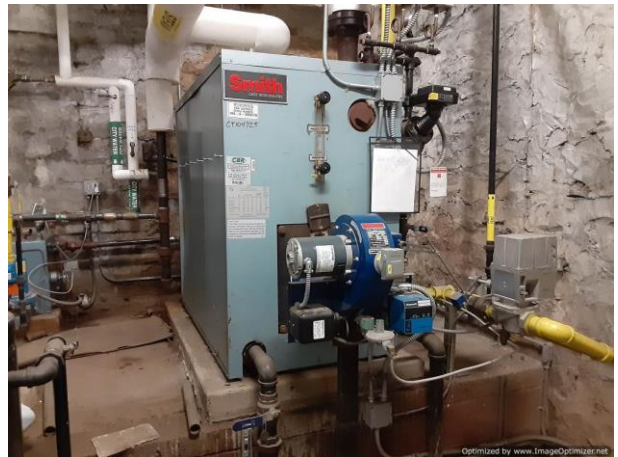
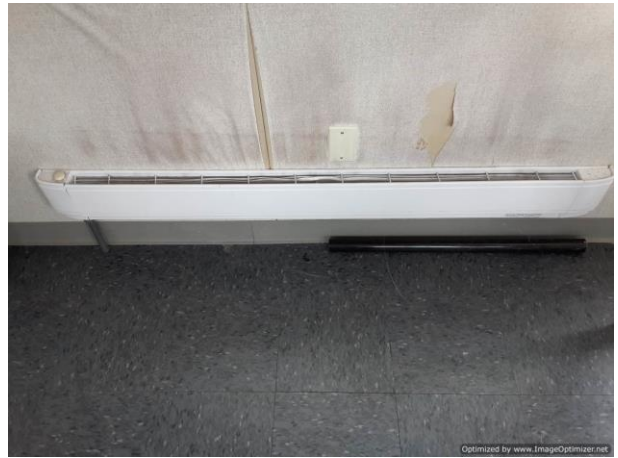
The visitor (west) grandstand offices, locker room and storage areas are heated by steam radiators, fin tube radiation and unit heaters which look largely original to the building. The steam boiler was replaced in 2010. Two window air conditioning units provide cooling to the office areas. Exhaust fans to each area are installed through the exterior wall. The home (east) grandstand restrooms and storage areas are heated by electric space heaters. Air conditioning is provided to some areas by ductless split systems. Exhaust fans are ceiling hung and ducted to the exterior. The concession stand and press box are heated by electric baseboard heaters. There is no air conditioning provided. All of the steam piping, radiators, fin tube radiation, unit heaters, exhaust fans, air conditioning systems and electric heaters should be replaced within the assessment period.

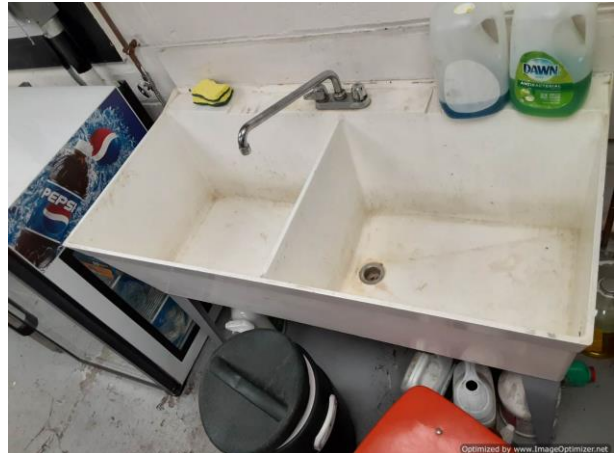
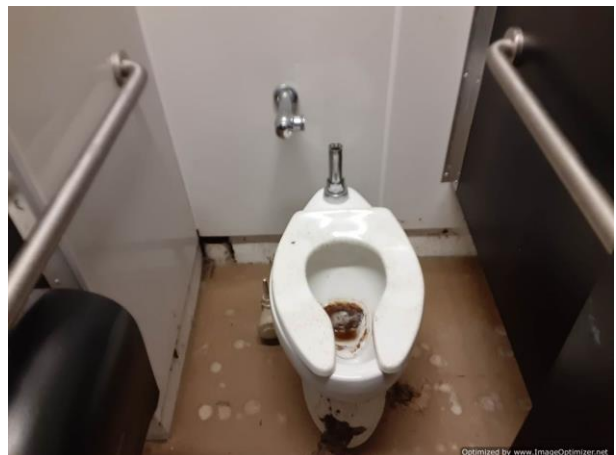
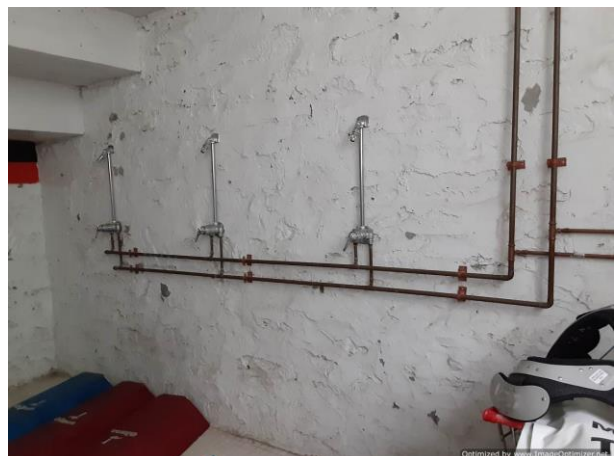
The plumbing systems and fixtures in both grandstands appears to be largely original. Hot water is provided to the locker rooms in the visitor grandstands by a gas fired hot water heater that was replaced in 2019. Hot water is provided to the restrooms in the home grandstands and concession stand by individual electric hot water heaters. The electric hot water heaters, fixtures, domestic water and sanitary waste piping should be replaced within the assessment period.

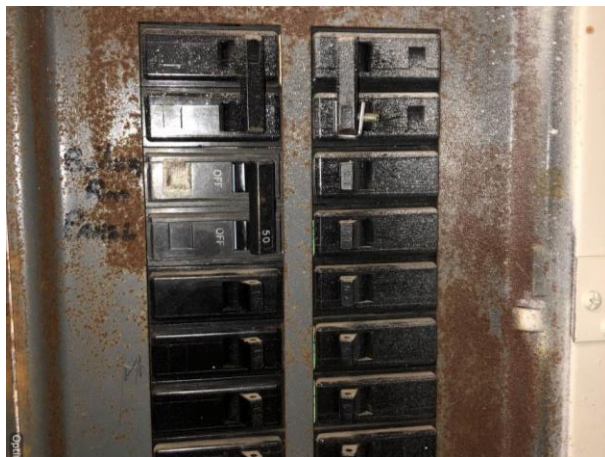
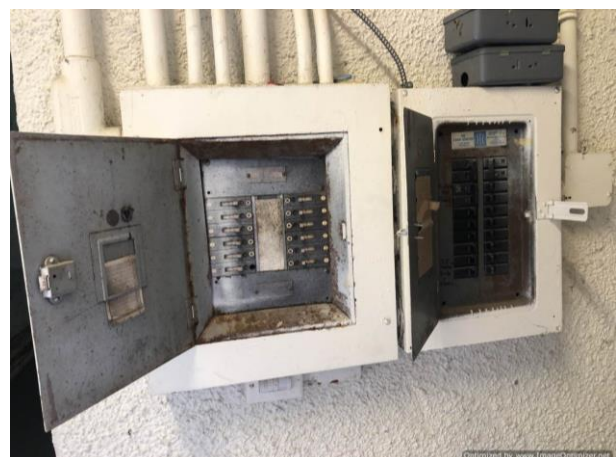
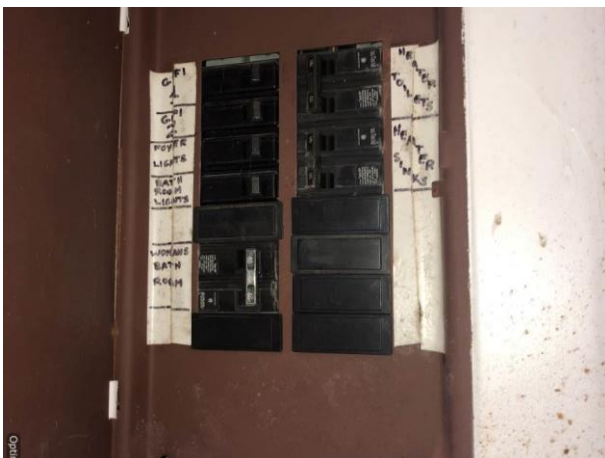
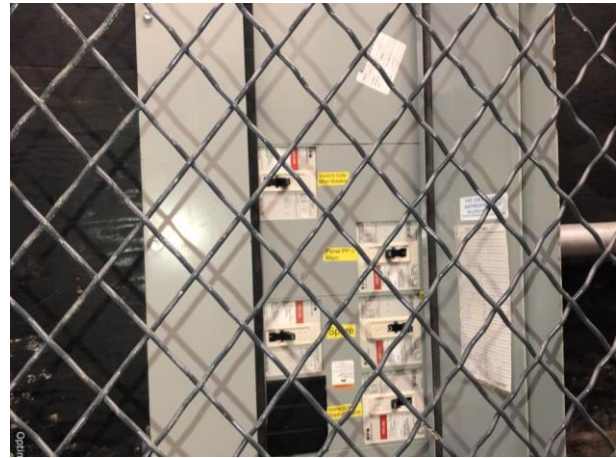
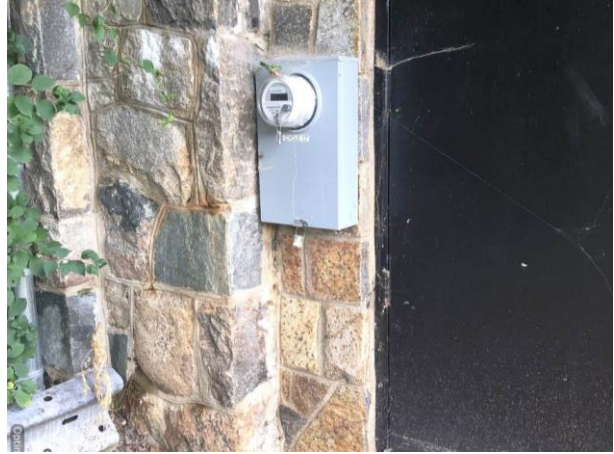
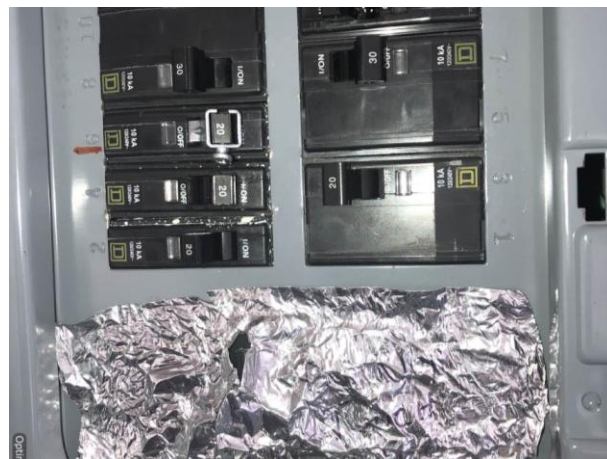
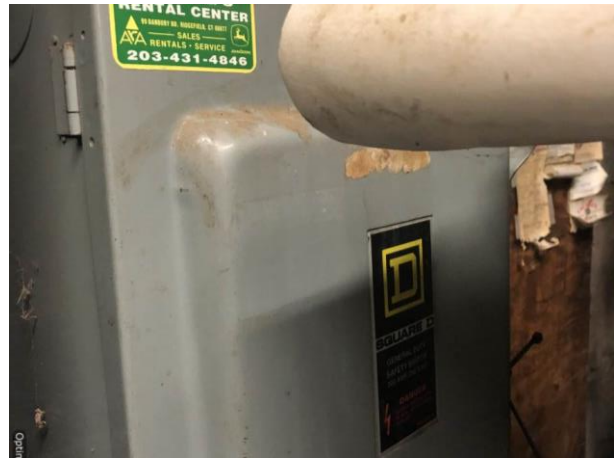
The Stadium has a “Home” side and a “Visitor” side. The Home side has a newer Press Box installed in 2013 with all newer panel boards and wiring. In the basement (under the stairs) is a 150 amp main and 150 amp spare which feeds other panels in the basement and upstairs in the Press Box. The visitor’s side contains a 200 amp Main breaker which resides in the Home basement. The visitor’s side appears original from time of construction. This assessment covers replacement of all wiring, panel boards and lighting on the visitor’s side.

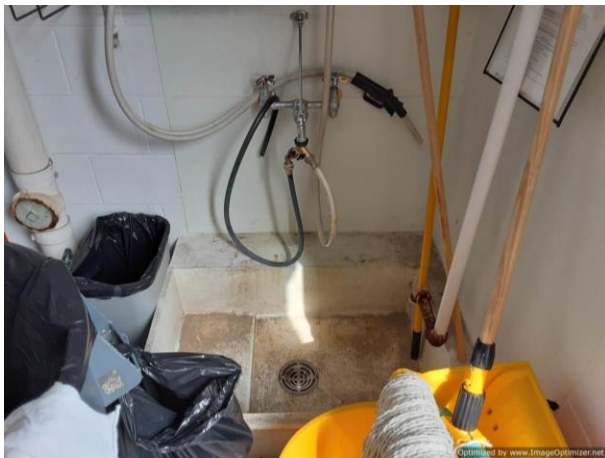
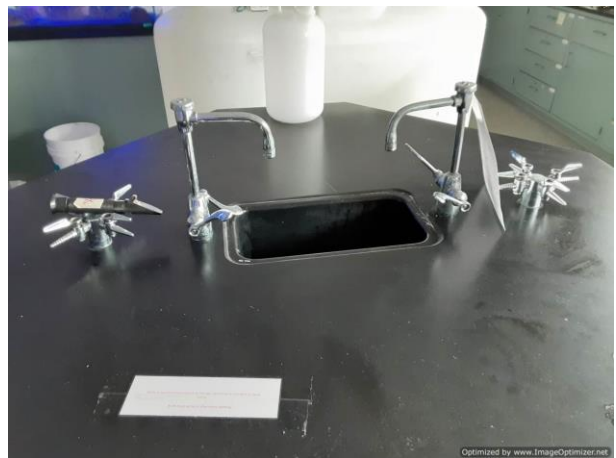
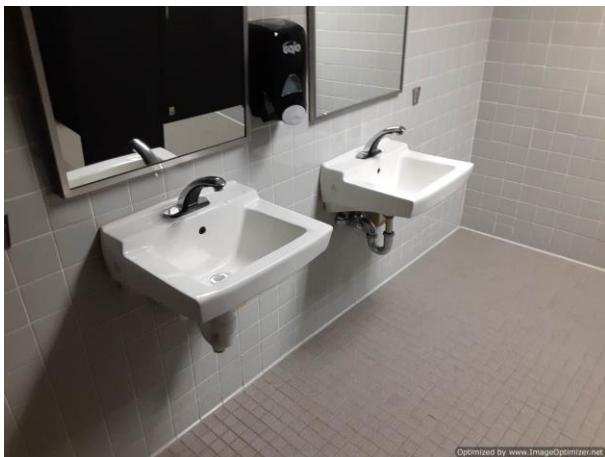
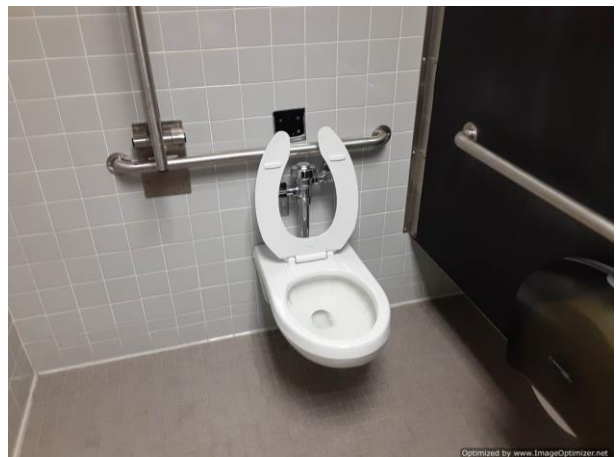
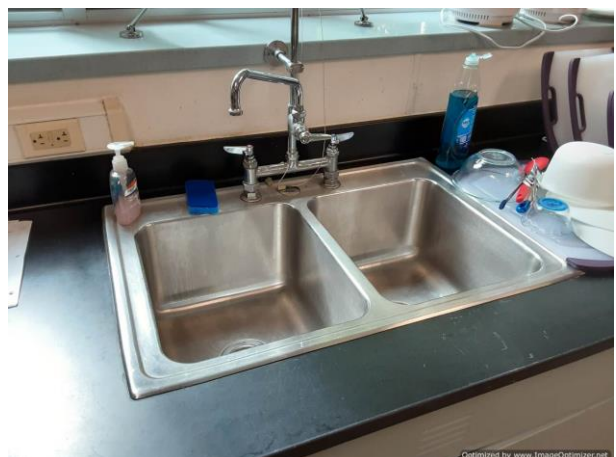
The main building plumbing systems appear to largely be original. Hot water is provided by a gas fired hot water boiler and storage tank with circulators that were replaced in 2019. Fixtures appear to be original with sporadic maintenance throughout the years on an as needed basis. Fixtures should be replaced within the assessment period.

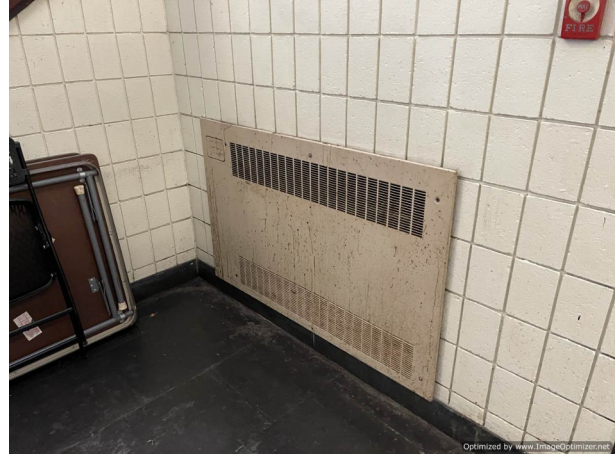
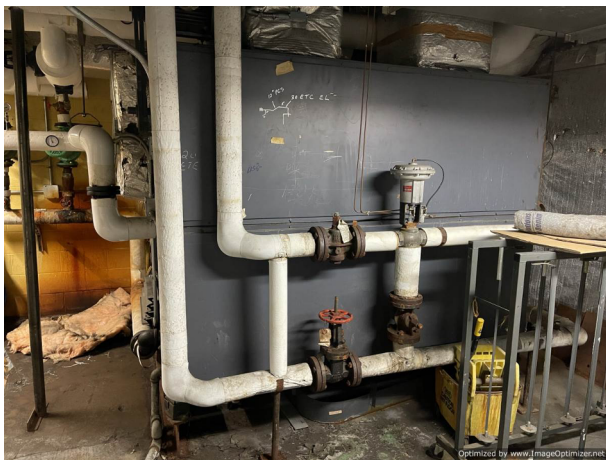
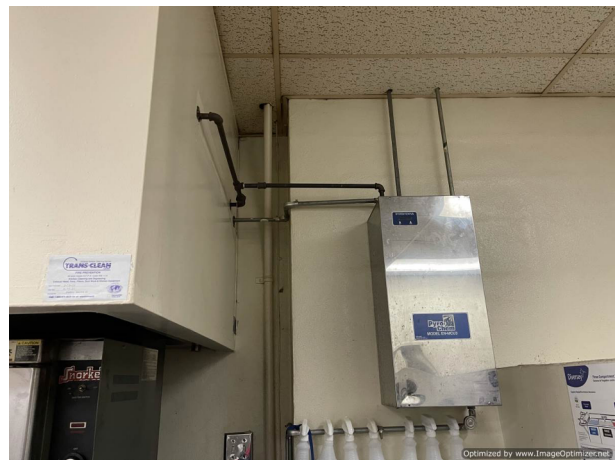
Most of the HVAC systems are at or beyond their expected useful lives. Refer to the appendices for a detailed report of recommended corrective actions of specific HVAC replacement or repair improvements.

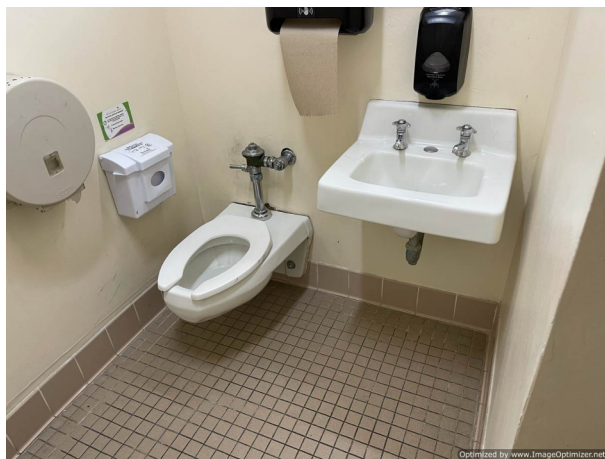
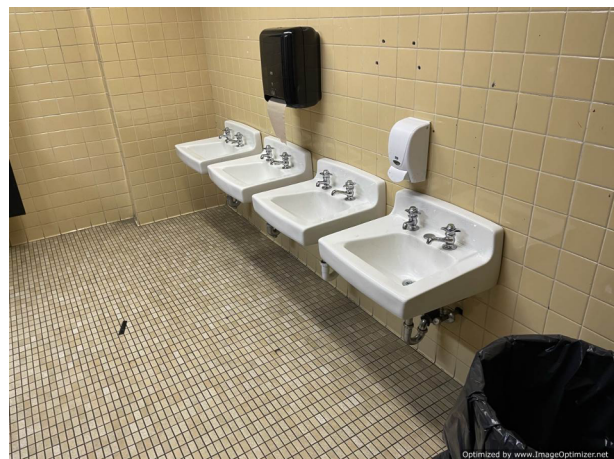
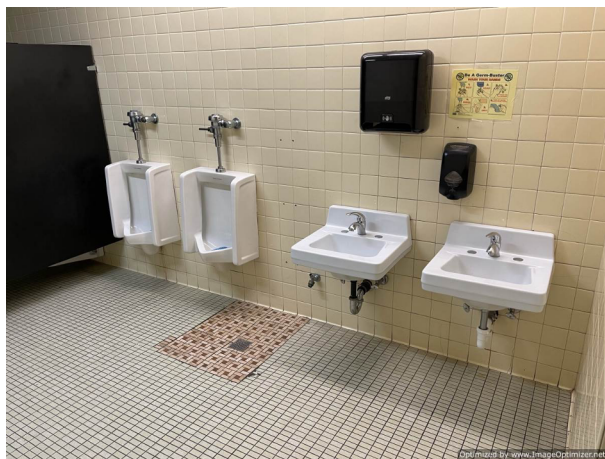
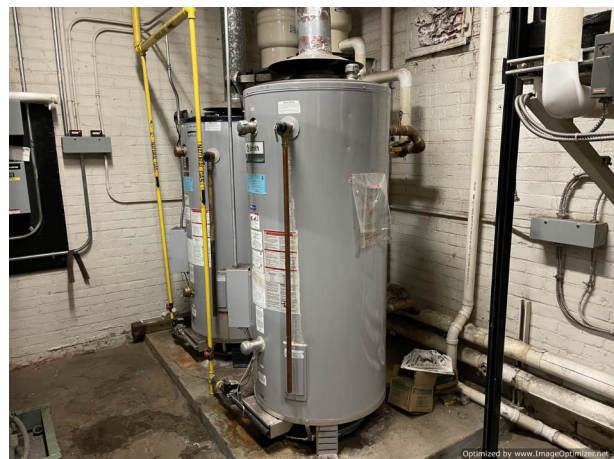
The plumbing supply and sanitary piping are approaching the end of their expected useful lives. The above mentioned domestic hot water heaters are failing according to maintenance staff as well. Most of the plumbing fixtures appear to be in good condition. Refer to the corrections report for specific plumbing replacement or repair recommendations.
