REGIONAL SCHOOL DISTRICT 18

Facility Study – Center School

August 15, 2021

Regional School District 18 Lyme & Old Lyme Facilities Study & Educational Specifications

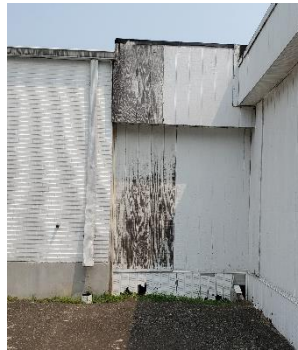
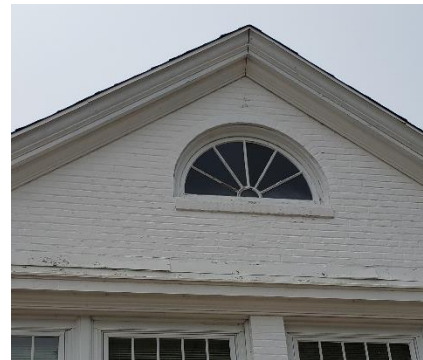
Masonry: The primary exterior wall assembly is consistent throughout the building. The exterior walls clad in brick and painted white are generally in good condition. Visible cosmetic white paint chipping is evident near the base of the walls typically near downspouts or water areas. Several vents to the tunnels / basement areas have deteriorated and collapsed due to asphalt paving brought up to the edge of the building. The portable units at the rear of the building have heavily deteriorated. Siding is peeling, broken and in full disrepair.

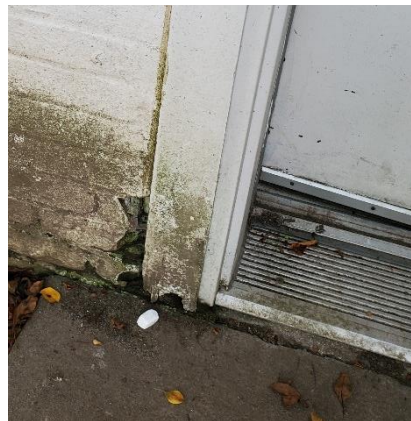
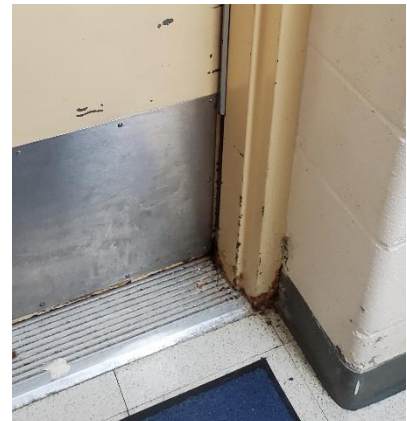
Interior doors appear to be in reasonable shape and are consistent throughout the building. Hardware has been upgraded over the years and is in reasonable shape as well. Exterior doors have weathered more than the interior doors. Being exposed to the elements the metal frames have started to rust at the base, weather seals are no longer continuous, and several doors would no longer close fully without manual force.

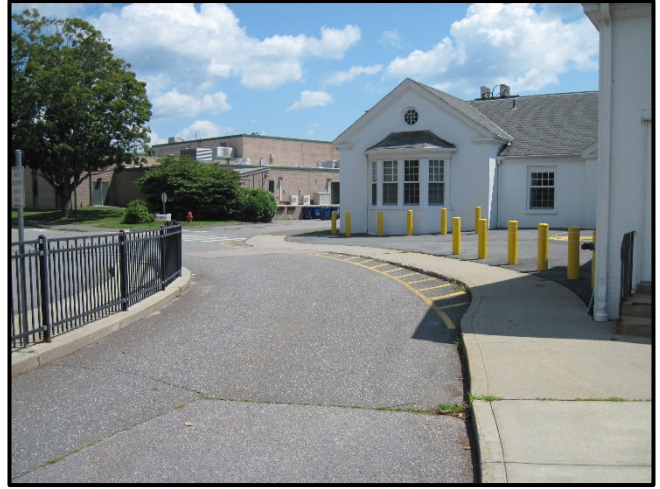
Drive 1 looking southeast. Center School on right. Seam cracking and east/west block crack visible.

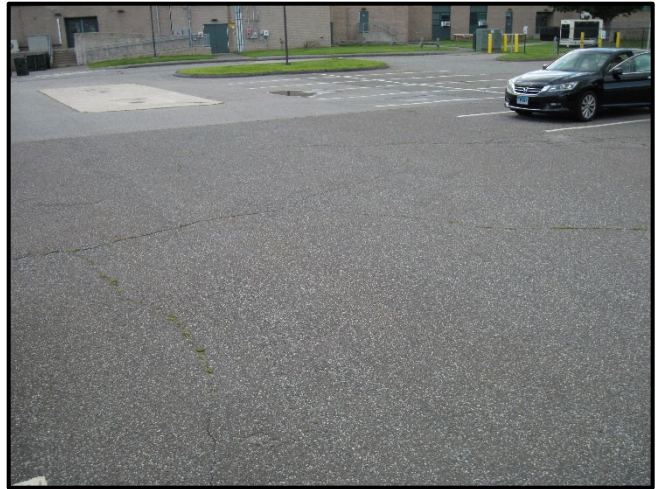
Lot 1 looking east. Fatigue cracking visible. Underground storage tank pad at left/rear of photo.

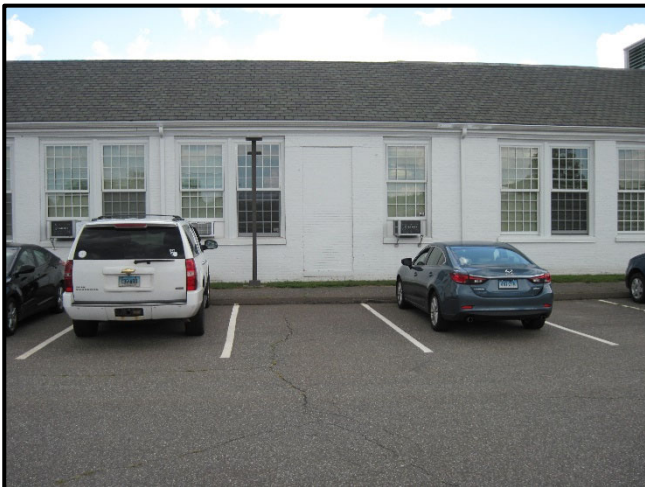
Lot 1 looking north. Fatigue cracking visible.

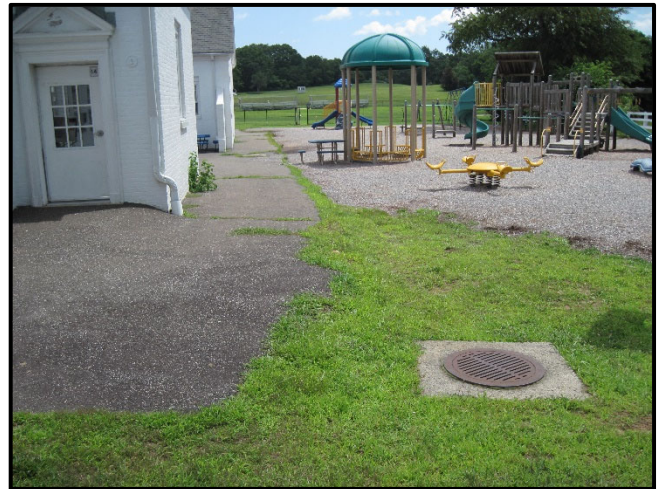
Walkway at west side of school looking south. Cracks and grade change at playground visible.

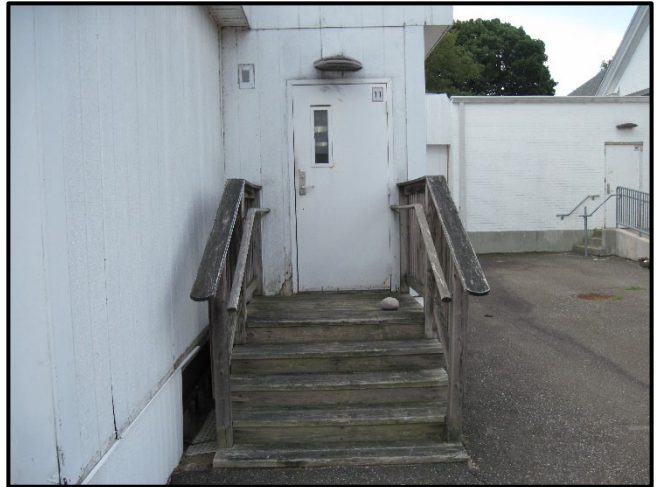
**Stairs at Door 11 to portables. Lack of lower handrail
extensions and returns visible.**

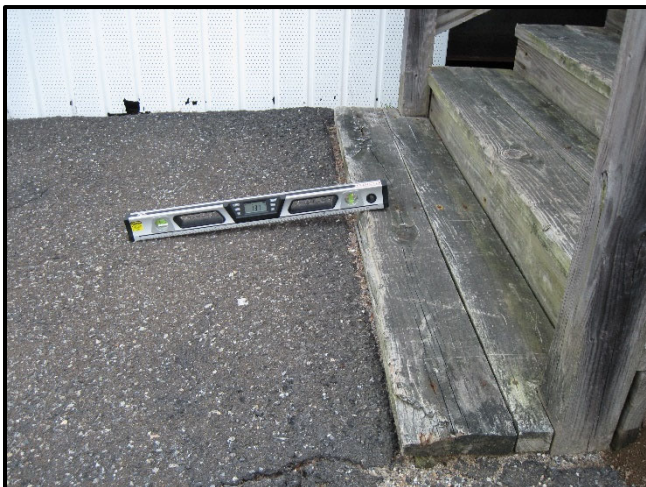
Grade differential at lower landing, stairs at Door 11.

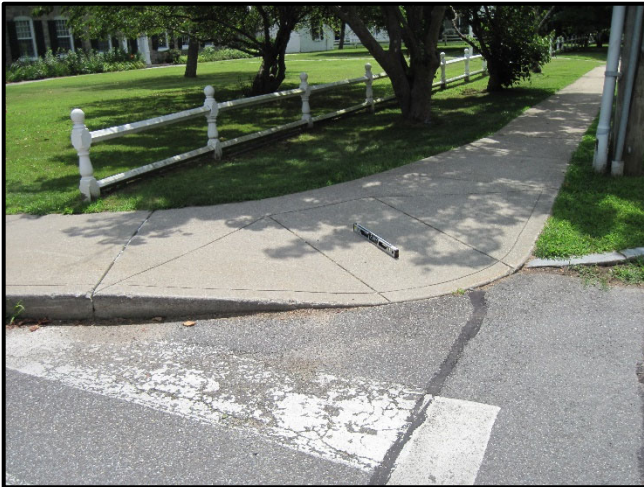
Curb ramp at Lyme Street and Center School Drive 1. Ramp slope $>1:12$ and does not have a top landing.

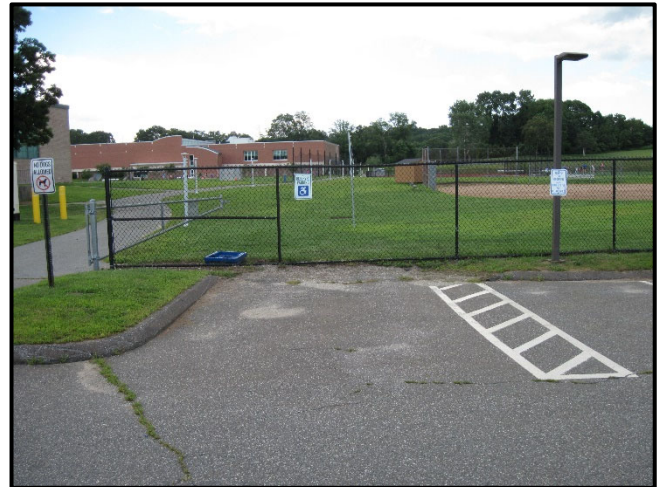
Accessible parking "HC1" at southwest corner of Lot 1. Access aisle not connected to "Accessible Route".

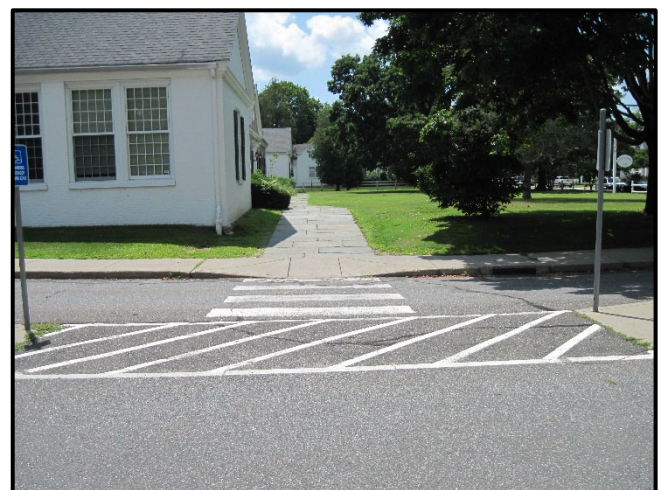
Curb ramp and slate walkway beyond looking west. Ramp slope $>1:12$ and does not have a top landing.

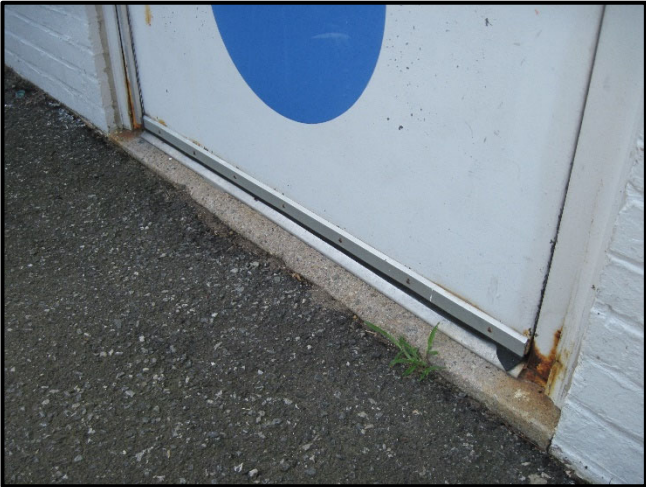
Floor differential at Door 4. Door does not comply with ICC A117.1 404.2.3 for maneuvering clearance.

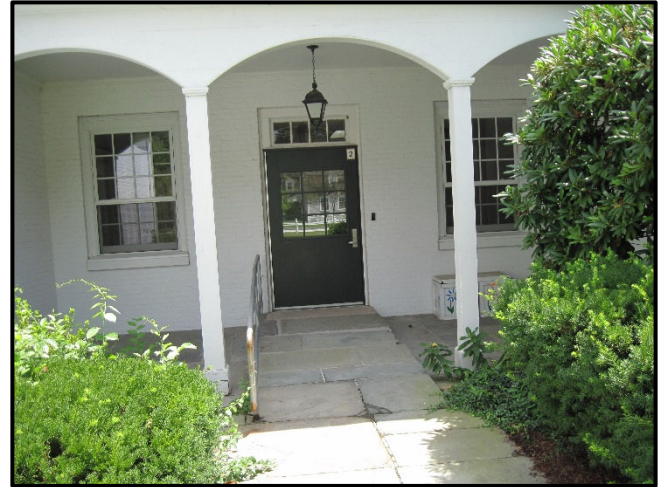
Bluestone ramp at Door 2. Ramp $>1:12$. Door does not comply with ICC A117.1 404.2.3.

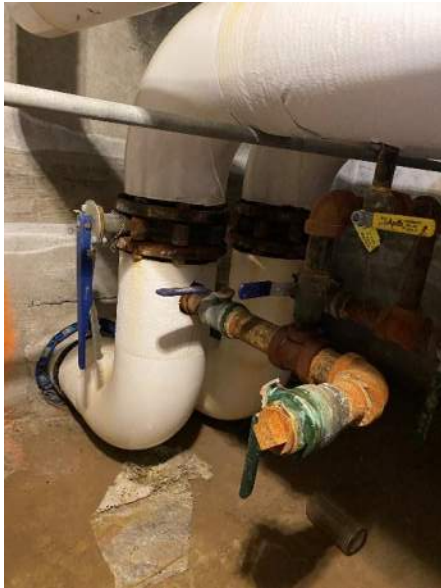
Pipe Entrance to Building

1. Heating for the building is based on a hot water circulation system which originates at the adjacent middle school. Piping runs below the driveway into the Center School basement in 6" insulated supply and return lines. This hot water circulates around the school in tunnels beneath the majority of the facility. A portion of the piping was surveyed visually and it appears to be in fair condition. Piping was installed approximately 20 years ago and can have a useful life of 40-50 years depending on water quality maintenance.

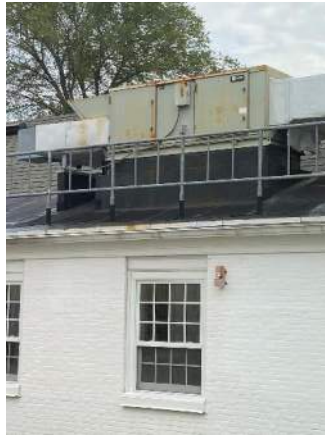
Existing Rooftop Unit

1. Five rooftop units and a single indoor air handler provide ventilation to the building. RTU-4 serves the administration offices, library, and media center and it includes cooling. The remaining units only provide heated air. The rooftop units are over 20 years old and appear to be in poor condition. Casings for each unit are rusted and showing signs of wear. A typical rooftop unit has an approximately 20 year useful life which these are beyond. In addition, the motor efficiency, filter quality, and other features are not meeting today's standard for schools. Lastly, cooling or dehumidification systems are strongly recommended for modern schools.

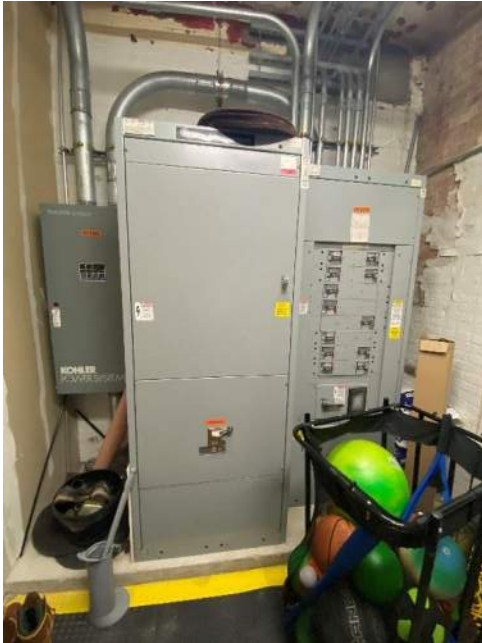
Main Switch and ATS

3. The adjacent Middle School includes an emergency generator which will be assessed in the report for that school. Power from the nearby generator enters the Center School and is controlled by a 400 A Kohler automatic transfer switch. The output of the transfer switch is an emergency distribution panel which feeds emergency lighting, cooking operations, and various emergency circuits within the building. The transfer switch and panelboards are in good condition.

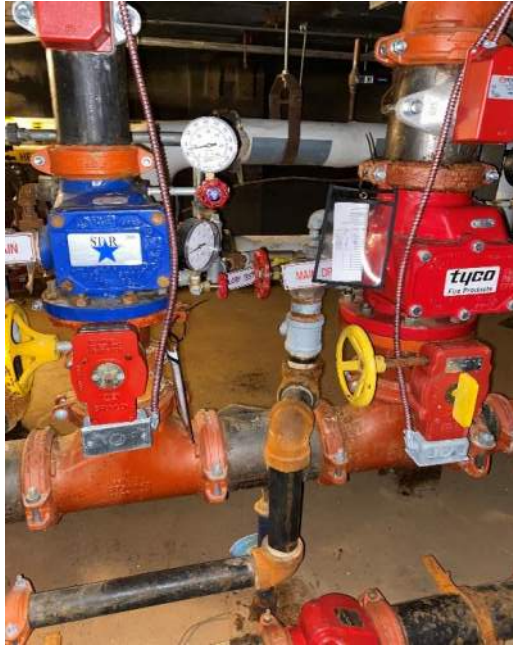
Fire Service

1. A 6" fire service enters the building below the cafeteria adjacent to the domestic hot water and heating lines. The entrance includes a 4" double check valve assembly and two zone valves in the basement. All valves and piping appear to be approximately 20 years old and in fair condition, with a 30-50 year useful life.
2. Sprinkler mains within the tunnels have minor corrosion on the exterior due to humidity, however, no significant corrosion or leaking was apparent.
