REGIONAL SCHOOL DISTRICT 18

Facility Study – Consolidated School

August 15, 2021

Regional School District 18 Lyme & Old Lyme Facilities Study & Educational Specifications

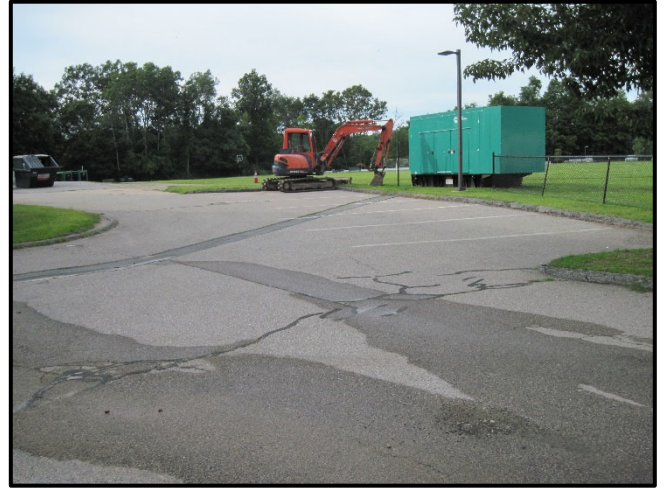
It was noted that the emergency generator, located on the east side of the building adjacent to Lot 2, is not protected by bollards and is not surrounded by any type of protective enclosure. The pad-mounted electrical transformer is located on the south side of the school and is surrounded by a chain link fence. It was also noted that tires have been placed around the two water supply wells. It is recommended that these tires be replaced with tamperproof steel protective enclosures that protect the wellhead, but do not provide opportunities for animal nesting.

Lot 2 looking north. Generator at edge of Lot 2 visible in background with no vehicle protection.

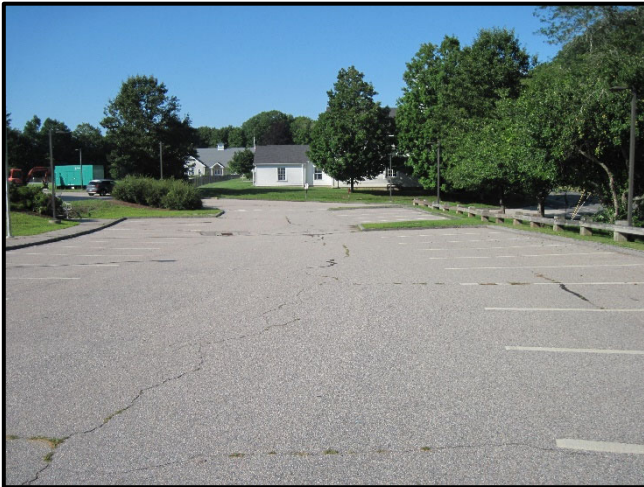
Lot 1 looking north. Various cracks visible in pavement.

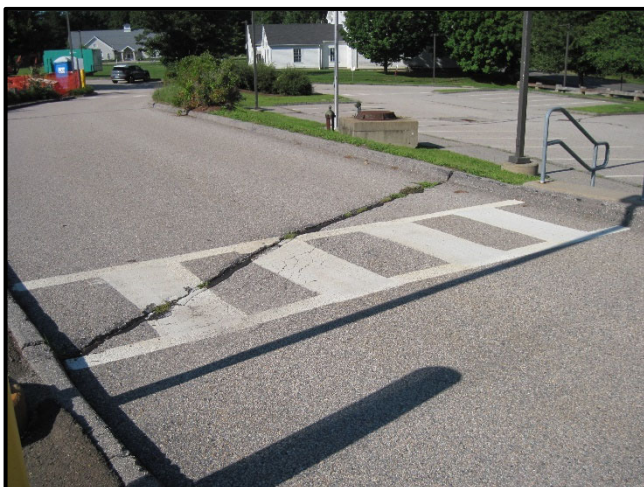
Some of the cracks observed have been treated with asphaltic crack sealer while other areas of cracking have not been treated. It was also noted that some of the previously treated/sealed cracks exhibit signs of additional crack expansion/sealing failure, including the presence of grassy vegetation. An example of this is a large crack at the southern end of Drive 2.

Drive 2 at south pedestrian crossing, large crack visible extending through pavement and bituminous curbs.

Area	Classification	Commentary
Drive 1	Fair	Crack repairs recommended.
Drive 2	Fair	Crack repairs recommended; Cut/repair large crack at south end.
Lot 1	Fair	Crack repairs recommended
Lot 2	Fair	Crack repairs recommended

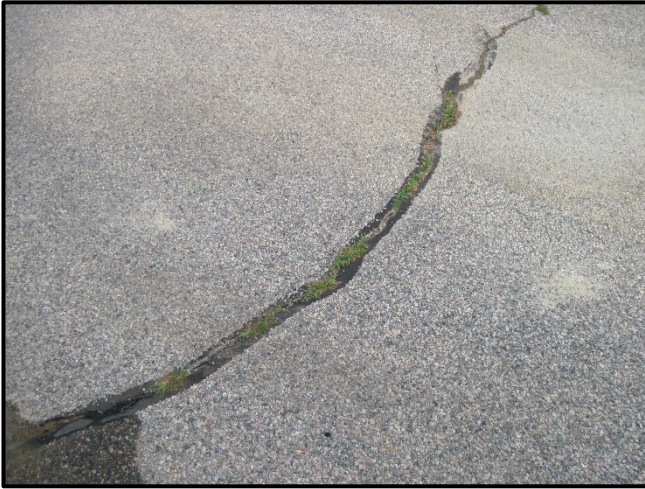
Example of previously repaired crack in bituminous pavement.

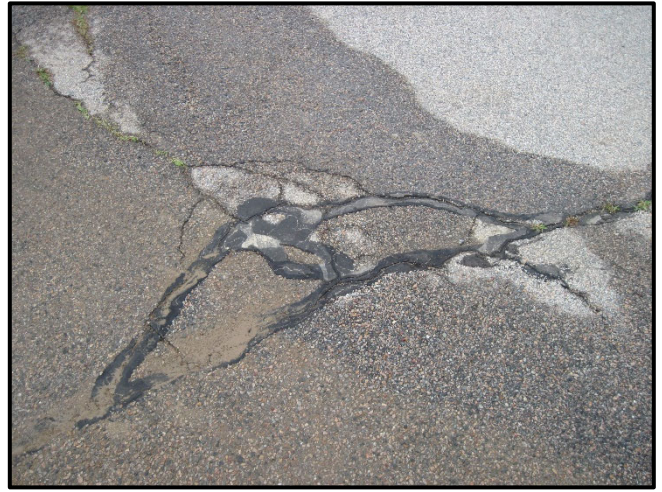
Example of localized fatigue cracking.

- Funding should be allocated for localized repairs (removal and patching) when warranted. These localized repairs should target areas where localized pavement deterioration/fatigue cracking is significant, including locations where block cracking, longitudinal crack or

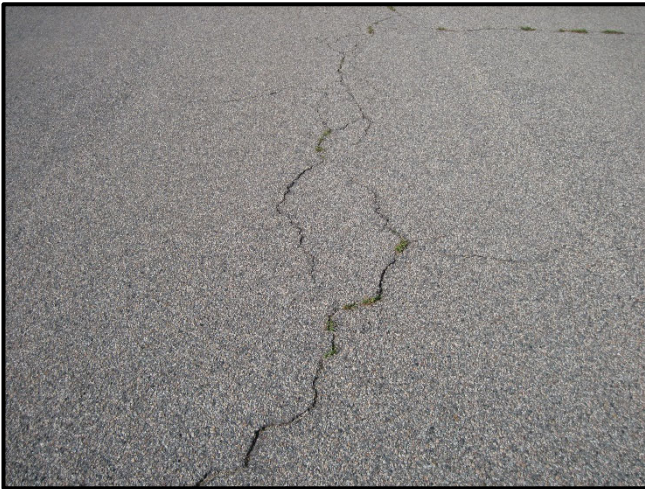
A combination of transverse cracking and longitudinal cracking was noted to varying degrees in all areas observed. These cracks are indicative of the pavement material’s age. Some block cracking was also observed, which is also a function of the pavement’s age. Pavement seams that have cracked at the edges of patching, presumably for utility installations, was also observed in several locations (e.g. Lot 2 and Drive 1). Some areas of localized pavement deterioration/fatigue cracking were noted, including locations where block cracking, longitudinal crack or transverse crack propagation has occurred. In these areas, it is probable

that progressive block cracking has allowed water to penetrate the base, resulting in localized structural compromise, which in-turn causes further pavement degradation/cracking. Based on the overall condition of the pavement at the school, these areas are not indicative of a global base failure.

Block cracking with additional cracks propagating.

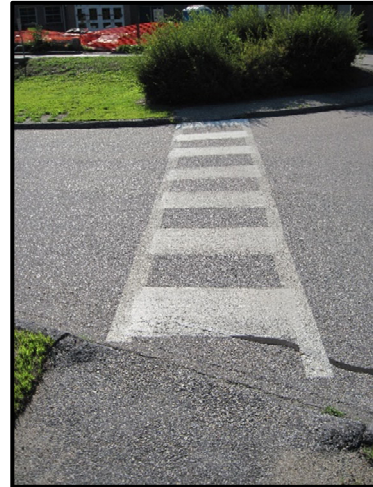
Overall, pavement markings are in “Fair” condition. All pavement markings show signs of wear and/or discoloration, to varying degrees, with some being affected by crack sealing material. Pavement markings at accessible parking spaces or generally in “Satisfactory” condition, although as indicated herein, as marked, are not code compliant (refer to Section 3.4).

Typical pavement markings.

Based on the anticipated rate of deterioration, funding should be allocated for the re-painting of existing pavement markings within 3 to 5 years. Directional arrow pavement markings should be added at the school’s main driveway, and at Drive 1 and Drive 2 to clarify the intended one-way direction of vehicle movement.

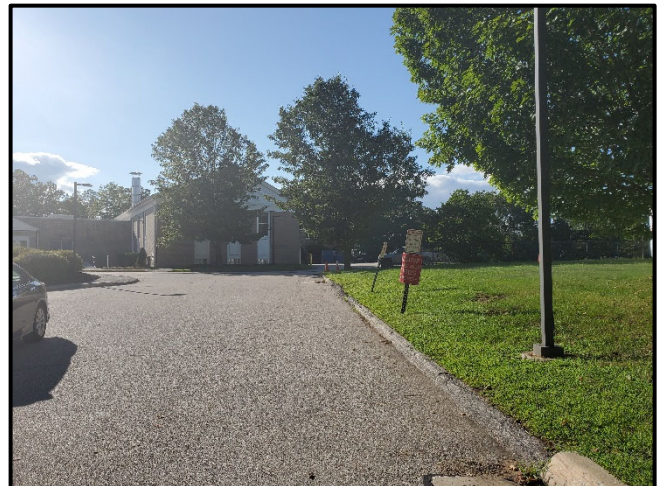
Overall, site signage is in “Fair” condition, although some signs are heavily faded or on posts that are damaged. All signs observed were metal sheeting on metal posts. Signs are mounted on a combination of U-channel and tube-type posts. All posts are ground penetration type configurations. No breakaway-type mounts were observed. Sign mounting height varied across the site. Several accessible parking signs are not mounted at the correct height (refer to Section 3.4). It should be noted that sign retroreflectivity testing was not conducted during the study.

Damaged signs along entrance drive, looking west.

Site signage that is heavily faded or on damaged posts should be replaced (for example, on the north side of the site driveway). Other signs should be monitored for degradation and replaced as needed. The District should also select a standard sign type, mounting type, and post type to facilitate upkeep

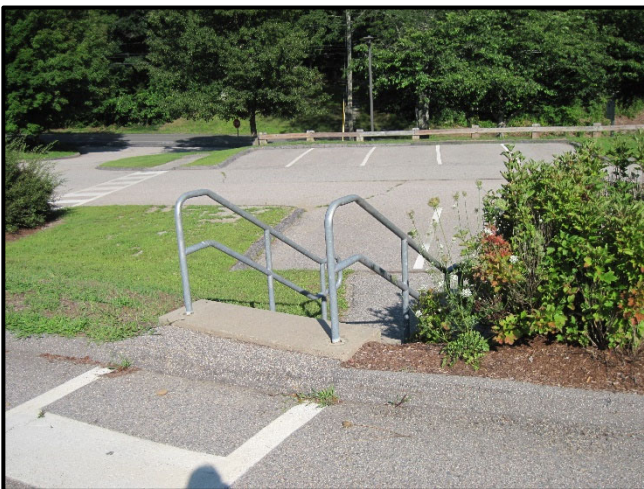
Site stairway "Stair 1" looking east. Stairway lacks a landing complying with 2015 IBC 1011.6.

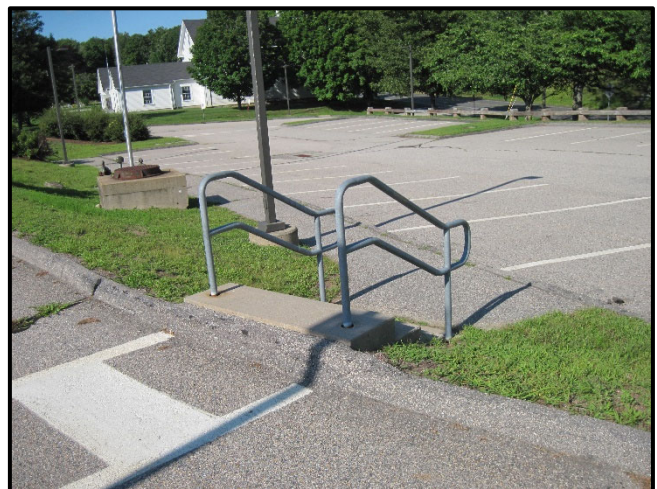
Site stairway "Stair 2" looking northeast. Stairway lacks a landing complying with 2015 IBC 1011.6.

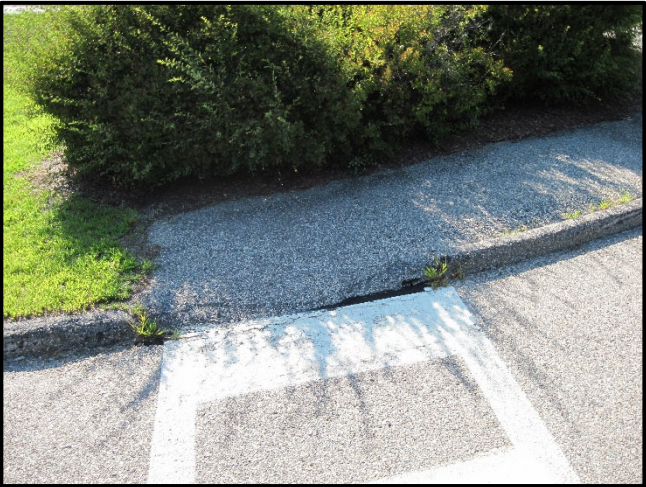
Curb ramp at crosswalk, north end of Lot 1. Ramp is not in compliance with ICC A117.1, 406 (opposing ramp same).

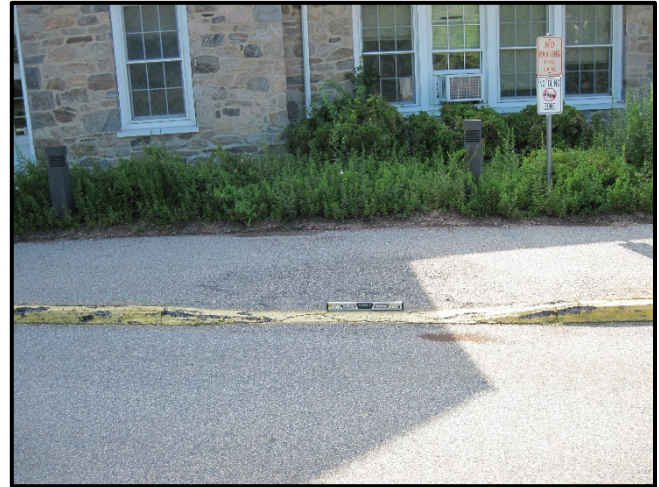
Curb ramp at front of school along bus lane. Ramp is not in compliance with ICC A117.1, 406.

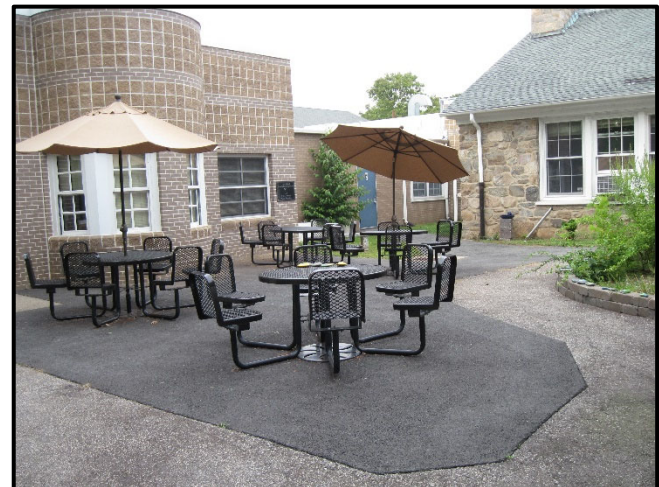
Outdoor seating area, west side of school. Accessible Routes should be confirmed for exterior areas and doors.

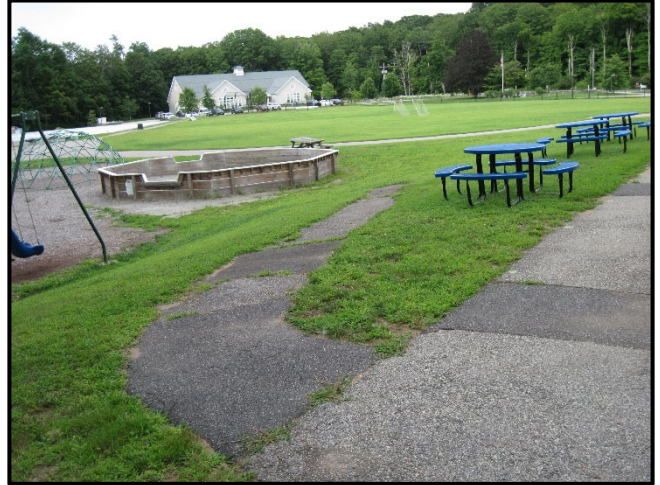
Play Area 2 looking northeast. Bituminous walkway does not comply with ICC A117.1 403.3 (slopes).

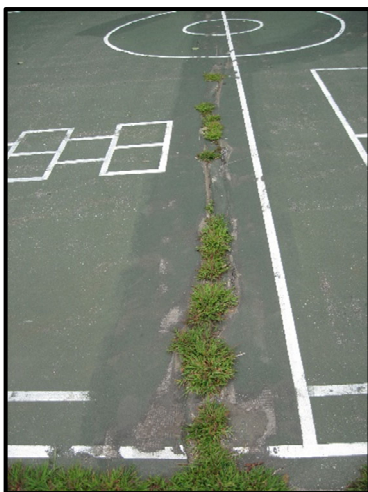
Cracks in basketball court surface. Previous repairs apparent.

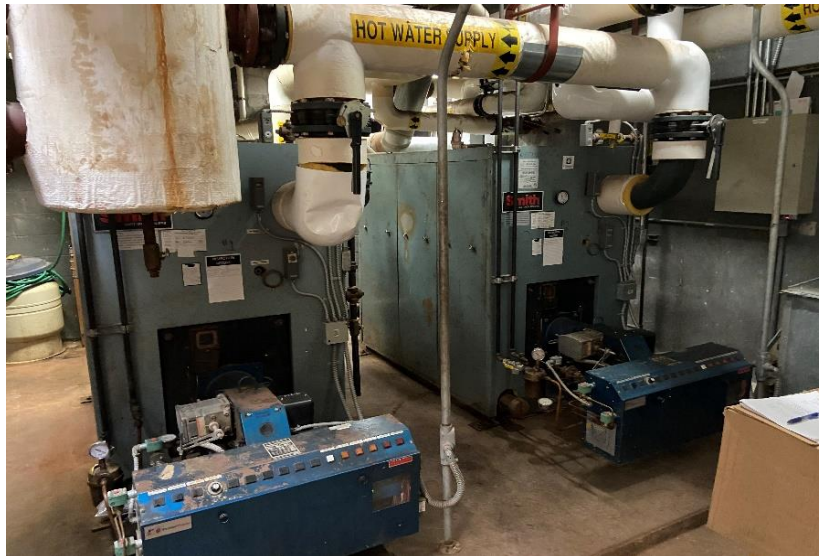
Heating Hot Water Boiler Plant

1. Heating for the building is generated by two oil fired boilers manufactured by HB Smith. The boilers are 20 years old and nearing their approximately 25 year useful life. Regular maintenance appears to be occurring based on maintenance notes on the units.
2. Hot water circulation pumps are base mounted constant speed end suction pumps which appear to be regularly maintained. Any changes to the hot water heating plant should include upgrade to newer pumps with variable speed drives for energy efficiency.
3. Hot water system uses a propylene / glycol water solution.
4. Oil for the boiler and water heater systems is circulated through a duplex Webster oil pump set. This appears to be 20 years old and nearing its useful life expectancy.

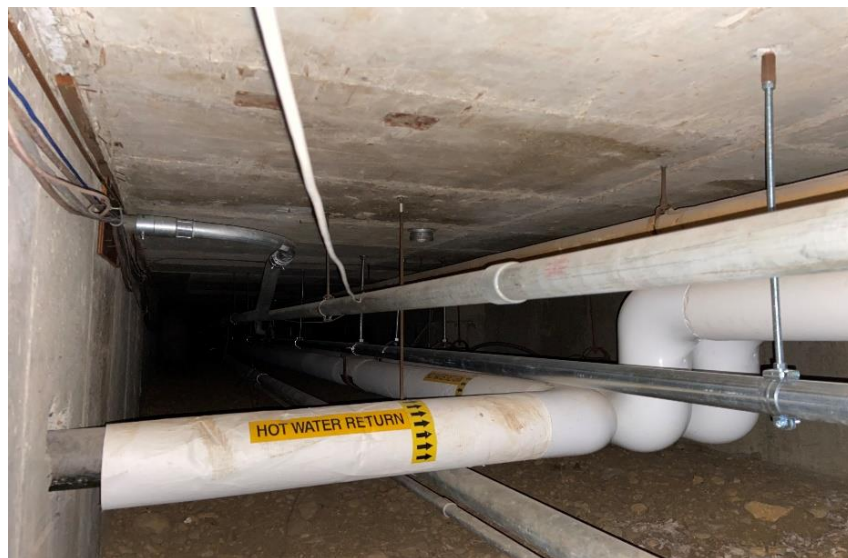
Piping in Tunnel

5. Hot water piping for the building exists both in tunnels and above ceilings. The majority of piping was replaced 20 years ago and is fair condition. Heating piping has a useful life of 40-50 years which this may be coming close to.

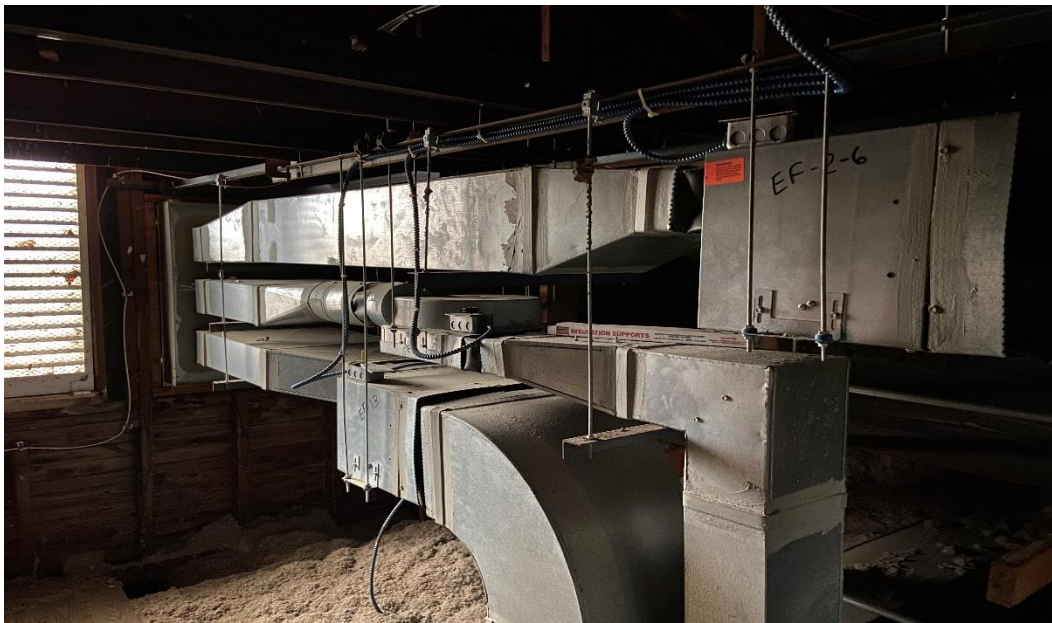
Exhaust Fans in the Attic

2. Ventilation of the classrooms and toilet rooms is served by multiple exhaust fans in the attic. The fans are over 20 years old and appear to be in fair to poor condition. A typical fan has an approximately 20 year useful life which these are beyond.

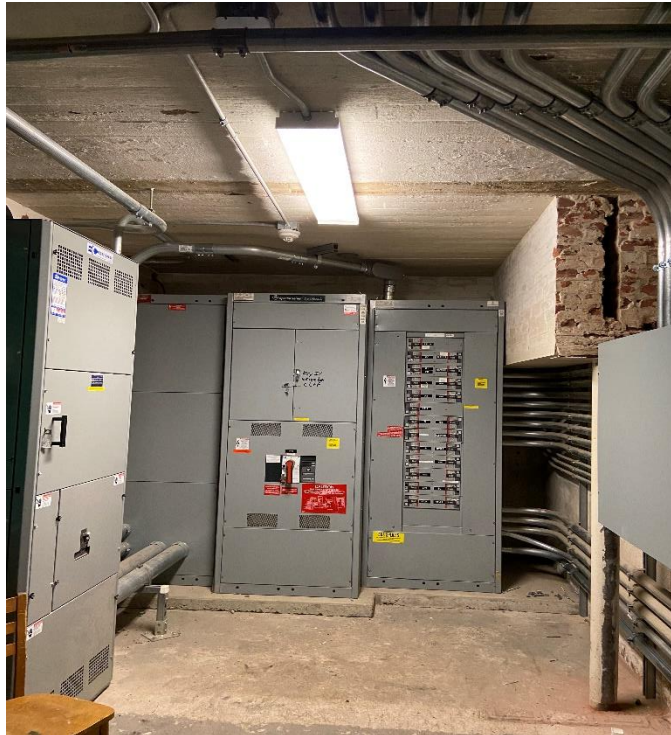
Main Switchboard at Electrical Room

1. The Main Service Switch and distribution section is rated at 1600A, 120/208V, 3-phase, and is manufactured by General Electric. The main switchgear is approximately 20 years old and is in good condition. All panelboards and conduits within the electrical room appear to be clean, dry, and well labeled. Switchgear which is well maintained has a useful life of 30-50 years or more.

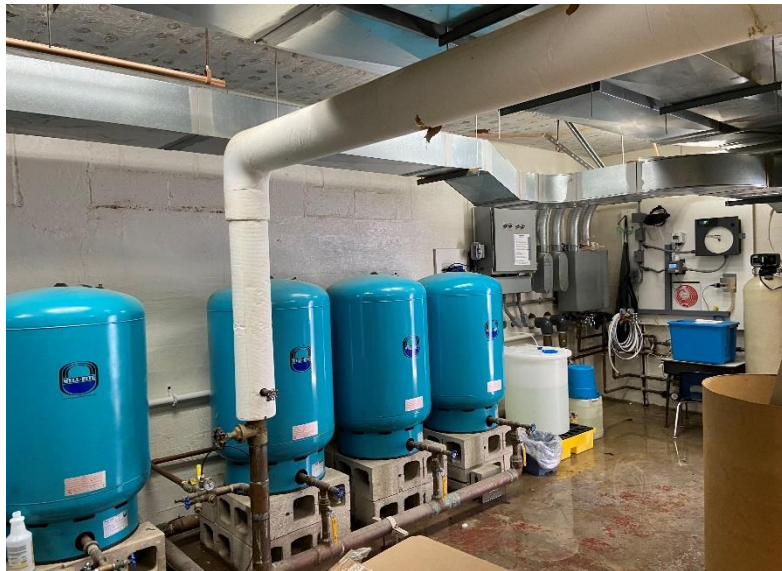
Well Water Storage Tanks

1. Domestic Water is served from a well pump on site and storage tanks/filters/ pressure controls in the basement. The storage tanks are 20 years old and nearing their approximately 25 year useful life.

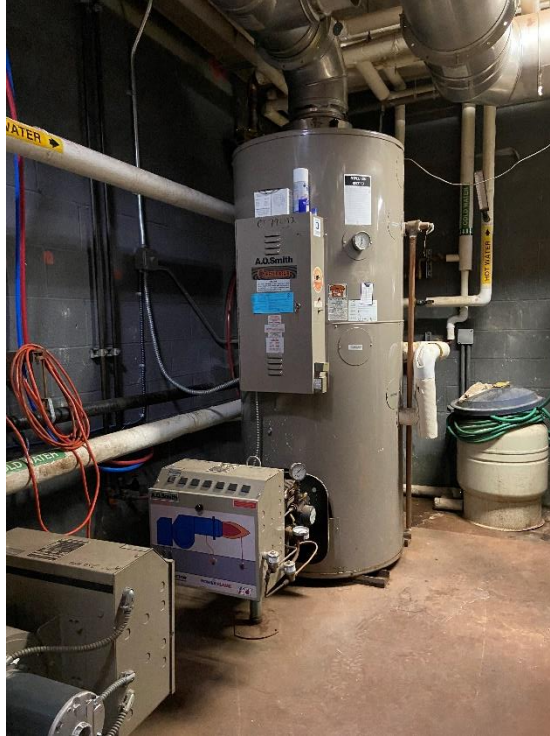
Fuel Fired Water Heaters

1. Domestic hot water is generated by two oil fired water heaters manufactured by AO Smith. The water heaters are 20 years old and nearing their approximately 25 year useful life. Regular maintenance appears to be occurring
2. Two hot water mixing stations exist in this room. One serves general hot water at 110 degrees, and the other serves kitchen hot water at 140 degrees. Each service is served by a hot water recirculation pump which appear to be in fair condition.
