REGIONAL SCHOOL DISTRICT 18

Facility Study – Middle School

August 15, 2021

Regional School District 18
Lyme & Old Lyme
Facilities Study & Educational Specifications

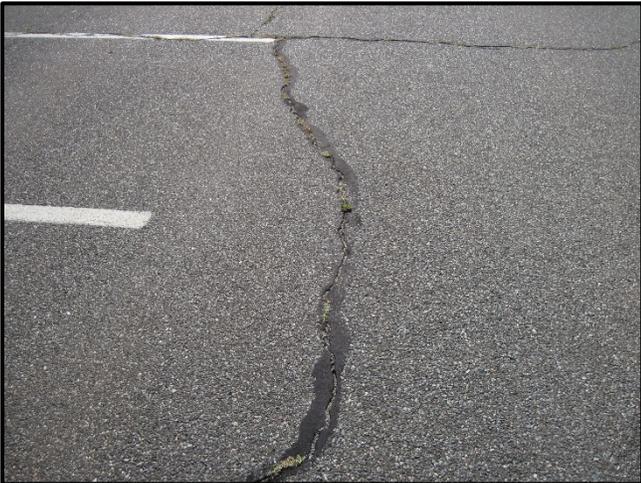
Many of the cracks observed have been treated with asphaltic crack sealer while other areas of cracking have not been treated. It was also noted that some of the previously treated/sealed cracks exhibit signs of additional crack expansion/sealing failure, including the presence of grassy vegetation.

Typical failure of crack sealant.

- A Routine Maintenance Program should be implemented and revisited on (at least) an annual basis. This maintenance program should incorporate the following:
 - 1) Monitoring of cracks.
 - 2) Frequent and consistent removal of vegetation and debris from cracks.

- 3) Removal of debris (sand, etc.) from the pavement surface.
- 4) Crack sealing.
- 5) Surface sealing; (select areas or full coverage).

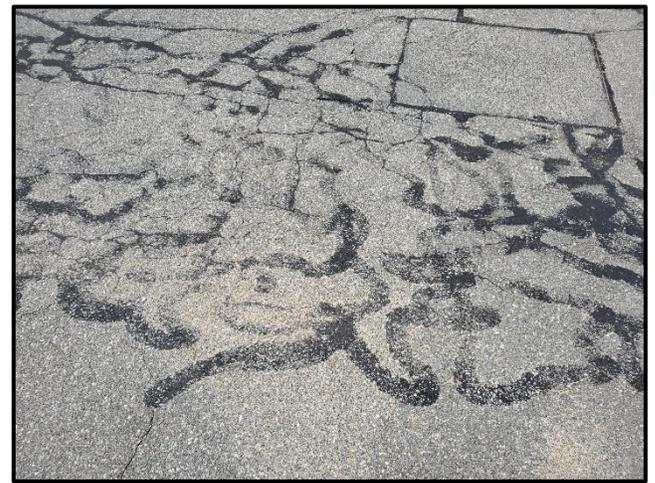
A combination of transverse cracking and longitudinal cracking was noted to varying degrees in all areas observed. These cracks are indicative of the pavement material’s age. Some block cracking and limited edge cracking were also observed. This is also a function of the pavement’s age. Pavement seams that have cracked at the edges of patching, presumably for utility installations, was also observed in several locations. Some areas of localized pavement deterioration/fatigue cracking were noted, including locations where block cracking, longitudinal crack or transverse crack propagation has occurred. In these areas, it is probable that progressive block cracking has allowed water to penetrate the base, resulting in localized structural compromise, which in-turn causes further pavement degradation/cracking. Based on the overall condition of the pavement at the school, these areas are not indicative of a global base failure.

Localized area of block failure

- Funding should be allocated for localized repairs (removal and patching) when warranted. These localized repairs should target areas where localized pavement deterioration/fatigue cracking is significant, including locations where block cracking, longitudinal crack or transverse crack propagation has occurred, and where this deterioration has resulted in potholes.
- Coordination with the recommendations of other aspects of this facilities study should be noted to avoid expending maintenance efforts on pavement areas that may be subject to reconfiguration or replacement as a result of other repair or mitigation efforts.

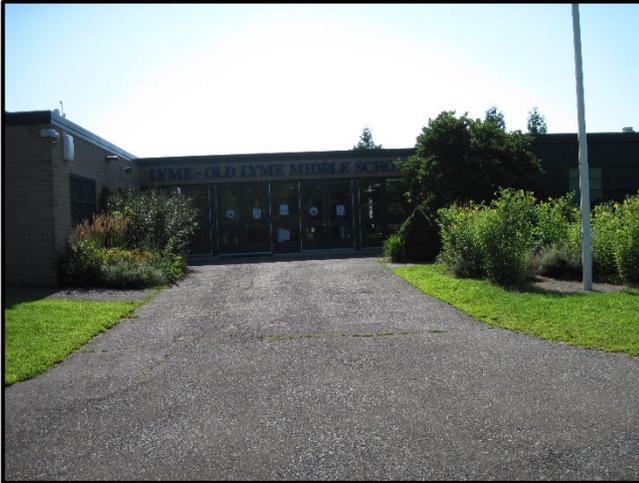
Bituminous walkway at primary school entrance. Cracks showing vegetative growth visible.

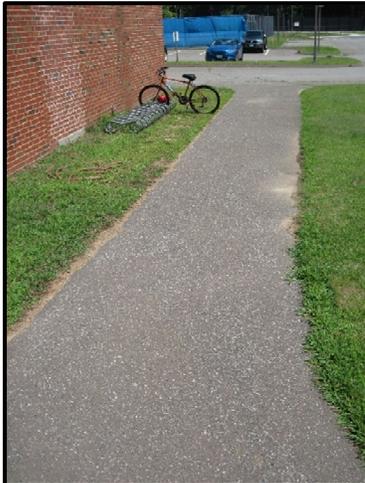
Bituminous site walkway, looking north at Door 7. Minor edge deterioration visible.

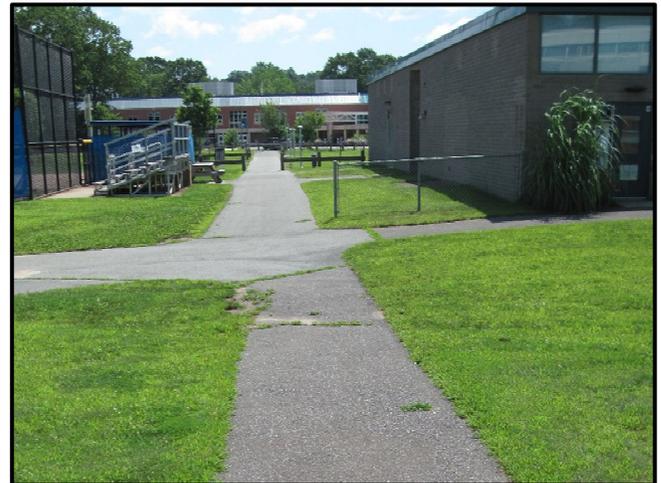
Bituminous site walkway, looking west from Door 7. Localized cracking and settlement visible.

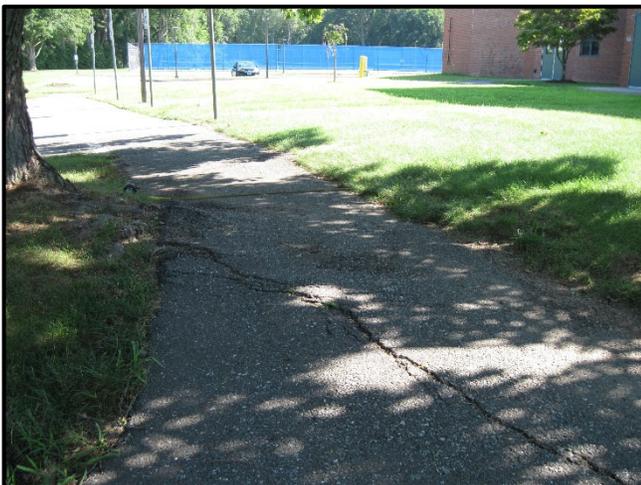
Walkway at front of school with heaving/root damage.

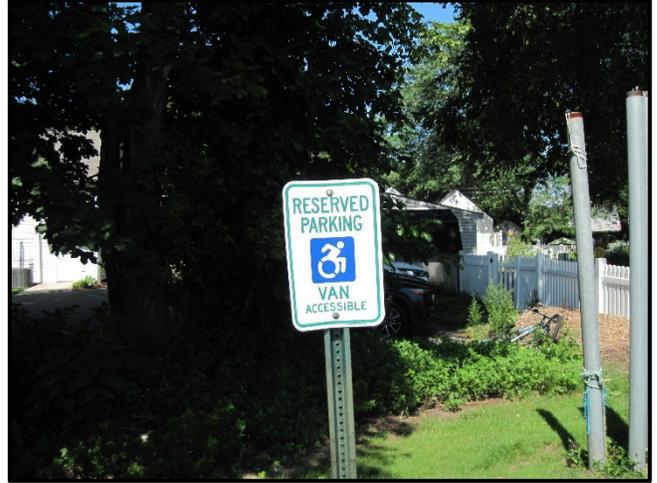
Existing accessible parking sign at Lot 1. Not compliant with CGS 14-253a subsection (h); CTBC Amd 1111.1.

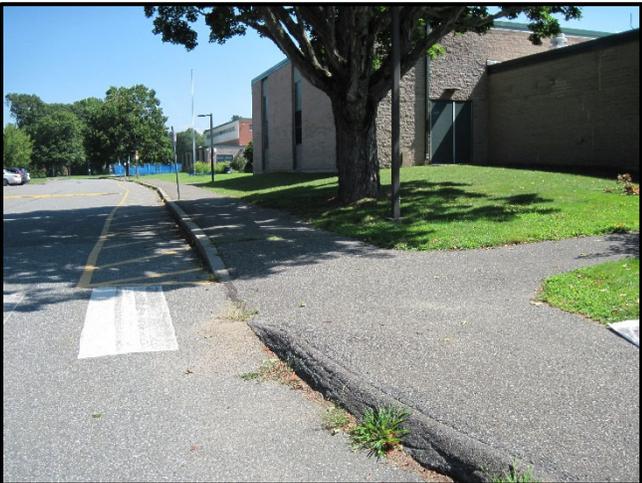
Curb ramp across from accessible parking in Lot 1 at crosswalk. Lacking 36-inch level landing.

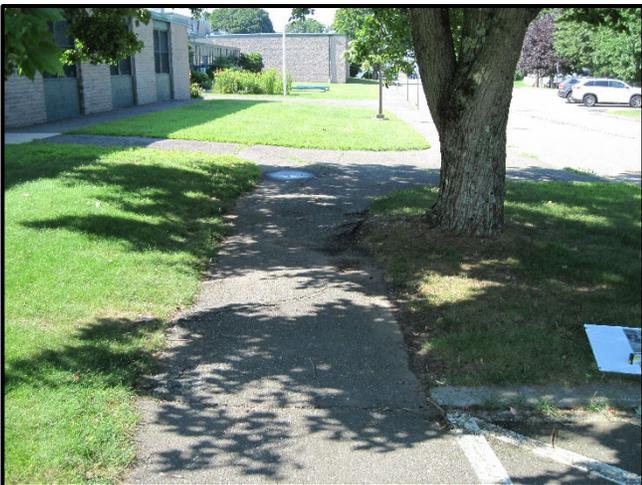
Walkway "Accessible Route" at Lot 3, looking south. Heaving and cracks from tree roots visible.

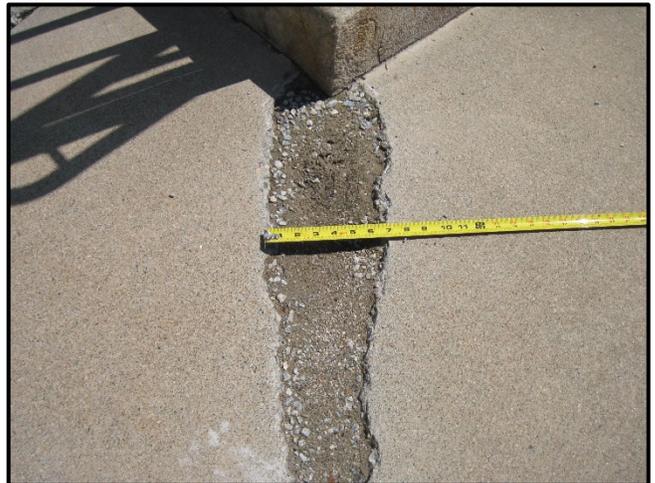
Pedestrian ramp 1, walking surface damage at top Landing.

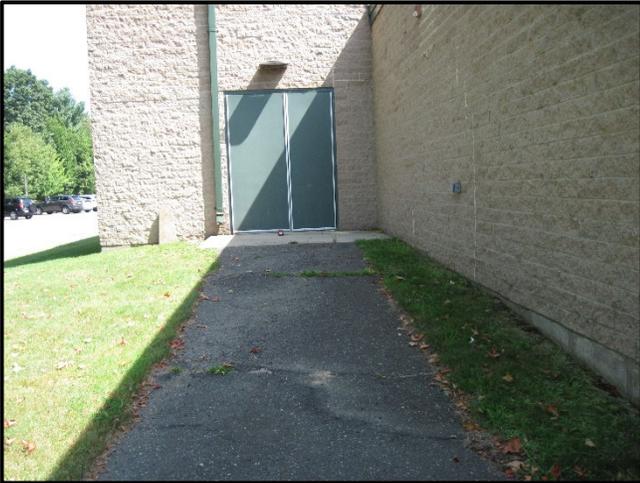
Accessible Route from cafeteria egress door. Cracks

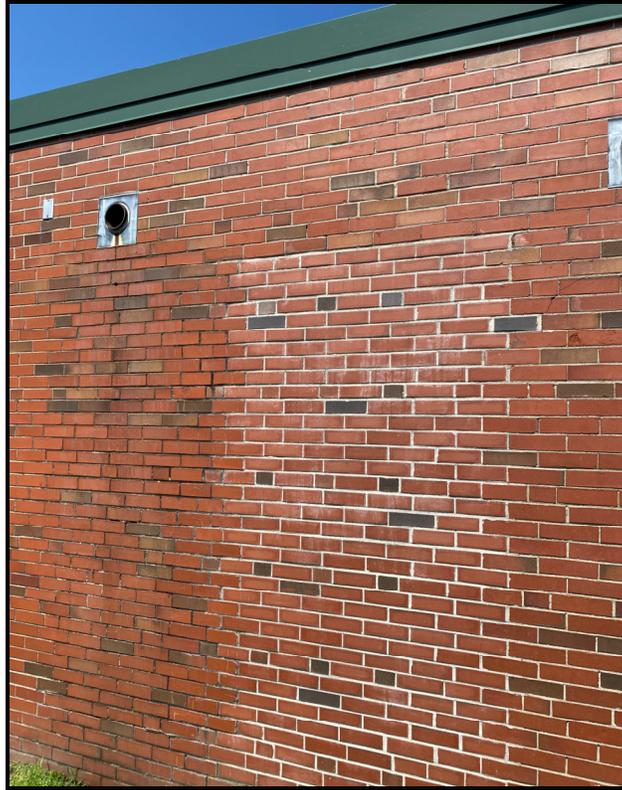
PHOTO 1: 7/23/2021 - Area D – East Wall - Cracked Brick and mortar joints requiring repointing.

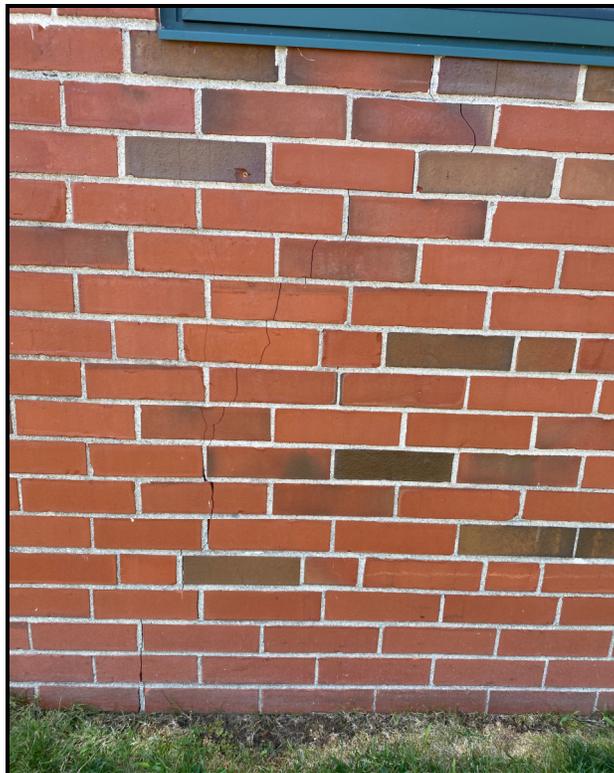
PHOTO 2: 7/23/2021 – Area D – East Wall - Cracked Brick

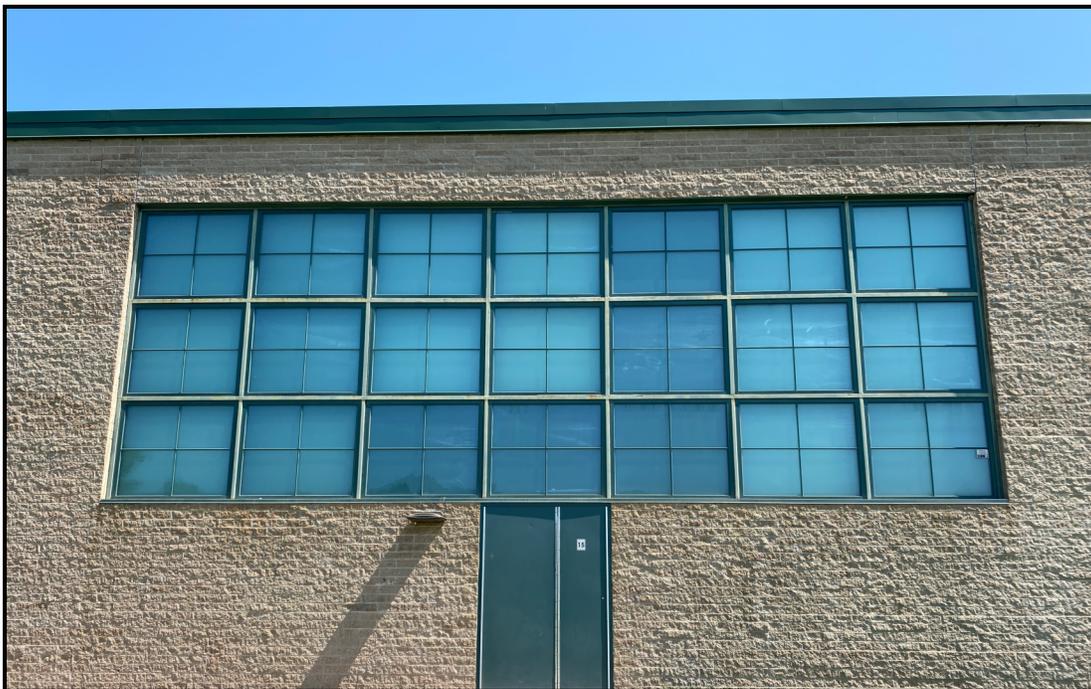
PHOTO 4: 7/23/2021 – South Elevation of Media Center – Cracked CMU and missing control joints

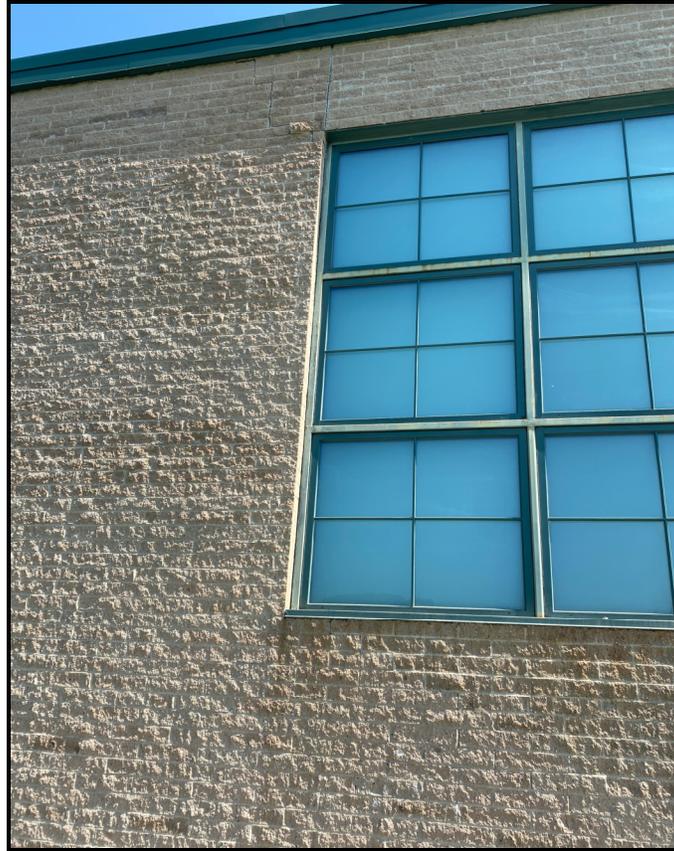
PHOTO 5: 7/23/2021 – South Elevation of Media Center – Cracked CMU and missing control joints

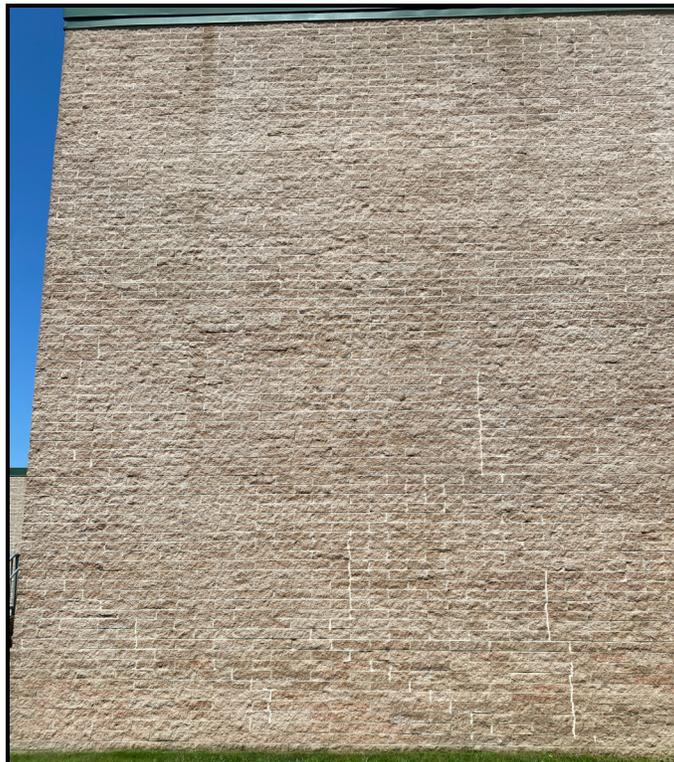
PHOTO 6: 7/23/2021 – North Elevation of Media Center – Cracked CMU caulked control joints

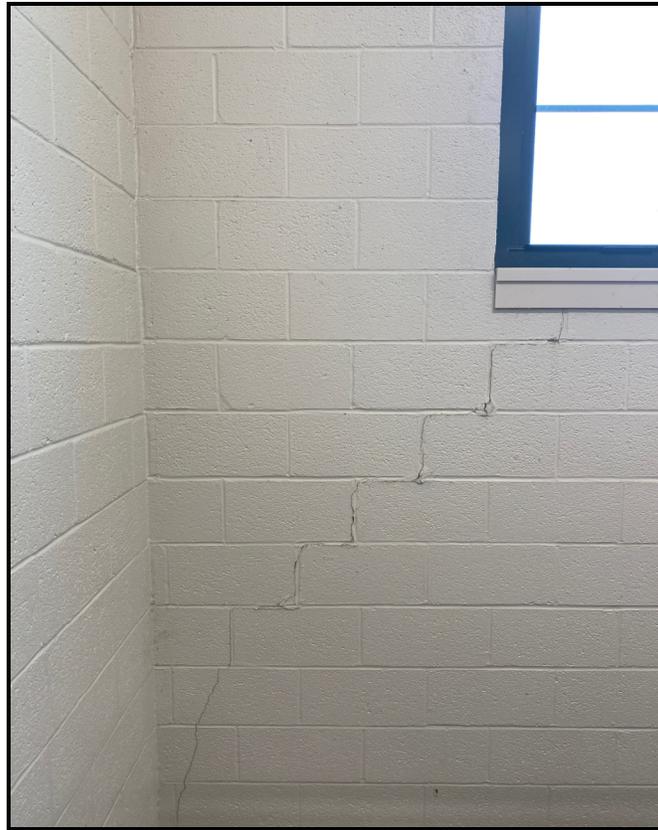
PHOTO 7: 7/23/2021 – Interior Stairwell – Settlement cracks

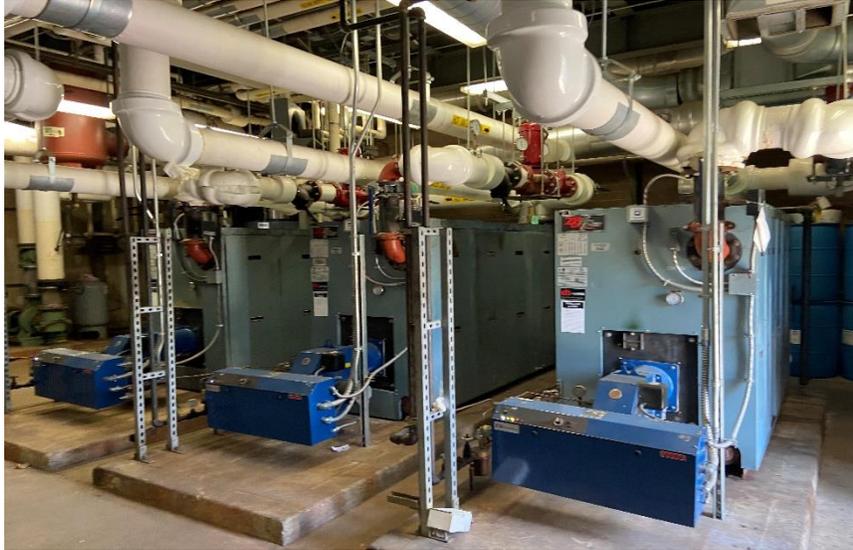
Heating Hot Water Boiler Plant

1. Heating for the building is generated by three oil fired boilers manufactured by Smith. The boilers are 19 years old and nearing their approximately 25 year useful life. Regular maintenance appears to be occurring.
2. Hot water circulation pumps are in line and base mounted end suction pumps which appear to be regularly maintained.
3. Boilers also serve the adjacent Center School. Two pumps are dedicated to the Center School Piping drops down through the floor; buried to the adjacent school.

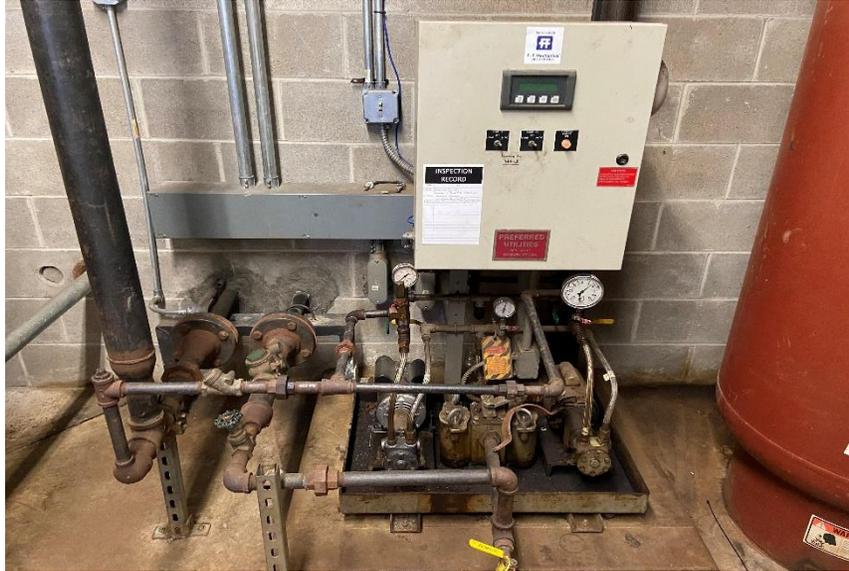
Fuel Oil Pumps

4. Oil for the boiler and water heater systems is circulated through a duplex Webster oil pump set. This appears to be 19 years old and nearing its useful life expectancy.
5. Hot water piping for the building exists both in tunnels and above ceilings. The majority of piping was replaced 19 years ago and is fair condition. Heating piping has a useful life of 40-50 years which this may be coming close to.

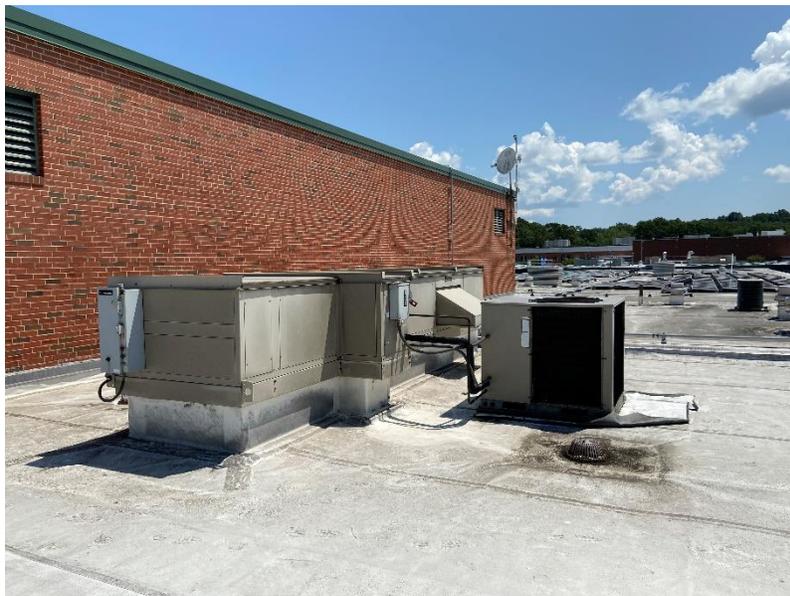
1. Multiple rooftop units provide a majority of the ventilation to the building.. These units are over 19 years old and appear to be in poor condition. Casings for each unit are rusted and showing signs of wear. A typical rooftop unit has an approximately 20 year useful life which these are beyond. In addition, the motor efficiency, filter quality, and other features are not meeting today's standard for schools. Lastly, cooling or dehumidification systems are strongly recommended for modern schools.

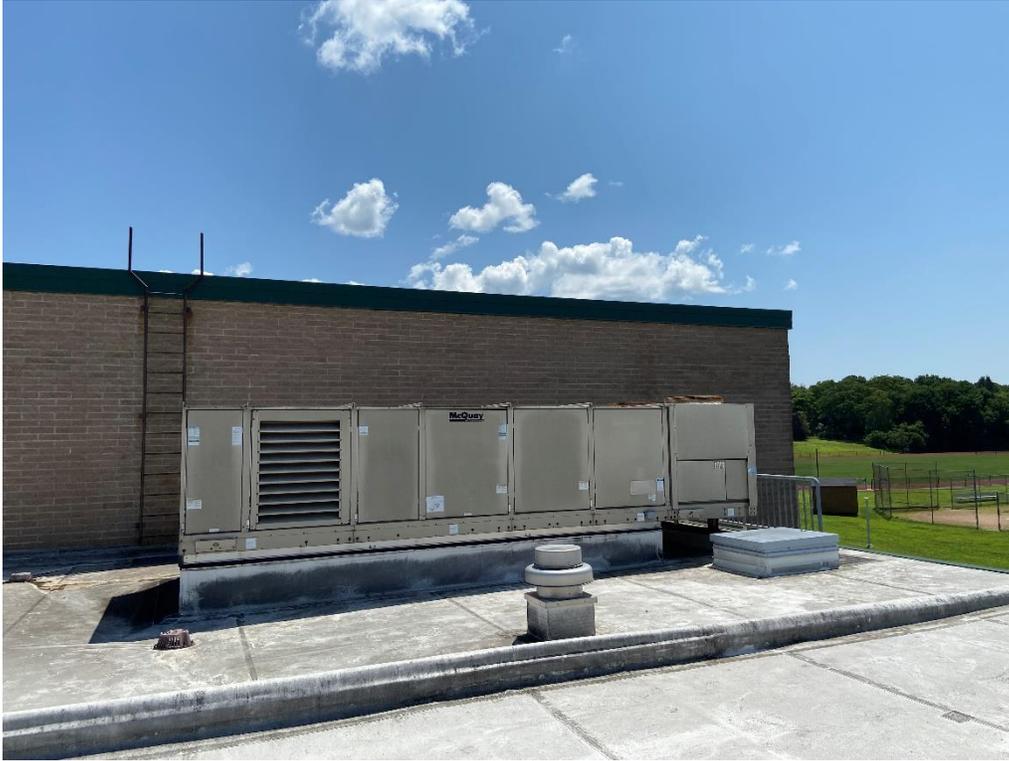
Packaged Rooftop Unit

1. Certain areas of the building are served by packaged rooftop units; or heating and ventilation units with remote compressor / condensers. These units are over 19 years old and appear to be in poor condition.

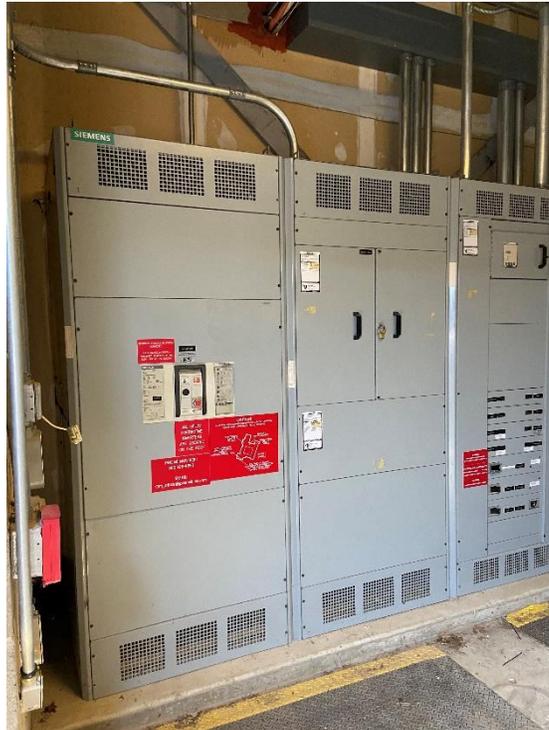
Main Switchboard at Electrical Room

1. The Main Service Switch and distribution section is rated at 2500A, 277/480, 3-phase, and is manufactured by Siemens. The main switchgear is approximately 19 years old and is in good condition. All panelboards and conduits within the electrical room appear to be clean, dry, and well labeled. Switchgear which is well maintained has a useful life of 30-50 years or more.

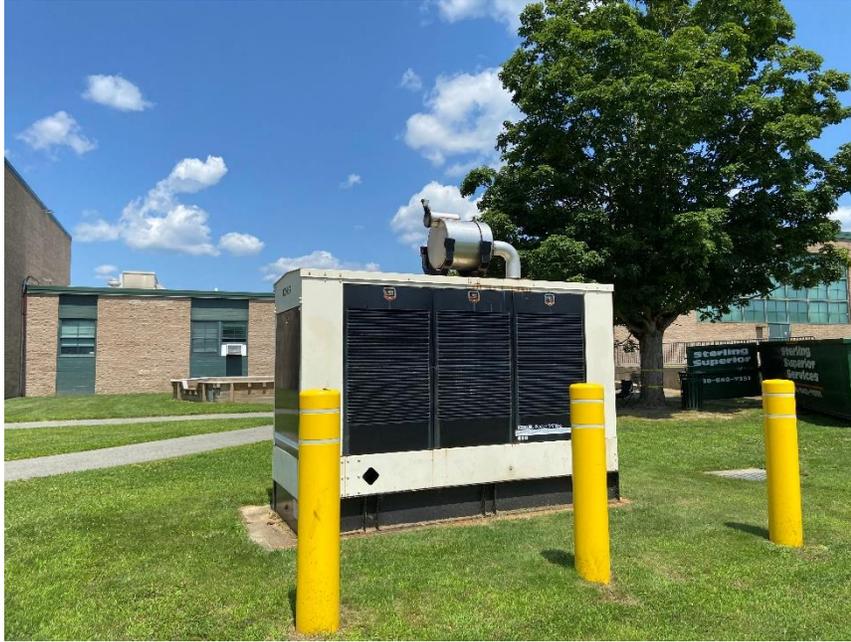
Emergency Generator

4. There is a Kohler 400 emergency generator on the property which serves the Middle School and Center Schools. Power from the generator enters the school and is controlled by a Kohler automatic transfer switch. The output of the transfer switch is an emergency distribution panel. The transfer switch and panelboards are in good condition.

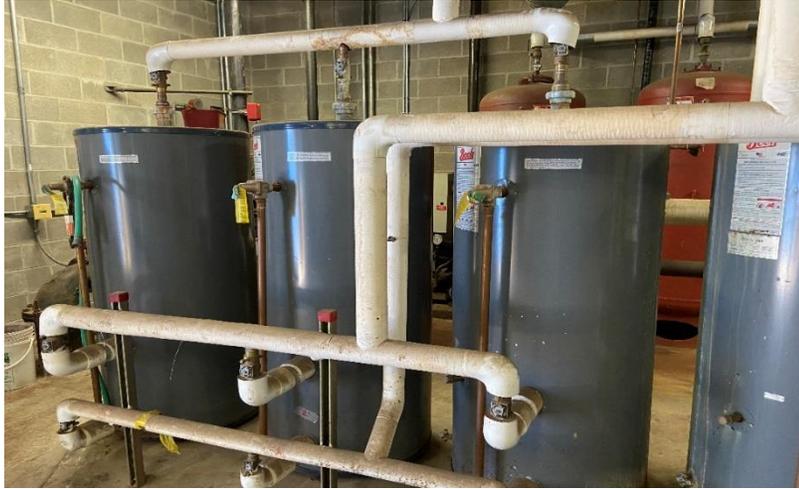
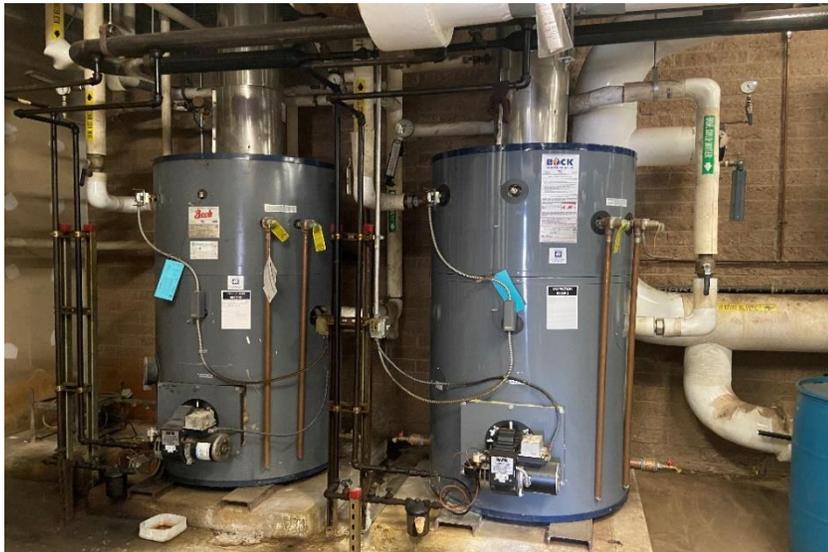
1. Domestic hot water is generated by two oil fired water heaters manufactured by Bock and five storage tanks; Bock 119 gallons each. The water heaters and tanks are 19 years old and nearing their approximately 25 year useful life. Regular maintenance appears to be occurring
2. Two hot water mixing stations exist in this room. One serves general hot water at 110 degrees, and the other serves kitchen hot water at 140 degrees. Each service is served by a hot water recirculation pump which appear to be in fair condition.

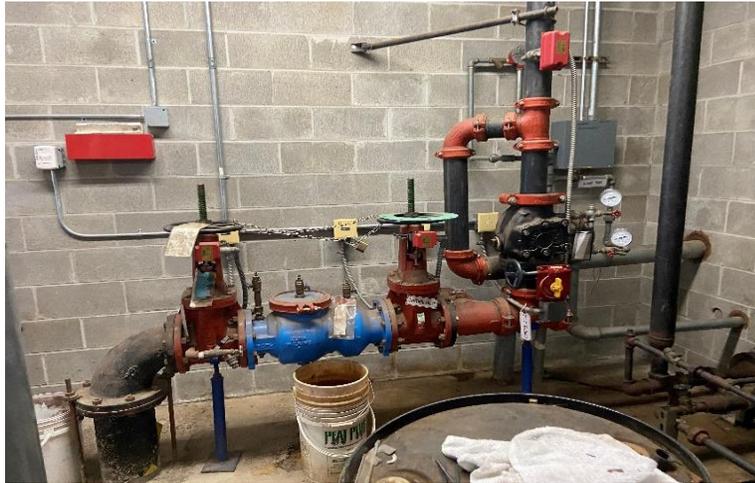
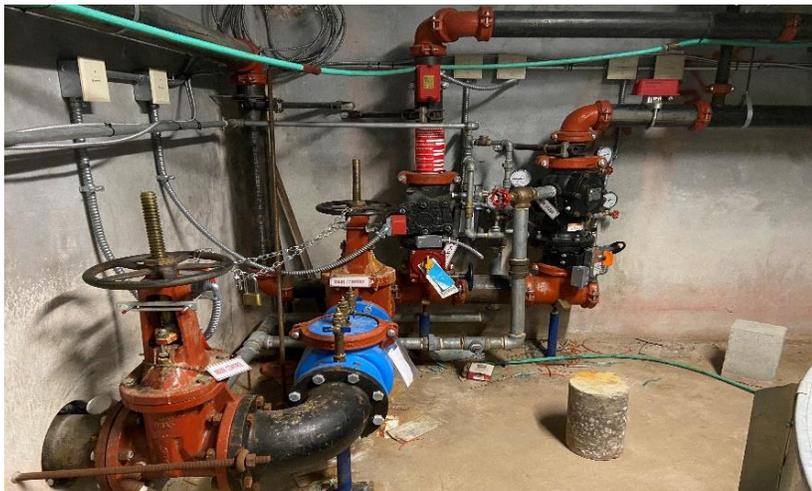
1. Fire services enter the building at multiple locations. The entrance in the boiler room and basement include a 6" double check valve assembly and zone valves. All valves and piping appear to be approximately 19 years old and in fair condition, with a 30-50 year useful life.
2. Sprinkler mains within the tunnels have minor corrosion on the exterior due to humidity, however, no significant corrosion or leaking was apparent.
