Project Observation Report

Project Name:	Tri Tech East Building	Project No.	2208
Report #:	1		
Observation Date:	10-12-22	Last Report:	2-15-22
Prepared By:	Steve Mallory, AIA	Contractor:	Banlin

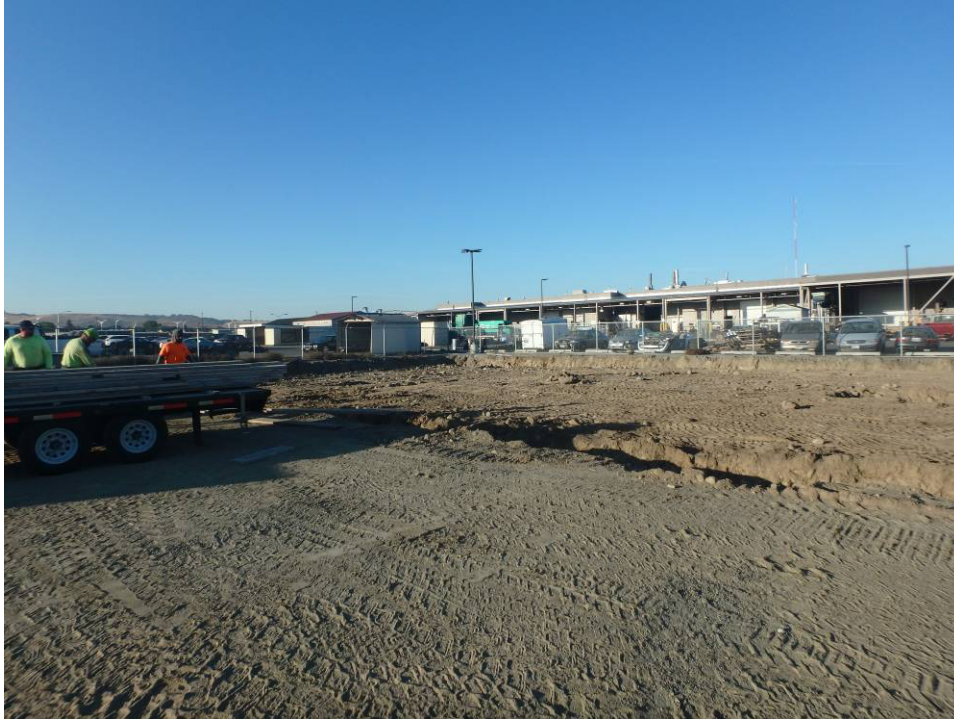
Looking southwest across the building footprint

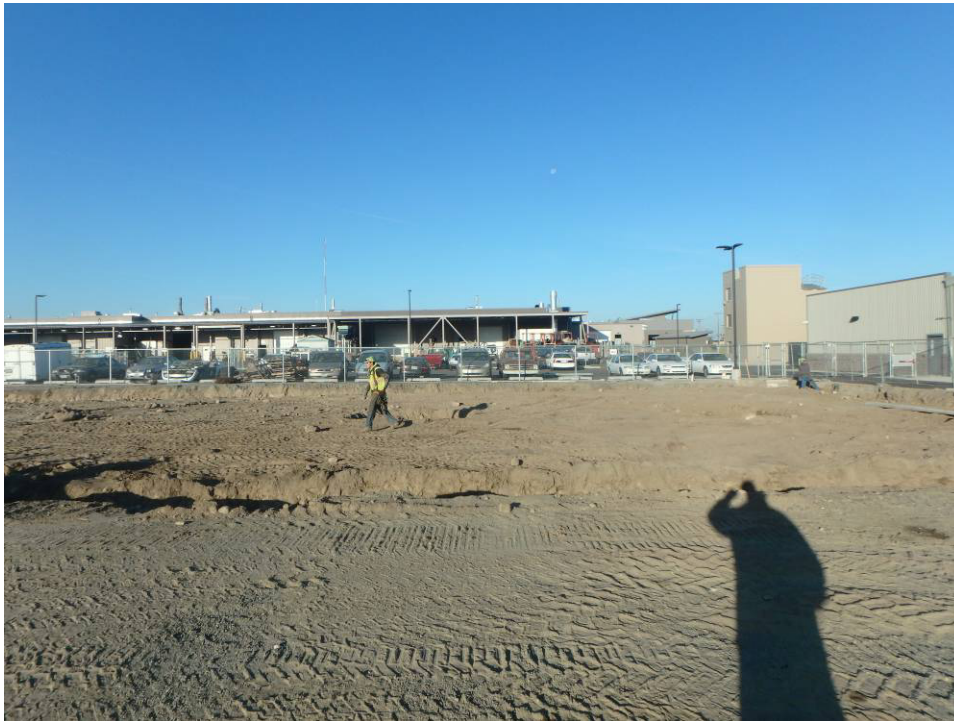
Looking west at the north half of the building footprint and

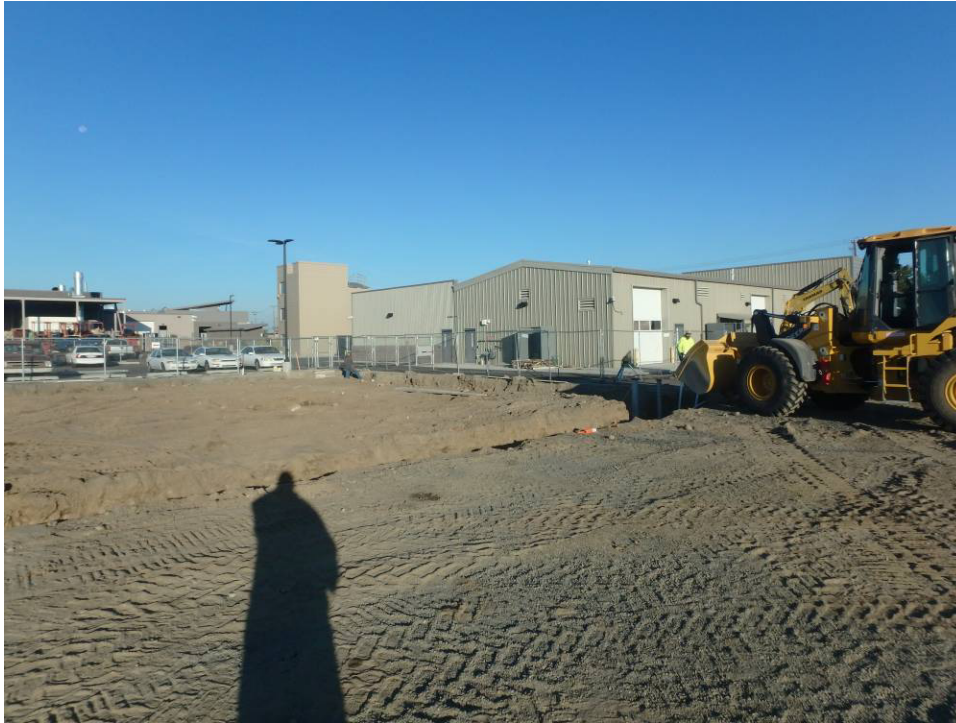
Looking at the northeast corner of the building footprint

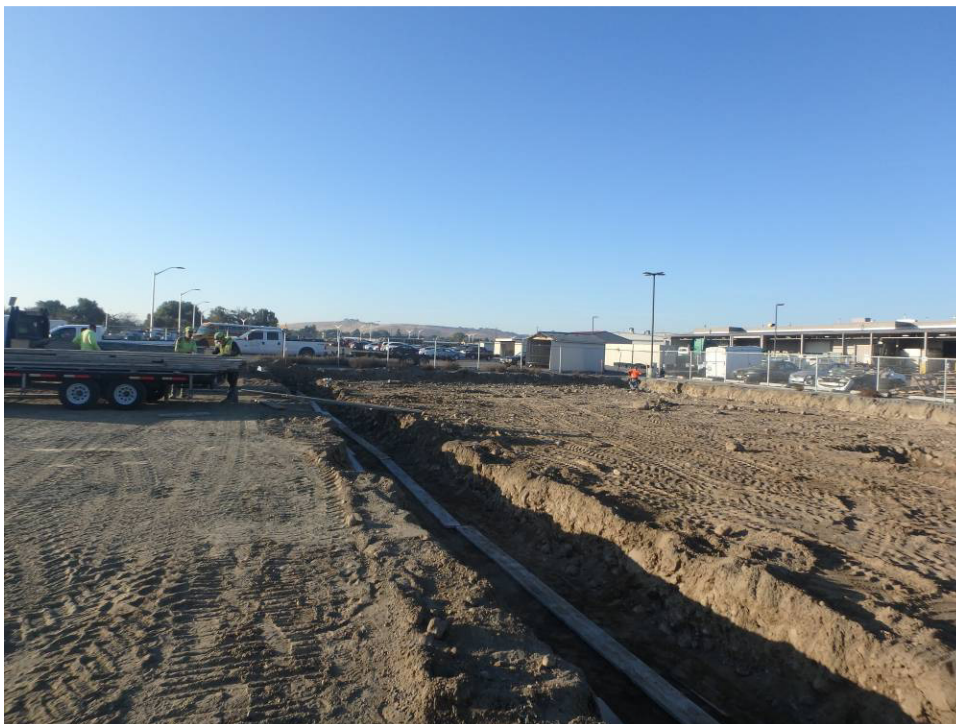
Looking south at the east foundation wall trench

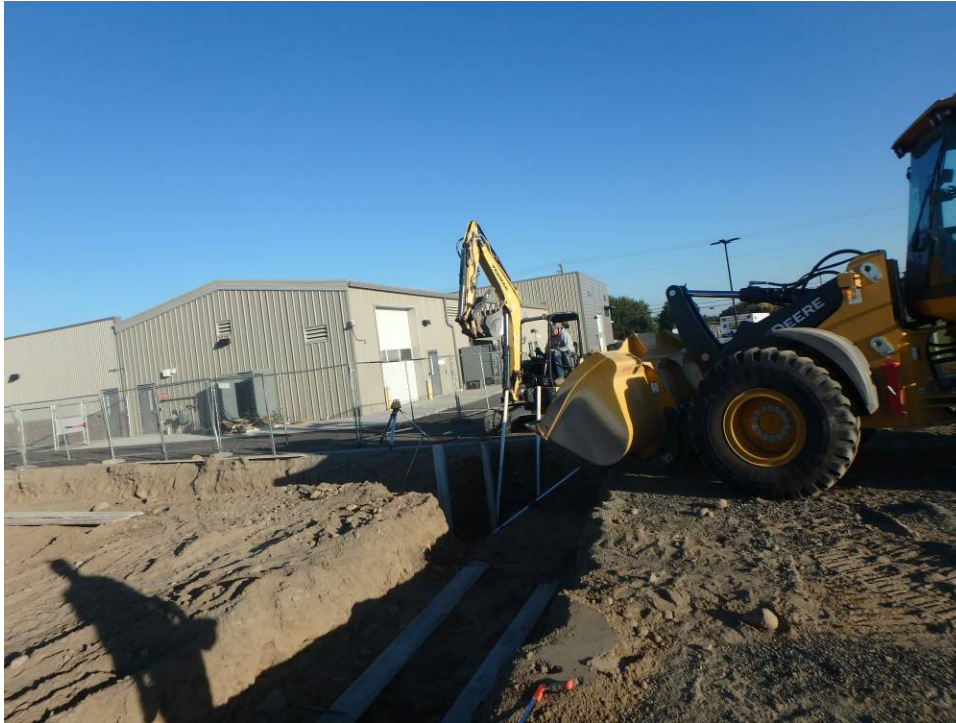
Forming the thrust block

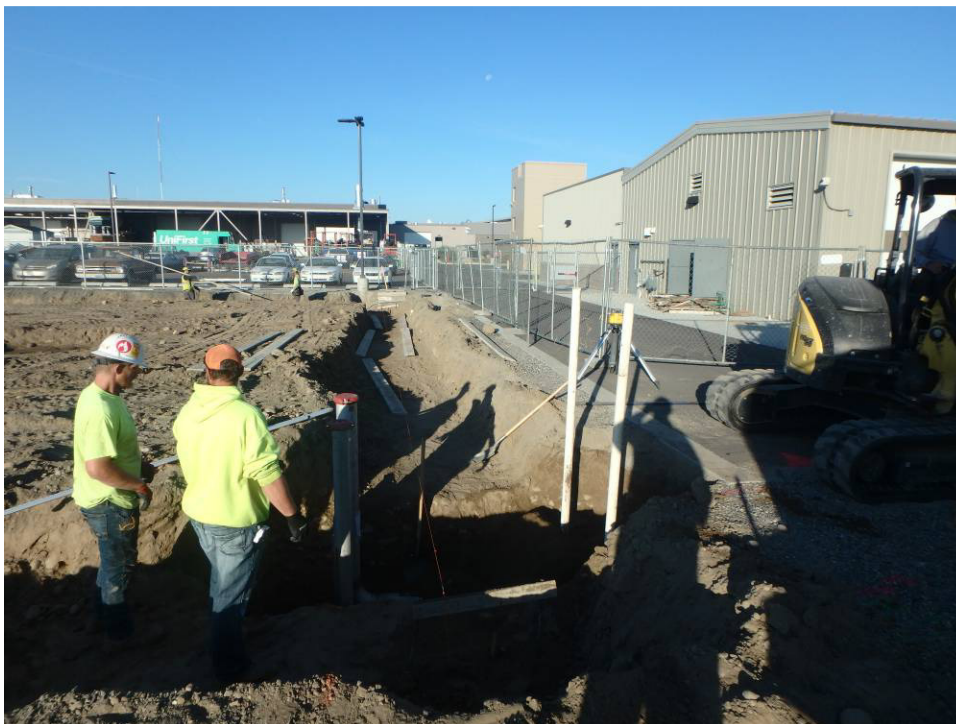
Looking west along the north foundation trench

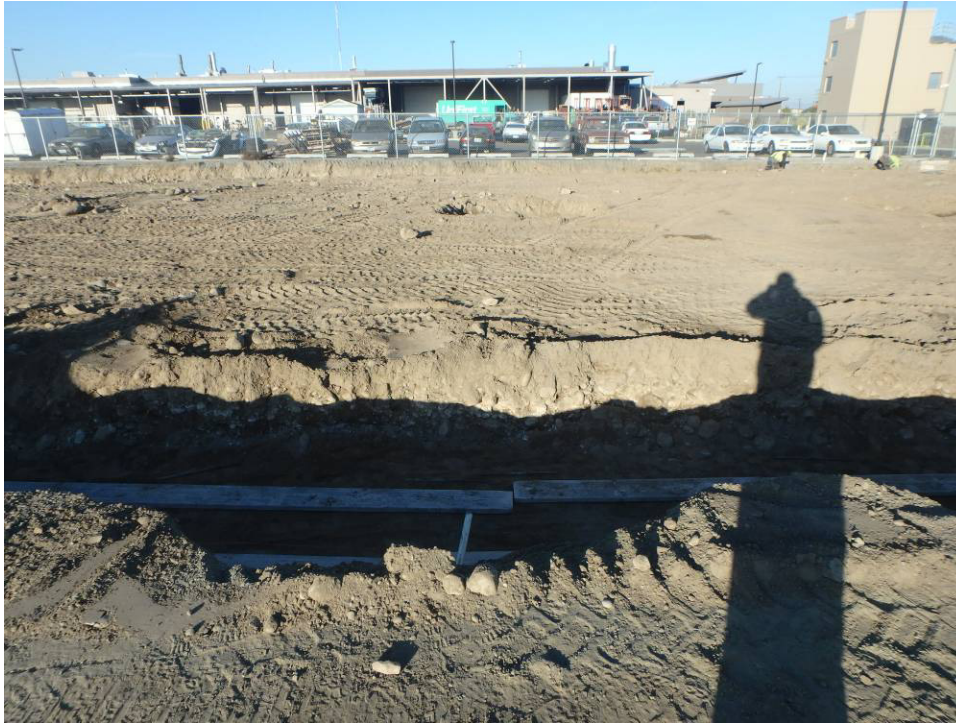
Looking west across the center of the building footprint

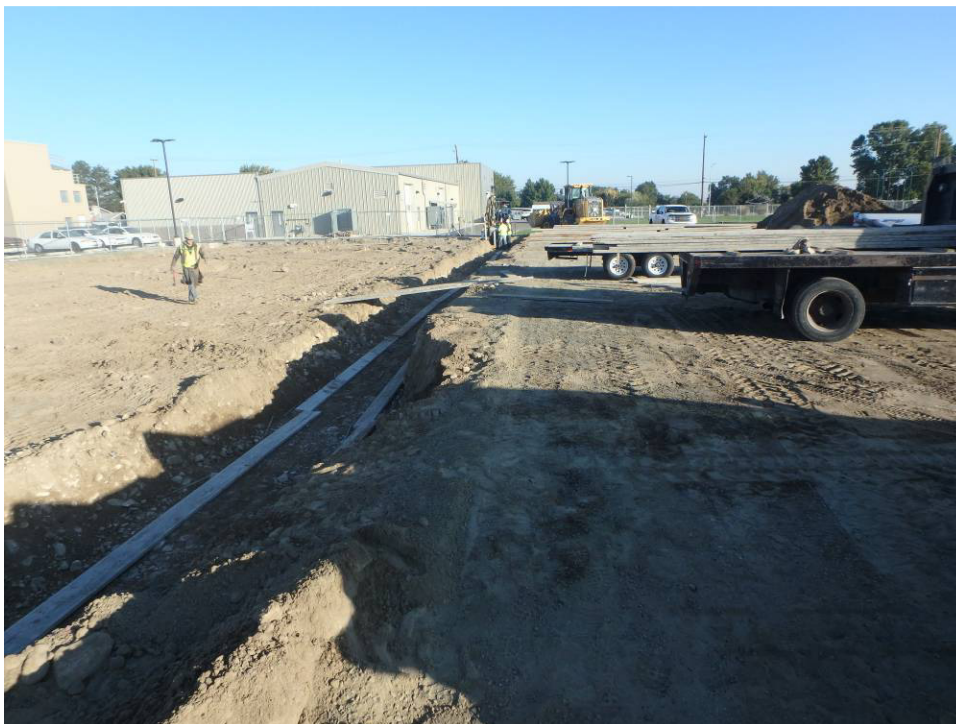
Looking north across the east side of the building footprint

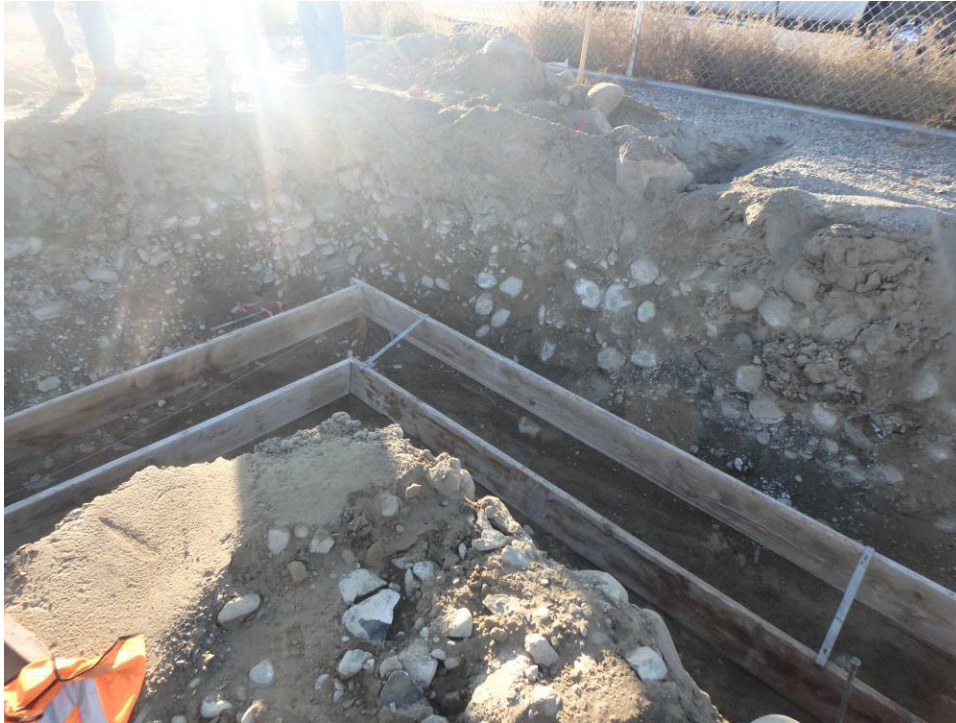
Southeast corner of the building footing trench

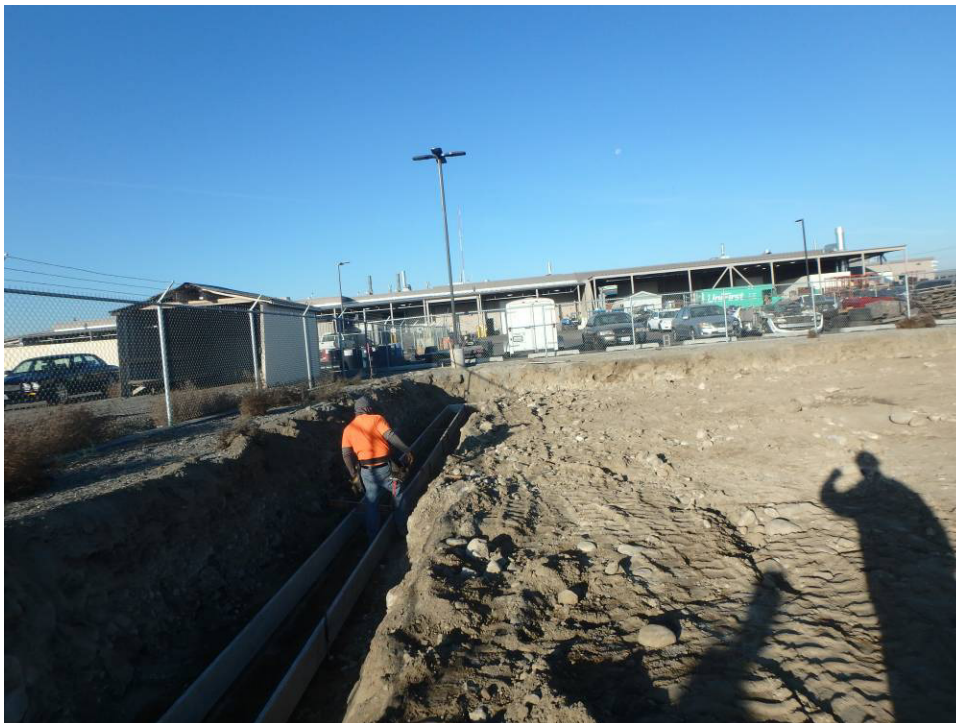
Looking west across the south trench and footing formwork of the building

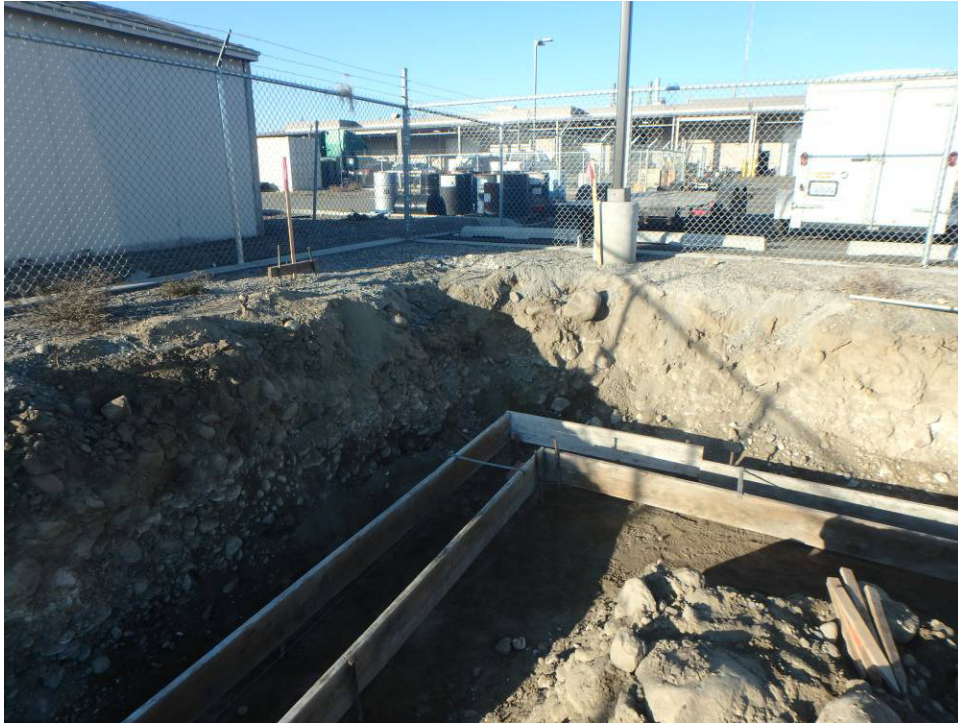
Southwest corner of the building footing trench

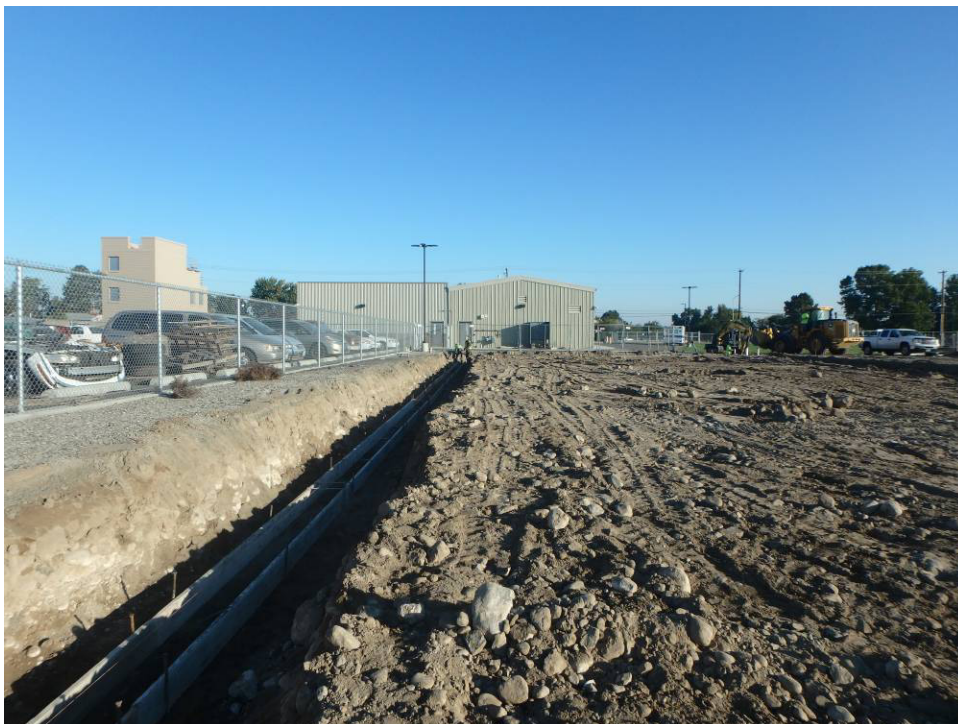
Looking south at the west foundation wall trench

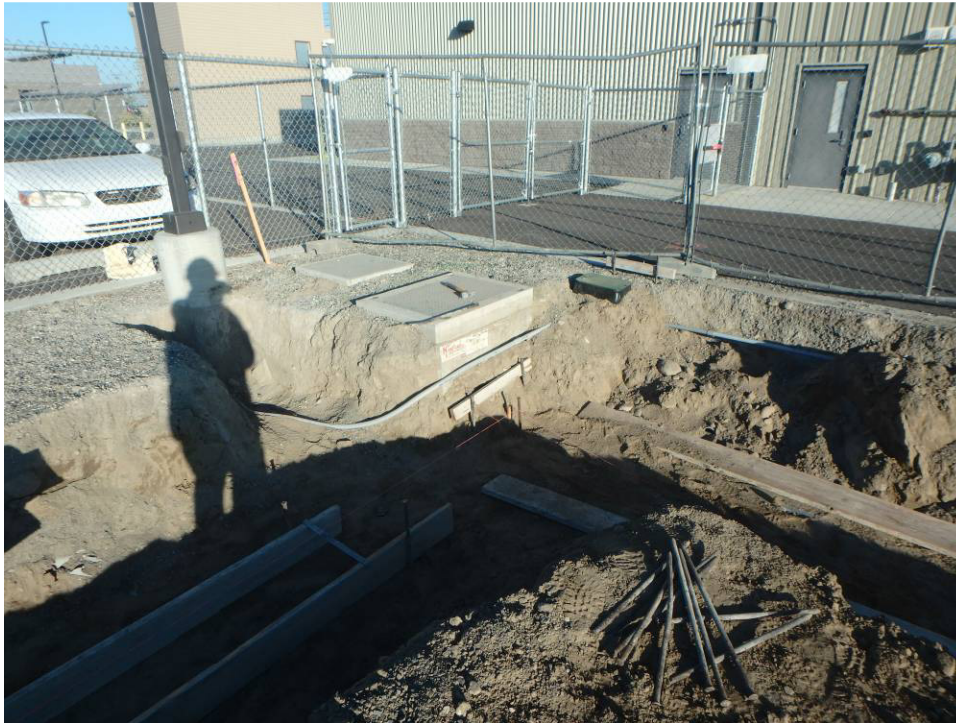
Northwest corner of the building footing trench looking west

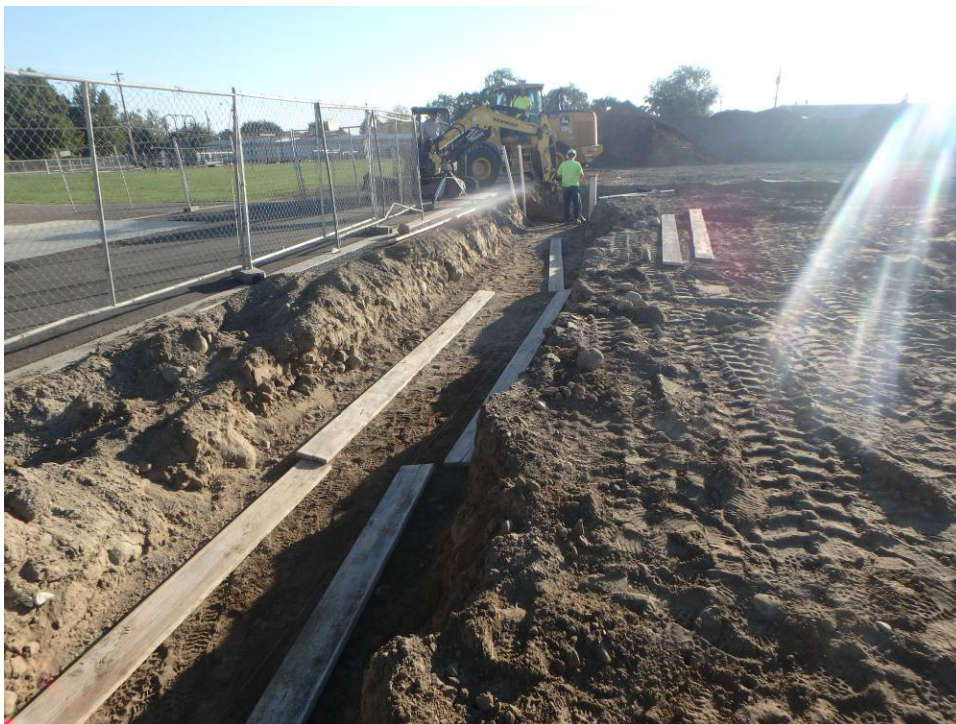
Looking east along the north foundation trench

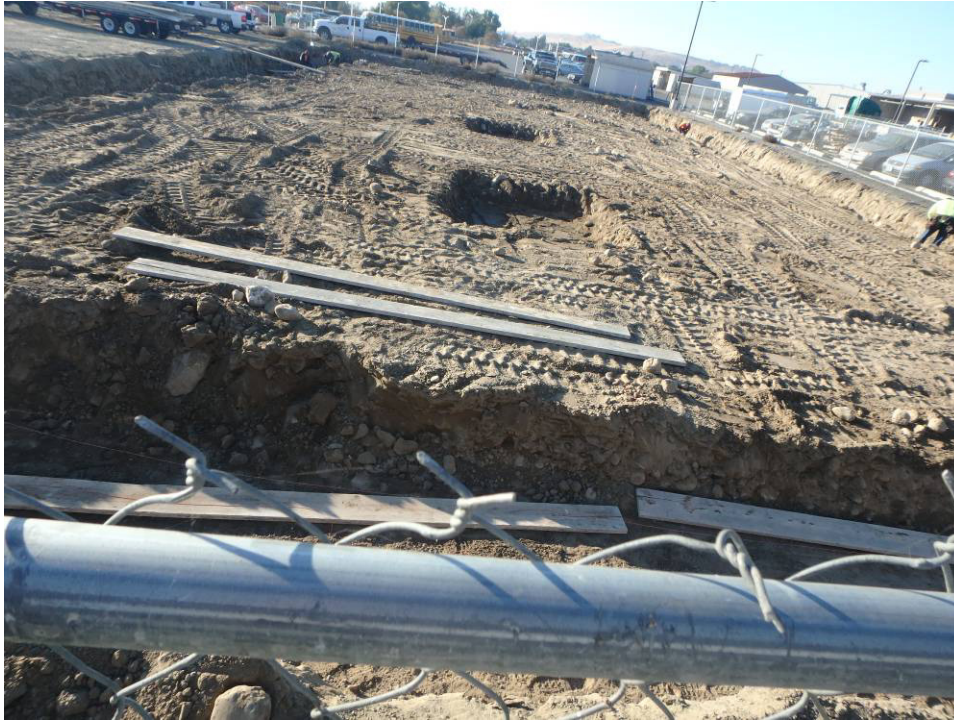
Looking south across the center of the building footprint

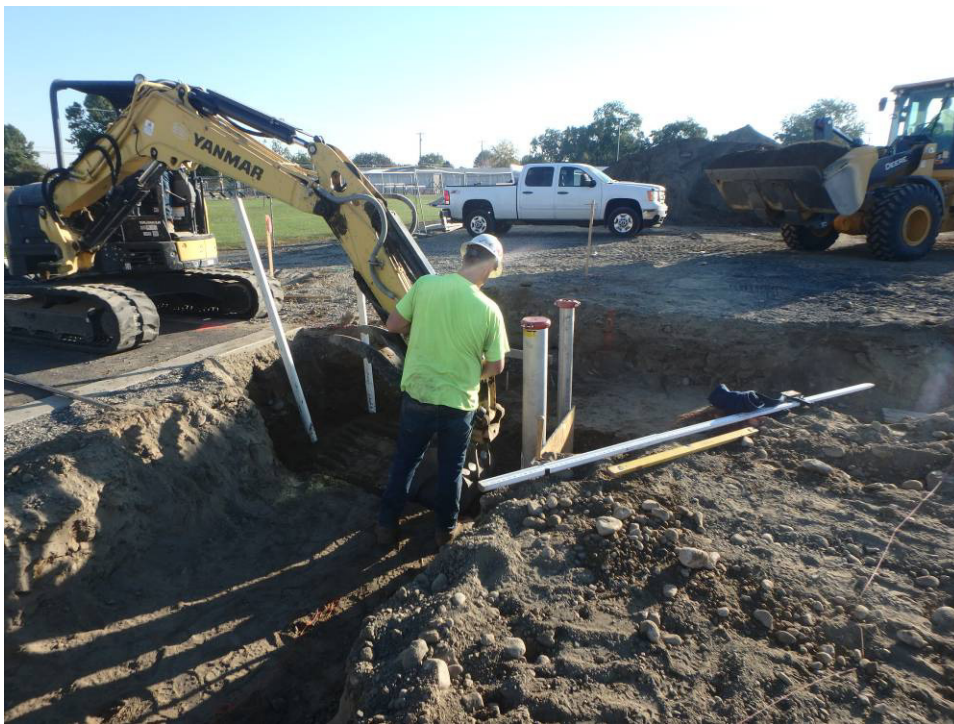
Base rock for the thrust block

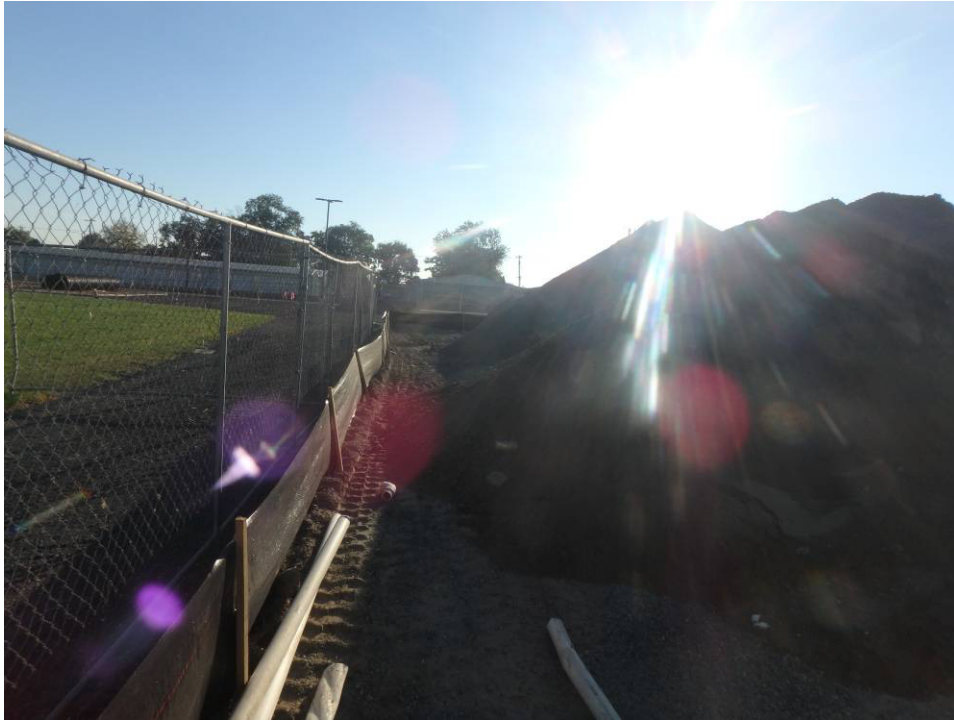
Looking east along the north project site to the northeast corner

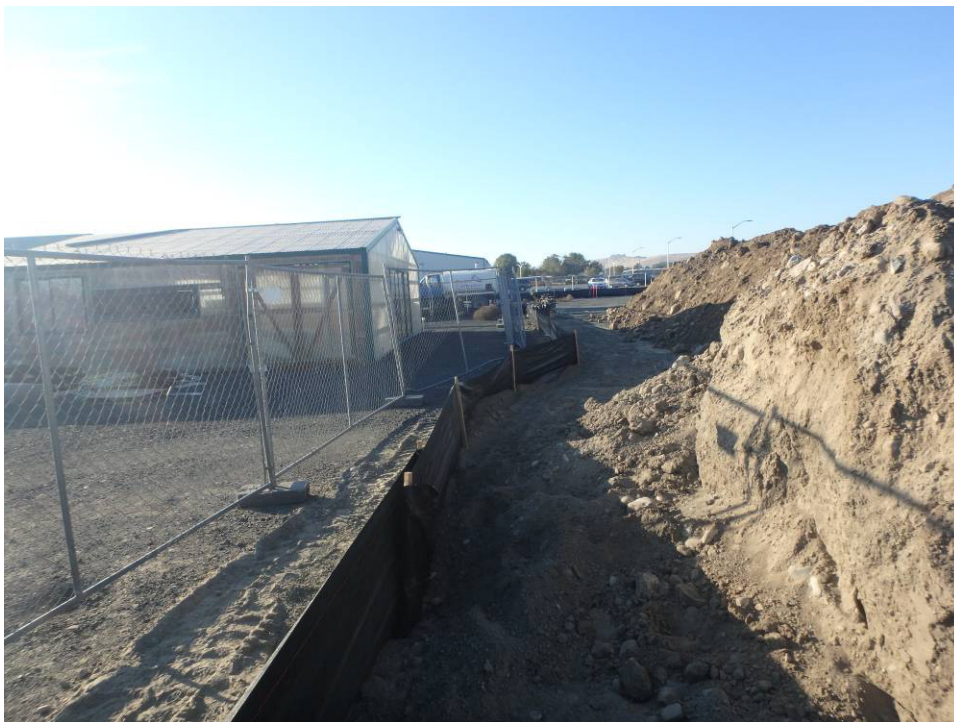
Looking south along the northeast project site

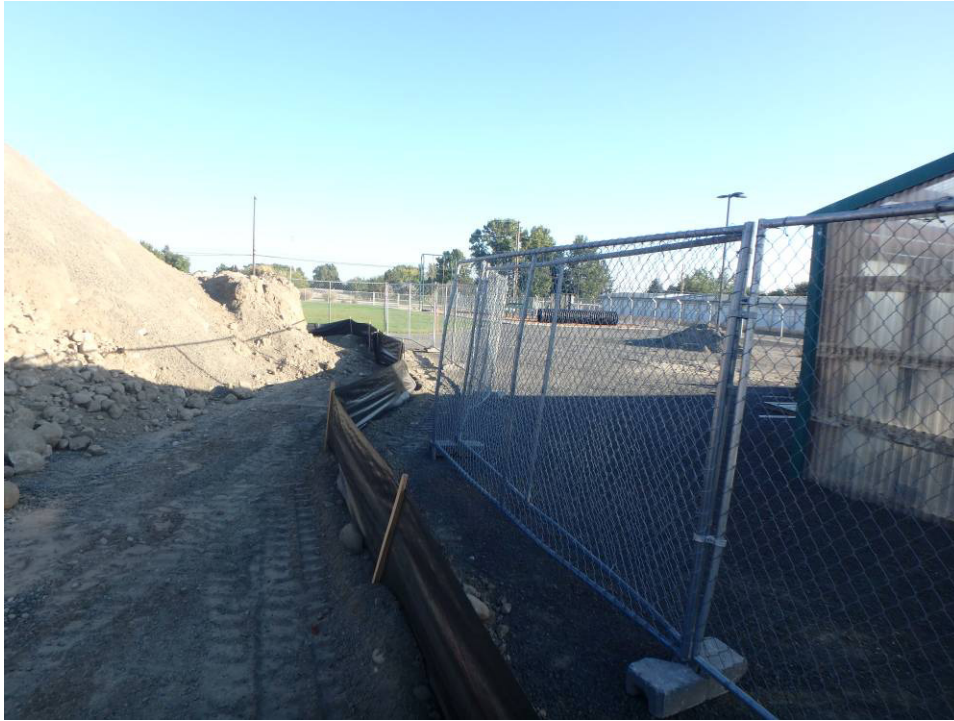
Looking north along the northeast project site

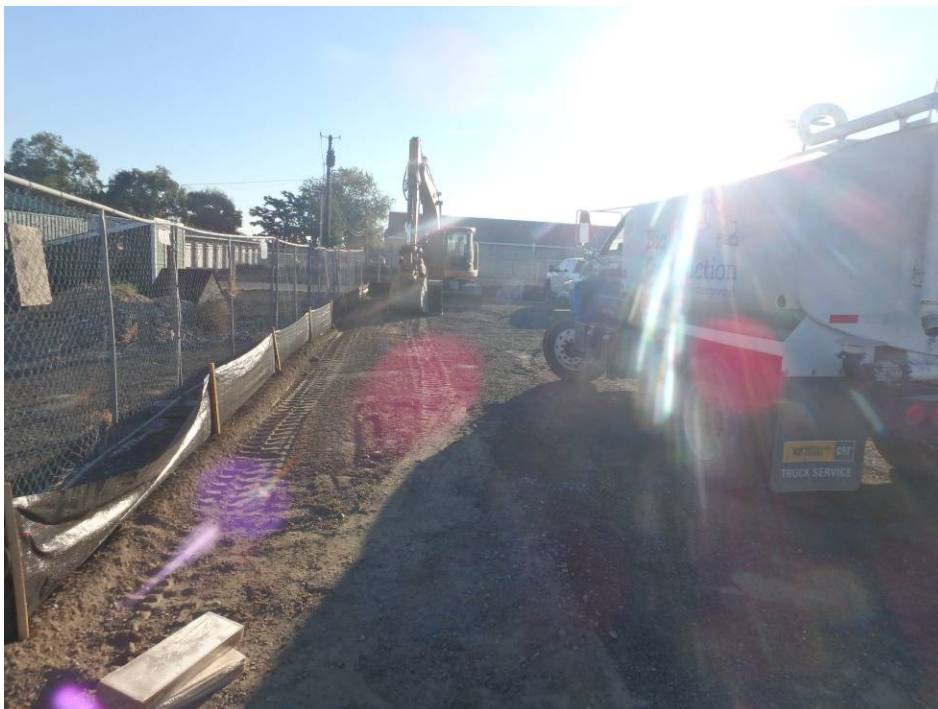
Looking east along the southeast project site

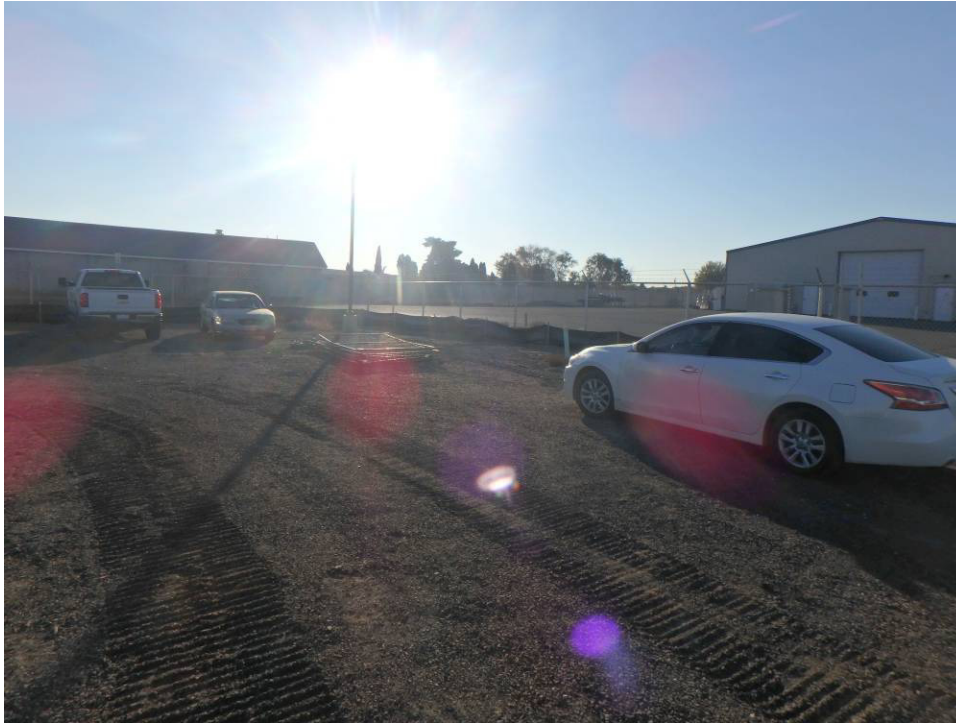
Looking southeast at the east project site

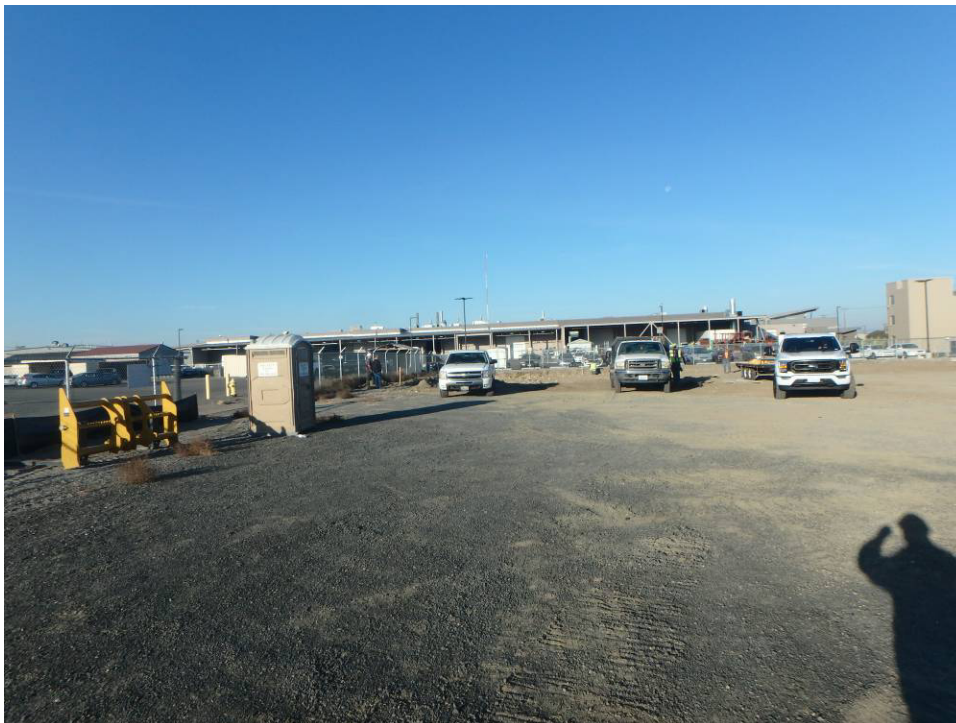
Looking west along the south project line
