# CAPITAL ASSESSMENT PLAN

Cologne Academy  
1221 South Village Pkwy  
Cologne, MN 55320

JB Vang Management, LLC  
1335 Pierce Butler Route  
St. Paul, MN 55104

January 11, 2021

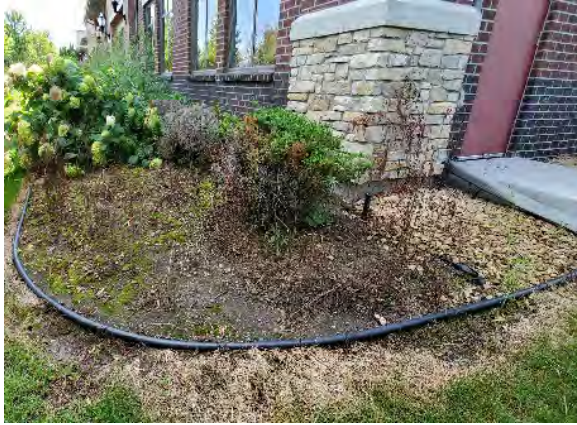
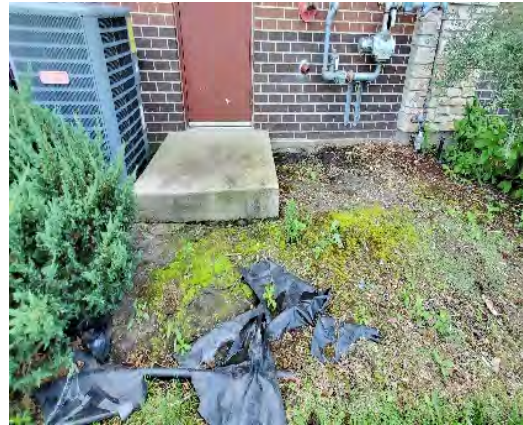
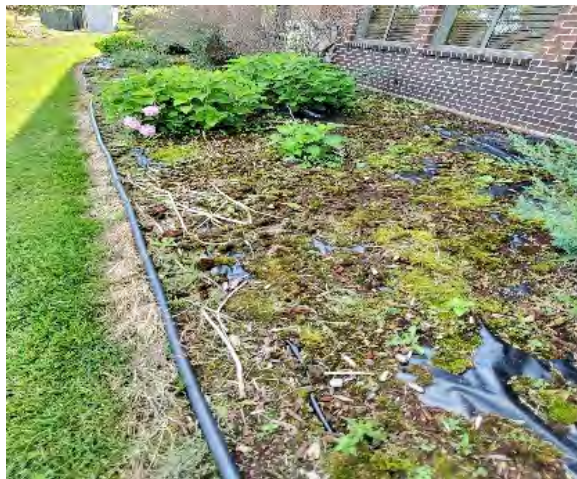
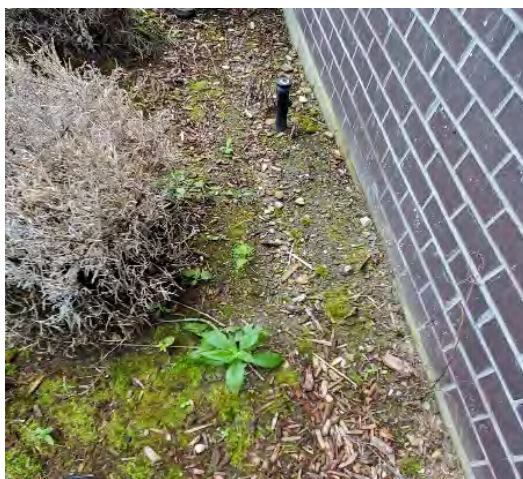
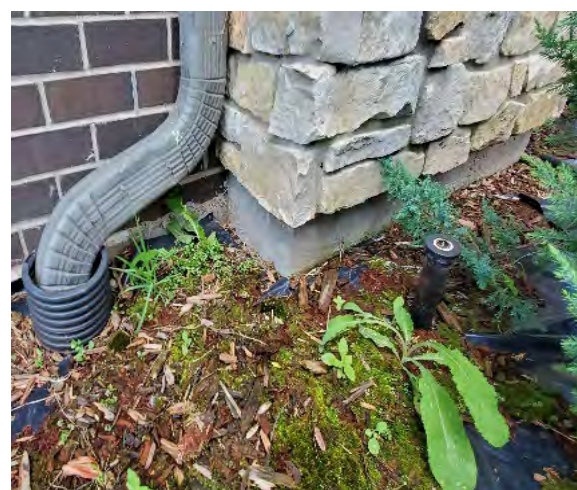
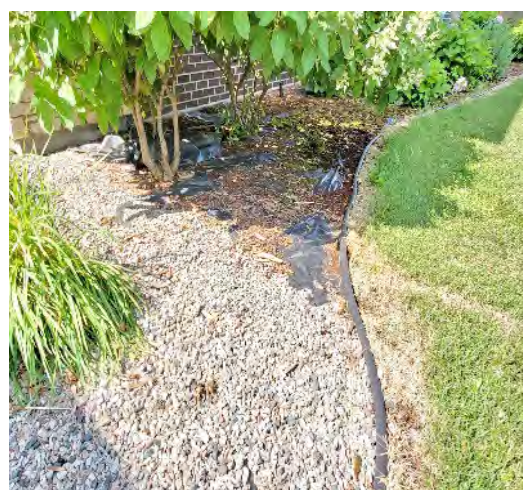
Location 1: This includes the flower bed and landscaping along the whole north side of the building. The mulch and poly have deteriorated and left a 2" – 5" depression between the plastic poly bedding and the top of the grade. The lack of mulch causes water to get into the foundation and door landings. If this condition continues, the egress landing and the building foundation will be undermined. Adding new poly and mulch will remedy this condition.

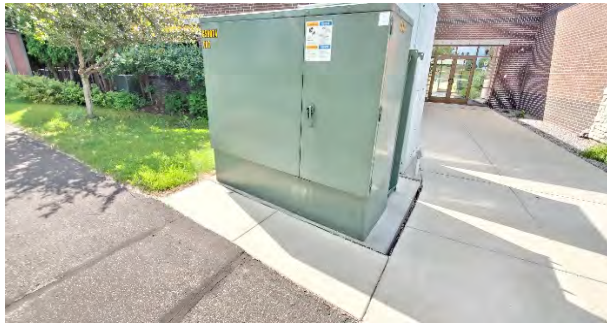
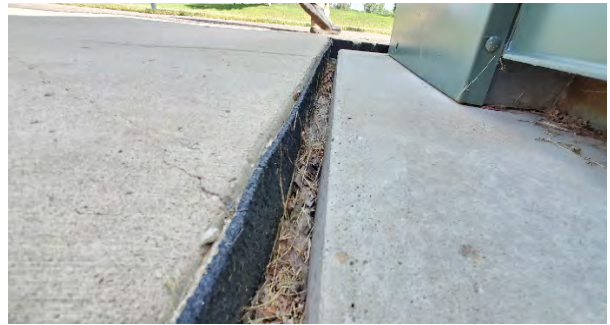
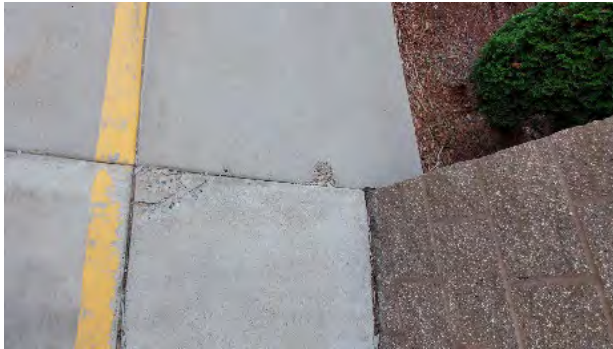
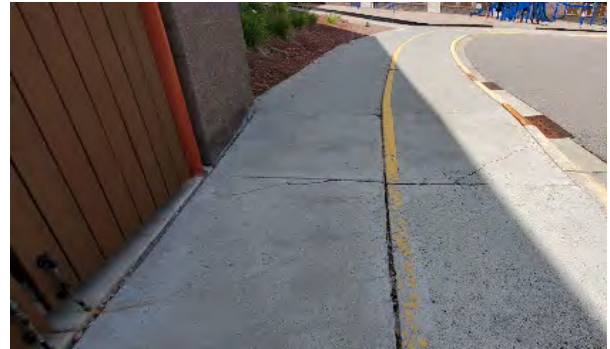
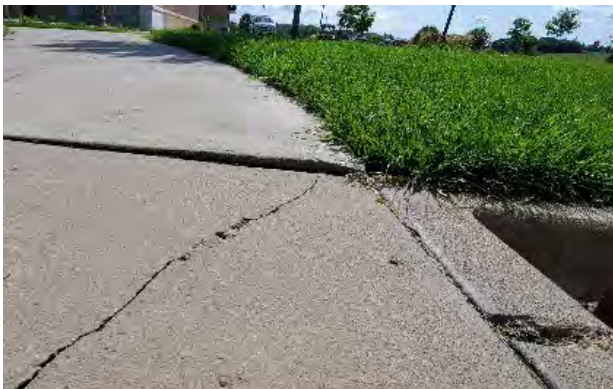
Locations 2, 4 & 9: There are sections of the sidewalk throughout the site that are cracked, broken and/or are uneven. This condition should be watched closely with the freeze and thaw cycle to ensure that it does not get worse. If this condition continues, the concrete section should be grinded, caulked and patched or fully replaced to avoid a trip hazard.

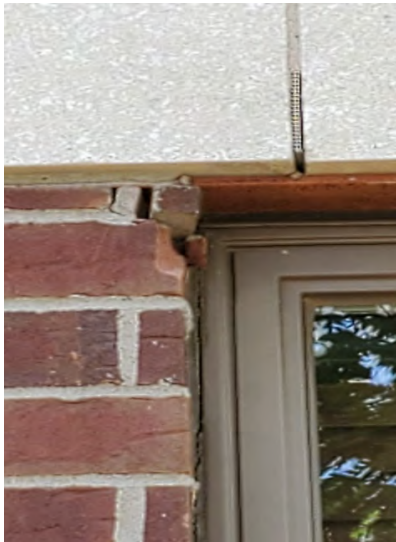
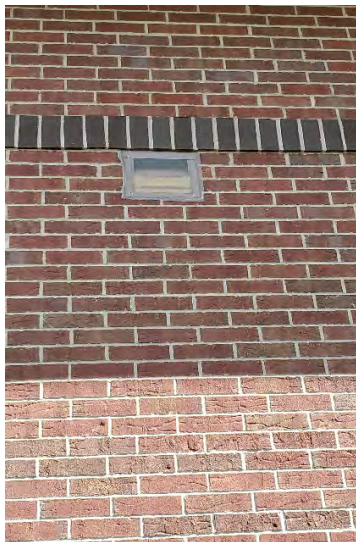
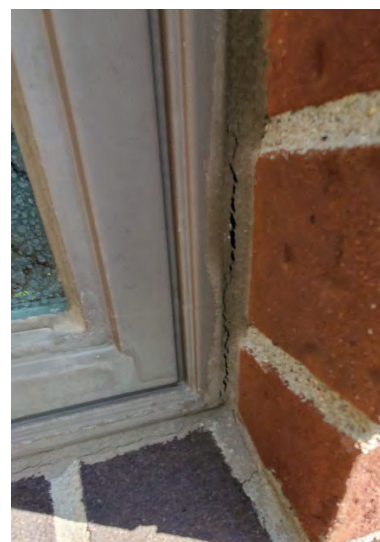
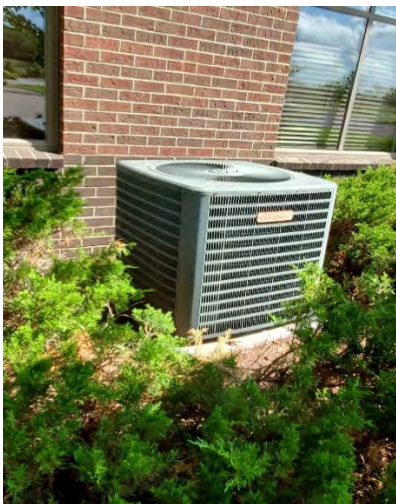
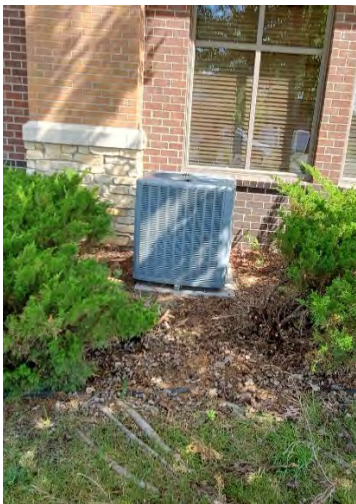
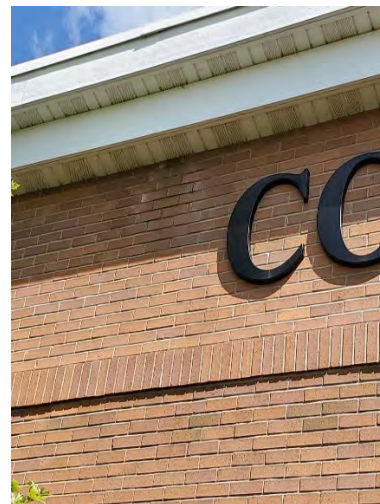
Location 3: This is the section along the south side of the Phase 1 and Phase 2 portions of the building. There are a number of areas that should be evaluated. The brick at the corner of the classroom window requires tuck pointing and grouting along the seams to avoid water intrusion. One vent has a mesh screen which appears to be blocked by debris. The screen should be removed to allow proper venting. A few areas of the window's caulking show cracks and need to be re-caulked to prevent water intrusion. The evergreen on the ground around the condenser unit needs to be trimmed to allow maximum airflow to the unit for optimal operation. The section of bricks above the Cologne sign has calcium build up. This showed a sign of water intrusion. This condition should be watched closely to ensure it does not deteriorate.

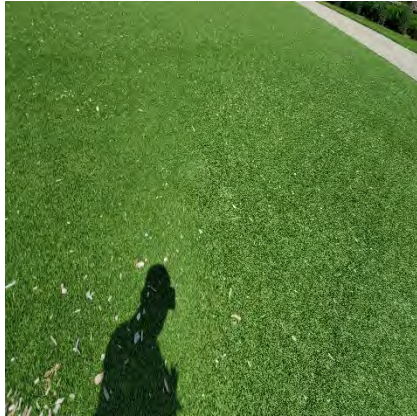
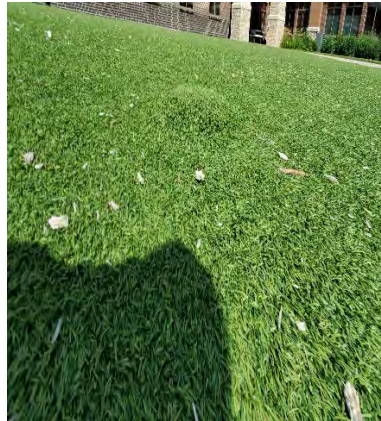
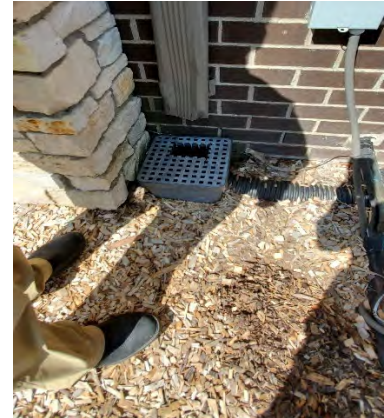
Location 5: This location is the artificial turf section outside the main office and the playground area. There is a utility cleanout drain hidden underneath the artificial turf. The ground around the utility clean out has settled creating a 2" – 4" depression. This situation creates a trip hazard for students as they play around it. Removing the turf and adding more base materials will remedy this. The natural mulch in the playground area has deteriorated and created a 1" - 3" depression in a high traffic area. The water from the downspout is washing the mulch away exposing drain tiles and building foundations. The spout should be extended into the catch box and additional mulch should be added to remedy this situation.

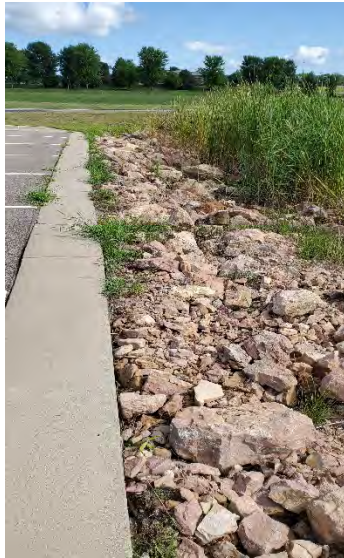
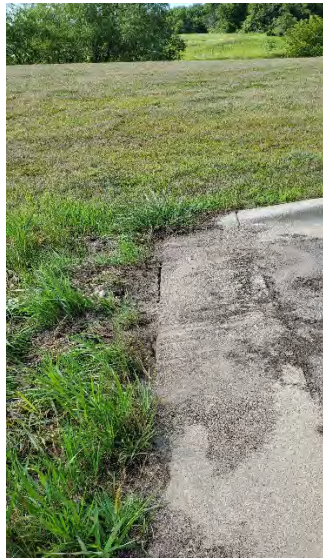
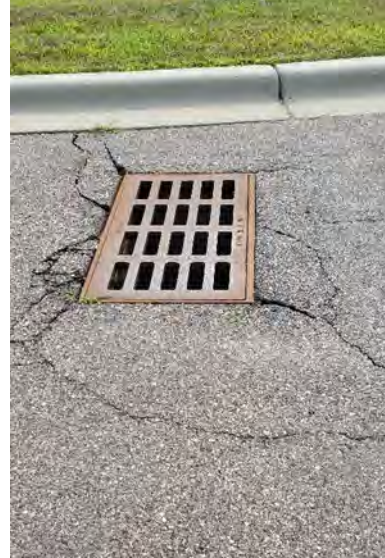
Location 7: This area runs from the east side of the parking lot east of the gym towards the pond along School St. Rocks that build up the rip-rap have been washed down. Adding more and larger rocks will help prevent wash down and will slow the water. This will prevent further erosion which can undermine the parking lot curb.

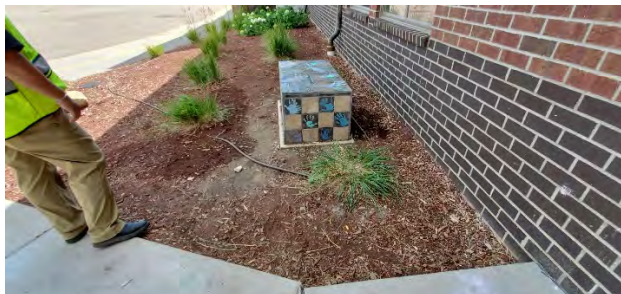
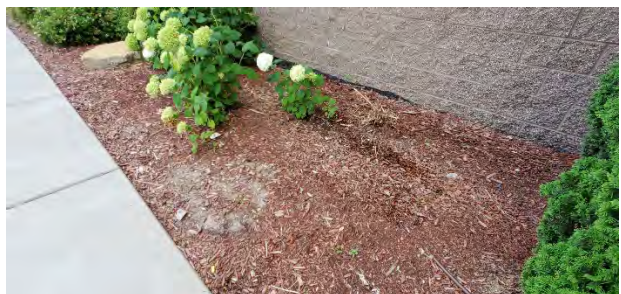
The mulch on the north side of the gym has been washed away and the sprinkler line is exposed.

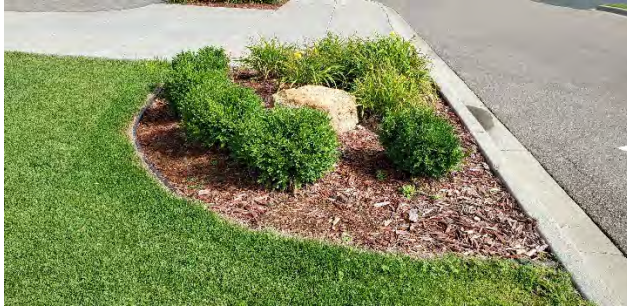
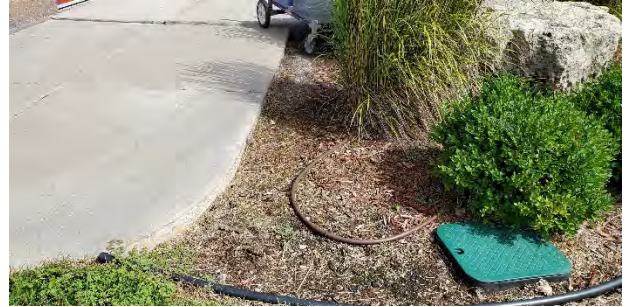
The flower bedding on the east side of the gym has been washed out. The sprinkler line is exposed and is susceptible to damage.

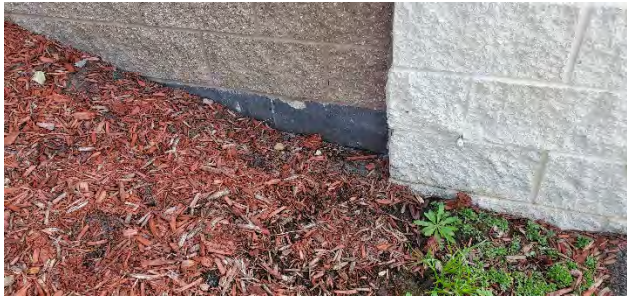
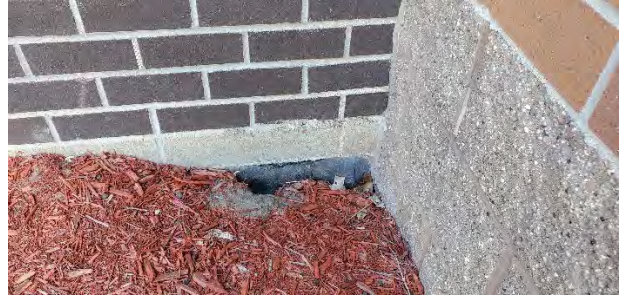
Lack of mulch caused water to wash away dirt and create entry points that may undermine the building foundation.

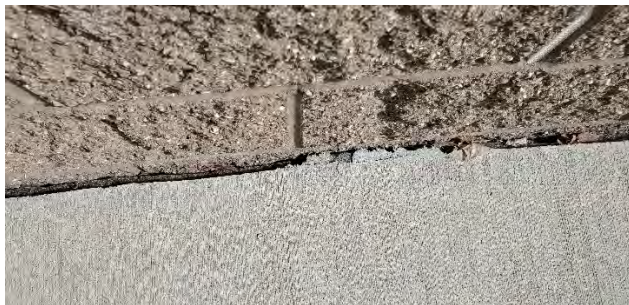
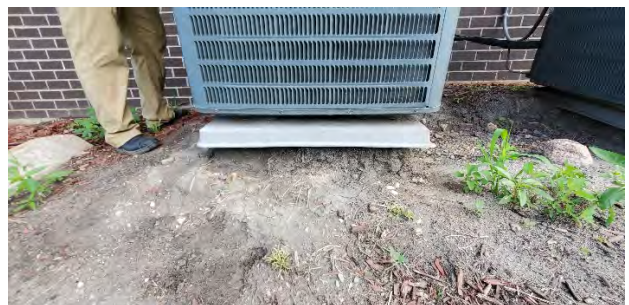
The gap between the sidewalk and the building may need to be caulked. This condition will need to be monitored closely. The freeze and thaw cycle may push the sidewalk away from the building and may undermine the building foundation later.

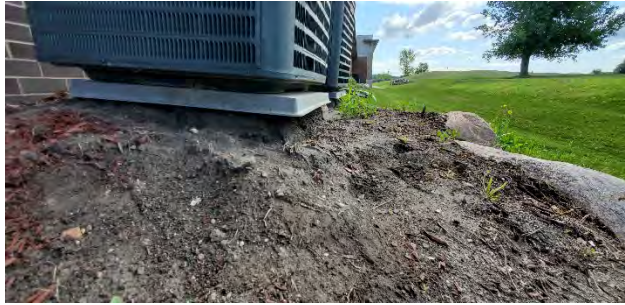
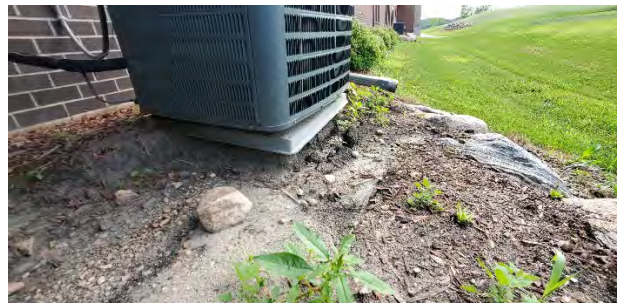
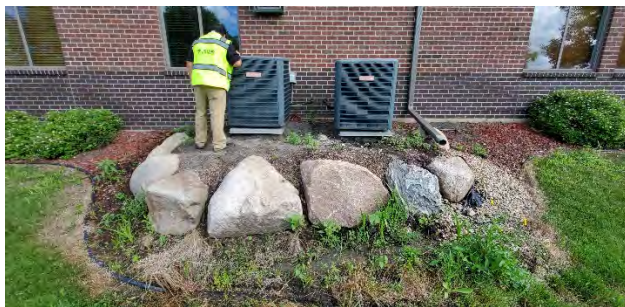
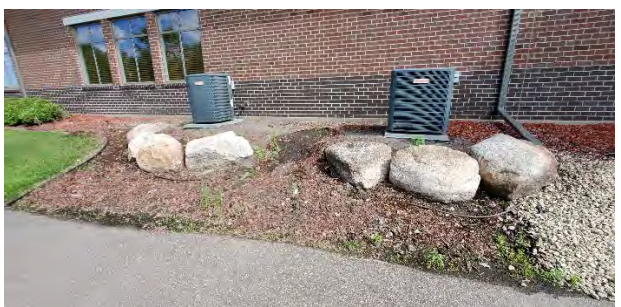
The lack of mulch caused the soil foundation around the condenser platform to be undermined. This will need to be addressed right away. It may cause the condenser unit to tip over and damage the cooling line and unit. Creating a solid foundation with new poly and class 5 around the unit should help stabilize the units.

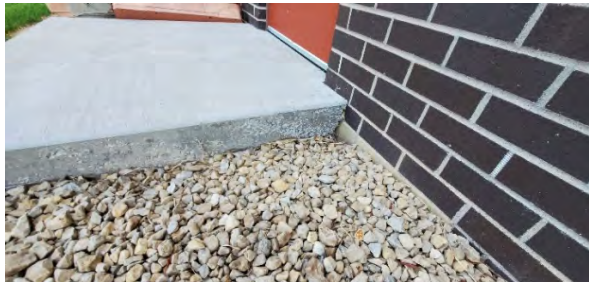
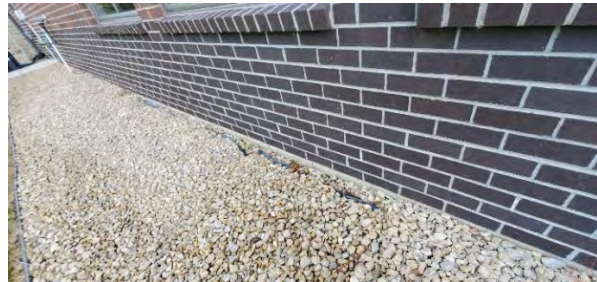
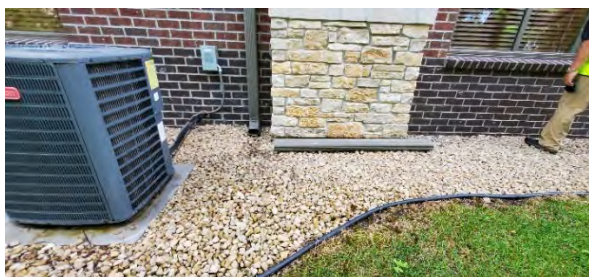
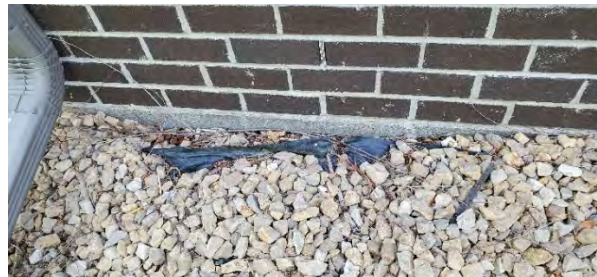
Location 11: This area is the west side of the main building. The issue along this side is that the class 5 is settling and causing a 1"-3" depression. This will lead to water undermining the door landing and the building foundation. Adding more class 5 will remedy the issues. A downspout needs to be reconnected so the water is discharged away from the building.

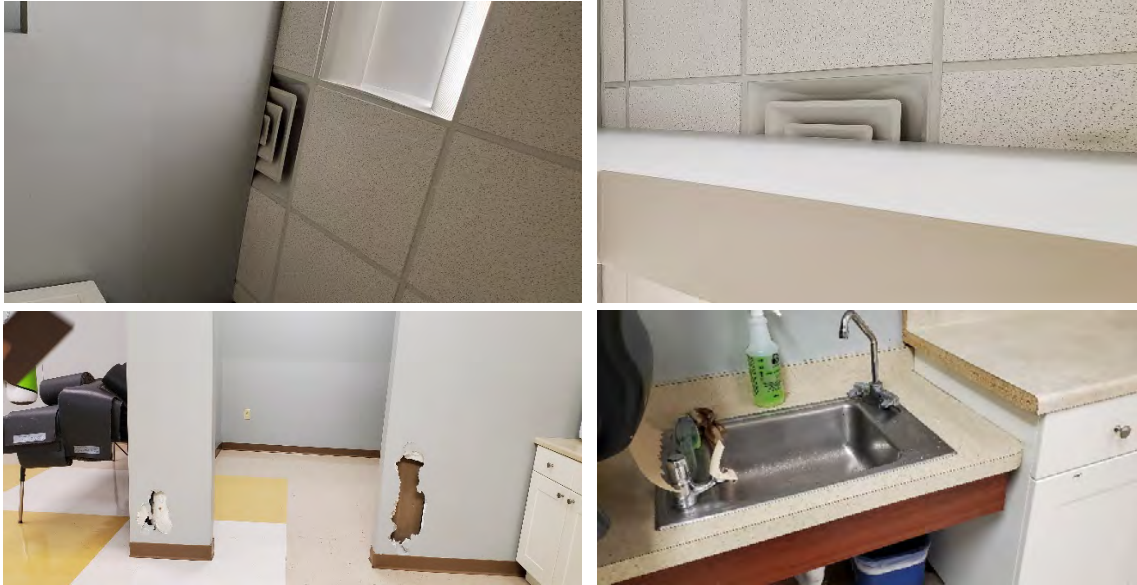
Location #4: Classroom 112 has two holes in the wall. The wall will need to be patched, taped, and painted. The diffuser should not be in between the wall; it will need to be fully moved into the smaller room. The countertop is de-laminating at the edge by the sink. Laminating the edge will prevent it from absorbing water and further damaging to the countertop.

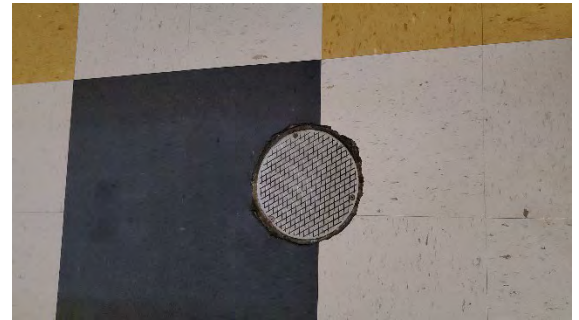
Location #8: The VCT tiles around the clean out drain are cracked and broken off. It could become a trip hazard if it's not corrected. A bead of silicone or grout should fill the hole and fix the issue.

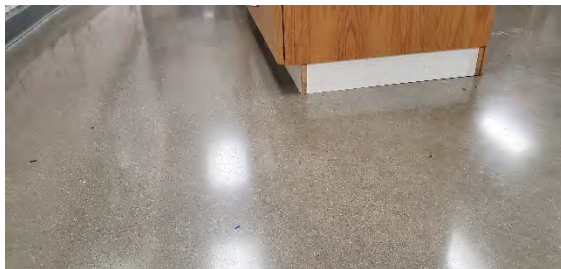
Location #12: The cabinets in classroom 501 need to be based. JB Vang will talk to Rochon about getting all the cabinets based.

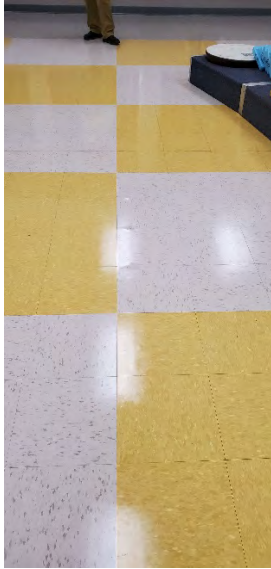
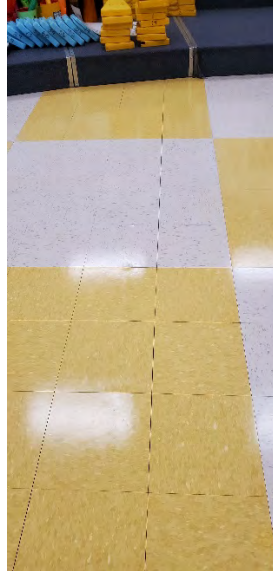
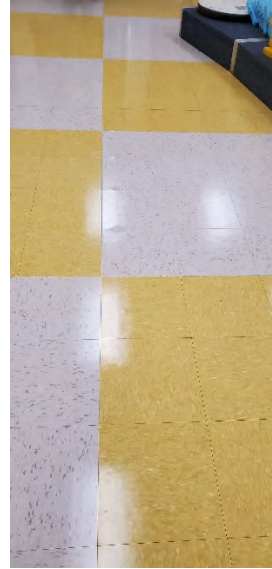
Location #14: The VCT cracks and bump in room 527A are telegraphed through the tiles. The VCT will need to be monitored and replaced if the cracks get worse. This is caused from the floor slab moving back and forth.

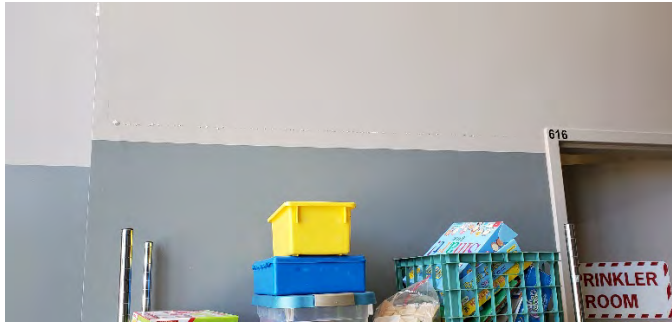
Location #19: Above the door frame of the concession stand, the wall is cracked at the drywall joint line. This was caused by the building moving and shifting. The cracks will need to be taped, mudded and painted to avoid it cracking further.

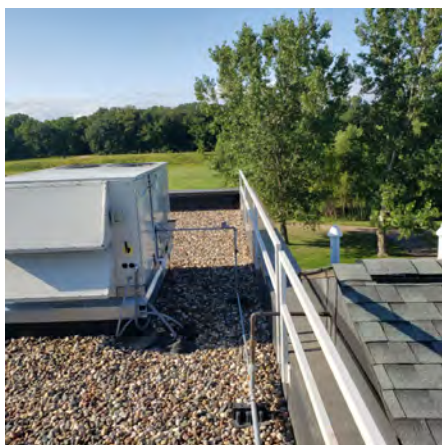
We noted a membrane puncture on the lower roof section. This would be repaired during our priority repair visit

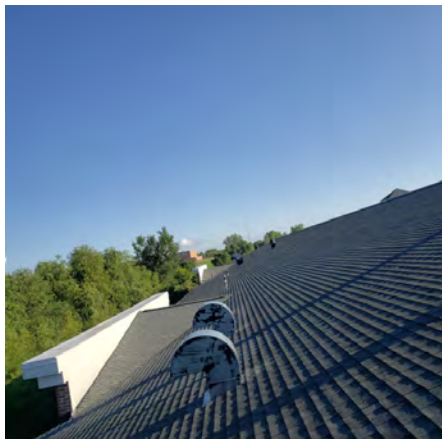
These roofs are in good shape with some maintenance repairs recommended

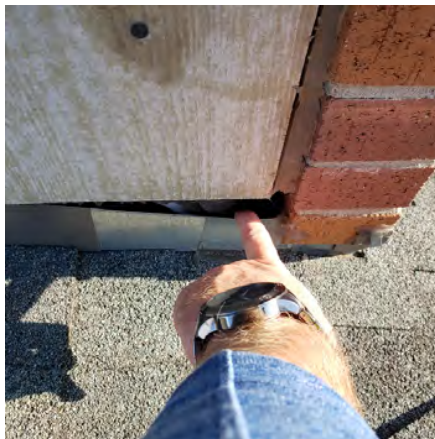
We noted a few areas directly open to water infiltration. We recommend immediate repair

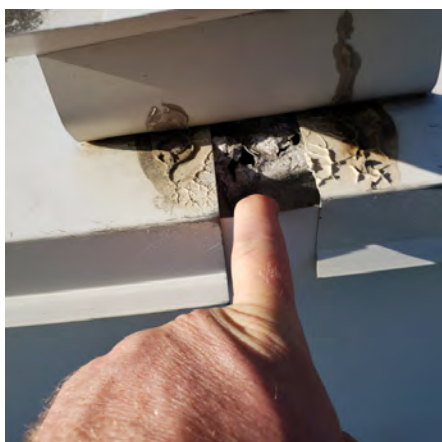
Coping caps need to be inspected and sealed as necessary. This one is directly open to water infiltration.
