### Project Observation Report

Project Name:	Tri Tech East Building	Project No.	2208
Report #:	4		
Observation Date:	11-2-22	Last Report:	10-26-22
Prepared By:	Steve Mallory, AIA	Contractor:	Banlin

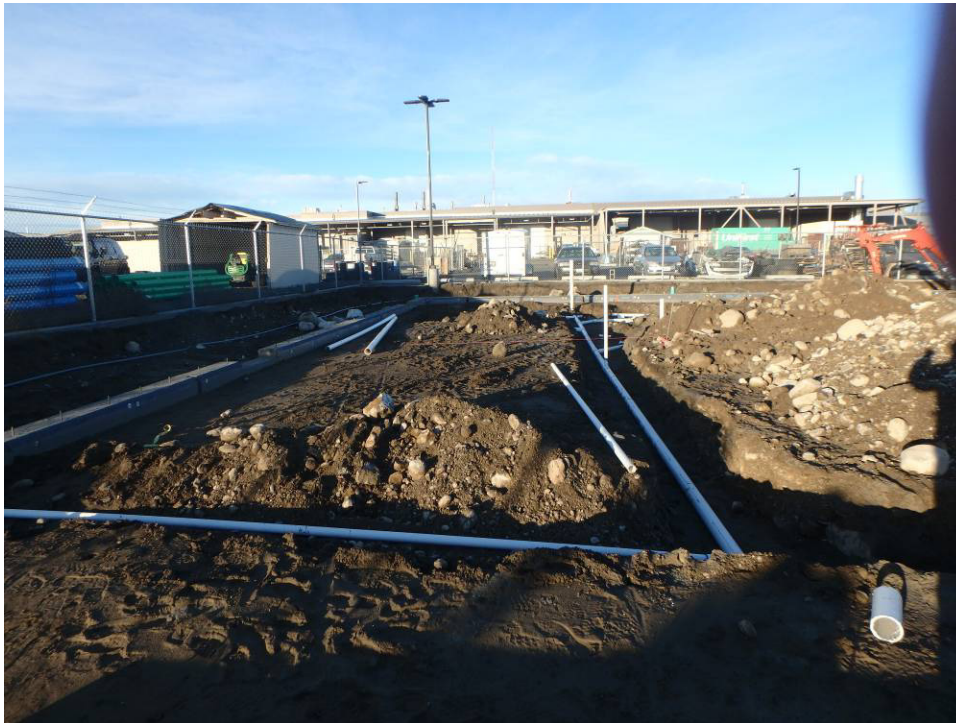
Looking west at the south sub-slab piping

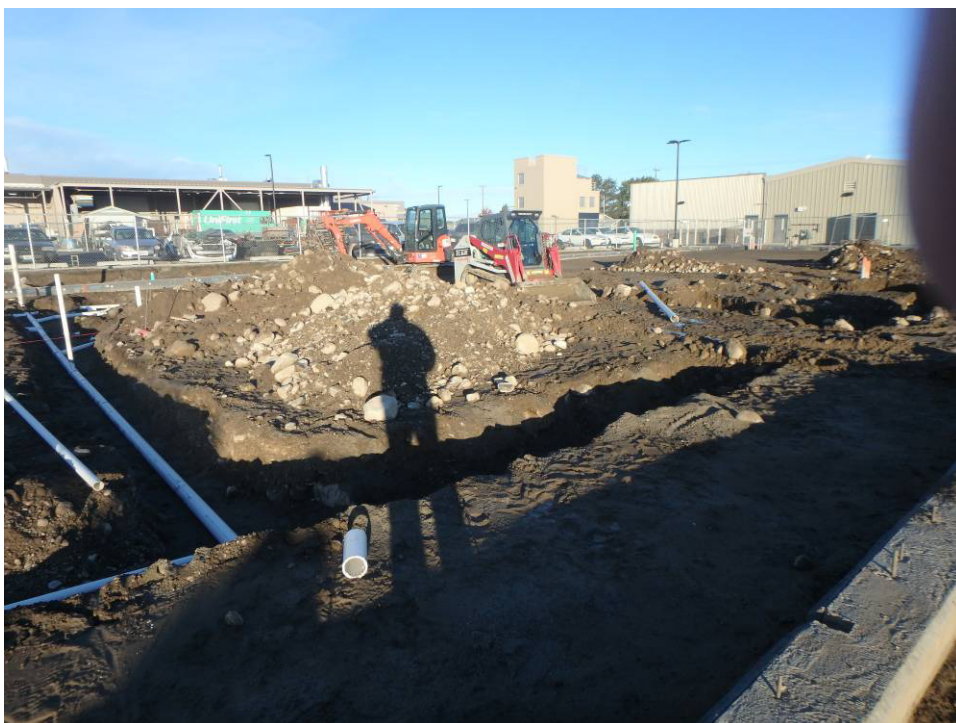
Looking northwest at the south sub-slab piping

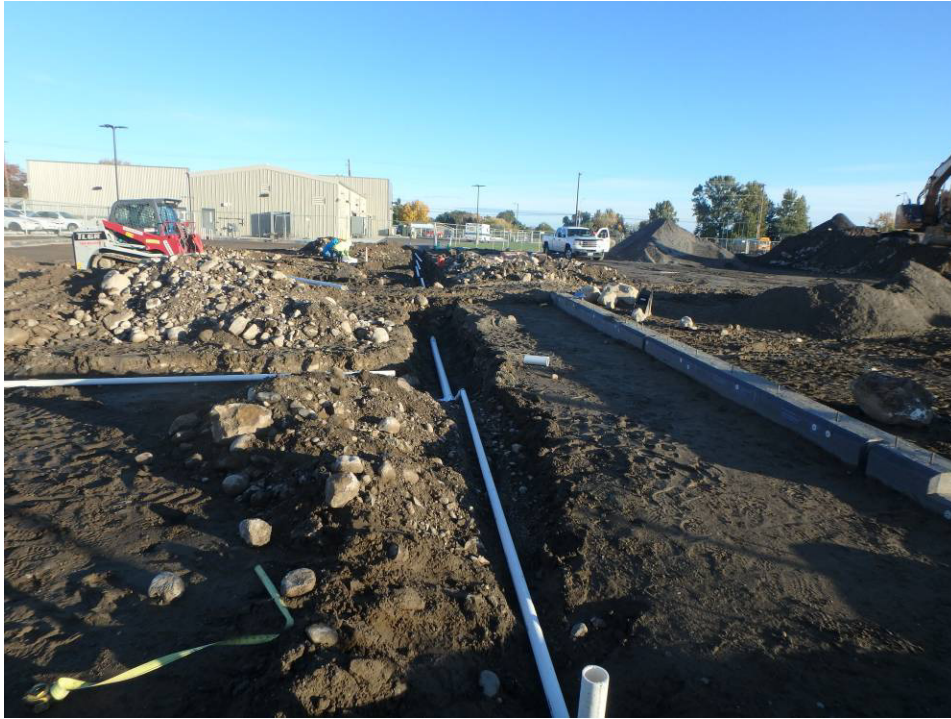
Looking north at the east foundation wall and piping

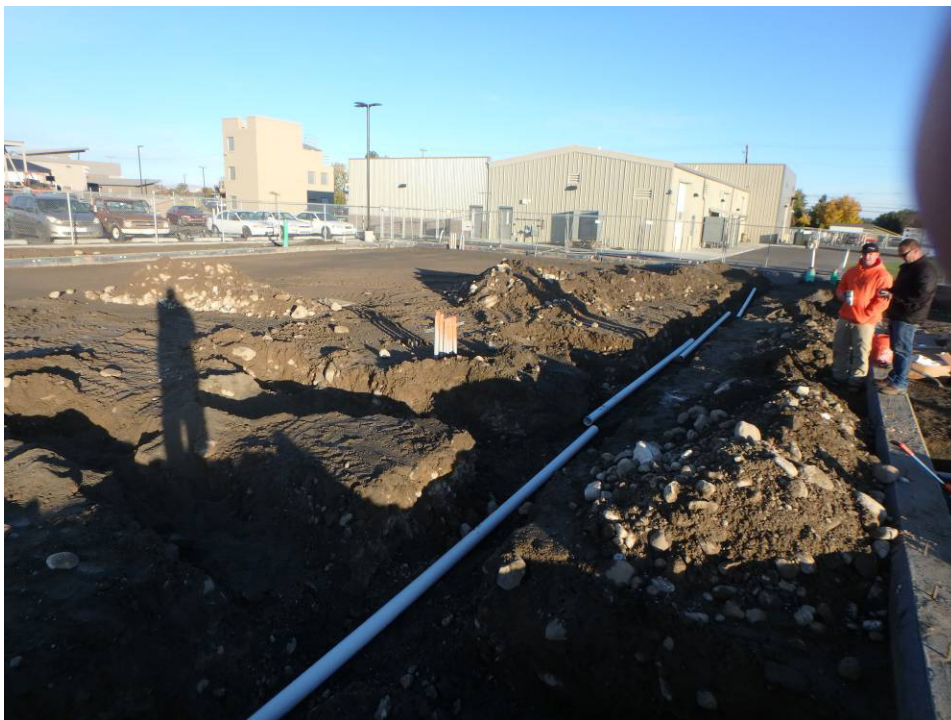
Looking north at the east foundation wall and piping, north half

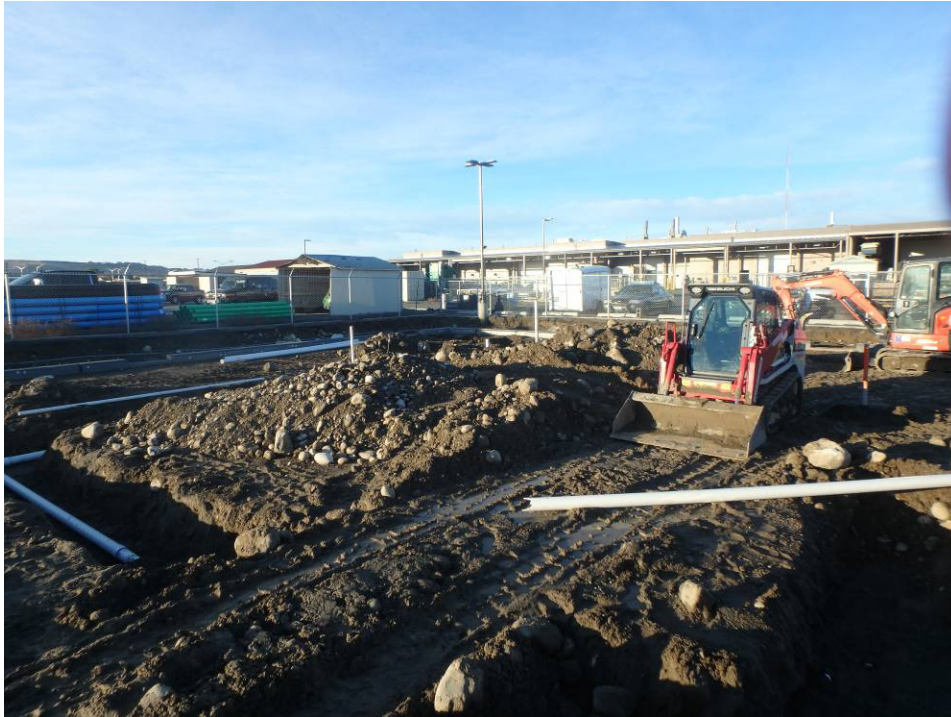
Looking southwest across the building footprint south half

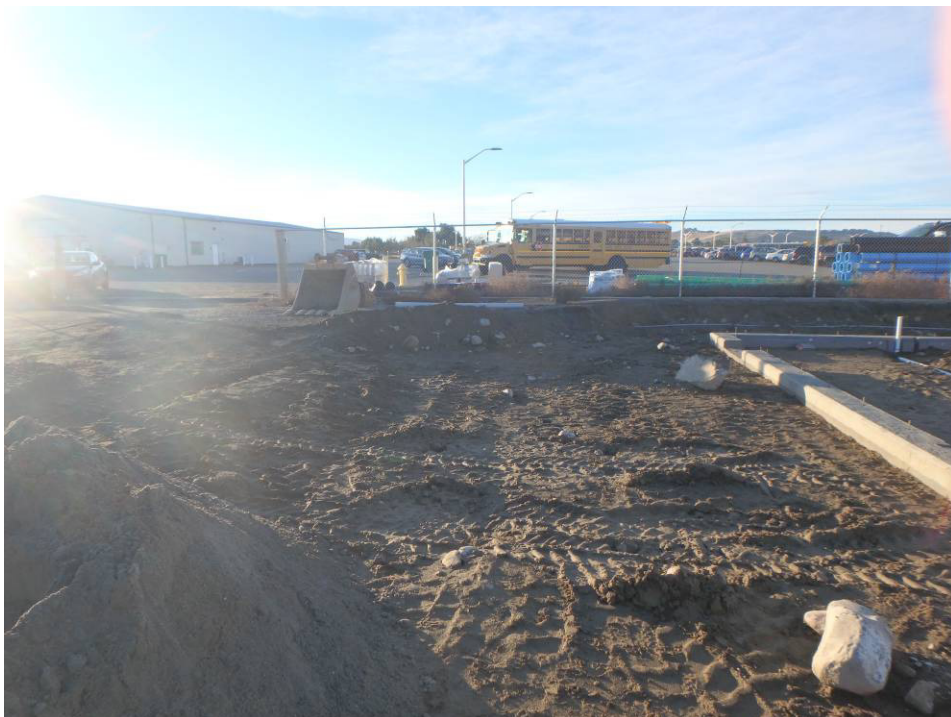
Looking south at the SE corner of the building

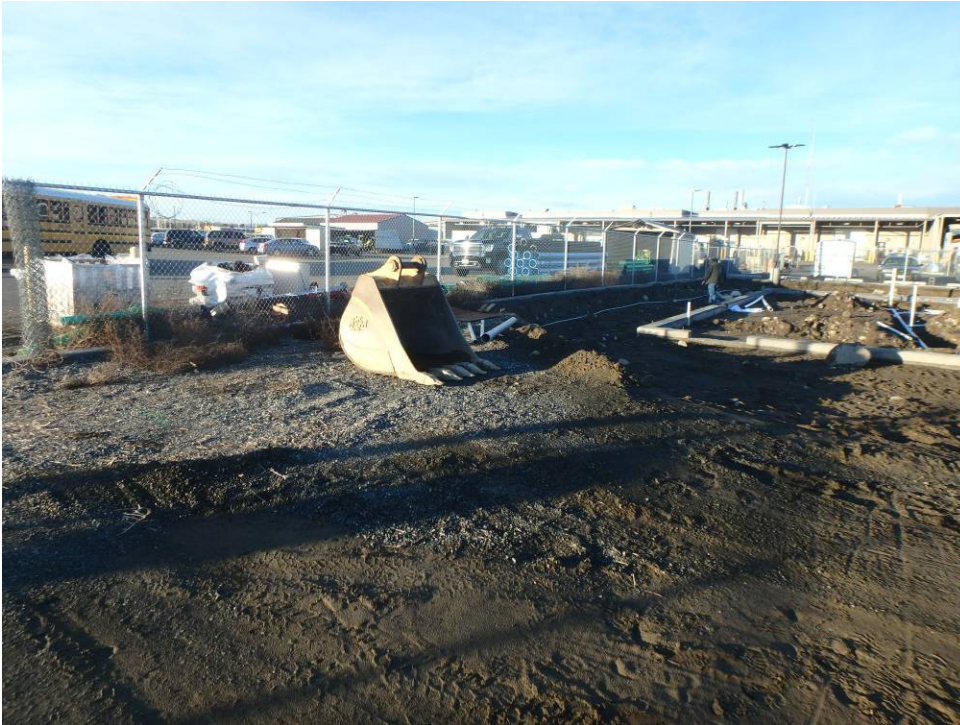
Looking southwest at the SE corner of the building and south property line

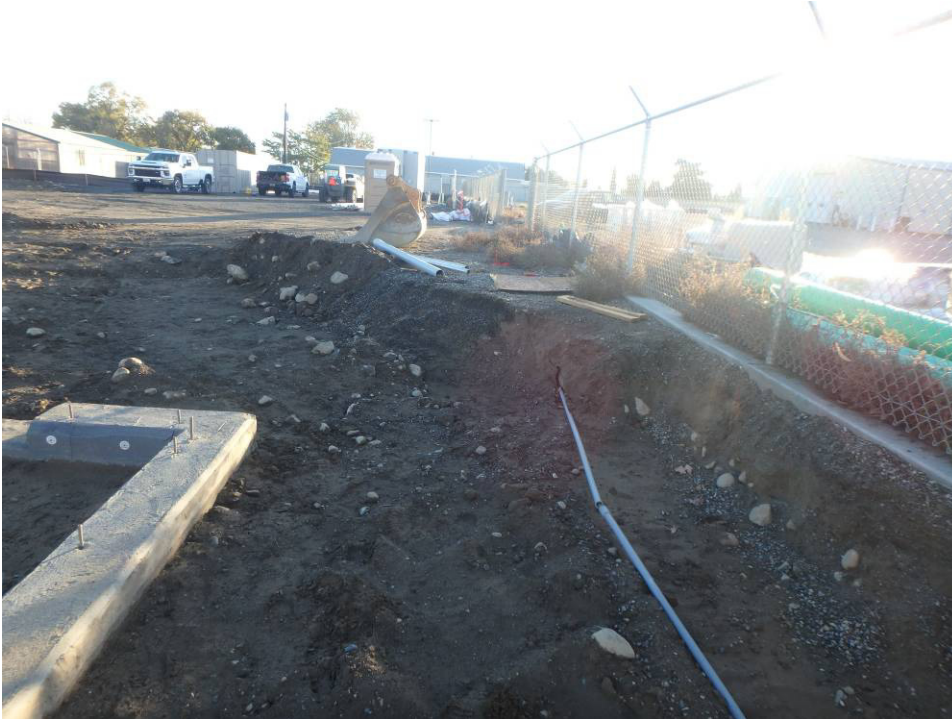
Looking east at the SE corner of the building and SE retaining wall

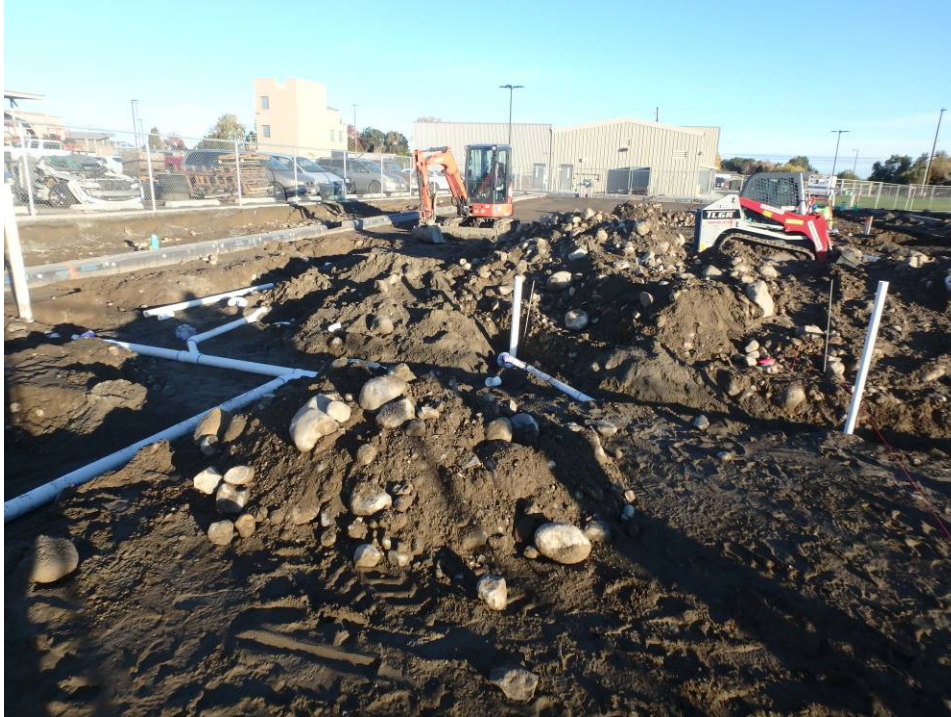
Looking northwest across the building footprint

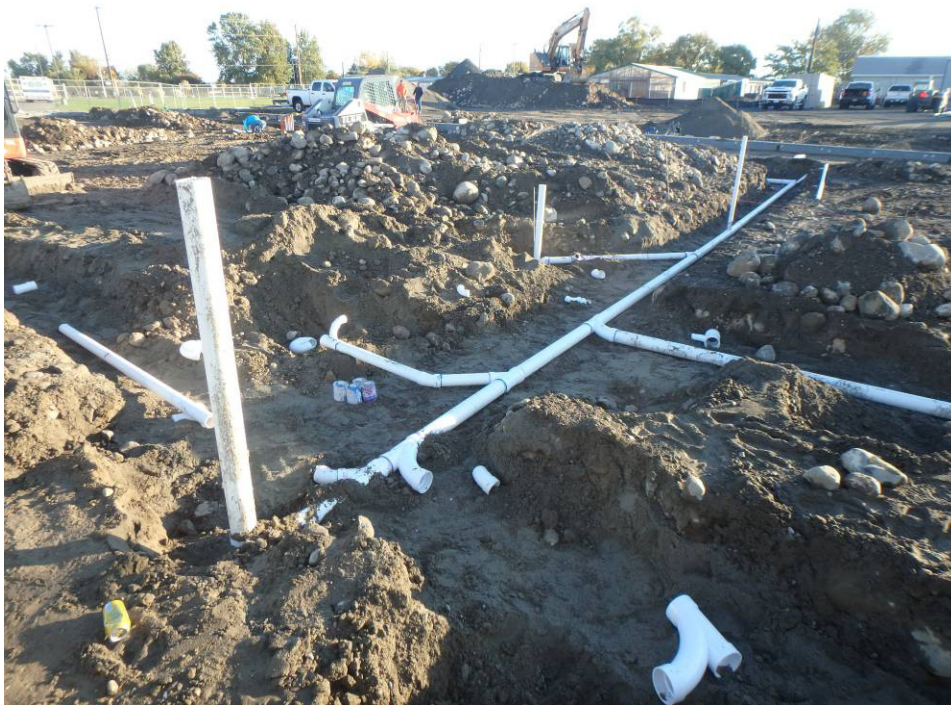
South piping looking NE

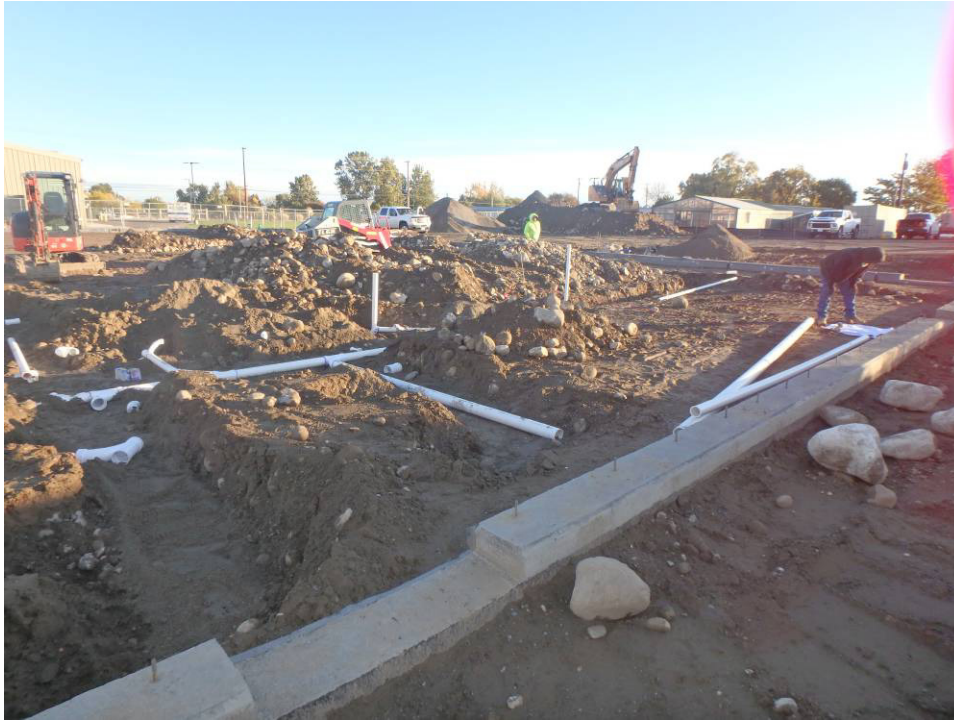
Looking northeast across the building and site

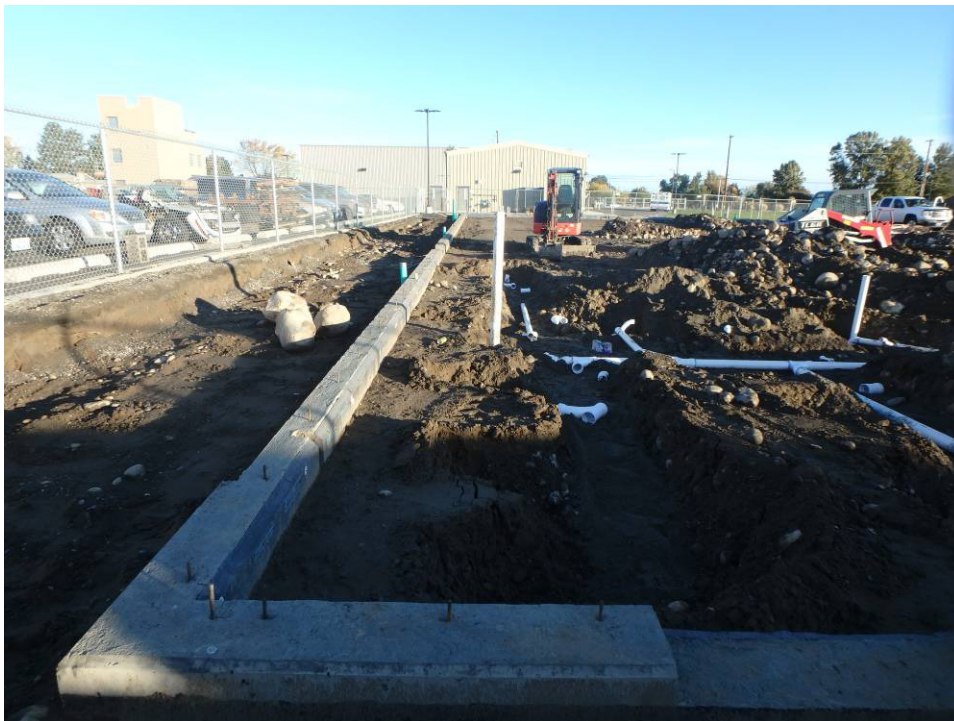
Looking north along the west foundation

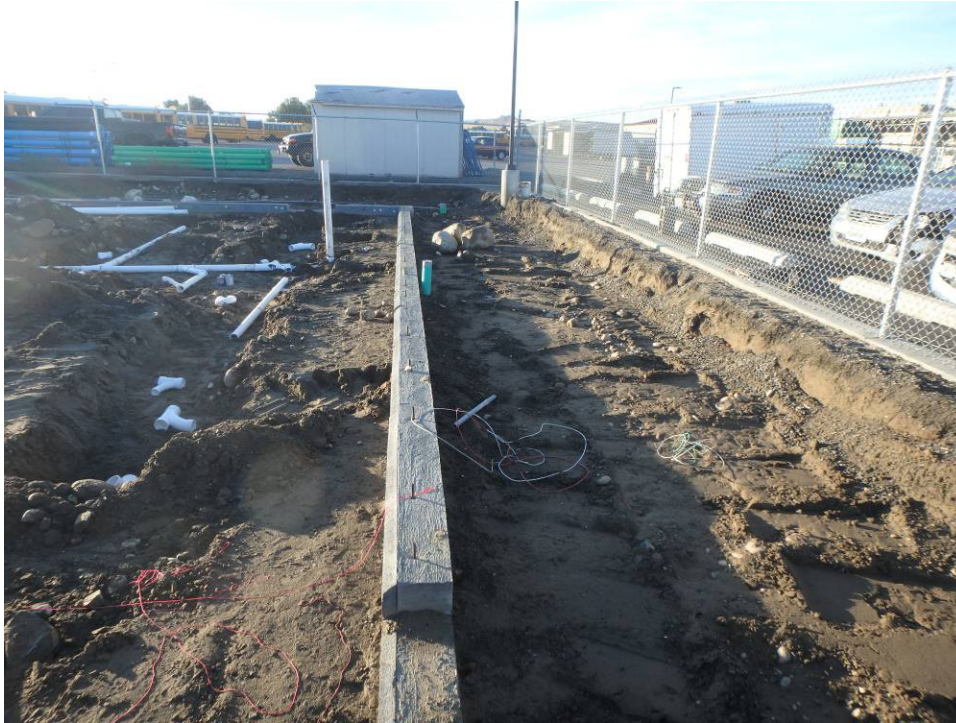
Looking south at the west foundation wall and northwest trench

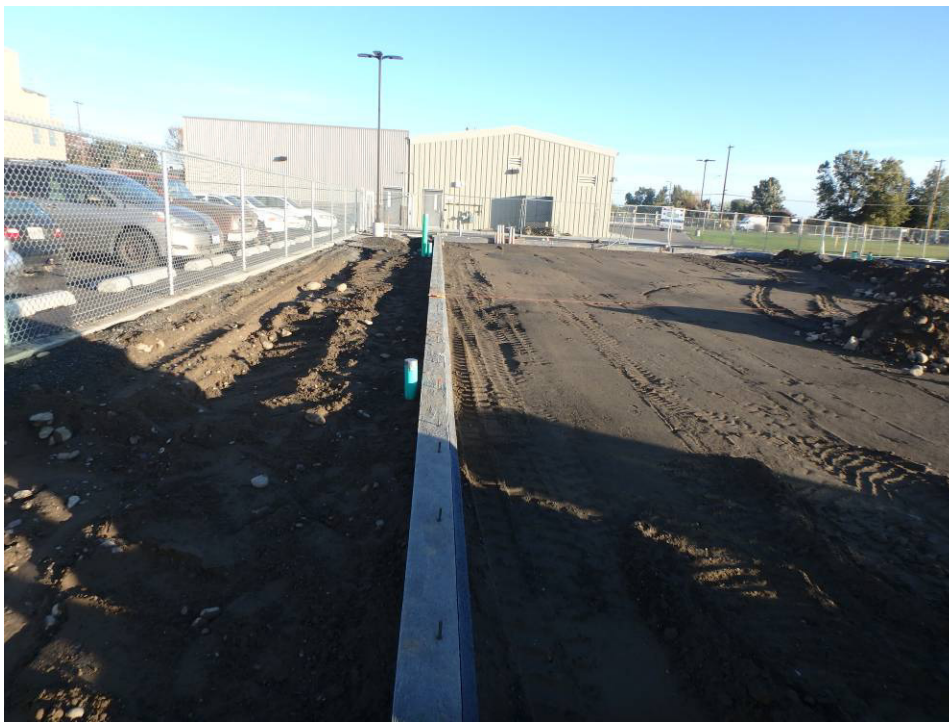
Looking north at the west foundation wall

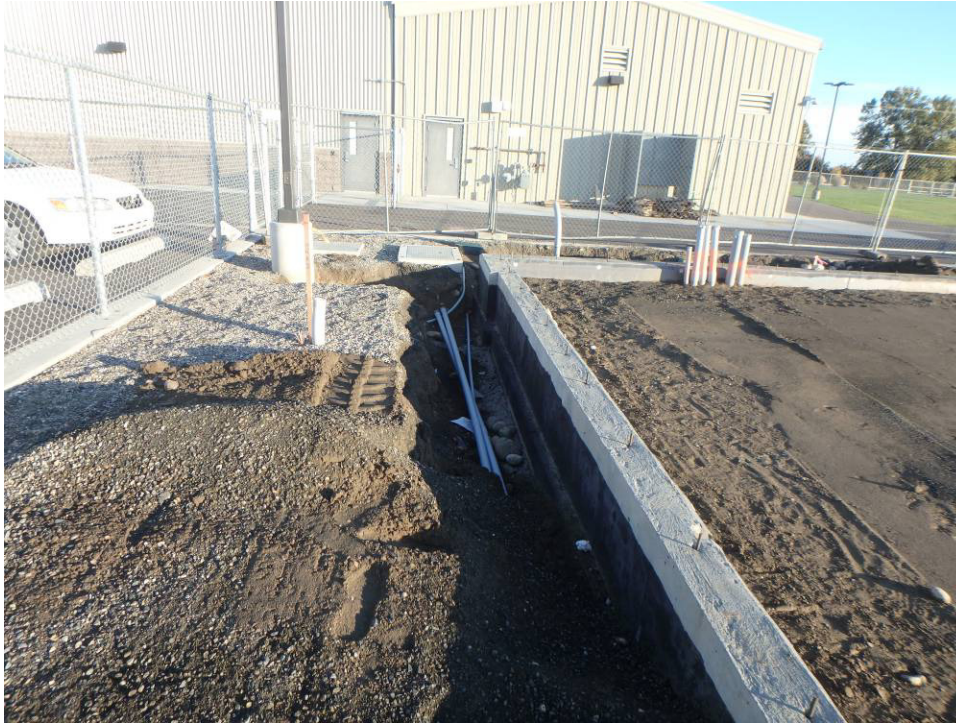
Northwest corner of the building and foundation walls

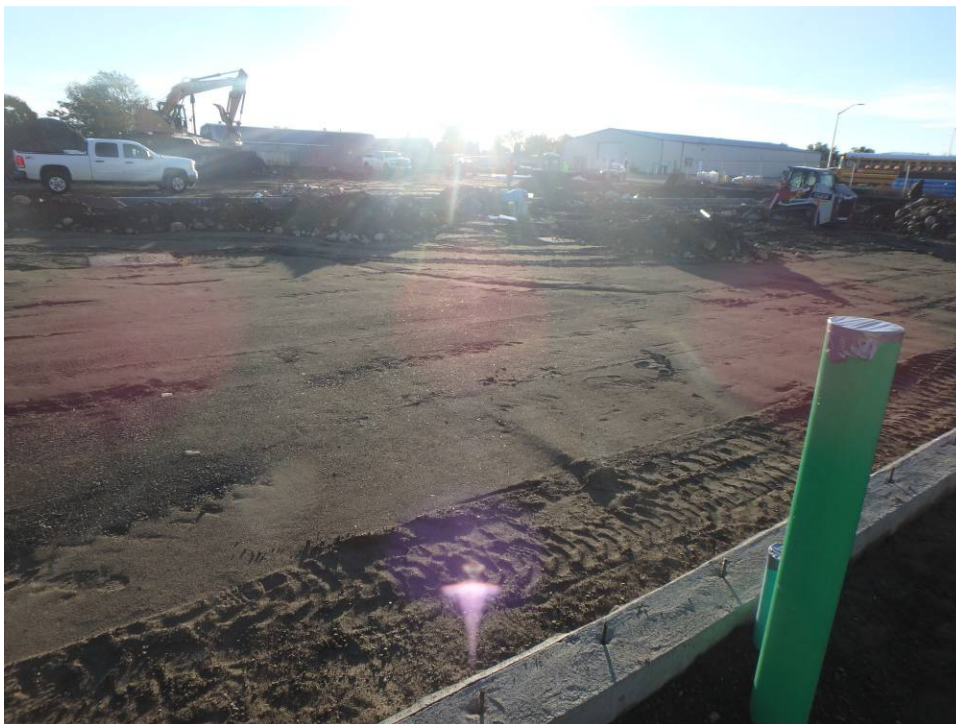
Looking southeast at the north half of the building footprint

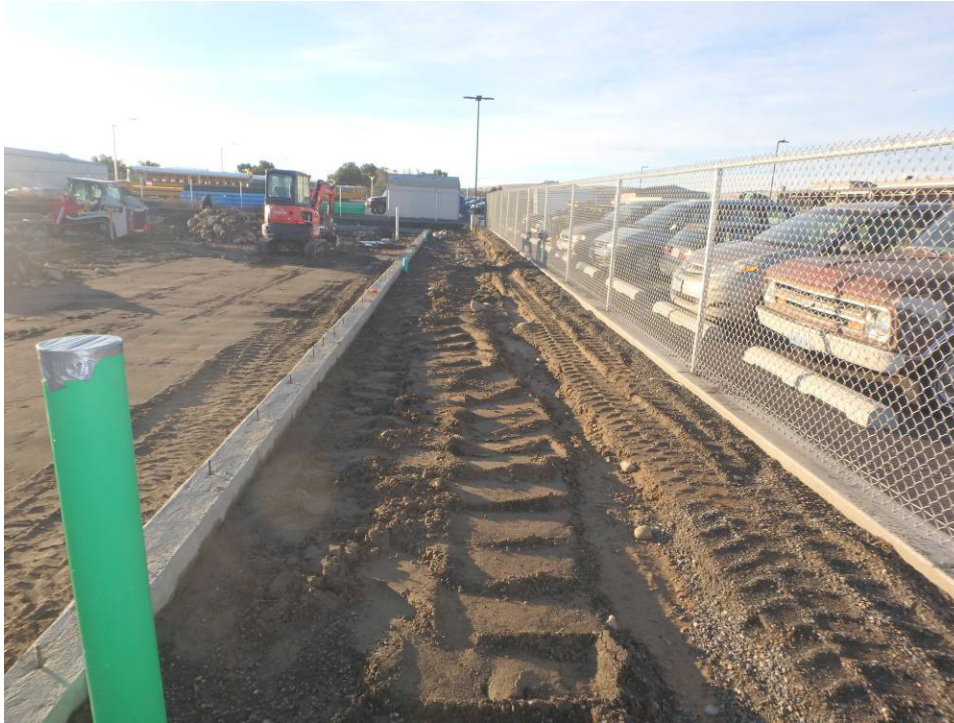
Looking south along the west foundation wall and grade from the NW corner

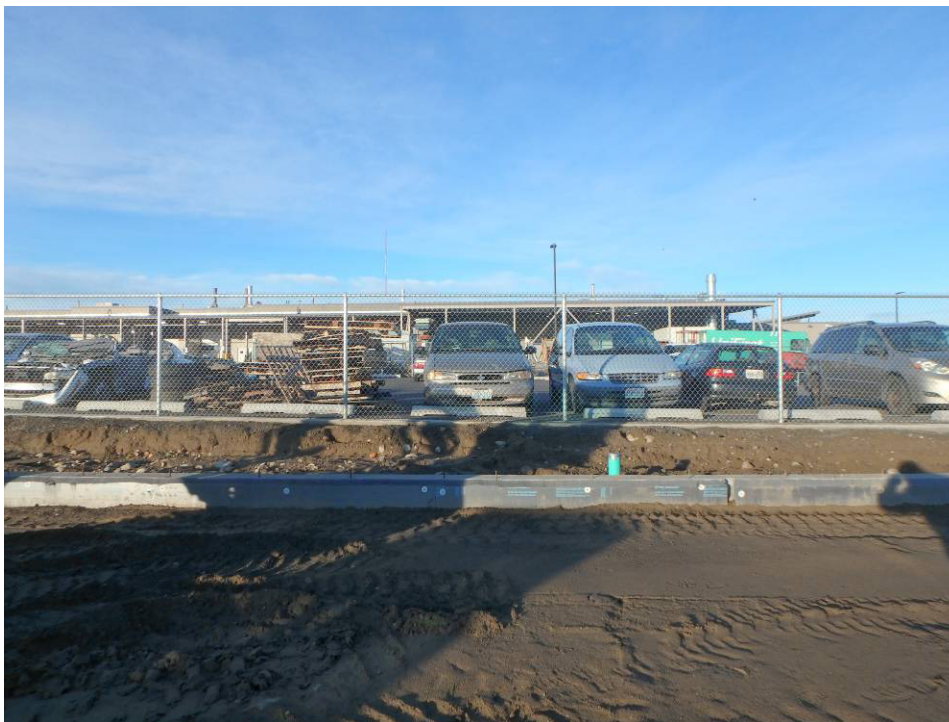
West retaining wall extended to approx. 5' left of the green pipe

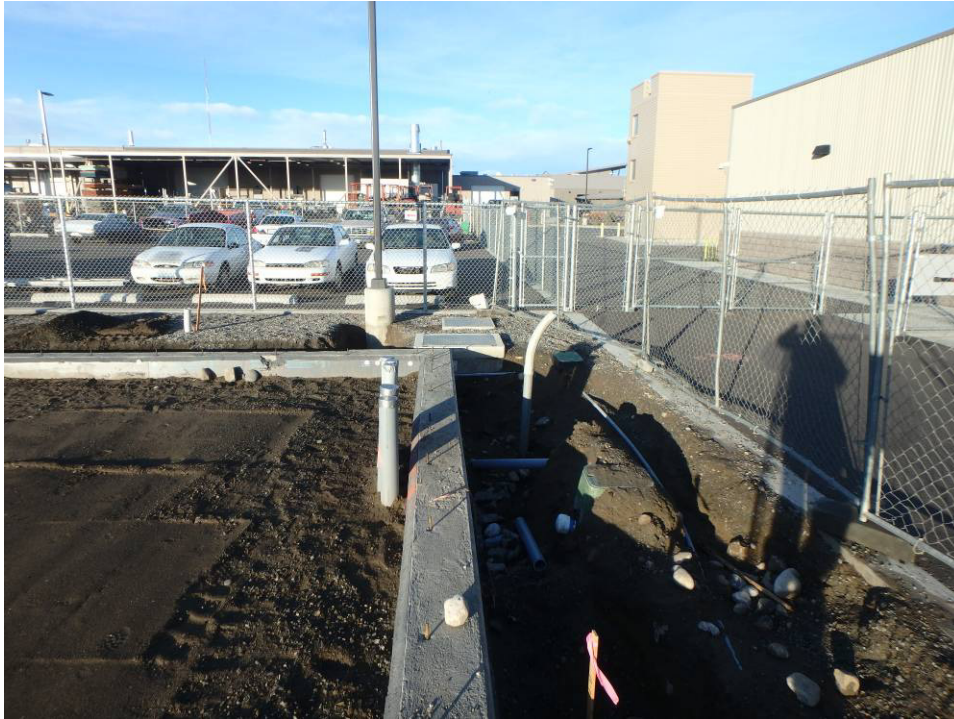
Looking west at the northwest corner of the building

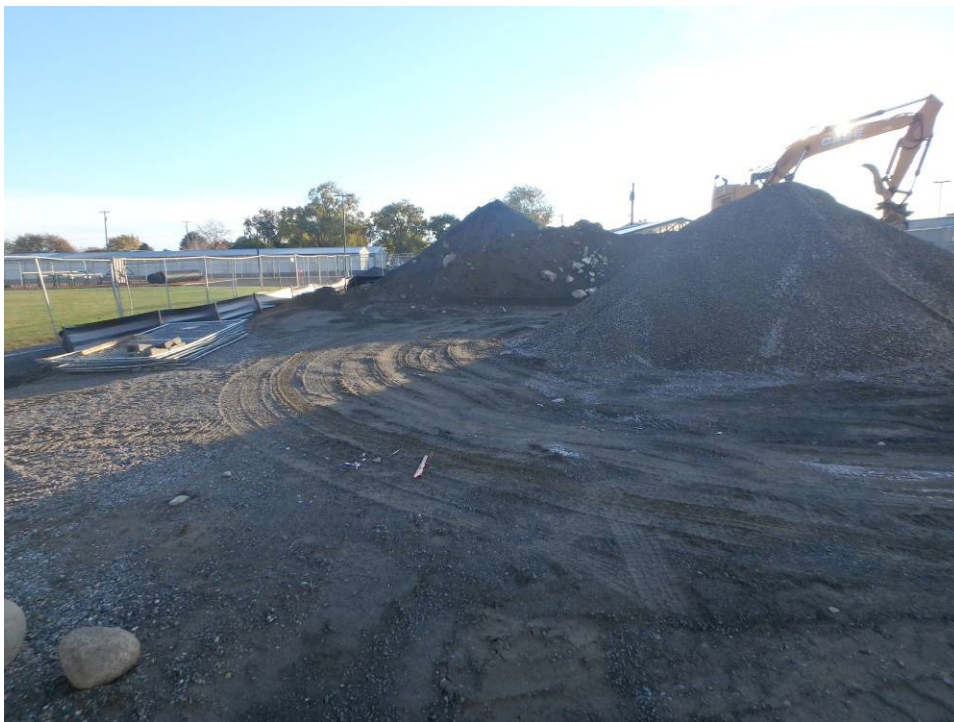
Looking east along the north project site to the northeast corner

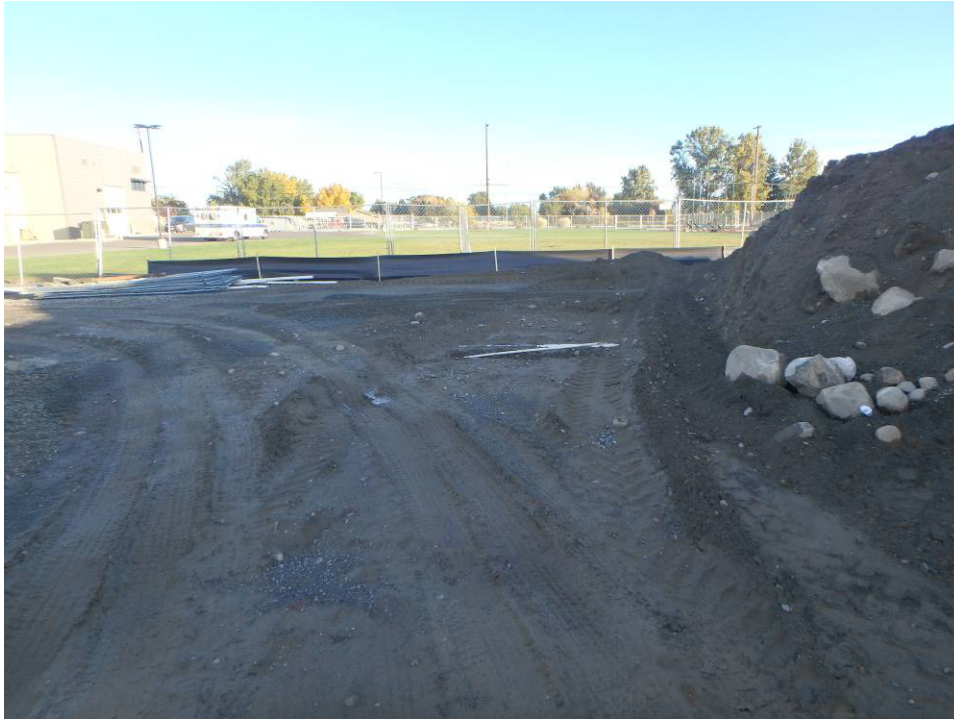
Looking north at the exposed irrigation 3" pipe (behind the 1" pipe)

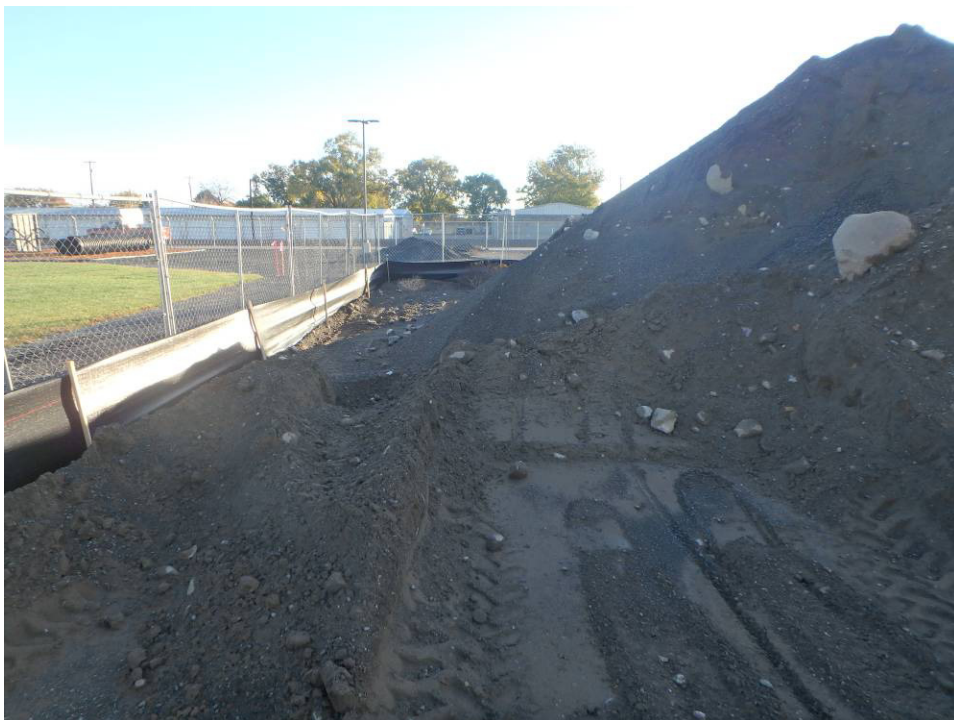
Looking east at the soil stockpile

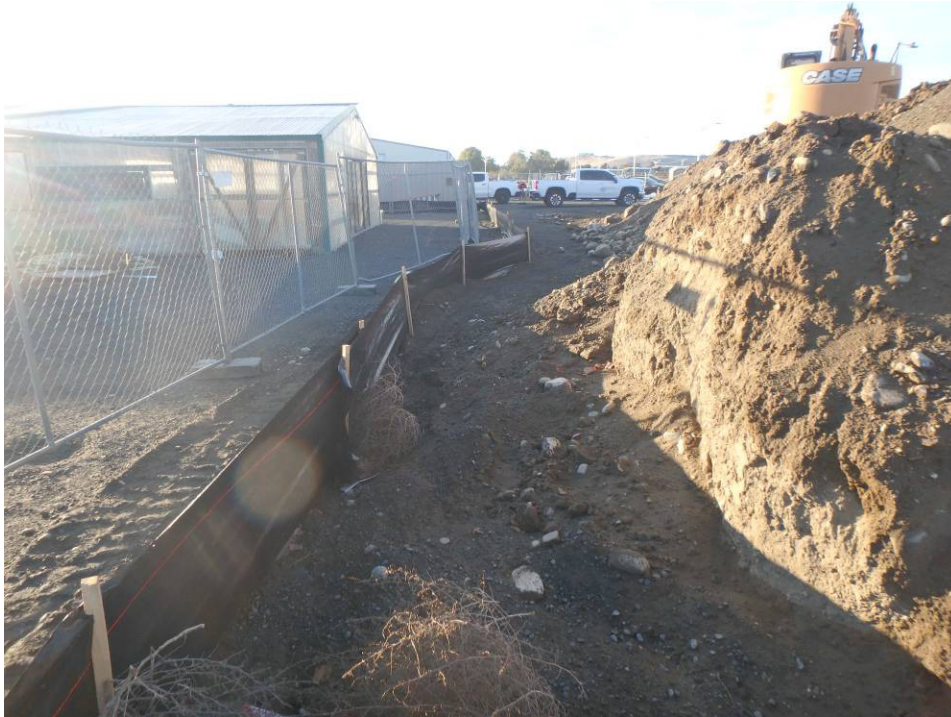
Looking south at the soil stockpile at the property line near the greenhouse

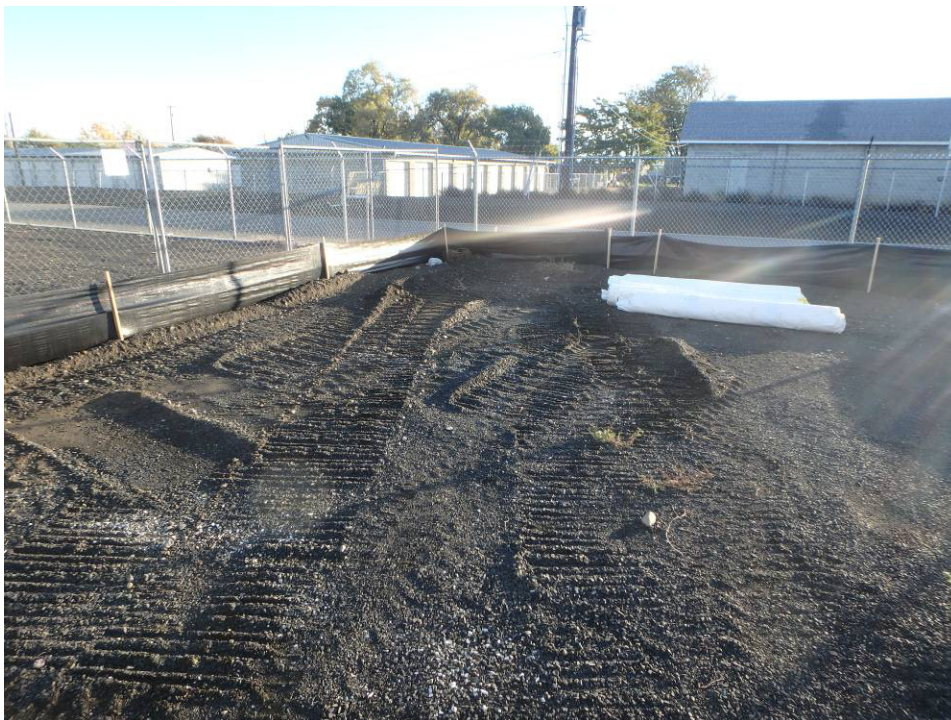
Silt fence at the northeast corner of the site

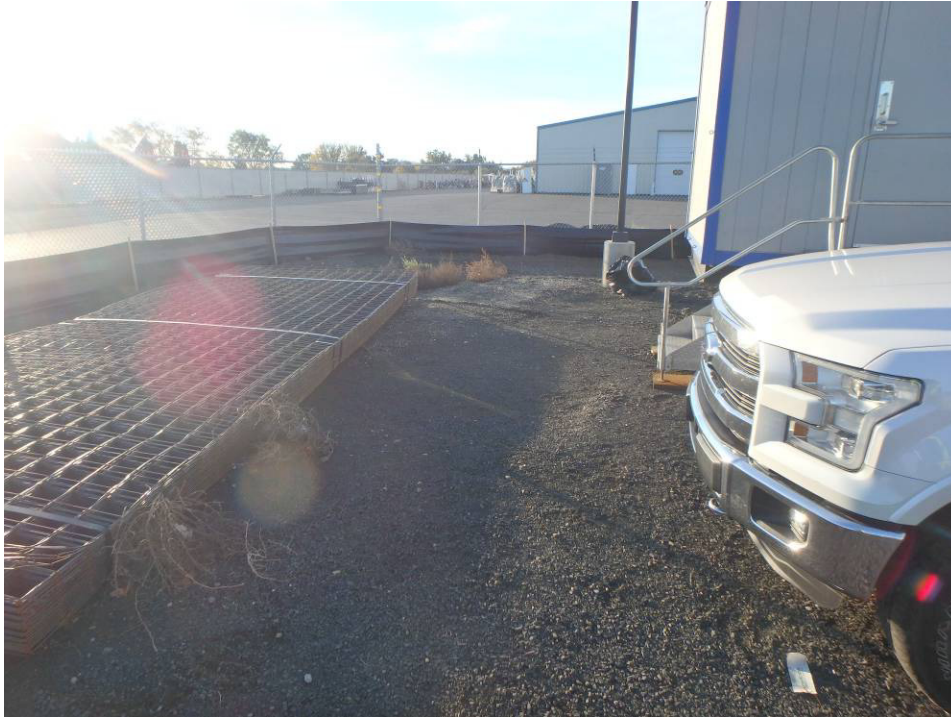
Silt fence at the southeast corner of the site

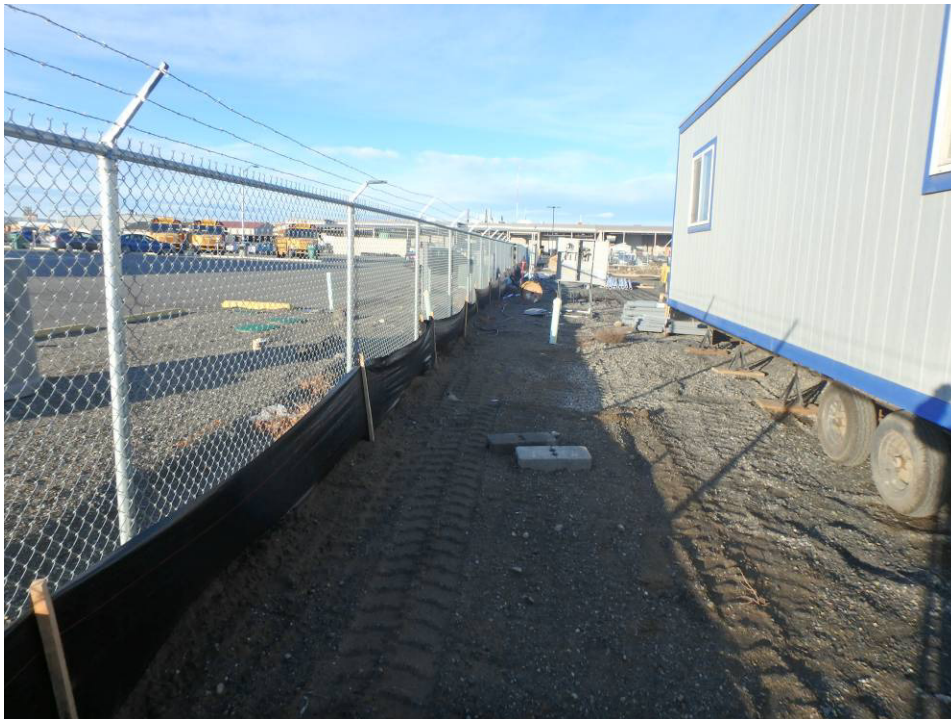
Looking west at the south property line from the SE corner

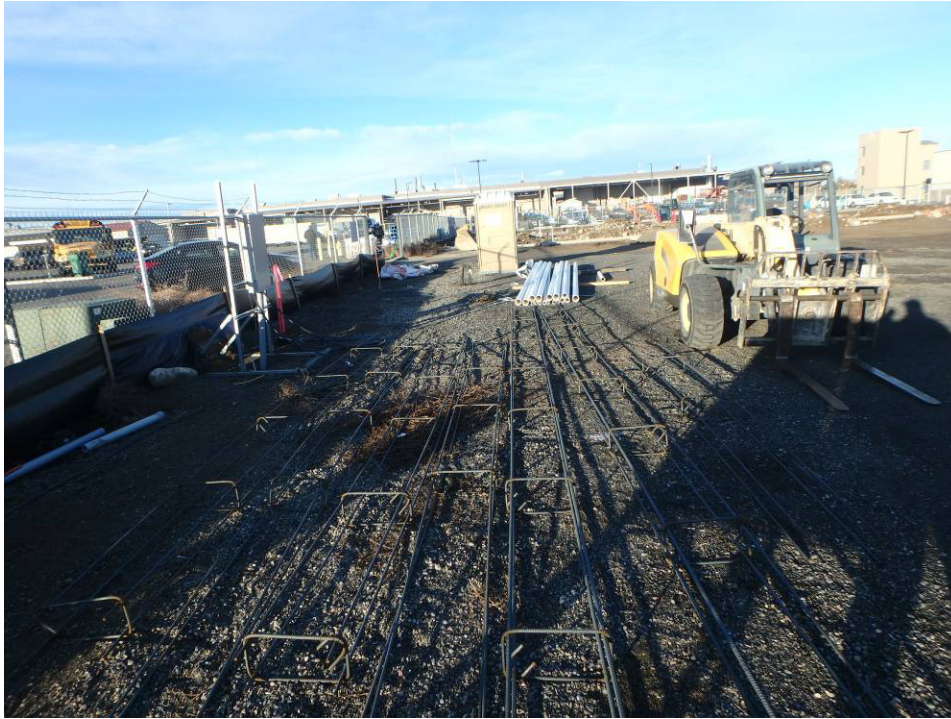
Looking west at the rebar cages along the south property line

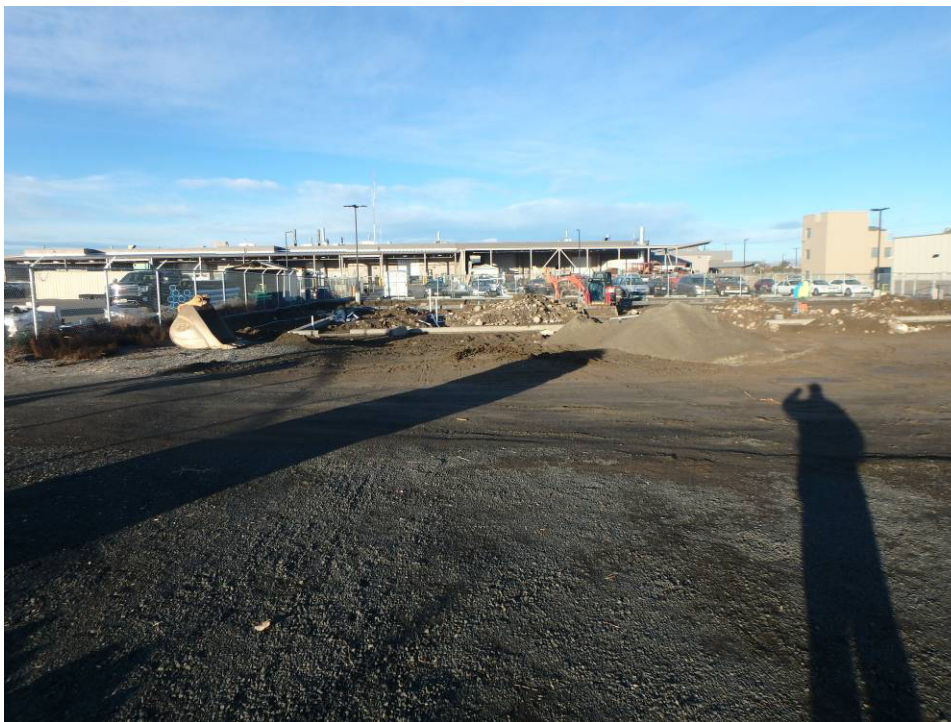
Looking west at the south foundation wall from the site entry

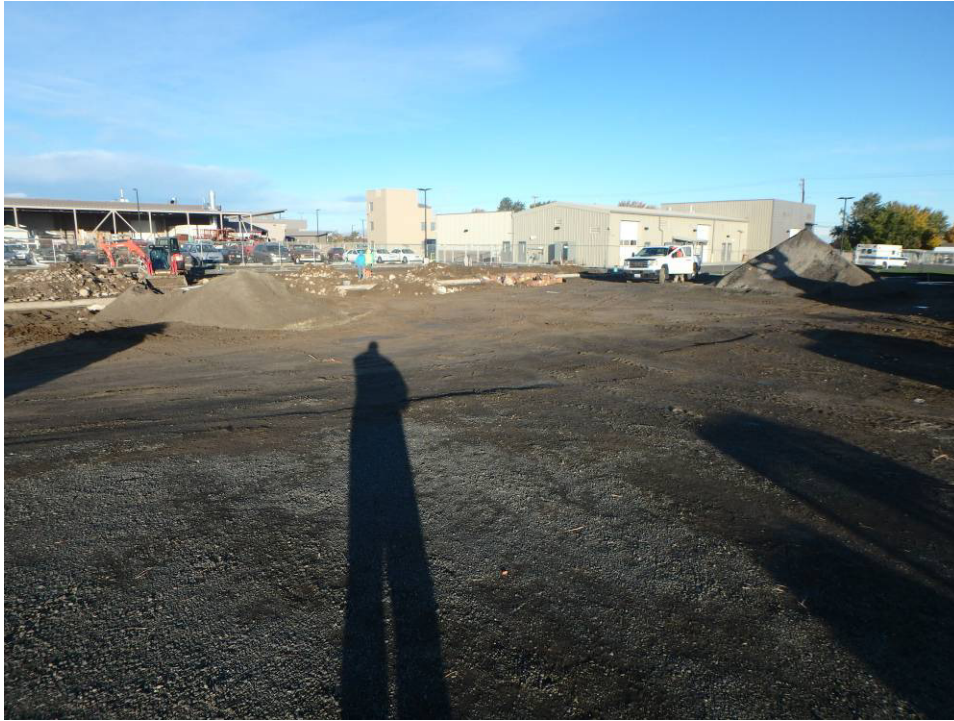
Looking northwest across the site

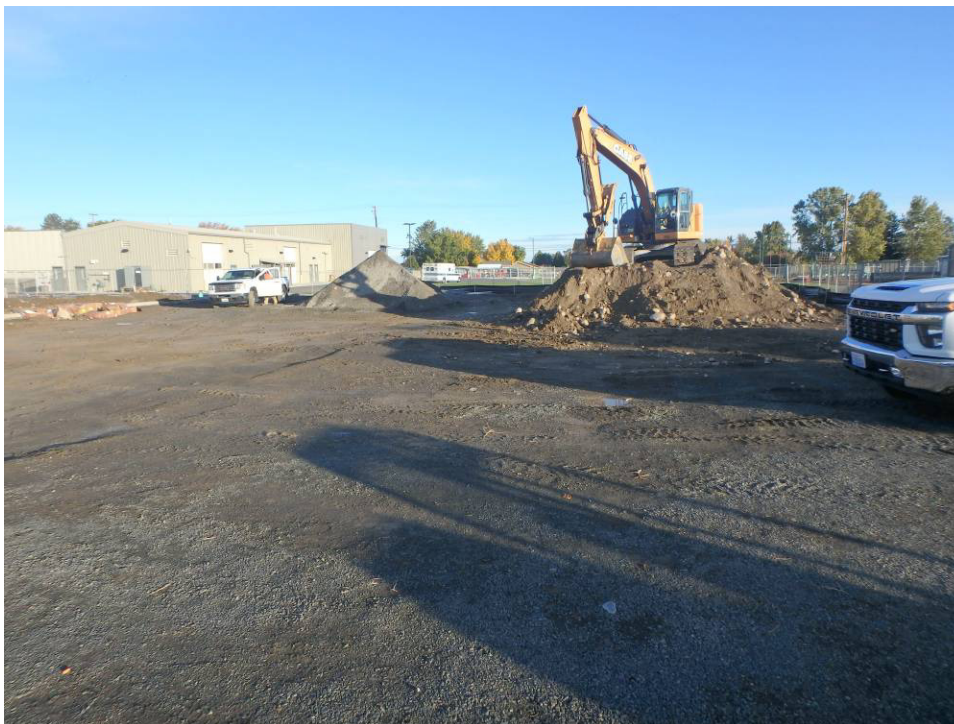
Looking north across the center of the site and soil stockpile
