WALKER RESERVOIR DAM

VERNON, CONNECTICUT

#14616

INSPECTION REPORT

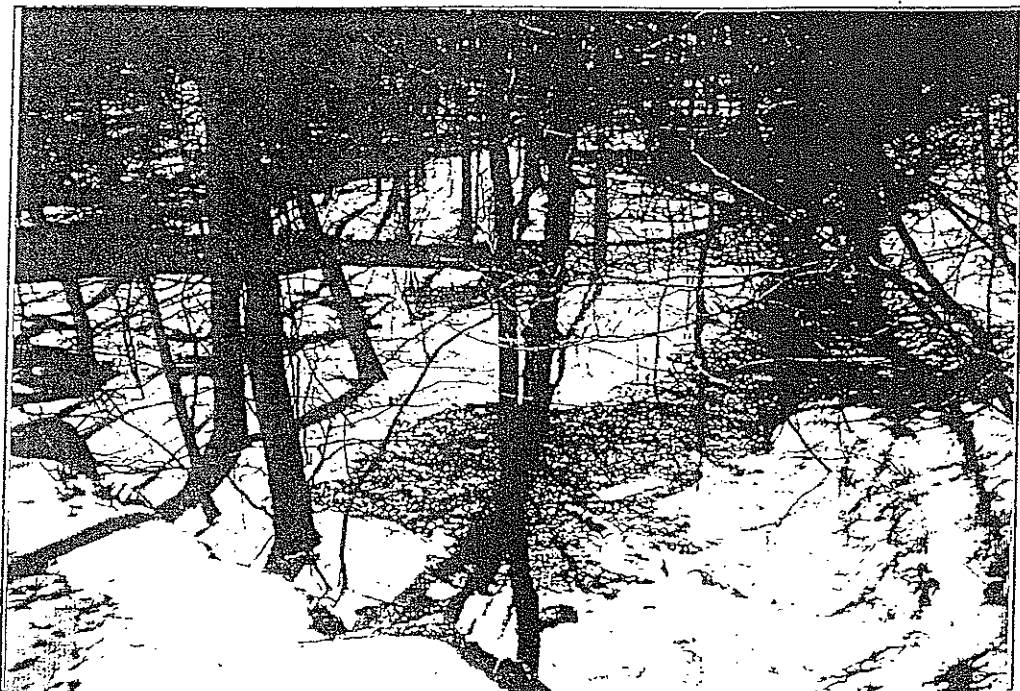
0598A-1

- [0598A-1] The right downstream toe area of the dam as taken from the right top crest. Note the wet area in the center of the photo and the tree growth.

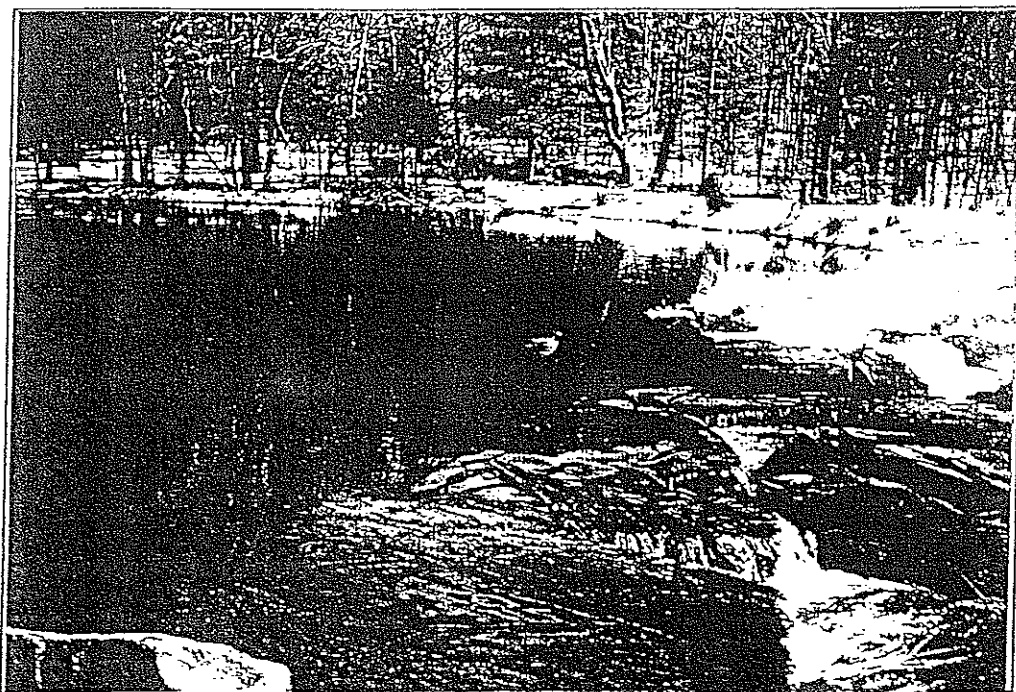
0598A-2

- [0598A-2] The upstream portion of the stone spillway. Note that the crest line is not well defined and that there are numerous open and washed out areas between stones.

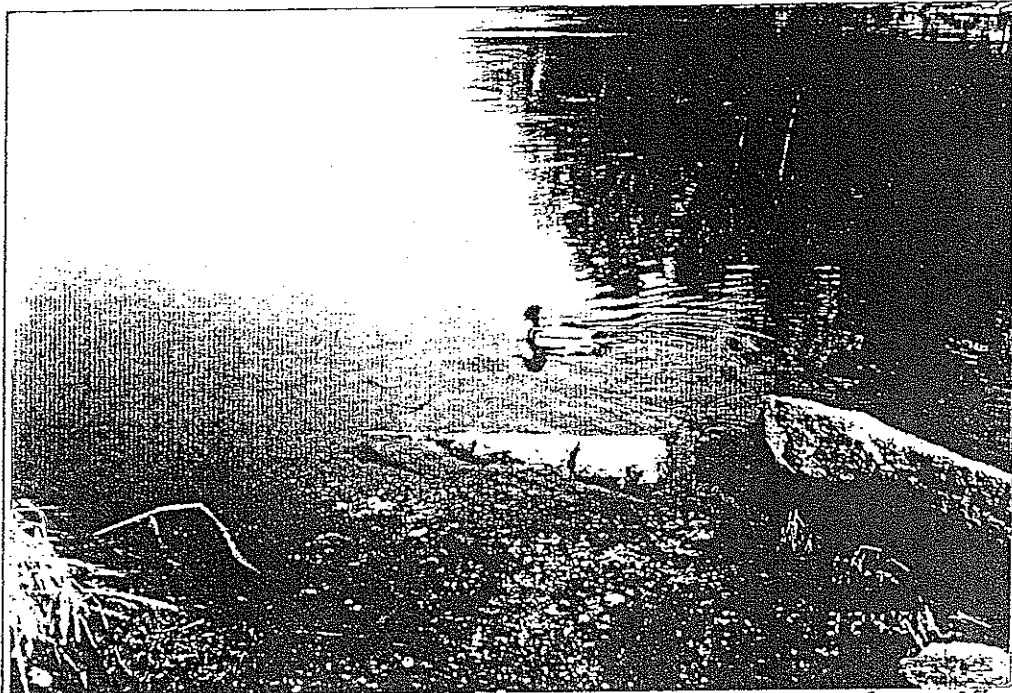
0598A-3

- [0598A-3] The right upstream side of the spillway training wall area, washed out from erosion during high flow events and probable overtopping of low areas adjacent to the spillway. Local resident providing voluntary inspection services is visible at center of photo.

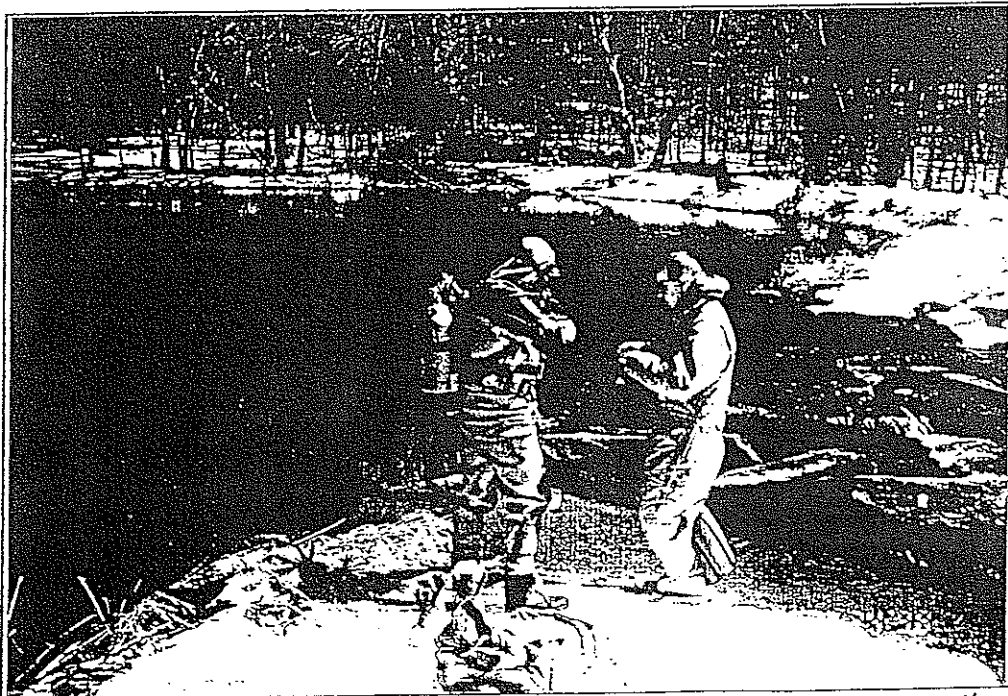
0598A-4

- [0598A-4] Diver preparing for inspection of intake and low level outlet. Again, note the eroded area directly adjacent to the right spillway training wall.

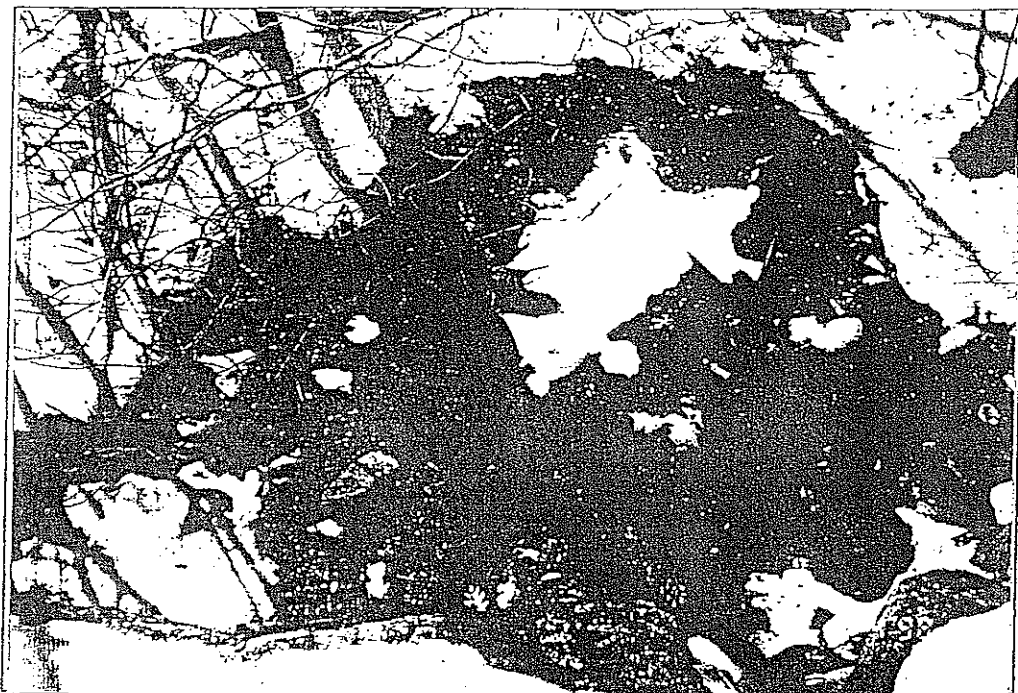
0598A-5

- [0598A-5] The right downstream toe showing another wet area to the left of the one pointed out in 0598A-1, above. This is still to the right of the spillway and downstream channel, directly at the base of the downstream stone masonry wall of the dam.

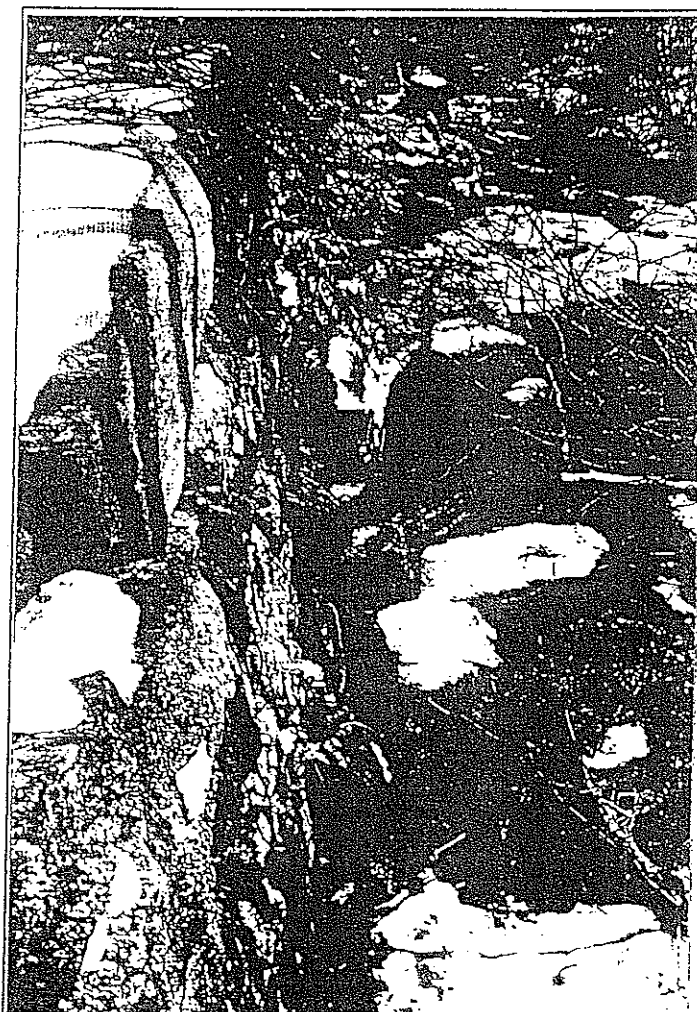
0598A-6

- [0598A-6] A view of the downstream toe area just to the left of the spillway discharge channel. The low level outlet pipe is discharging a small amount of flow visible at the base of the wall in the center of the photo.

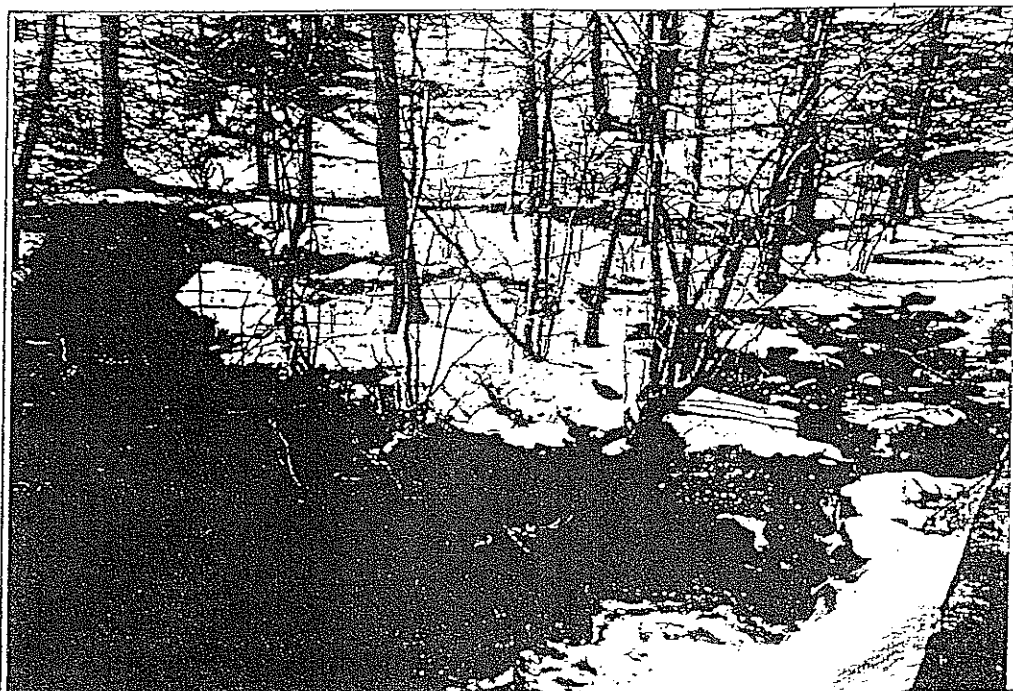
0598A-7

- [0598A-7] An overview of the right downstream toe area showing the extent of the wetland and toe seepage at the base of the dam. The spillway is in the bottom right corner of the photo.

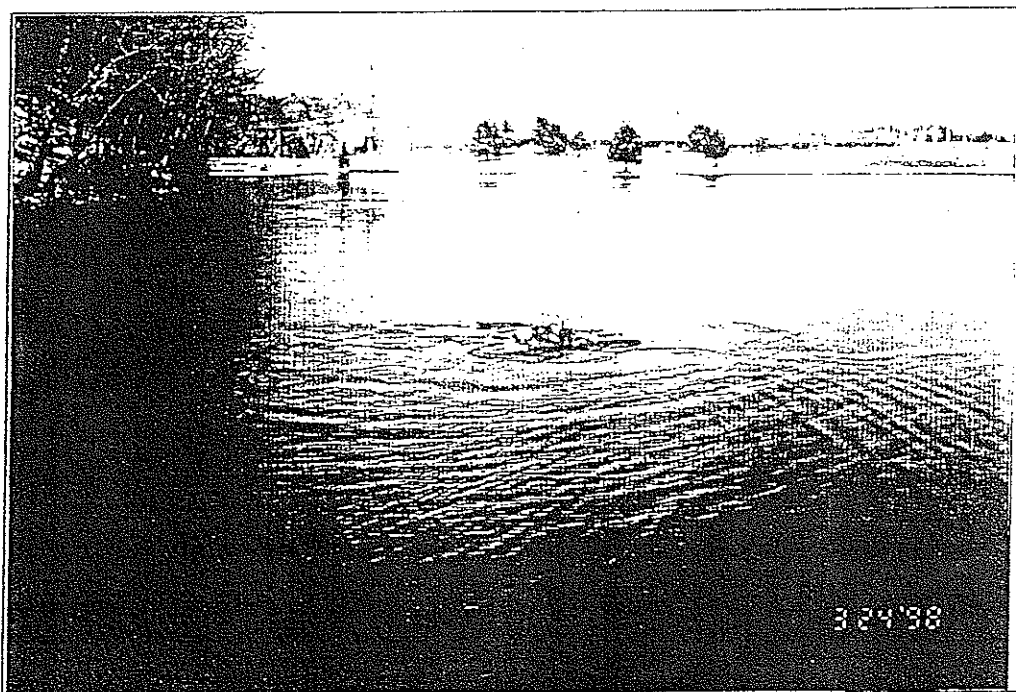
0598A-8

- [0598A-8] A view of Walker Reservoir East looking north from the upstream side of the dam. The diver visible in the center of the photo is searching for the pipe intake, as well as checking the upstream slope of the dam for any signs of depressions, piping through the embankment and any problems of a general nature.

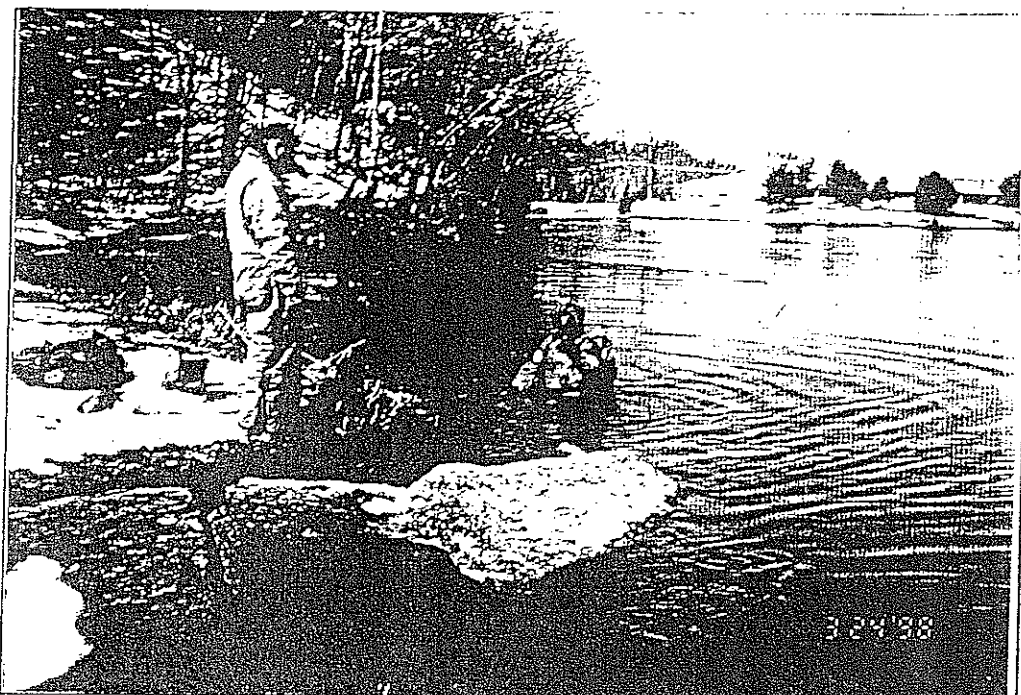
0598A-9

- [0598A-9] Another view of the diver at right upstream spillway area. Note again the wash area behind the wall and the northerly end of the pond. Reservoir Road is located at the center rear of the photo.

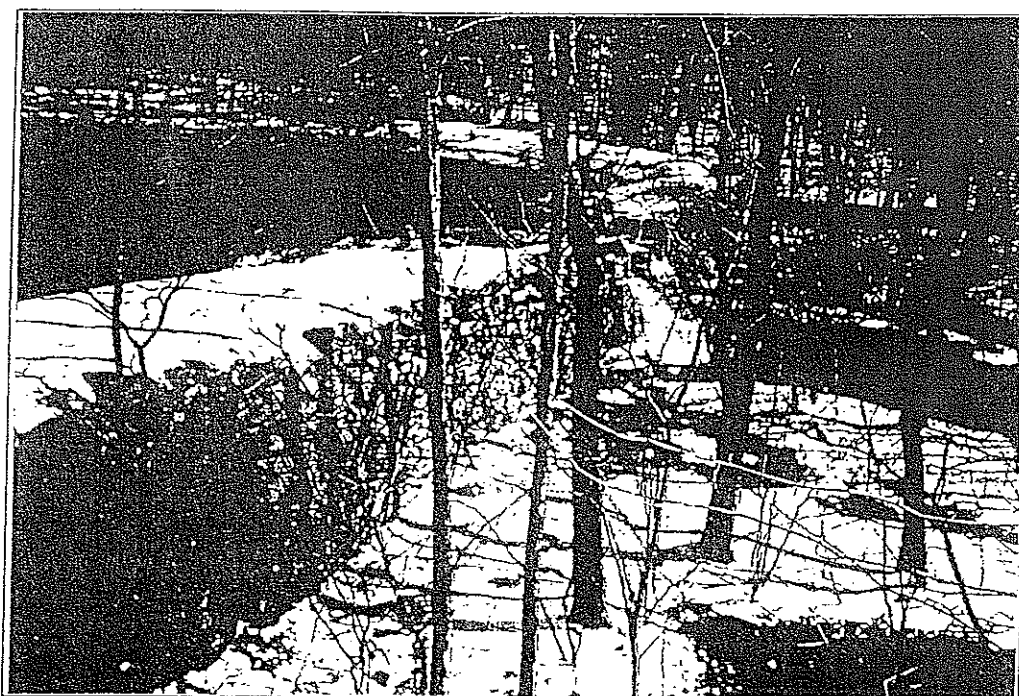
0598A-10

- [0598A-10] A view of the right downstream wall and toe area of the dam. Once again, note the seepage and wetland areas and trees growing in close proximity to the dam. The spillway discharge and downstream channel are visible at the right center of the photo.

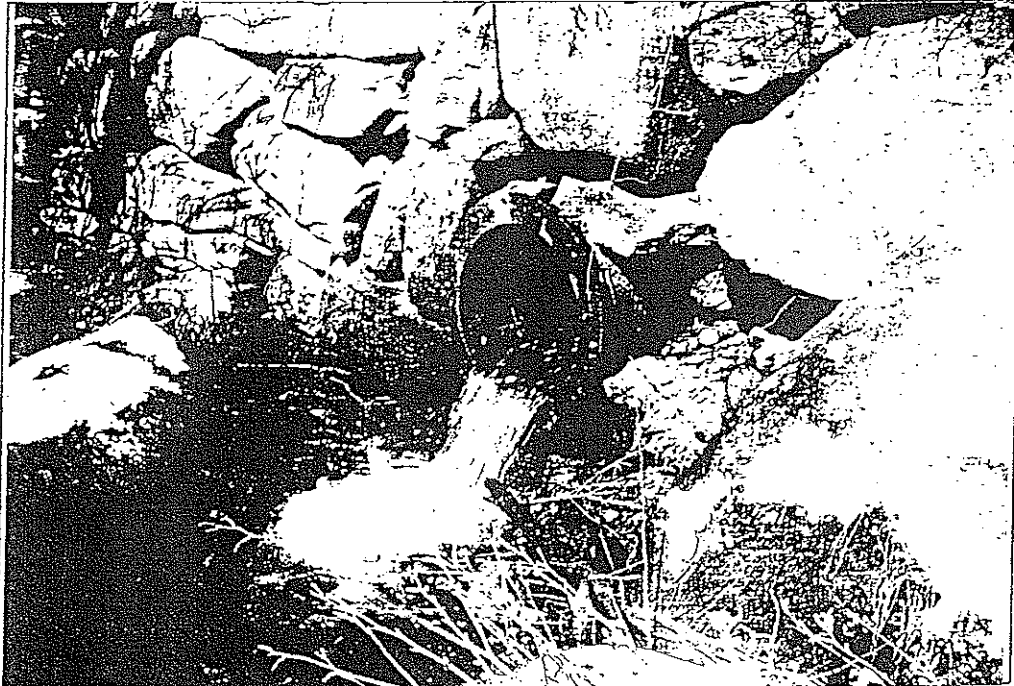
0598A-11

- [0598A-11] The low level outlet pipe located at the base of the downstream wall just left of the spillway. Note that the discharge is located directly at the base of the wall and that it is ponded and flowing against the stone masonry.

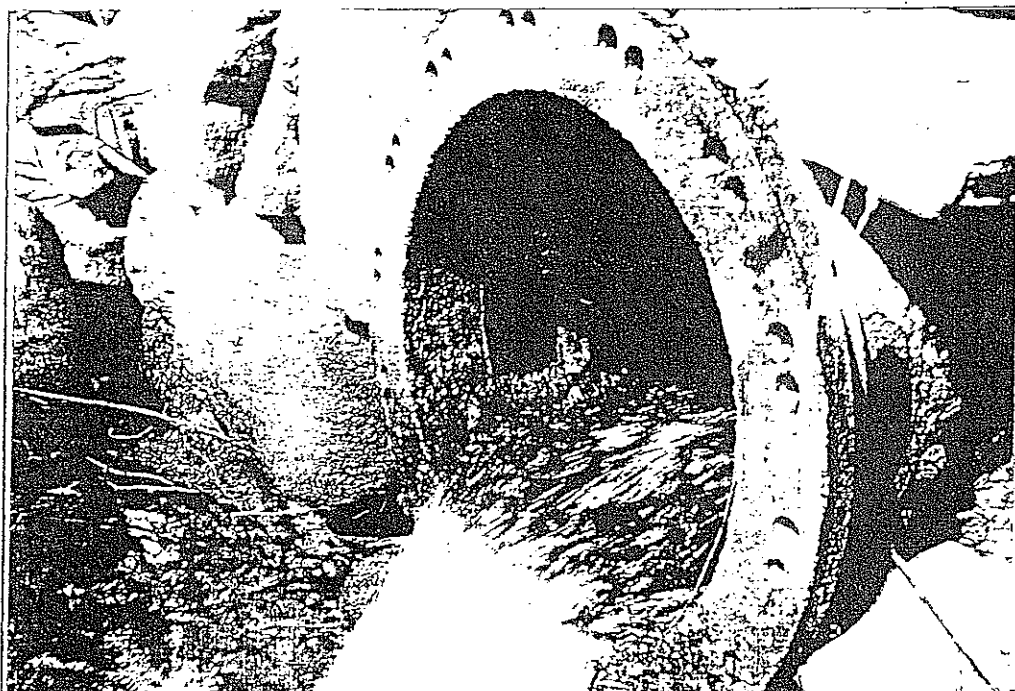
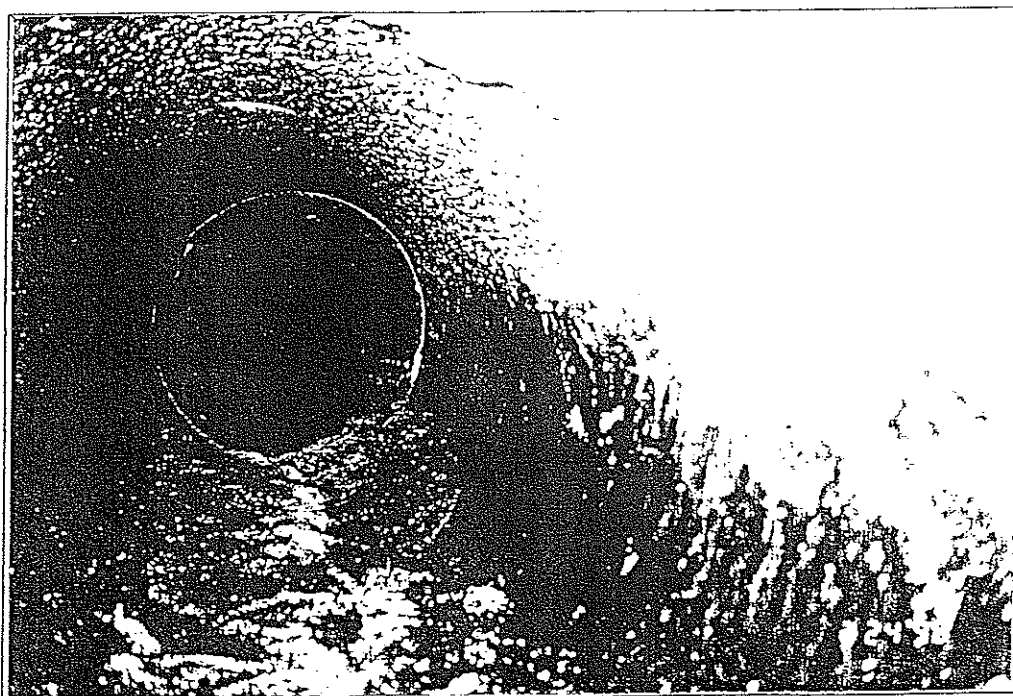
- [0598A-13] Another closeup view of the pipe end, showing a hole in its right side wall as well as the left.
- [0598A-14] The interior of the low level discharge as seen from the downstream end. Note the flow of water emanating not from the gate in the background, but from the pipe joint visible at the end of the riveted pipe section. It appears that the riveted pipe may have been a part of the original low level outlet. Later, the sluice gate and the corrugated metal pipe at the rear were probably added. At some point, the cast iron flanged end section visible at the outside in the previous photos was probably pushed into the end of the wall to replace a deteriorating riveted section.

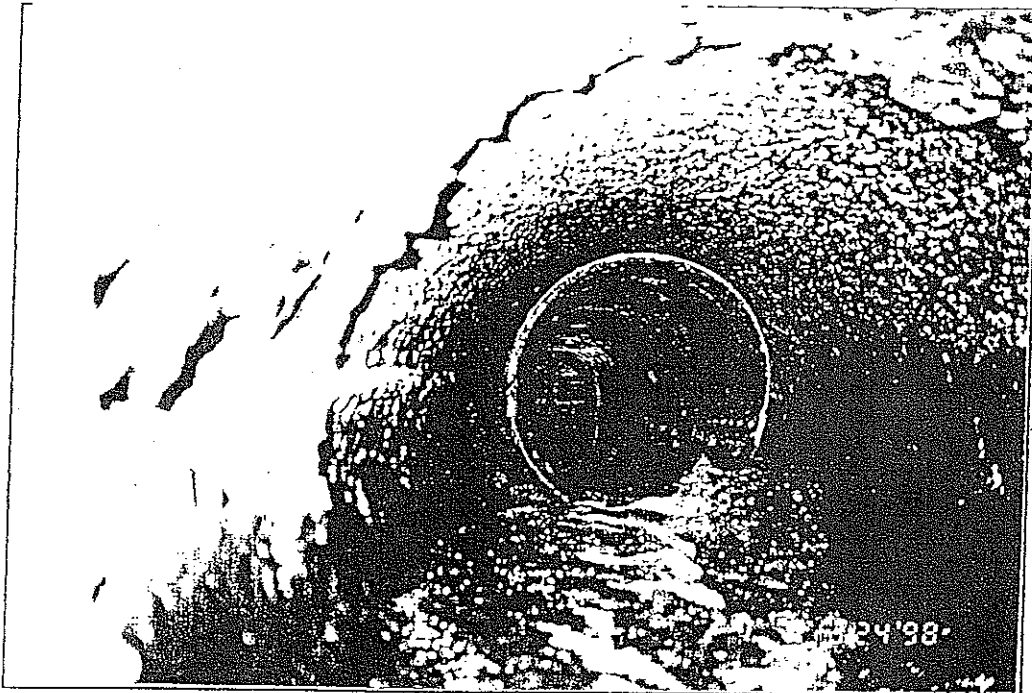
CS98A-15

- [0598A-15] Another view of the pipe interior; the three different pipe types are now clearly visible - deteriorating cast iron in the foreground, followed by riveted steel pipe and corrugated metal pipe at the upstream end.

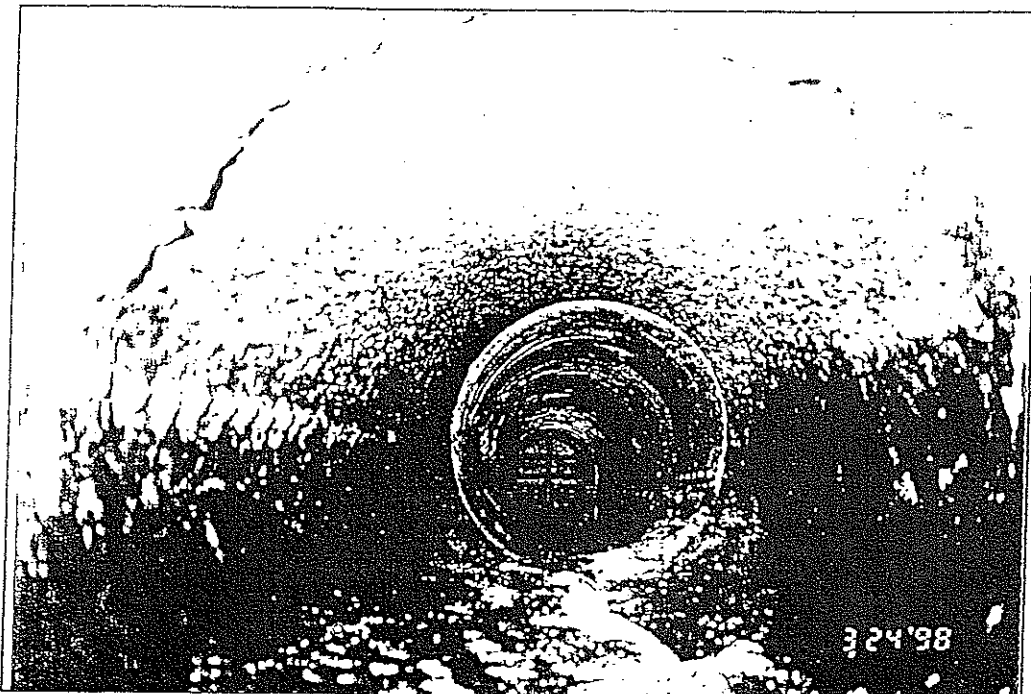
CS98A-16

- [0598A-16] Looking straight up the center of the low level outlet with a clear view of the sluice gate at the end of the pipe. The gate was not operated during this inspection since little of its history is known and because once opened, the gate might not close and thus slowly drain the reservoir.

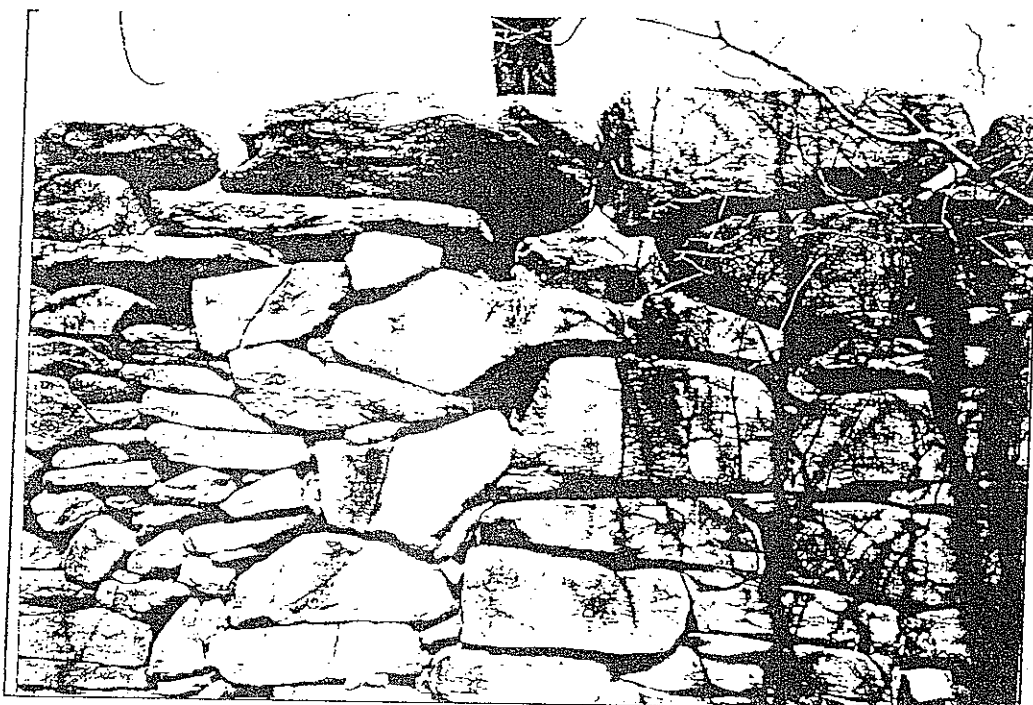
5598A-23

- [0598A-22] The spillway as seen from the right downstream channel embankment.
- [0598A-23] The right downstream stone wall showing many of the voids between the stones. Note also the probable repair area of smaller stones at the left side of the wall where larger stones had fallen down to the base.

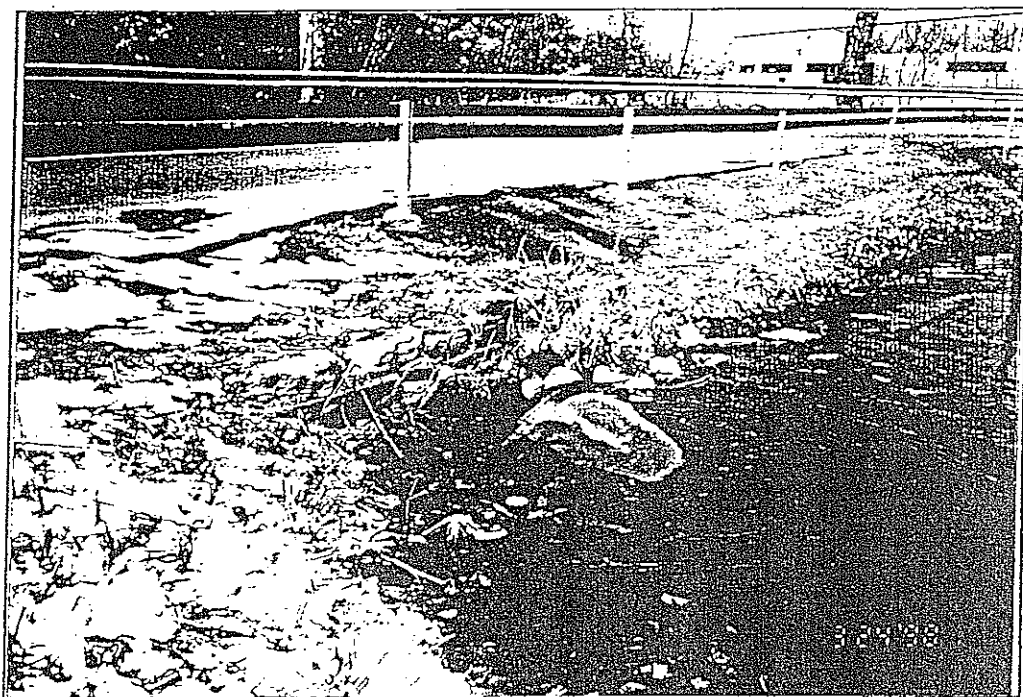
0598B-1

- [0598B-1] The diver searching for the pipe culvert passing beneath Reservoir Road between Walker Reservoir East and Walker Reservoir West. Because of heavy debris, no defined culvert opening could be found at the downstream end beneath the shallow stone headwall section visible in the center of the photo. A pipe opening was found on the upstream side, but because it was also filled with debris, its exact size and material type could not be determined. It appears that it is a small pipe and from the curve at its top, it appears to be smaller than 12 inches in size. Because of the blockage and small flow openings, the head differential (i.e., the elevation difference) on the day of inspection between reservoir sections was approximately 0.5 feet. It should be noted that in the storm water management plan prepared by SEA Consultants, Inc. in 1989 and 1990, this pipe was described as a 12-inch RCP. If so, the information may be on file at either Engineering or Public Works. It could not be verified by this inspection.

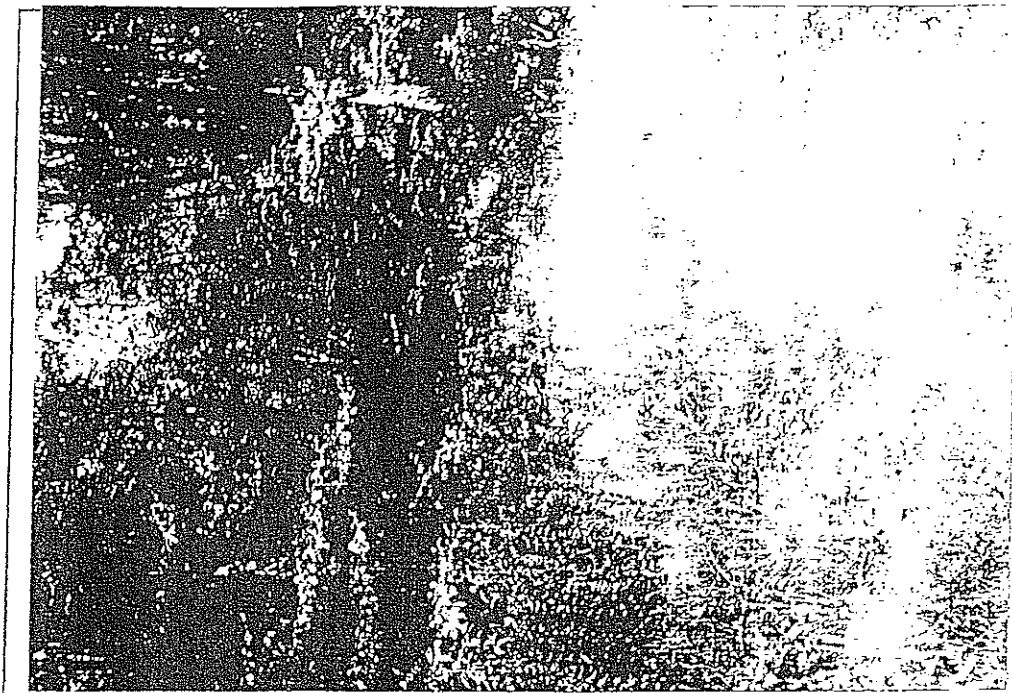
- [0798C-25] Although less extensive than in previous photos, the spillway discharge continues to flow beneath and through the downstream wall.
- [0798C-26] The right abutment area as seen from the right crest of the dam. Note the dense vegetation and a small path leading westerly from the dam. This would represent the most likely access point for future maintenance work on the dam.
