Facilities Assessment

Bayberry Elementary School

113 Bayberry Lane
Watchung, NJ 07069

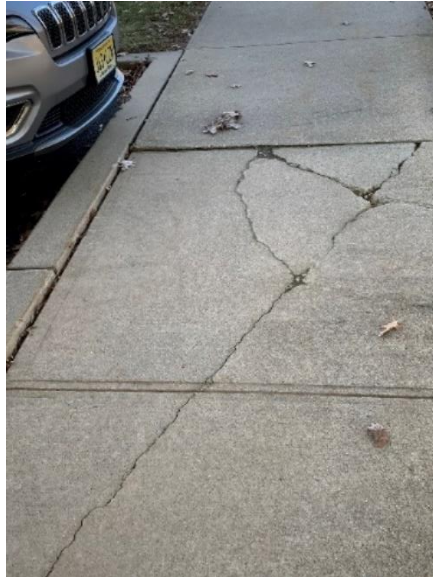
CONCRETE SIDEWALKS: While the overall condition of the sidewalks is good, there are two (2) sections of walkway beneath the solar panel canopy that are in very poor shape. They are badly cracked and have sunk below the edge of the adjacent curb - and are a tripping hazard.

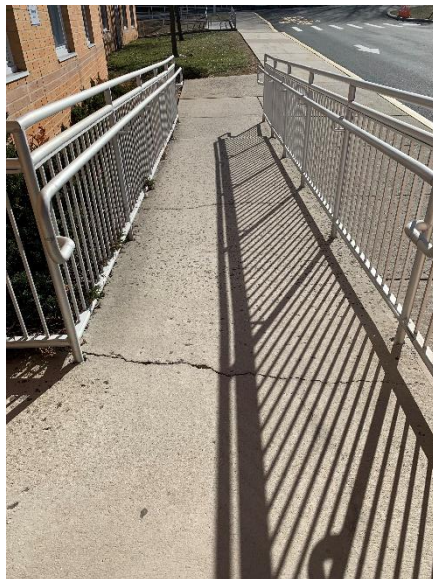
The concrete in the ramp up to main entrance has noticeable cracks running from side to side and should be monitored.

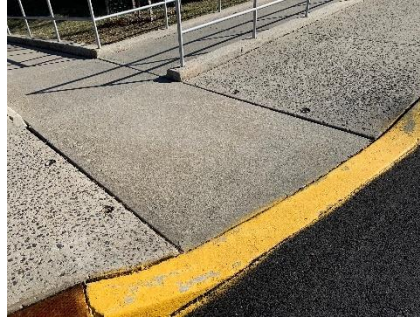
ADA REQUIREMENTS: All of the curb cuts are missing detectable/tactile warning surfaces:

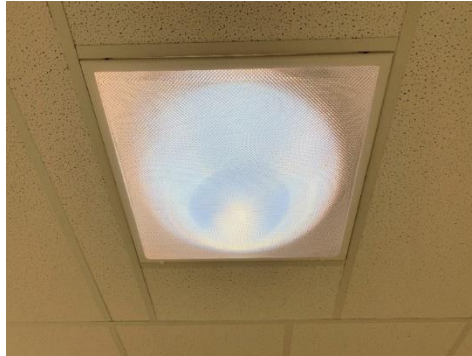
ROOF/SKYLIGHT CONDITIONS: The skylights in the original wing of the school appear to be original to the building. It also appears that when the roof over this portion of the school was replaced, the curbs for the skylights were replaced, but not the skylights themselves. The skylights are a white translucent plastic – and are extremely energy inefficient. At certain times of the day/year the classroom teachers need to move students/desks because of the extreme brightness and heat. These should eventually either be replaced with energy-efficient skylights or removed entirely – with the roof opening infilled.

This is true for the skylights in the corridors too:

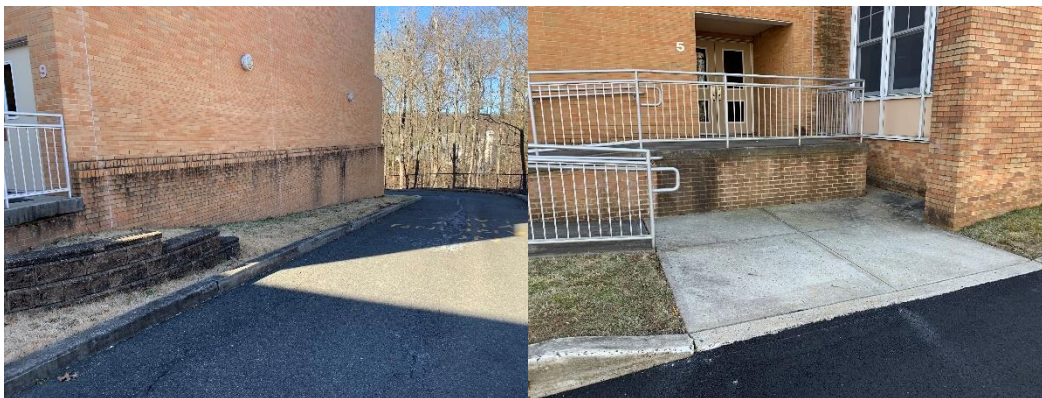
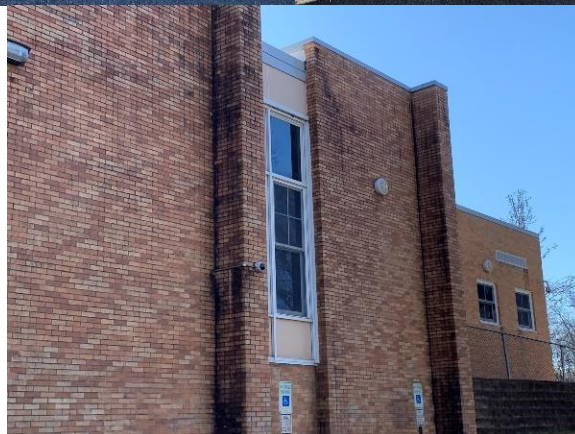
EXTERIOR WALL CONDITIONS: The exterior walls are in good condition, however – the some of the brick on the northeast and northwest facades of the Gymnasium (below the water table feature) and on the brick on one of the stairwells adjacent to the Gymnasium have become very discolored.

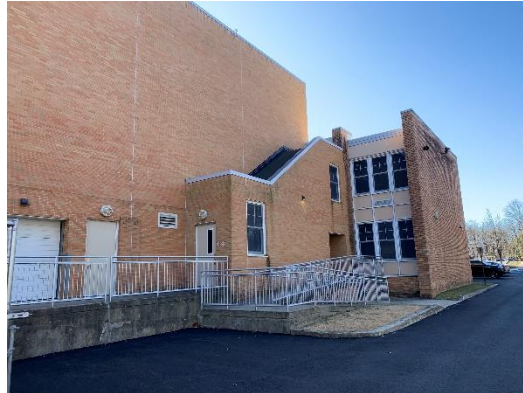
The cement parge coat on the wall of the ramps in that same area needs repair.

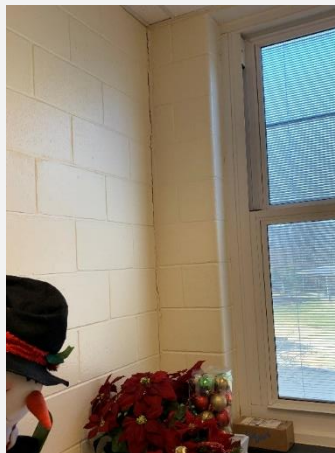
INTERIOR WALL CONDITIONS: The interior walls are in good shape apart from some of the walls in the Nurse's Suite (missing a control joint):

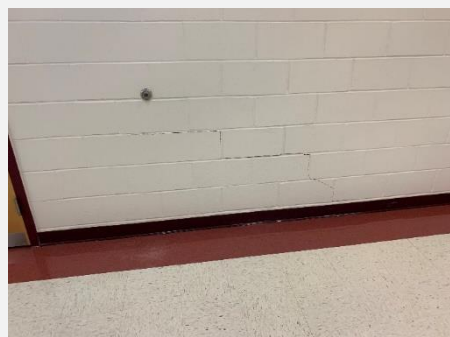
There are also cracks in the CMU wall in the corridor outside of the Nurse's Suite:

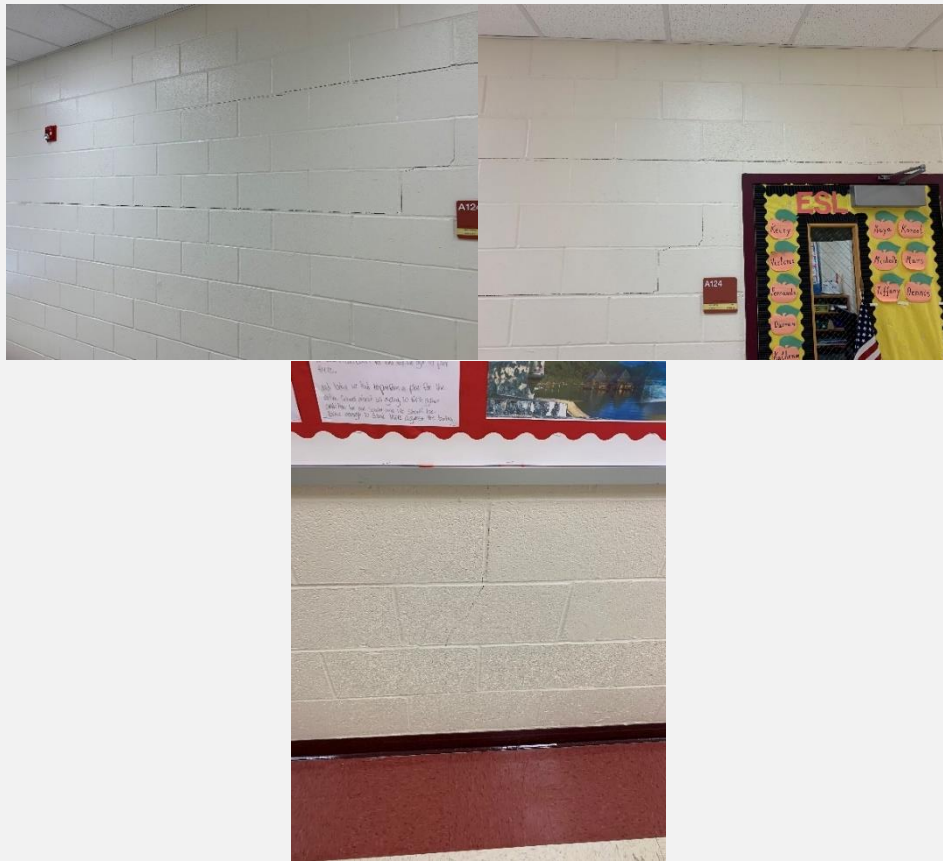
There are also cracks in the walls of the corridor adjacent to the Media Center:

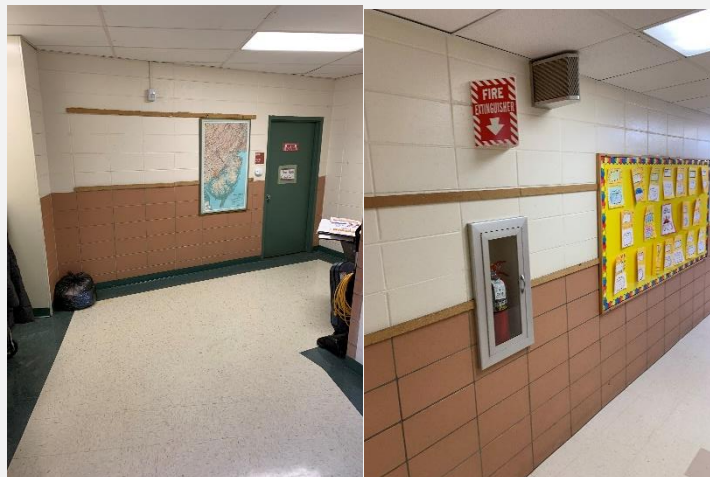
The corridor walls in the original wing of the school have a glazed structural block wainscoting that is a muddy salmon color. The block could easily be painted over with an epoxy paint that would update and brighten the overall look of the corridors.

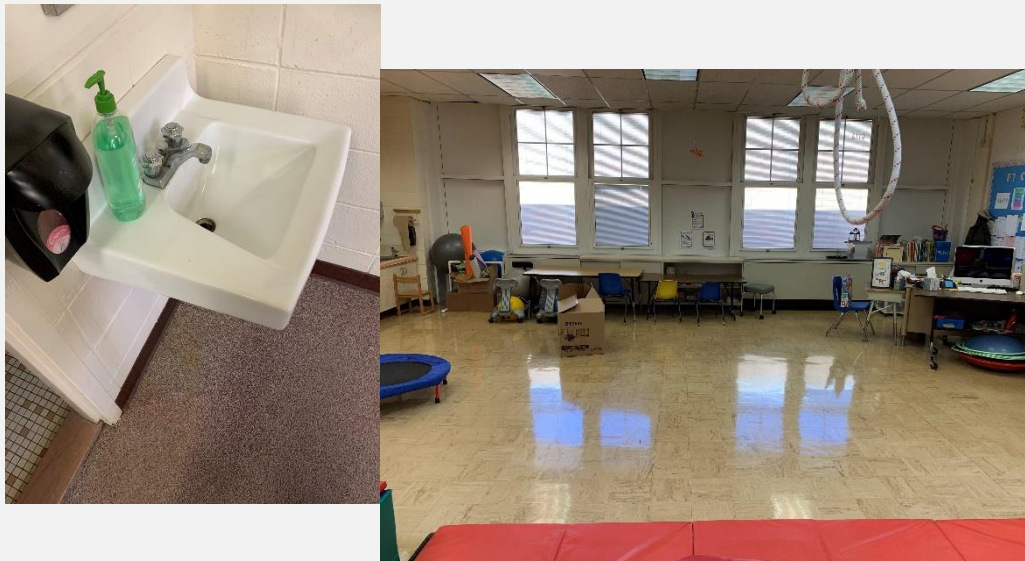
FLOORS: In the original wing of the school (upper level), apart from Classroom #124 (which has newer Vinyl Composition Tile (VCT), the flooring is for the most part carpeting – or a combination of carpeting and Vinyl Asbestos Tile (VAT). The carpeting may have been installed over the original VAT. The BOE was going to see what is shown in the latest AHERA report. Many of these classrooms also have sinks so the carpeting easily gets wet. Ideally all the carpeting should be removed, any original VAT flooring removed/abated – and new VCT installed.

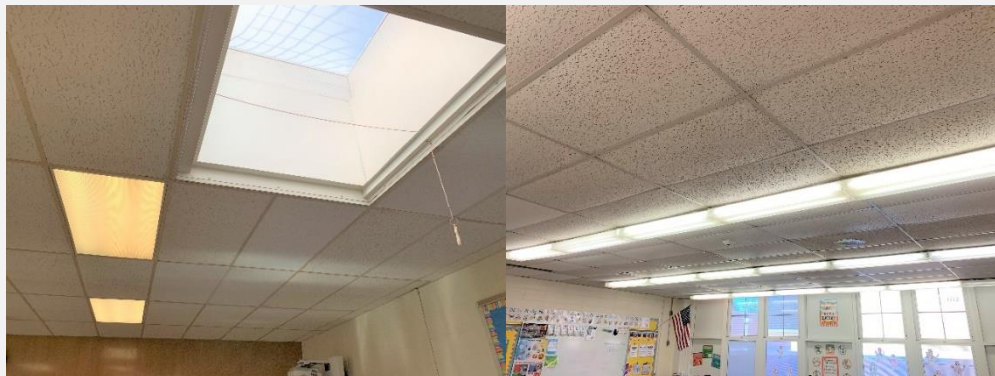
CEILINGS: The acoustic ceiling tiles (and the ceiling grid system) in the spaces located in the original wing of the building are somewhat discolored and many of the tiles have become warped and are sagging. Over the years damaged tiles have been replaced with mismatched tiles.

The ceiling grids can be primed and painted and new ceiling tiles installed.

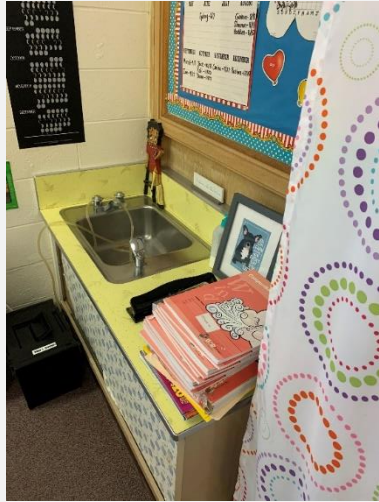
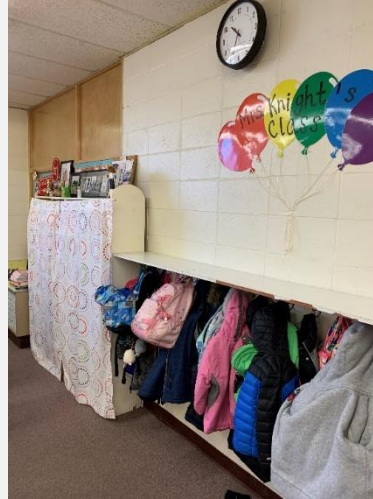
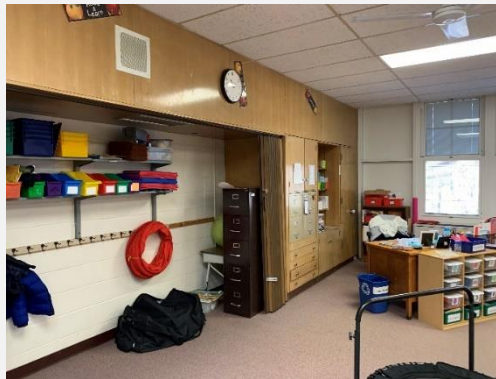
CASEWORK: What casework there is in the classrooms located in the original wing of the school is original to the space and is inadequate for the grades being taught. It would be preferable to replace the existing casework with more up-to-date storage cubbies

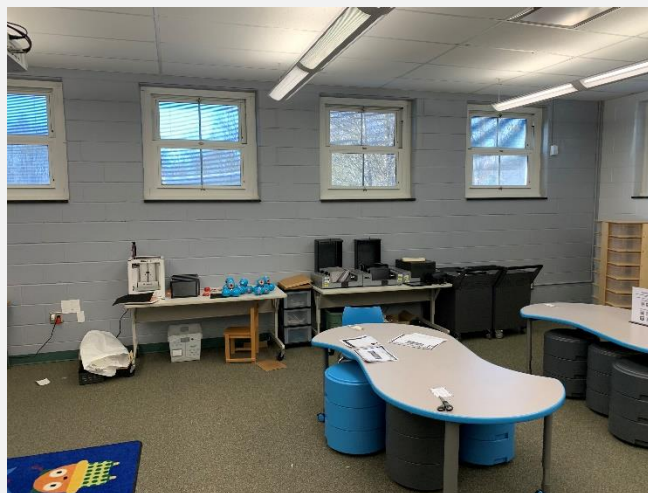
The STEM Classroom/Lab is lacking in storage. Additional storage could easily be added along the walls:

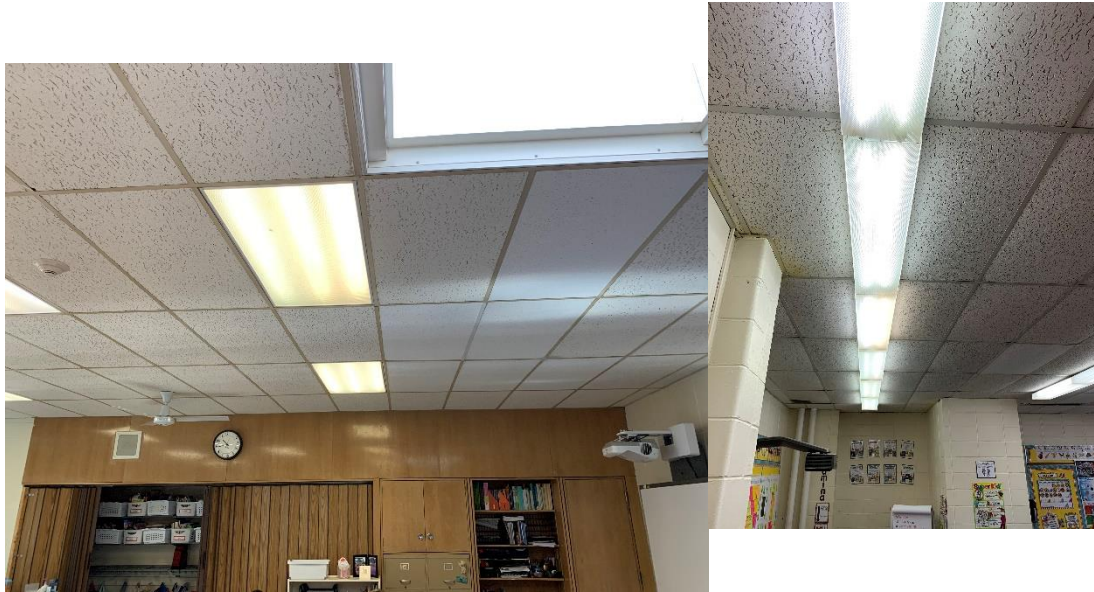
INTERIOR LIGHTING: All existing fluorescent fixtures should be replaced with LED fixtures for increased energy efficiency and light quality. Pricing of LED fixtures is now very competitive and the maintenance (bulb, ballast replacement) is greatly reduced. For any existing 2' x 4' lay in fixtures, LED retro fit kits are available. **THIS WORK WAS DONE OVER THE SUMMER OF 2020.**

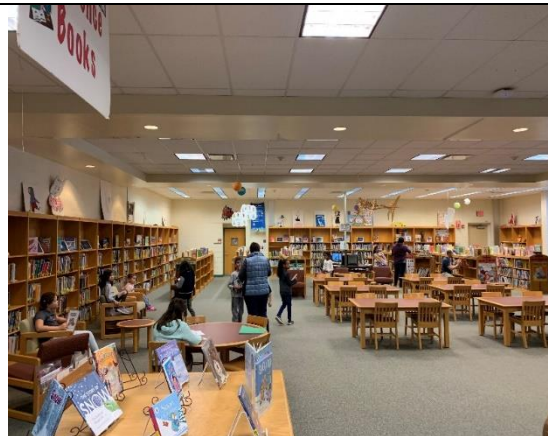
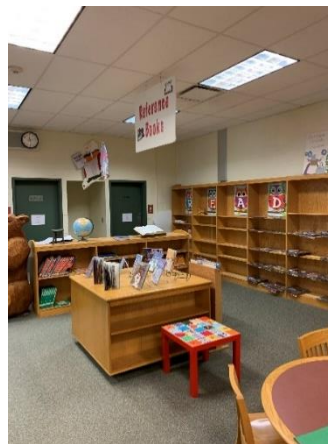
MEDIA CENTER: The Media Center is a large space that was designed as a “Library” as we knew them 20-years ago. The space is underutilized – much of this due to the location of the circulation desk and the arrangement of the low bookshelves that take up most of the floor space at the rear of the room:

Ideally, the tall shelving units around the perimeter of the space would remain, the lower (permanent) shelving would be replaced with mobile shelving units – and the furniture would be replaced with modular furniture.
