Facilities Assessment

Valley View Middle School

50 Valley View Road
Watchung, NJ 07069

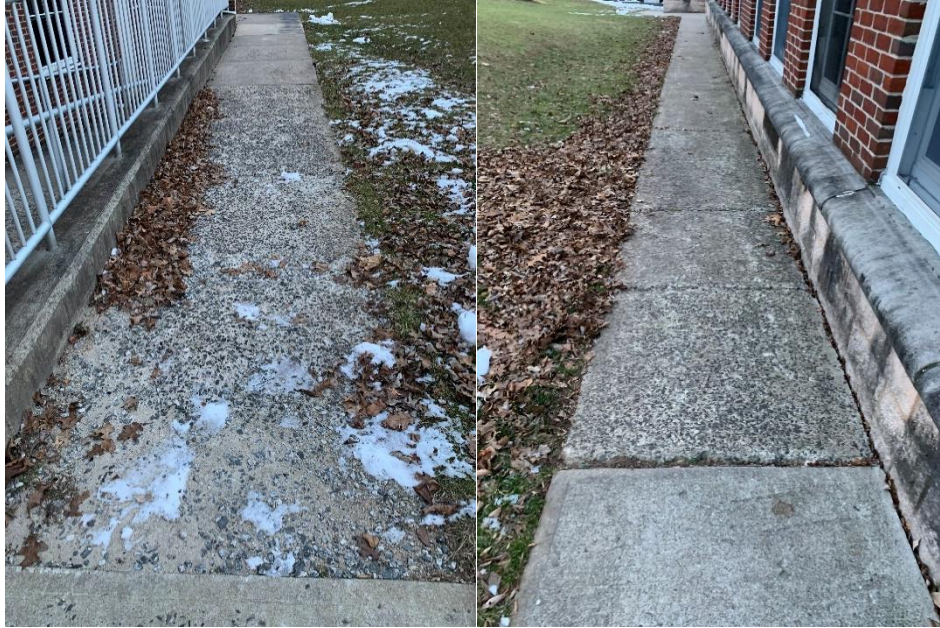
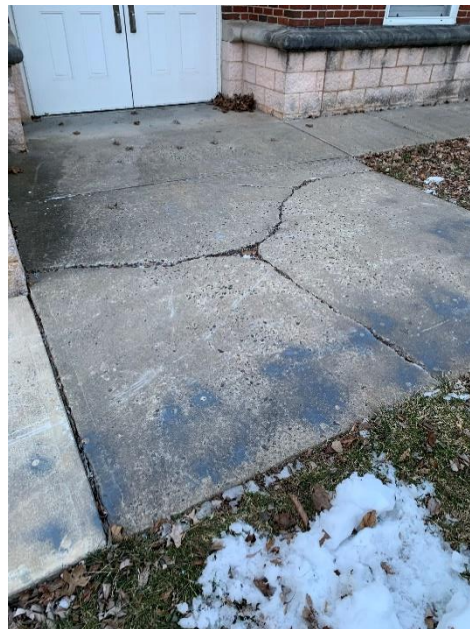
CONCRETE SIDEWALKS: The sidewalks are in good shape, except the sidewalk on the northeast side of the building. There are large sections of the walkways that appear as if the topcoat of concrete has spalled – and is completely missing; the aggregate is clearly visible. Other sections have noticeable cracks that should be monitored.

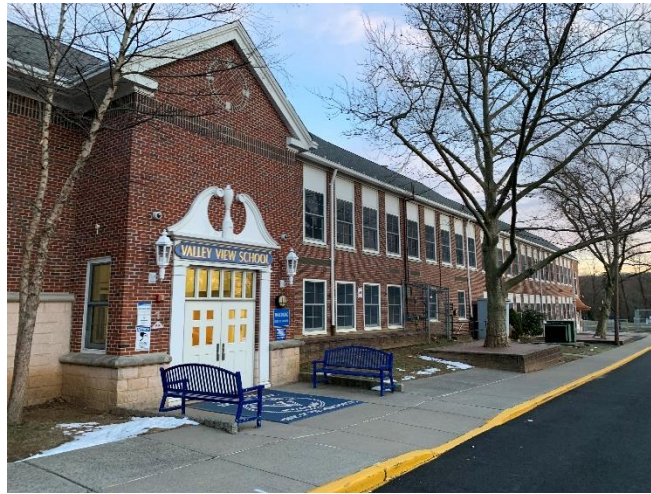
ADA REQUIREMENTS: The curb cuts are missing detectable/tactile warning surfaces:

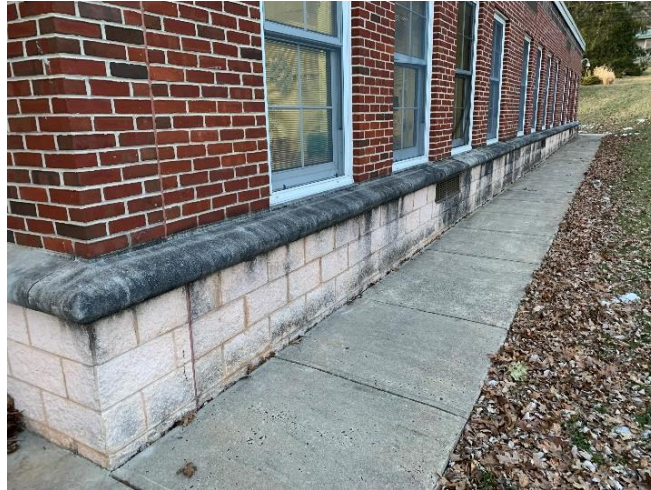
EXTERIOR WALL CONDITIONS: While the exterior brick is in good condition there is a section of the water table feature on the northeast side of the building (new addition) that is noticeably stained and should be addressed.

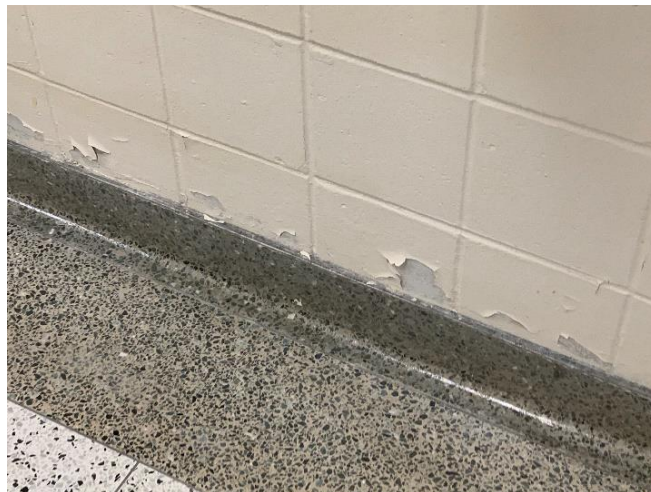
INTERIOR WALL CONDITIONS: The interior walls are in good condition. There is one (1) small area in the corridor outside off the Girl's Locker Room that needs to be scraped and repainted.

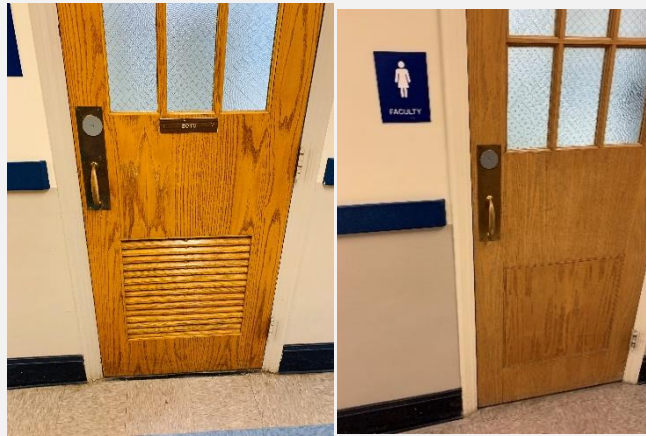
INTERIOR DOOR CONDITIONS / BF: While most of the doors and hardware have been replaced/updated, there are still some doors (in the original school building) that have not been replaced – even though their corresponding spaces have been renovated. The doors and hardware should be replaced – as the toilet rooms were renovated to be ADA compliant.

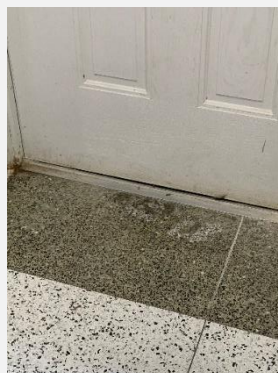
There is one (1) small area near exterior door (outside of the Girl's Locker Room where the terrazzo is damaged (possibly from salt).

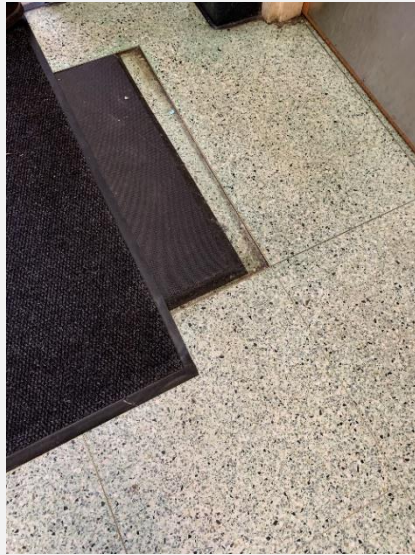
There is one (1) other area in the original section of the school building (near the entrance from the parking lot) where an inlaid traffic mat was removed. A smaller mat was placed in the depression – not completely infilling it – with another, larger traffic mat placed over that. This is a tripping hazard.

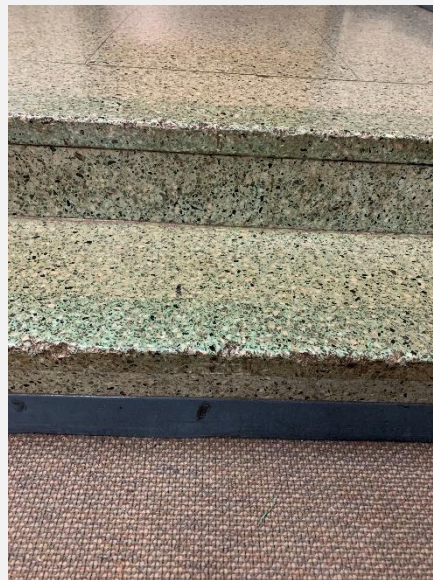
The rise of the steps down into the Instrumental Music Room are unequal. The typical rise is 7" (top step), but the bottom step is closer to 11". This throws people's rhythm off as they come into the room via the steps.

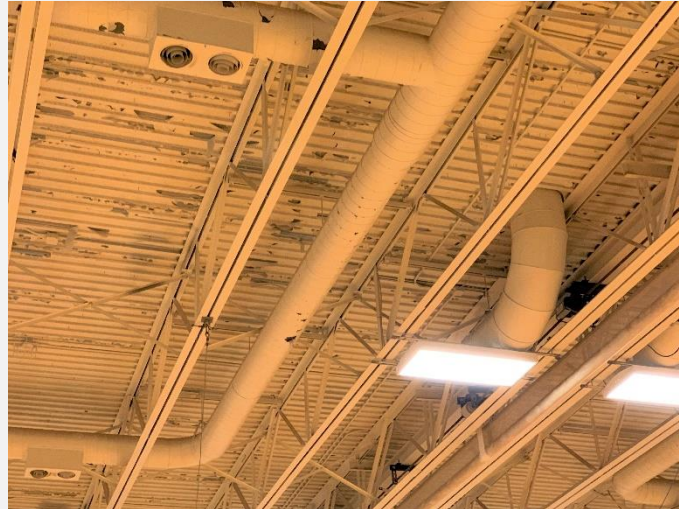
CEILINGS: The ceiling in the Gymnasium, (the exposed roof deck) is peeling badly and needs to be scraped and repainted. Care should be taken to make sure that the correct primer is used.

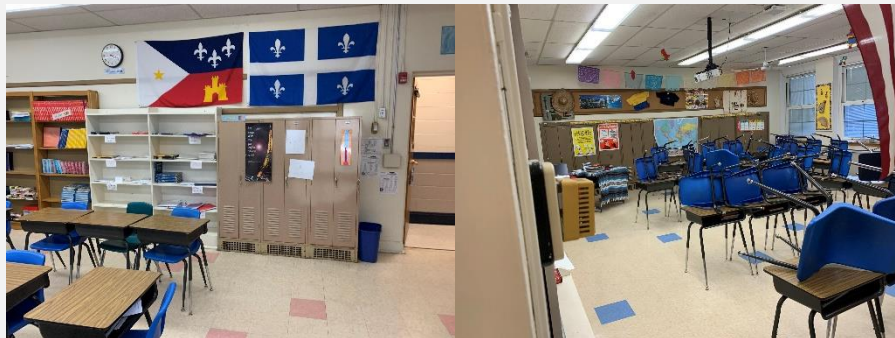
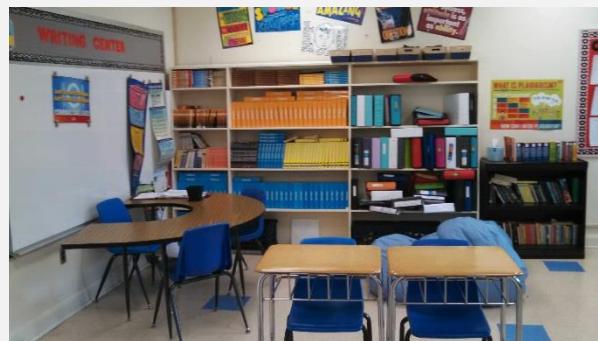
CASEWORK: The classrooms in the original wings of the school for the most part are furnished with open shelving and metal lockers; some in better condition than others. It would be preferable to replace the existing casework with more up-to-date storage cubbies/lockers along with additional storage units – possibly some that were a combination of doors and file drawers, all lockable.

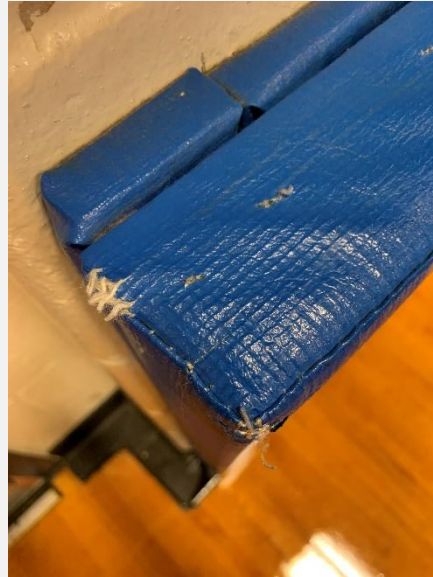
Although the protective wall pads in the Gymnasium are in fair condition, the edges and seams are showing signs of wear – and should be monitored.

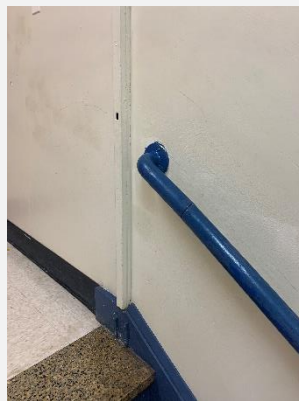
ADA: The existing handrails on the stairs are not ADA compliant. See attachments at the end of this report.

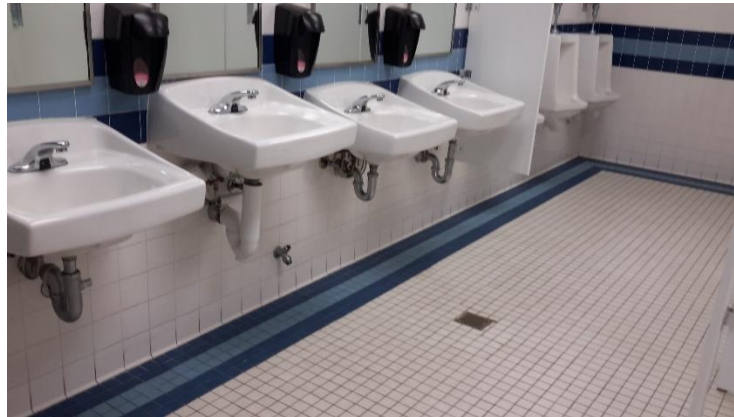
LAVATORIES: The lavatories in the gang toilet rooms have automatic sensor type faucets which are ADA compliant. Only the lavatories set at ADA height have the required piping insulation on the supply and drain lines.

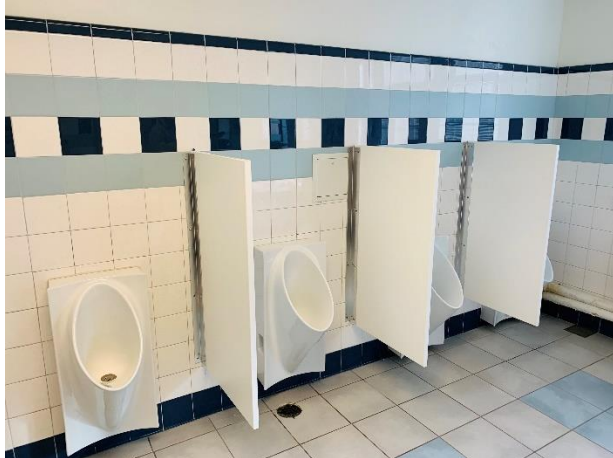
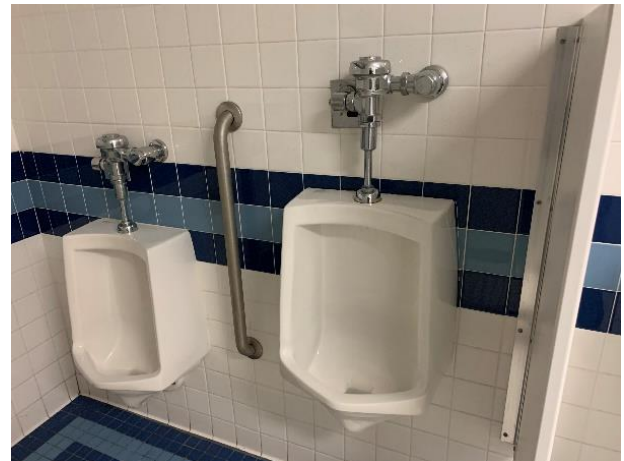
WATER CLOSETS/URINALS: The majority of the water closets in the school have automatic sensor flushometer valves. This is also true for the urinals. There is one ganged toilet room that has four waterless urinals (see below). The Boy's Room (2nd floor of the original building) was renovated during the 2002 renovations but no privacy screen was installed between the urinals (see below).

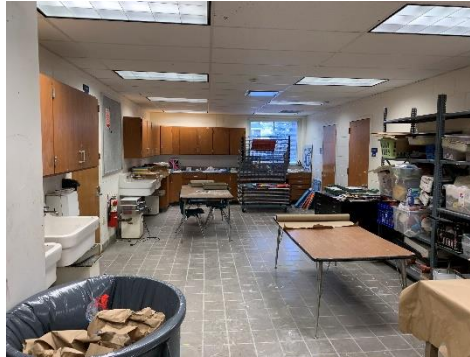
Art Room: The Art Room was reconfigured as part of the 2002 renovations – with no input from the art teaching staff. Although the overall space is adequate, it is configured somewhat oddly – and with only one (1) window as the only source of natural light. Instead of the sinks being located/distributed all around the room, they are located at the “rear” of the room near the Kiln and Storage Rooms.

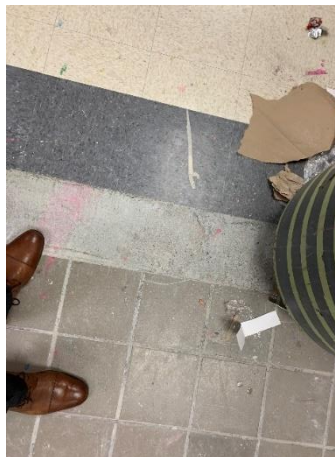
The transition between the VCT flooring in the “instructional” section of the room and the quarry tile on the floor in the rear of room (where the sinks are located) is quite noticeable due to a difference in the elevations of the floors. The quarry tile extremely difficult to clean.

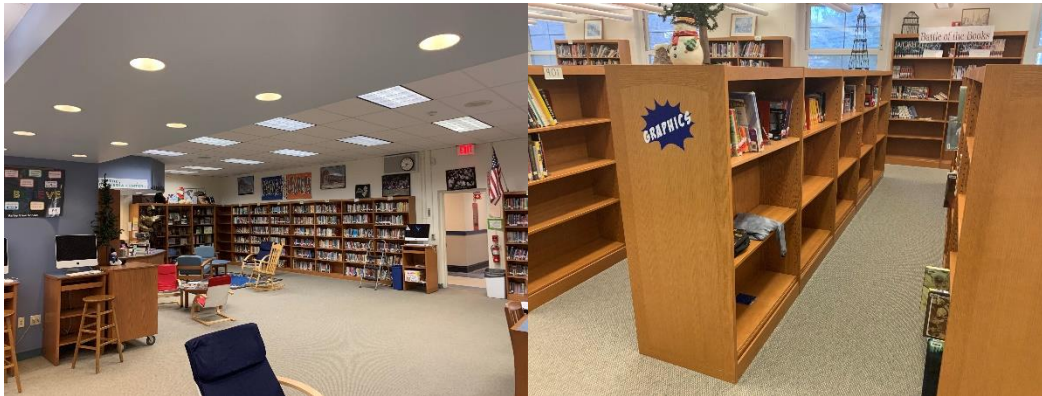
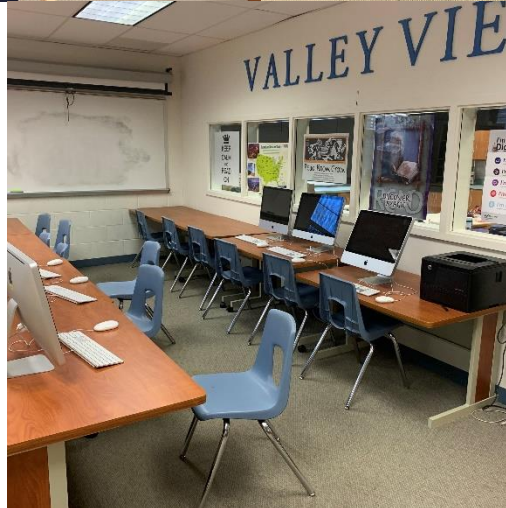
MEDIA CENTER: Like the media Center at Bayberry, the Media Center is a large space that was designed as a “Library” as we knew them 20-years ago. The space is underutilized – much of this due to the location of the circulation desk and the arrangement of the low bookshelves that take up most of the floor space and many of the shelves are empty.

Ideally, the tall shelving units around the perimeter of the space would remain, the remaining shelving would be replaced with mobile shelving units – and the furniture would be replaced with modular furniture.

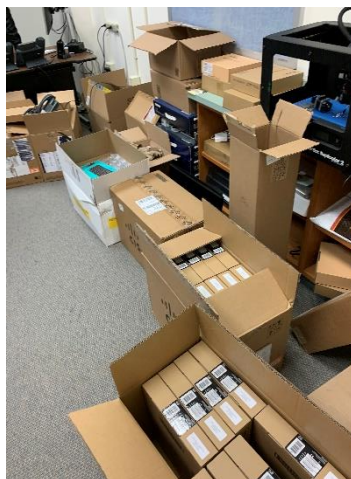
IT: The Technology Suite has no storage whatsoever for all of the computer/IT equipment. Boxes of equipment and parts are just on the placed on the floor as there is no place else to store them.

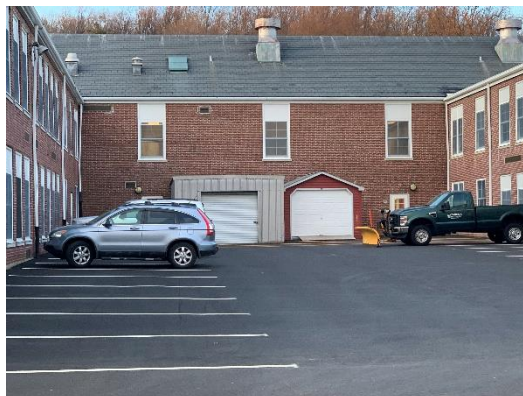
STORAGE: The two (2) existing storage sheds behind the school are NOT adequate for the needs of the school.
