Building Information - Valley View Local SD (48744) - Valley View Intermediate

Program Type	Classroom Facilities Assistance Program (CFAP) - Regular
Setting	Small City
Assessment Name	Valley View Intermediate with 2019 Costs, 2015 EEA & Scope Adjustments
Assessment Date (on-site; non-EEA)	2015-11-06
Kitchen Type	Full Kitchen
Cost Set:	2019
Building Name	Valley View Intermediate
Building IRN	11395
Building Address	64 Comstock Street
Building City	Germantown
Building Zipcode	45327
Building Phone	937-855-4203
Acreage	20.85
Current Grades:	PK, 4-6
Teaching Stations	40
Number of Floors	4
Student Capacity	620
Current Enrollment	433
Enrollment Date	2019-07-02
Enrollment Date is the date in which the current enrollment was taken.	
Number of Classrooms	28
Historical Register	NO
Building's Principal	Lindsey Schmidt
Building Type	Elementary/Middle

Building Construction Information - Valley View Local SD (48744) - Valley View Intermediate (11395)

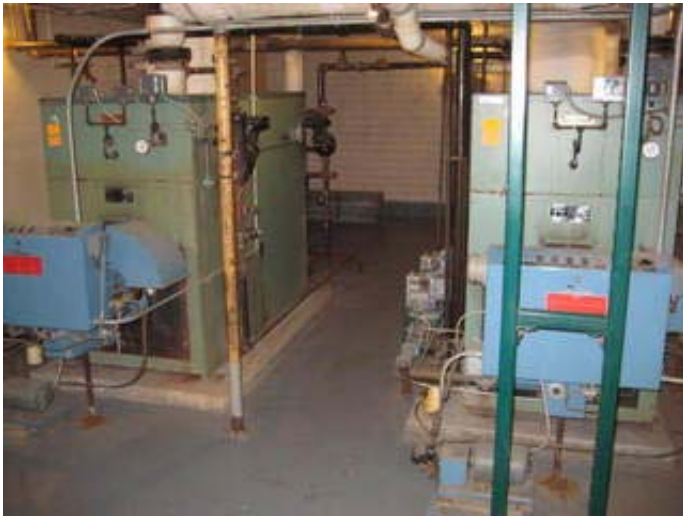
Description: The existing system for the 1922 Original Construction is a natural gas fired steam boiler type system which supplies steam to a constant air volume air handler, installed in 1922 with incremental upgrades to the hot deck, and is in fair / poor condition. The existing system for the 1951 Addition is made up of four (4) Bryant roof top packaged HVAC units, installed in 2002, and in good / fair condition. The systems in the 1922 Auditorium Fixed Seating Area, 1922 Board Offices, and 1956 Addition are an extension of that found in the 1922 Original Construction. The system in the 1962 Addition is an extension of the natural gas fired steam boiler type system found in the adjacent Germantown Elementary School 1948 Original Construction. 2-pipe vs. 4-pipe designations are not applicable in this facility, as no central air conditioning is provided. The two (2) steam boilers, manufactured by Peerless, were installed in 1980 and are in poor condition. Steam is distributed to terminal units consisting of unit ventilators in the 1962 Addition, and an air handler with zone dampers at Classrooms, cabinet heaters, and fin tubes in the 1922 Original Construction, 1922 Auditorium Fixed Seating Area, and 1922 Board Offices. Heating air is distributed via four (4) Bryant roof top ducted packaged HVAC units in the 1951 Addition, which were installed in 2002 and in good condition. Steam is distributed via unit heaters with fans / blowers in the 1956 Addition. The terminal equipment is original to each addition and is in fair condition. The system does not comply with the 15 CFM per person fresh air requirements of the Ohio Building Code mechanical code and Ohio School Design Manual. The pneumatic type system temperature controls are original to each addition with incremental upgrades and are in fair / poor condition. The system does not feature individual temperature controls in all spaces required by the OSDM. The overall system does not feature any central energy recovery systems. The 1922 Original Construction, 1922 Auditorium Fixed Seating Area, 1922 Board Offices, and 1951 and 1956 Additions are not equipped with louvered interior doors to facilitate Corridor utilization as return air plenums. The 1962 Addition is equipped with louvered interior doors to facilitate Corridor utilization as return air plenums. The existing systems are ducted in the 1922 Original Construction, 1922 Auditorium Fixed Seating Area, 1922 Board Offices, and 1951 Addition, but the ductwork cannot be integrated into a possible future system due to arrangement, air volume, and routing of existing ductwork. The existing system in the 1956 and 1963 Additions are not ducted, but floor to structural deck heights will accommodate the installation of properly sized ductwork for a future Ohio School Design Manual approved system. The overall heating system is evaluated as not being in safe and efficient working order, though long term life expectancy of the existing system is not anticipated. The structure is not equipped with central air conditioning. The site does contain underground fuel tanks that are not currently in use.

Rating: 3 Needs Replacement

Peerless Steam Boilers

Recommendations: Provide new overall heating, ventilating, and air conditioning system to achieve compliance with Ohio Building Code and Ohio School Design Manual standards. Convert the 1956 and 1962 Additions to a ducted system to facilitate efficient exchange of conditioned air. Replace existing ductwork in the 1922 Original Construction, 1922 Auditorium Fixed Seating Area, 1922 Board Offices, and 1951 Addition to facilitate efficient exchange of conditioned air with pricing included in HVAC system replacement. Provide architectural soffits to accommodate the installation of ductwork, with funding provided in conversion to ducted system replacement.

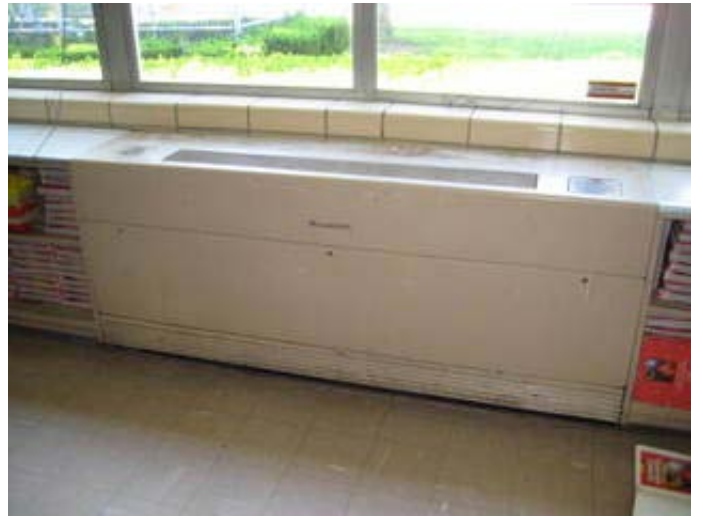
1962 Addition Steam Unit Ventilator

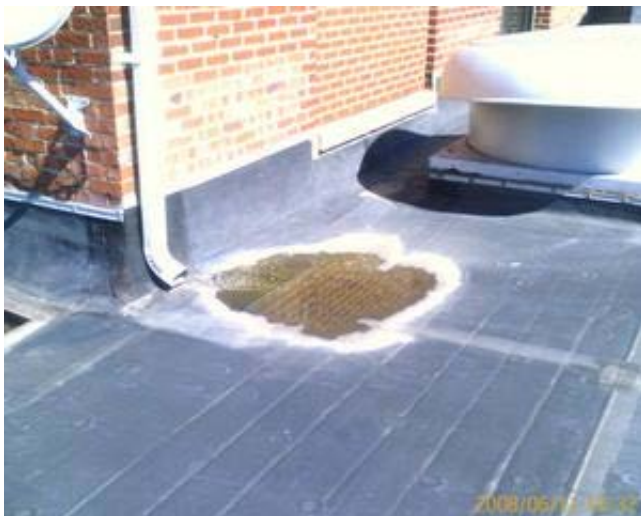
Description: The roof over the 1922 Original Construction is an EPDM fully adhered membrane system that was installed in 1995 and 1997, and is in good to fair condition. The roof over the 1951 and 1962 Additions is a thermoplastic fully adhered membrane system that was installed in 2006 and 2007, and is in good condition. The roof over the 1956 Addition is a combination of an EPDM fully adhered membrane system and a built-up asphalt with a reflective paint coat cover system that was installed in 1995, and is in poor condition. The 1922 Auditorium Fixed Seating Area and 1922 Board Offices are not affected by any roofing since both spaces are located within the second floor area of the 1922 Original Construction. There are District reports of current leaking. Signs of past leaking were observed during the physical assessment. Access to the roof was gained by a combination of a roof hatch and ladder, an extension ladder, and an access door, which are in good condition. Fall safety protection cages are required. There were observations of standing water on the roof. Metal and terracotta cap flashings and copings are in good condition. Roof storm drainage is addressed through a combined system of gutters, downspouts, and roof drains which are properly located, and in good condition. The roof is not equipped with overflow roof drains. Overflow roof drains are not required in the 1951 and 1962 Additions, but will be required in areas of roof replacement in the 1922 Original Construction. No problems requiring attention were encountered with any roof penetrations. There are covered walkways attached to this structure connecting Valley View Middle School with Germantown Elementary. Walkway structure type is metal standing seam roof on steel frame and is in good condition.

Rating: 2 Needs Repair

Typical Standing Water Condition

Recommendations: The roof over the 1922 Original Construction requires replacement to meet Ohio School Design Manual guidelines for age of system and due to condition. Provide new roof hatch, ladder and fall safety cage in the 1956 Addition. Contract for replacement of the roof over the 1956 Addition has been awarded by the District. Roofing membrane will be replaced during summer 2008. To facilitate the school's compliance with OBC provide new overflow roof drains in areas of roof replacement in the 1922 Original Construction.

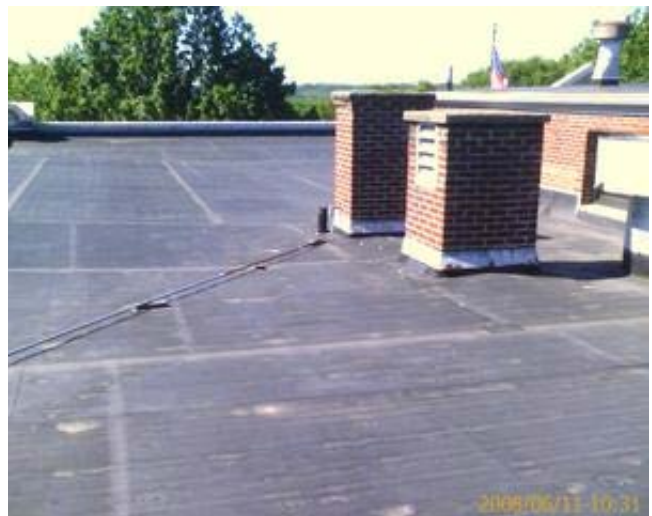
Typical EPDM Roofing Condition

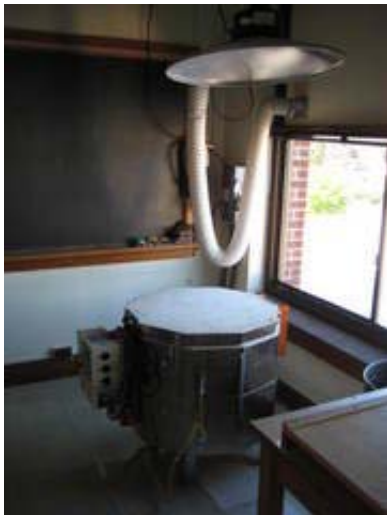
Rating: 2 Needs Repair

Art Program Kiln Exhaust System

Recommendations: Provide an air conditioning system to meet with Ohio Building Code and Ohio School Design Manual requirements. Pricing included in Item A. Replace the existing general building exhaust system. Replace the existing Art Program kiln ventilation system due to age and condition.

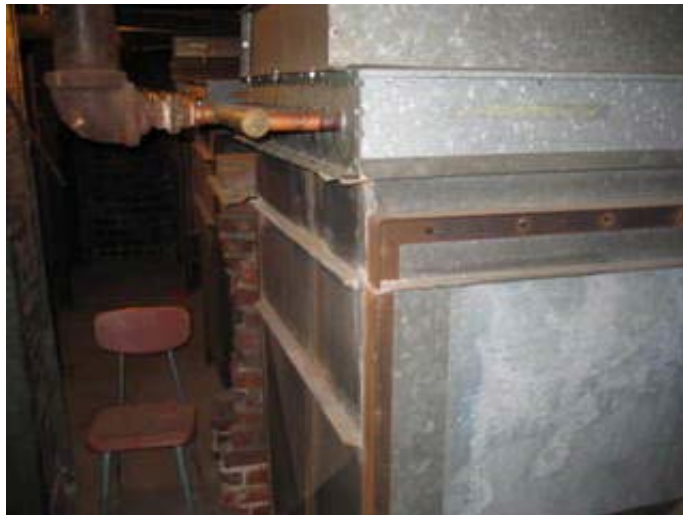
1922 Original Construction Air Handler

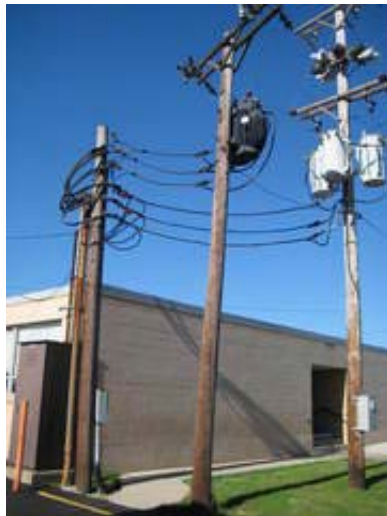
Rating: 3 Needs Replacement

Pole-Mounted Transformers

Recommendations: The entire electrical system requires replacement to meet Ohio School Design Manual guidelines for overall capacity and Classroom capacity due to age, condition, lack of OSDM-required features, and to accommodate the addition of an air conditioning system. Replace the existing emergency generator, with funding included in the electrical system replacement. Provide adequate lightning protection safeguards in the overall facility, including associated grounding system, with funding included in the electrical system replacement. Provide control panel, dimmers, and breakers to support the Stage lighting system, with funding included in the electrical system replacement.

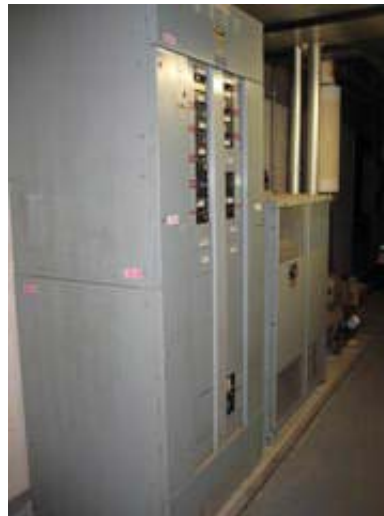
Main Electrical Distribution Panel

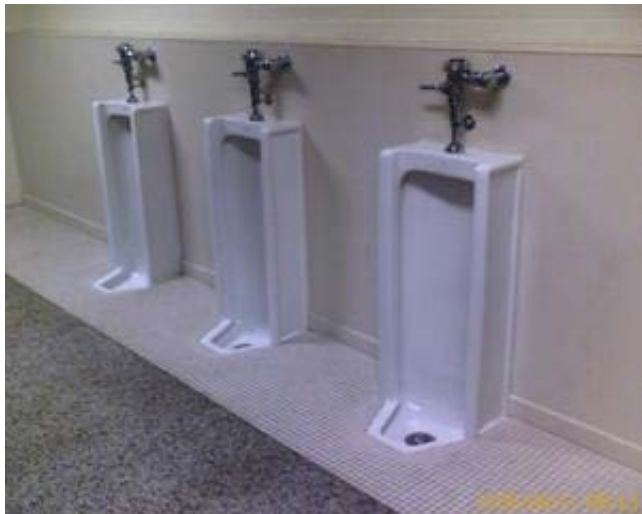
Rating: 3 Needs Replacement

Typical Floor Mounted Urinals

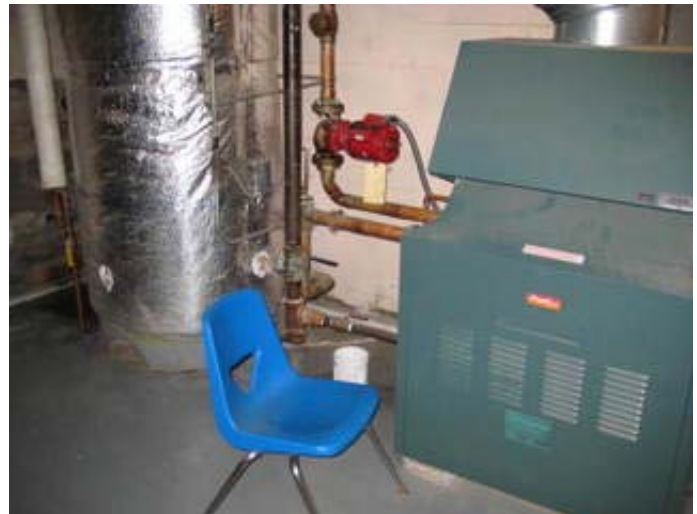
Domestic Hot Water Heater and Storage Tank

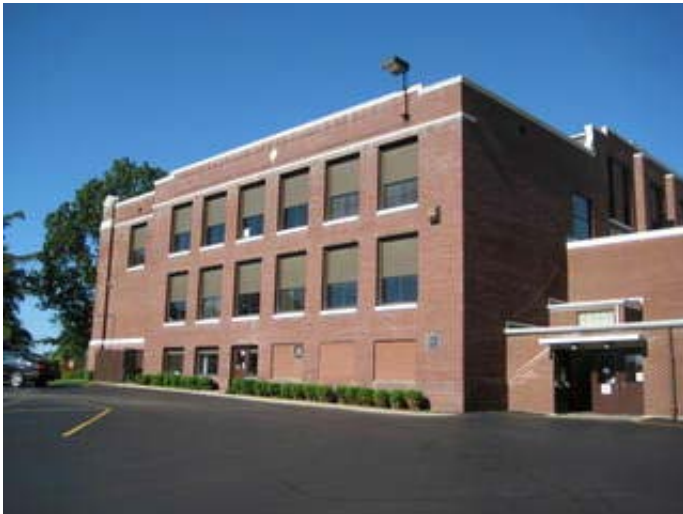
Rating: 3 Needs Replacement

Typical Aluminum Frame Windows

Recommendations: Provide a new insulated window system with integral blinds in the overall facility to meet with Ohio School Design Manual requirements. Replace the existing glass block in the 1956 and 1962 Additions with a new insulated window system with integral blinds to meet with Ohio School Design Manual requirements. Replace window transoms and sidelights in exterior doors of the 1922 Original Construction, 1951 and 1962 Addition to meet with Ohio School Design Manual requirements.

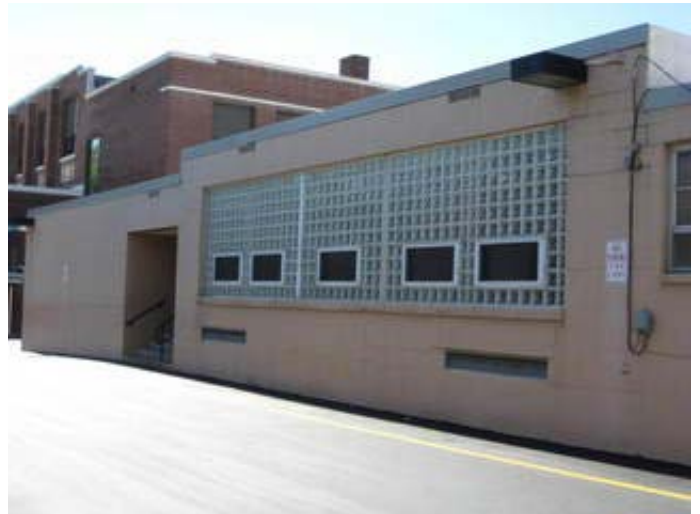
Glass Block Windows

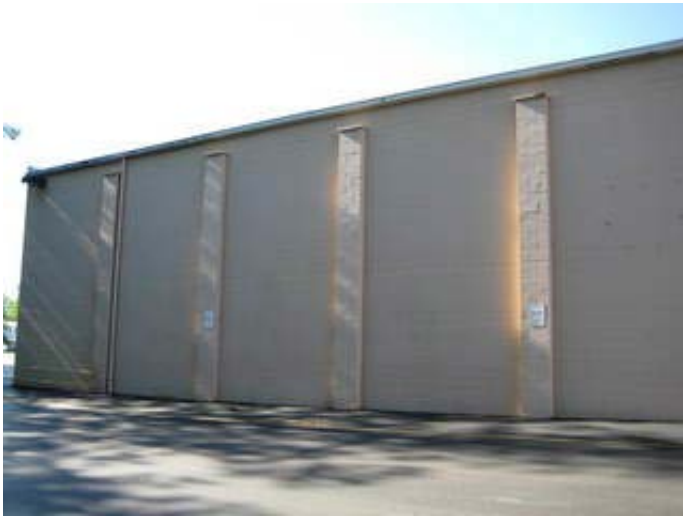
Rating: 2 Needs Repair

CMU Condition

Other: Replace Steel Lintels	\$150.00	in.ft.				160 Required				\$24,000.00	Replace steel lintels as required in the 1922 Original Construction due to condition.
Other: Scrape and Paint	\$10.00	sq.ft. (Qty)					5,122 Required	5,841 Required	4,593 Required	\$155,560.00	Paint exterior concrete masonry unit walls (after tuckpointing) as required in the 1951, 1956, and 1962 Additions.
Other: Scrape and Paint Canopies	\$10.00	sq.ft. (Qty)					138 Required	165 Required		\$3,030.00	Paint concrete canopies as required in the 1951 and 1956 Additions.
Other: Scrape and Paint Lintels	\$5.00	in.ft.			26 Required	513 Required	113 Required	11 Required	454 Required	\$5,585.00	Scrape and paint steel lintels as required in the overall facility.
Sum:			\$438,729.00	\$11,395.00	\$5,250.00	\$85,085.00	\$79,417.50	\$113,260.00	\$144,321.50

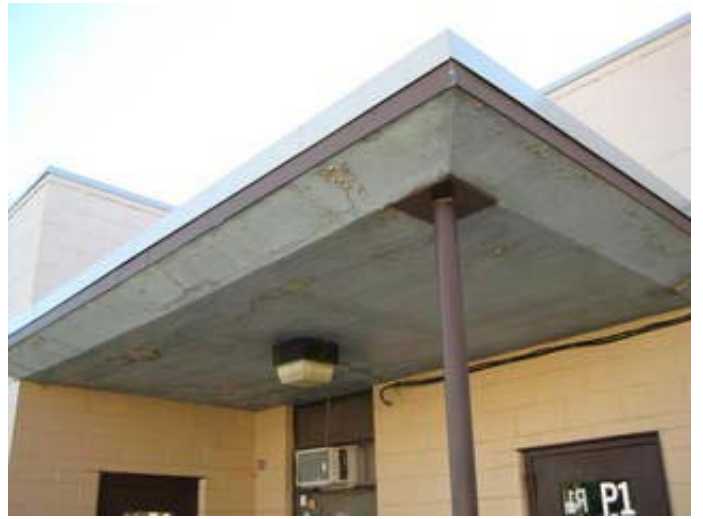
Concrete Canopies

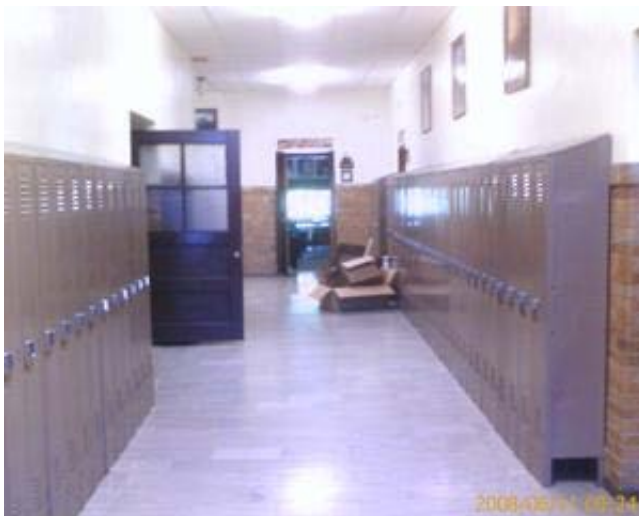
Rating: 3 Needs Replacement

Typical Corridor

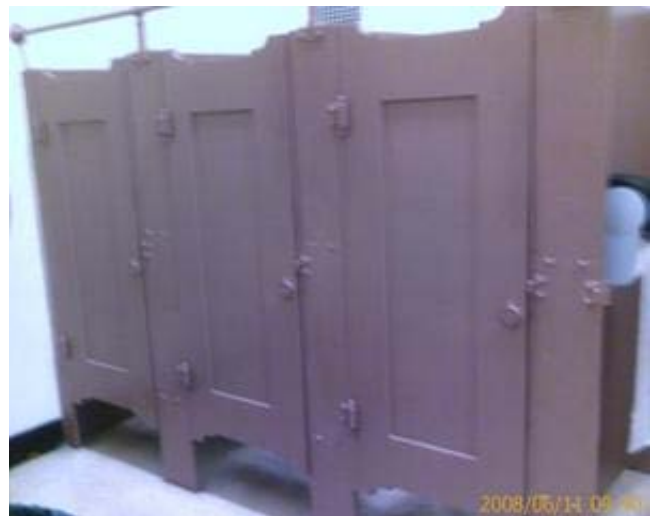
Typical Toilet Partition

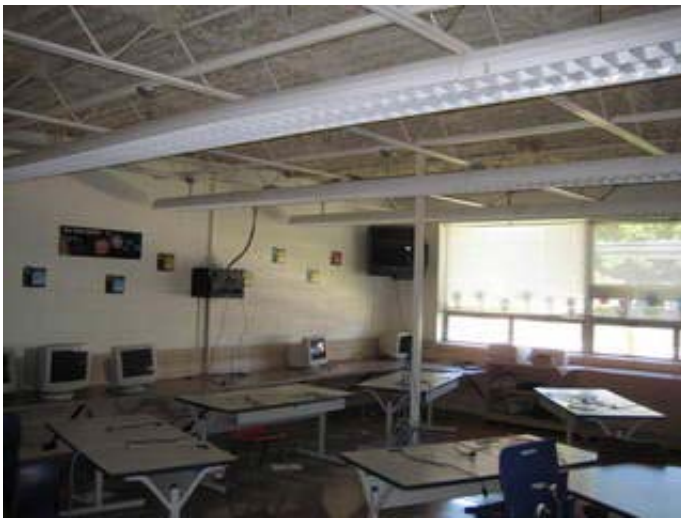
3 Needs Replacement

1962 Addition Classroom Fluorescent Light Fixtures

Provide complete replacement of lighting system due to age, condition, inadequate lighting levels, lack of multilevel switching, the utilization of incandescent fixtures, and installation of systems outlined in Items A, C, J, and U.

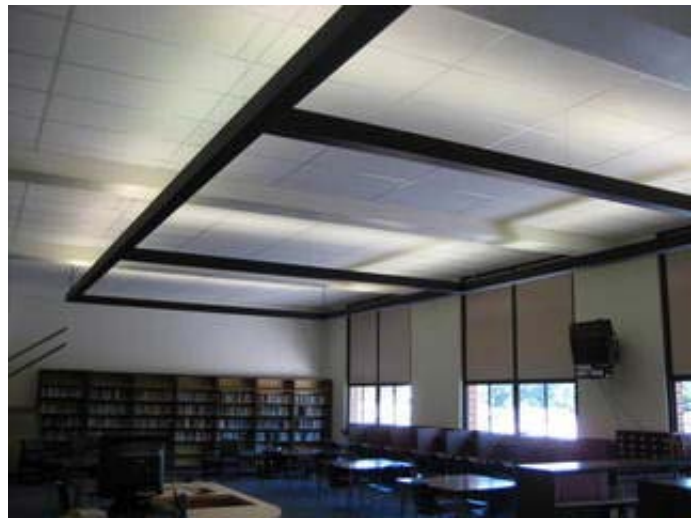
1922 Original Construction Media Center Indirect Fluorescent Light Fixtures

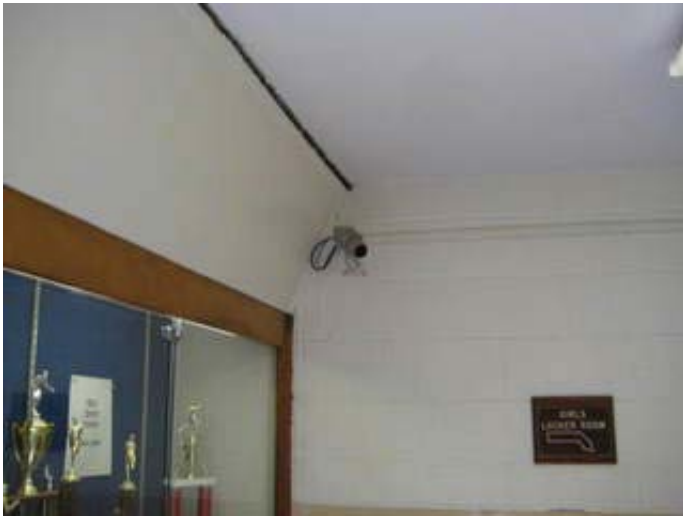
CCTV Camera

Recommendations: Provide complete replacement of security system to meet Ohio School Design Manual guidelines. Provide complete replacement of exterior site lighting system to meet Ohio School Design Manual guidelines. Provide additional playground fencing to meet Ohio School Design Manual guidelines, funding included in complete replacement of security system. POST-ASSESSMENT NOTE: Rii 1-21-19 Removed scope from Board Office Addition per current methodology.

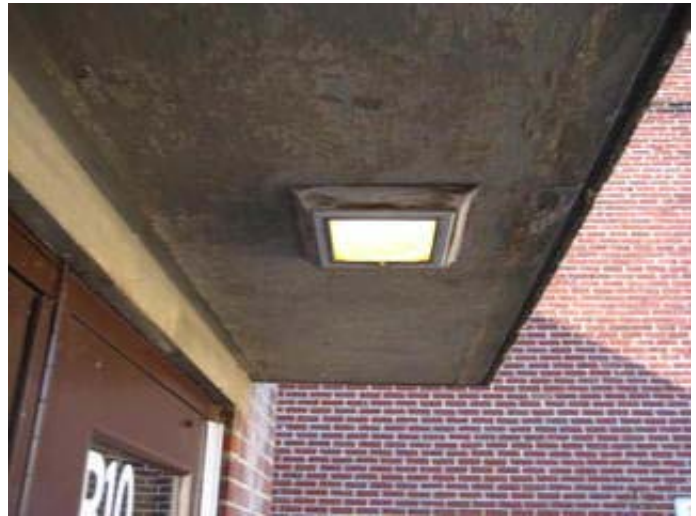
Recessed Entry Light Fixture

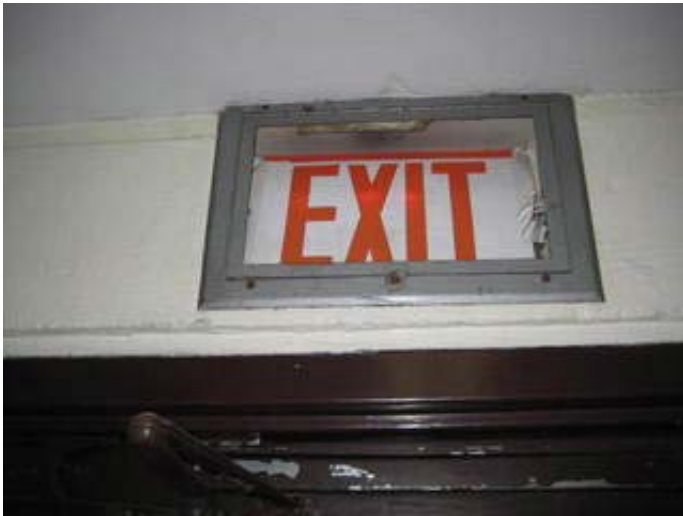
Non-Compliant Non-Illuminated Exit Sign

Recommendations: Provide complete replacement of emergency / egress lighting system to meet Ohio School Design Manual guidelines. Although funding for emergency / egress lighting is not shown for the 1922 Auditorium Fixed Seating Area, work is considered mandatory and funding will be provided via Life Safety Allowance in master planning. POST-ASSESSMENT NOTE: Rii 1-21-19 Added scope in Auditorium Fixed Seating Addition, per current methodology.

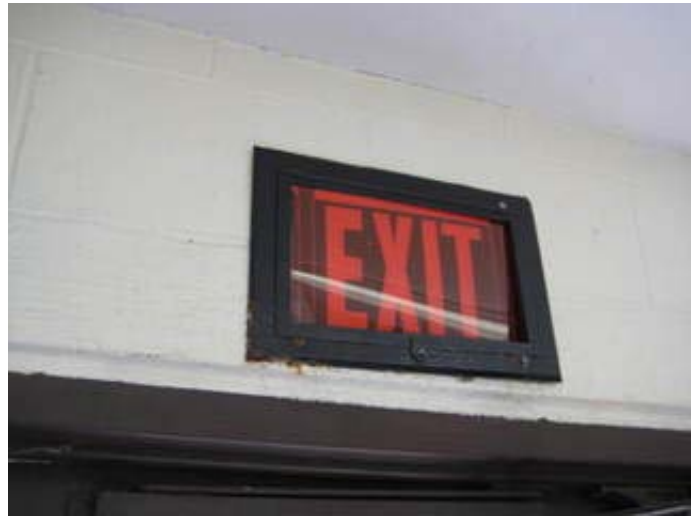
Non-Compliant Exit Sign

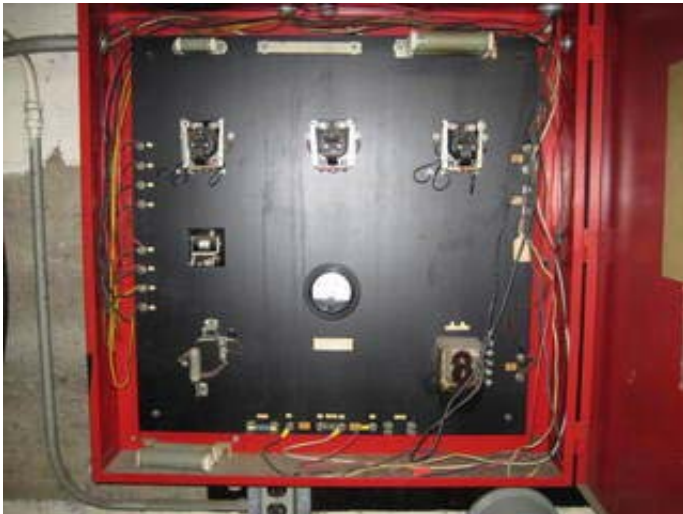
Fire Alarm System Control Panel

Recommendations: Provide complete replacement of fire alarm system to meet OBC, NFPA, and Ohio School Design Manual guidelines. Although funding for fire alarm is not shown for the 1922 Auditorium Fixed Seating Area, work is considered mandatory and funding will be provided via Life Safety Allowance in master planning. POST-ASSESSMENT NOTE: Rii 1-21-19 Added scope in Auditorium Fixed Seating Addition, per current methodology.

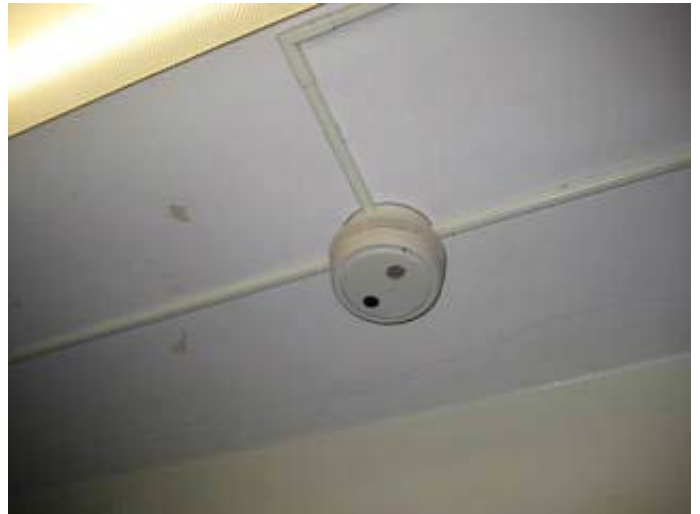
Fire Alarm System Smoke Detection Device

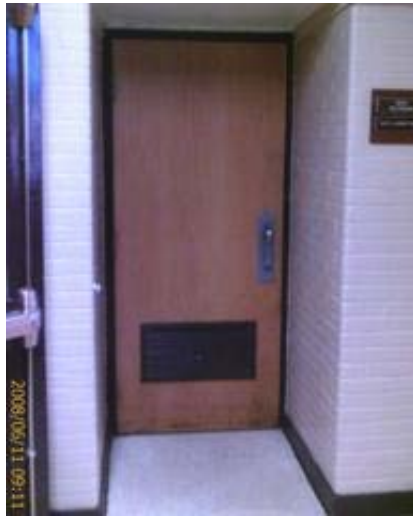
Typical Narrow Recessed Door

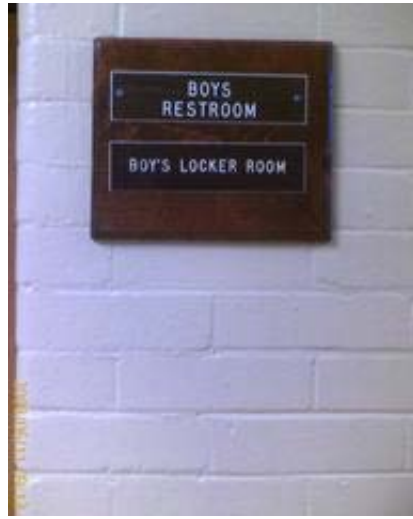
Typical Signage

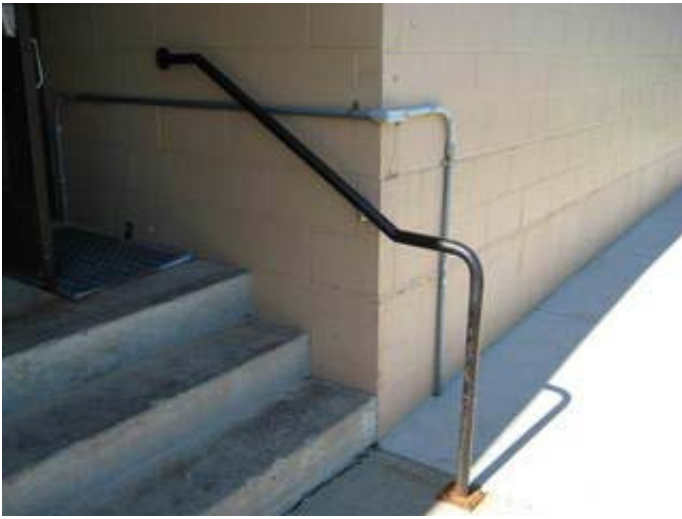
Handrail Condition

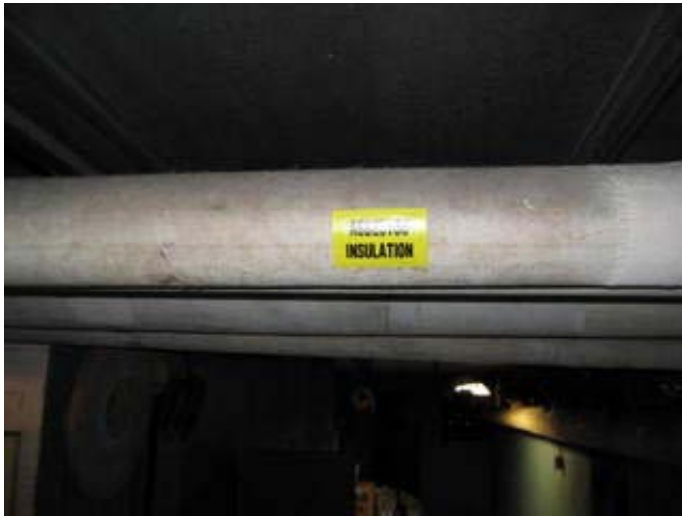
Pipe Insulation

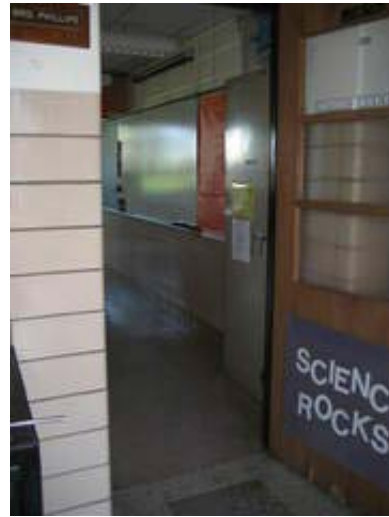
VAT in Classroom

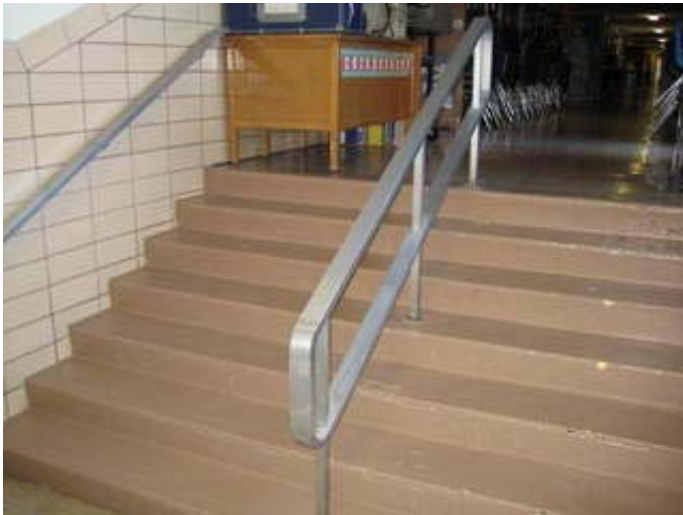
Non-Compliant Stairway and Railing

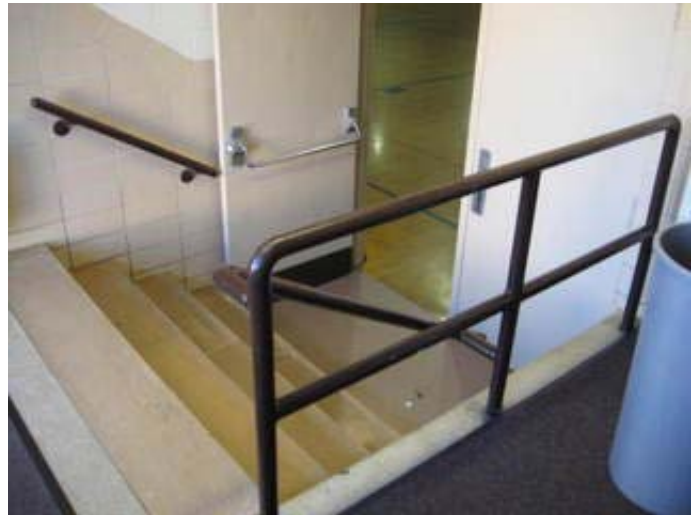
Non-Compliant Stairway and Railing

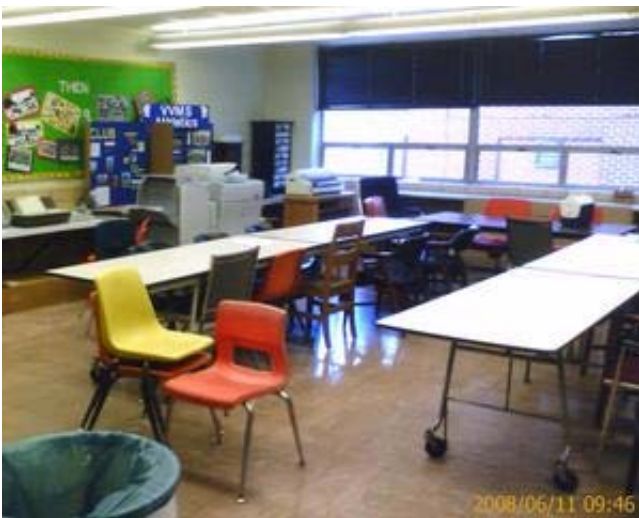
Typical Furniture Condition
