Project Observation Report

Project Name:	Tri Tech East Building	Project No.	2208
Report #:	6		
Observation Date:	11-16-22	Last Report:	11-9-22
Prepared By:	Steve Mallory, AIA	Contractor:	Banlin

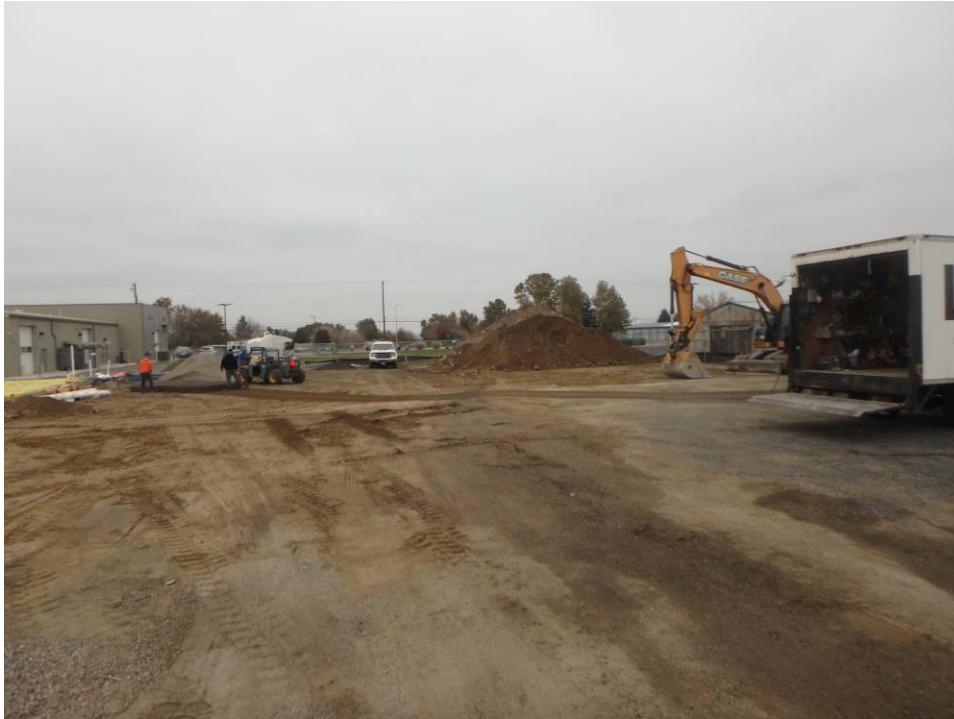
Looking north from the south site entry

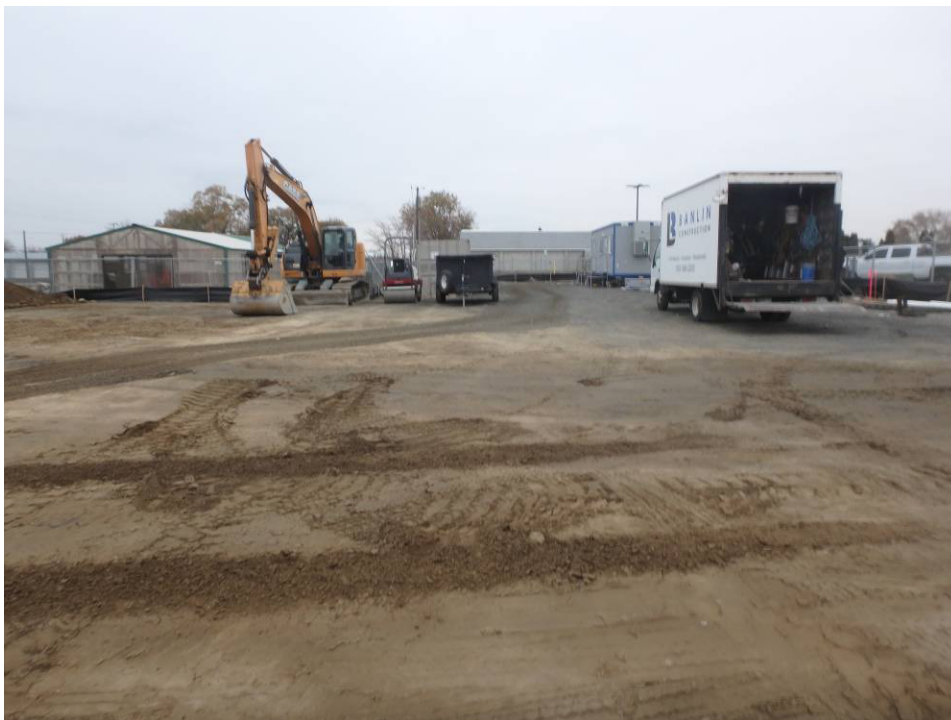
Looking east from the center of the site

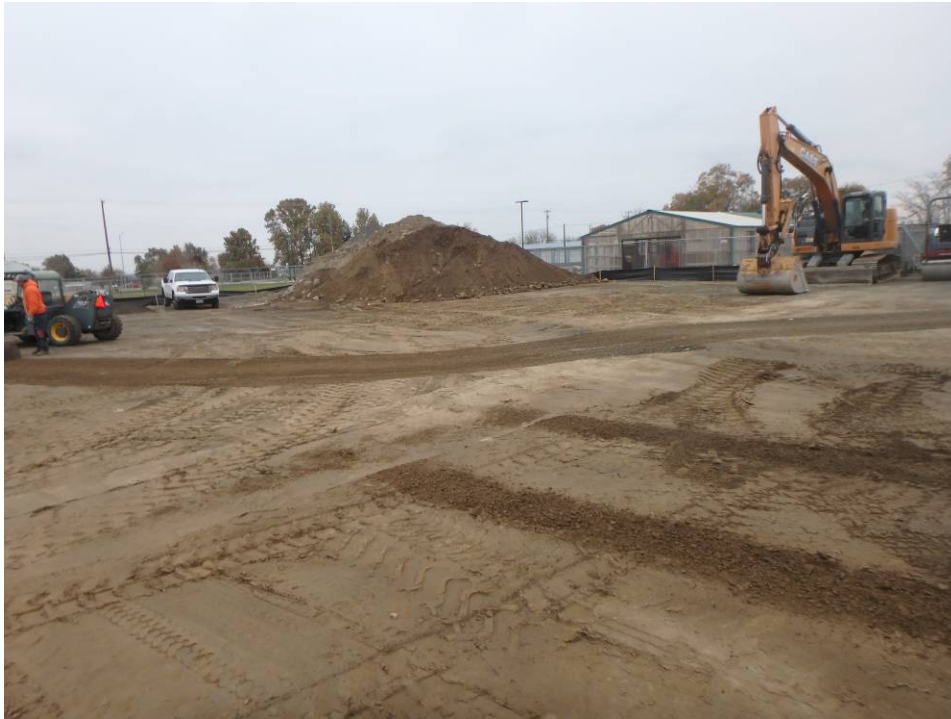
The south half of the soil stockpile has been removed

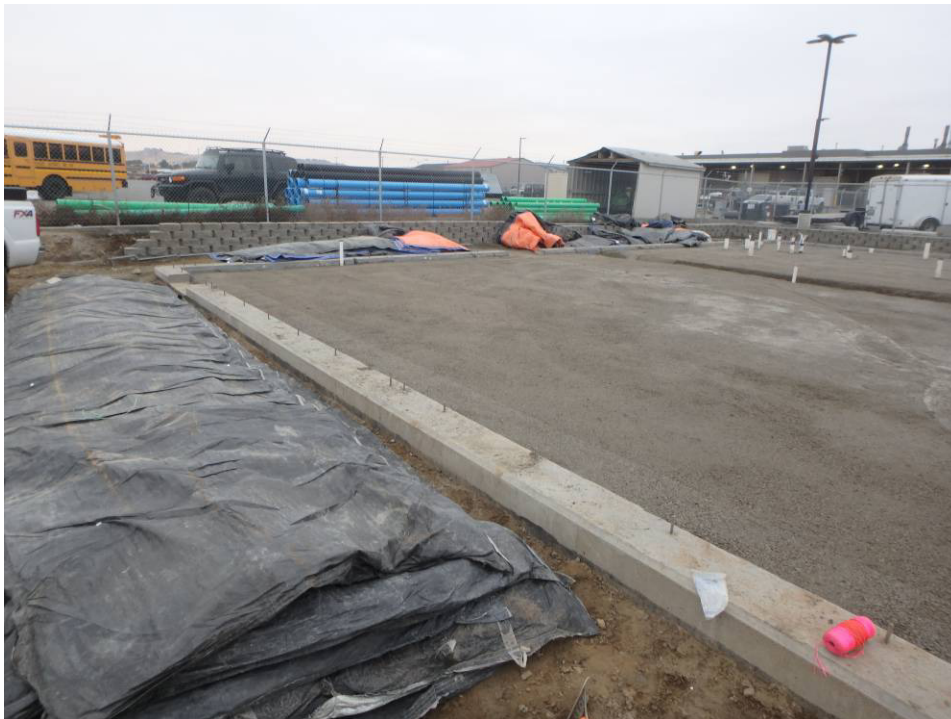
Looking south at the south side of the building

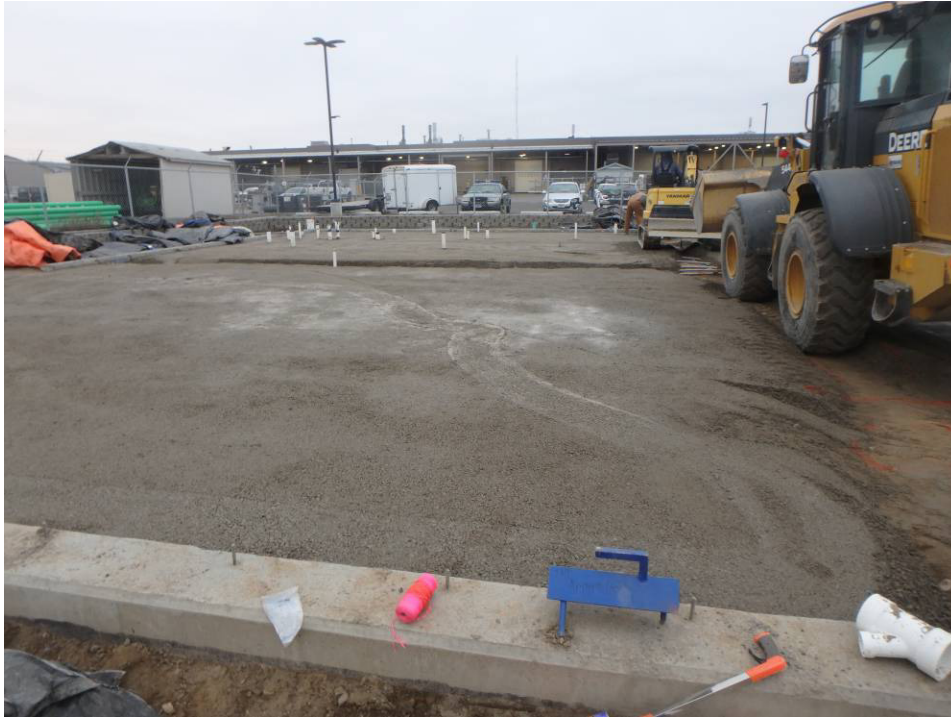
Looking southwest at the south end of the slab area

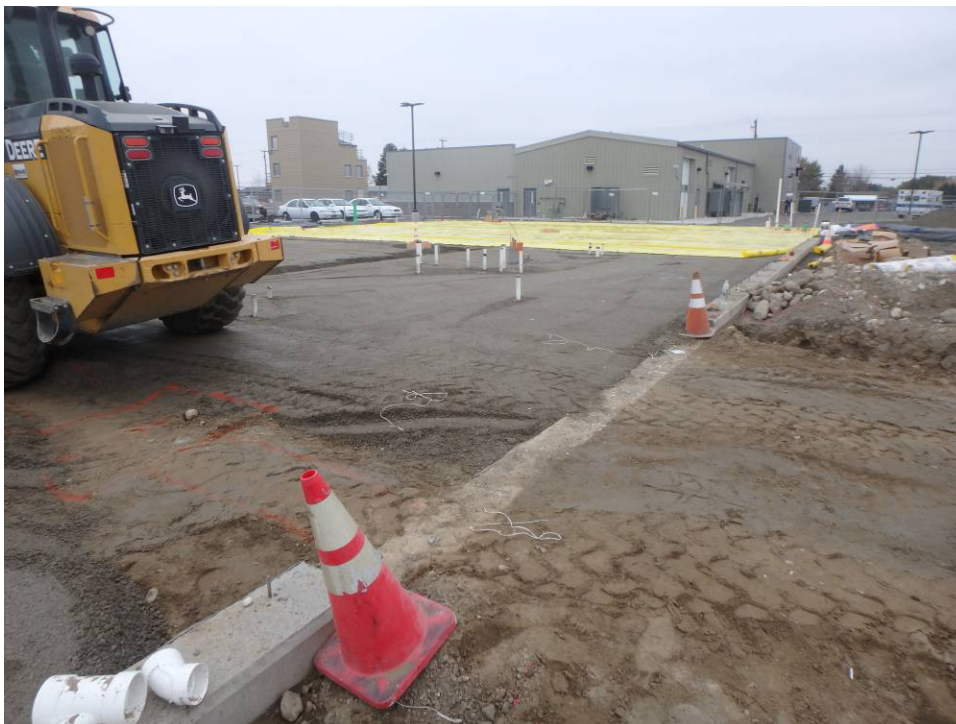
Looking north at the north slab area and vapor barrier

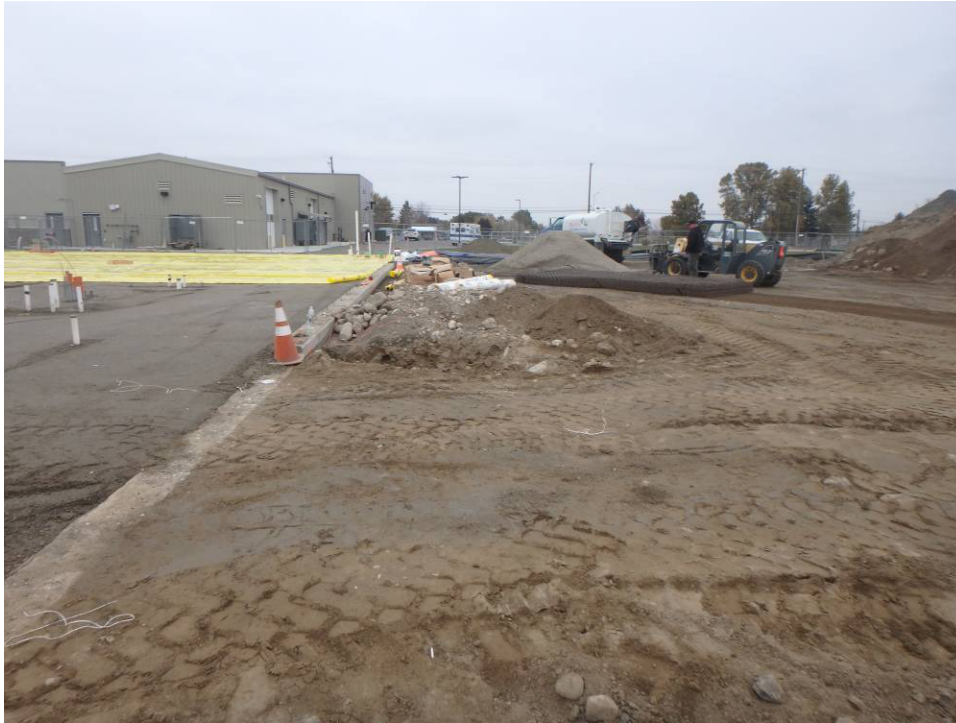
Looking north at the east foundation wall

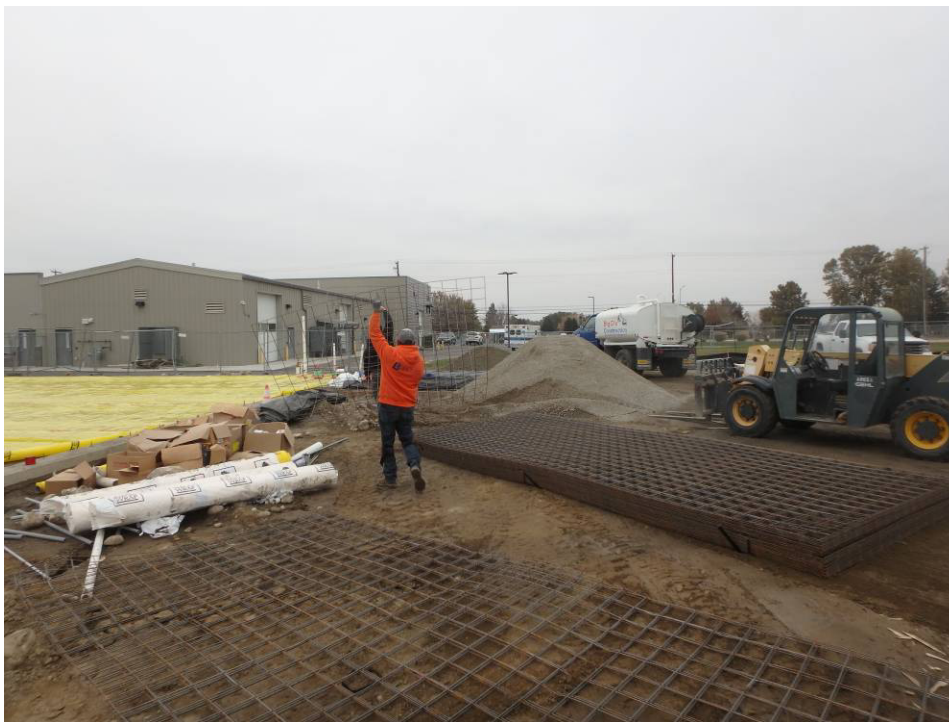
Moving the welded wire mesh reinforcement into place

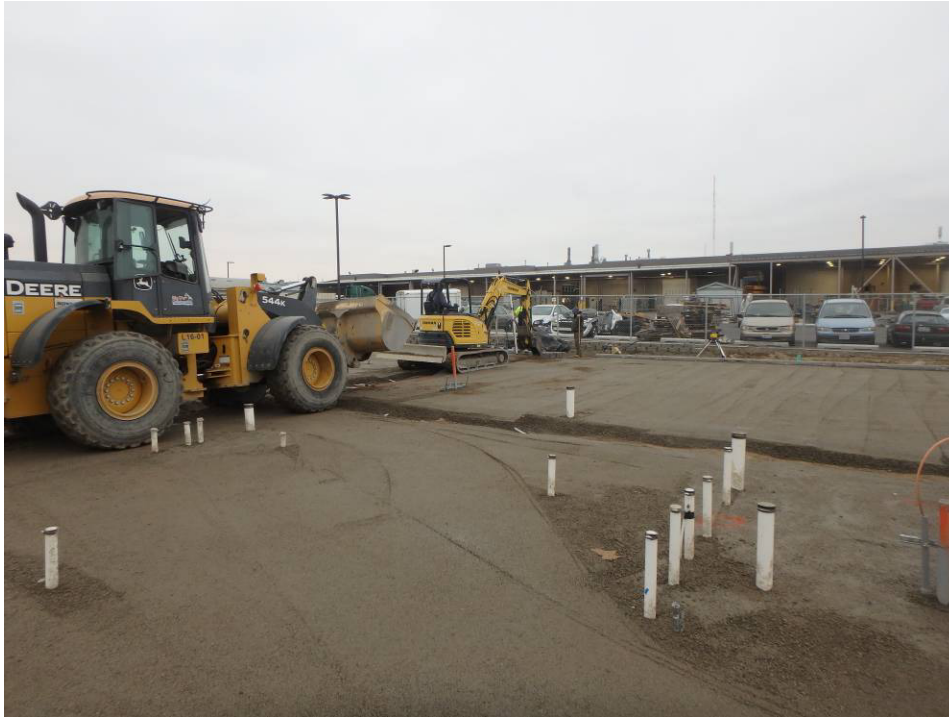
Looking west at the central thickened slab excavating

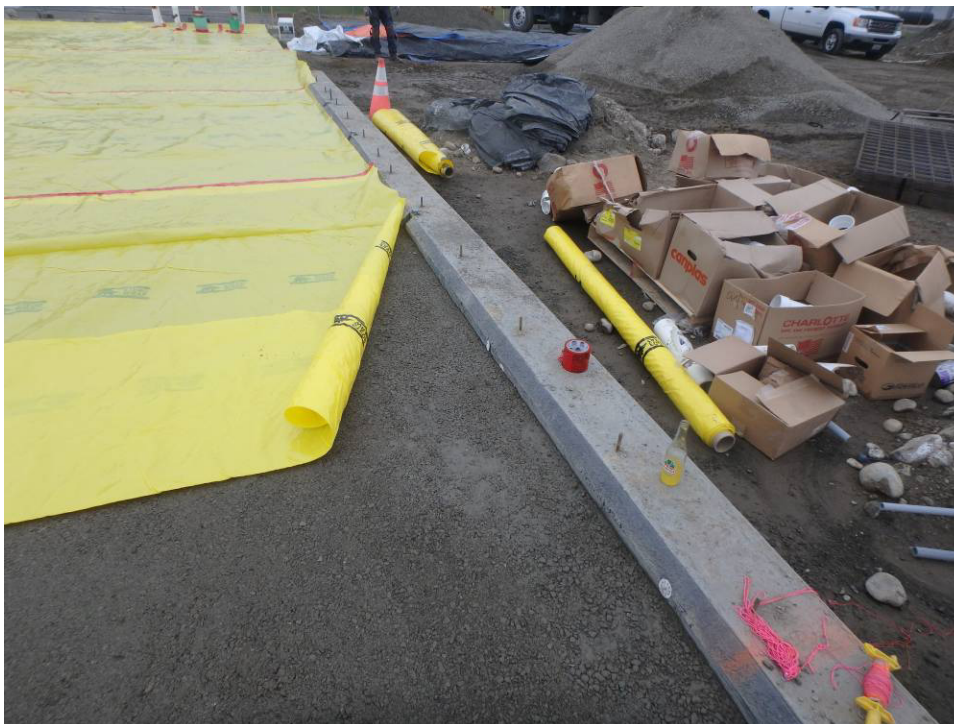
Vapor barrier sheeting

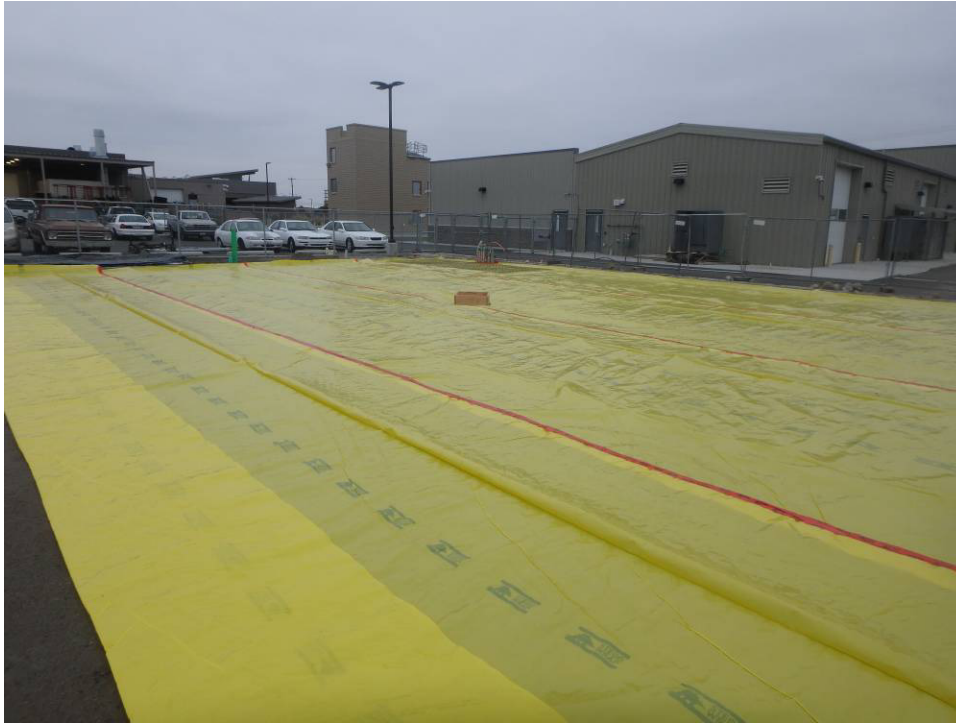
Looking northwest at the north end vapor barrier

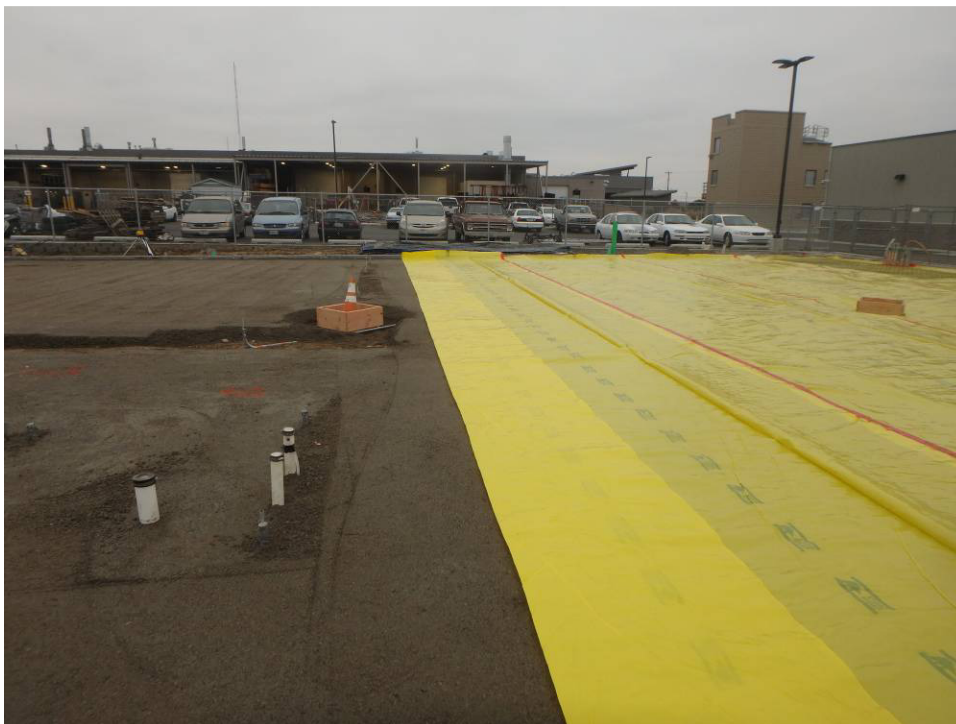
Looking west at the north end vapor barrier and “diamond” column forms

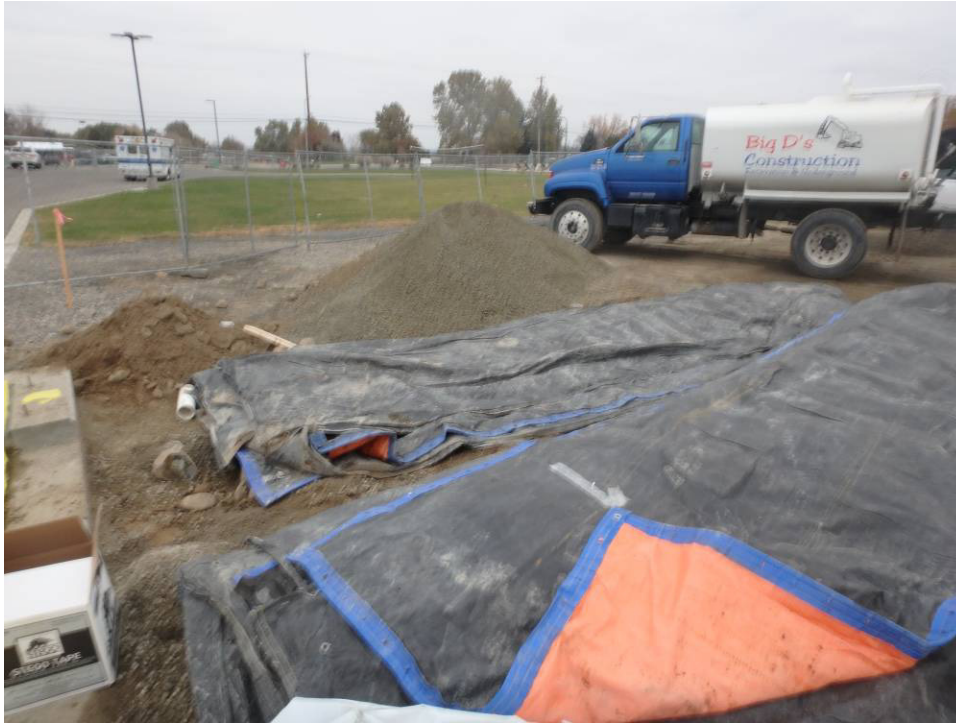
Slab/ soil warming blankets

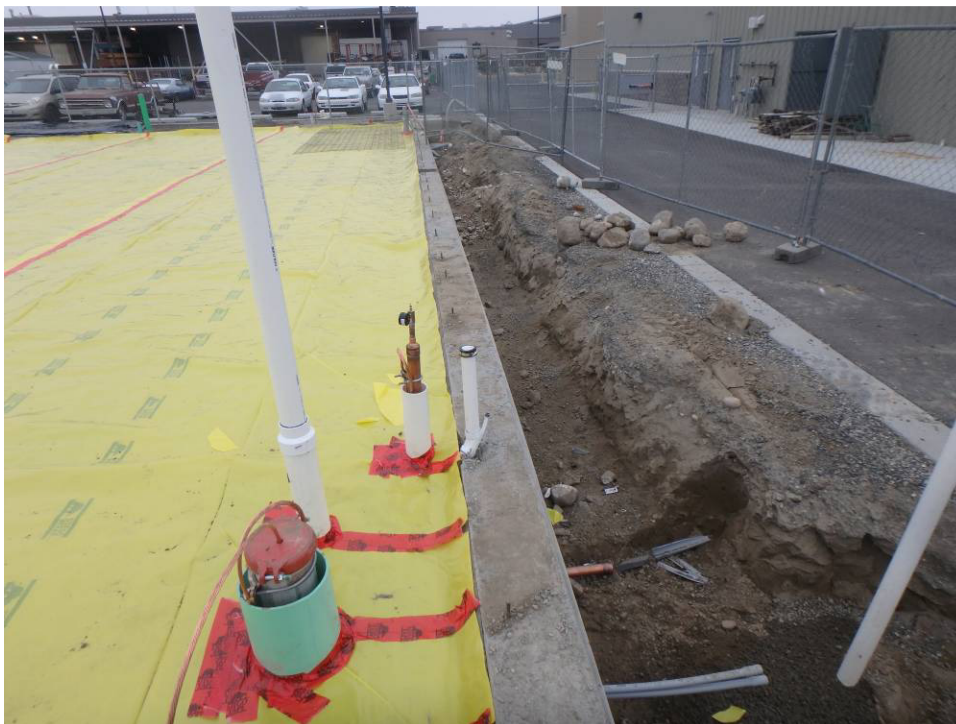
Looking west along the north foundation wall to the northwest corner

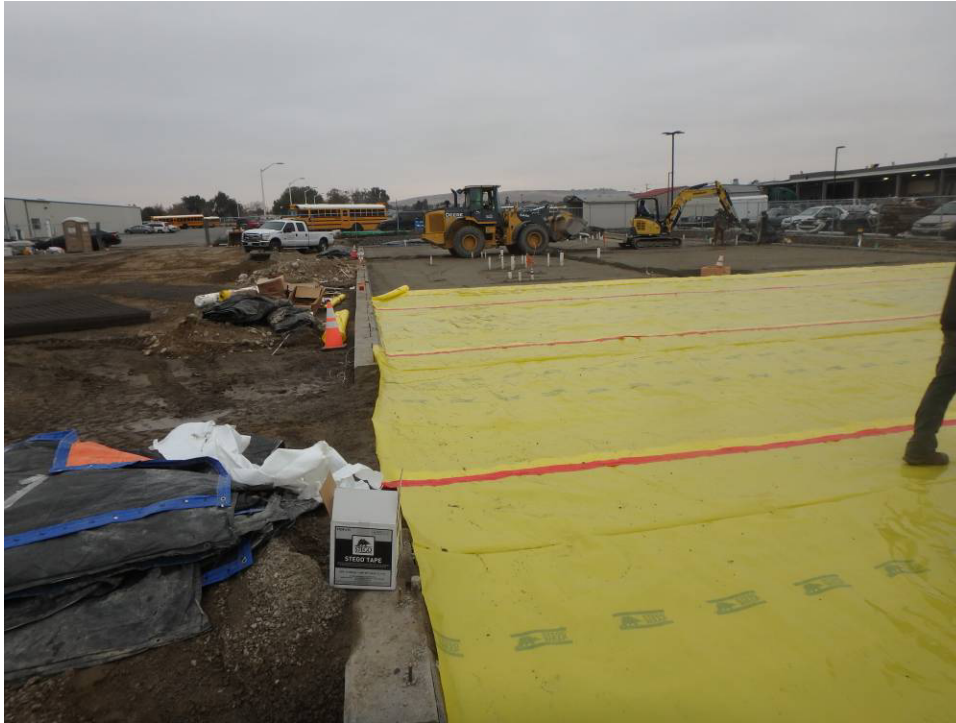
Looking south at the east foundation wall

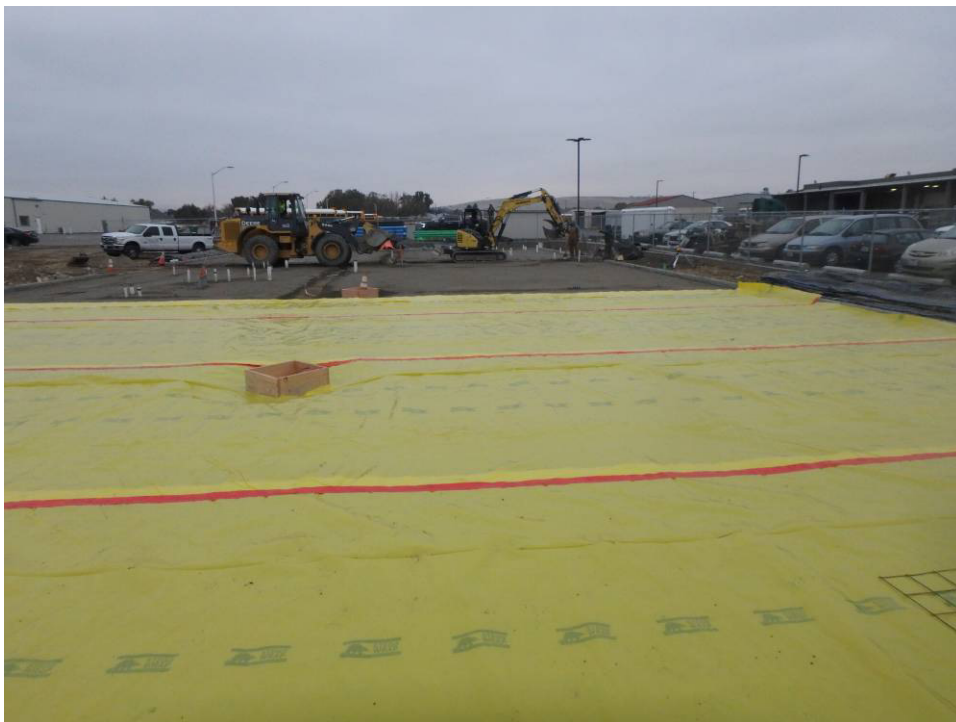
Looking south at the central building area

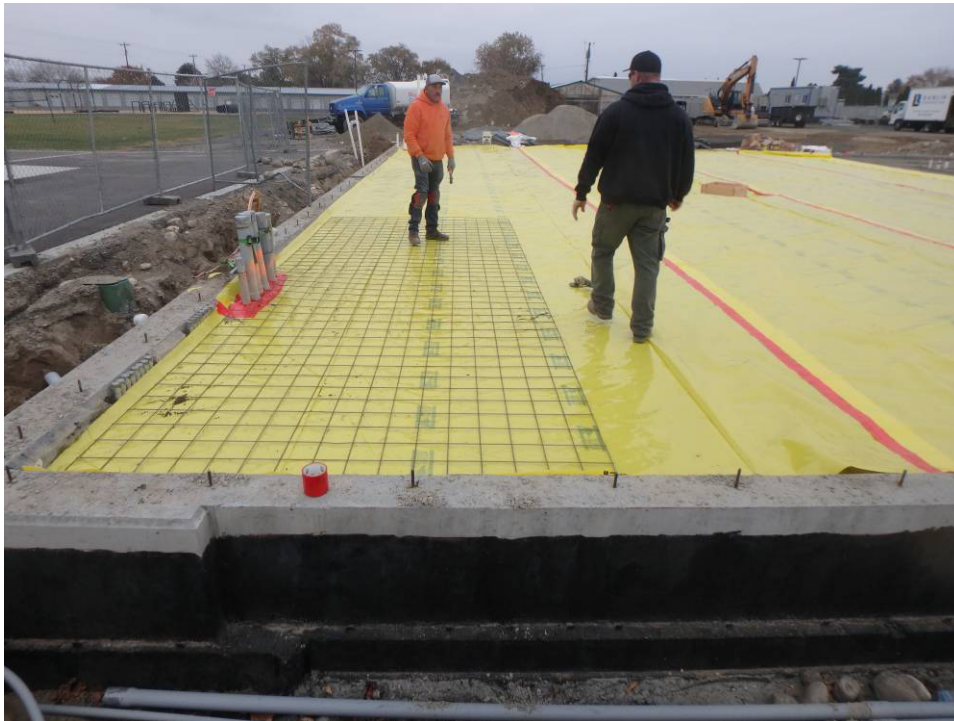
Looking east at the northwest corner of the foundation wall and first section of welded wire mesh

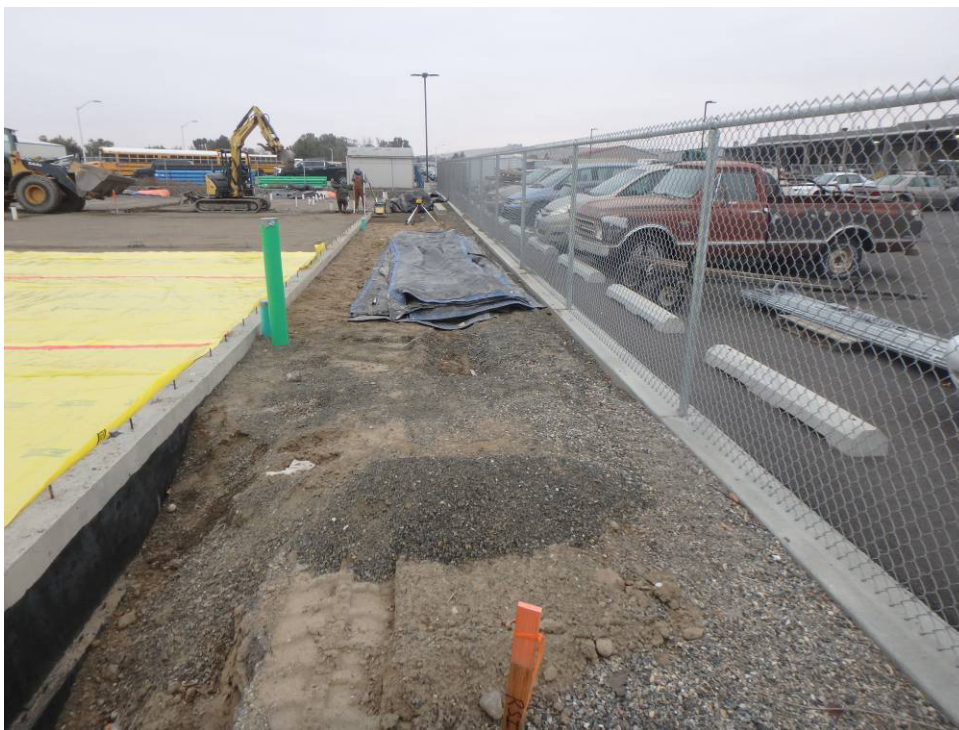
Looking south at the west retaining wall

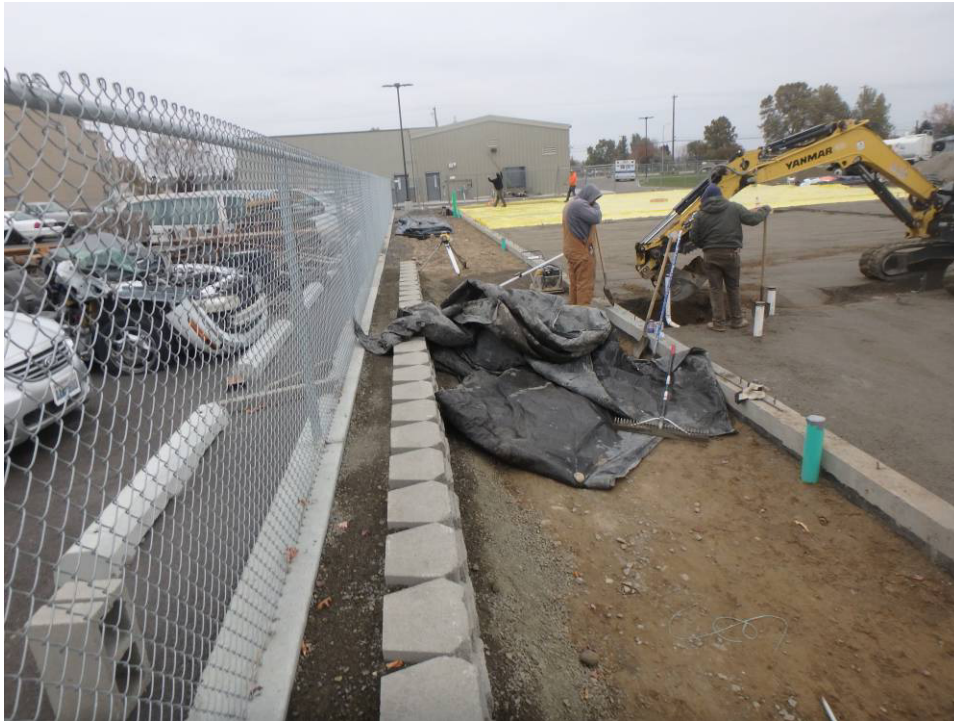
Looking south along the west foundation wall and retaining wall and thickened slab trench digging

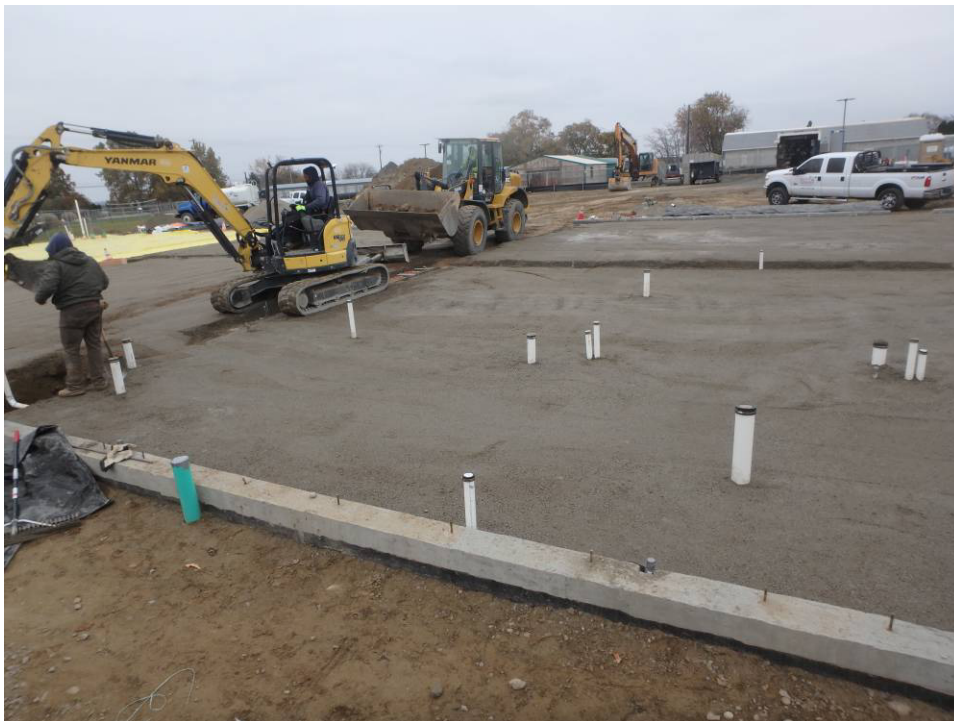
Thickened slab trench digging

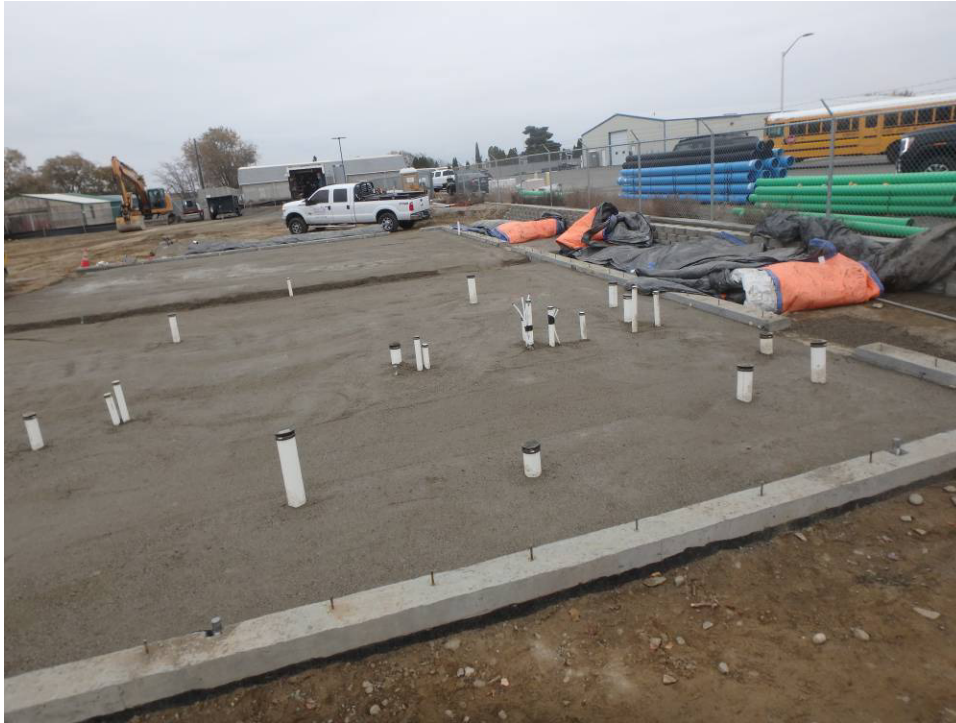
Looking east along the north foundation wall and retaining wall from the SW corner

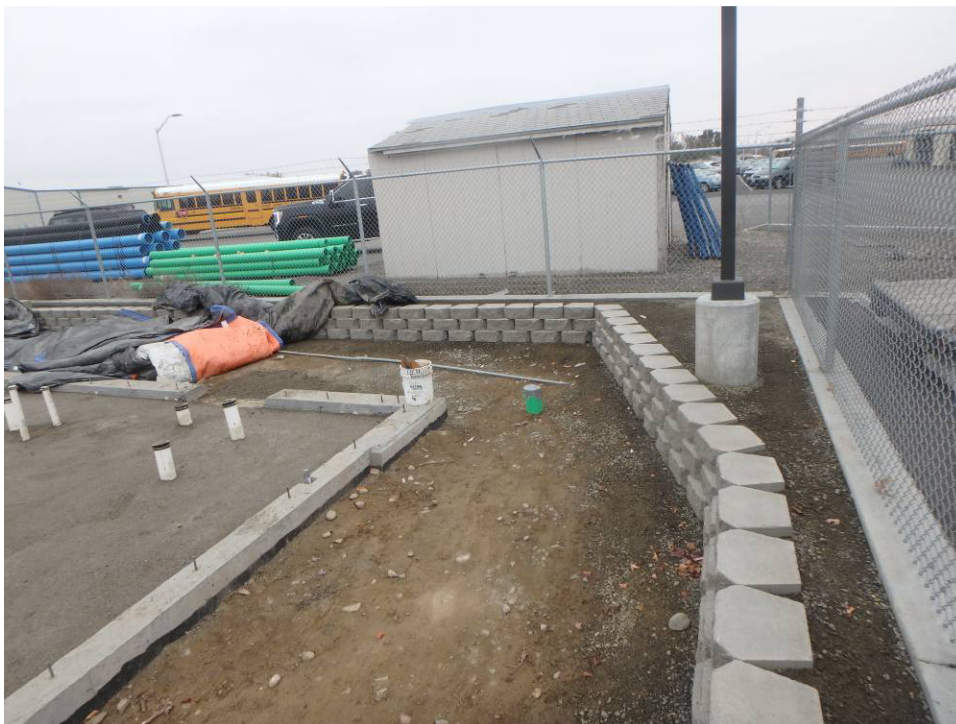
Southwest corner foundation and retaining walls

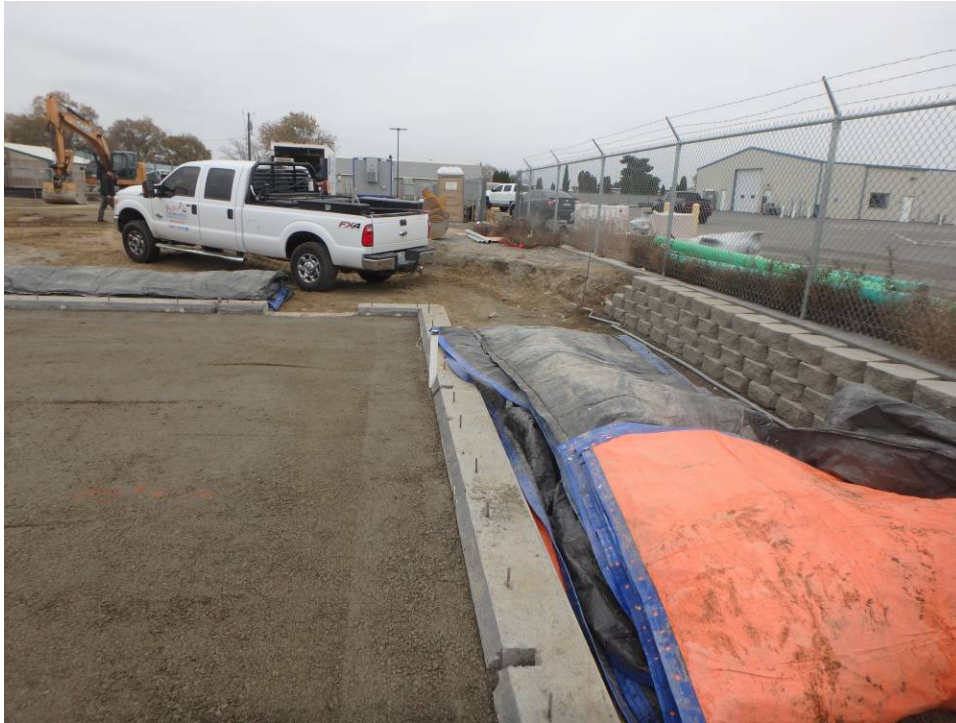
Looking east along the north foundation wall and retaining wall towards the SW corner

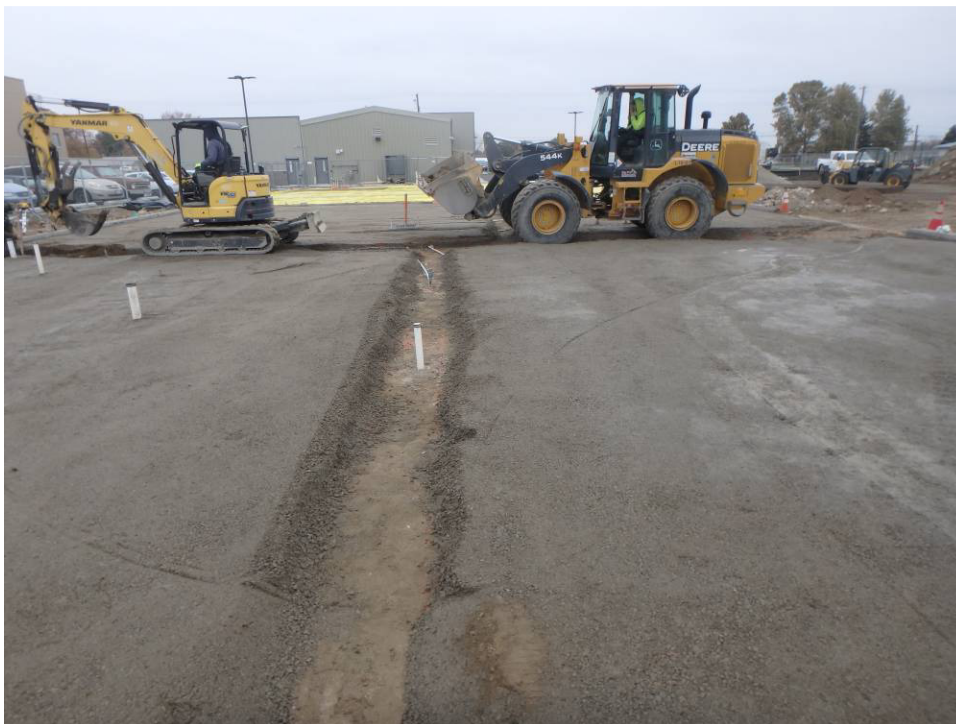
Looking north across the building footprint and the central thickened edge trench

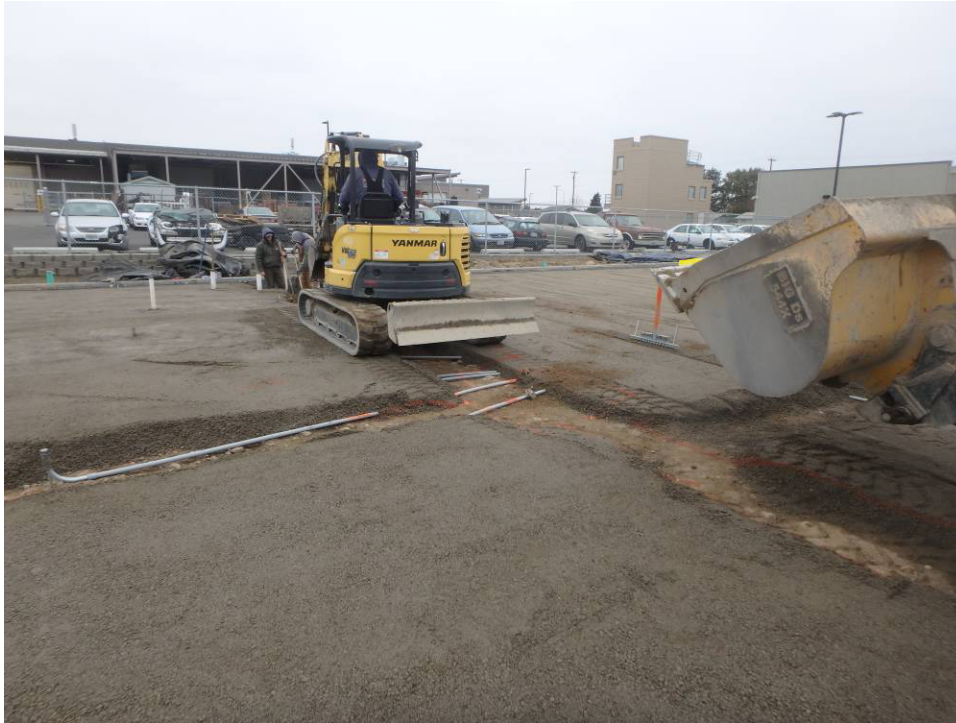
Looking west central trenches and conduit

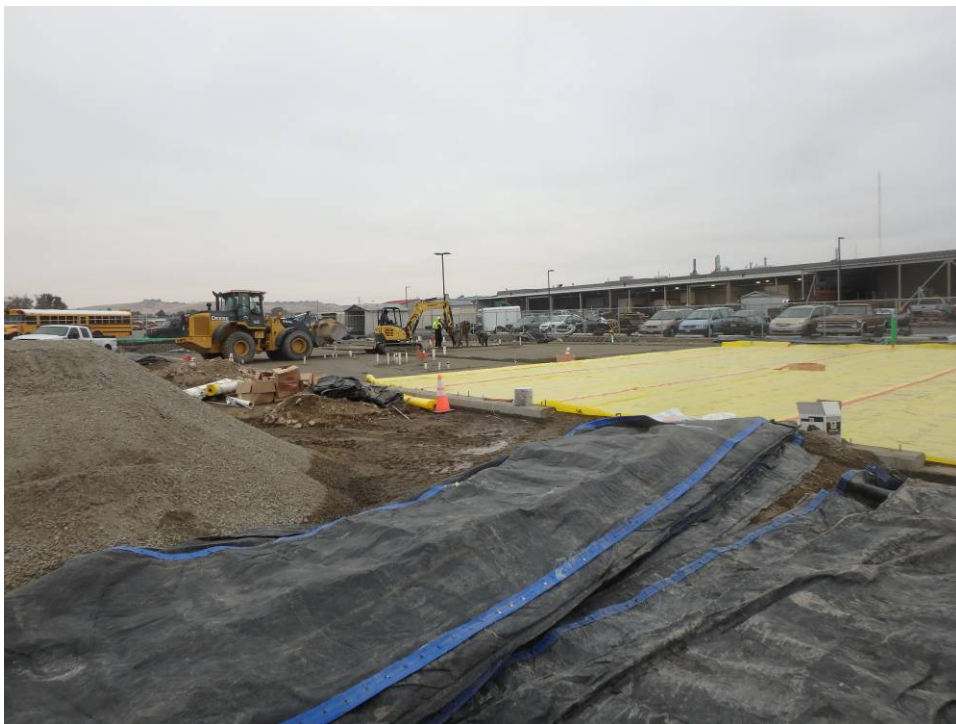
Looking southwest across the building footprint
