MERCER ISLAND SCHOOL DISTRICT
LONG-RANGE FACILITY PLAN

Issue Paper 3: Existing Facility Condition

16 DECEMBER 2019

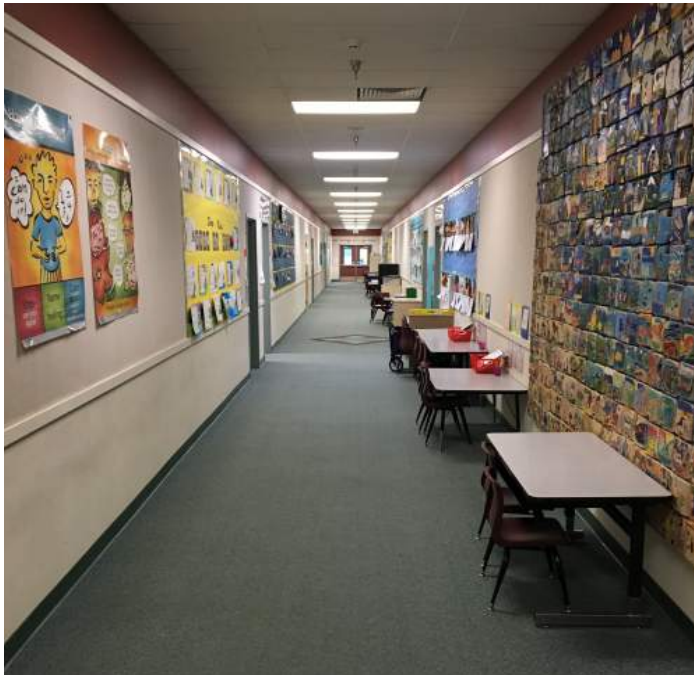
Lakeridge Elementary School: Hallway use for pull-out learning activities and lack of natural light

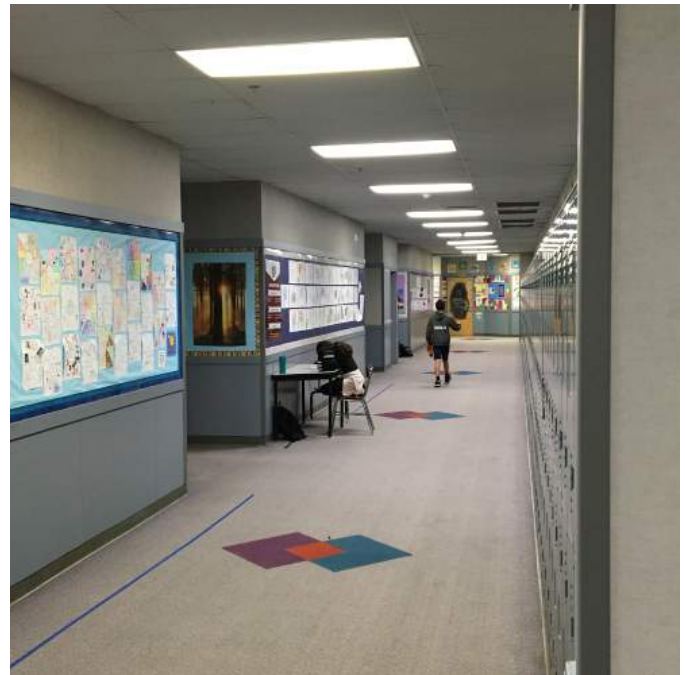
Islander Middle School: Hallway use for pull-out learning activities and lack of natural light

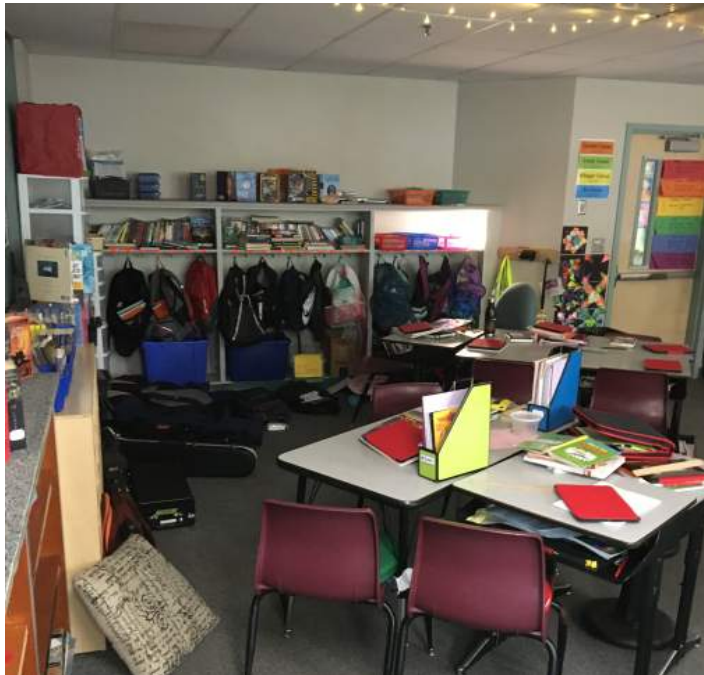
Island Park Elementary School: Classroom with limited storage and functional limitations

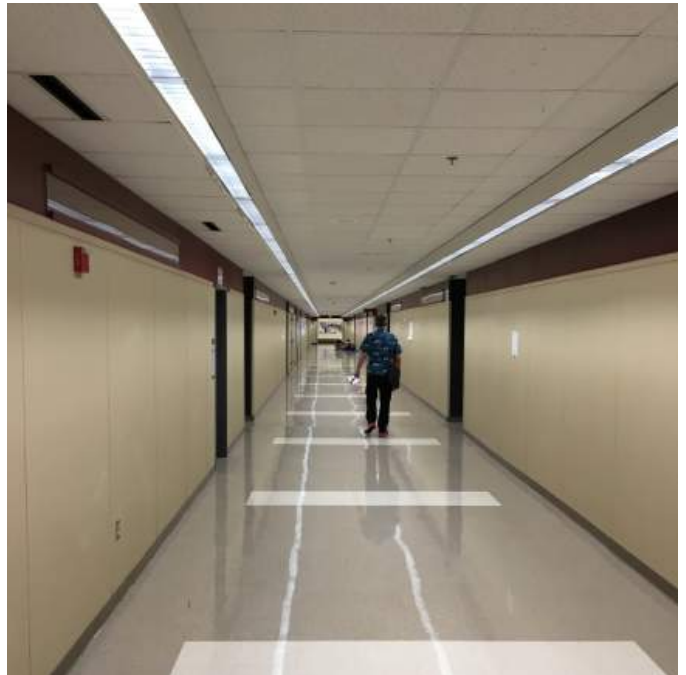
Mercer Island High School: Long corridors can make wayfinding difficult (and have limited or no natural light)

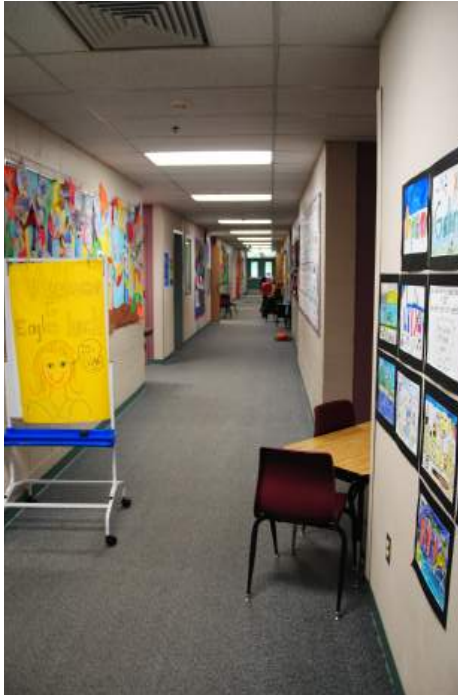
Island Park Elementary School: Small group learning / pull-out areas in hallways

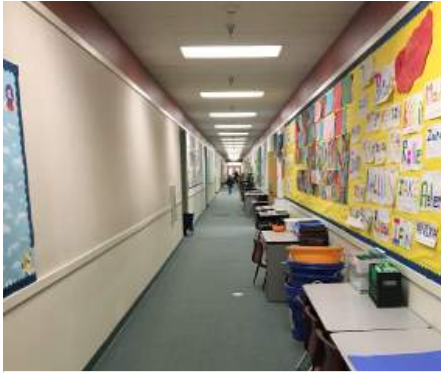
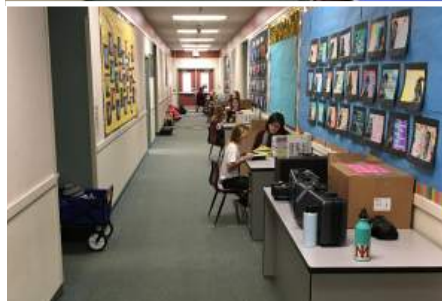
Lakeridge Elementary School: Small group learning / pull-out areas in hallways

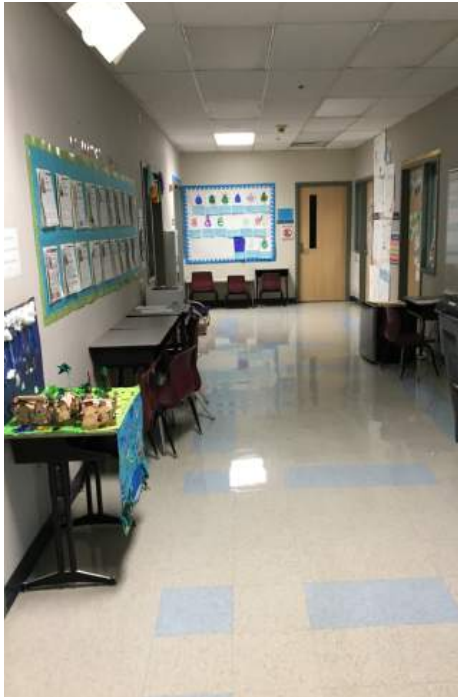
West Mercer Elementary School: Small group learning / pull-out areas in hallways

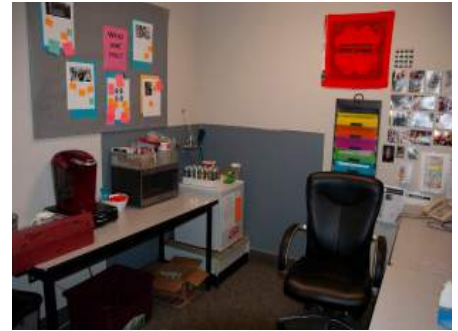
IMS Classic Building: Office in custodial closet

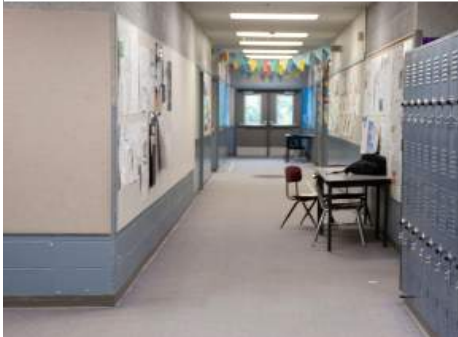
IMS Classic Building: Lack of natural light

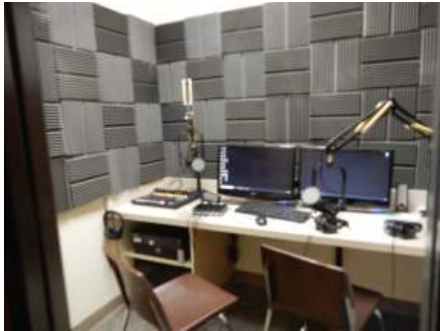
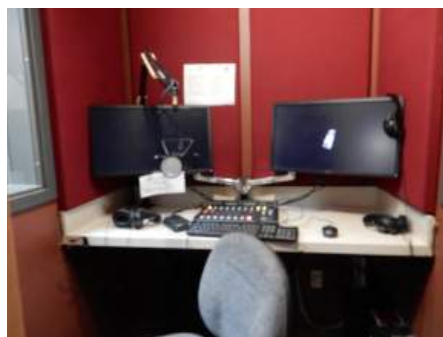
Mercer Island High School: Undersized broadcast program areas

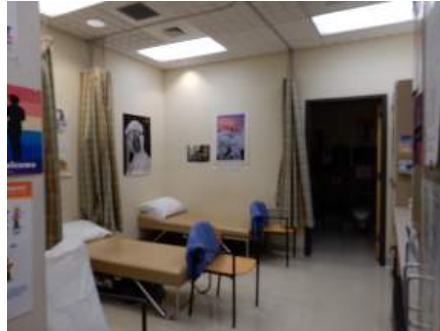
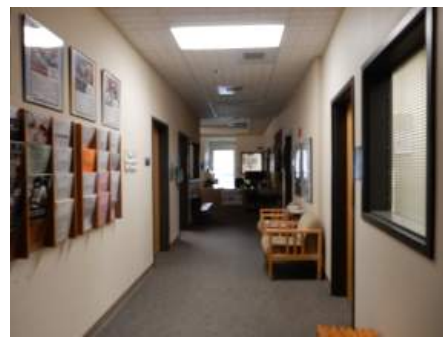
Mercer Island High School: Inadequate health room and counseling area

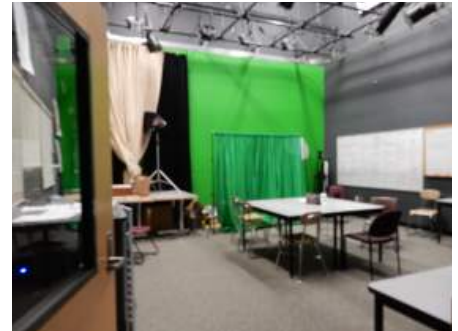
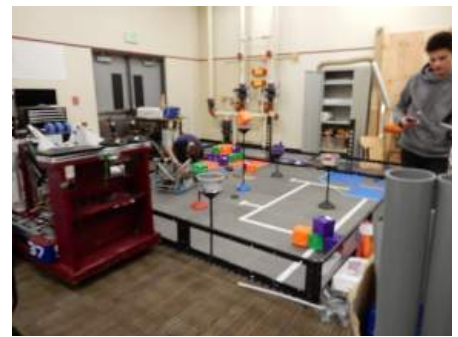
Mercer Island High School: Robotics classroom in the old gas engine shop
