MASSACHUSETTS SCHOOL BUILDING AUTHORITY 2022 STATEMENT OF INTEREST

BROCKTON HIGH SCHOOL 470 FOREST AVENUE BROCKTON, MA 02301

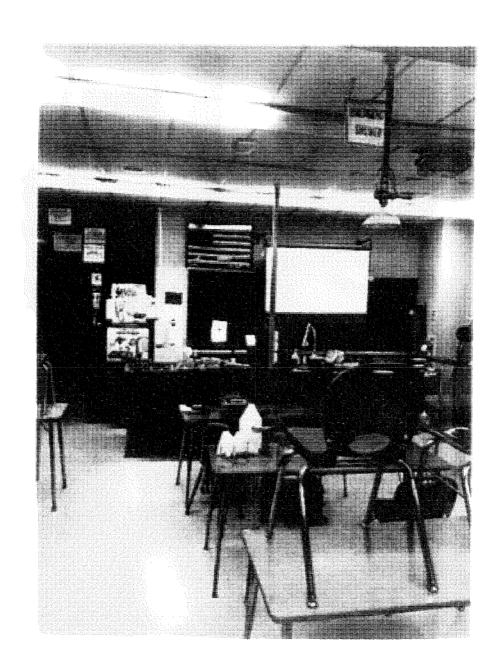
2-[

General Building Conditions
