Project Observation Report

Project Name:	Tri Tech East Building	Project No.	2208
Report #:	9		
Observation Date:	12-7-22	Last Report:	11-30-22
Prepared By:	Steve Mallory, AIA	Contractor:	Banlin

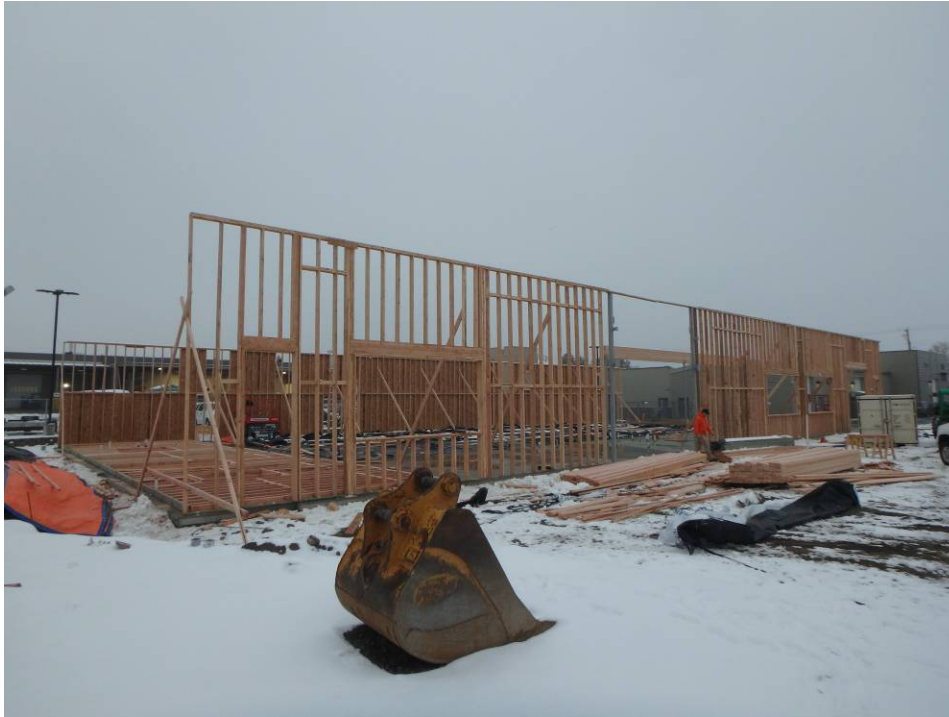
East wall framing

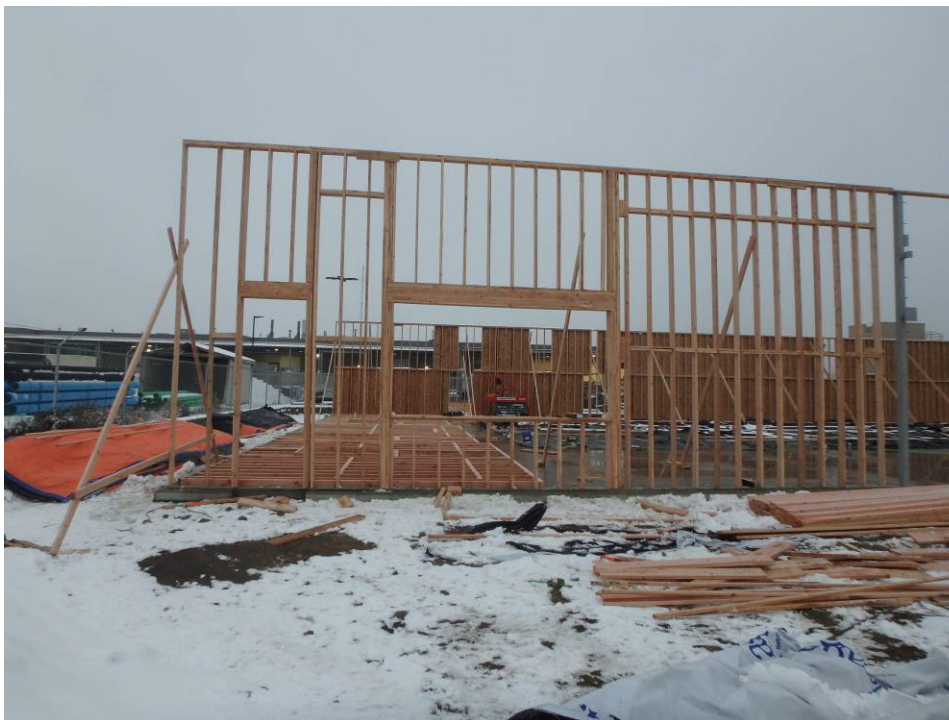
Looking at the south end of the east wall framing, south wall framing ready to be stood

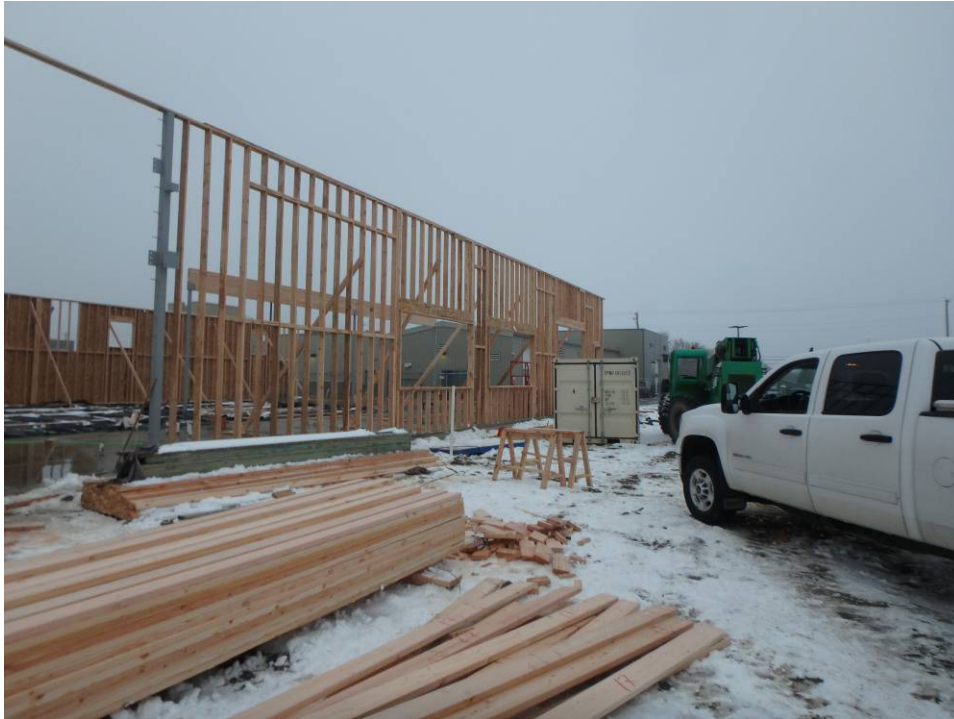
Looking at the north end of the east wall framing

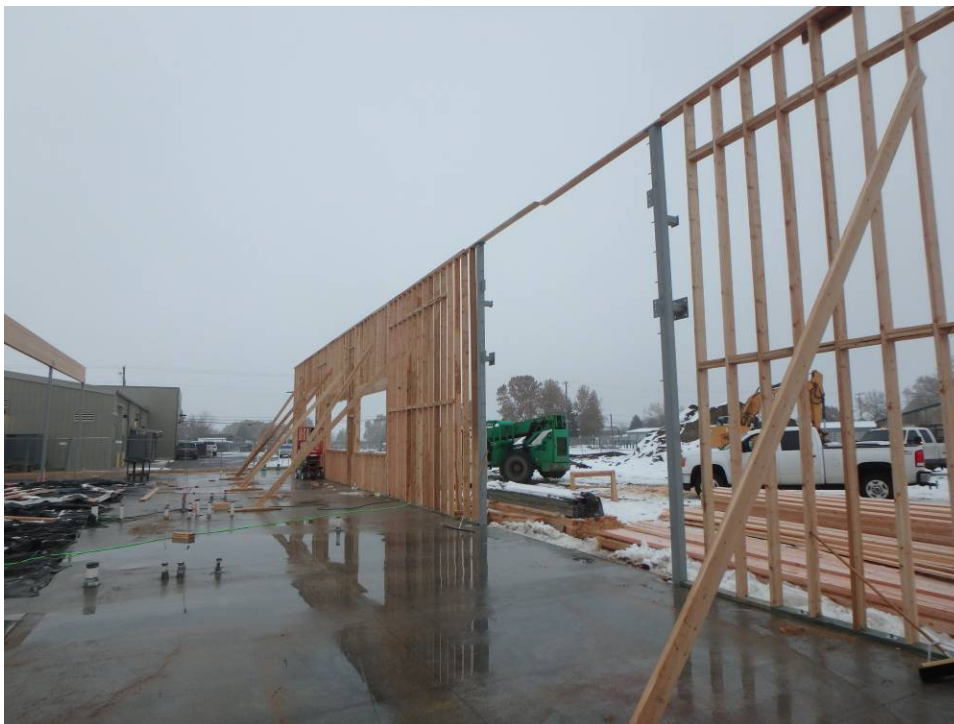
Looking north at the east wall framing and east opening

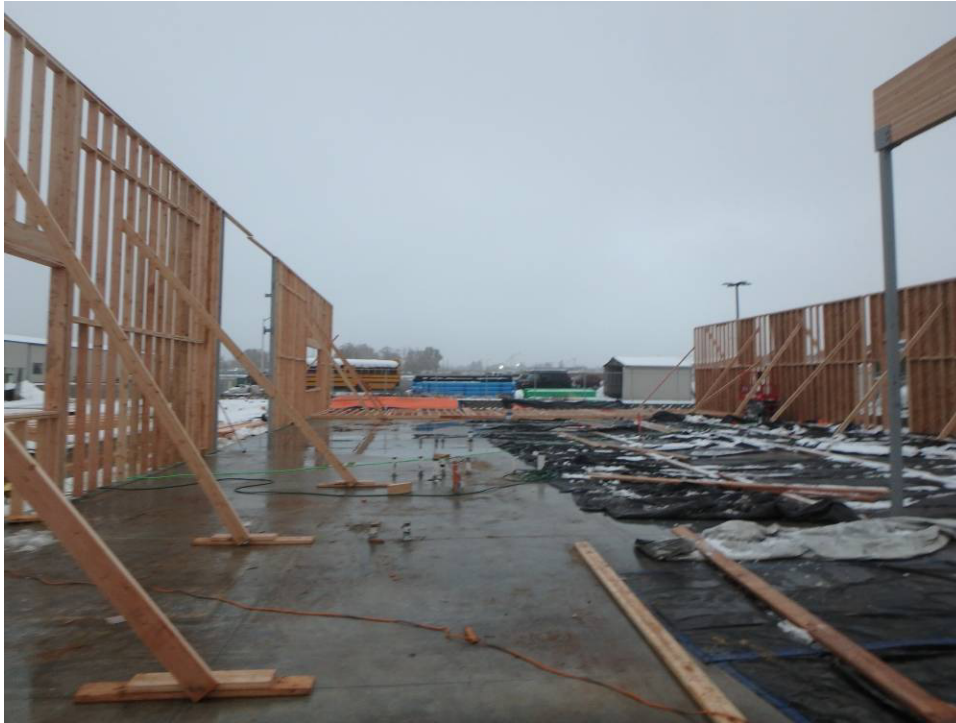
Looking south across the slab and framing

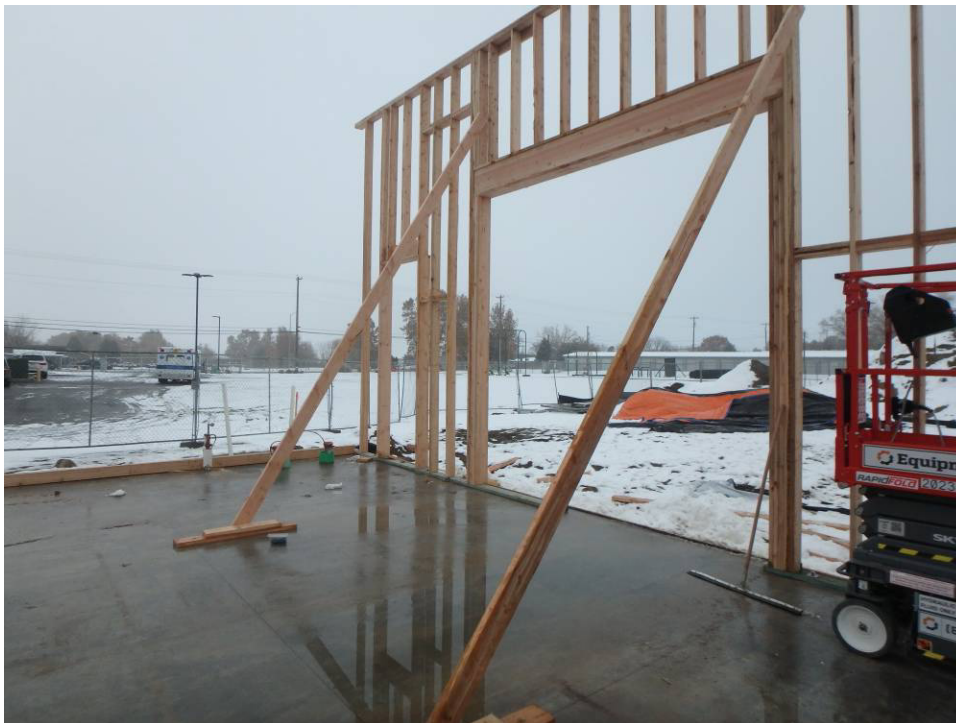
Looking at the northeast corner

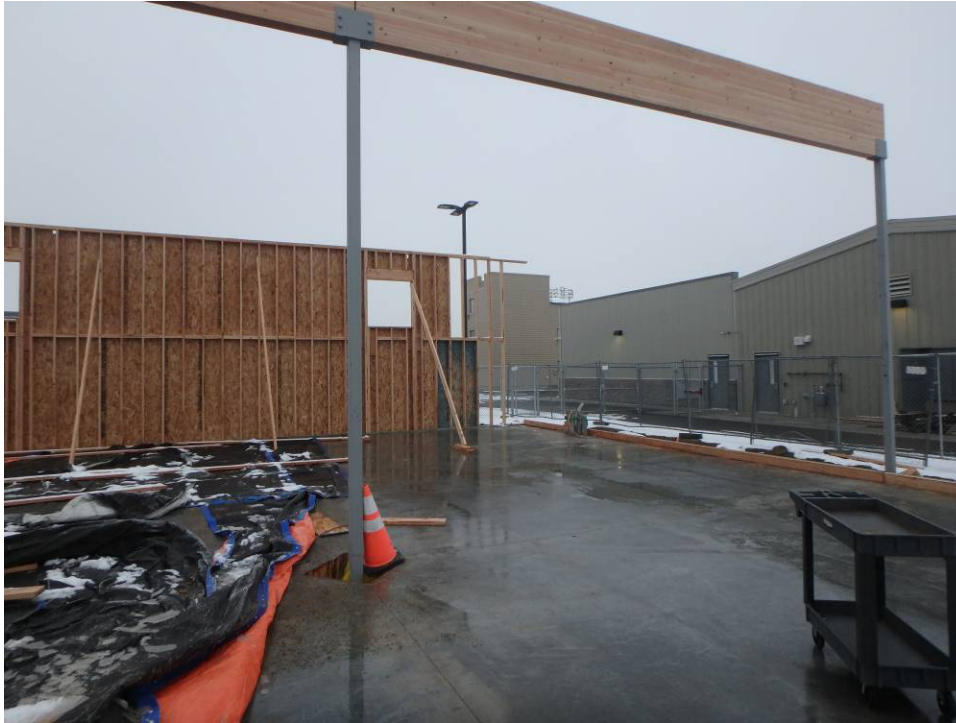
Looking at the northwest corner and glue lam beam

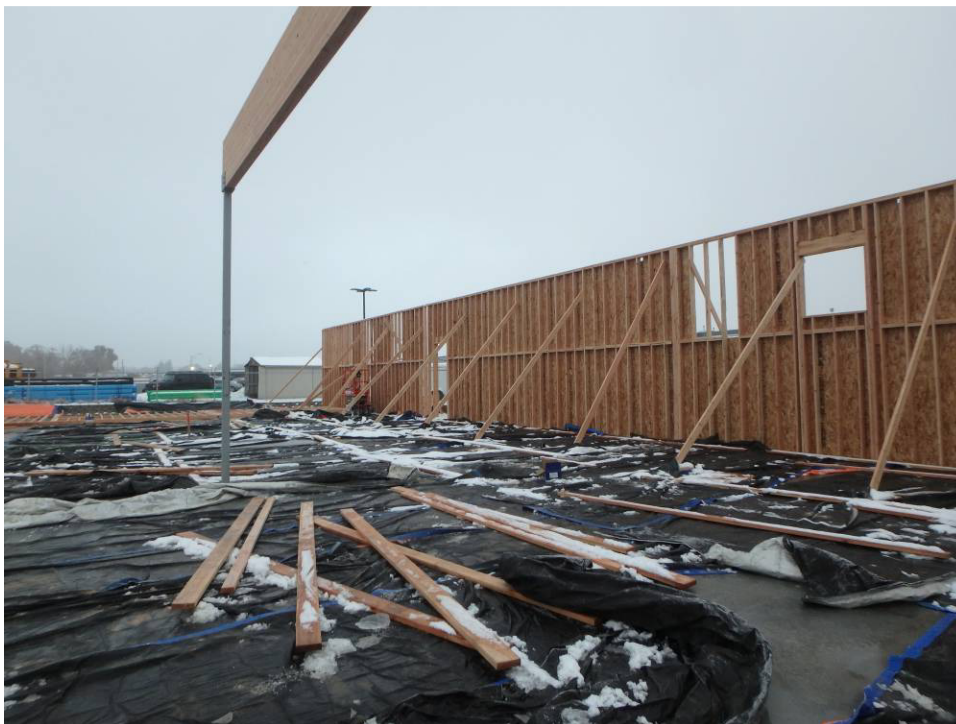
Looking southwest at the west wall framing

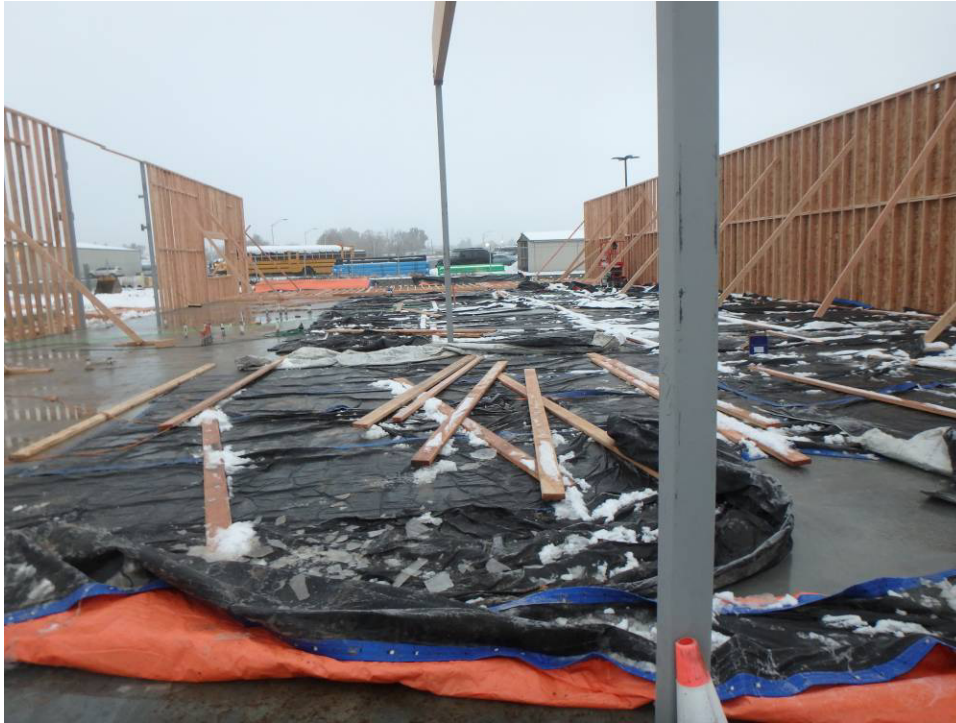
Looking south down the center of the building

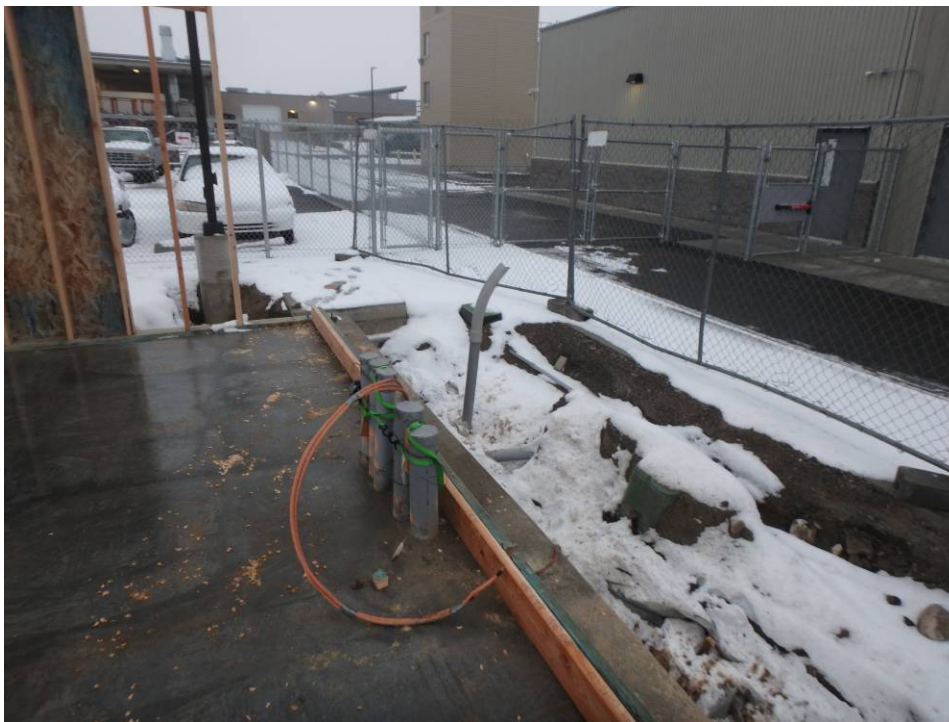
Looking northwest at the northwest corner slab

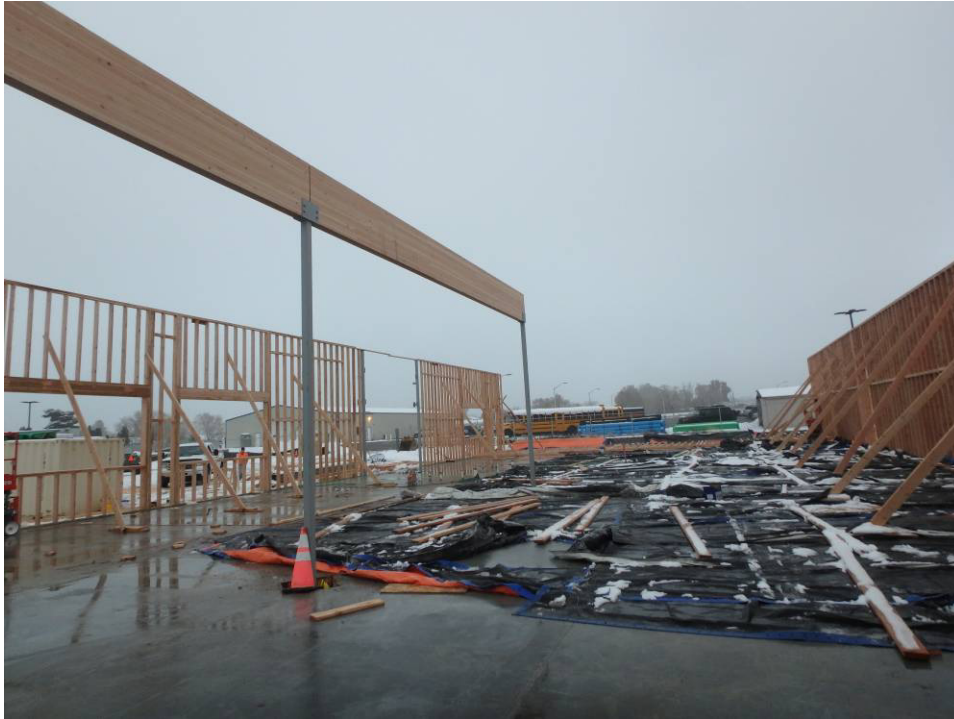
Looking southeast at the east wall framing and glue lam beam

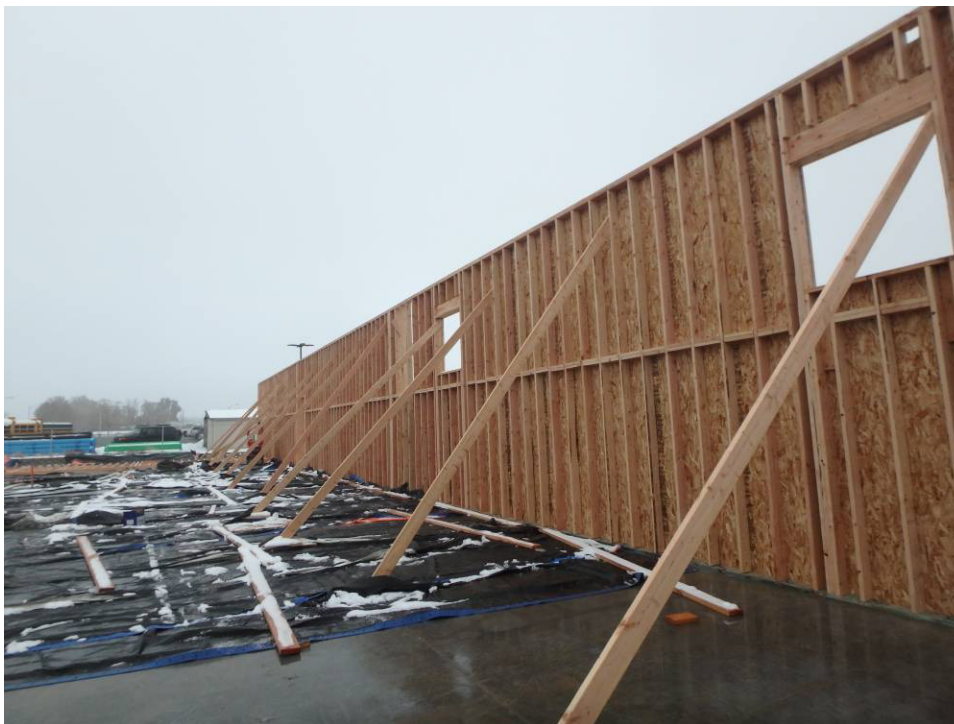
Looking South at the west wall framing

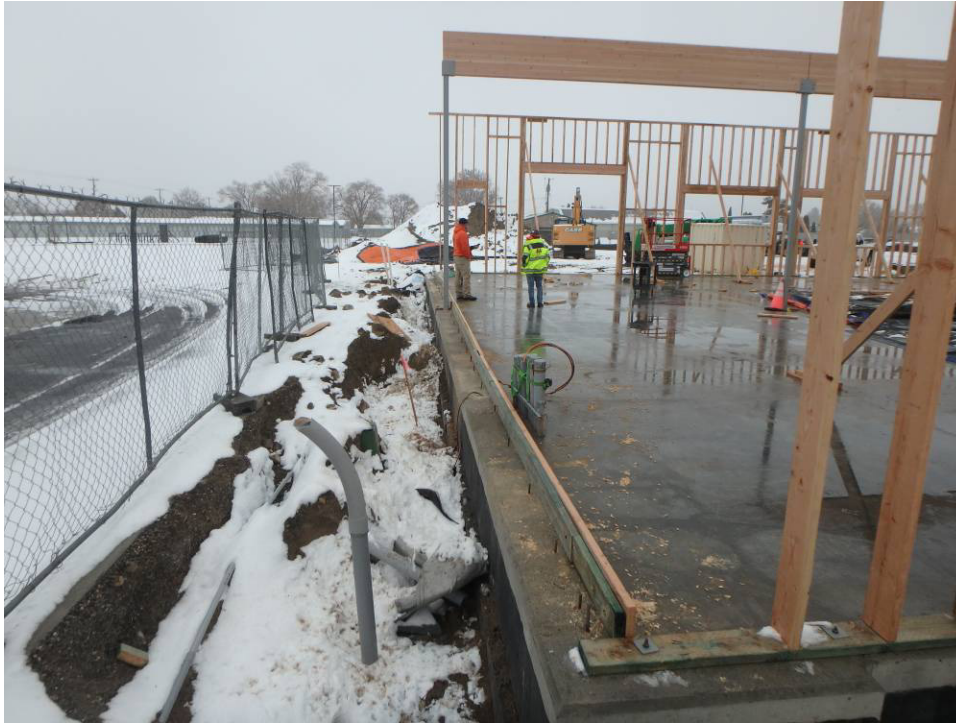
Looking east at the north slab, north side

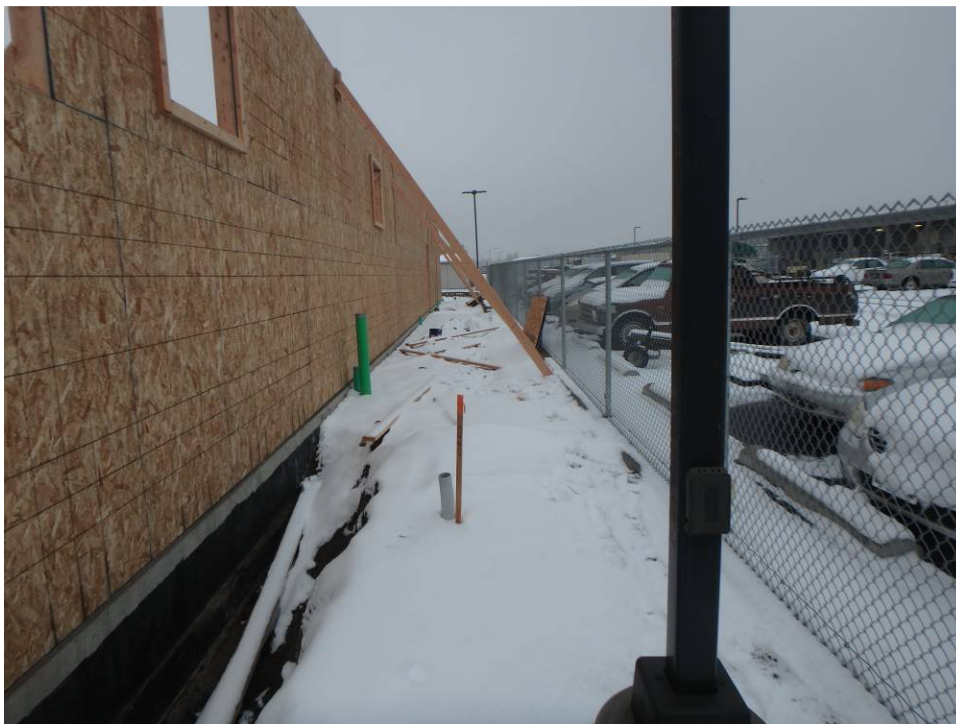
Looking south along the west elevation

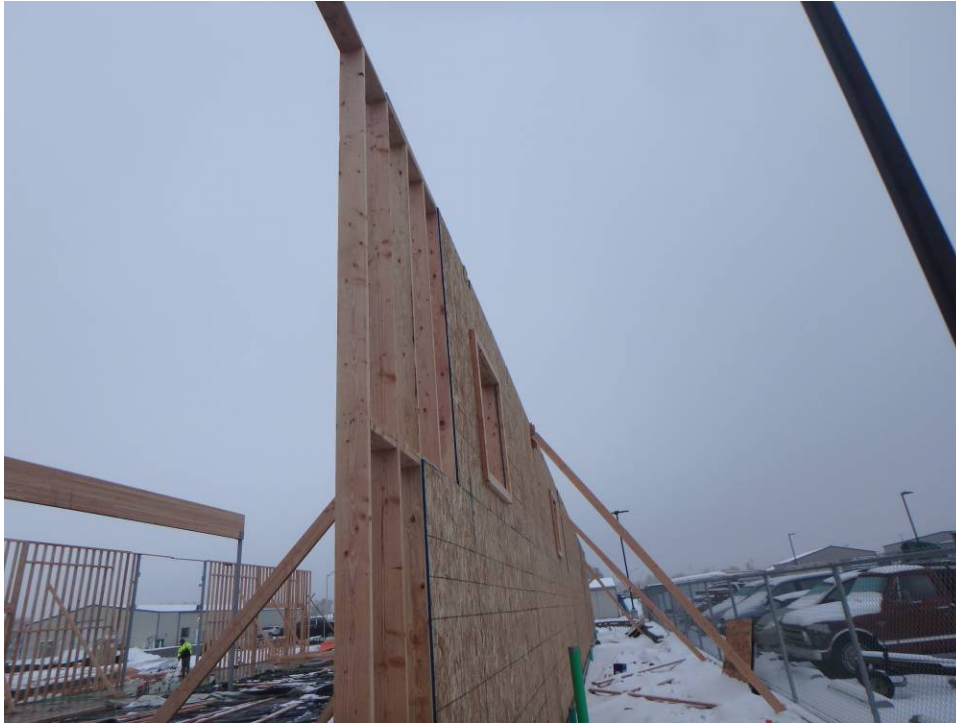
West wall openings and Framing offset

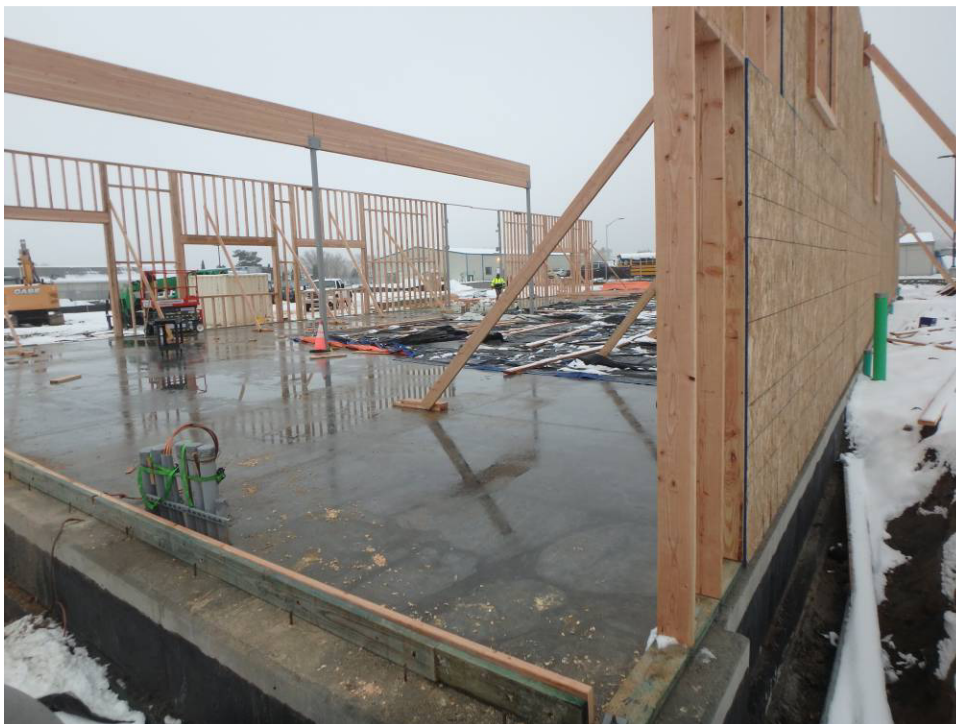
Looking southeast across the building and the north slab and blankets

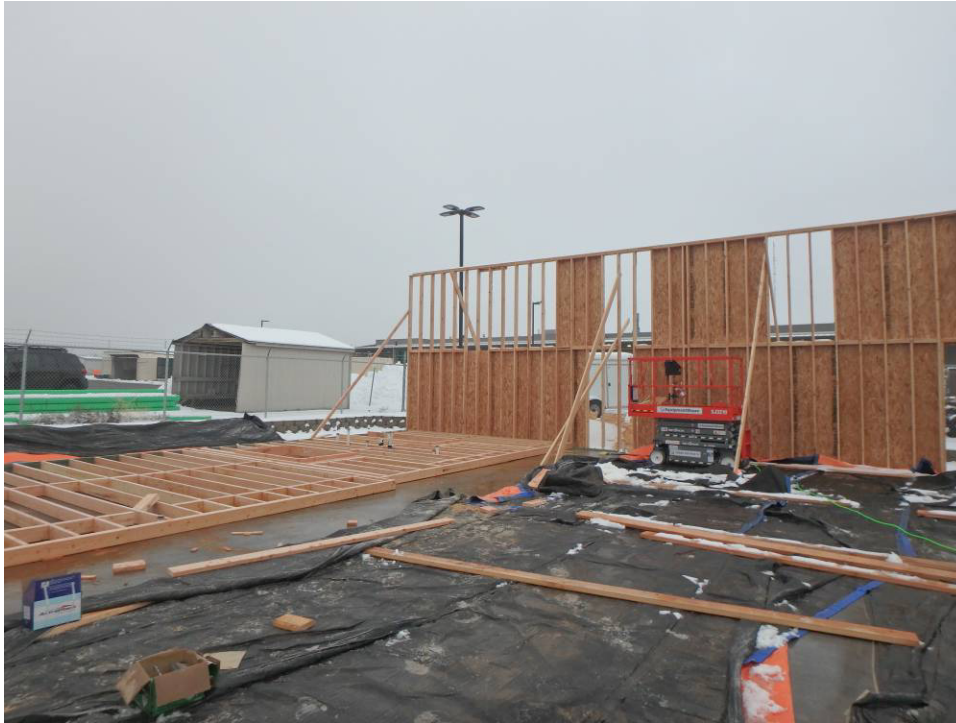
Looking west at the south end of the slab, west wall framing

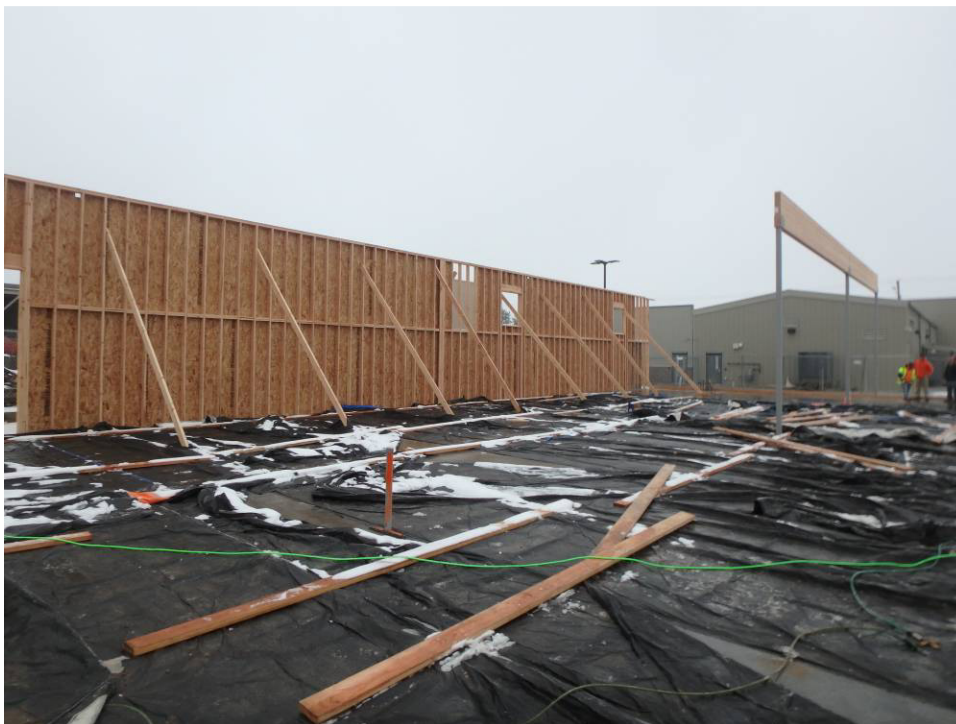
Looking northwest at the central building area and 3 new north columns

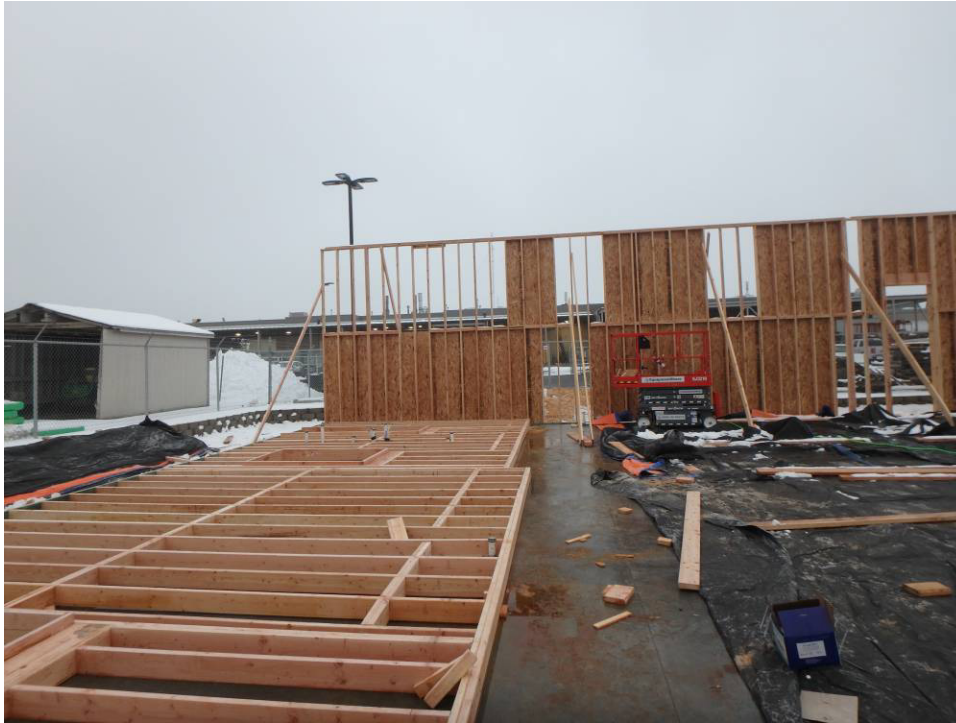
Looking west at the south wall framing

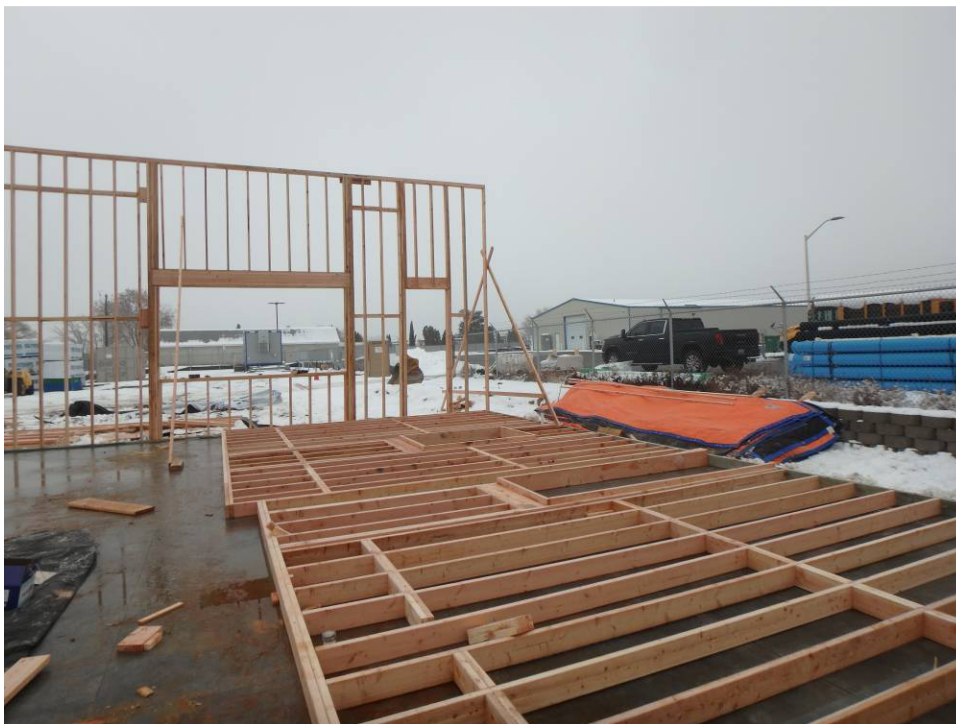
Looking east at the south wall framing

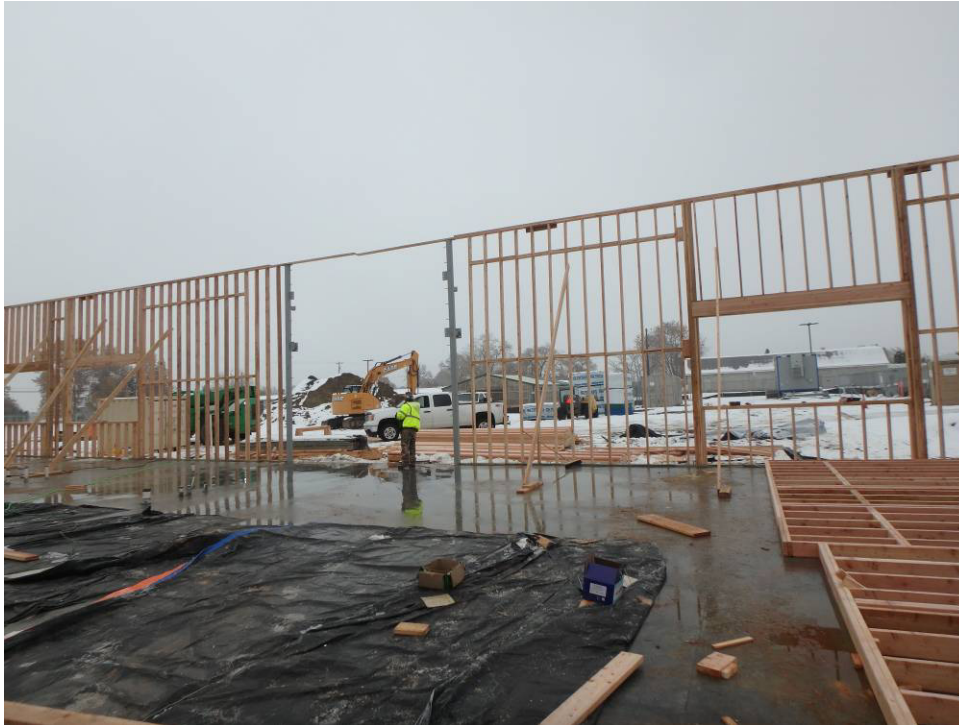
Looking east at the central east wall framing

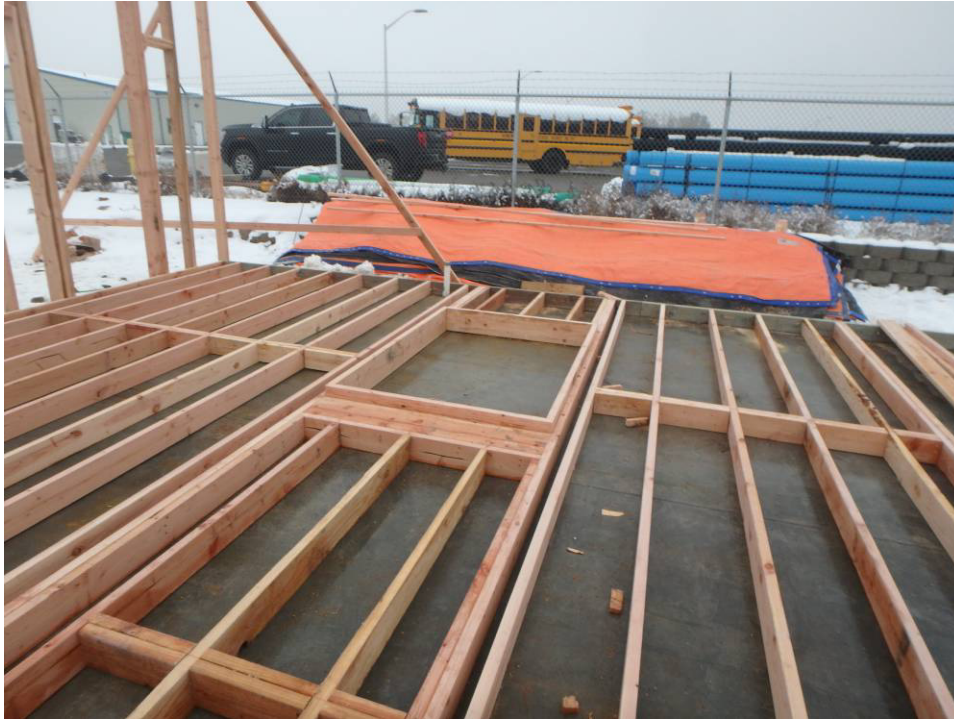
Southeast corner wall framing

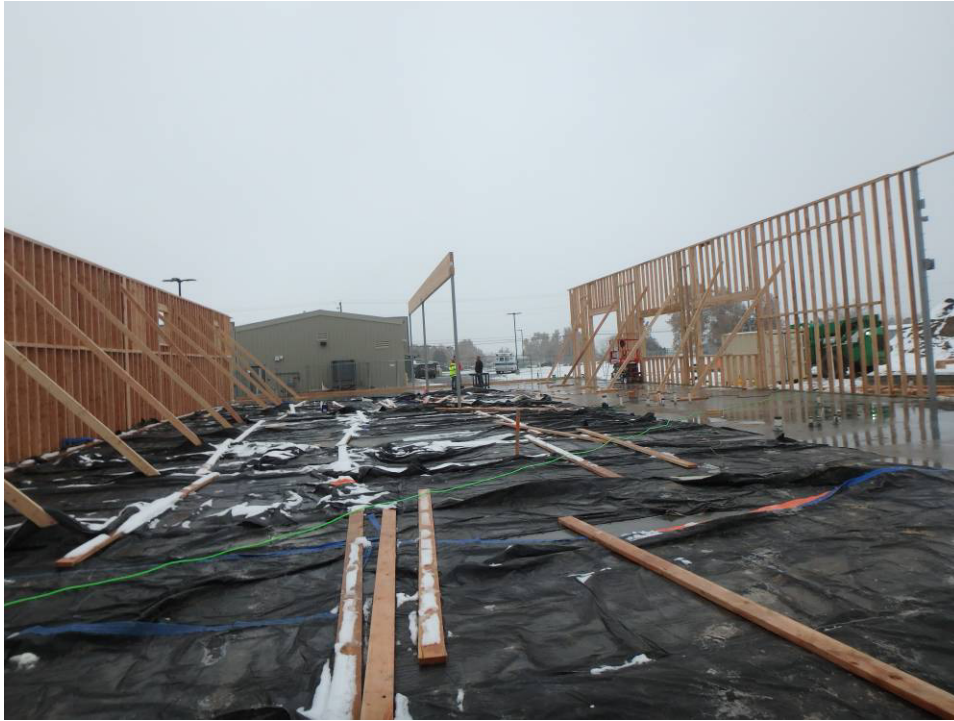
Looking north at the covered building slab
