Project Observation Report

Project Name:	Tri Tech East Building	Project No.	2208
Report #:	10		
Observation Date:	12-14-22	Last Report:	12-7-22
Prepared By:	Steve Mallory, AIA	Contractor:	Banlin

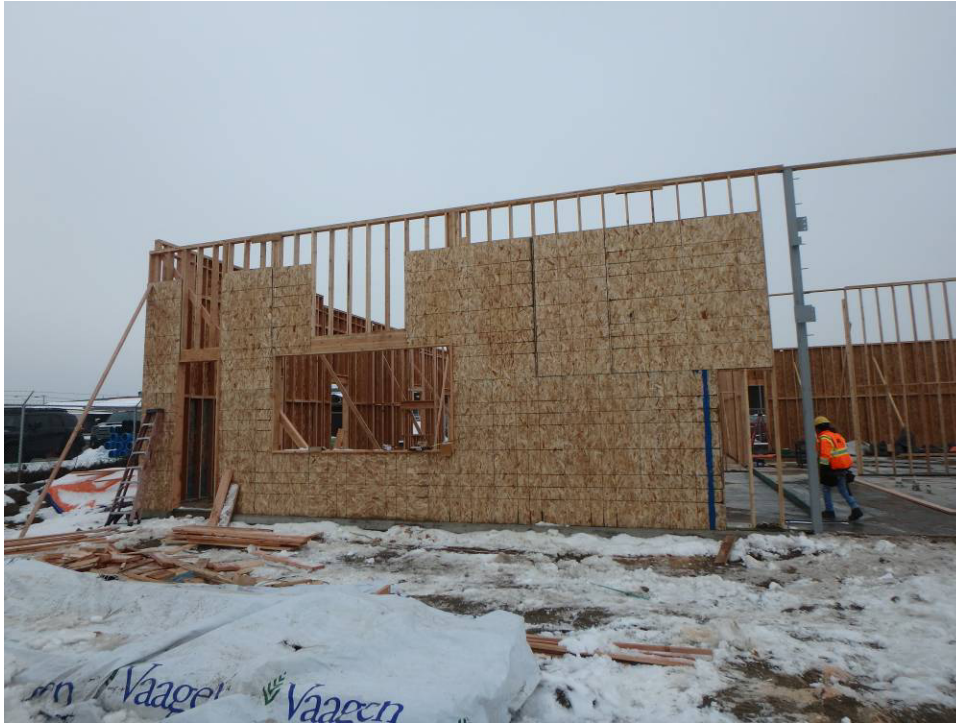
Looking at the south end of the east wall framing

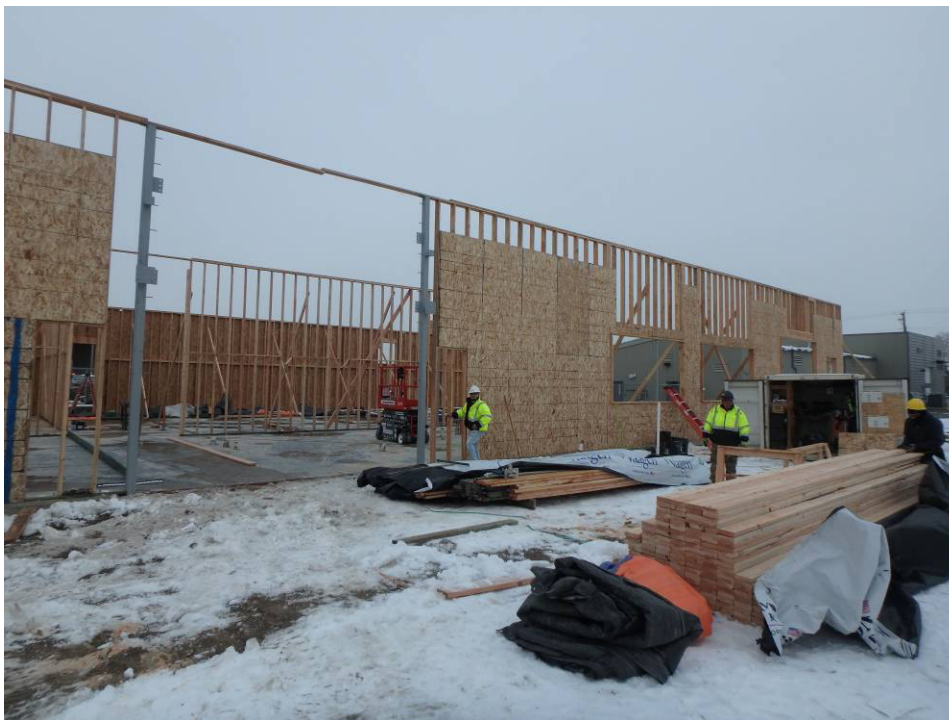
Looking at the north end of the east wall framing

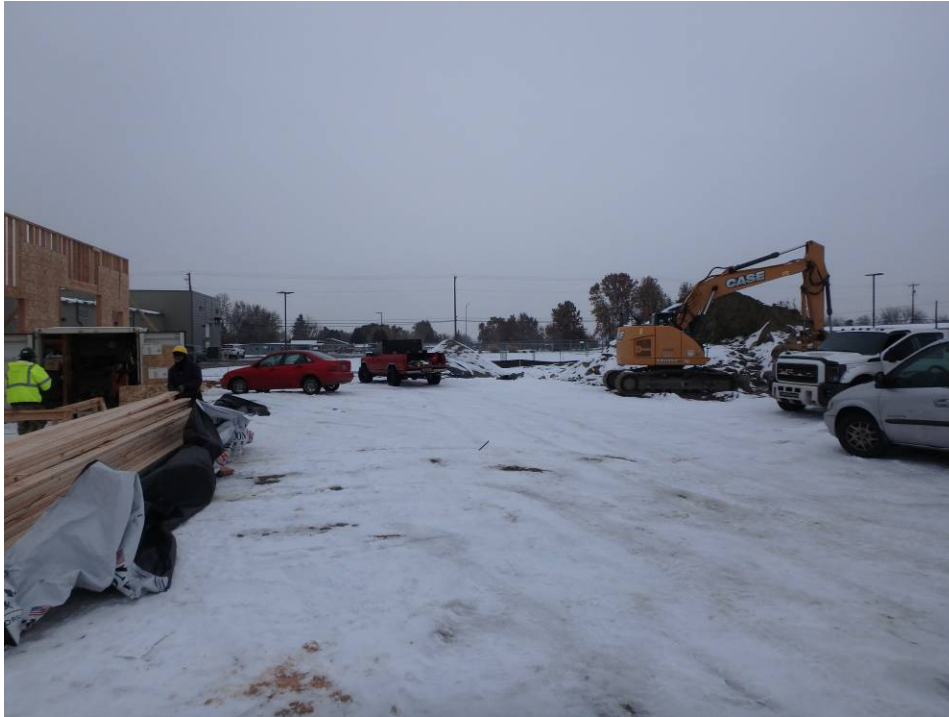
Looking north at the north central side of the site

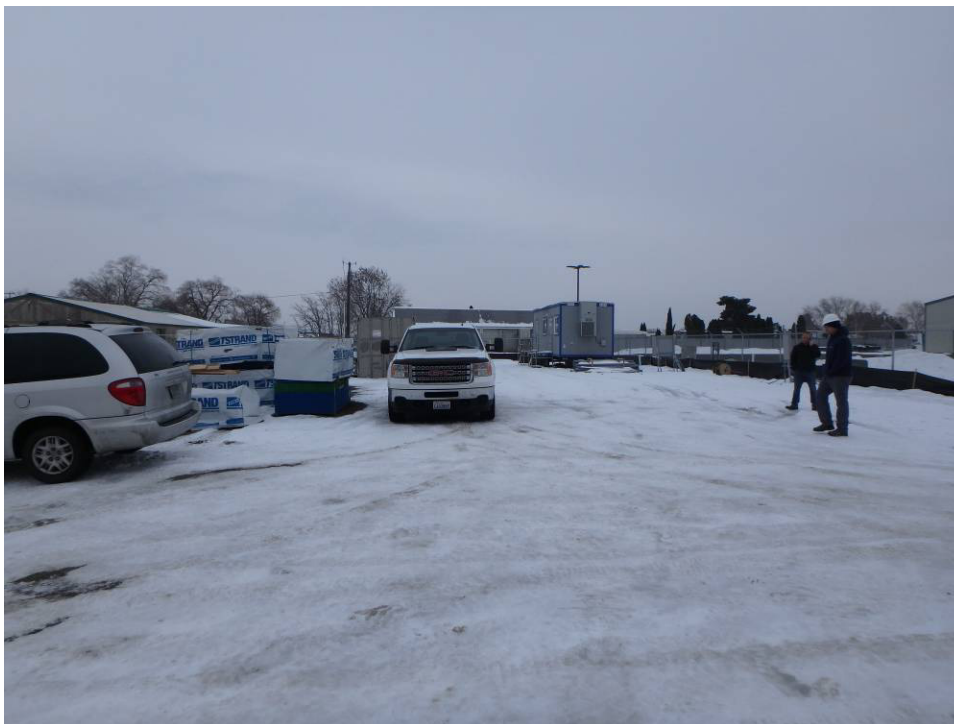
Looking at the east side of the site

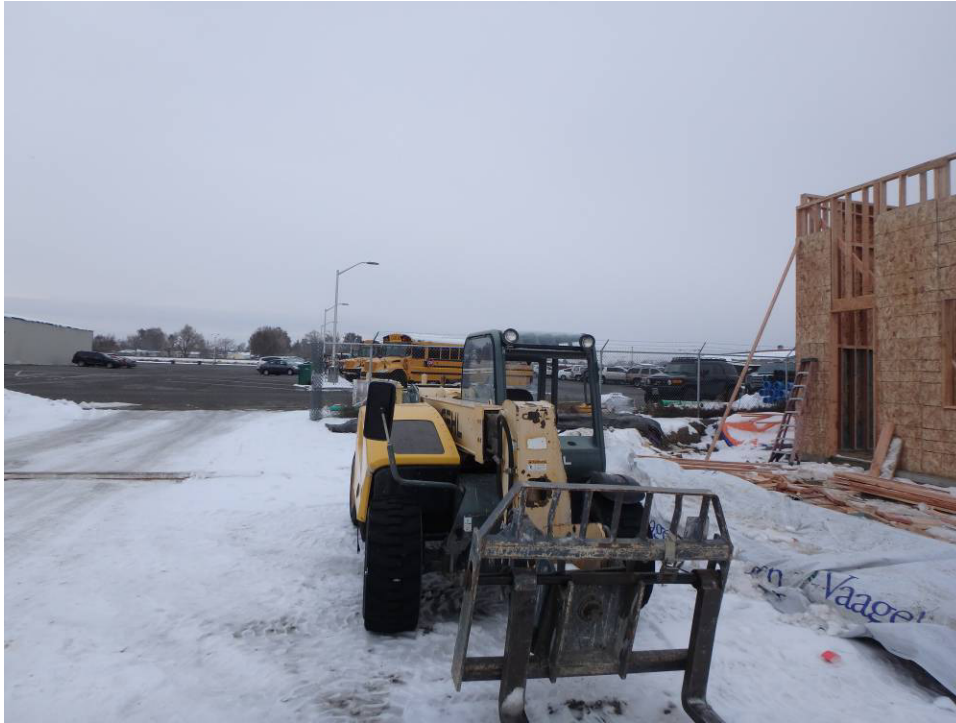
Looking south at the site entry

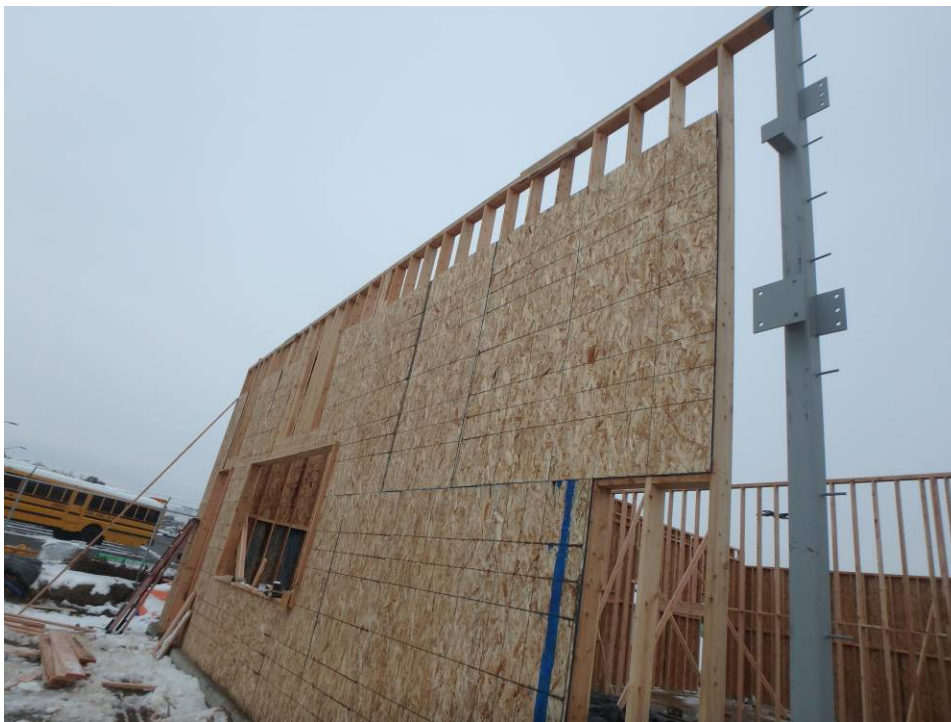
East wall south sheathing

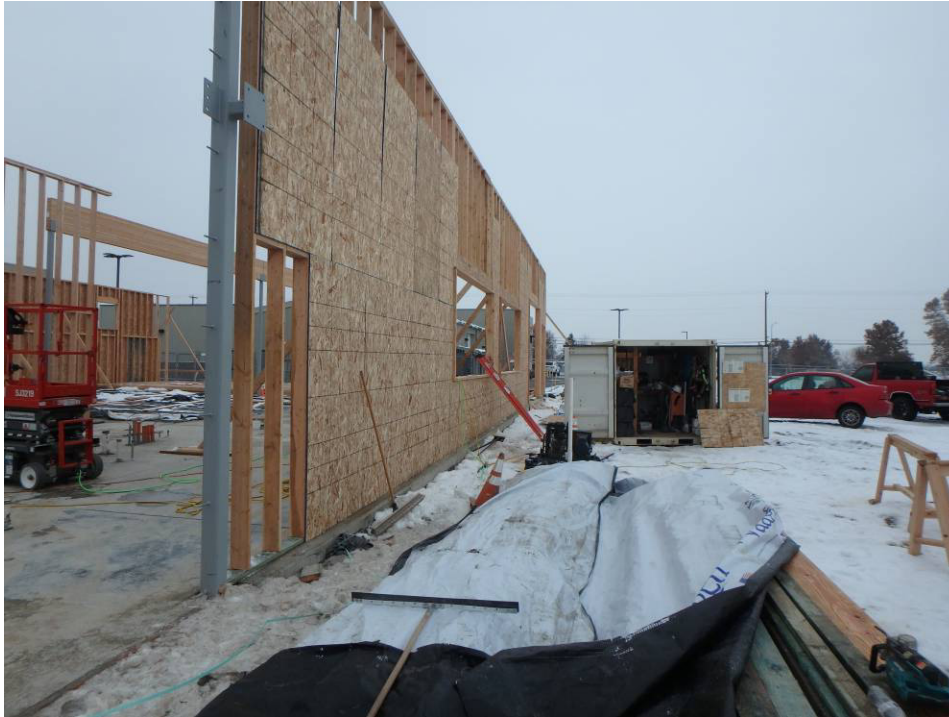
East wall north sheathing

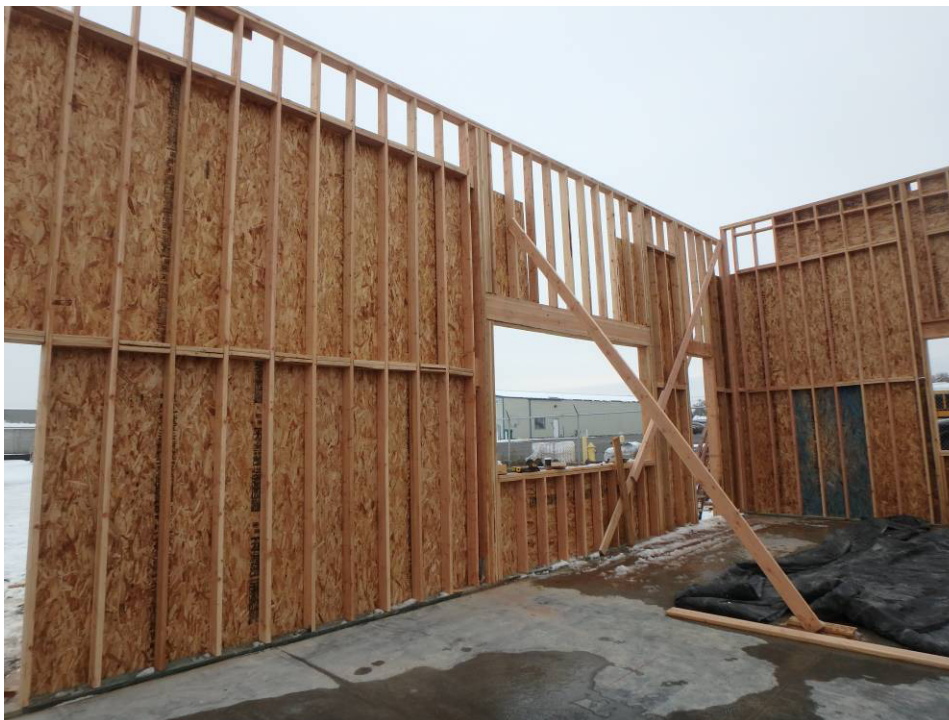
Looking southeast corner framing

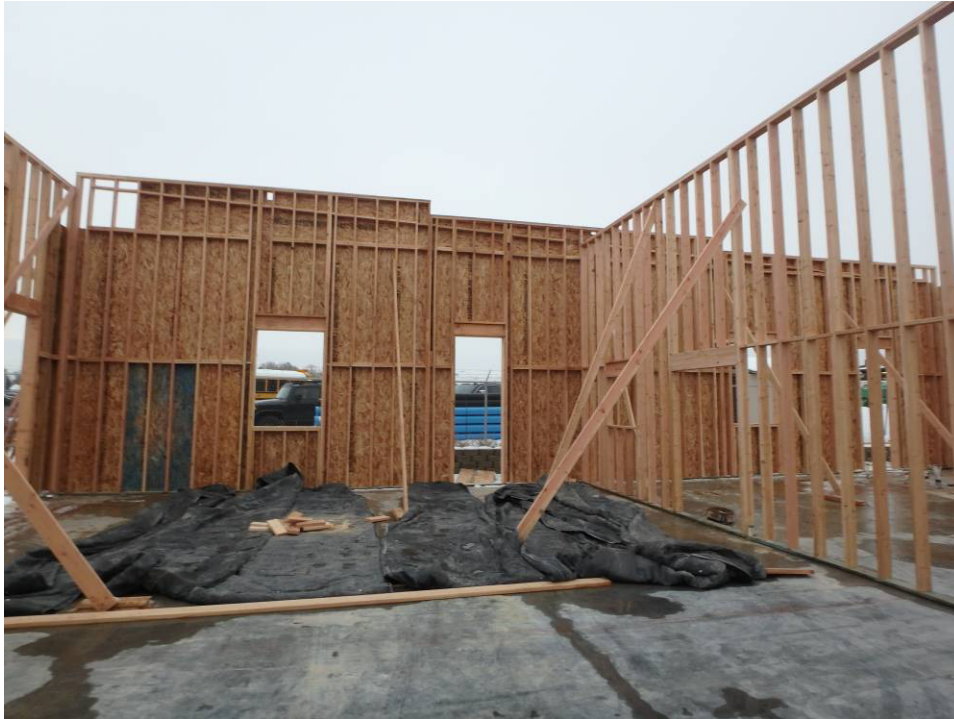
Looking south at the south wall framing and sheathing

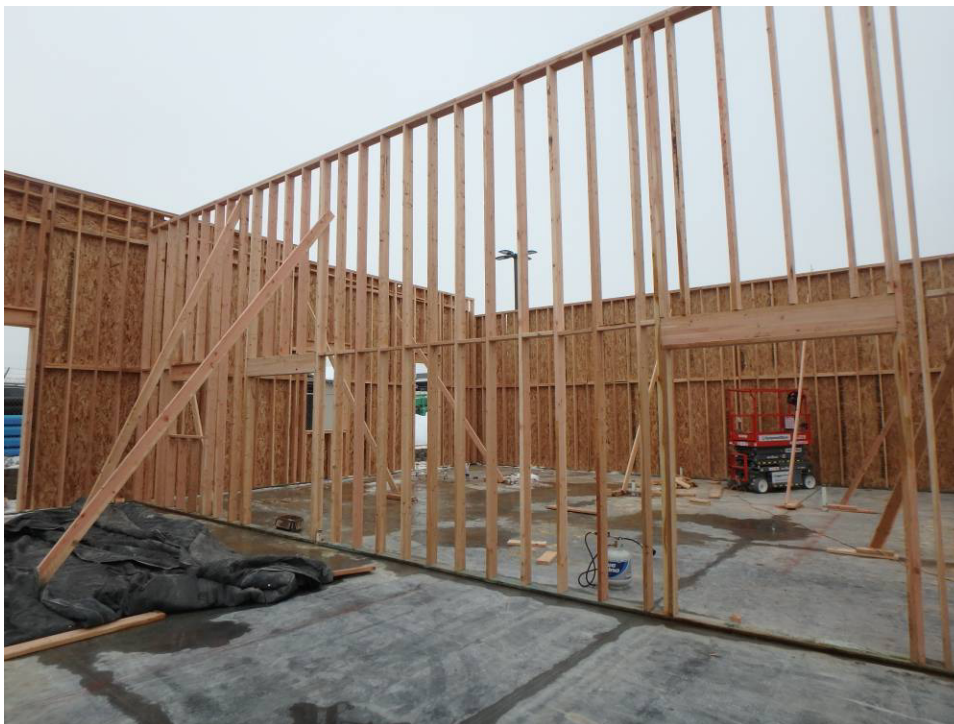
Looking southeast corner framing and sheathing and central south wall

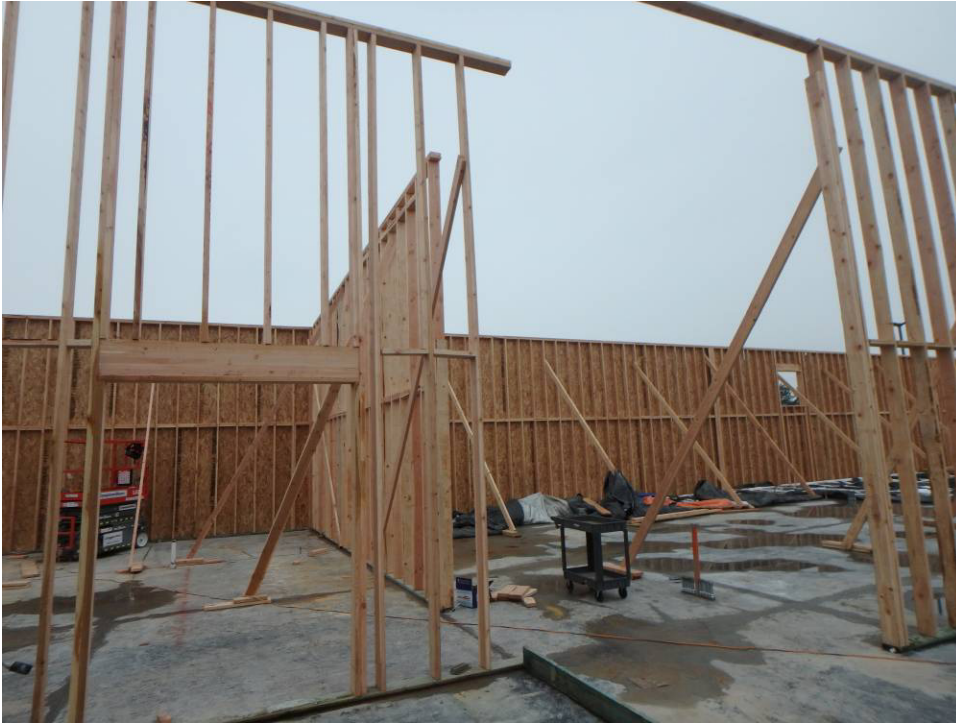
Looking at the west wall framing and sheathing

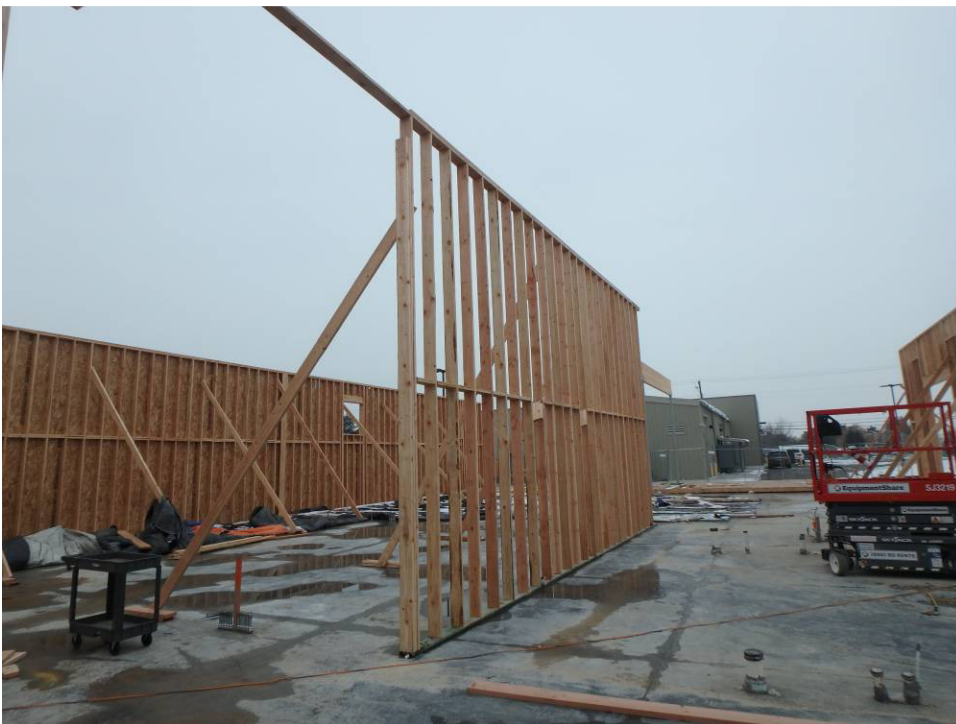
Looking north at the central wall framing

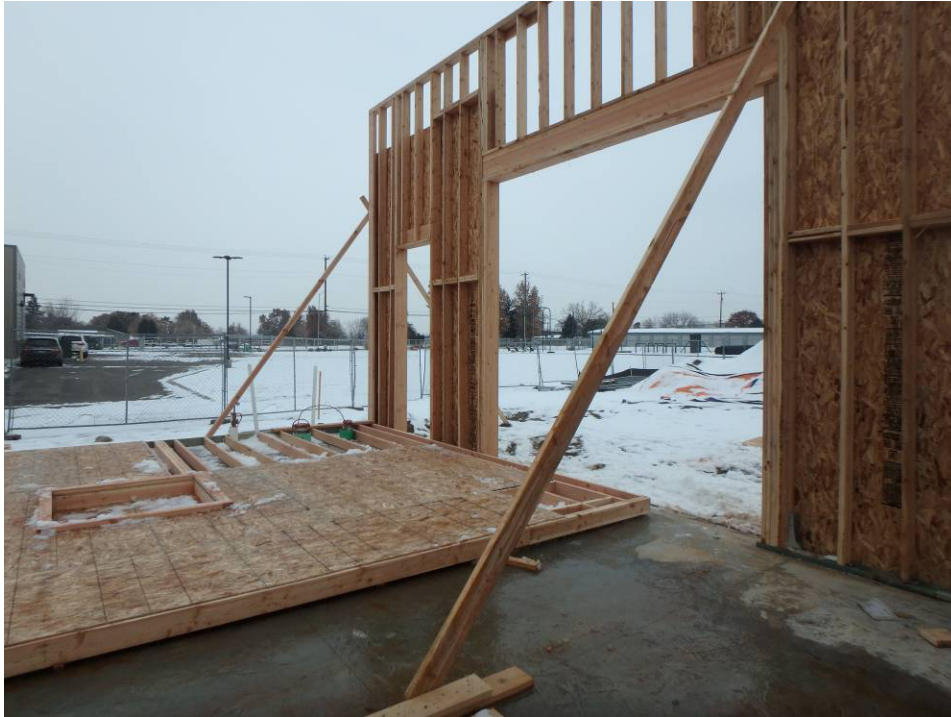
Looking at the northeast corner and the north wall framed and ready to set in place

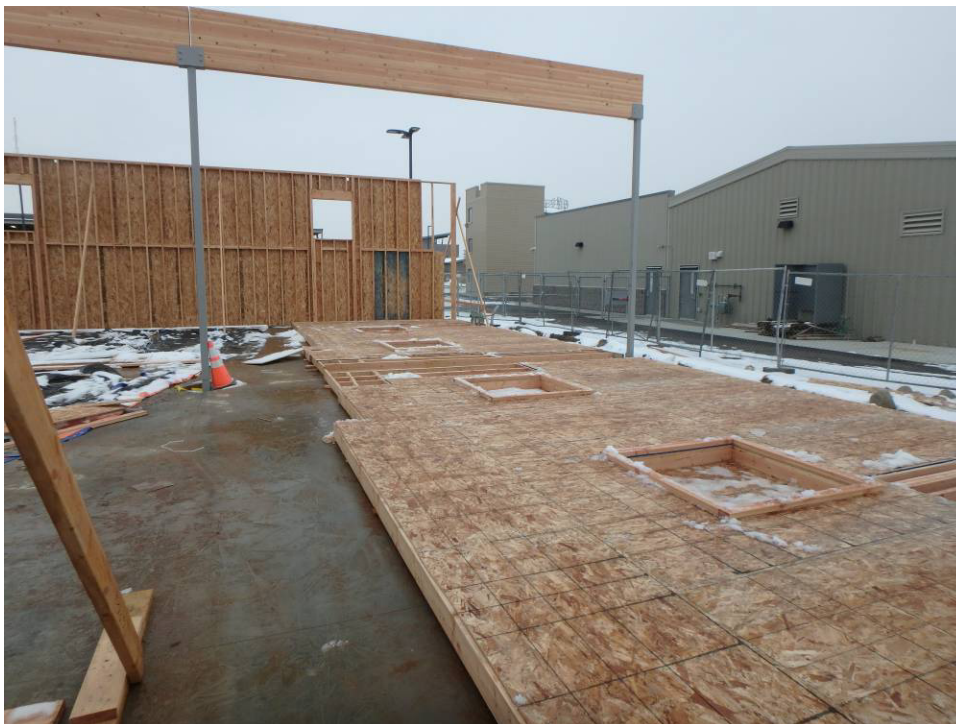
Looking at the northwest corner and glue lam beam

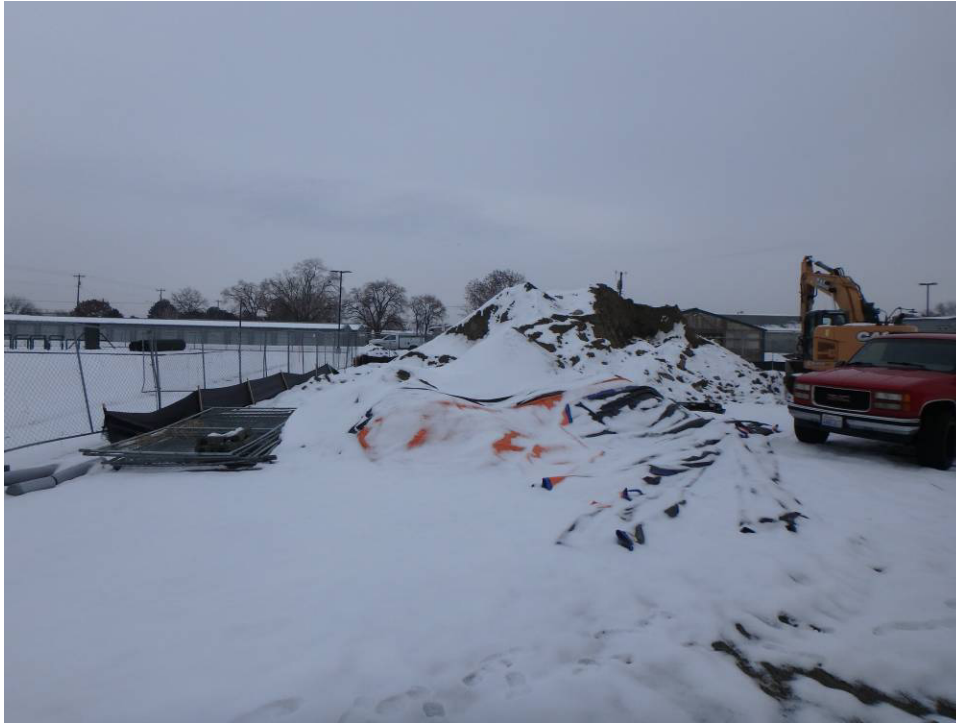
Soil stockpile

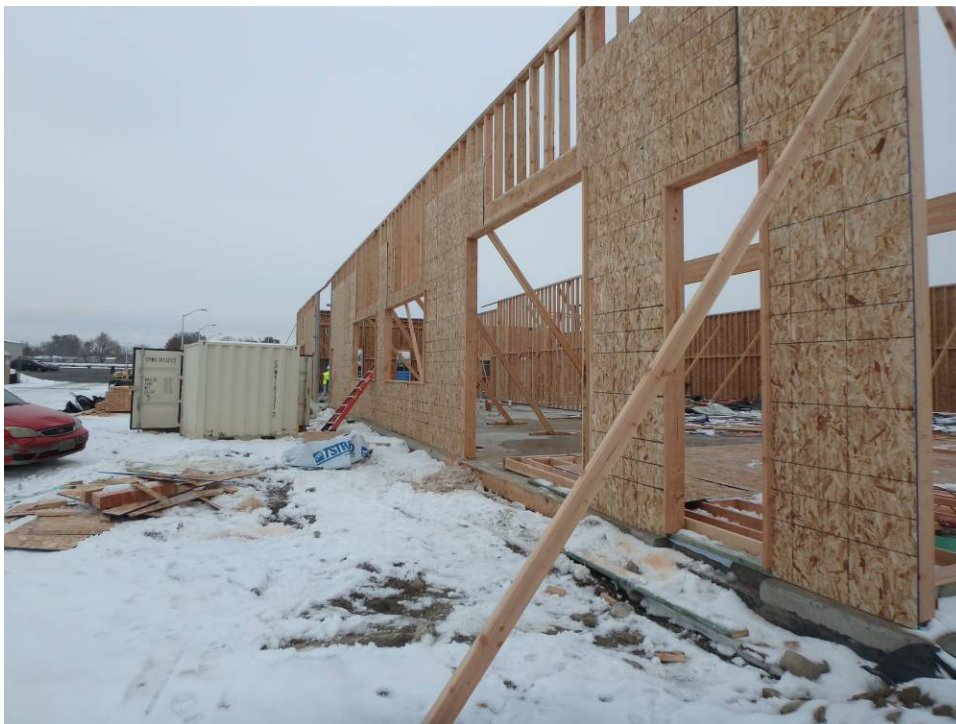
Looking southwest at the east wall

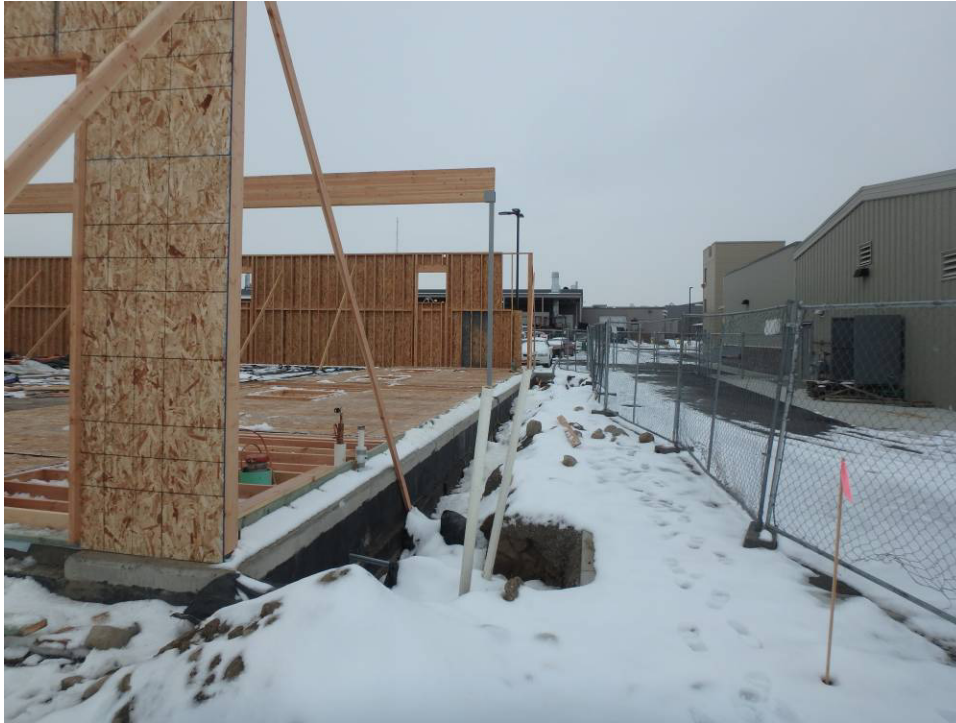
Looking west at the north side

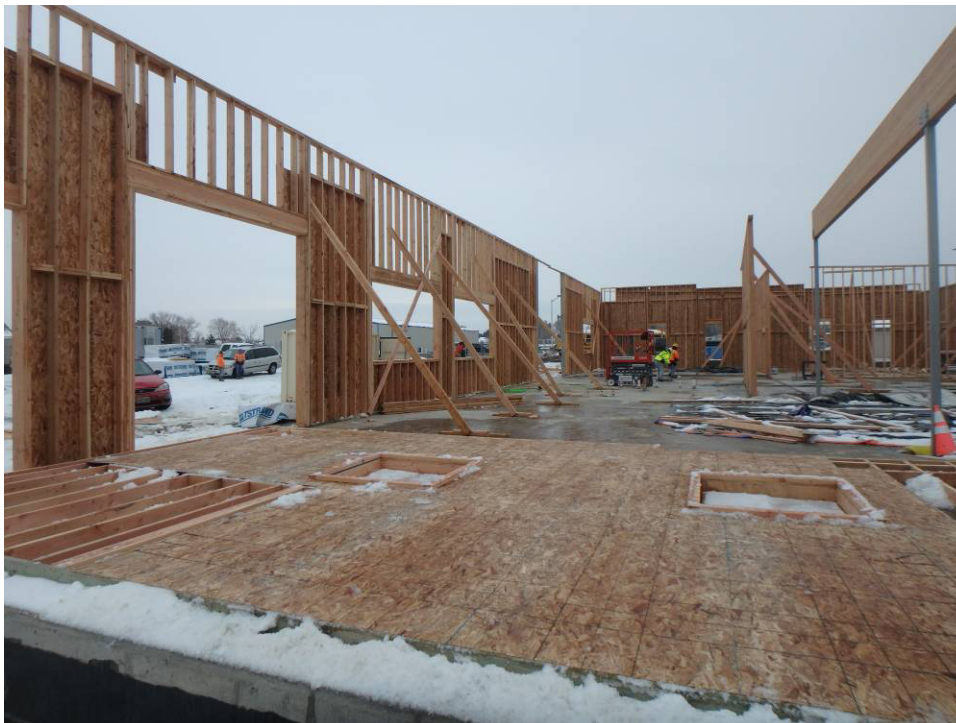
Looking south down the center of the building east side

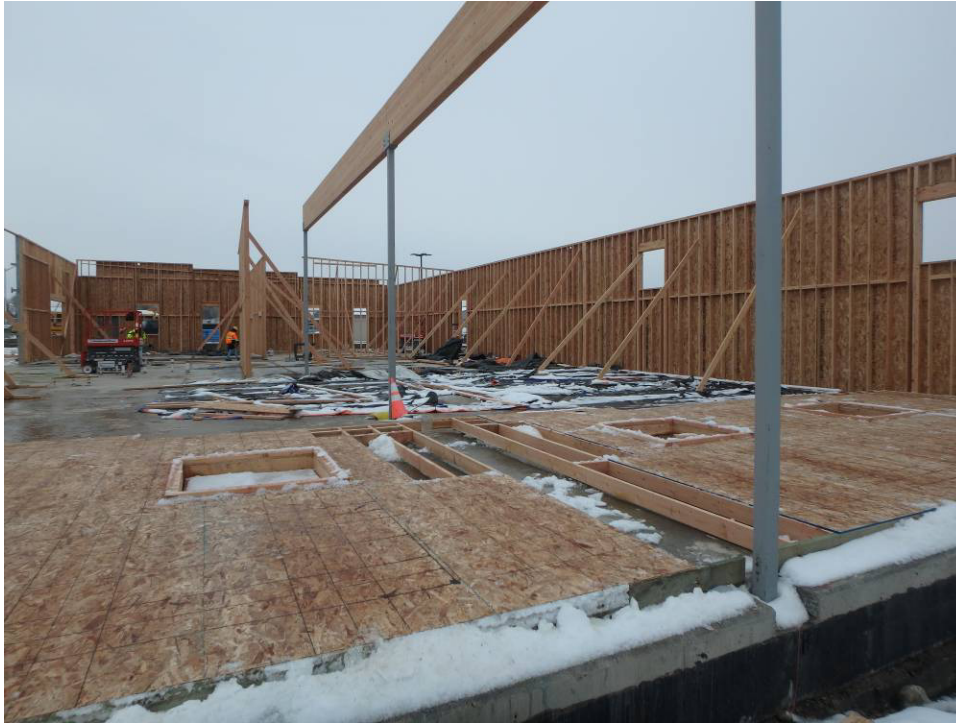
Looking south down the center of the building west side

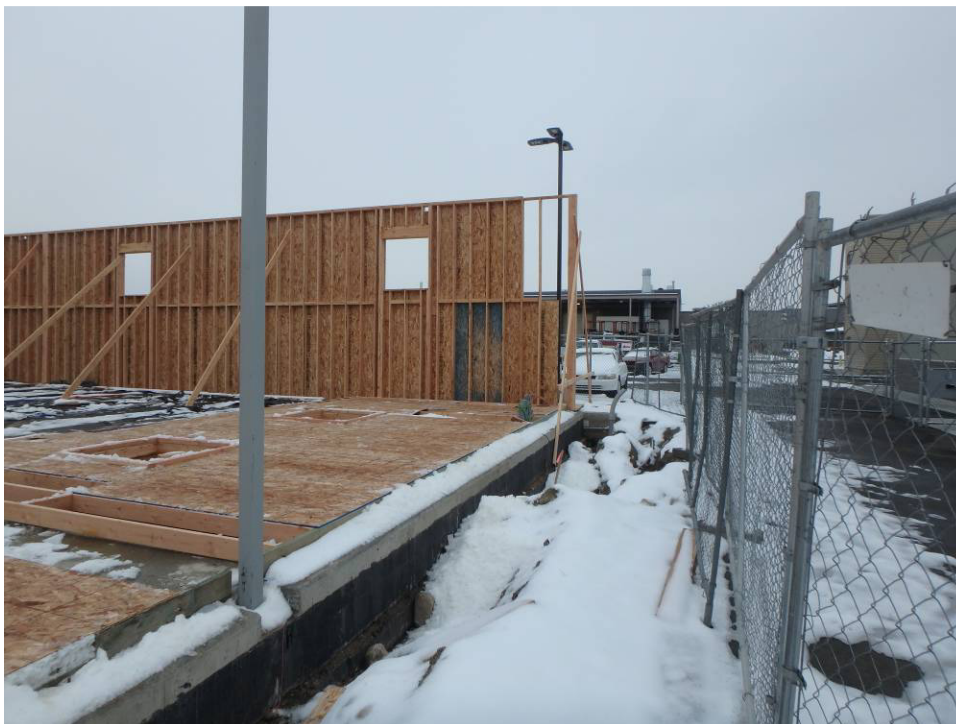
Looking west at the northwest corner

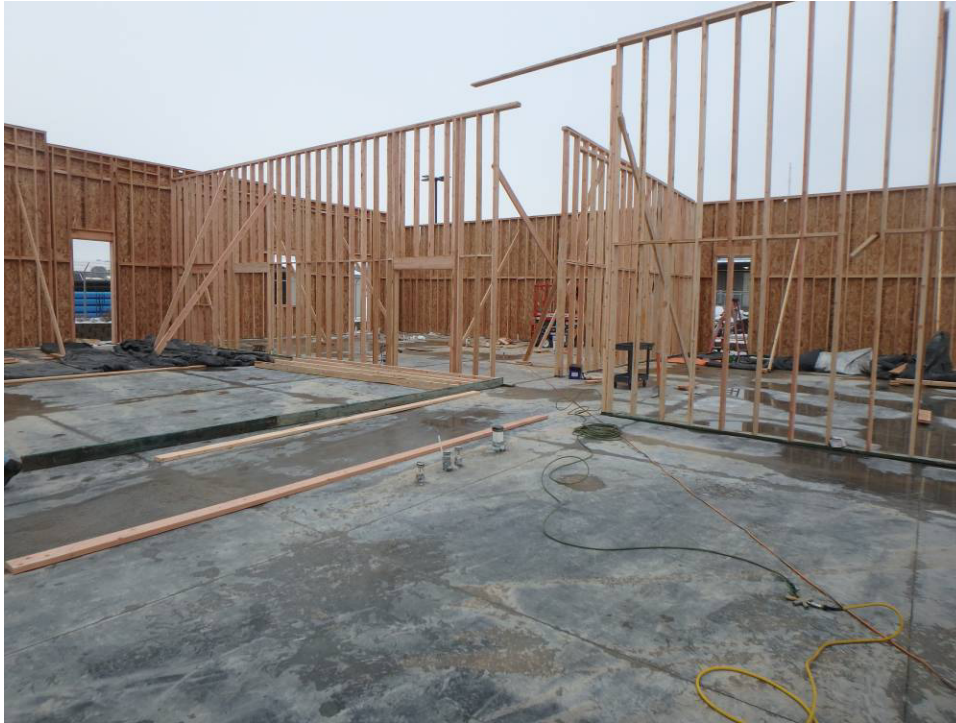
Looking Southwest at the interior wall framing

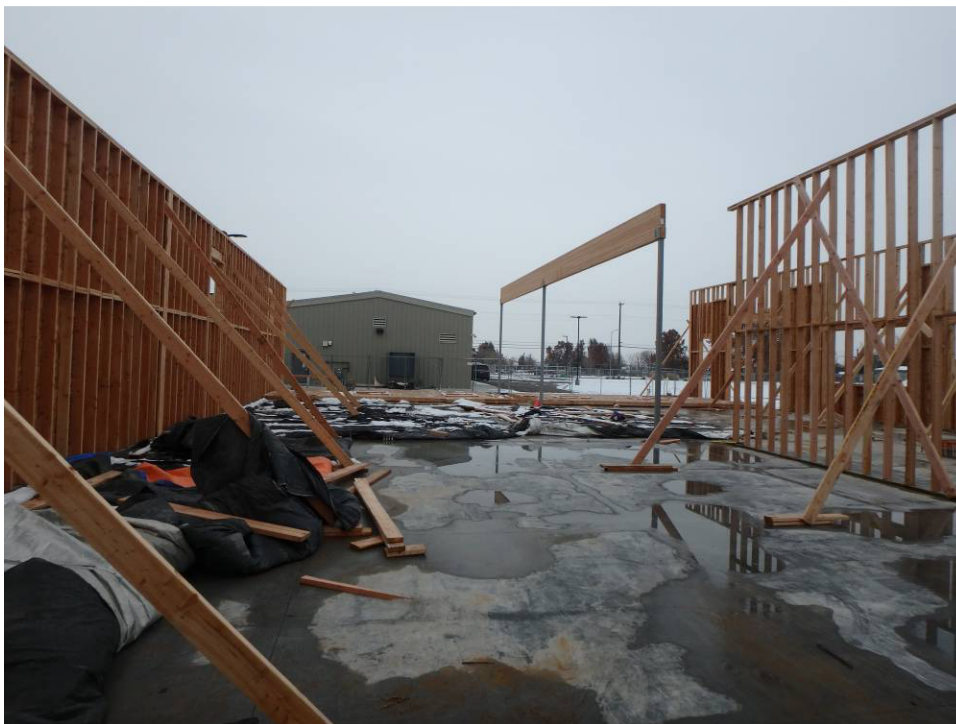
Looking north at the glue lam beam

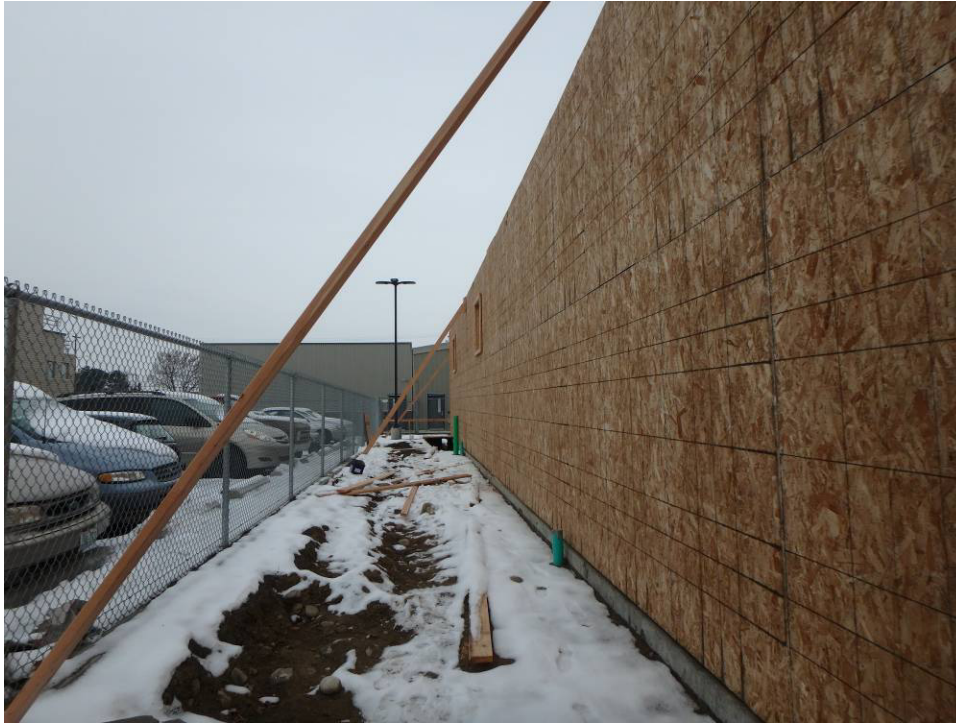
Looking north at the west elevation

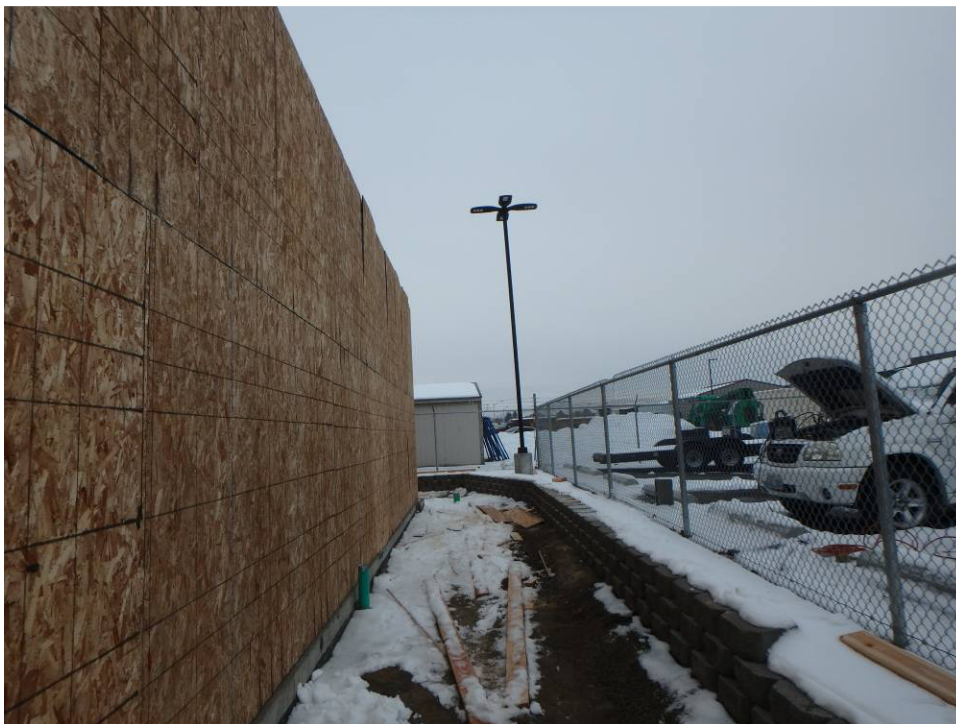
Looking south at the west elevation

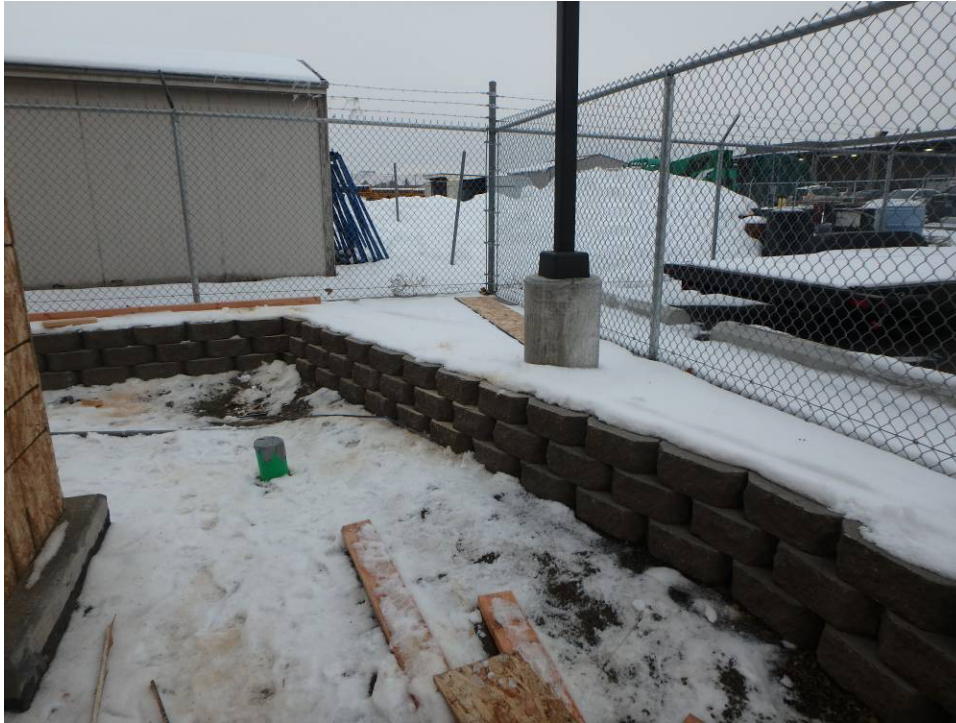
Southwest corner of the site

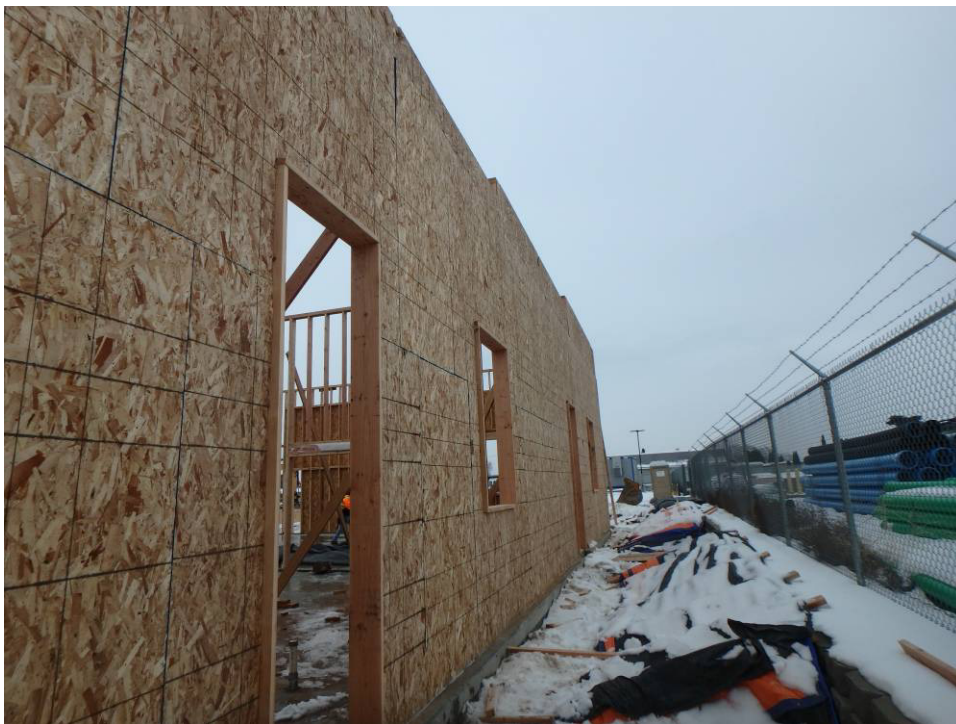
Looking east at the south wall

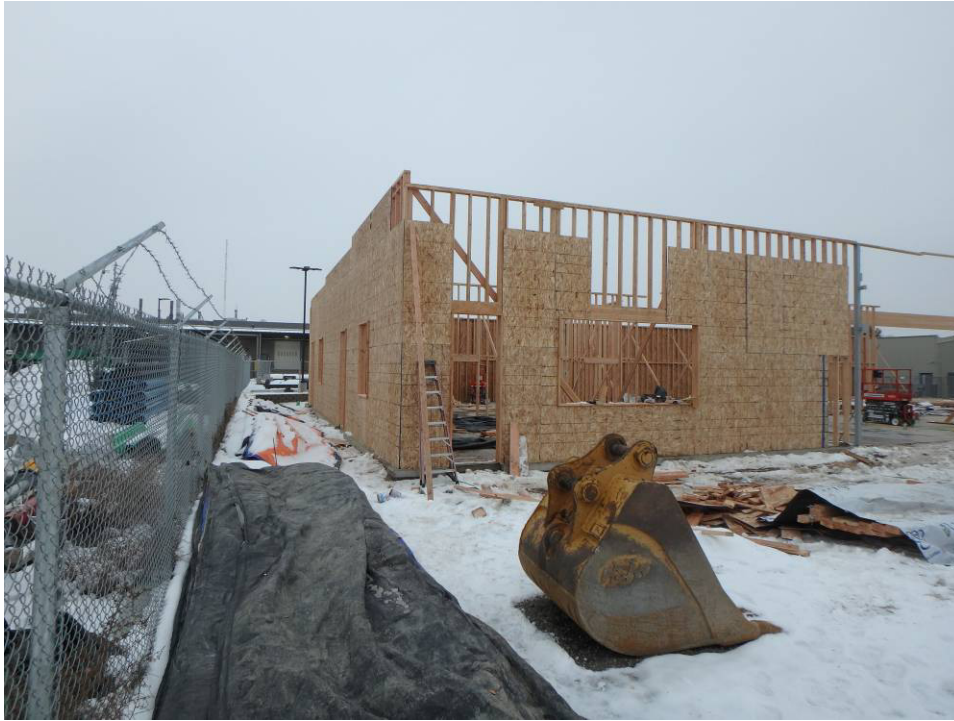
Looking at the southeast corner of the building
