Re: Oak Park and River Forest High School
2021 Visual Observation
East & West Pool
Oak Park, IL 60302
LEI Project No: 21210579.000

VISUAL OBSERVATION OF THE
OAK PARK AND RIVER FOREST HIGH SCHOOL
EAST AND WEST POOL
OAK PARK, IL 60302

LEI PROJECT NO. 21210579:000

JULY 19, 2021

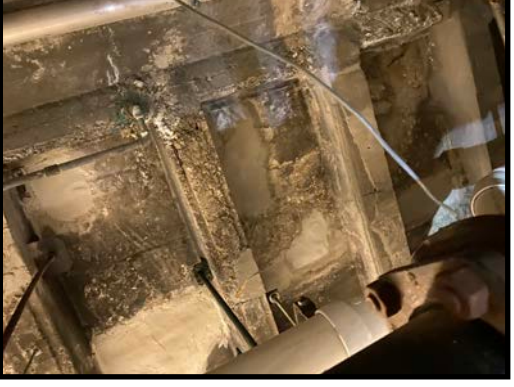
03

The pool deck framing consists of concrete beams and pan joists on the south, east and north sides. The deck on the west side of the pool is a one-way slab. On three sides of the pool, south, north and west, the floor deck concrete framing had undergone significant repair work after the time of our observation in 2013. The previous repair work appears to be in good condition, but as stated in our last report, there are still a few areas of spalled concrete and exposed rebar [Photos 1&2]. At a few locations, such as the northwest corner of the pool, exposed and corroded reinforcement is visible in areas previously patched, indicating that some of the patch material has spalled. This was noted in our previous report and the condition appears nearly the same. [Photo 3].

With the repairs that were implemented after our observation in 2013, we feel the pool decks are in fair condition. The areas of exposed reinforcement and spalled concrete are relatively limited and as such do not indicate a need for immediate repair. However, the corrosion and deterioration will likely worsen. Ongoing repairs will be necessary because it will not be possible to remove all steel that has begun to corrode, and new cracks are likely to develop. Steel that has begun to corrode will continue to corrode from water and chlorine wicking through the concrete.

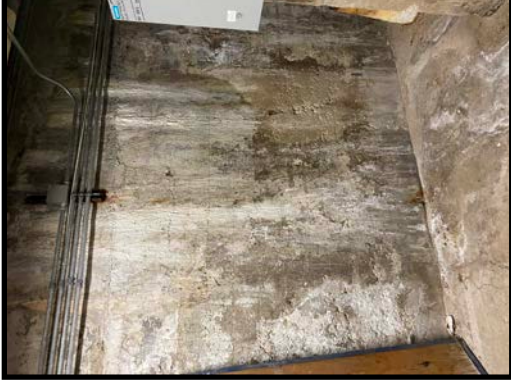
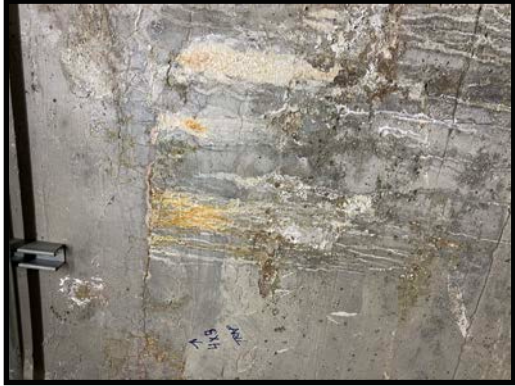
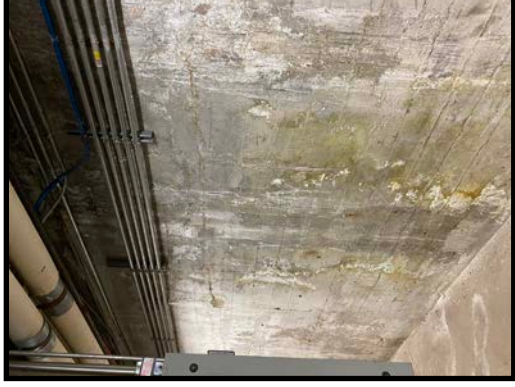
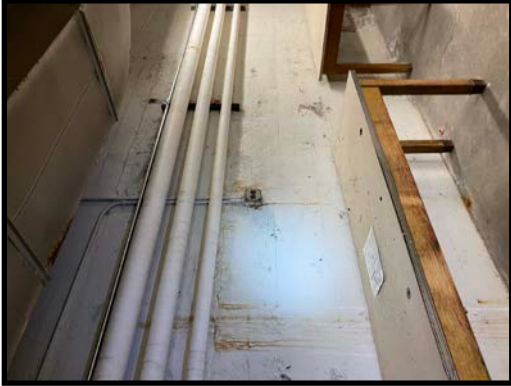
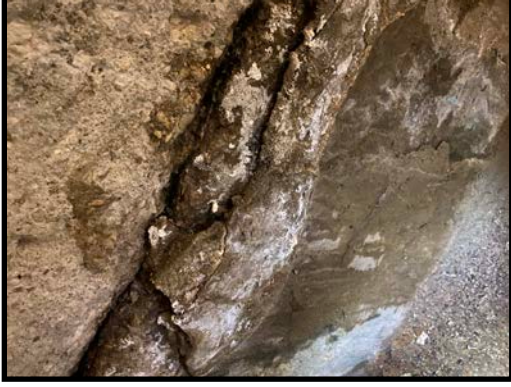
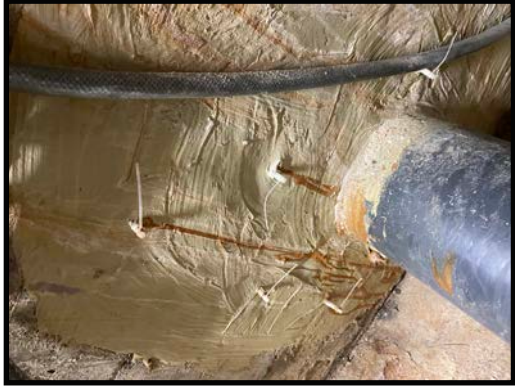
The walls of the east pool were primarily dry with a few areas of water seepage, although there were numerous stains indicating previous water leakage [Photos 4,5,6,7,8, & 9] Many of these stains were present at the time of our last observation, but it is likely that some have developed in the last seven years. As noted in our last report, some cracks in the walls of the pool have been filled with an injected epoxy. Also noted in our last report, some cracks have not been repaired and the concrete is delaminating and deteriorating. [Photos 10-15] Some seepage stains appear that they may be at concrete joints between separate concrete pours when the pool was first constructed. [Photos 16-19].

Repairs and reinforcement of the concrete walls are necessary to provide strength to the walls to replace the strength loss of the reinforcement compromised by corrosion and the concrete deterioration. We have previously recommended reinforcing the pool walls with a system of carbon fiber reinforcement polymer. Carbon fiber reinforcement polymer (CFRP) can be utilized by bonding sheets of carbon fibers to the non-water side of the pool walls (the tension faces). The process requires sand-blasting the pool walls to remove all loose particles and deleterious materials, and bonding carbon fibers to the cleaned surfaces of the walls. This will strengthen the walls some, but ongoing seepage will make implementing this difficult and likely cause it to become de-bonded as concrete delaminates or salts leach through. In light of the current condition of the pool walls, CFRP may not be effective unless the interior of the pool is treated to prevent water entering the concrete. This would require removal of the tile lining, installation of some type of waterproof membrane and then reinstalling tile. This process should be done in combination with epoxy injecting to seal cracks in the walls wherever possible. All sides of both pools should be reinforced, although repair to the walls of the west pool should be a priority. It is our understanding that a contractor specializing in CFRP systems was consulted prior to 2015. Although it was verified at that time that CFRP could be applied to the pools, the condition of the pool walls has deteriorated since that time so a consultant specializing in CFRP should again be consulted to verify the feasibility applying it to the pool walls in their current state.

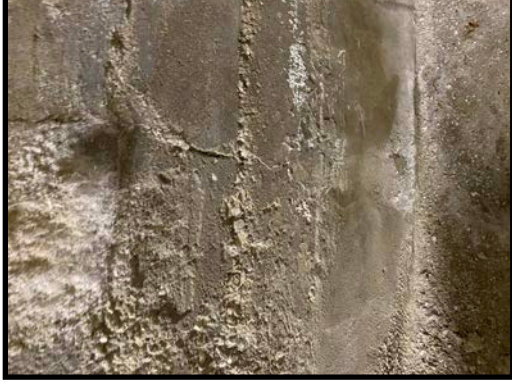
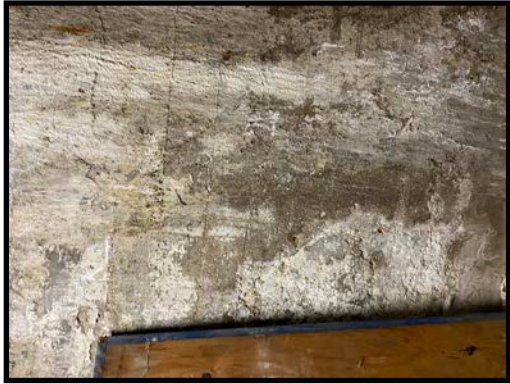
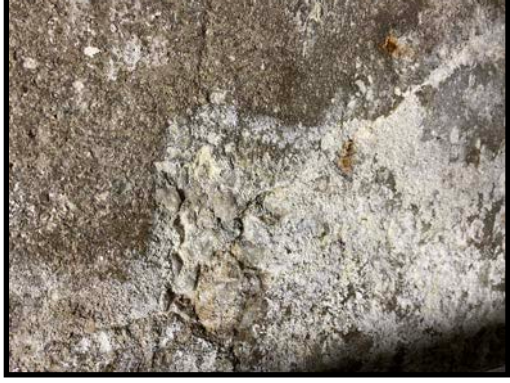
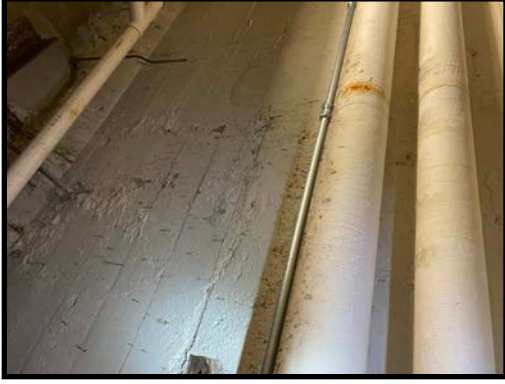
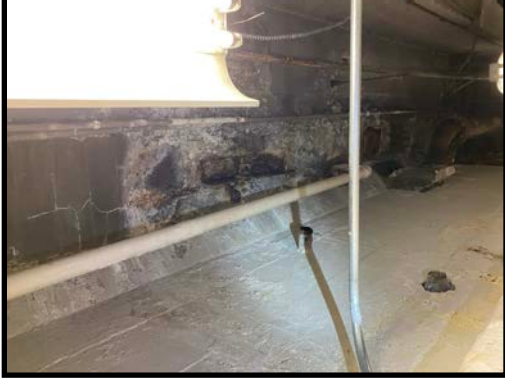
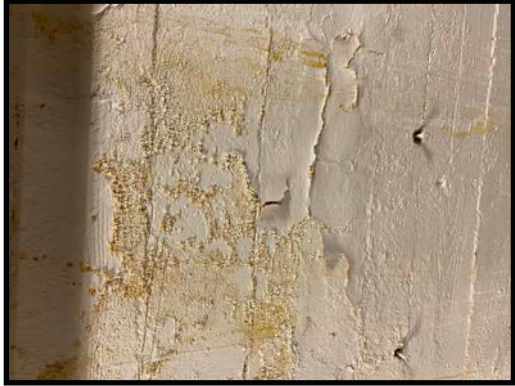
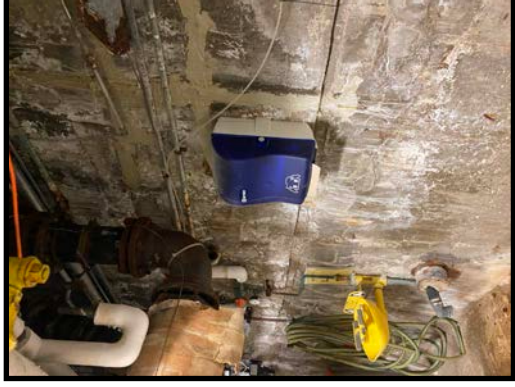
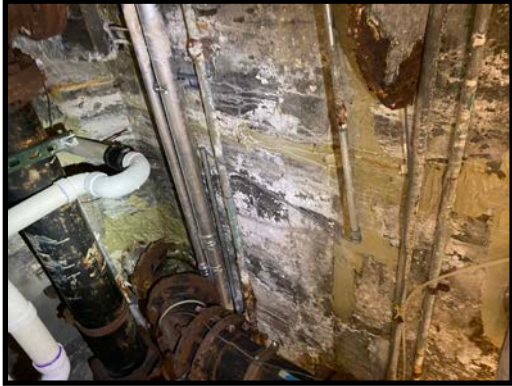
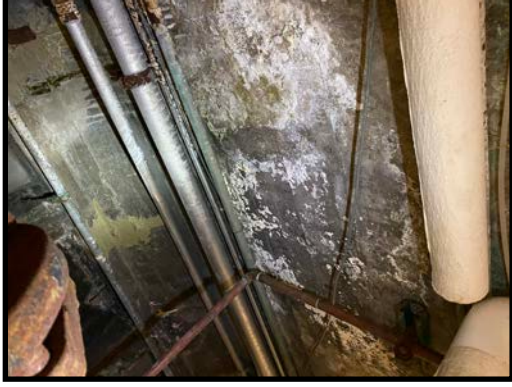
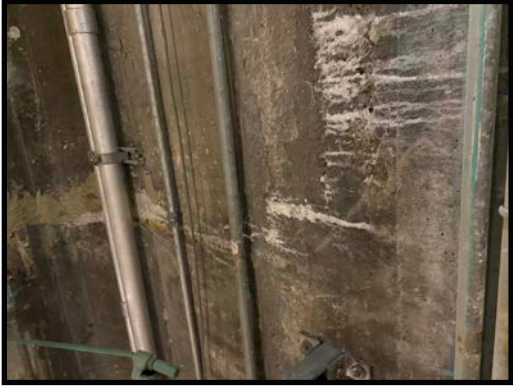
At numerous locations along the walls, the surface of the wall has notable efflorescence. Photos 20-29] Efflorescence is caused by moisture migrating through concrete bringing soluble salts to the surface.

The dark stains at leaks in the walls of the west pool indicate ongoing corrosion and deterioration of the steel reinforcement in the walls. The presence of efflorescence on the pool walls of both pools indicates continued movement of water into the walls. Leaks and cracks in the pool walls indicate that the capacity of the walls to support the fluid pressure of the water has been compromised by the steel corrosion and concrete deterioration. The corrosion of steel reinforcement within the walls that had begun some time ago has most likely continued to develop and further weaken the flexural and shear capacities of the pool walls.

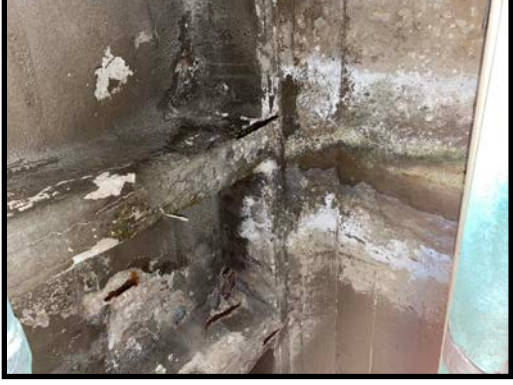
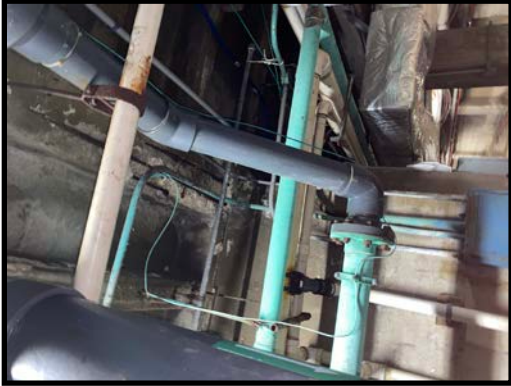
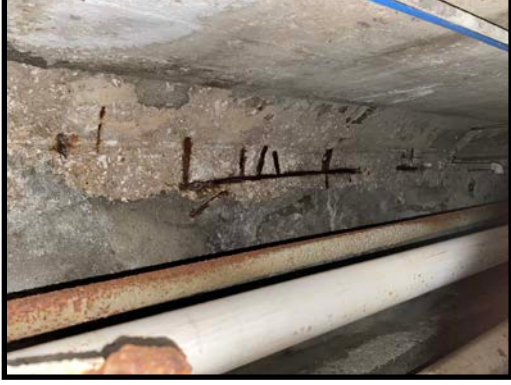
The deck around the west pool had a few locations of notably exposed and corroded reinforcement [Photos 30-32].

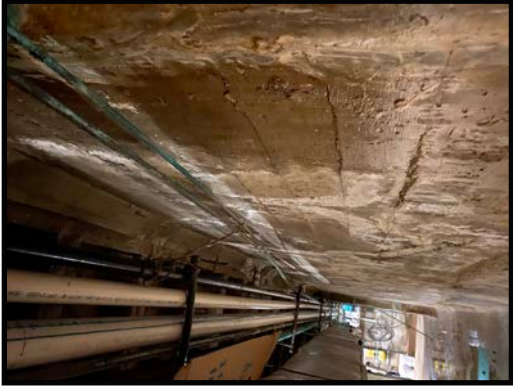
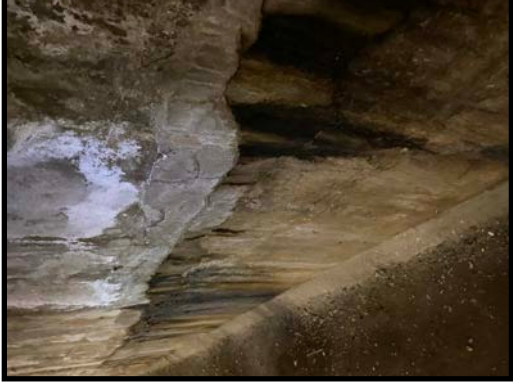
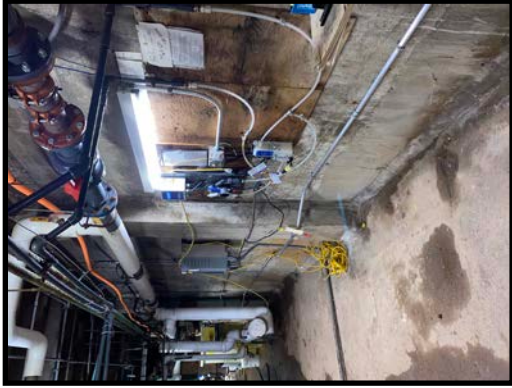
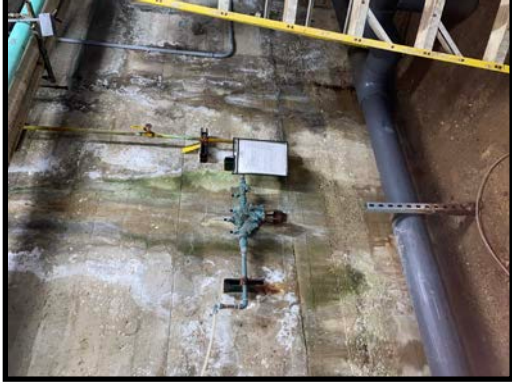
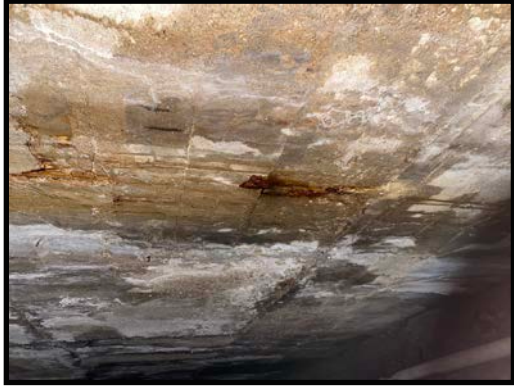
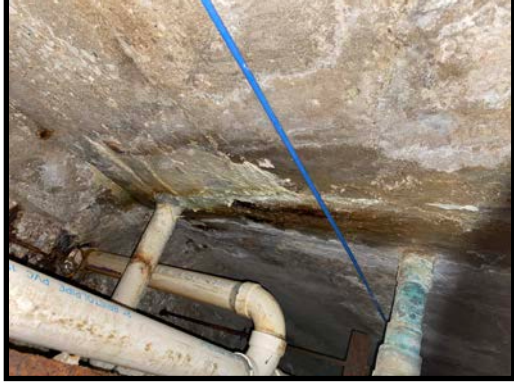
The walls of the west pool each had several areas of water seeping through cracks in the walls or at joints of pipes penetrating the wall at the time of our observation [Photos 33-38]. The east wall had the most significant seepage as well as stains from seepage, some of which were very dark rust stains. Most of the areas with dark rust stains continued to seep water during our visit [Photos 39-42] There were large areas of standing water on the floor at the time of our observation [Photos 43-44] At numerous locations along the walls, there is notable efflorescence. [Photo 45]. As previously noted, the south end of the east wall has an outward bow (with outward being away from the water side); however, it could not be determined if the degree of bow has increased since this characteristic was first observed in 2013.

Until repairs are made and the pool walls reinforced, temporary bracing of the walls should be installed. We recommend that the temporary bracing be installed within the next 3 months. Like the permanent bracing describe above, the temporary bracing should be designed by a licensed Structural Engineer and implemented in a manner that will reduce stresses and properly transfer loads to surrounding structure that have the capacity to support the bracing loads.

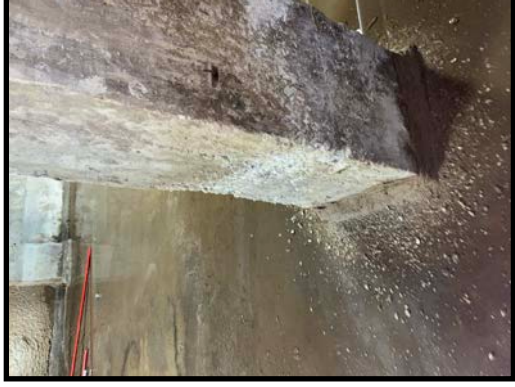
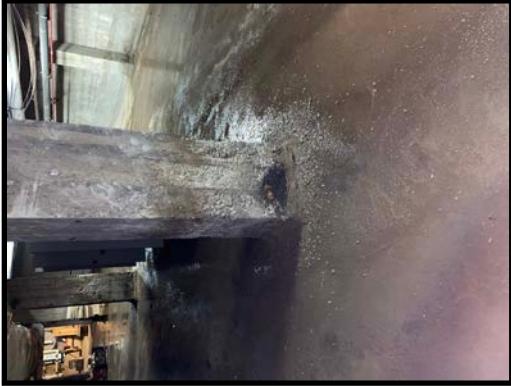
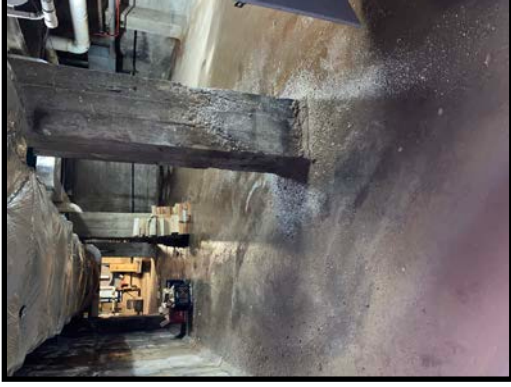
The columns directly east of the pool walls are showing signs of deterioration. The concrete near the bases has spalled at several locations and there is efflorescence on the column surfaces [Photos 46-48]. Two of the columns on the west side of the pool, which are integral with the foundation wall, have cracks with water seepage and some deterioration [Photos 49-53].
