**McCluskey Engineering Corporation**

February 22, 2022

Re: Visual Observation Letter  
Oak Park and River Forest High School  
Pool Remediation  
201 Scoville Avenue  
Oak Park, IL 60302  
MEC Project Number: S22005

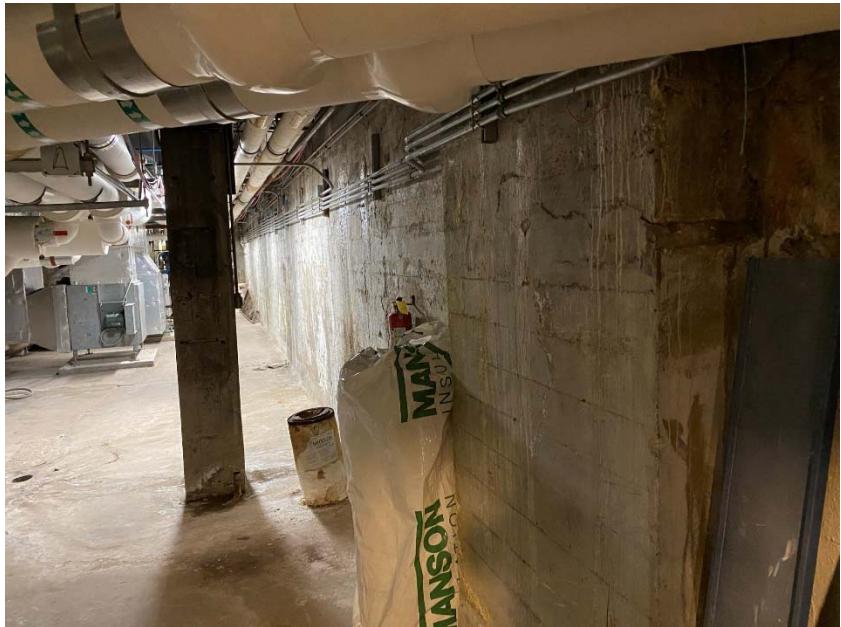
General observation of the walls found evidence of leakage on all four walls of both pools. Some leaks were active at the time of our visits, leaving portions of the walls wet and creating puddles on the floor. At other locations, stains on the walls indicated where previous leaks had dried up, likely sealed by the same minerals in the water that are now observed on the surface of the wall. Efflorescence was observed at many locations on the walls of the west pool, indicating previous water penetration of the walls. Rust stains were observed at both active and inactive leaks, particularly at the west pool, indicating corrosion of the steel reinforcement inside the wall. The leaks originated at cracks and pinholes in the walls, as well as at pipe penetrations through the walls. Some cracks had been filled by epoxy injection, notably at the east pool and many of the pipe penetrations had been sealed.

Photo 1: Active Leaks.

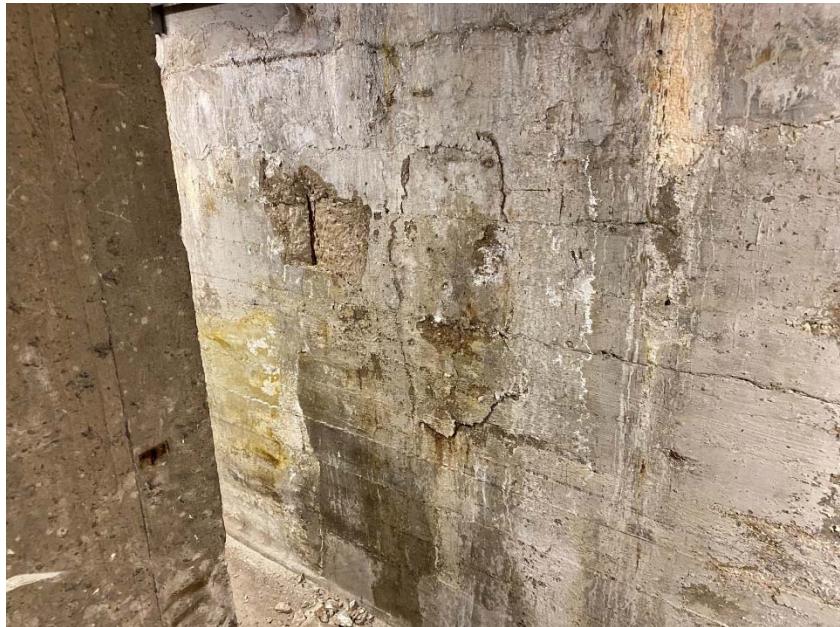
Photo 2: Patched and Delaminated Concrete.

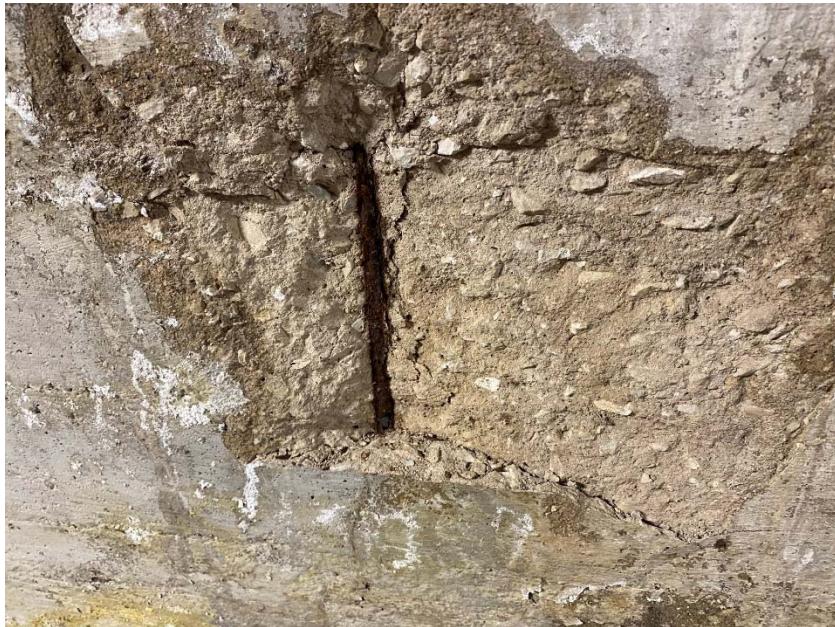
Photo 3: Corroded Rebar at Delaminated Patch.

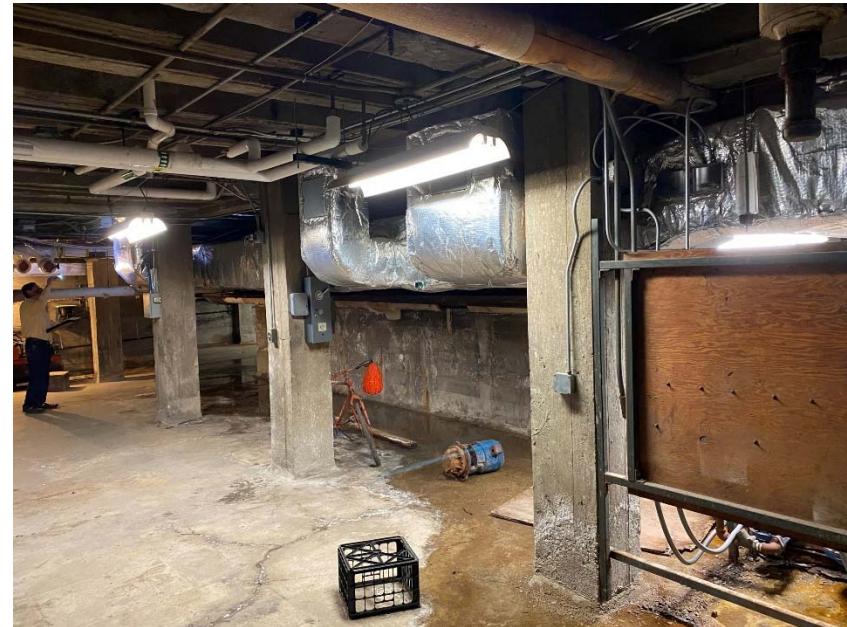
The walls of the west pool and the basement floor around it were generally wetter than those of the east pool. The north wall had several leaks, some of them below the pool floor, and significant portions of the floor in this area were wet (Photo 4). Large amounts of efflorescence were observed on the upper portions of the east wall and the floor was wet all along the wall (Photo 5). Many active leaks with dark rust staining were noted at the construction joint, particularly at the south end of the pool (Photo 6). Portions of this joint had been previously patched, done in such a manner as to create a noticeable bulge in the surface of the wall. When a delaminated portion of this patch was removed, the rate at which the water leaked at that location increased noticeably. The south wall had previous patching, similar to the east wall, and some active leaks (Photo 7).

Photo 4: Puddles Around the West Pool.

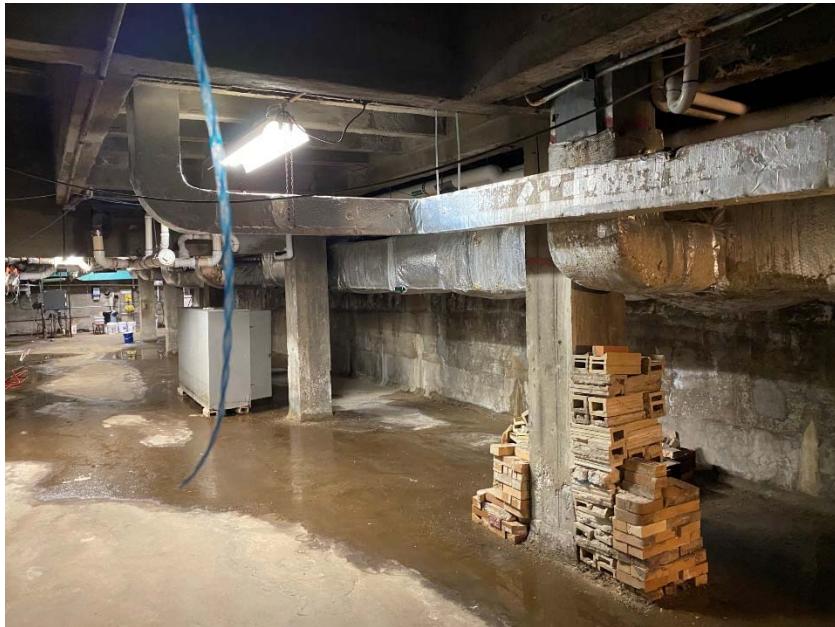
Photo 5: Efflorescence on the Walls and Puddles on the Floor.

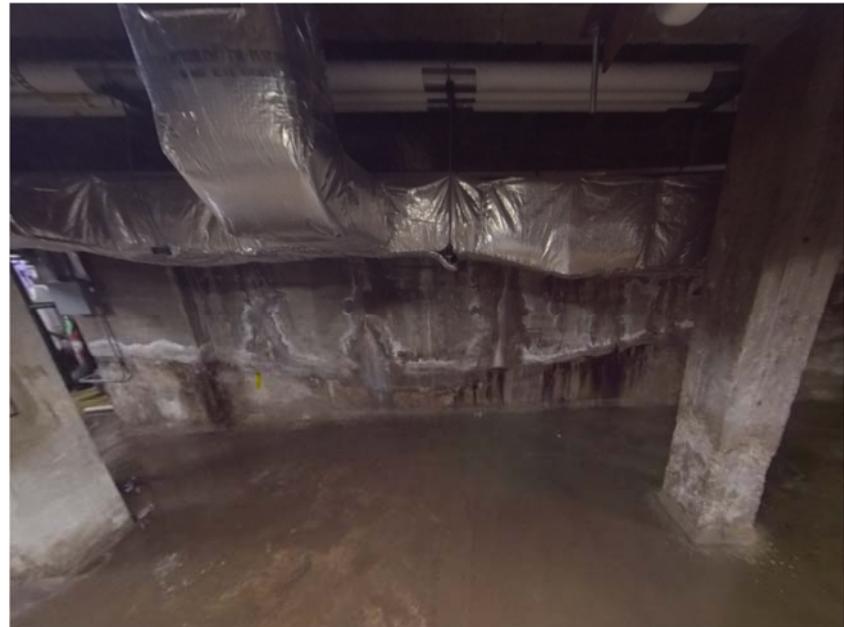
Photo 6: Efflorescence Above the Control Joint and Dark Rust Stains Below.

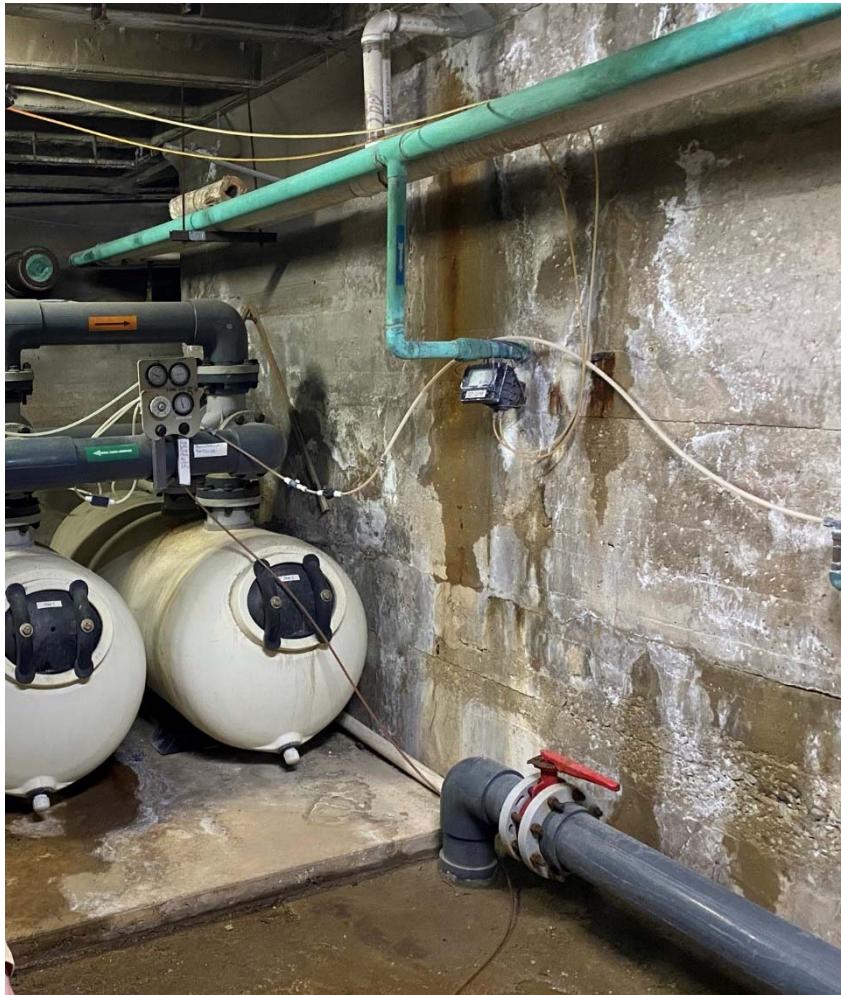
Photo 7: Active Leaks.

The east wall of the east pool as well as the east, south, and west walls of the west pool are assigned a 4 rating. The walls' surfaces should be sounded and all delamination or spalled concrete removed. All areas with lost concrete should be repaired in the following manner. Loose concrete should be removed and the exposed surfaces prepared according to the patching compound's manufacturer directions, including cleaning and chipping. The existing steel should be cleaned of all corrosion and analyzed for section loss due to corrosion. While we do not anticipate areas of significant steel loss due to corrosion, it does remain a possibility, now and in the future. Where corrosion has reduced the steel area by more than ten percent, supplemental reinforcement should be added as required on a case-by-case basis. The concrete should then be patched, restoring the walls to their original thickness and providing adequate cover over all reinforcement. Note that the reinforcement in the walls is likely to continue to corrode in both patched and unpatched areas so the walls' surfaces should be inspected periodically after the repairs are made.

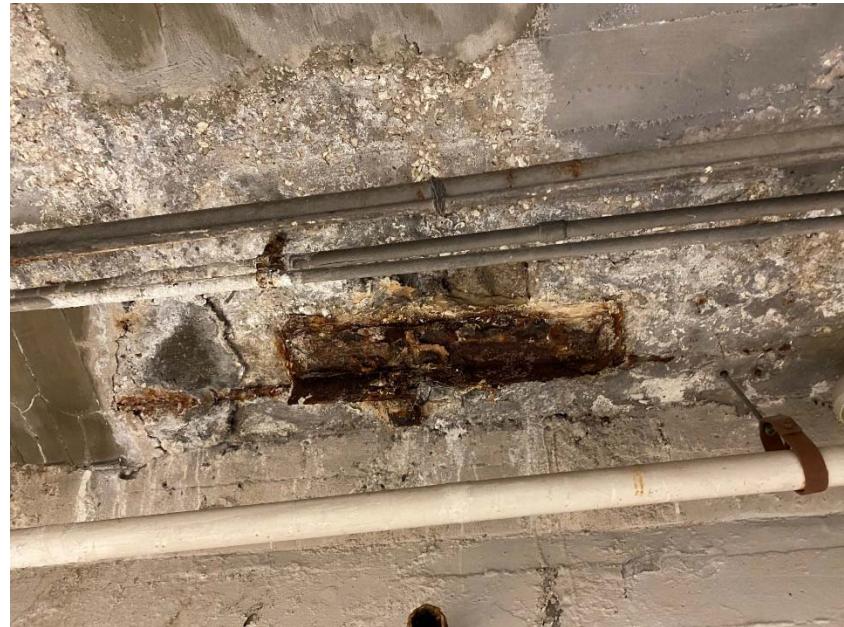
Around the east pool, the deck on the north side exhibited delamination of the concrete and corrosion of the reinforcement below five of the six starting blocks located on top of the deck at that end of the pool (Photo 8). The concrete below one of the blocks had been repaired (Photo 9). On the east side of the pool, several of the concrete joists showed signs of rebar corrosion. Many of the concrete joists on the south side of the pool had been repaired and appeared to be in good condition. Several were still in need of repair with the reinforcing in two joists being devoid of concrete cover for one to two feet of length (Photo 10). Portions of the deck above the west side of the pool had been repaired and appeared to be in good condition. There were several locations with exposed and corroded reinforcement that remained in need of repair.

Photo 8: Corrosion and Delamination Below a Starter Block.

The decks on the north and south sides of the east pool, as well as the east and south sides of the west pool are assigned a 3 rating. All areas with exposed reinforcing should be repaired in the following manner. Loose concrete should be removed and the exposed surfaces prepared according to the patching compound's manufacturer directions, including cleaning and chipping. The existing steel should be cleaned of all corrosion and analyzed for section loss due to corrosion. Where corrosion has reduced the steel area by more than twenty percent, supplemental reinforcement should be added as required. The concrete should then be patched, restoring the members to their original size and shape and providing adequate cover over all reinforcement. Note that the reinforcement in the decks is likely to continue to corrode in both repaired and unrepainted areas so the decks should be inspected periodically after the repairs are made.

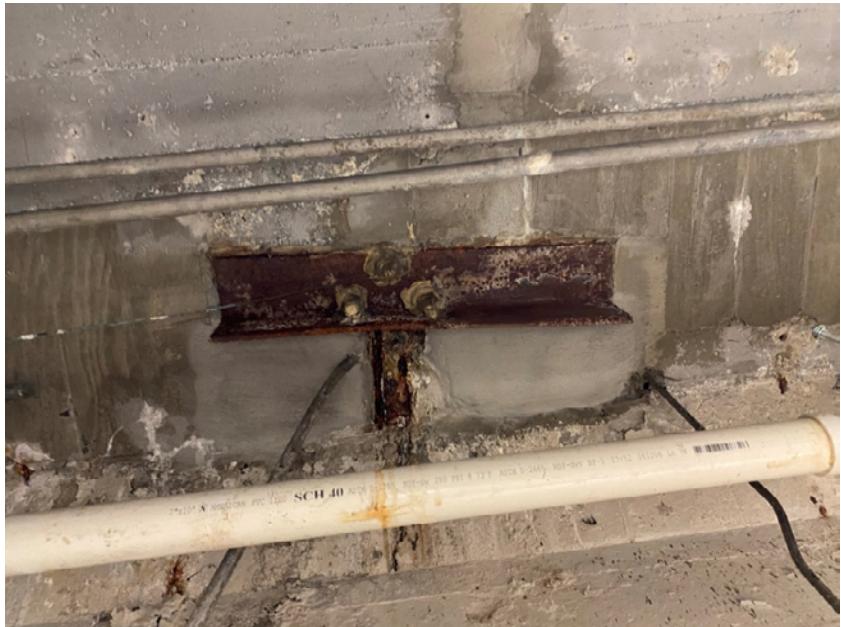
Photo 9: Repaired Concrete Below a Starter Block.

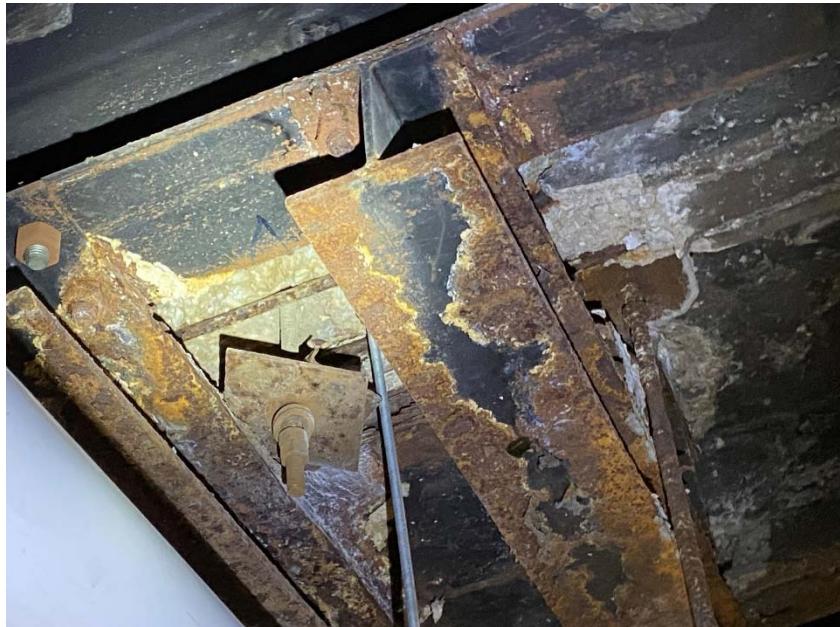
Photo 10: Exposed Reinforcing.

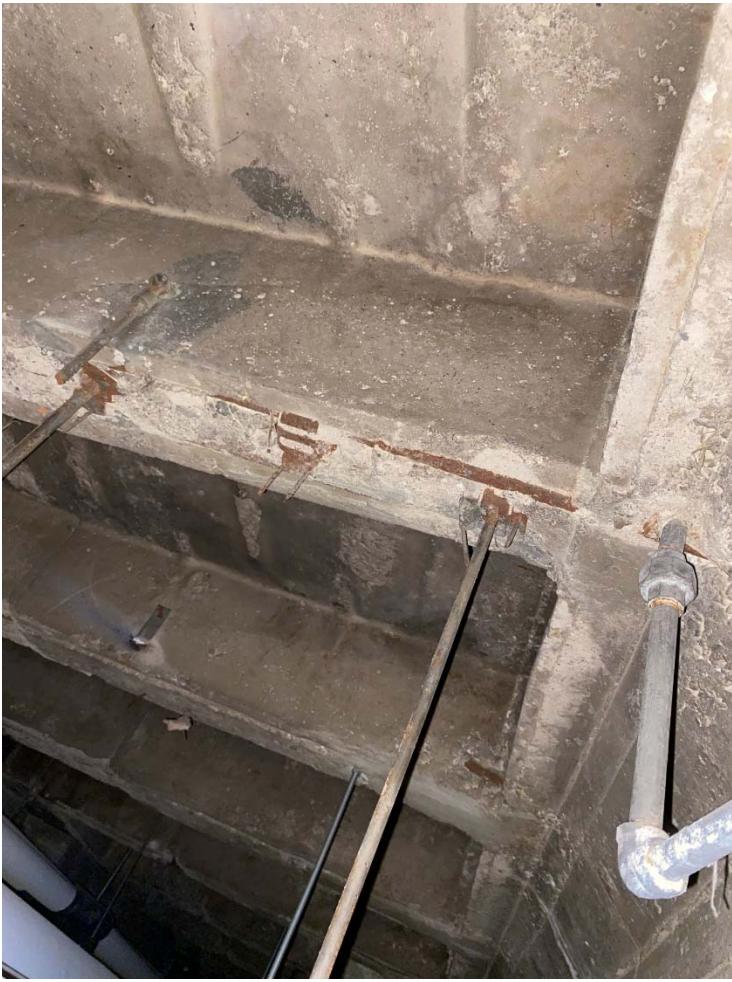
Around the west pool, the concrete joists on the north side had been repaired and appeared to be in good condition. Several of the concrete joists on the east side of the pool have concrete delamination and exposed, corroded reinforcement (Photo 11) and the concrete has spalled at least two of the deck drains that penetrate the concrete structure (Photos 12 and 13). On the south side, there are many instances of joist reinforcement that is exposed and corroded. In one instance the rebar is separated from the concrete for at least two feet (Photo 14). There are also several locations where the reinforcement of the thin slab between the joists is exposed and corroded (Photo 15). The bottom surface of the 4" thick concrete slab on the west side of the pool is delaminated for a significant portion of its area (Photo 16). The exposed rebar is corroded, at times resulting in the complete loss of the bar. A disconnected deck drain appears to be responsible for some of the damage on this side of the pool.

Photo 11: Exposed Reinforcement.

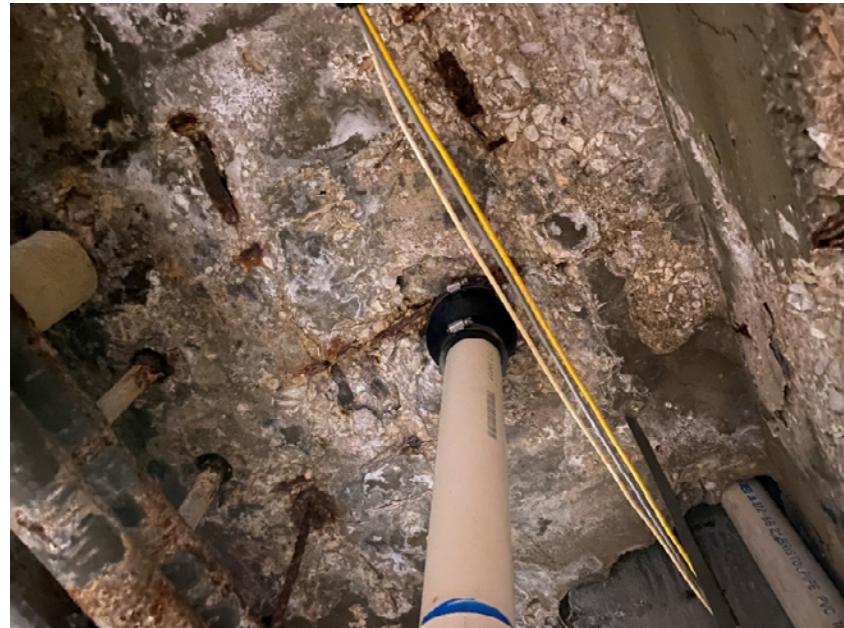
Photo 12: Spalled Concrete at Deck Drain Penetration.

For the decks, all disconnected deck drains should be fixed and all penetrations through the deck that are currently leaking should be sealed.

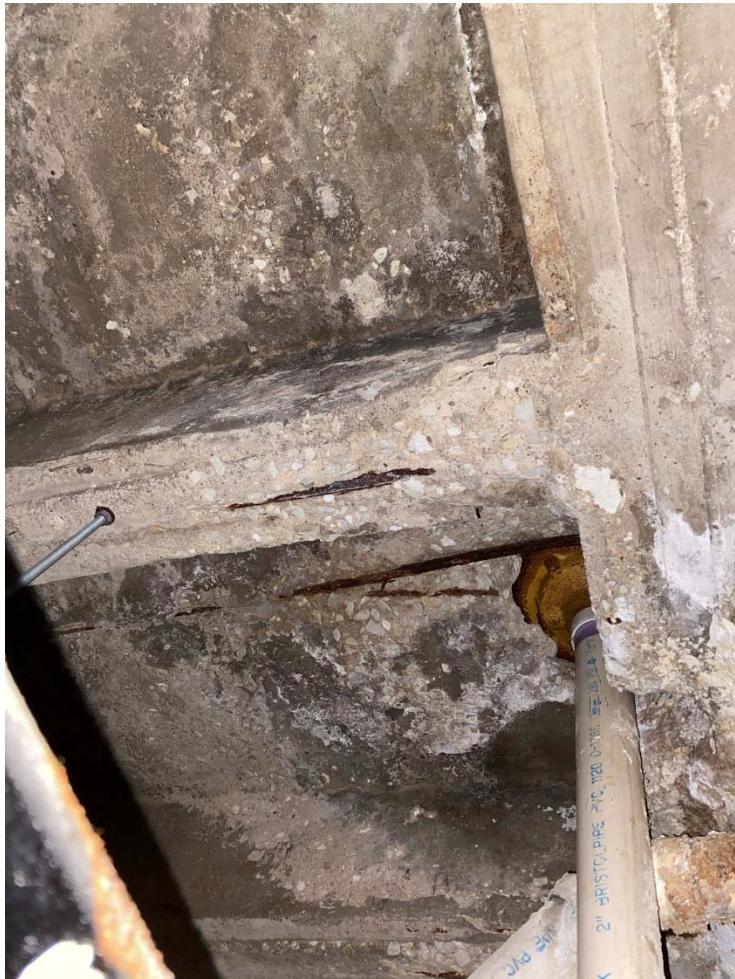
Photo 13: Spalled Concrete at Deck Drain Penetration.

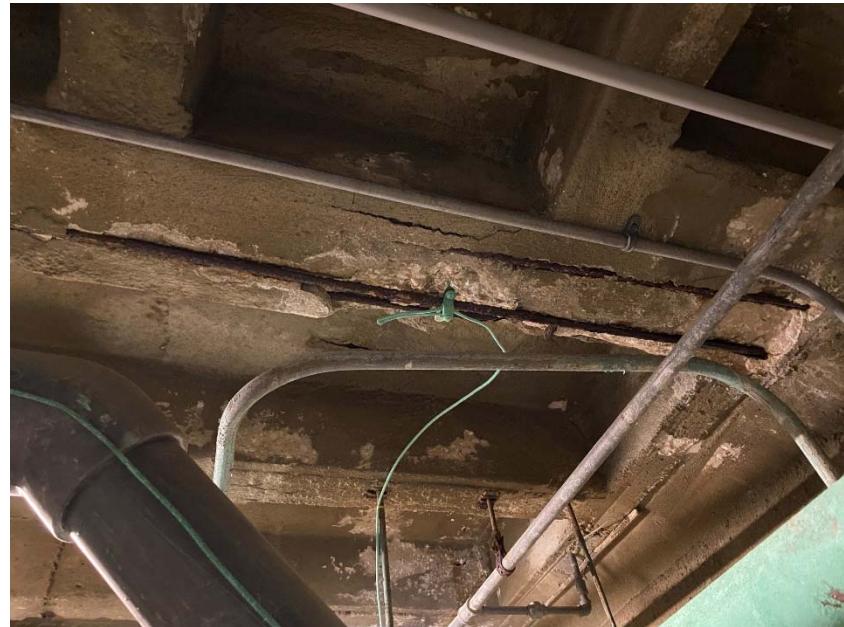
Photo 14: Exposed Reinforcement.

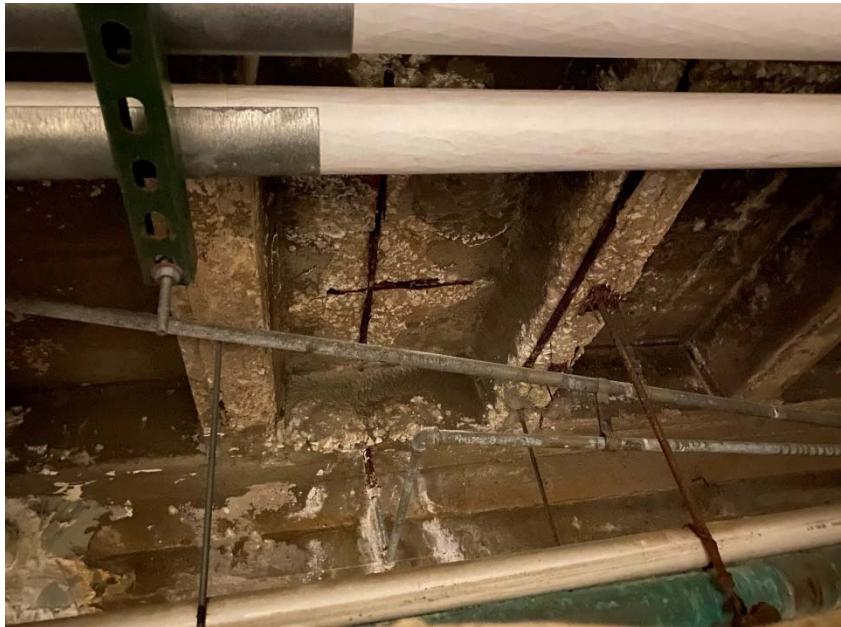
Photo 15: Corroded Reinforcement in the Thin Slab Between Concrete Joists.

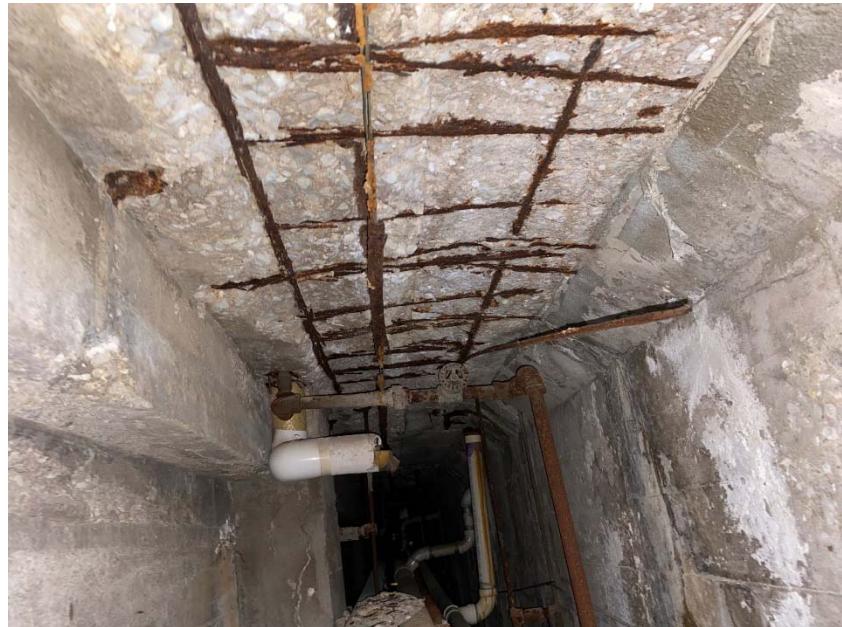
Photo 16: Extensive Delamination and Corrosion.

The deck on the west side of the west pool is assigned a 5 rating. These repairs should be made as soon as possible. They should be made in the same manner as described for the east wall of the east pool and the other walls that were assigned a 4 rating. If the pools are to be replaced in the near future, consideration may be given to shoring this deck in lieu of repairing it.
