Project Observation Report

Project Name: Tri Tech East Building

Project No. 2208

Report #: 11

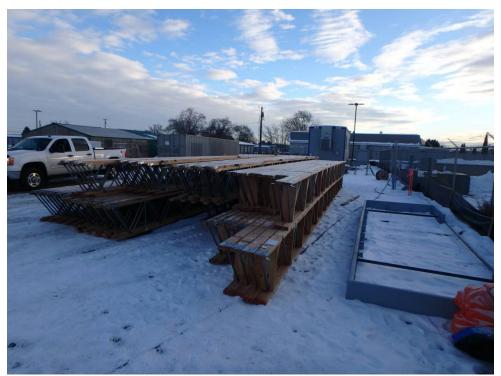
New roof trusses

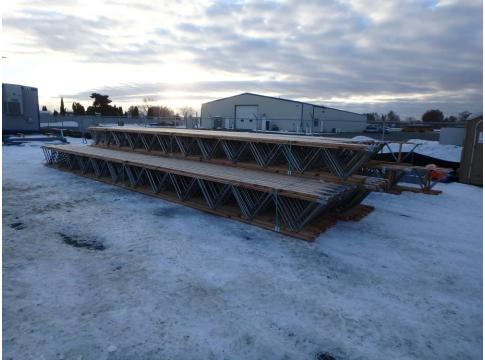
New roof trusses

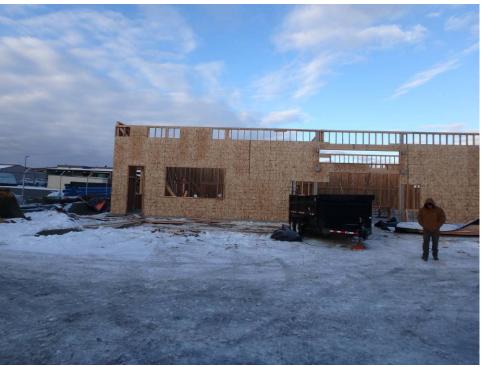
Looking at the south end of the east wall framing

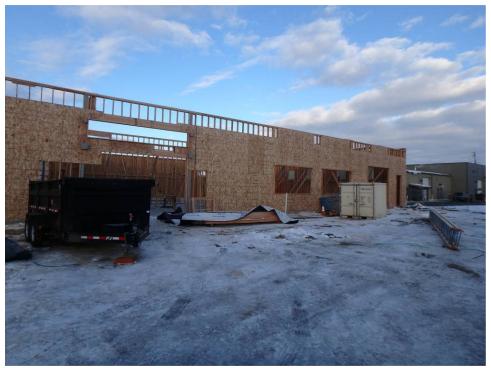
Looking at the north end of the east wall framing

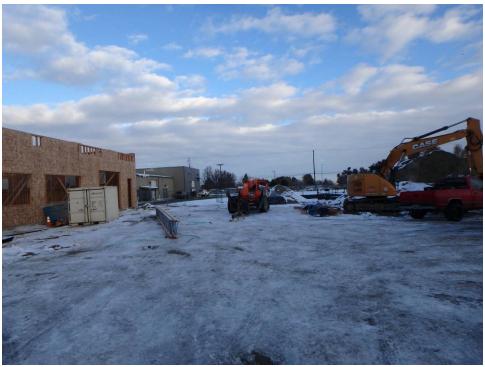
Looking north at the north central side of the site

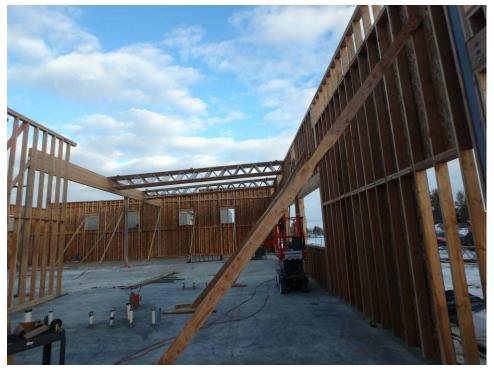
Looking at the East wall north framing, sheathing and set trusses

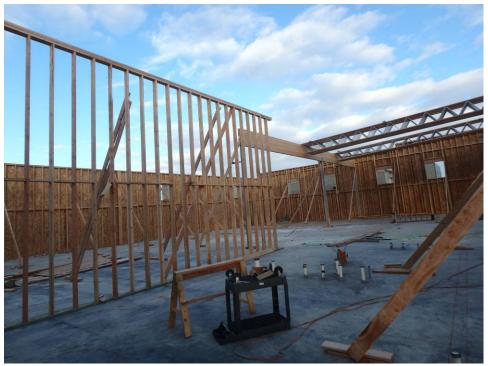
Looking northwest at the central wall and set trusses

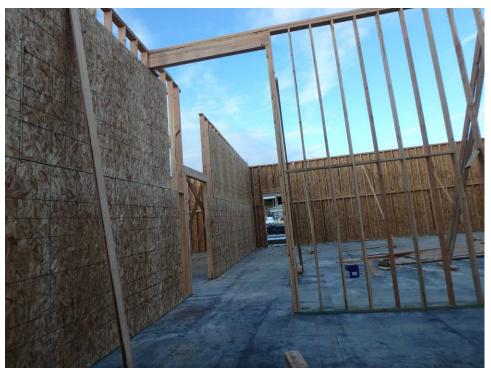
Looking west at the central east-west wall sheathing

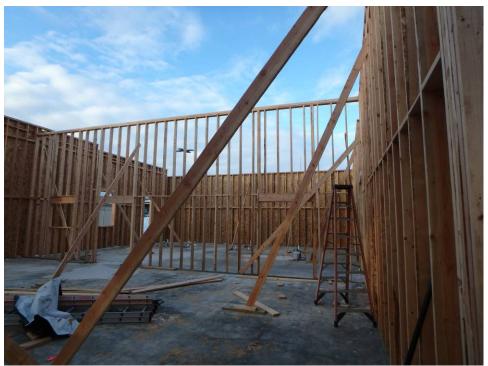
Looking Southwest at the interior wall framing

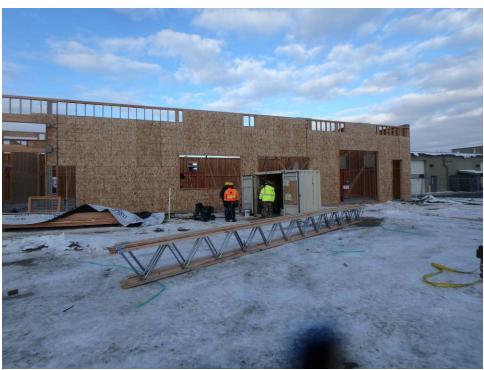
Looking at the east wall framing and sheathing

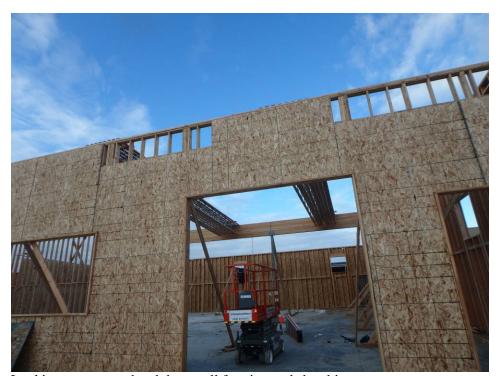
Looking at east overhead door wall framing and sheathing

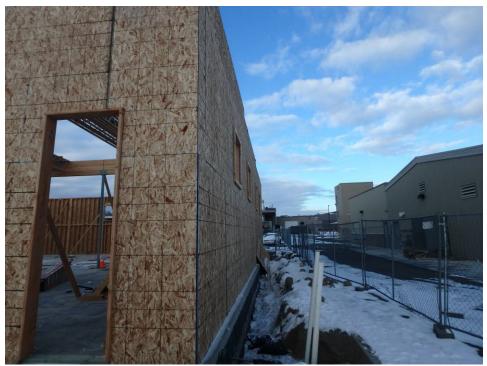
Looking west at the northeast corner

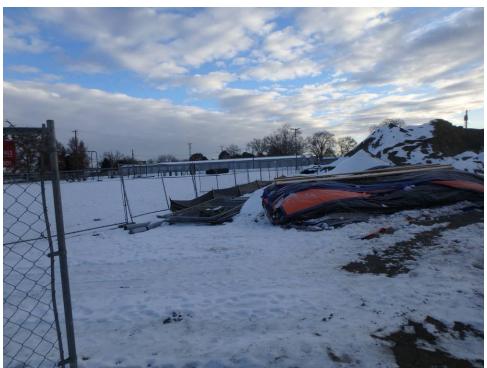
Looking at the northeast corner at the northeast corner of the site and stockpile of soil

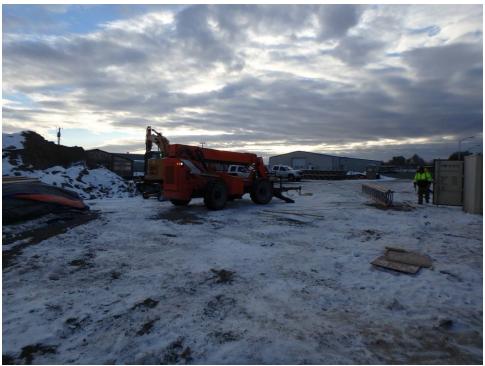
Looking southeast across the site

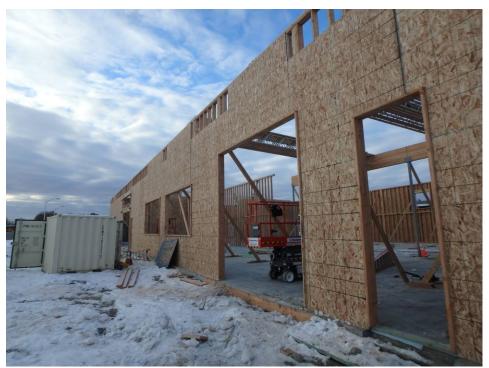
Looking south at the east wall

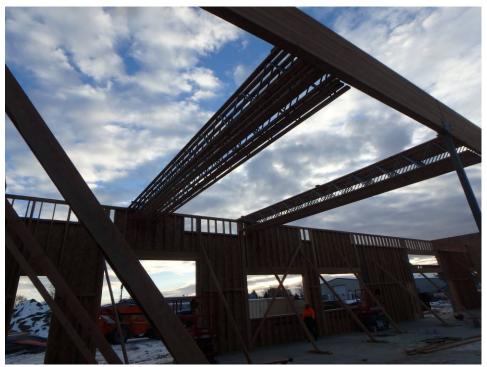
Looking east at the set trusses

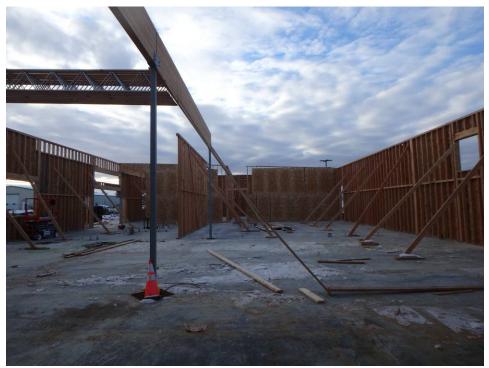
Looking south down the center of the building west side

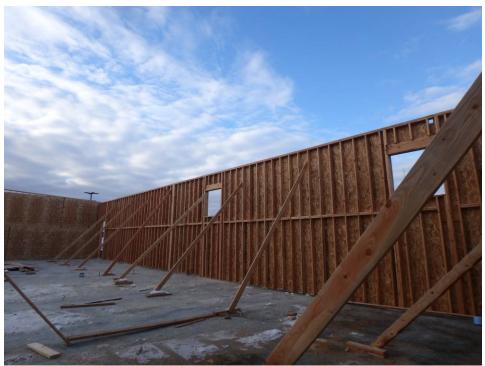
Looking south at the west wall framing and sheathing, north portion

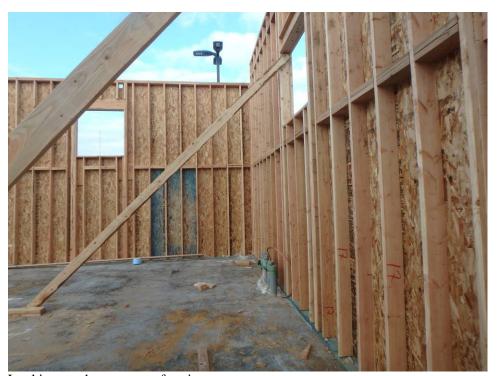
Looking northeast corner framing

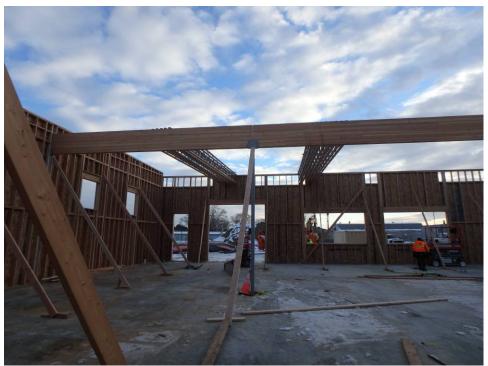
Looking east at the glue lam beam and trusses

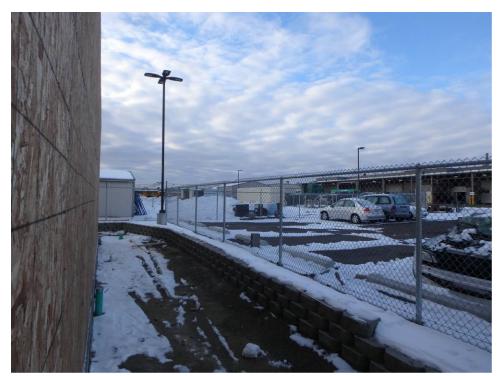
Looking south at the southwest corner of the site

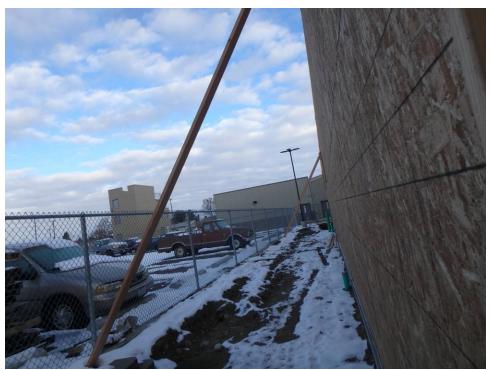
Looking north along the west elevation

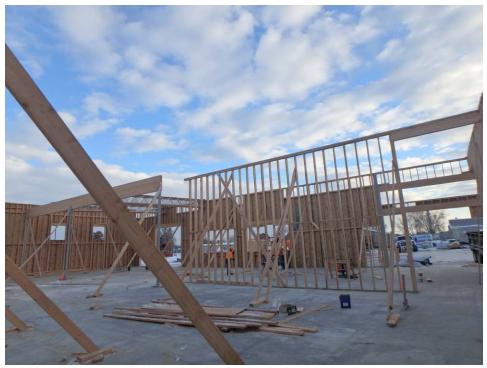
Looking northeast across the center of the building

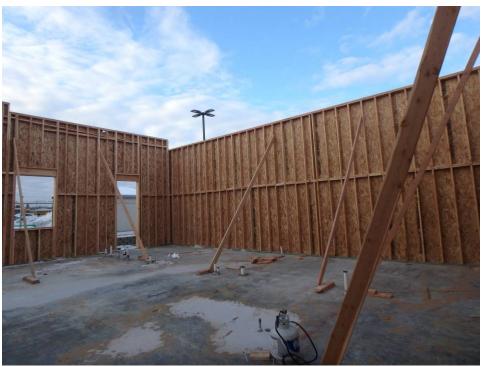
Looking at the southwest corner of the building

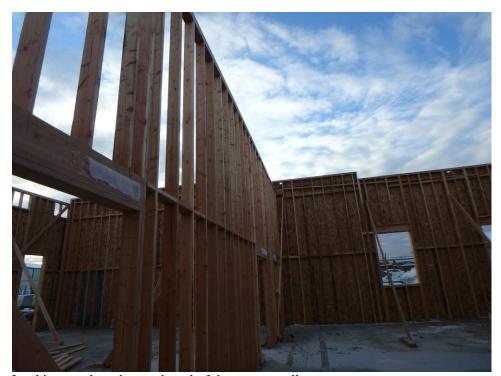
Looking south at the south end of the center wall

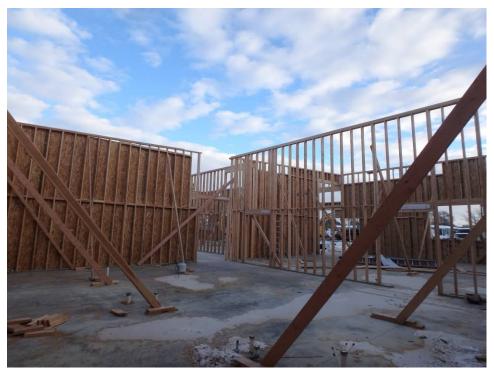
Looking northeast at the SW classroom entrance

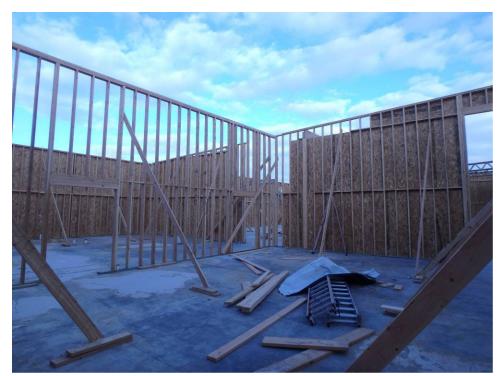
Looking northwest at the SE classroom entrance

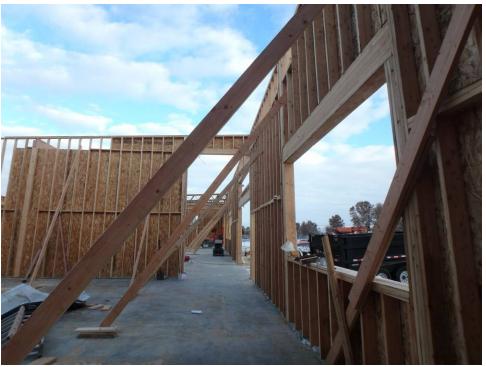
Looking north along the inside of the east wall
