Project Observation Report

Project Name:	Tri Tech East Building	Project No.	2208
Report #:	12		
Observation Date:	12-27-22, 12-29-22	Last Report:	12-21-22
Prepared By:	Steve Mallory, AIA	Contractor:	Banlin

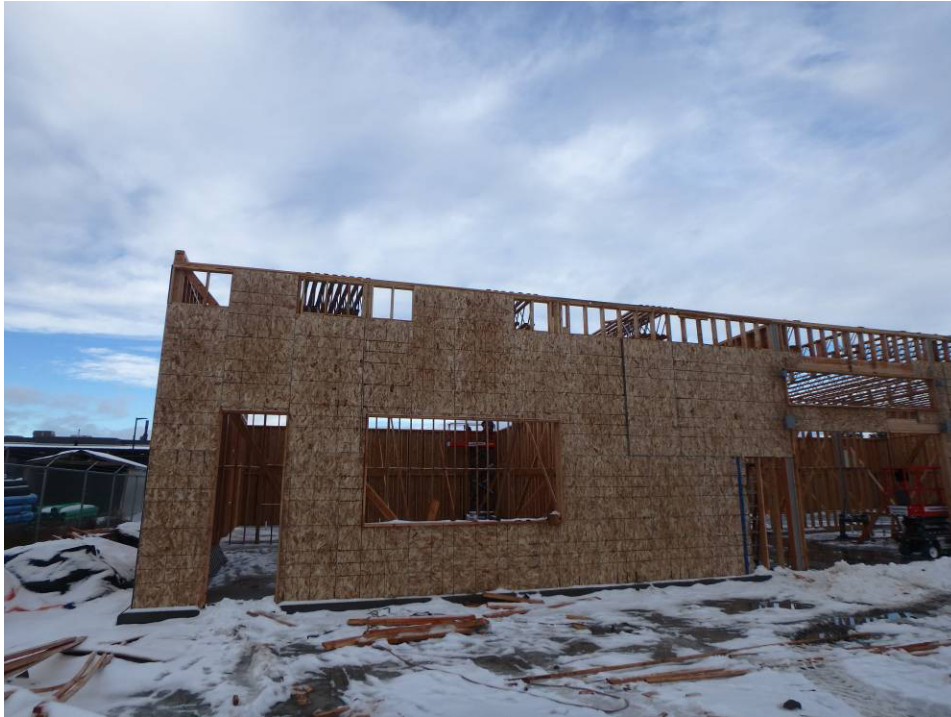
East wall south end

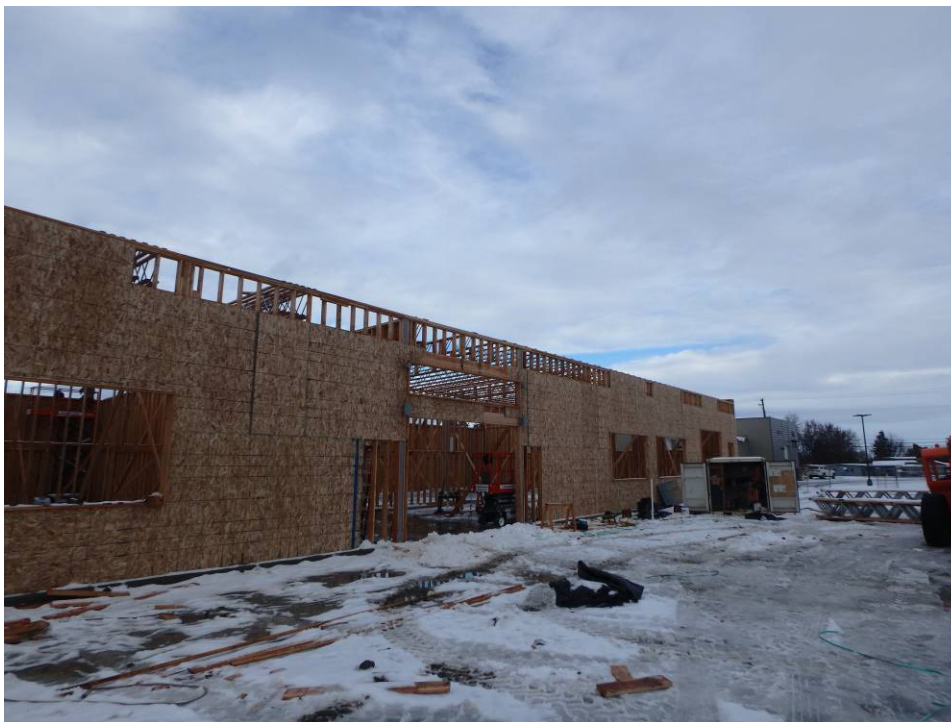
East wall north end

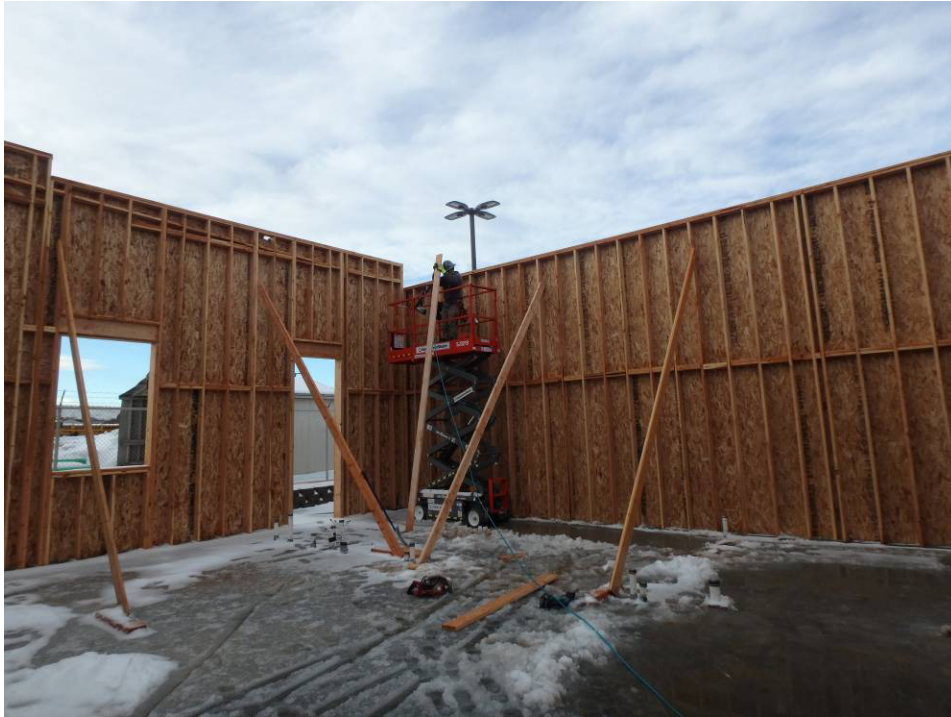
Setting the top plate and preparing for the new roof trusses

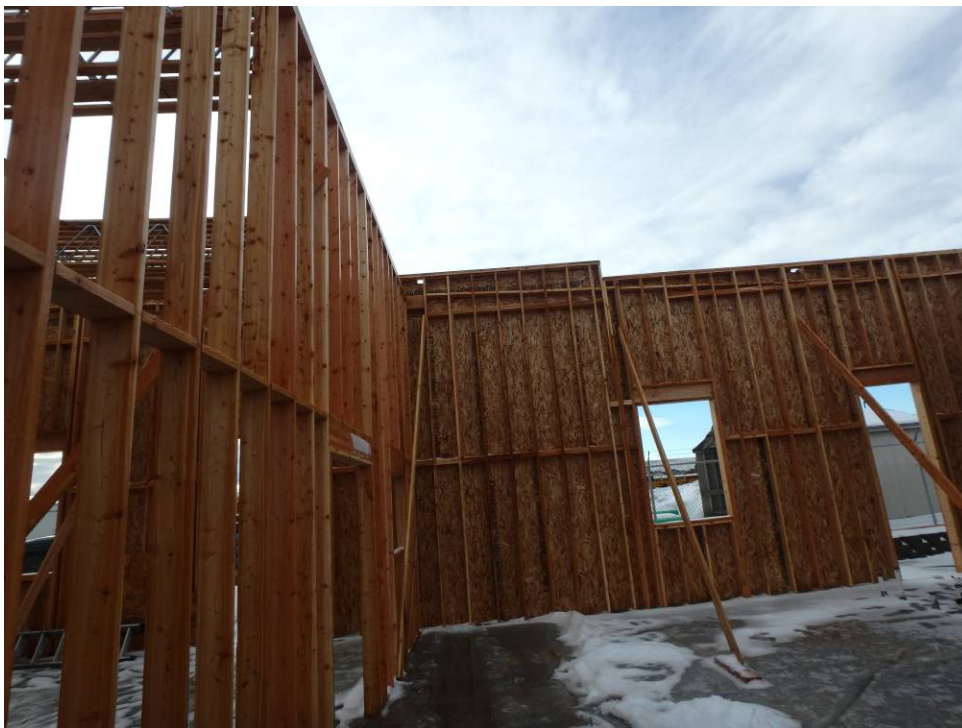
West wall framing

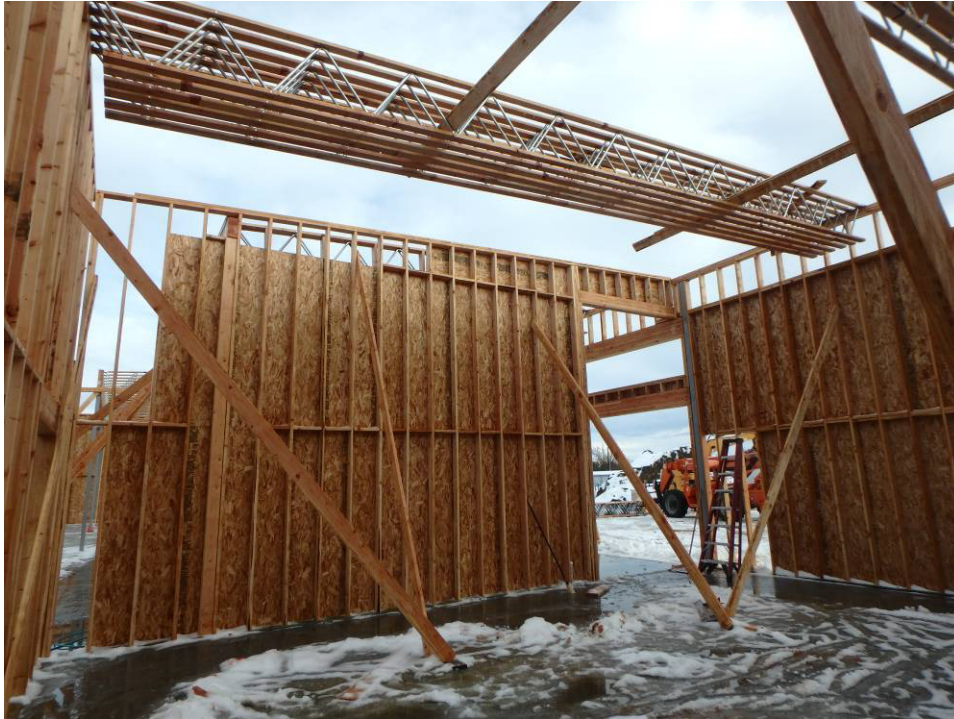
New roof trusses and central east-west wall framing

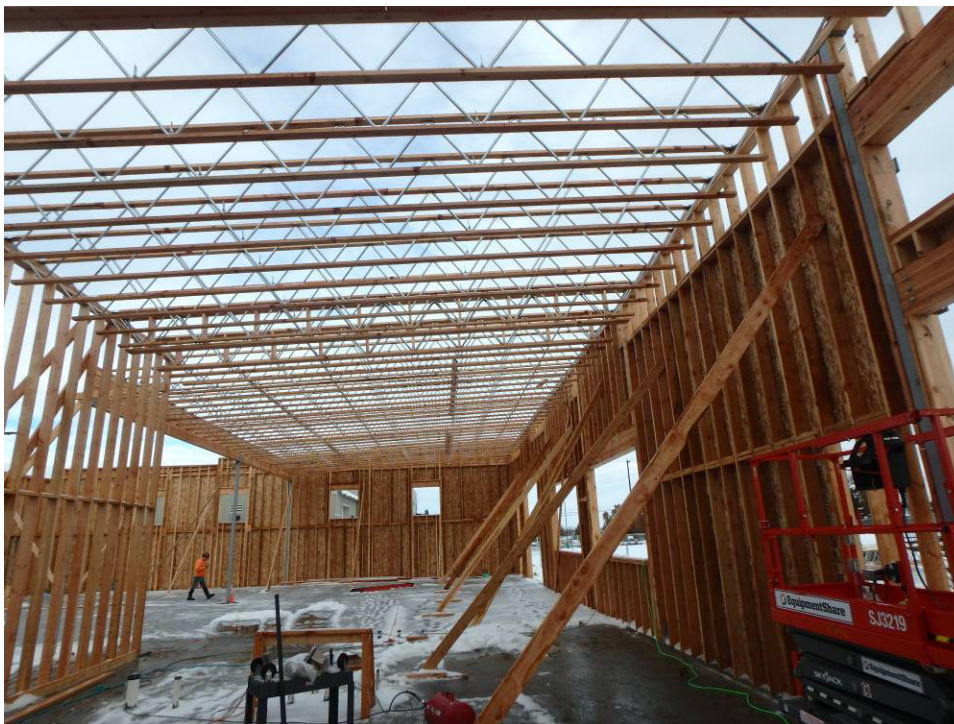
Northeast quarter roof trusses set

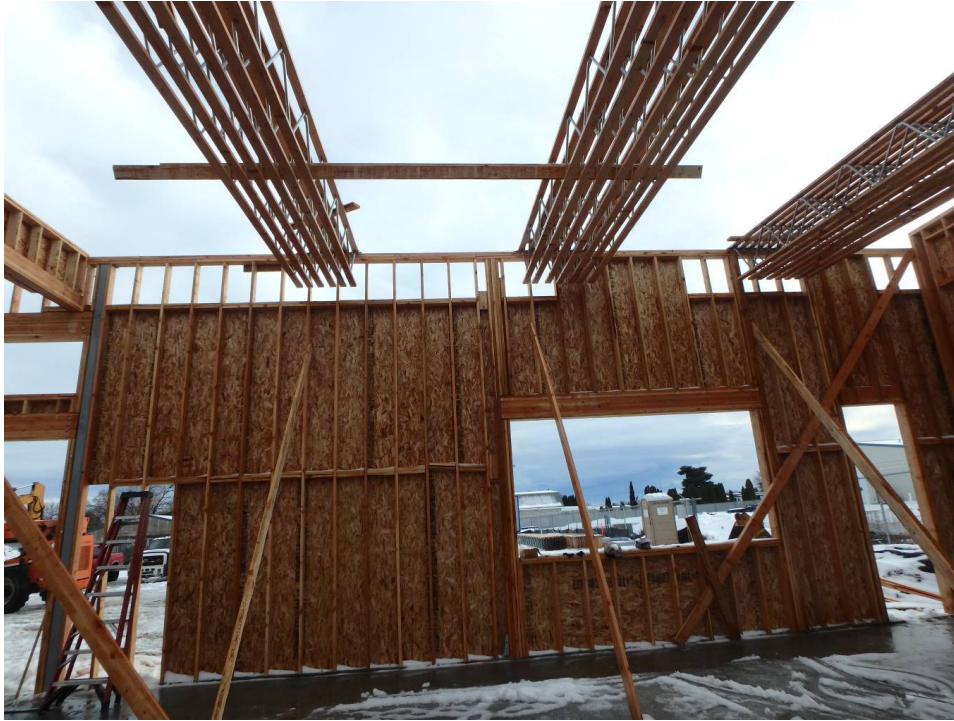
Looking at the east wall framing and the set roof trusses

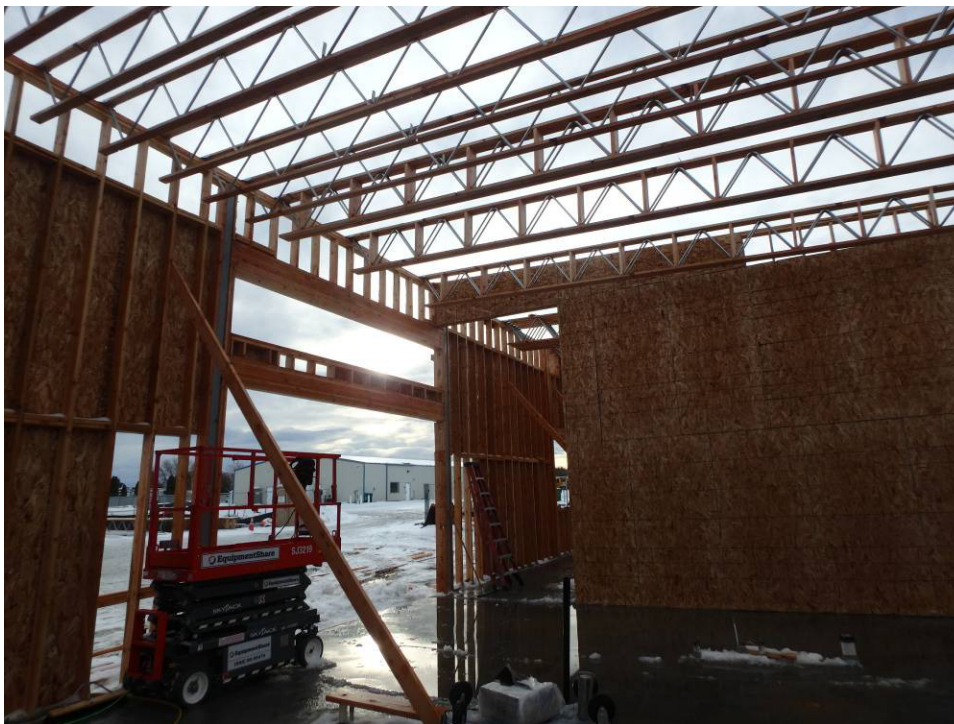
Trusses over the east wall central area

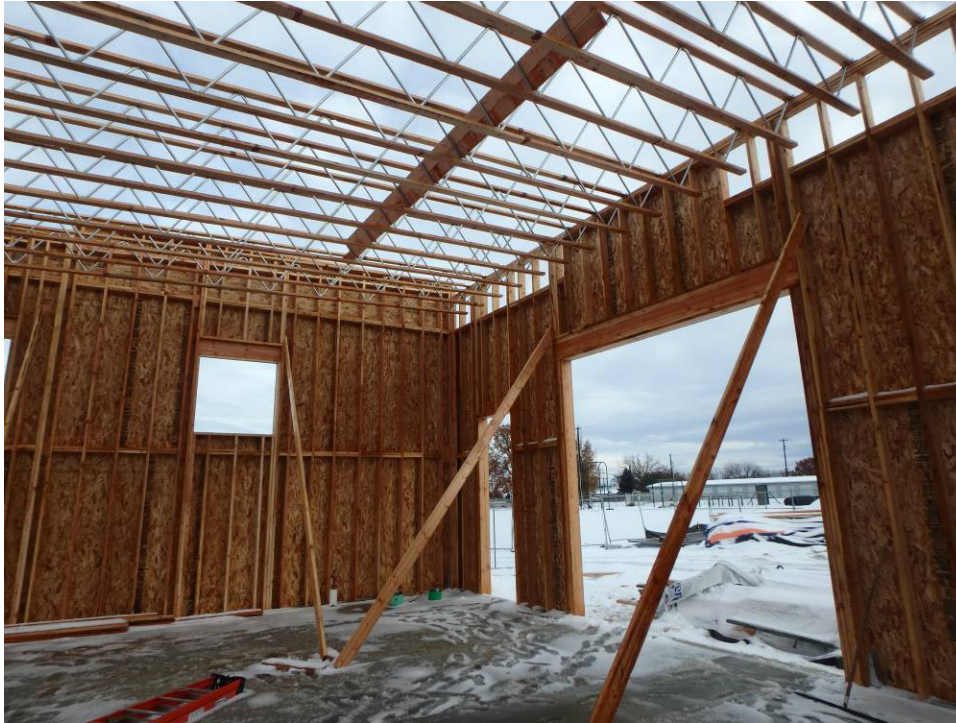
Looking at the northeast corner

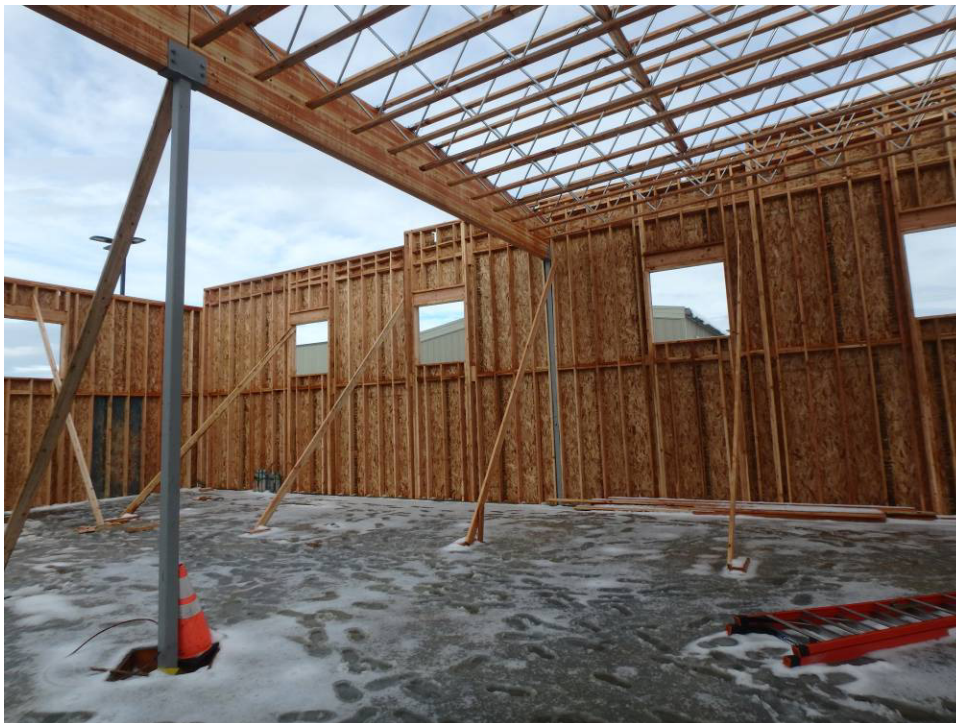
Looking at the northwest corner of the building

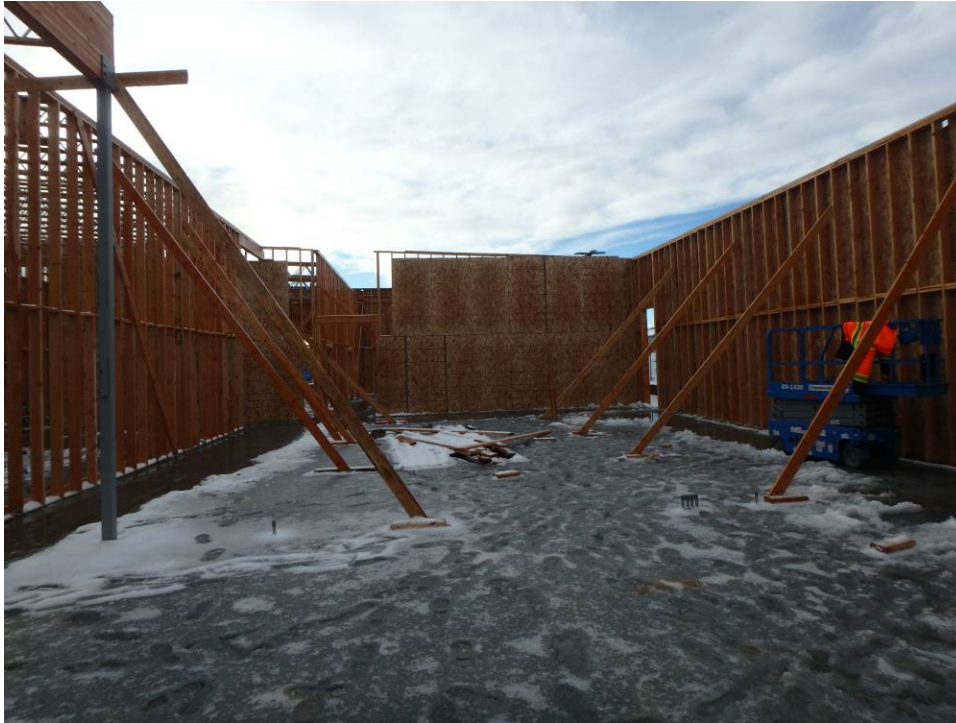
Looking south at the west central side of the building

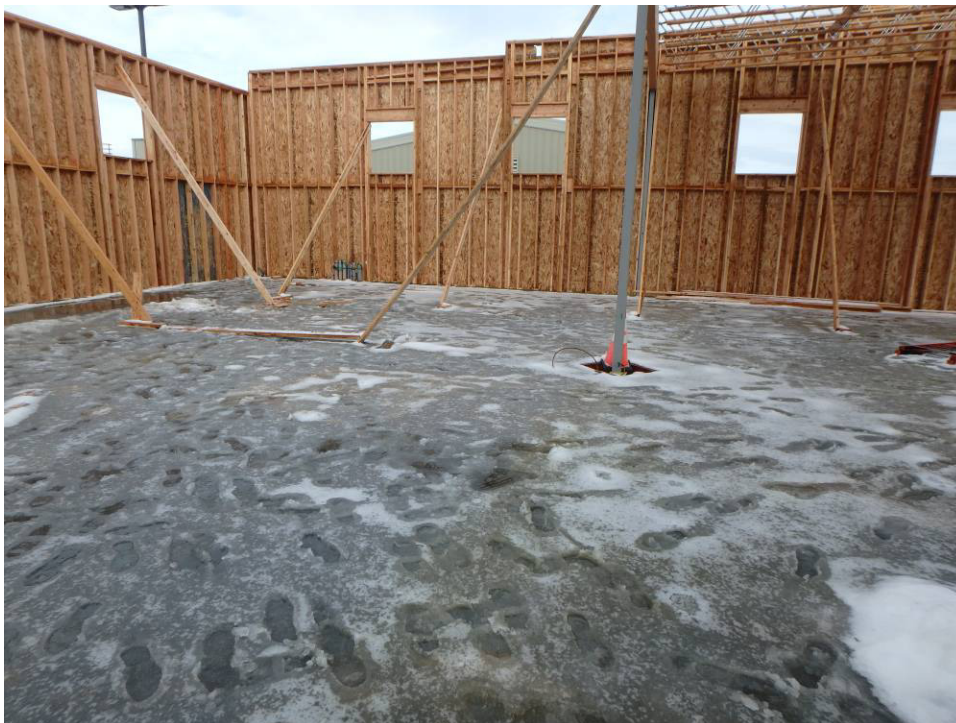
Looking at the northwest corner north framing and sheathing

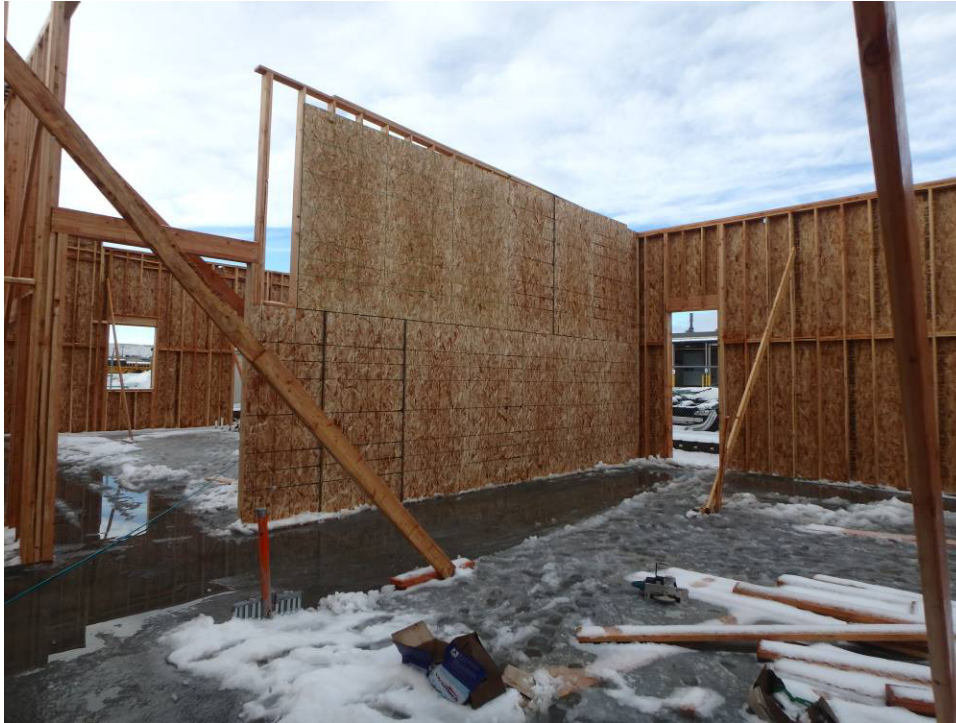
Looking west at the central east-west wall sheathing

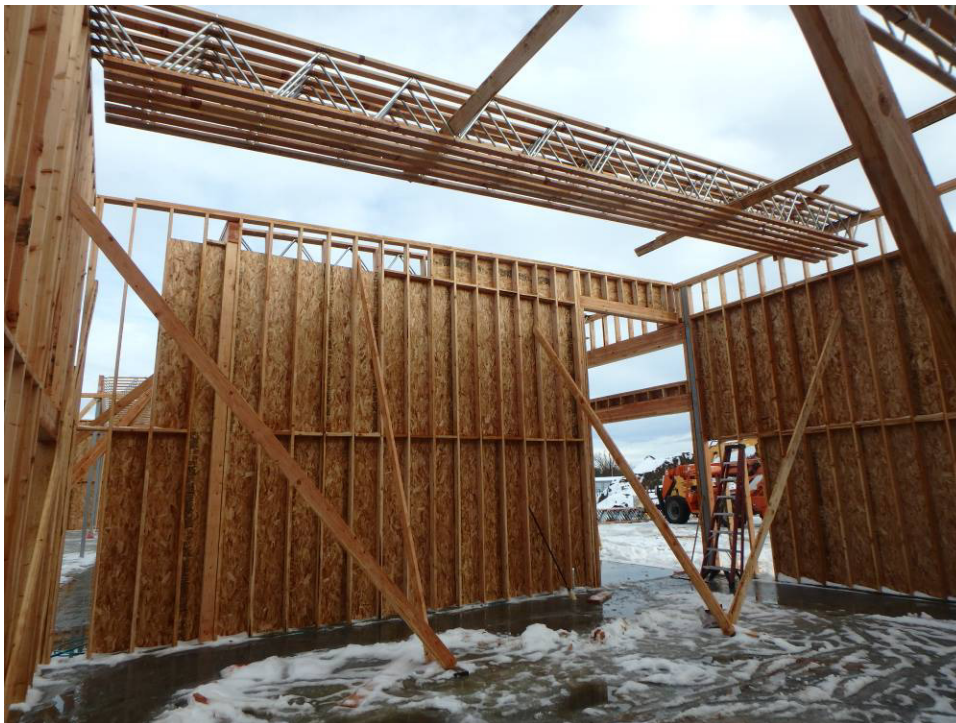
Looking northeast corner of the southeast corner at the central wall and set trusses

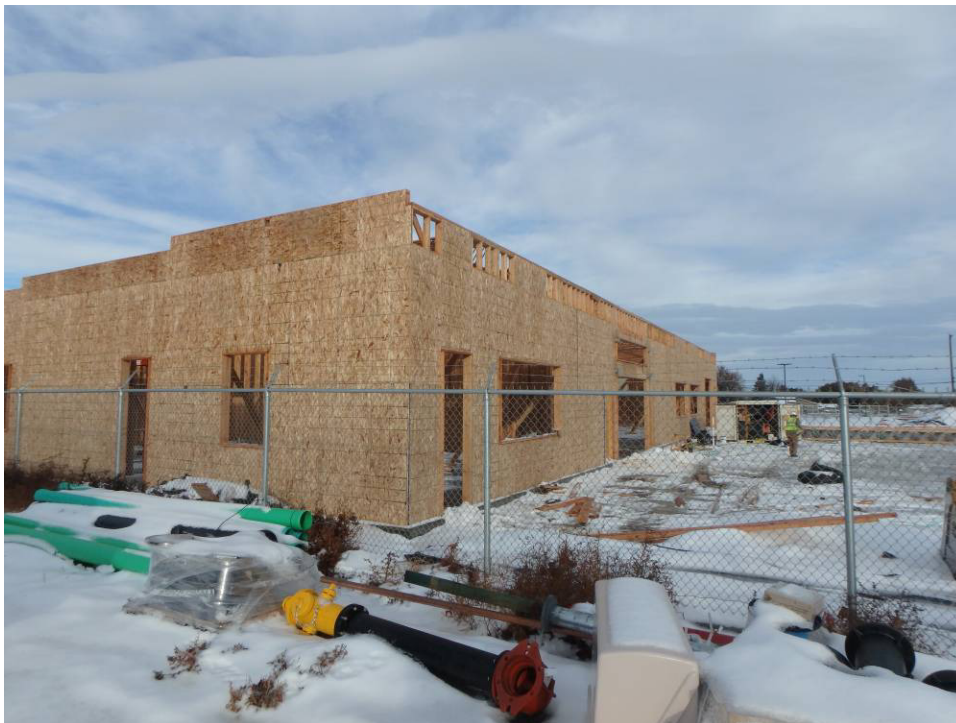
Looking at the southeast corner of the building

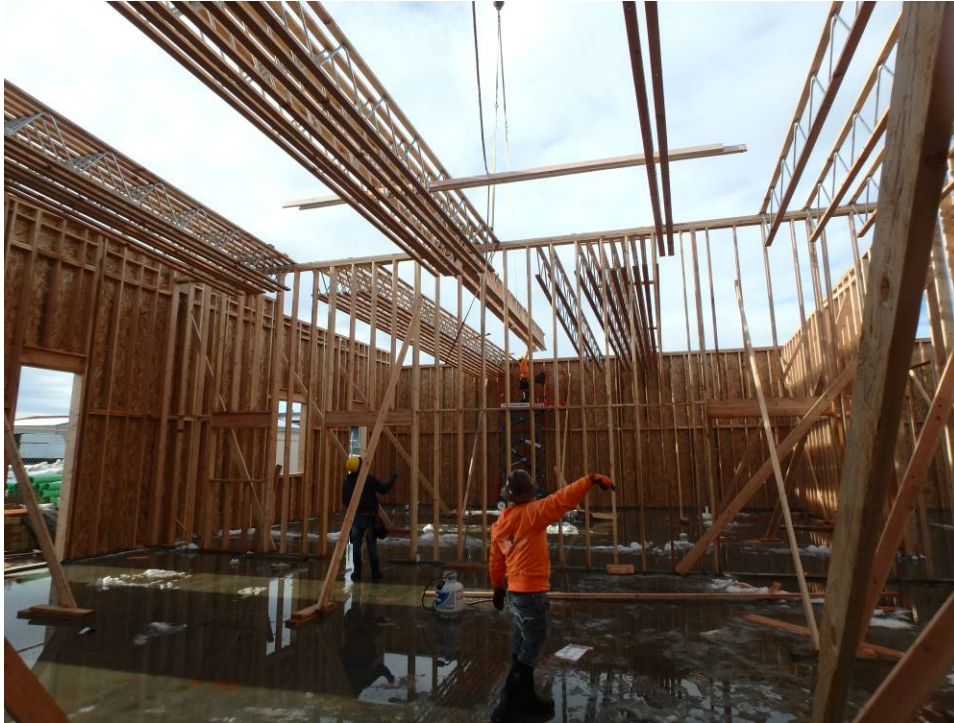
Trusses set on the south half of the building

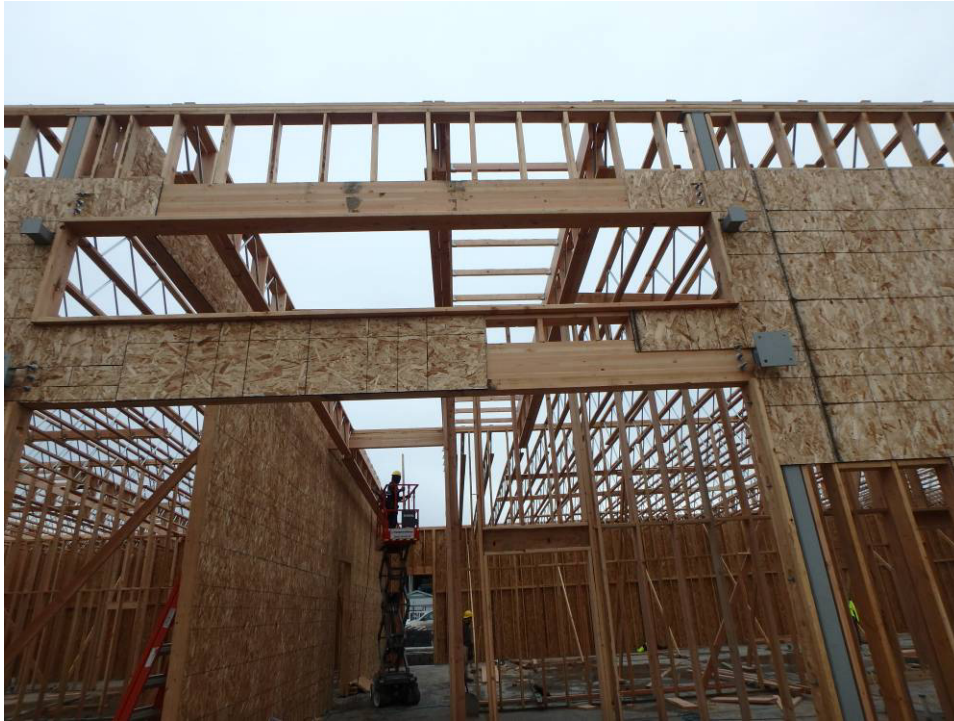
Looking north at the east wall framing and sheathing

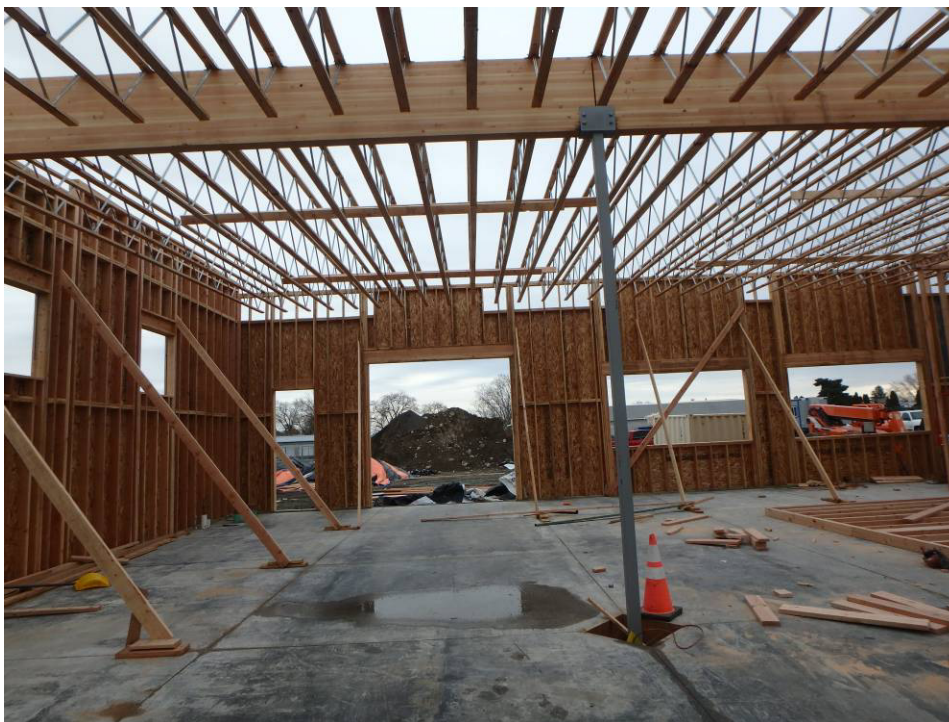
Looking east at the central area framing and roof framing

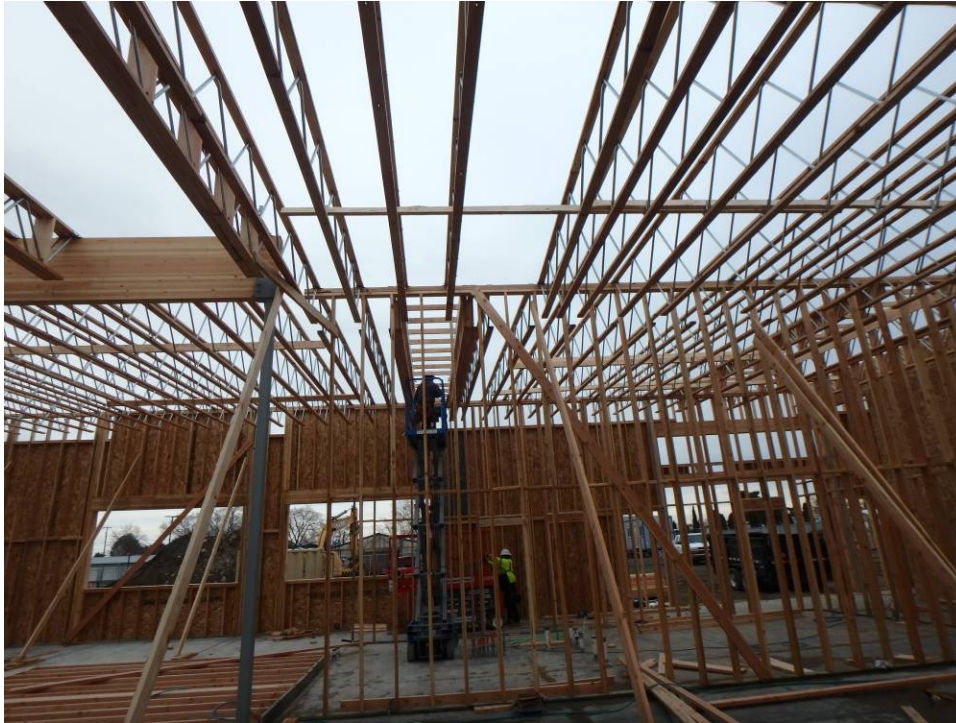
Looking west at the central area framing and roof framing

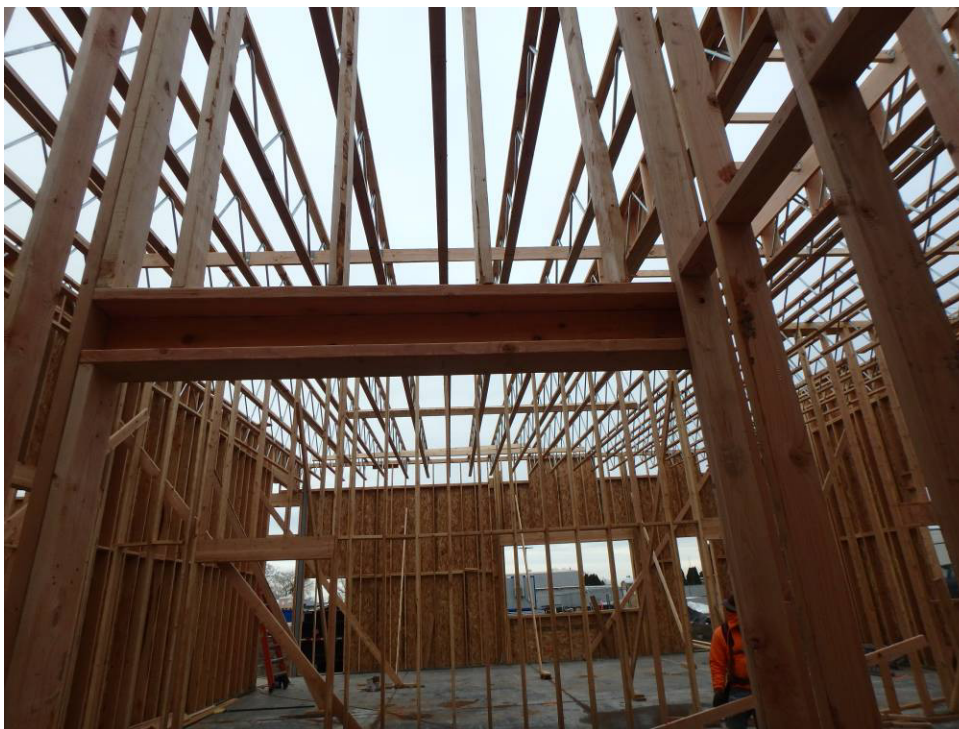
Looking east along the south wall, slab is ice free

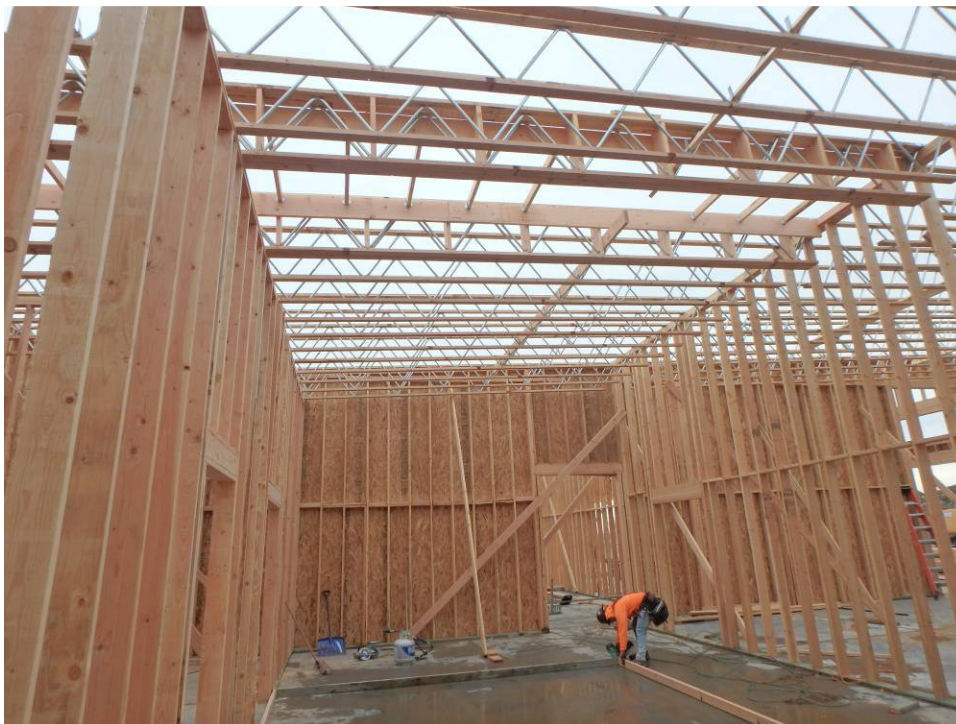
Looking northeast at the central east-west wall, all trusses are set
