Project Observation Report

Project Name:	Tri Tech East Building	Project No.	2208
Report #:	13		
Observation Date:	1-4-23	Last Report:	12-29-22
Prepared By:	Steve Mallory, AIA	Contractor:	Banlin

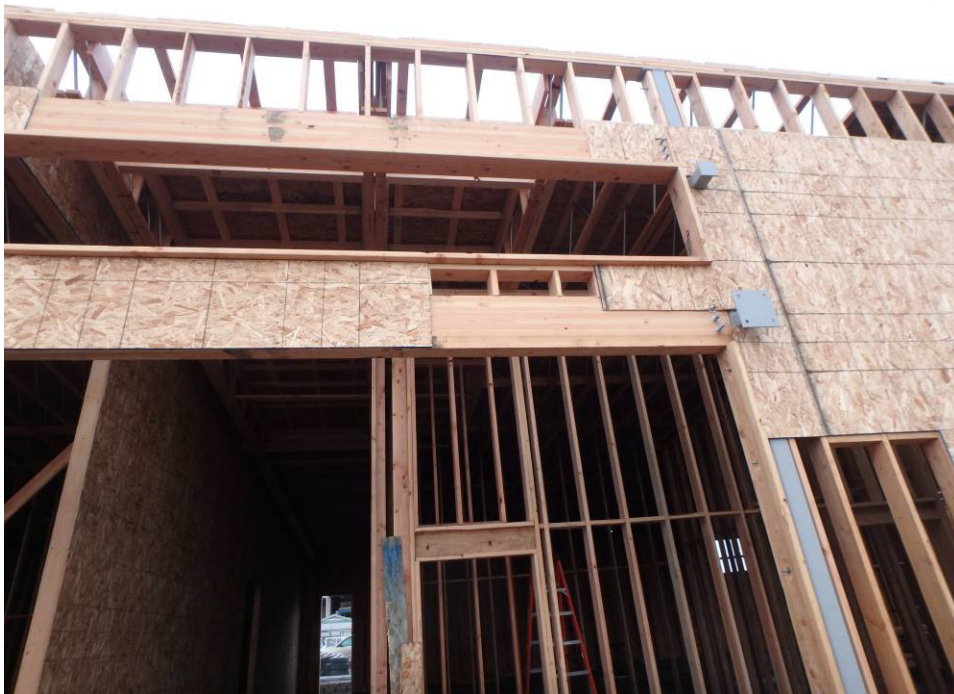
New roof trusses

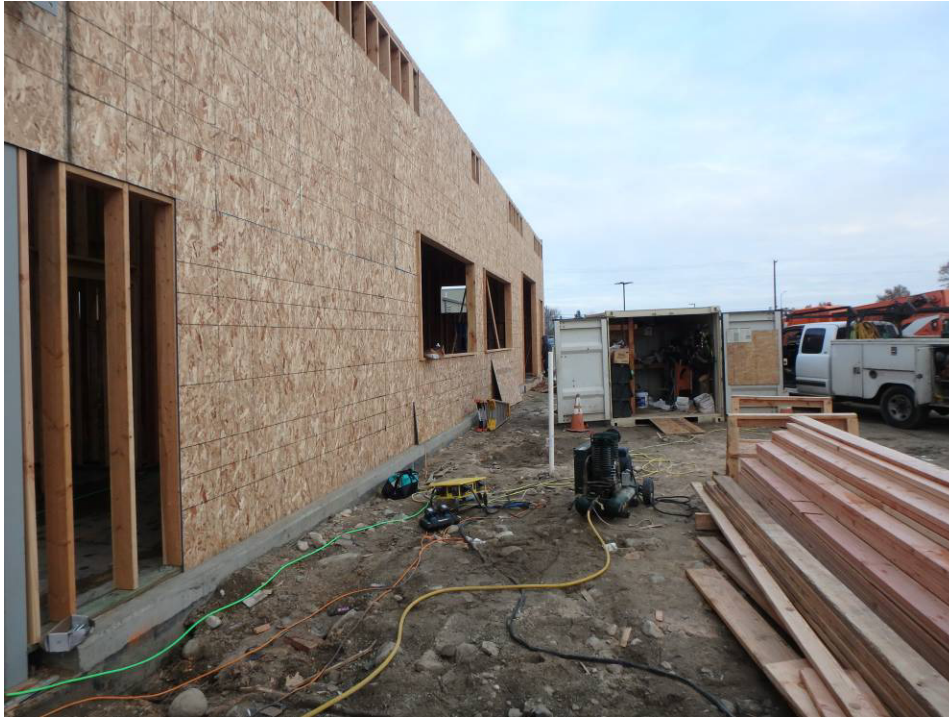
East wall sheathing

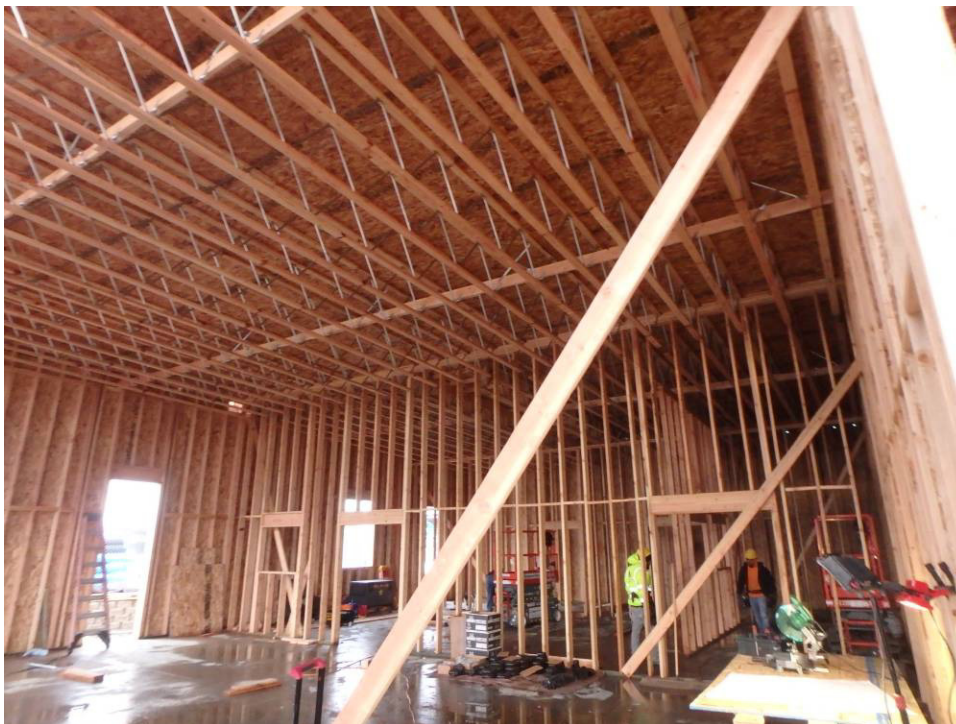
Roof trusses and sheathing in the south rooms

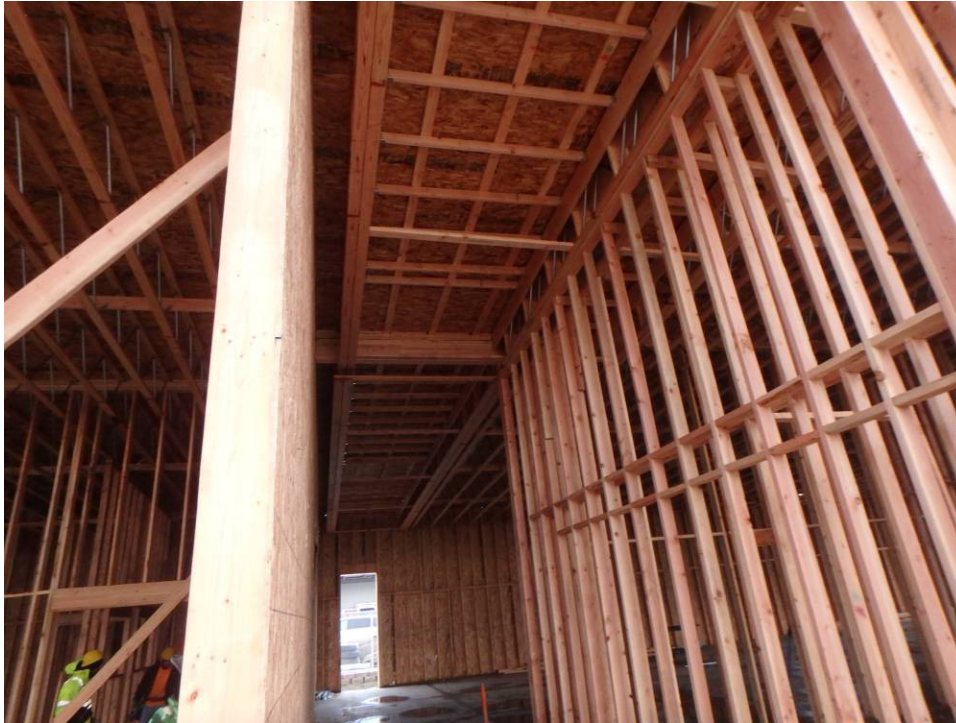
Framing of the east-west corridor

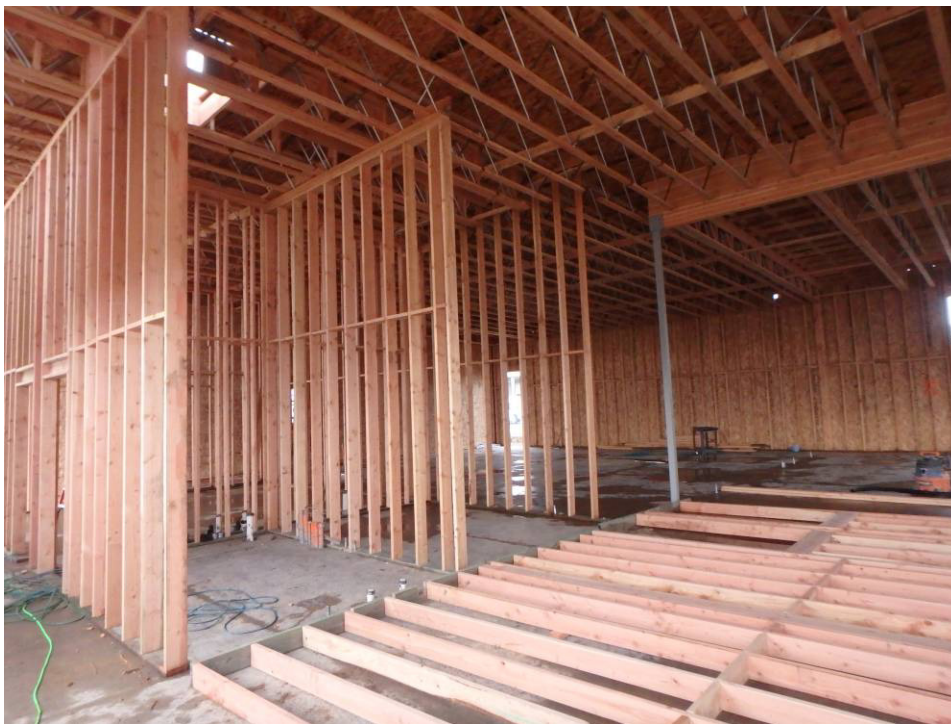
Wall framing in the north half of the building

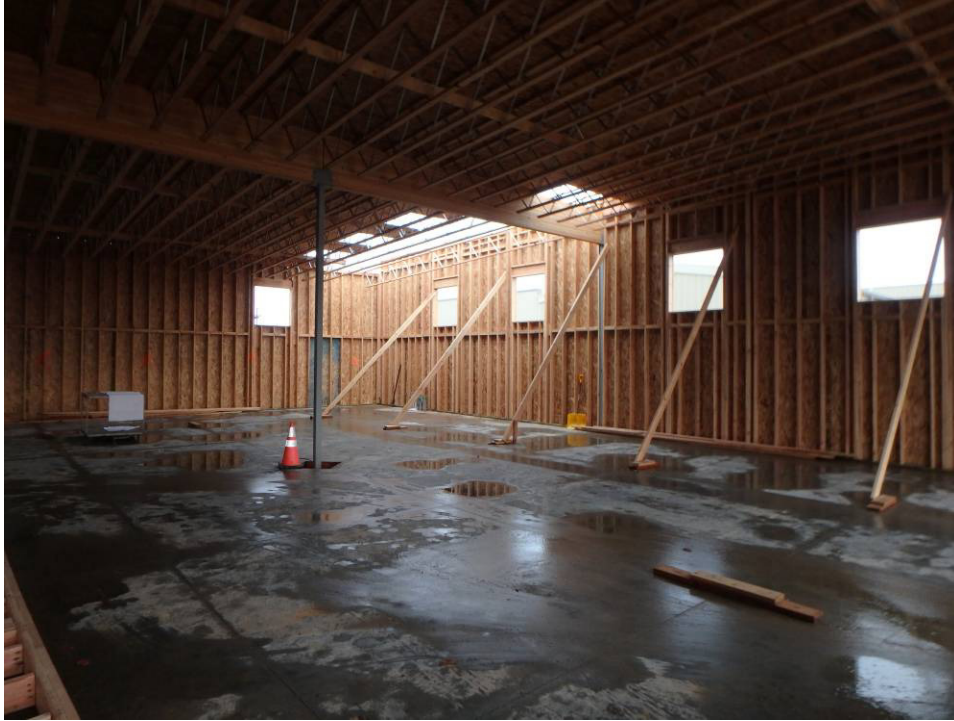
Looking at the northwest corner of the building and the roof opening

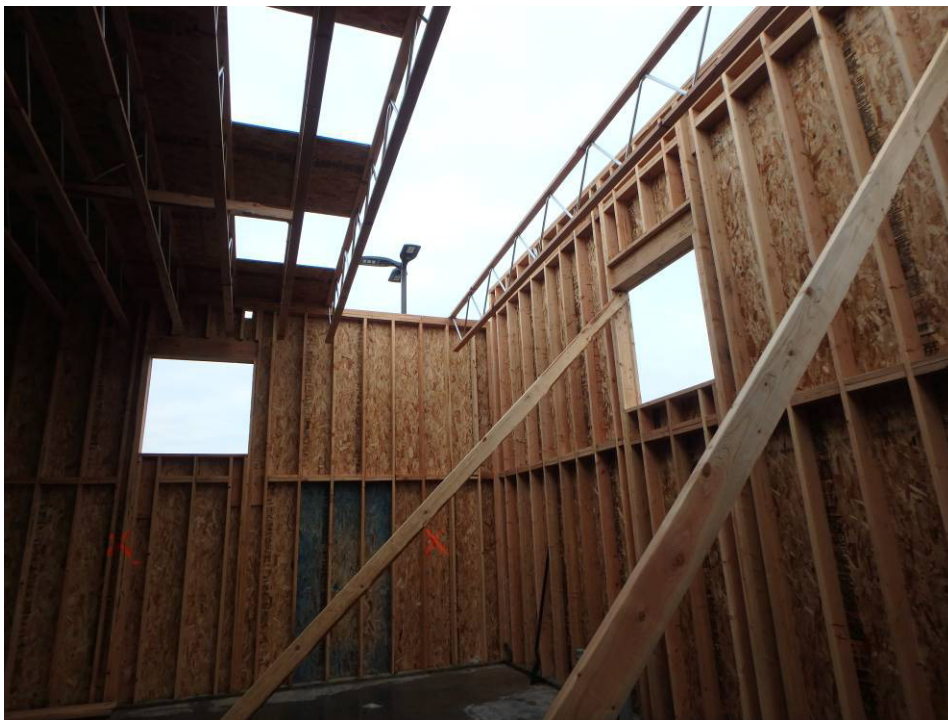
New roof trusses at the northwest corner

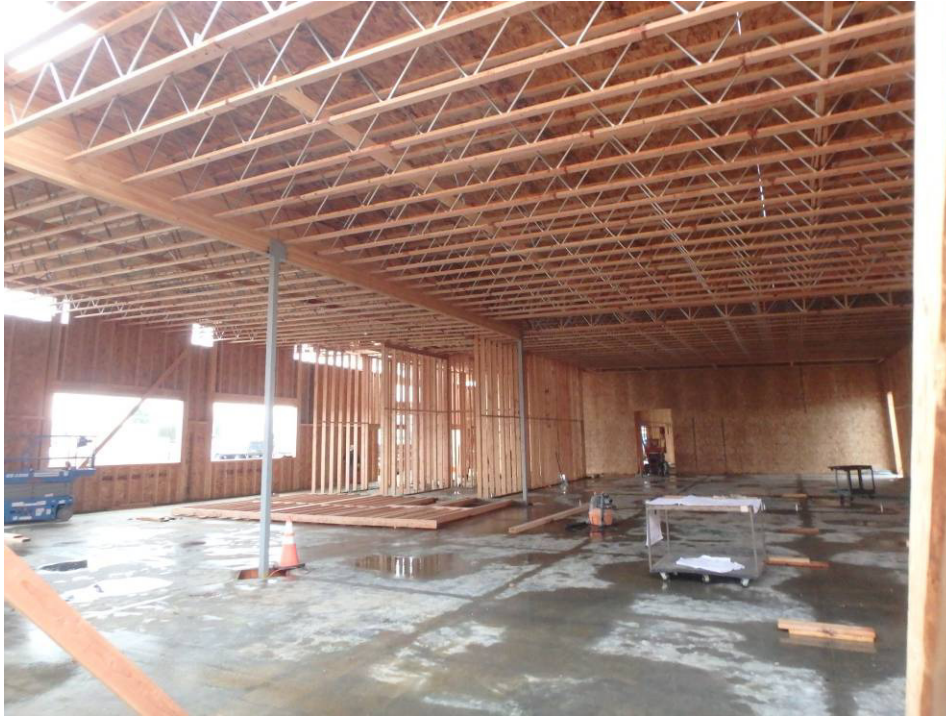
Looking southeast at the central wall and set trusses

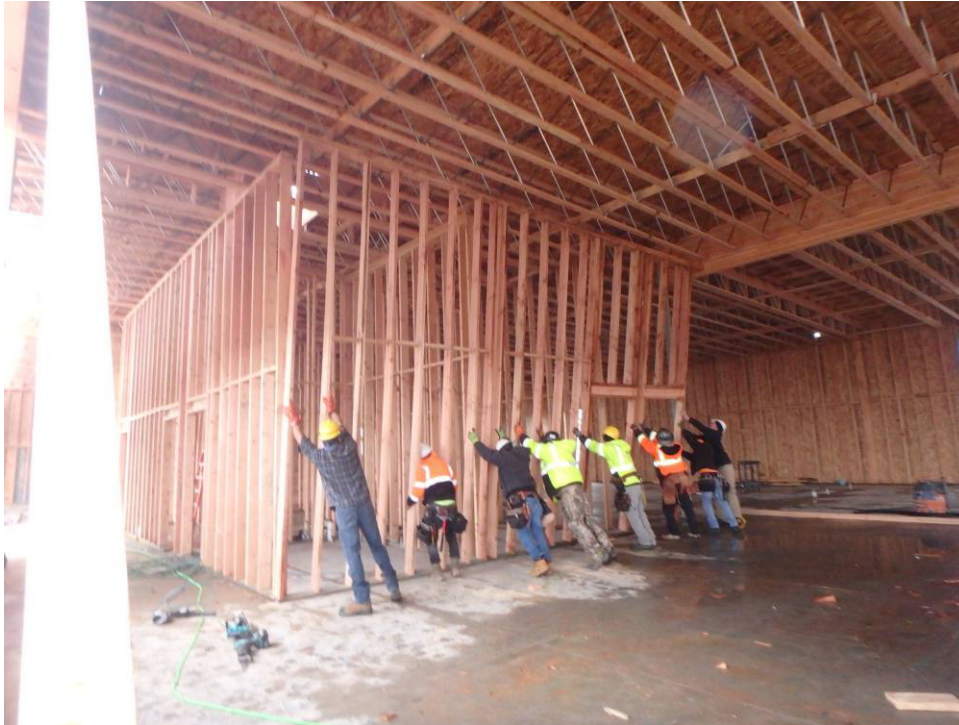
Raising the wall

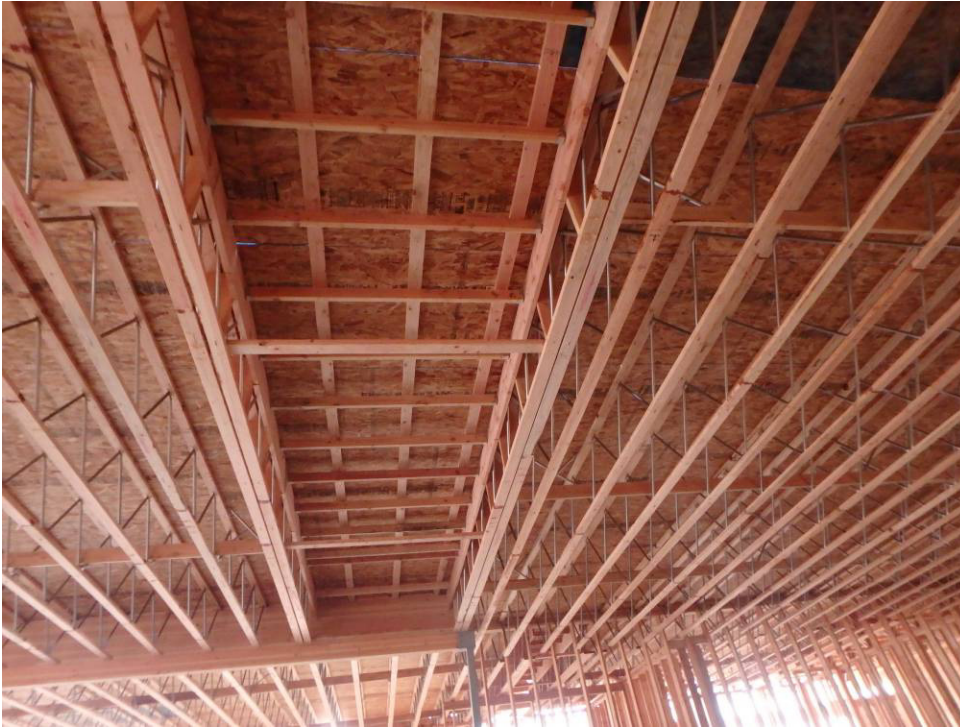
Looking east at the roof trusses and sheathing

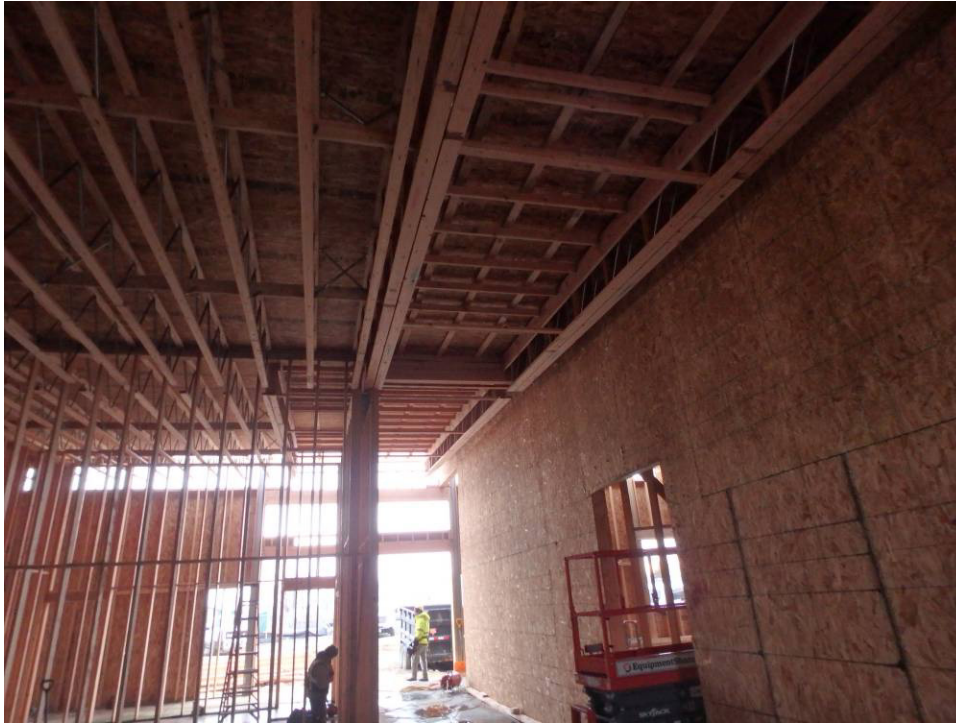
Looking east at the central east-west corridor framing and roof trusses

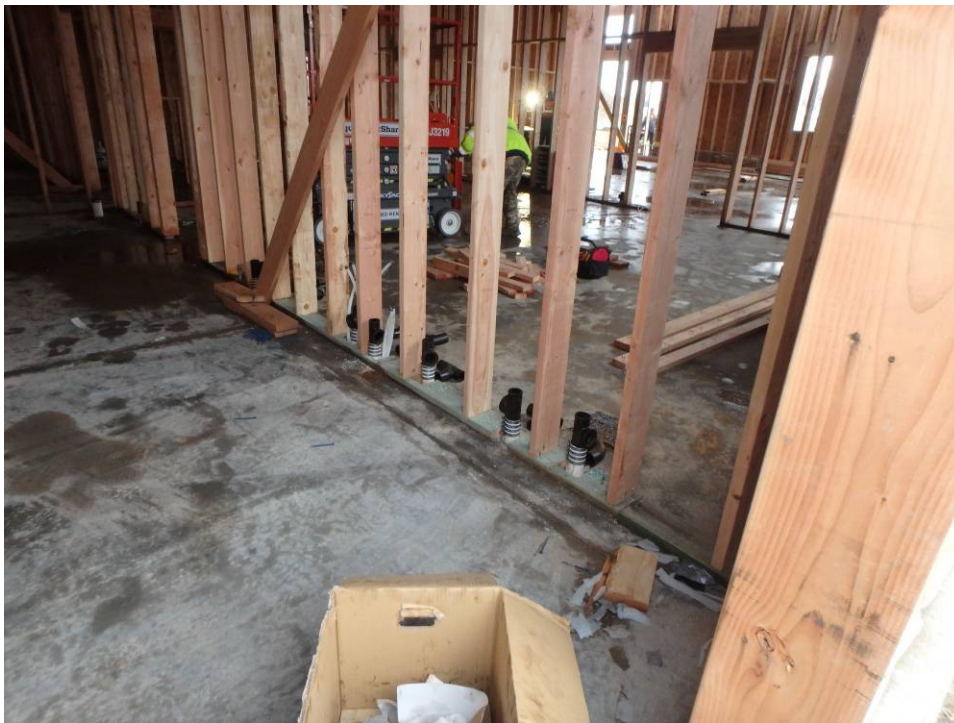
Plumbing stub-ups in the dog wash area

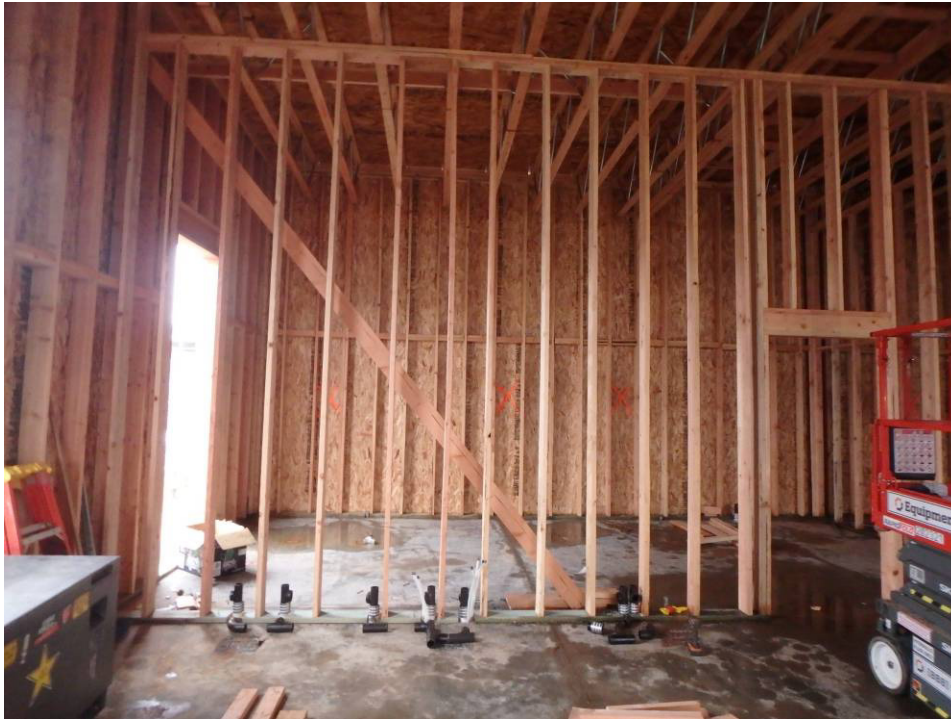
Plumbing stub-ups for the dog washes from the lab South center) room side through to the kennel
